UNITED STATES AIR FORCE
AIRCRAFT ACCIDENT INVESTIGATION
BOARD REPORT

TU-2S, T/N 80-001068

DATE OF ACCIDENT: 20 SEPTEMBER 2016

**United States Air Force Accident Investigation Board Report
TU-2S Mishap With Fatality, Beale AFB, CA**

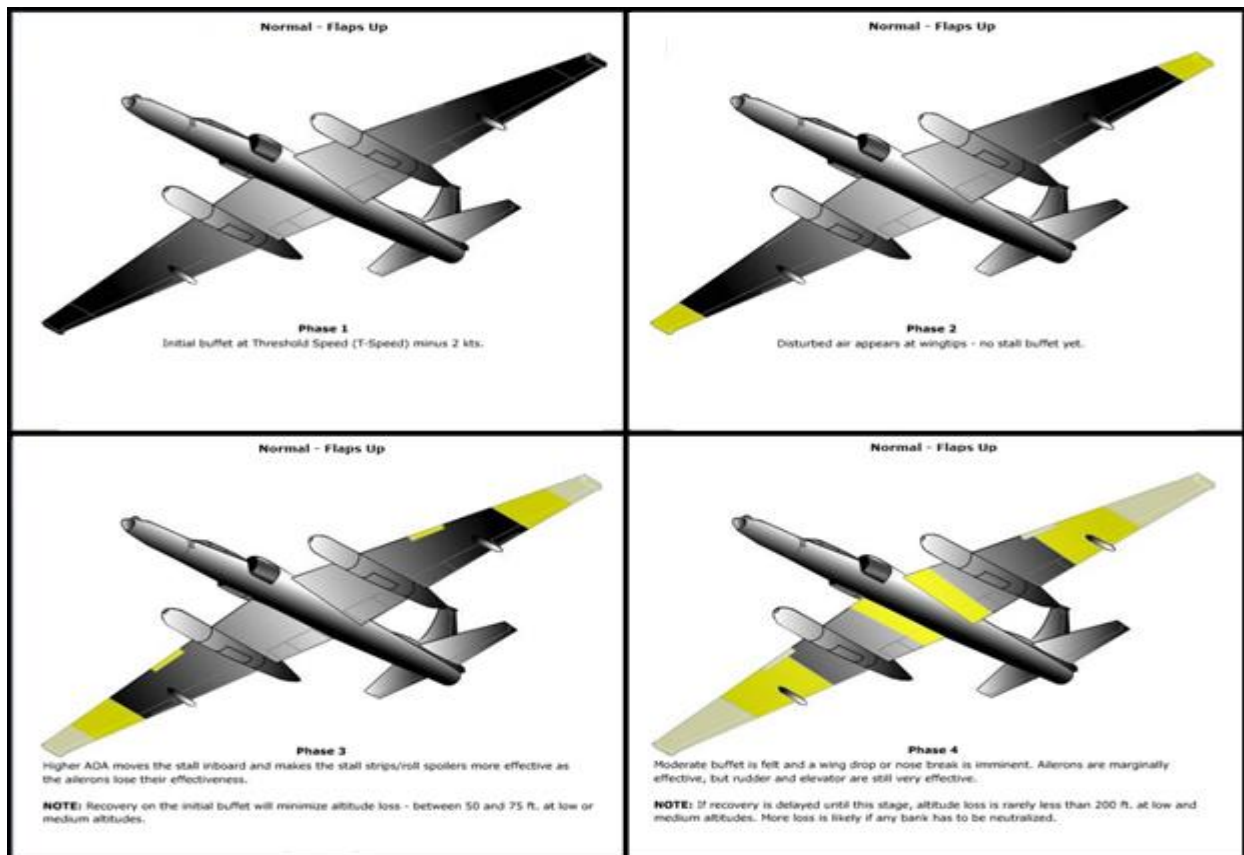
Figure 1. U-2S Stall Characteristics (Tab Z-7)

Aerodynamic stall occurs when the wings no-longer produce enough lift to keep the aircraft flying (Tab BB-89). Aerodynamic stall occurs at slower airspeeds, or when the angle between the aircraft wing and the relative wind becomes too steep (also known as the angle of attack (AOA)) (Tab BB-89). Different parts of the wing may stall at different times, depending on the wing’s design (Tab BB-89). In the TU-2S, aerodynamic stall begins at the wingtips and progresses inboard until a full aerodynamic stall, at which time the ailerons are marginally effective while the rudder and elevator are still very effective (Tabs Z-7 and Tab BB-89). See Figure 1.

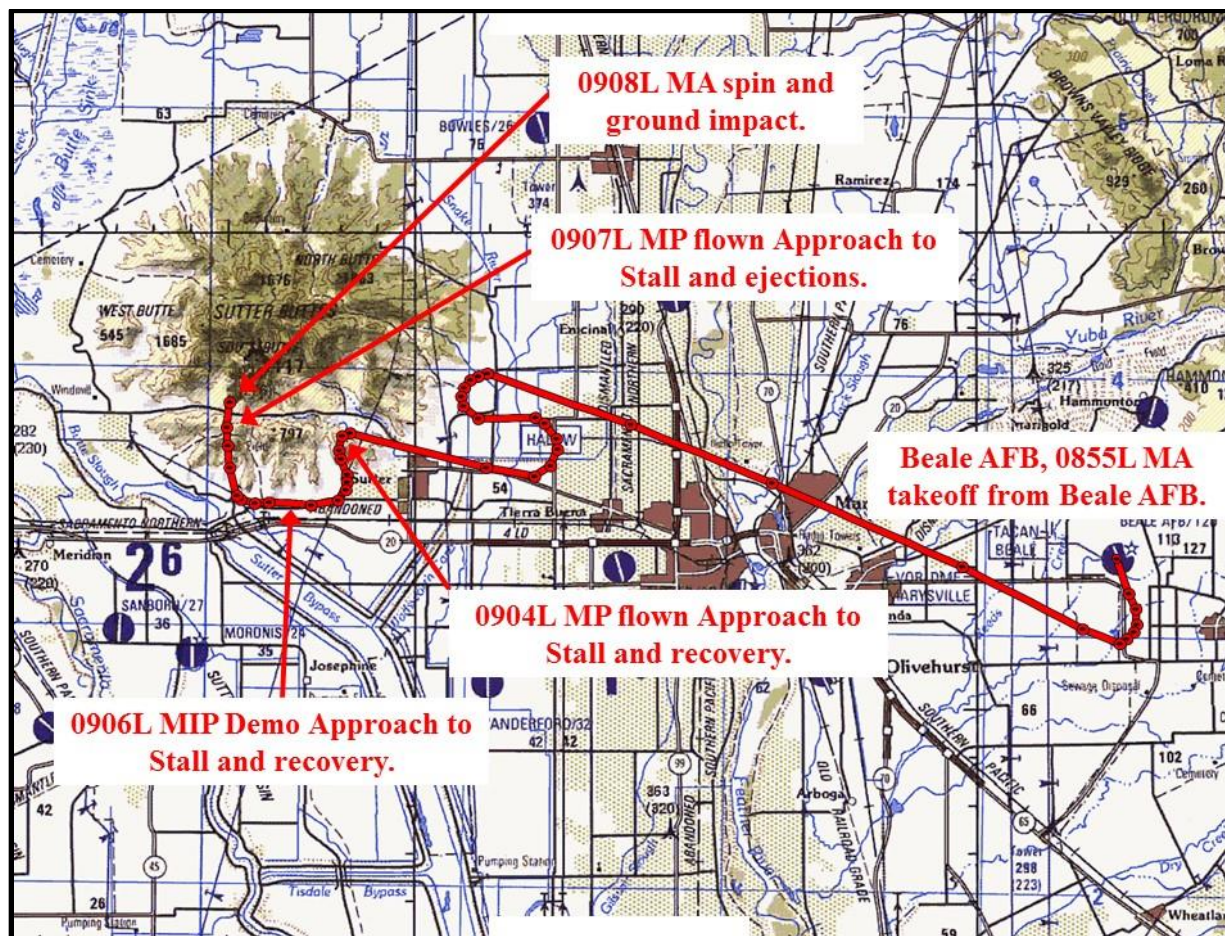
Figure 2. MA Flight Route (Tab Z-3)

Engine start, taxi and takeoff were uneventful (Tabs V-24.6 and Z-11). The MA took off at 0855L under the control of MIP (Tabs M-3, V-1.2, and DD-14). The route of flight consisted of a takeoff to the south on Runway 15 with an immediate right turn to the northwest towards the Sutter Buttes mountain range and climb to a final altitude 9,000 feet MSL (Tabs M-5 and Z-3). See Figure 2.

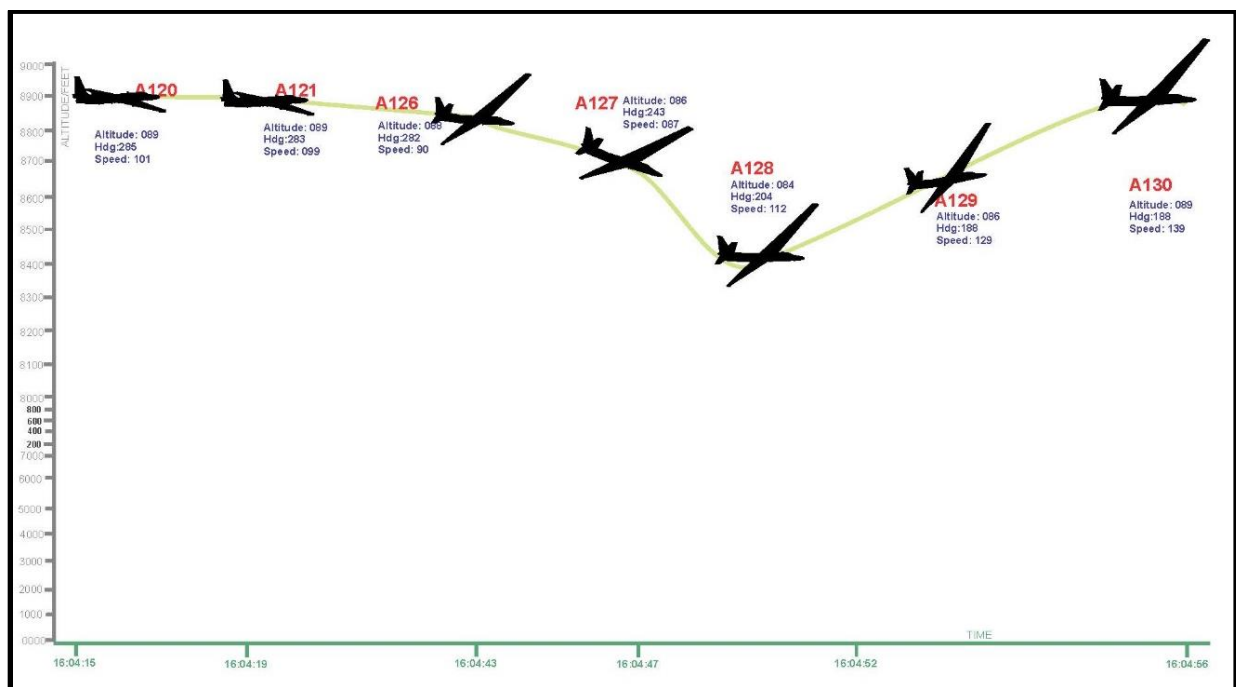
Figure 3. MA First “Approach to Stall” Maneuver (Flown by MP) (Tab Z-4)

To recover from the approach to stall, MP lowered MA’s nose approximately 5 degrees below the horizon by pushing forward on the control column, while simultaneously increasing power to Full (Tab V-1.3). Once the initial approach to stall was broken, MP levelled MA’s nose by pulling back on the control column (Tab V-1.3). During the recovery, MIP indicated MP’s control inputs were too aggressive and cautioned MP not to exceed MA’s G-limit (Tab V-1.3). MA also experienced an uncommanded left wing drop during this first maneuver, which led MP to use what he described as “stabbing” right aileron inputs to keep the wings level (Tab V-1.3). During the maneuver, MA lost approximately 500 feet in altitude and its heading changed by approximately 80 degrees (Tab M-5). After recovering, MA climbed to 8,900 feet MSL on a heading of 188 degrees and accelerated to 139 knots ground speed (KGS) (Tab M-5). See Figure 3.

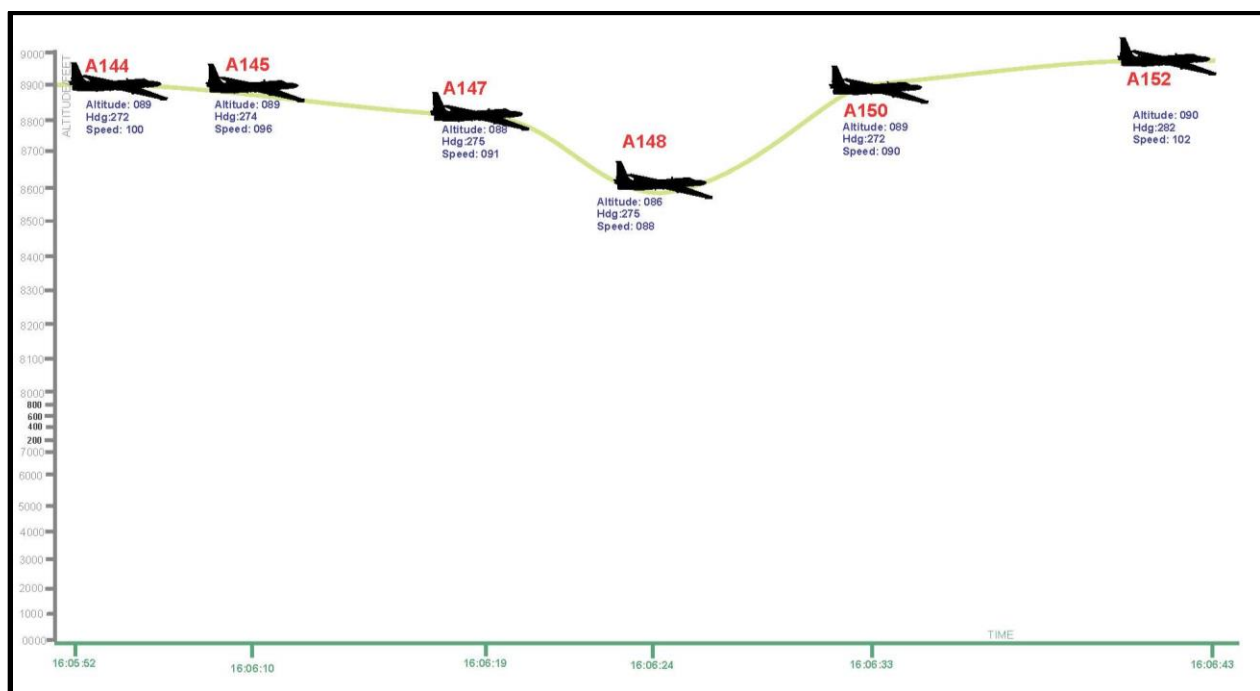
Figure 4. MA Second “Approach to Stall” Maneuver (Flown by MIP) (Tab Z-5)

After MP completed the first maneuver, he transferred aircraft control to the MIP for a no-flap “approach to stall” demonstration (Tab V-1.3). At approximately 0905L, MIP demonstrated a no-flap “approach to stall” and subsequent recovery by maintaining an approximate heading of 276 degrees, an altitude of 8,900 feet MSL and slowing the aircraft to approximately 88 KGS until the “approach to stall” indication (Tab M-5). MP “shadowed” (followed along the yoke without interfering) during the demonstration (Tab V-1.4). MP noticed and was surprised that MIP used nearly full right yoke (aileron) throughout the recovery to keep the wings level, but he did not note how much rudder MIP used (Tab V-1.4). MIP recovered the MA with a maximum altitude loss of 300 feet, to 8,600 feet MSL. MIP maintained a 275-degree heading, accelerated from a minimum of 88 KGS to 102 KGS, and climbed to 9,000 feet MSL (Tab M-5). Throughout the maneuver, MIP demonstrated how to be less aggressive with MA’s controls and to use smoother yoke movement (Tab V-1.4). MP noted that the recovery was “smoother” than the one he attempted (Tab V-1.4). See Figure 4.

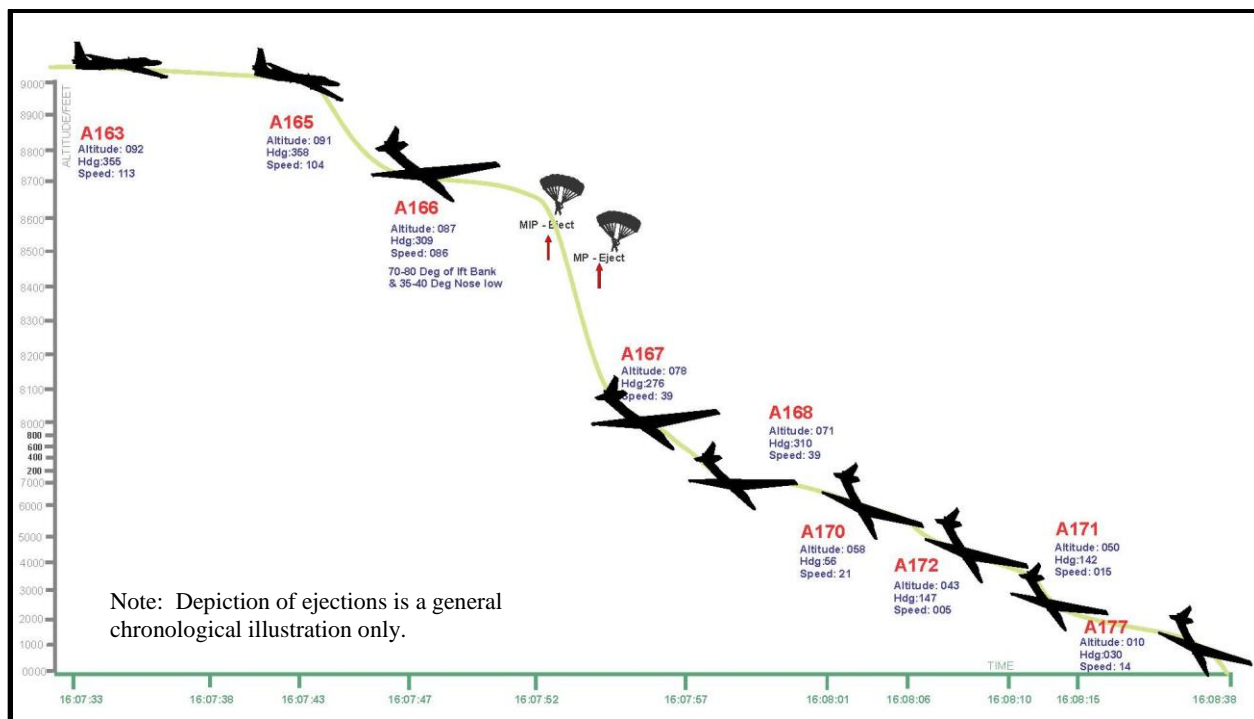
Figure 5. MA Third “Approach to Stall” Maneuver (Flown by MP) (Tab Z-6)

At approximately 0907L, MIP climbed to 9,200 feet MSL with an initial heading of 355 degrees and transferred aircraft control to MP (Tabs M-6, and V-1.4). MP reduced throttle to Idle to set up for another no-flap “approach to stall” maneuver and recovery (Tab V-1.4). During the recovery, MP recalled using what he described as much “more even yoke application” to lower MA’s nose, while simultaneously moving the throttle to Full (Tab V-1.4). As MA gained airspeed, MP applied slower and more deliberate backpressure on the control column to raise the nose (Tab V-1.4). MP also compensated for a “little bit” of left roll by applying full right yoke (aileron), as he saw MIP demonstrate (Tab V-1.4, V-15.4 to V-15.5, and V-16.3). He also used an indeterminate amount right rudder to keep MA’s wings level (Tab V-1.4). As the nose began to rise, MA rapidly entered an uncommanded left roll (Tab V-1.4). MP was surprised by the sudden left wing drop (Tab V-1.4). See Figure 5.

At approximately 8,500 feet MSL, the MA rapidly rolled to approximately 70-80 degrees of left bank with the nose 35-40 degrees below the horizon (Tabs M-6 and V-1.4). MP recognized the situation was “not normal” but was not alarmed due to his experience with similar attitudes as a T-38/A instructor pilot (Tab V-1.4). With MA rapidly approaching minimum uncontrolled ejection altitude of 7,500 MSL, MIP commanded ejection (Tabs V-1.5, Z-12, and BB-4). TU-2S guidance does not provide recovery techniques or procedures for departure uncontrolled flight or from a spin and directs ejection from the aircraft (Tab BB-4 to BB-5).

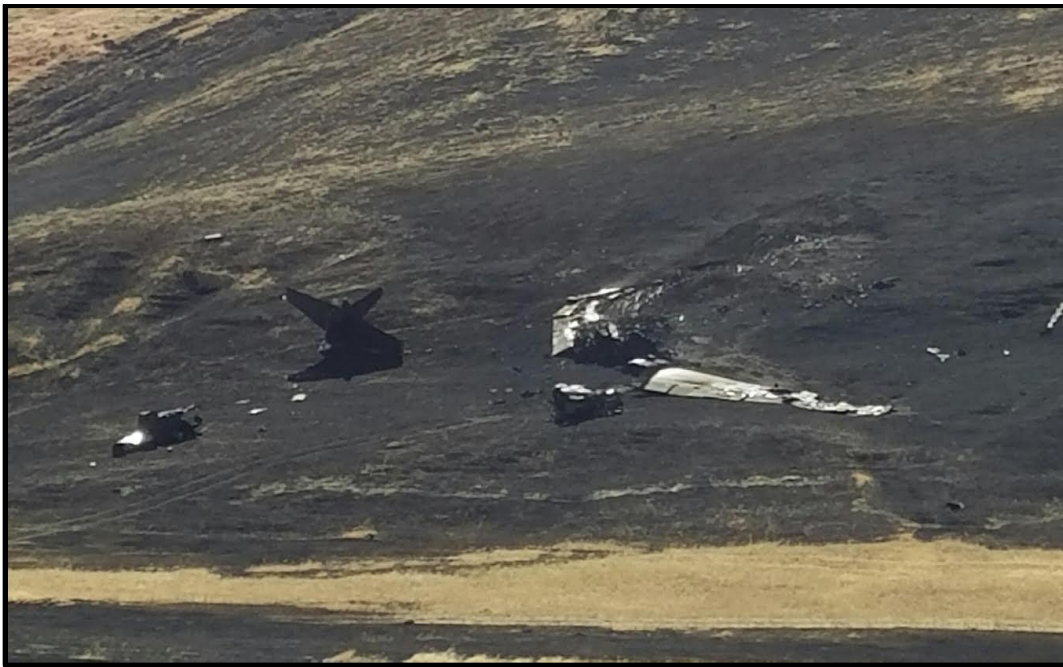
Figure 6. MA Main Impact Site (Tab Z-8)

MA entered into a left spin after both the MIP and MP ejected, impacting the uninhabited foothills south of the Sutter Buttes mountain range (Tabs M-6 and S-16). See Figure 6. Post-mishap analysis of the wreckage concluded MA hit the ground with minimal forward velocity in a 25-30 degrees nose down, 20-25 degrees left wing down attitude relative to the terrain (Tab EE-12). At impact, MA's landing gear was down; stall strips were extended; the flaps, lift spoilers and speed brakes were retracted; the ailerons and roll spoilers were configured for a left turn; and the engine was at a low power setting (Tab EE-87 to EE-88, and EE-190).

MA was intact at impact, with the exception of the right wing tip which was separated from MA prior to impact with the ground (Tab EE-20 to EE-21). MA sustained impact and fire damage to the nose, aft fuselage section, center fuselage, left and right wings, and the empennage (Tab E-11). The nose was separated from the fuselage and the center fuselage was broken into four sections (EE-15). The aft fuselage was separated from the center fuselage (Tab EE-15). The aft cockpit fairing broke into ten pieces and was scattered around the impact site (Tab EE-16). The removable nose was found separated from the forward fuselage with minor fire damage (EE-15). The fiberglass nose cone was separated from the nose with impact damage (Tab EE-15). Both wings had lower surface impact damage and extensive fire damage (Tab EE-20 to EE-21). The right folding wing tip was found intact, approximately 1,050 feet north of the main impact site, with the wing tip and outboard aileron intact (Tab EE-11, and EE-20 to EE-21).

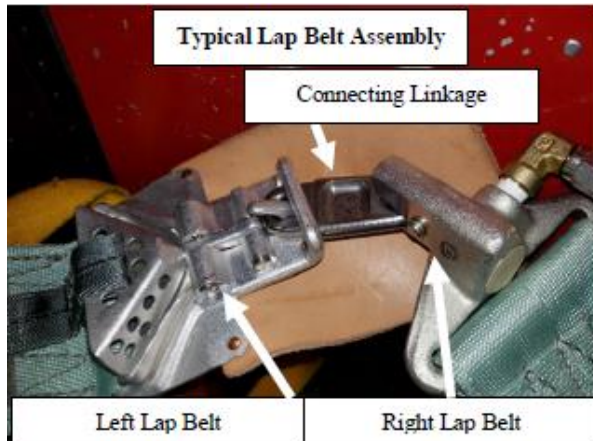
Figure 7. Typical Lap Belt Assembly
(Tab Z-13)

During normal lap belt operations, a metal connecting linkage fixed to the right lap belt is secured to the left lap belt by a locking lever (Tab H-11). See Figure 7. In addition to securing the pilot's lap belt, the connecting linkage attaches the pilot's shoulder harness to the lap belt (Tab H-16). During an ejection sequence, the shoulder harness retracts to pull the pilot into the proper ejection alignment with the seat before the seat departs the aircraft (Tab H-3 and H-5).

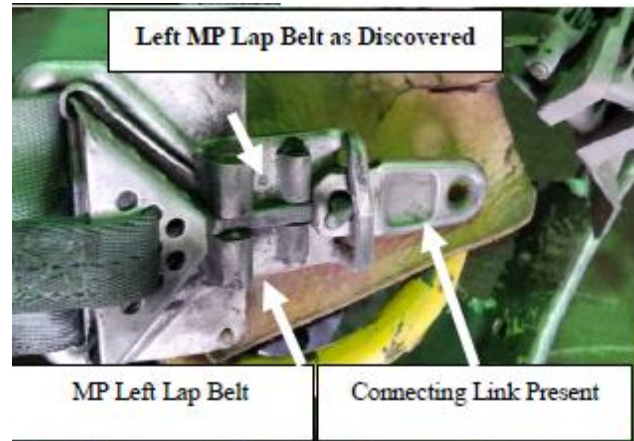
Figure 8. Left MP Lap Belt as Discovered
(Tab Z-13)

Once the seat departs the aircraft, and after the first and second stage ejection seat rocket motors stop firing, a gas-operated ballistic disconnect mechanism releases the connecting linkage from the right lap belt (Tab H-5 and H-11). This feature automatically separates the right and left lap belts, releases the shoulder harness, and frees the pilot from the ejection seat. If the left and right lap belts are properly secured prior to ejection, the connecting linkage should remain locked onto the left lap belt by the locking lever (Tab H-11). MP's left lap belt was found in this post-ejection configuration (Tab Z-13). See Figure 8.

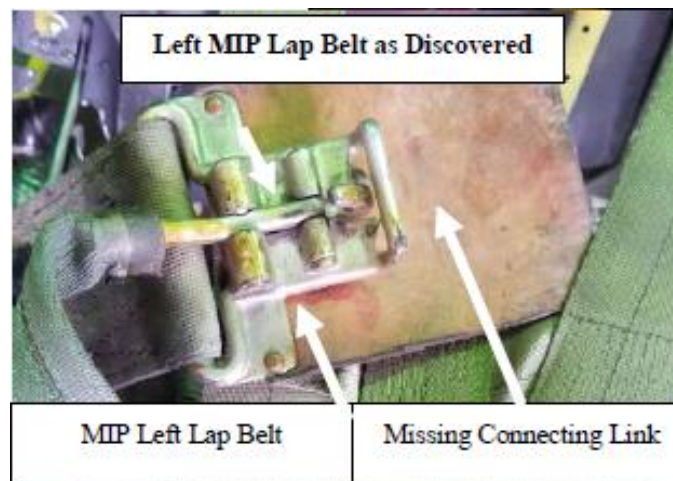
Figure 9. Left MIP Lap Belt as Discovered (Tab Z-13)

Post-mishap inspection revealed the ballistic disconnect mechanism on MIP's right belt functioned properly and released the connecting linkage as designed (Tab H-11). The locking lever on MIP's left belt was found in the locked position with no damage or excessive wear; however, the connecting linkage was missing and was not recovered (Tab H-11). See Figure 9. From these observations, engineers from the Air Force Life Cycle Management Center concluded MIP may not have been secured by his lap belt at the time of ejection (Tab H-16).

Evidence indicates it is probable MIP was not secured by his lap belt at the time of ejection, which could have exacerbated an already unstable trajectory during rocket motor initiation. However, there was insufficient data to re-create MIP’s ejection trajectory to determine conclusively whether MIP’s lap belt configuration caused him to strike the right wing tip. Specifically, the MA’s exact attitude and configuration at the time of MIP’s ejection could not be determined due to limited witness testimony and the lack of recorded flight data. Additionally, the ejection seat was likely in an unstabilized roll due to MA’s rolling motion, and there is no test data modeling the U-2S ejection seat’s expected trajectory from a rolling aircraft.

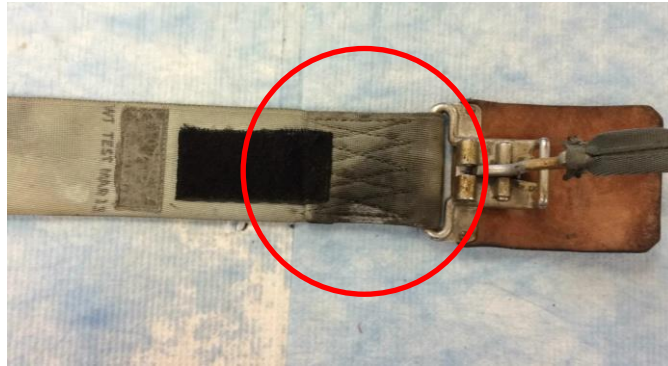
Figure 10. Blackened Area on MIP's Left Lap Belt (Tab Z-13)

Post-mishap inspection also revealed the nylon area adjacent to the lever mechanism on MIP's left lap belt was blackened (Tab Z-13). See Figure 10. Subsequent chemical analysis of the blackened area disclosed the presence of lead, which is a component of the the propellant used in the ejection seat rocket motor (Tab EE-200). Chemical analysis also revealed low levels of antimony, another element frequently found in propellants (Tab EE-202). Unblackened regions of the belt analyzed for comparison did not contain lead or antimony (Tab EE-205). This chemical analysis indicates

MIP's left lap belt was exposed to the ejection seat rocket motor exhaust near the bottom of the seat while the rocket was firing. As the lap belt ballistic disconnect mechanism is not designed to function until after the rocket motor has completed firing, the chemical analysis suggests MIP's lap belt may not have been secured at the time of ejection (Tab H-5).

If MIP's lap belt was not secured at the time of ejection, the shoulder harness would not have restrained MIP's torso to the seat back, which could have shifted the ejection seat's center of gravity and resulted in an unpredictable ejection trajectory (Tabs H-16 and BB-89 to BB-90). However, there was insufficient data to re-create MIP's ejection trajectory to determine conclusively whether MIP's lap belt configuration caused him to strike the right wing tip (Tabs H-16 and BB-89). Specifically, the MA's exact attitude and configuration at the time of MIP's ejection could not be determined due to limited witness testimony and the lack of recorded flight data (Tab BB-89 to BB-90). Additionally, the ejection seat was likely in an unstabilized roll due to MA's rolling motion, and there is no test data modeling the U-2S ejection seat's expected trajectory from a rolling aircraft (Tabs H-16 and BB-89 to BB-90).
