# **Carillon Tower Peer Review**

**National War Memorial, Taranaki Street  
Mount Cook  
Wellington 6021**

**Issues Register**

Date: 21 September 2020  
Project No: 140675.12  
Issue No: 3

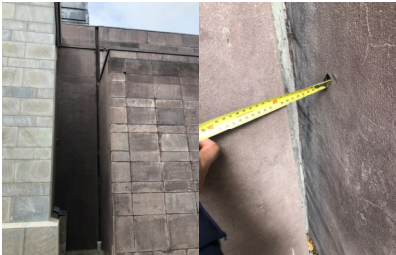
| 16 | | General | <p>What is the expected lateral movement in the North-South Direction? Site observations of western elevation appears to suggest between Hall of Memories and Carrillon structure is a 'sealant' with a downpipes embedded (~80mm gap t.b.c.). Has an on-site review of 120mm seismic gap detailing been conducted?</p> | <p>Table 15 of the Appendix shows the expected displacements at the interface with the Hall of Memories for each record at 100%NBS [13]. The average displacement of the 7 records is 70mm. The expected displacement of the Hall of Memories is less than 10mm at 100%NBS (13L 100-year design life). Extensive on-site investigation has not been completed, but the presence of the gap was observed during the works completed to the Hall of Memories.</p> | <p>Recommend sufficient verification of movement allowance (via inspection and intrusive investigation where necessary) be carried out in enough locations to provide confidence in assumptions being made. In the case of exterior elevation, a 'sealant' with a downpipes embedded was observed between the Hall of Memories and the Carrillon Tower (see below).</p> | | Open |
