PARKBRAKE FAULT: POLICE ACTION

Truck's Spring Brake Failure Kills Pedestrian

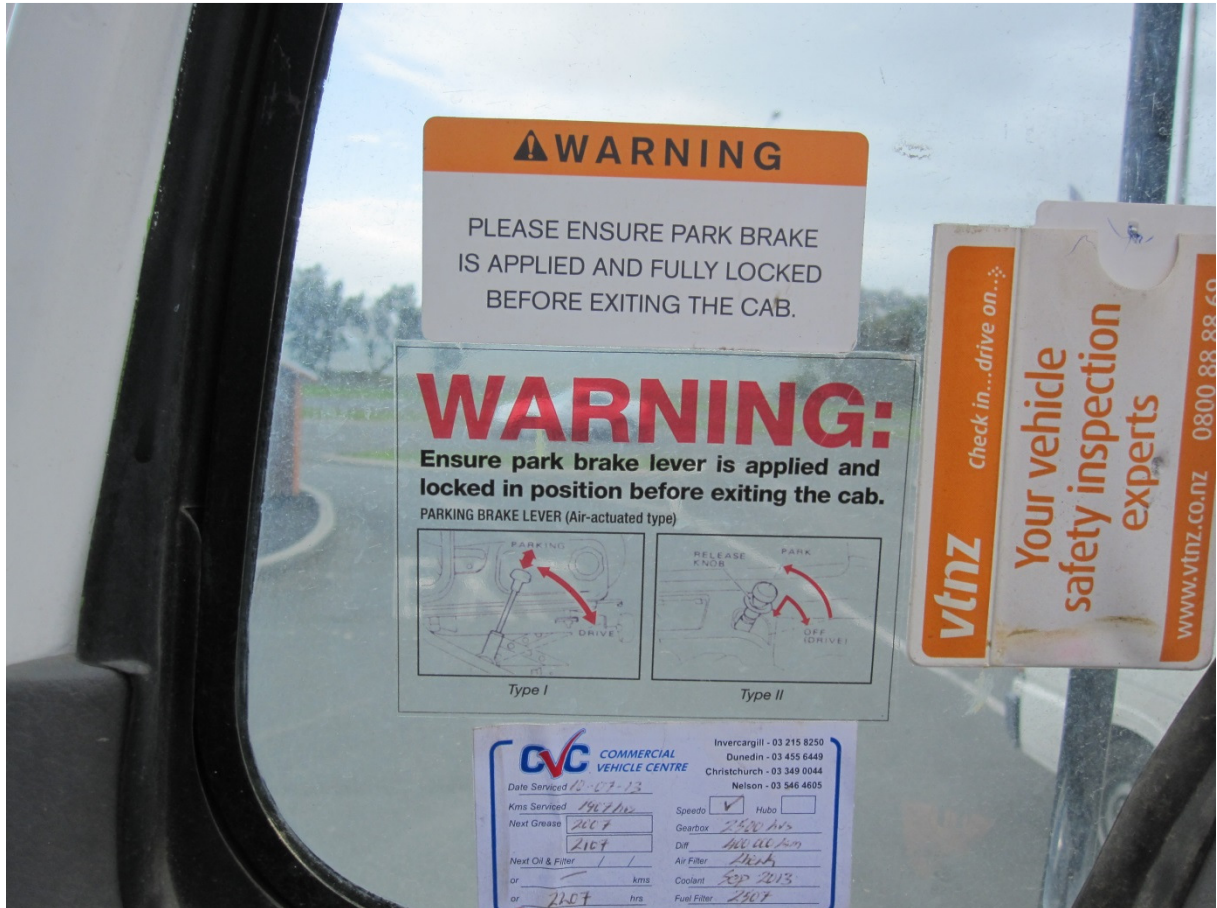
- the warning sticker with the orange band across the top is the one supplied by UD (Trucks) the one below was produced by a local service agent.*
- the Sanwa Seiki brake control although predominantly fitted to Nissans was apparently fitted to some Isuzu's of a similar vintage.*

- If they come across any Nissans Models from the CK300 through to the CK440 that were manufactured from 1993 to 2005, give them a copy of the Hazard alert.*
- If they have not got the orange warning sticker affixed to the door or dash board, make a phone enq with the operator at the time to establish if they have had any contact from UD trucks and if they aware of the hazard.*
- Advise the operator that this is a Health and Safety issue and advise them to contact UD trucks.*

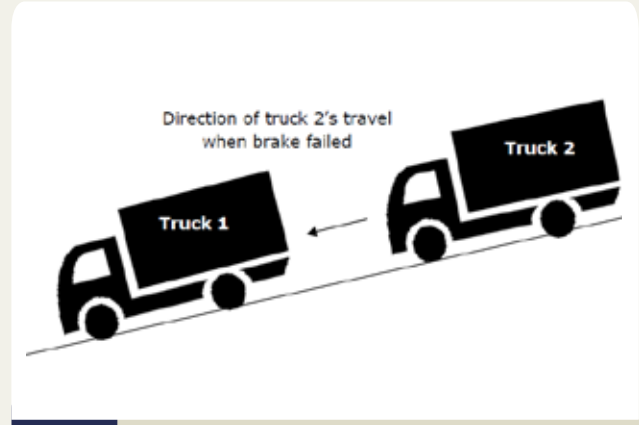
The uppermost truck (truck 2) parked behind the first (truck 1) and the driver applied the park brake (a spring brake). Truck 2's driver exited the truck's cab and walked towards the rear of the vehicle, when the park brake released. The truck rolled down the hill into truck 1, crushing a member of the public who was walking between the rear of truck 1 and the front of truck 2.

Figure 1: Diagram showing how the trucks were parked and the direction truck 2 travelled when the park brake failed.

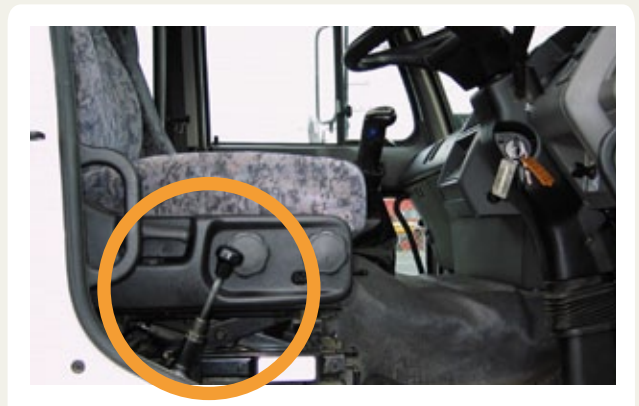
Truck 2 was fitted with a park brake control valve positioned at the base of the driver's seat. There are two known variants of brake valve – both operate the same way with the same locking system. They were manufactured up until approximately 2003.

In the case of truck 2, the locking dowel in the park brake control valve had not fully engaged in the valve body, and the brake released.

1. the park brake operating lever (located in the handle head of the park brake control valve body) was sticking, and
2. the locking hole in the park brake control valve body was worn and elongated.

Figure 2: shows the interior of a truck cab with a park brake control valve positioned at the base of the driver's seat. The park brake is in the "engaged" position.

When applying the park brake, the driver must ensure that the operating handle on the park brake control valve has fully dropped into its locking position. If this does not occur, the valve must be serviced immediately. The park brake control valve body wears down with use and, aided by the entry of dust and dirt, the smooth operation of the valve is affected – often to the degree that it will fail.

Dust boots on any such control valves must be in good condition.

Due to the position of the park brake control valve at the side of the seat base, the driver should make sure that he or she does not catch his or her clothing on the control lever when exiting the cab, because this, too, will often result in an uncontrolled park brake release.
