New Zealand Aluminium Smelters Limited

SCL GROUNDWATER STATUS

2020

Date: 29 March 2021

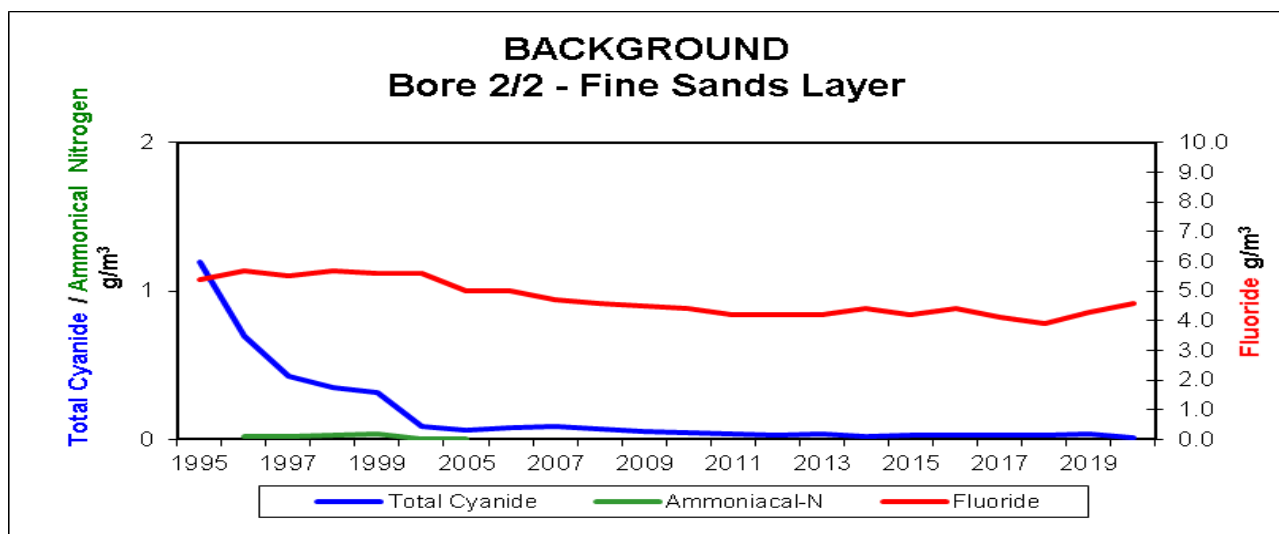
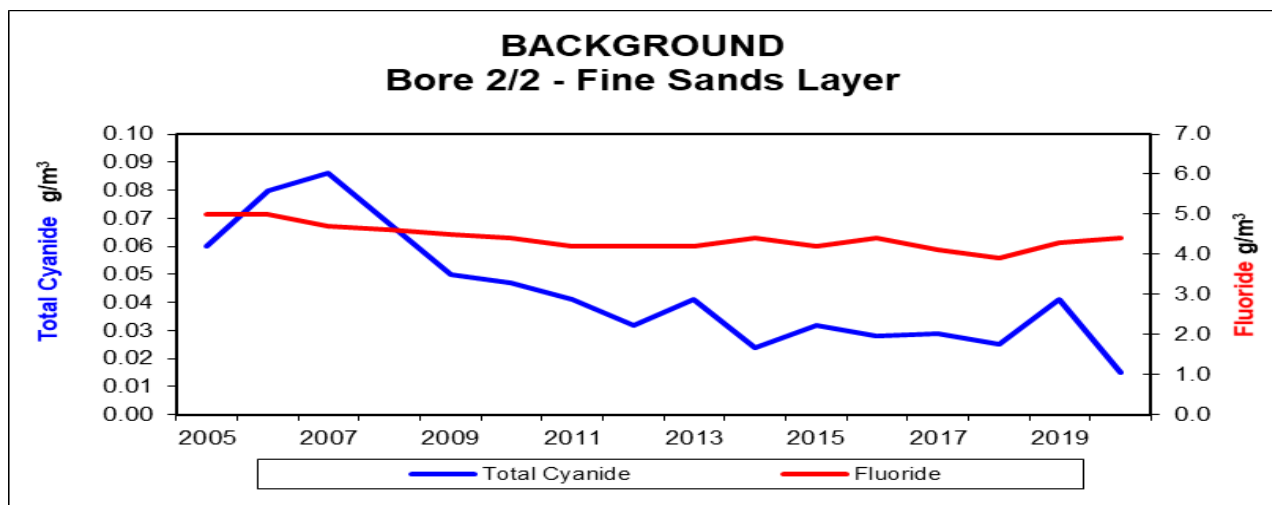
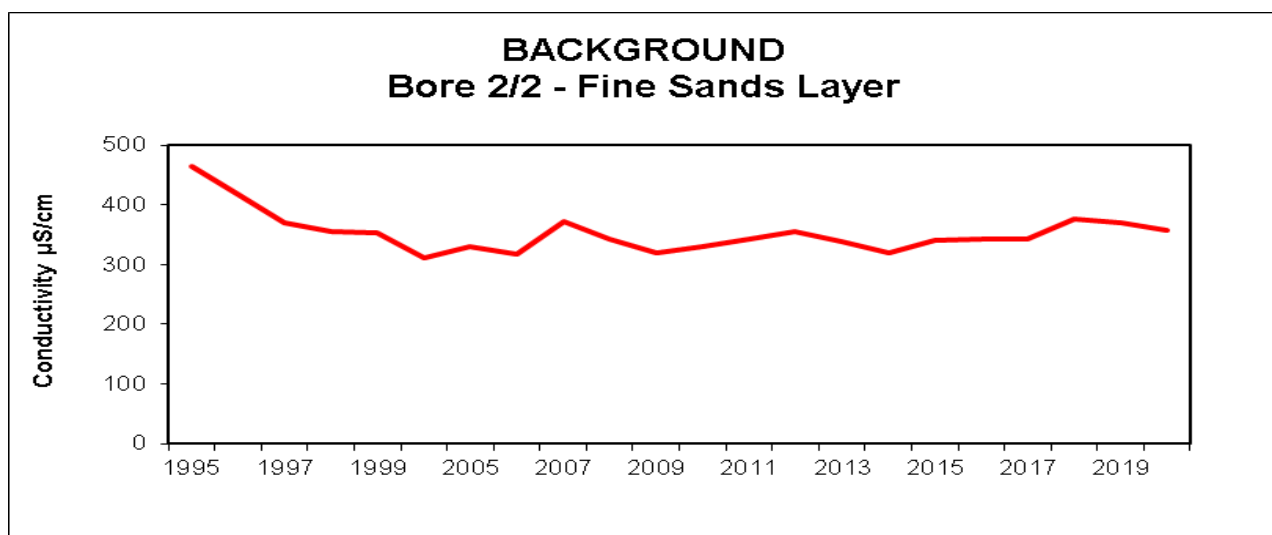
The following graph shows the annual average concentration of total cyanide, fluoride, and ammoniacal nitrogen measured in the groundwater from Bore 2/2 since 1995. Note that ammoniacal nitrogen has not been measured since May 2005. Total cyanide is typically measured at 0.05-0.02 mg/L with free cyanide < 0.01 mg/L.

The elevated levels of total cyanide in the early 1990s were due to SCL leachate entering the groundwater around the pad. The SCL material was shifted to a temporary concrete pad to the north of the existing pad while the original location was reconstructed. The original SCL pad was covered in 1992 to stop any further leachate entering groundwater.

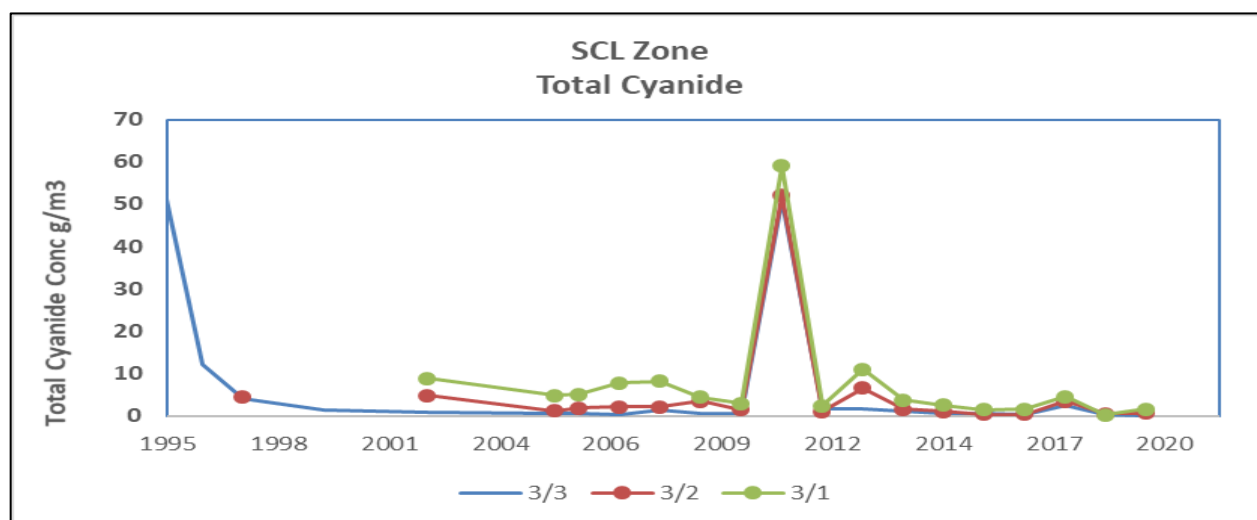
Free cyanide has ranged from < 0.01 – 0.32 mg/L for bores 3/3; 3/2; 3/1 with bore 3/3 showing the lowest free cyanide concentrations typically below 0.01 mg/L. The following graph shows the annual average concentration of total cyanide since 1995 (Note – $\text{g/m}^3 = \text{mg/L}$).

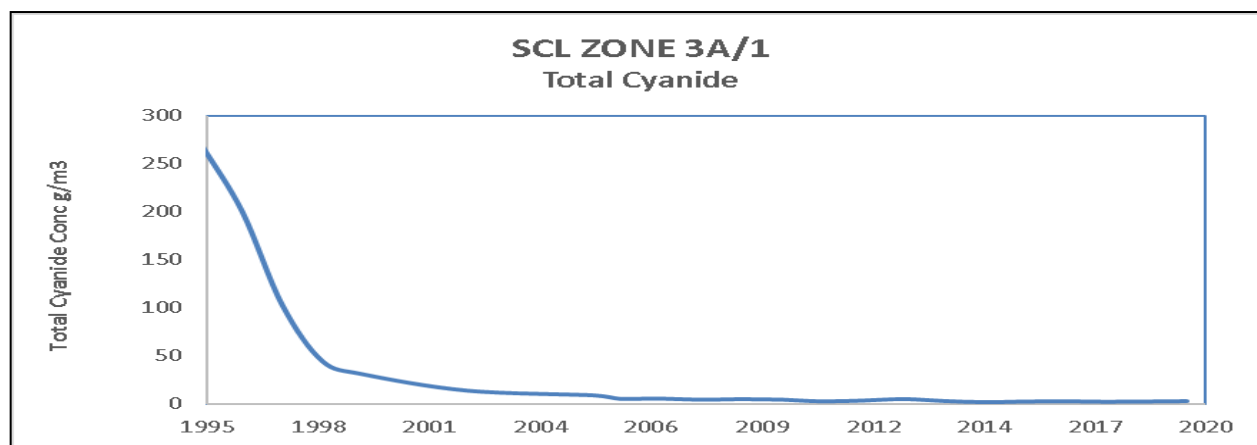
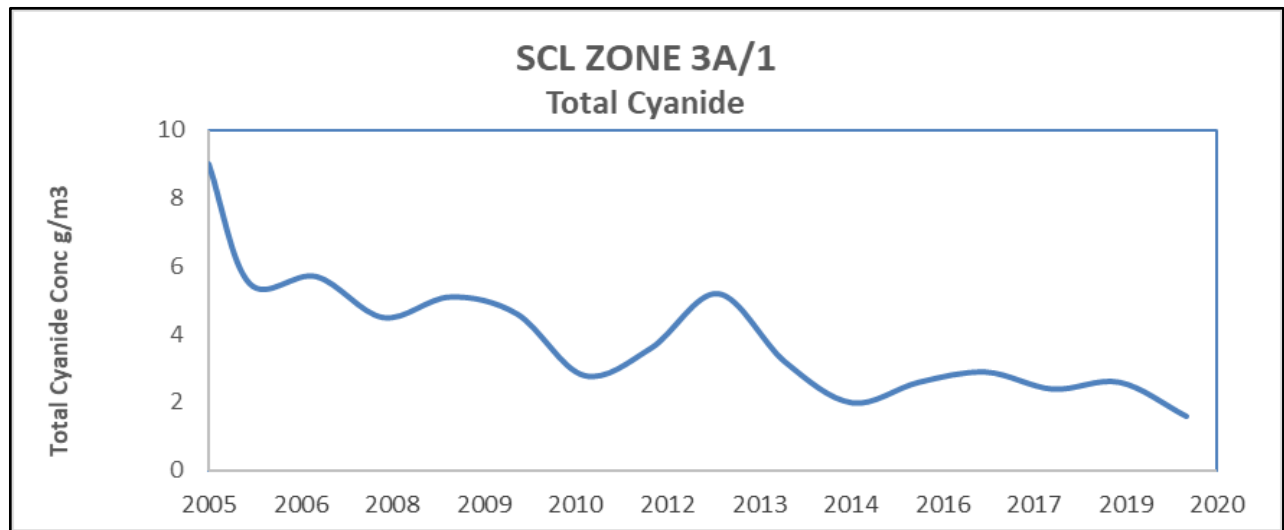
The following graph shows the annual average concentration of total cyanide from Bore 3A/1 since 1995. Free cyanide is consistently below 0.05 mg/L and typically < 0.01 mg/L.

Part of the same data set as displayed in the previous graph, is displayed in the graph below for years 2005 to 2020 to provide greater clarity of the most recent concentrations of total cyanide. Total cyanide remains elevated above background in Bore 3A/1.

Cyanide concentrations have continued to decrease over time. A cyanide spike was observed in July 2011 for the shallow bores 3/1, 3/2 and 3/3 located close to the southern side of the SCL pad. Only one sample was collected in 2011 and when re-sampled 6 months later it had decreased to previous concentrations of approximately 1 mg/L. A similar spike was not detected in deep bore 3A/1 located just a few metres downstream of bore 3/3. An investigation into the elevated levels was conducted but no underlying root cause was found.

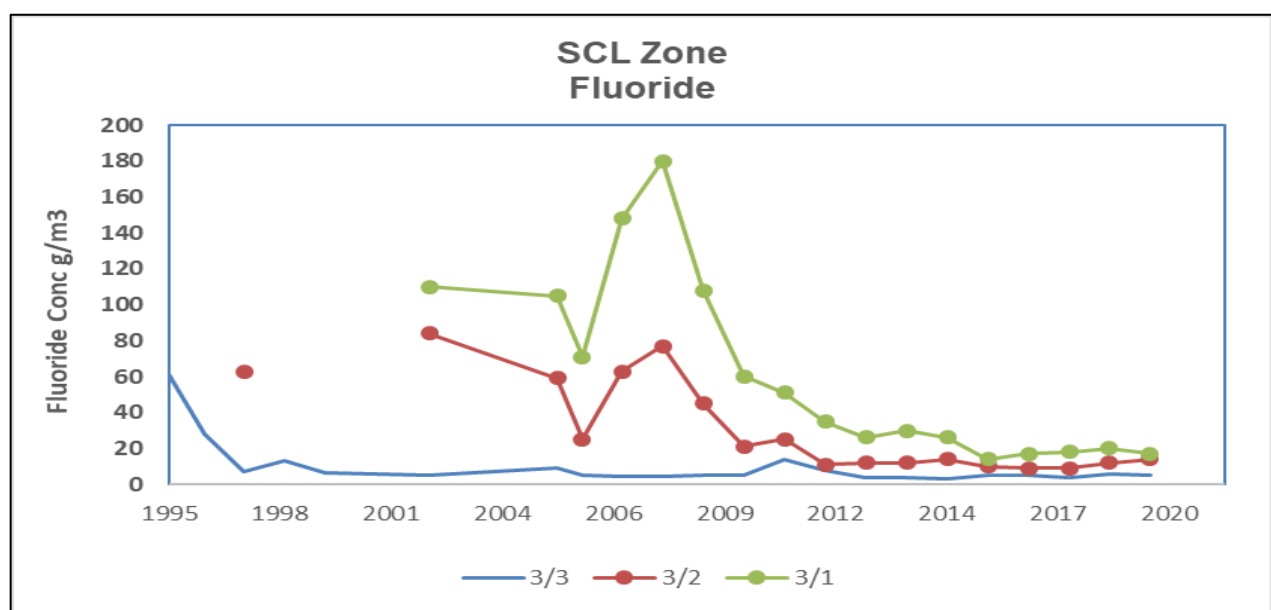
The following graph shows the annual average concentration of fluoride measured in the groundwater from shallow Bores 3/3, 3/2 and 3/1 since 1995.

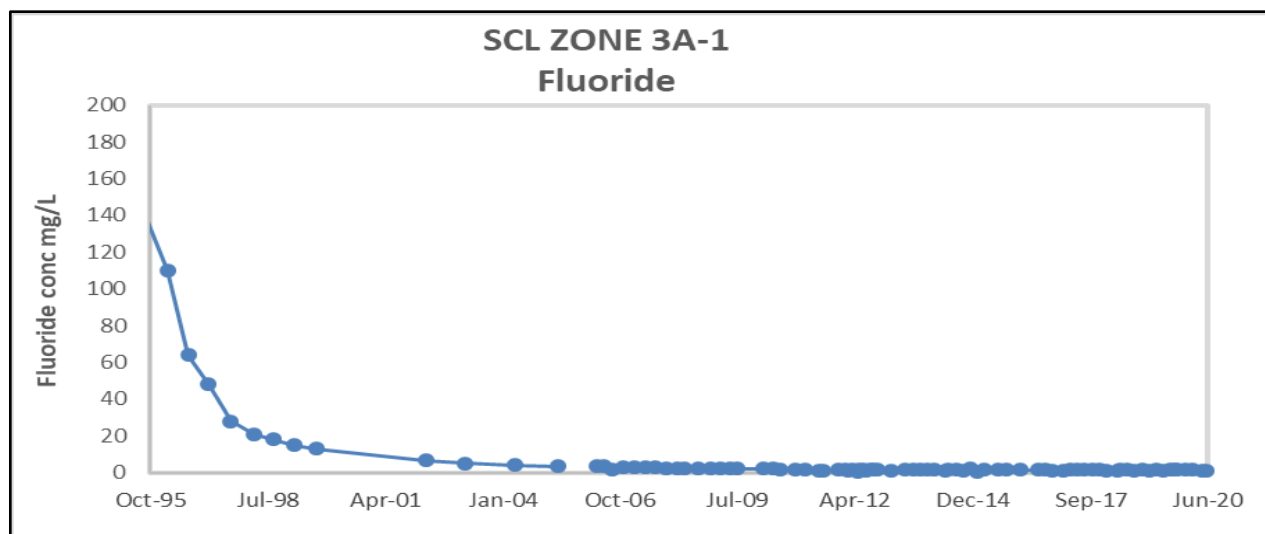
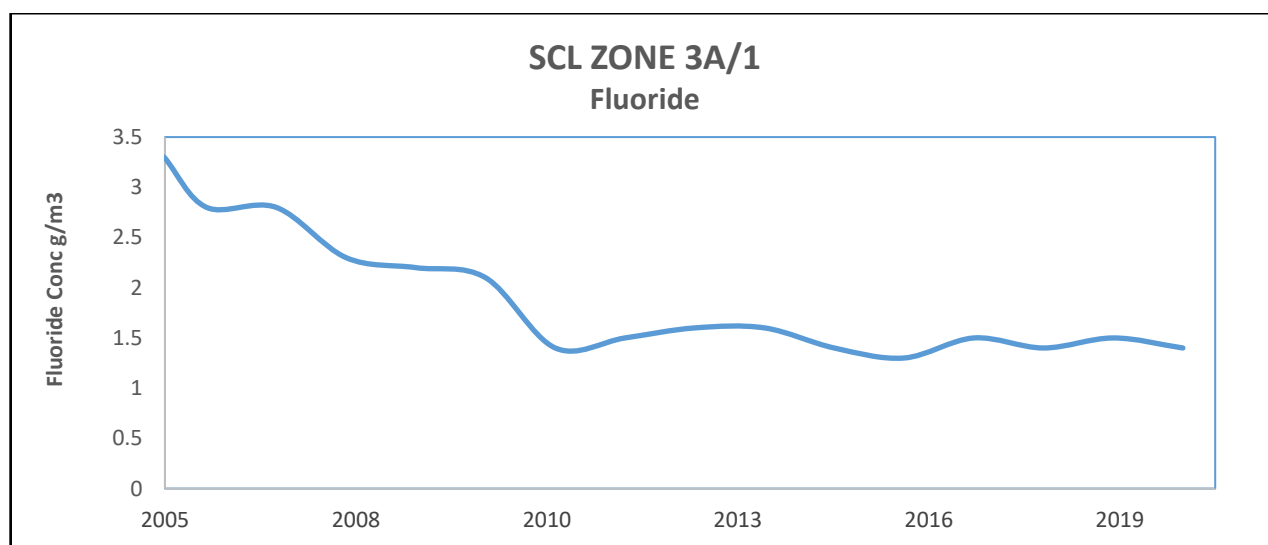
The following graph shows the annual average concentration of fluoride measured in deep bore 3A/1 since 1995.

The fluoride concentrations in the SCL zone have significantly decreased from 2005 till 2020. The decreases in concentration in groundwater from east to west with deep bore 3/1A showing the lowest concentration. A fluoride spike was observed for bore 3/2 and 3/1 between 2007-2009. No spike in fluoride was detected for deep bore 3A-1. The root cause for the spike was never identified. The underground discharge pipe which was replaced in 2003/2004 but is unlikely to be the source of contamination. Since 2010 the fluoride concentration in bore 3A/1 is nearing background levels found in seawater surrounding the Peninsula.

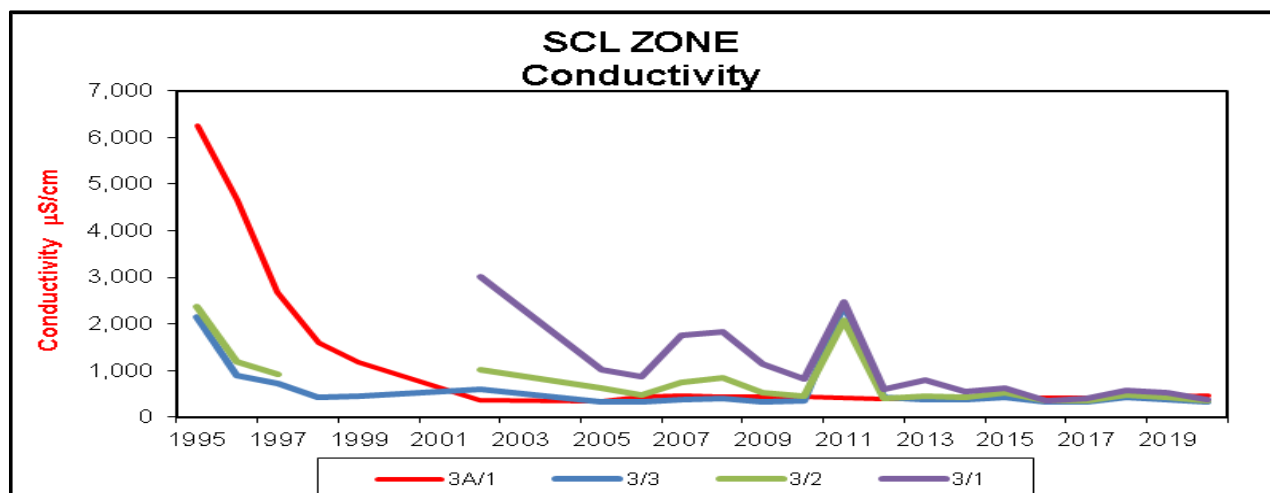
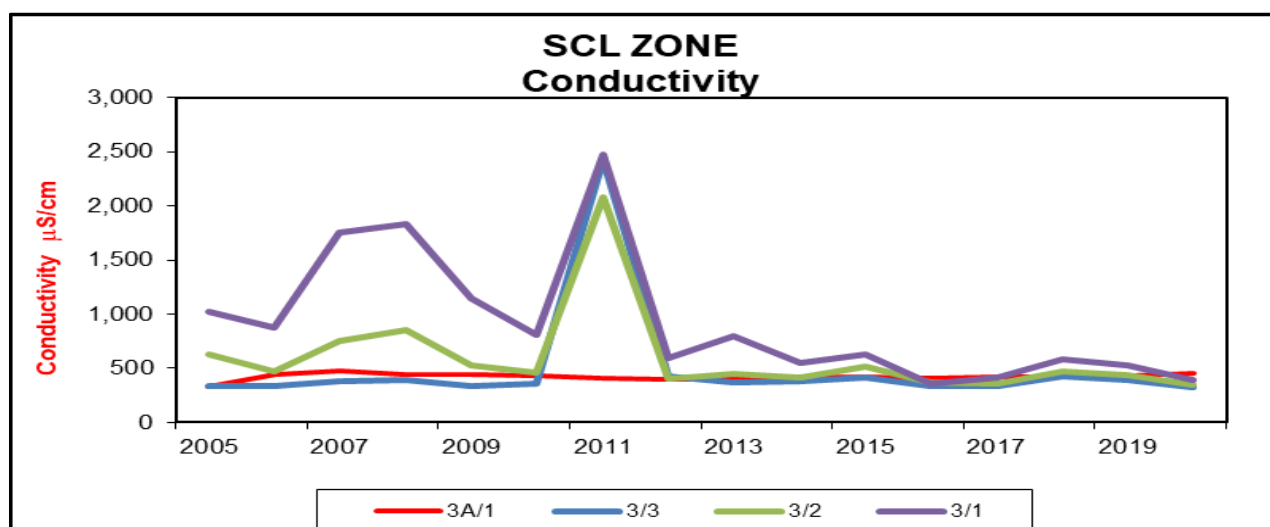
Conductivity has continued to decrease over time for bore 3/1 and 3/2. Monitoring at Bore 3A/1 indicates that the conductivity of the deeper groundwater layer in fine sands had recovered by 2005 and has maintained a conductivity of just below 500 µS/cm ever since. The same level of conductivity is observed at the sewage field and potable water supply areas of the aquifer.

An increase in conductivity was observed for Bores 3/1, 3/2 and 3/3 when the fluoride (2007-9) and cyanide (2011) levels increased. Currently the conductivity for these bores is approaching those of background bore 2/2.

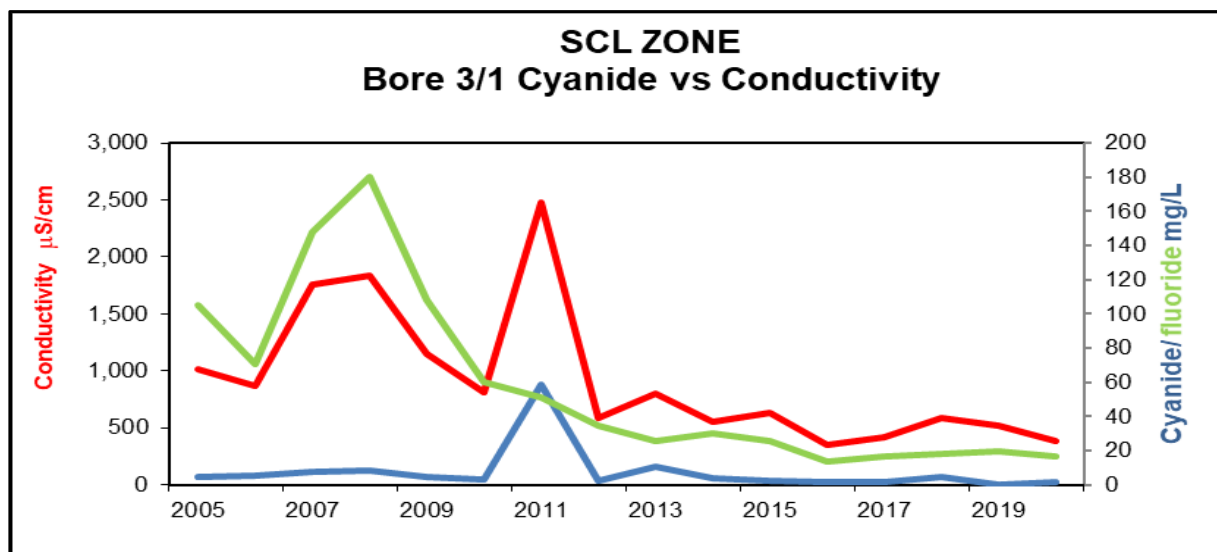
The cyanide concentrations track well with conductivity but not with fluoride for shallow bore 3/1 in the SCL Zone. See the graphs below for details. There appears to be limited or no correlation between total cyanide and fluoride concentrations for this bore.

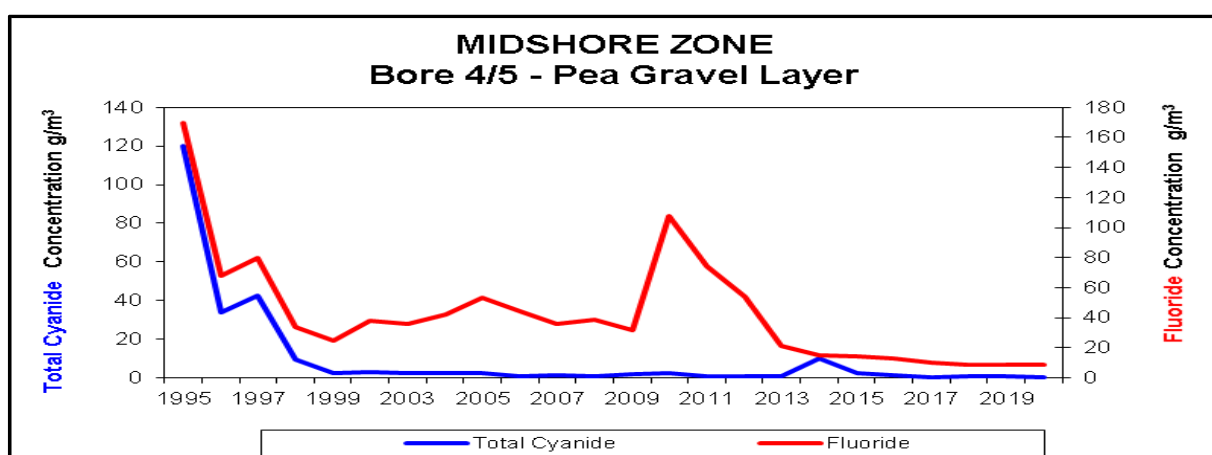
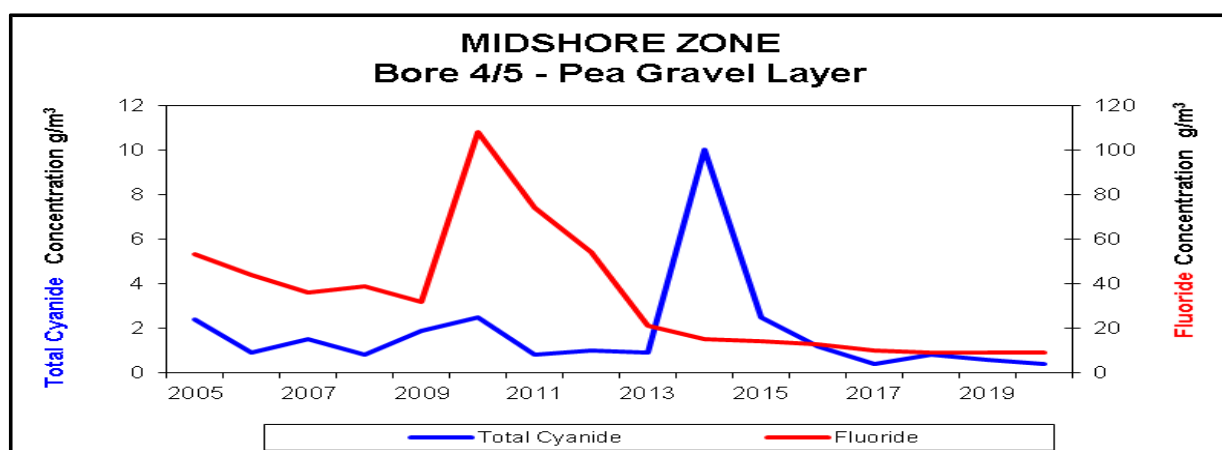
Both fluoride and cyanide levels have decreased significantly since monitoring began in 1995 and nearing the background values found in Bore 2/2. Total cyanide is higher than background but is much lower than that in the underlying fine sands layer. A spike in concentration for the analytes was observed for:

- fluoride in 2010/2011 which corresponds to a spike seen for bores in the SCL Zone occurring 3 years prior.
- cyanide in 2015 which corresponded to the spike observed for the SCL Zone bores in 2011. The underground discharge pipe was replaced in 2015 due to potential leakage.

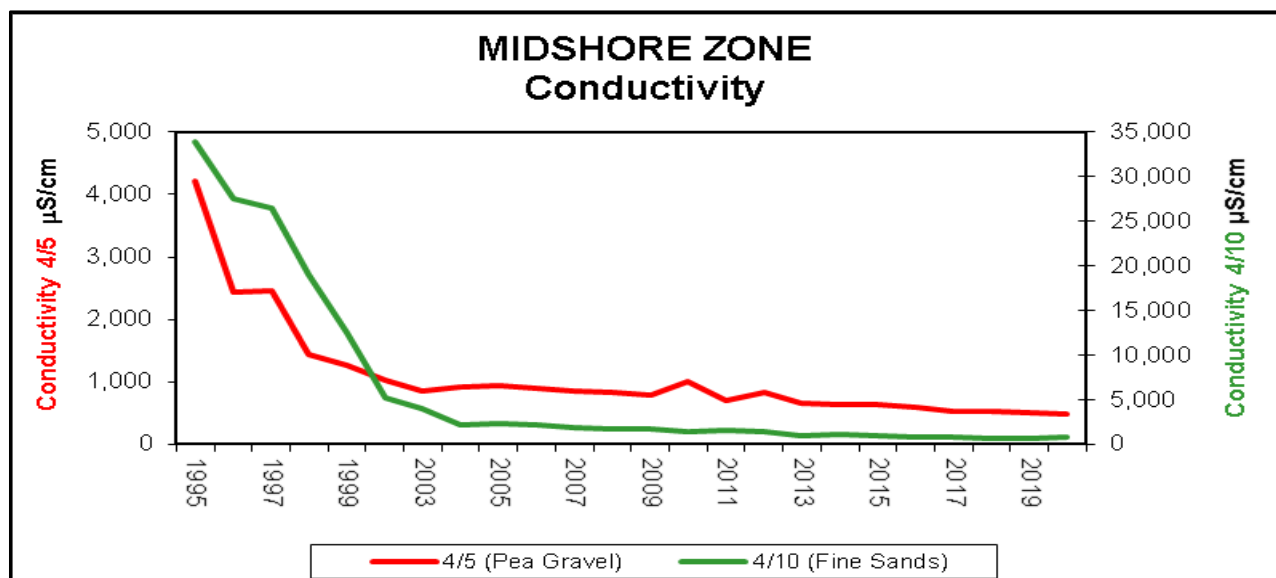
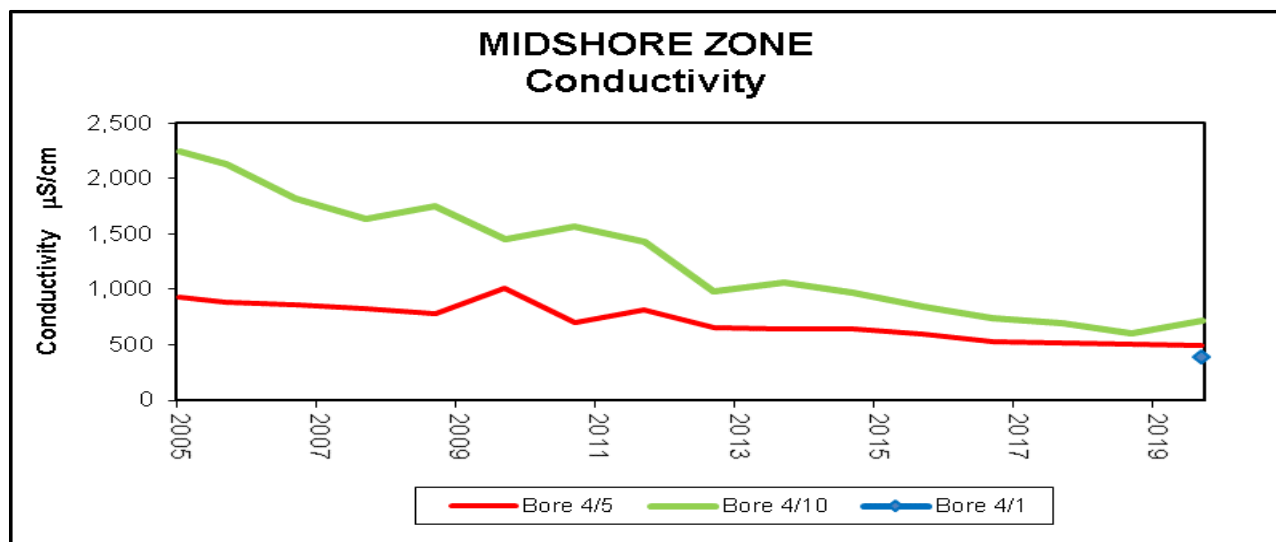
Contaminants are present in both layers, with the highest concentrations seen in the fine sands layer. The conductivity of the midshore bores 4/10 (deep) and 4/5 (shallow) have recovered significantly since monitoring began in 1995 and is approaching background levels, as are already seen in bore 4/1 (shallow). The conductivity in the midshore zone bores is 100-200 µS/cm above levels observed for the sewage field to the west of the pad.

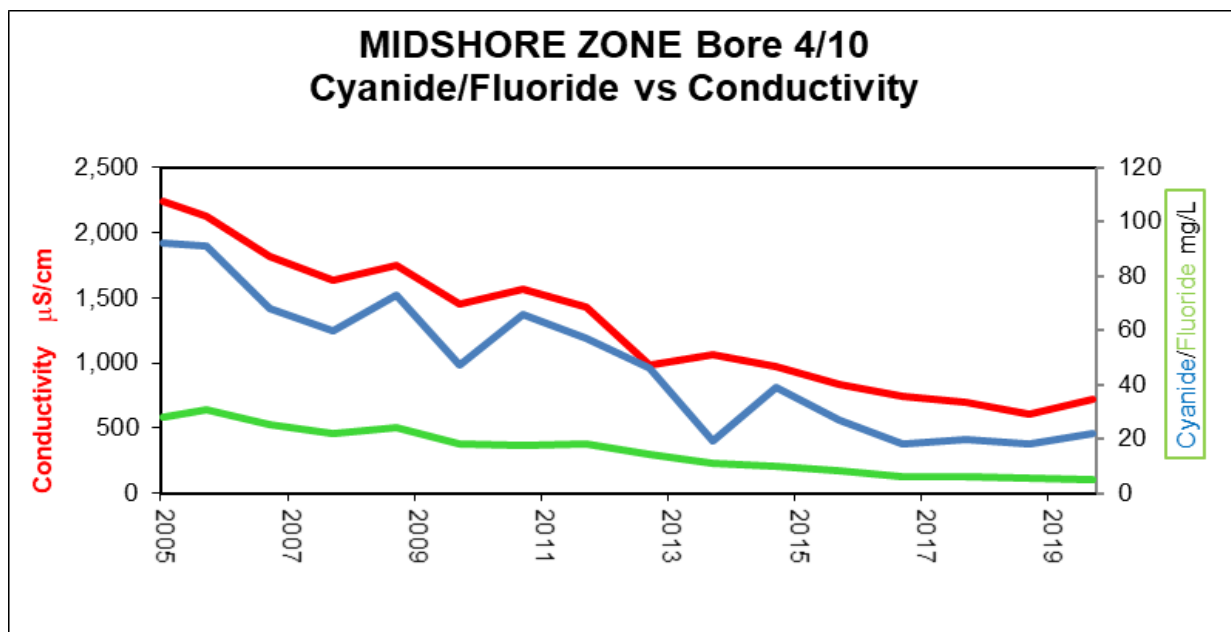
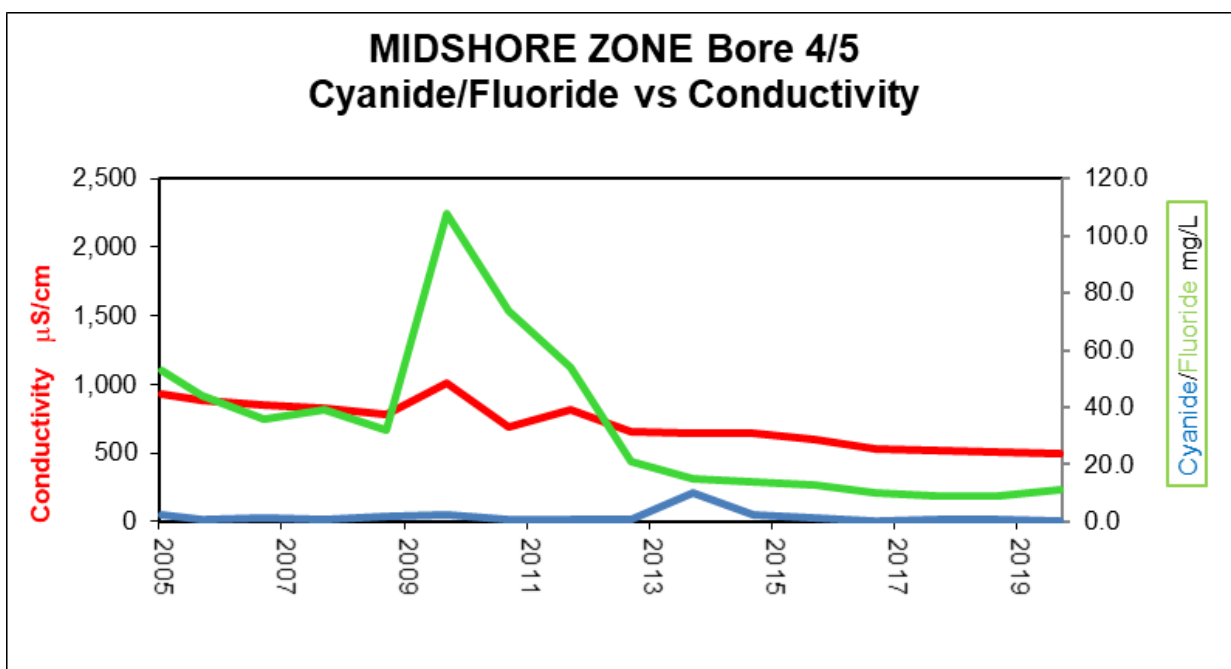
The cyanide concentrations track well with conductivity but less with fluoride for deep bore 4/10 in the Midshore Zone. There is limited correlation between cyanide and fluoride with conductivity for shallow bore 4/5. Both cyanide and fluoride have continued to decrease in the midshore zone.

There appears to be limited correlation between fluoride and total cyanide concentrations for the midshore bores. This is to be expected given the differences in the underlying pea gravel and fine sands layers.

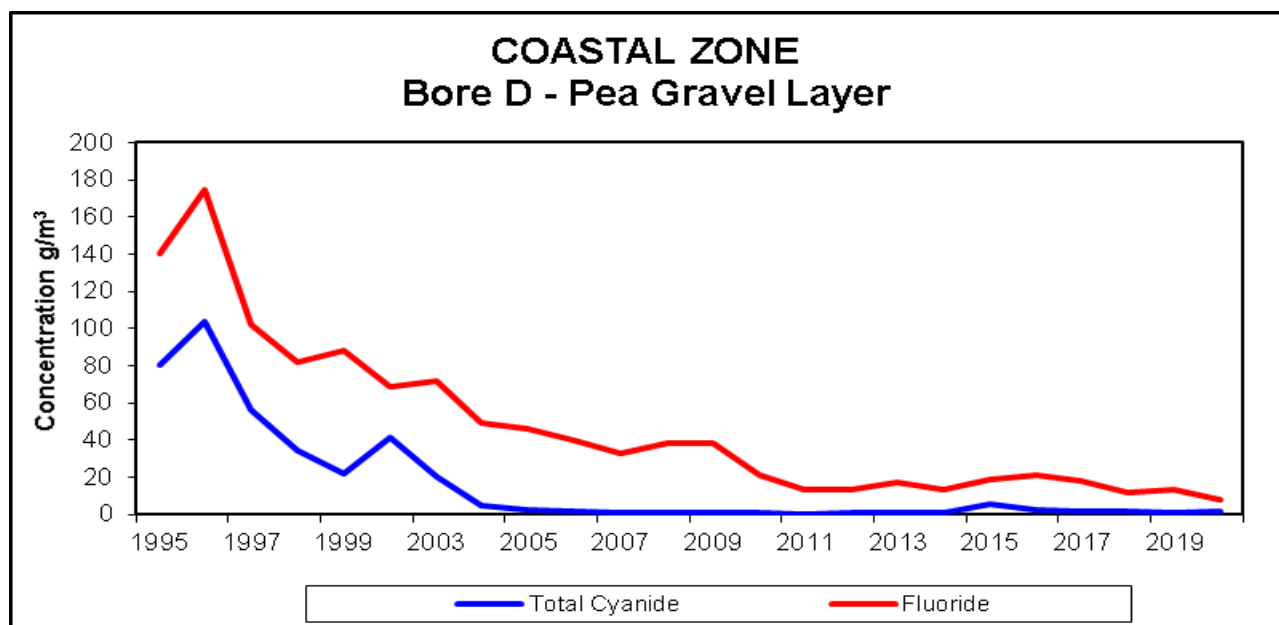
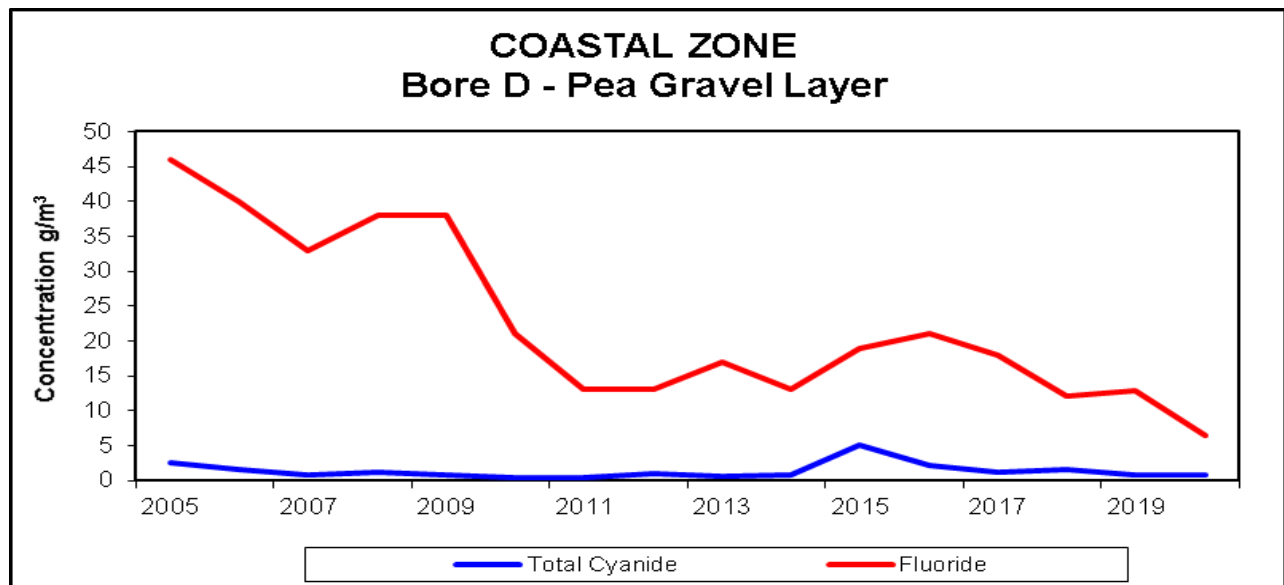
Fluoride and total cyanide concentrations in coastal Bore D have recovered significantly since monitoring began in 1995. Fluoride has stabilised to near background levels whereas the total cyanide level is above levels observed in bore 2/2. The total cyanide peak observed in the midshore bores for 2015 are also seen in coastal bore D. In August 2015 the underground discharge pipe was replaced as it was suspected to have broken in the coastal zone due to coastal erosion and or storm damage.

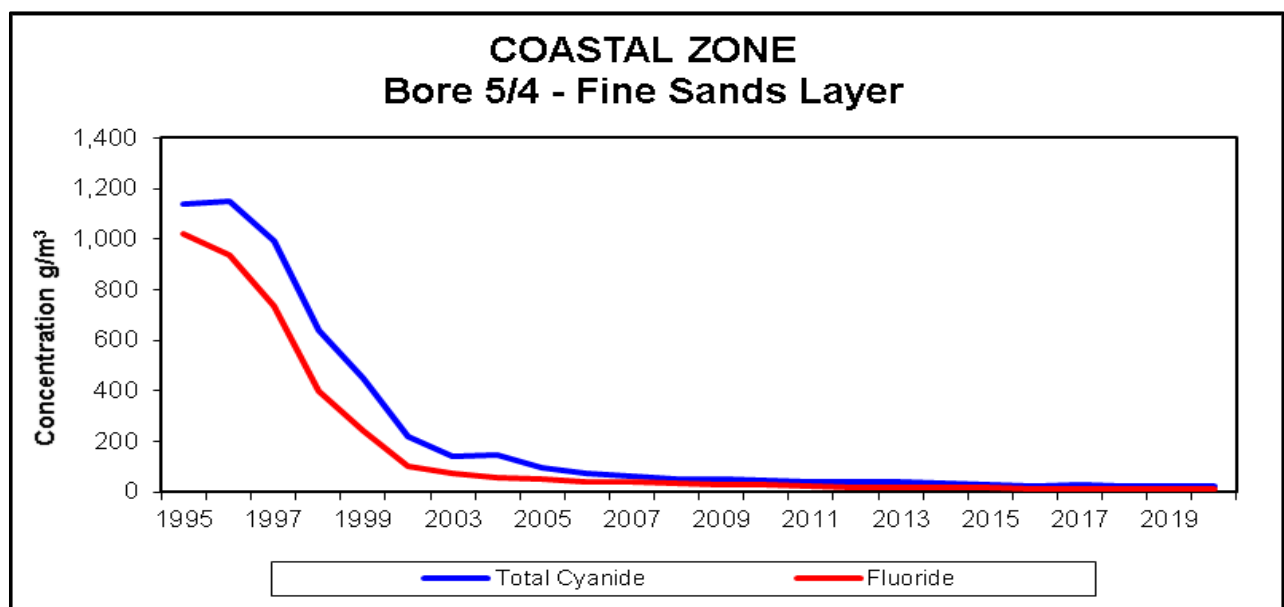
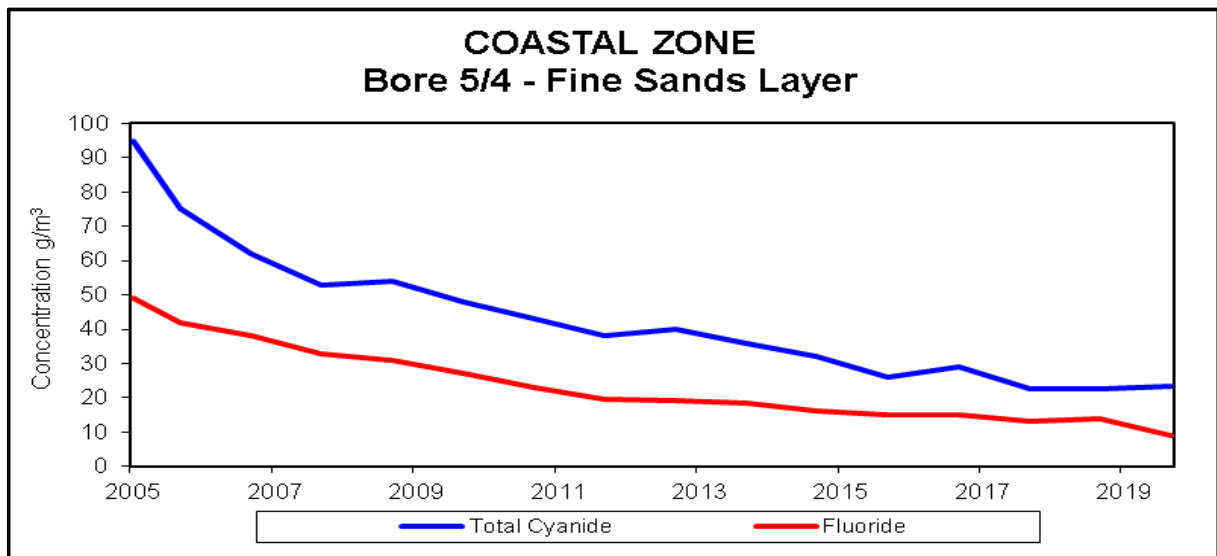
Fluoride and total cyanide concentrations of coastal bore 5/4 have recovered since monitoring began in 1995 and are continuing to decrease. Fluoride has reached the background level found in bore 2/2. Cyanide is still currently elevated compared to bore 2/2 and is similar in concentration to that in the up-gradient bore 4/10. Again, the concentration in the overlying pea gravel is much less than that in the deeper fine sands. This bore will continue to be monitored for seawater ingress as it is only currently 11 metres from the coast.

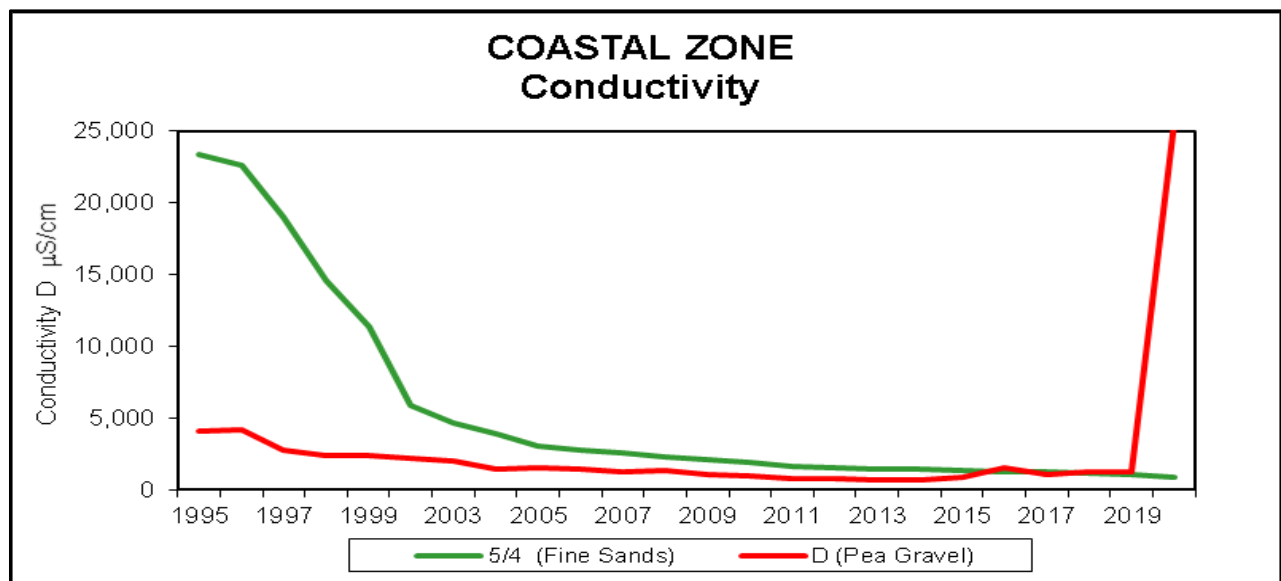
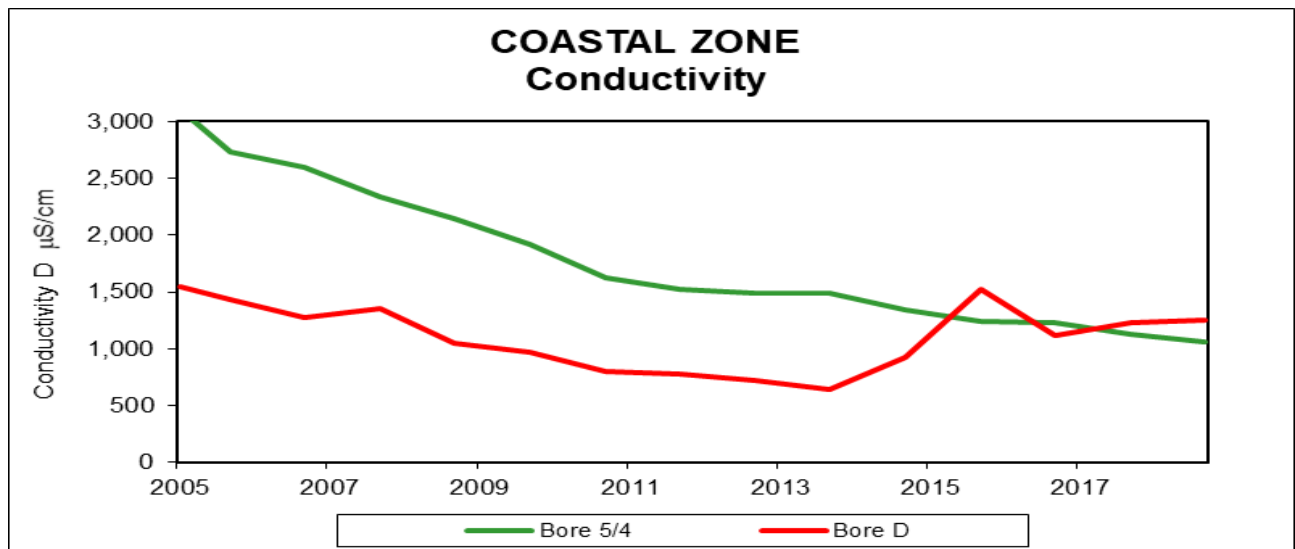
Monitoring at deep bore 5/4 in the fine sands layer demonstrates continued recovery over time. This bore is approximately 11 metres from the edge of the sand dunes to the beach. The conductivity is about 700 $\mu\text{S/cm}$ greater than levels observed in the background bore 2/2 and 500 $\mu\text{S/cm}$ above levels seen around the sewage field. This may be due to the start of sea water intrusion in this bore.

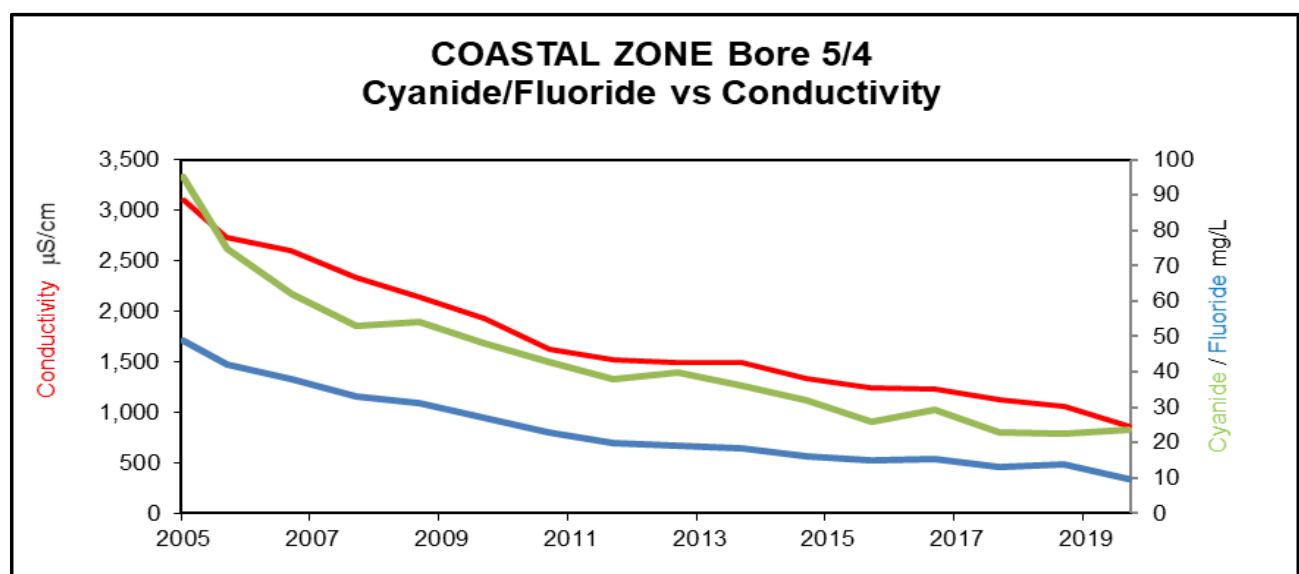
The cyanide and fluoride concentrations track reasonably well with conductivity for deep bore 5/4. Similar to what was observed for the SCL zone. See graphs below for detail.

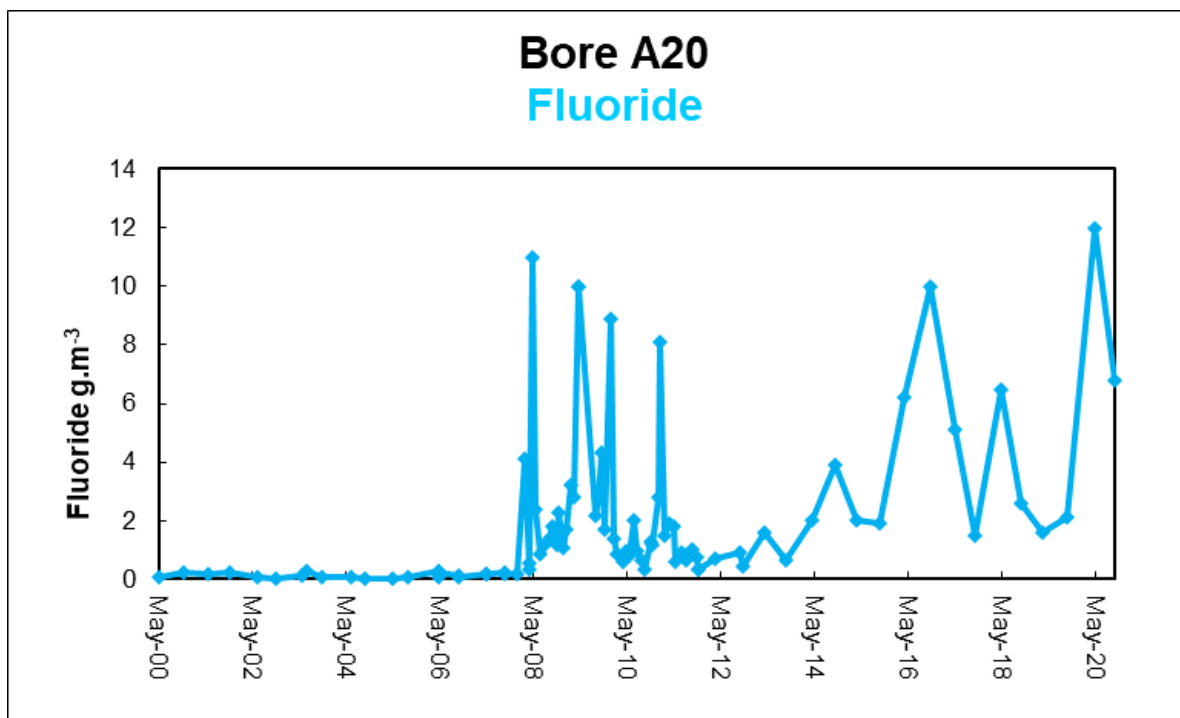
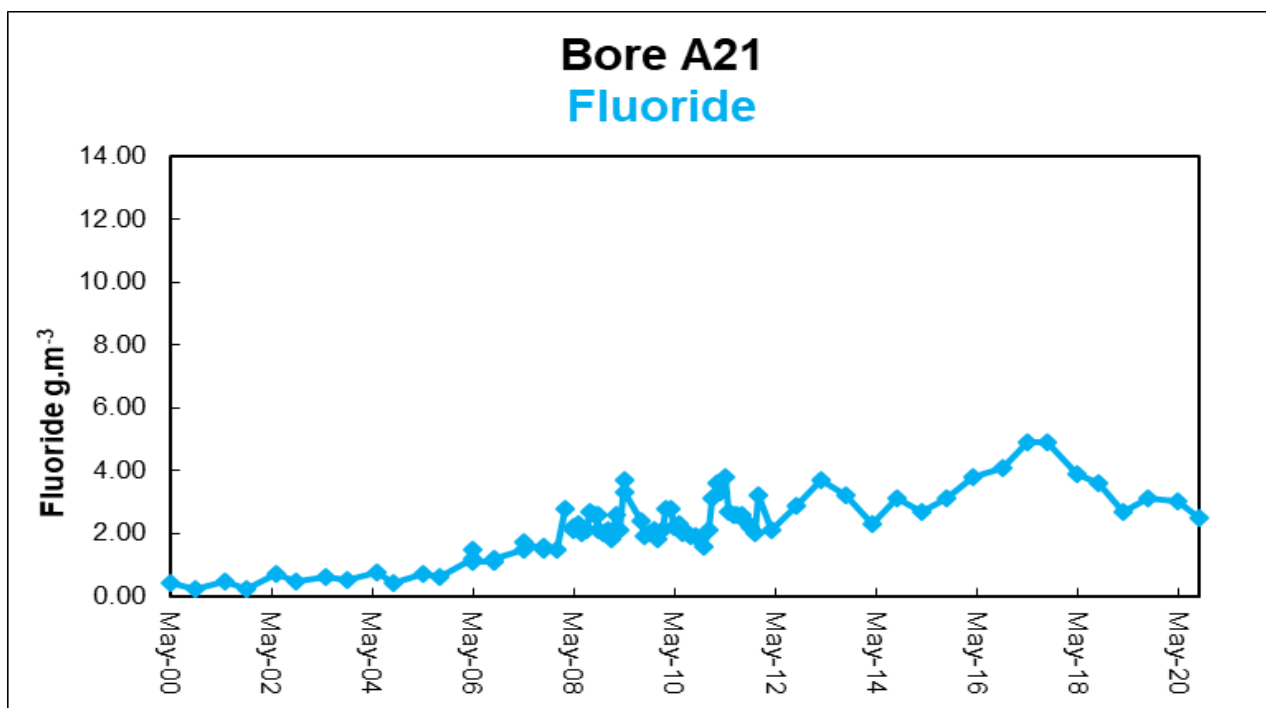
A 5-10 times increase in fluoride concentration in Bores **A20** and **A21** has been observed since 2007. The reason for fluoride increases in these bores is most likely due to a change in direction of groundwater flow resulting from changes in location where materials have been deposited in the Landfill, rather than being influenced by water from the nearby South drain.

Bore **A20** continues to be variable while small peaks in bore **A21** observed in 2008/2009, and in 2012, have reverted to a normal steady state of approximately <5 g/m³.

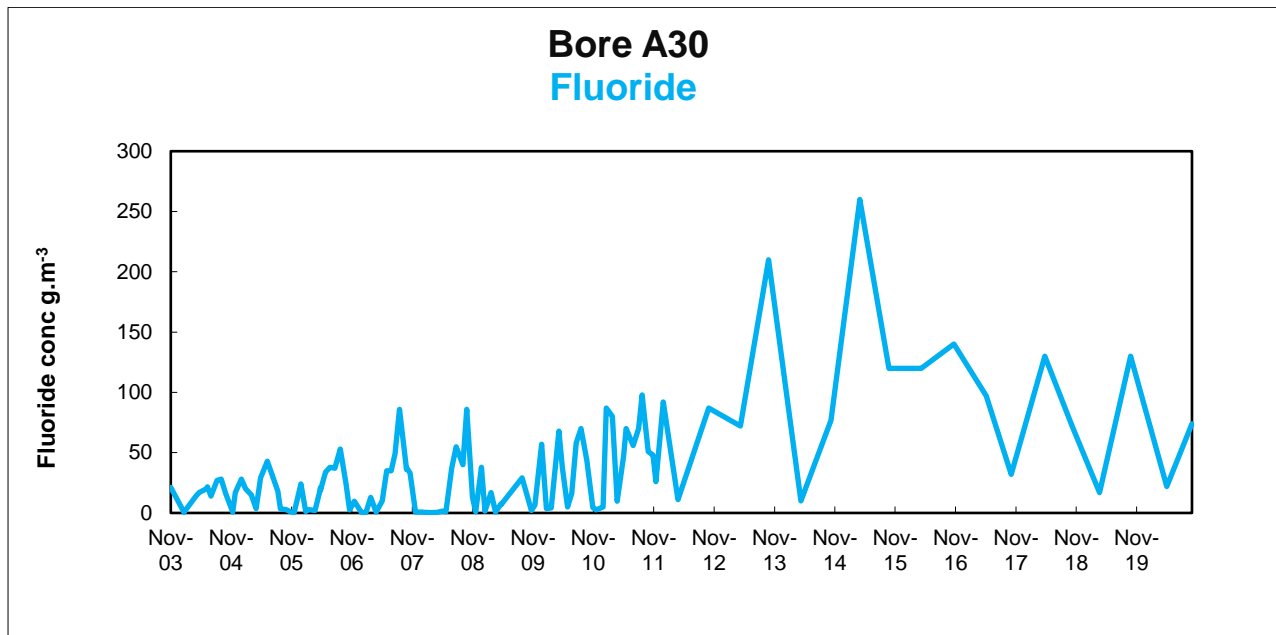
Bore **A30** is directly south of carbon piles which are not currently capped. This is likely to be the cause of the elevated fluoride levels observed in this location. Additionally, there are newer carbon deposits upstream of the capped carbon pile as well as fluoride rich alumina coated discarded torbed filter bags that are highly likely to contribute to the long-term increase in the fluoride levels at this bore.
