New Zealand Aluminium Smelters Limited

SCL GROUNDWATER STATUS

2020

Date: 29 March 2021

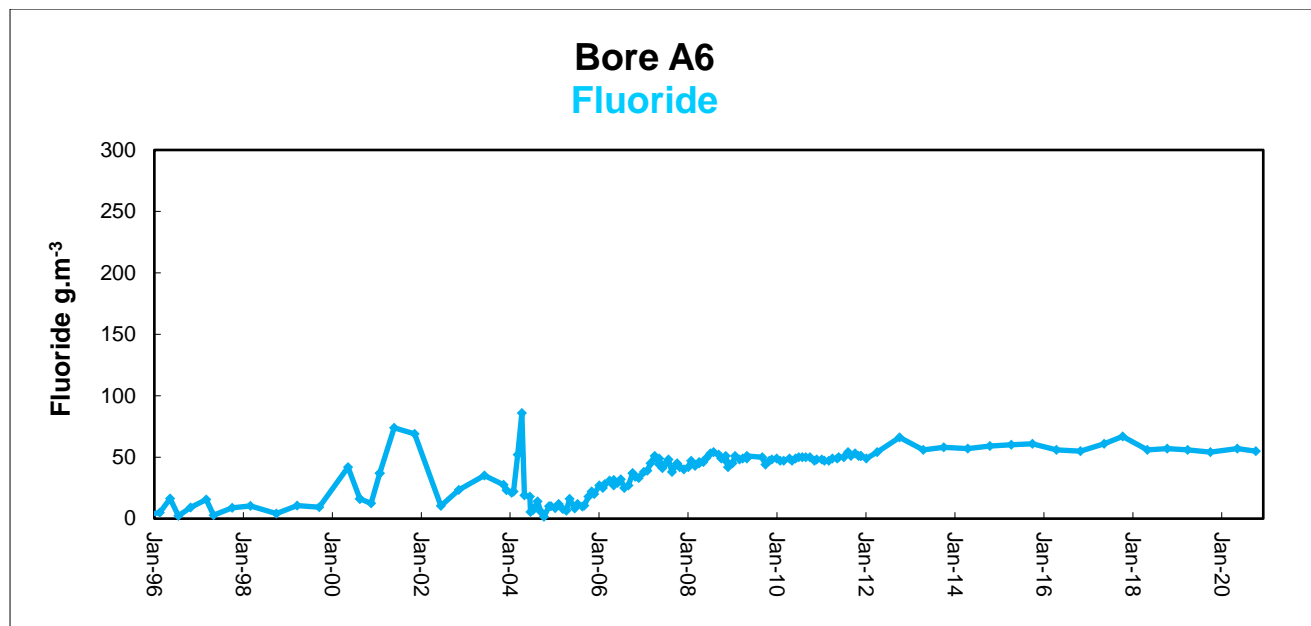
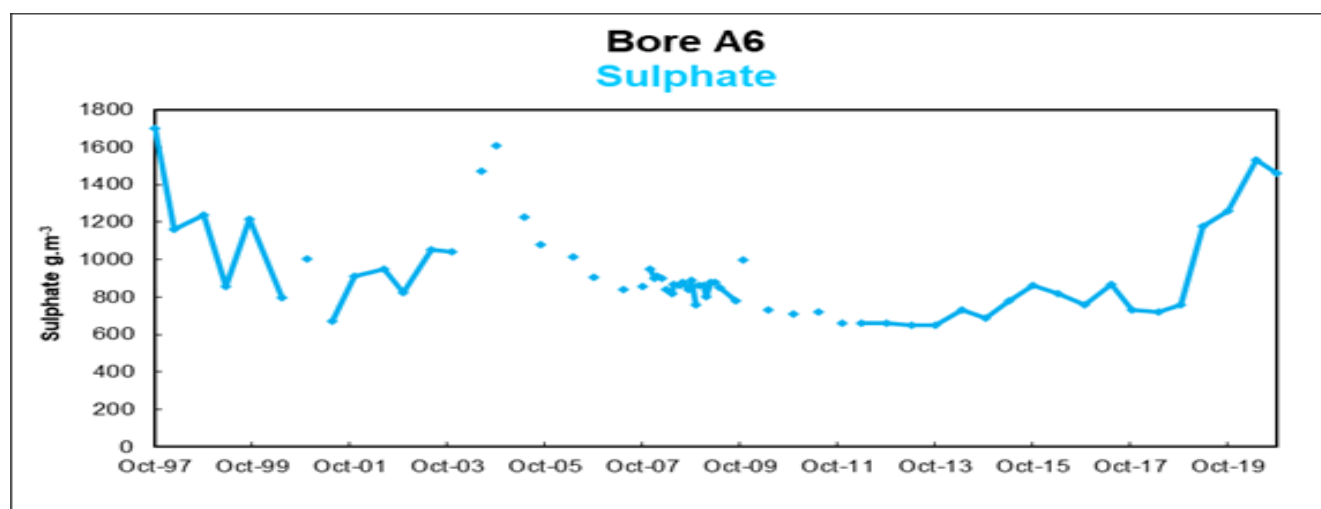
Bore **A6** is located north of Bore **A30** but not directly associated with any active waste piles. The level of fluoride contamination in this location is likely to be due to historical deposits of dross or bath.

There was a five-fold increase in fluoride between 2005 and 2008. Fluoride levels have now stabilised at levels slightly less than what is seen in Bore **A30**. Sulphate levels in upstream bores are generally less than 50 g/m³ indicating significant historical leaching of sulphate into groundwater as measured by Bore **A6**.

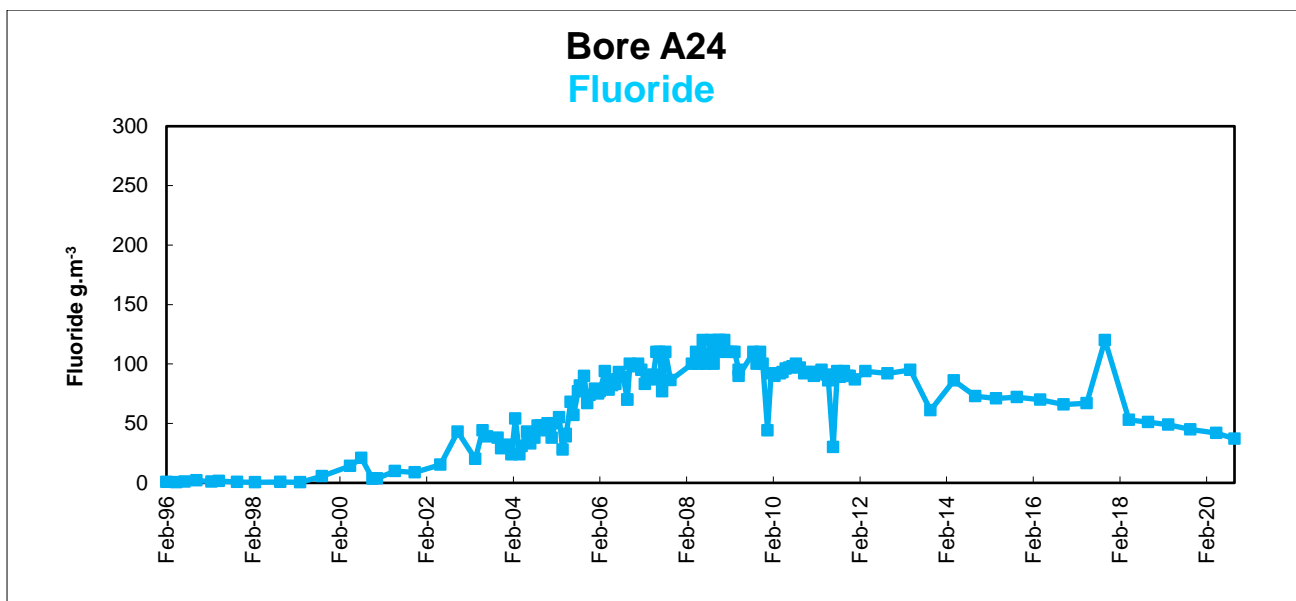
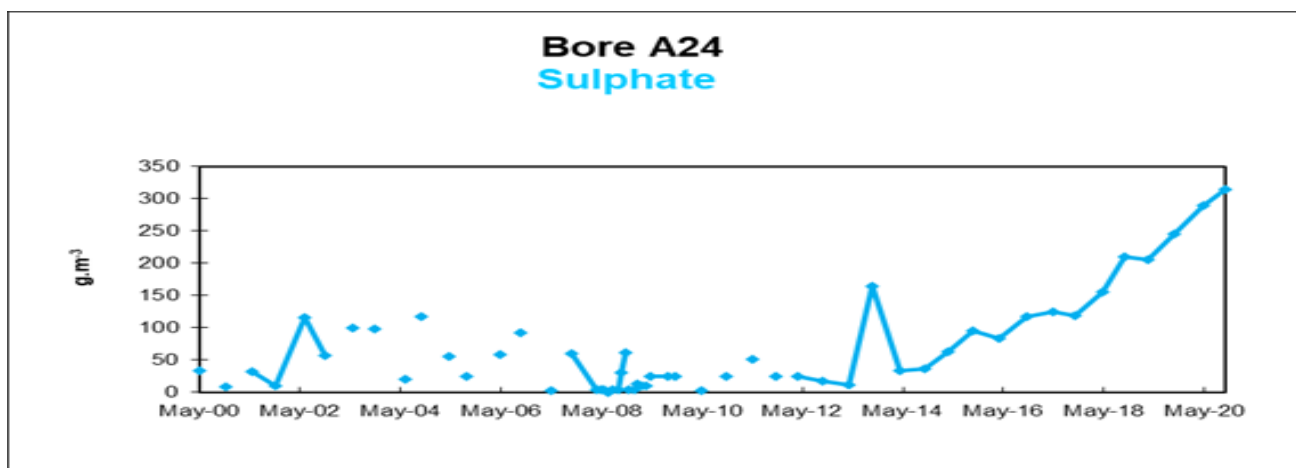
Bore **A24** is located downstream of the open cell of MRP dross. Levels of fluoride in this bore are steadily decreasing while sulphate is increasing. Sulphate levels in this bore started to increase in mid-2014 and continue to do so. Given the high concentrations in Bore **A6**, the elevated levels in Bore **A24** (see below) this may be due to the same source of sulphate as in Bore **A6**. Further work is required to identify the root cause of the high sulphate.

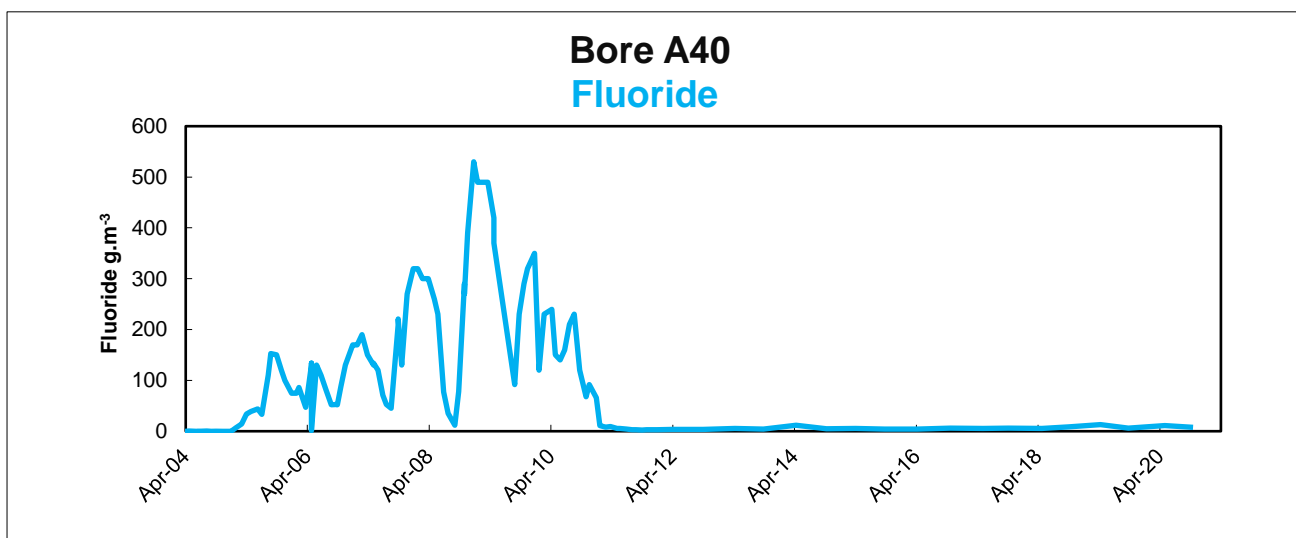
Bore **A40** is located south of the Haysom's dross. This material was deposited there around 2002/2003 and this is the reason why high fluoride values are observed at the start of the monitoring period. The leachate in this cell has steadied to a value under 10 g/m³ indicating minimal high fluoride leachate occurring after capping with an impermeable membrane in 2009. Fluoride levels are now similar to values seen in background bores.

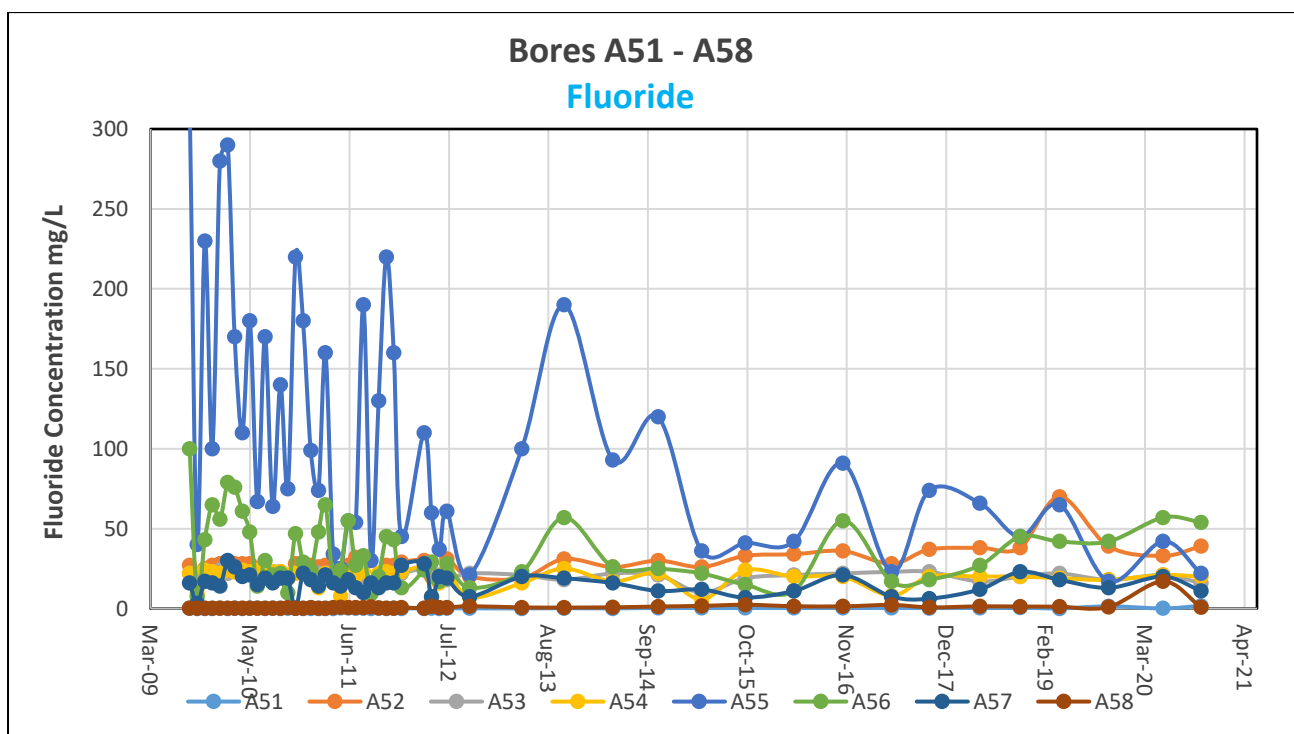
Elevated fluoride levels were observed in six of the eight coastal bores upon installation in 2009. There has been a general decrease in fluoride, or otherwise stable levels of fluoride, since that time.

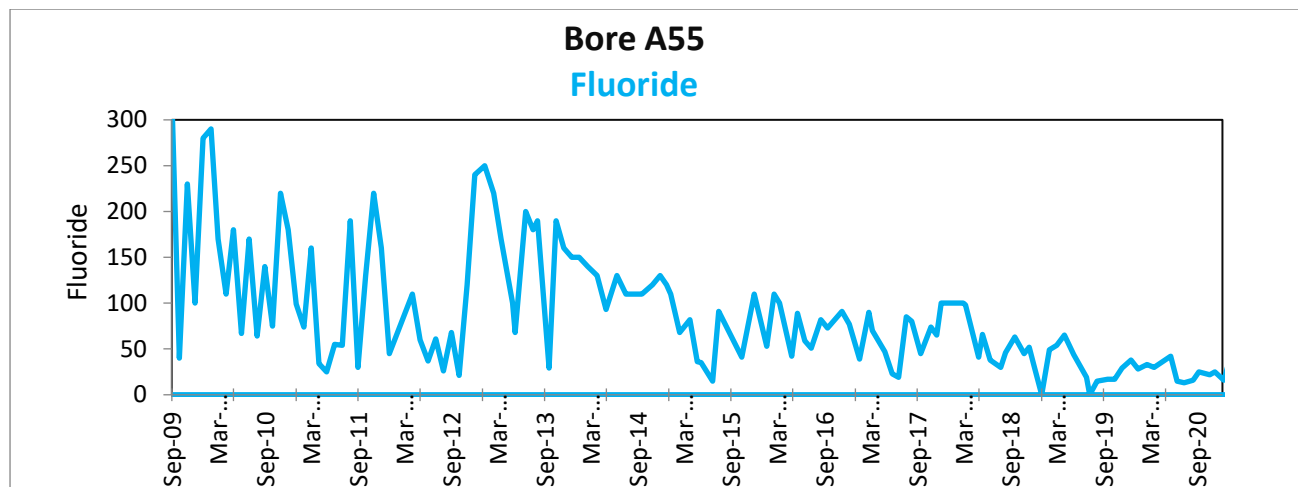
Bore **A55** south of the MRP dross pile has shown the greatest decrease in fluoride concentration over the last 10 years.

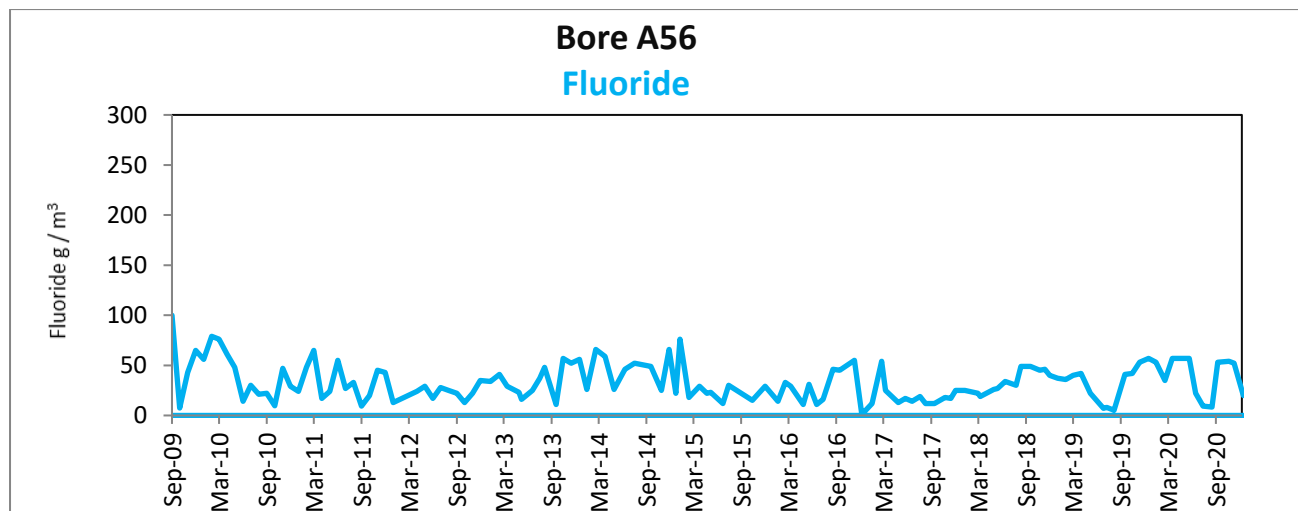
The adjacent Bore **A56**, located between the MRP area and the Haysom's cell is stable although still showing elevated fluoride levels indicative of leaching of fluoride from either of these two areas.

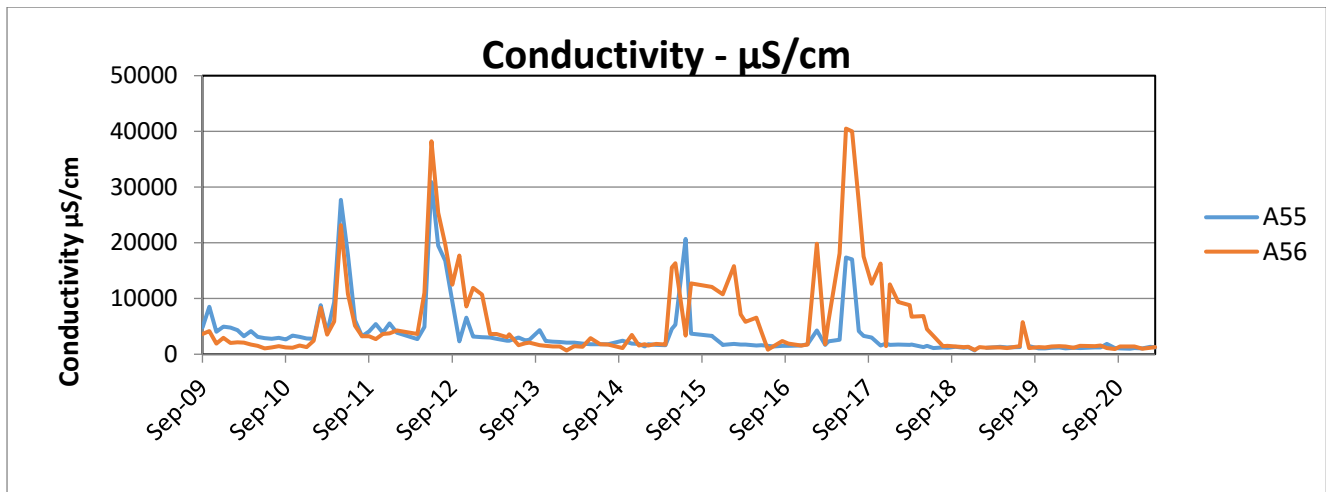
Conductivity is another indicator for potential contamination. Large spikes in conductivity are seen on several occasions which do not match the elevated fluoride levels. This is likely to be due to seawater ingress into the bore. Conductivity of seawater is approximately 50,000 $\mu\text{S}/\text{cm}$. The fluoride concentration in seawater is 1.3 g/m³ so if there was seawater intrusion into the bores there would be a minor but observable contribution to fluoride from the seawater. However, no correlation is observed and the absence of this correlation is not clear.
