## OBSERVATION REPORT

PARKSIDE I AND II, ELDERLY HOUSING

BRANFORD HOUSING AUTHORITY

DB FILE 9693

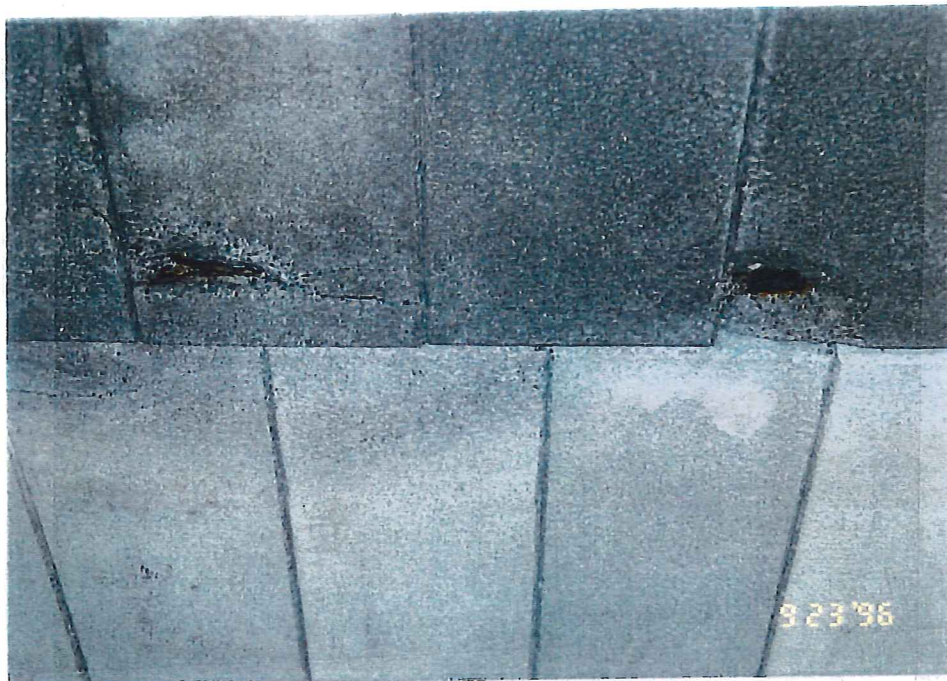
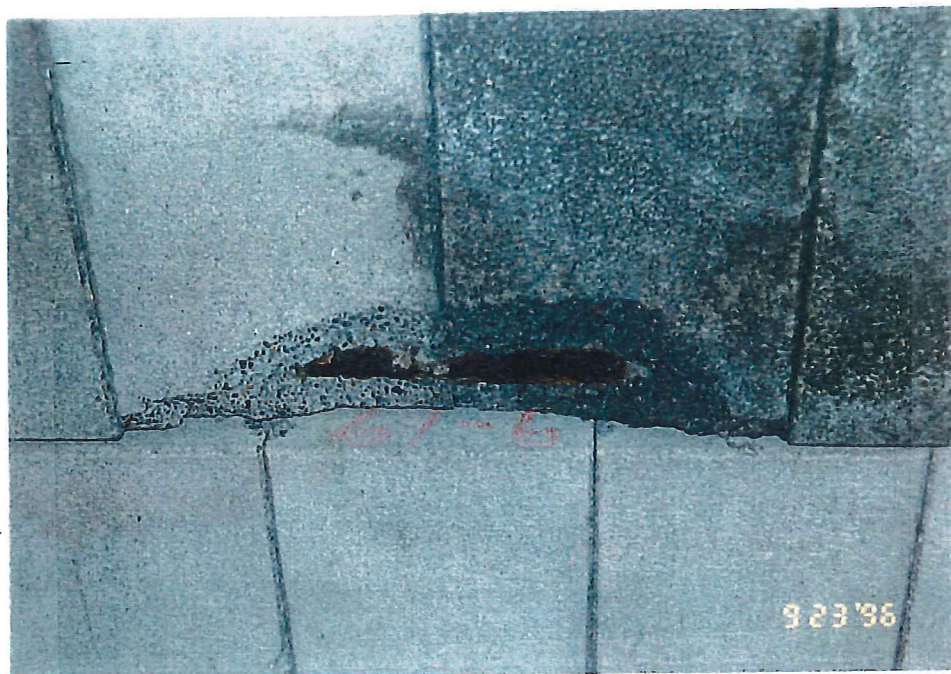
C. In one place, the bottom of the planks has spalled off. The rusty reinforcing bars are exposed there. The concrete topping over this area is apparently intact.

(1) The most likely cause of the problem, in my opinion, is that salt may have been used to melt ice at some time. I don't know if salt was used, but it is the most likely explanation for the condition. Salt water can penetrate most concrete, and salt "subverts" the protection afforded by the concrete. Salt should never, never be used on reinforced concrete.

SPALLING & RUSTY REINFORCING AT WALKWAY SOFFIT.

(2) I recommend flushing the area with clear water to draw out the salt. Once a day for two weeks should be adequate. Then remove the rust and adjacent concrete, treat them with a rust-retardant coating, and patch the areas with latex mortar. Alternatively, coat the steel with lime putty. Recommended priority: high medium; estimated cost of remedial work: \$1,150 for patching;

*\$4,154 for flushing, removing rust, and treating with coating. Rinsing can more economically be performed by staff.*

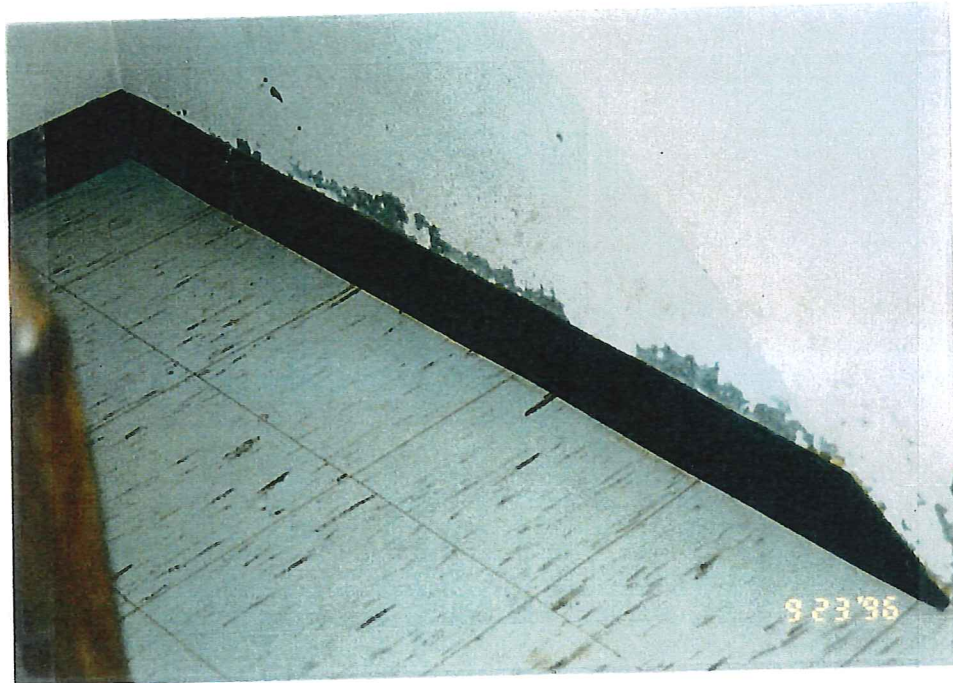
A. In one stairway where the ground level floor is partially below grade there are peeling paint and some efflorescence. This indicates that some water is penetrating through the wall or rising up from below. There is no apparent problem except visual. Therefore no remedy is required for functional reasons. For aesthetic reasons, I recommend scraping off all loose paint, cleaning the surface, and applying either lime wash or latex house paint, both of which will resist peeling when damp and will allow moisture to evaporate. Recommended priority: very low; estimated cost of remedial work: \$336. If a method of stopping the water infiltration is wanted, I can respond. However, one of the characteristics of "rising damp" is that

painting the inside surfaces makes the problem worse. Remedial work (to stop the rising damp, not to hide it) will probably be expensive and will not accomplish much.

"RISING DAMP" AT BOTTOM OF WALL IN PRIMARY STAIR ENCLOSURE.

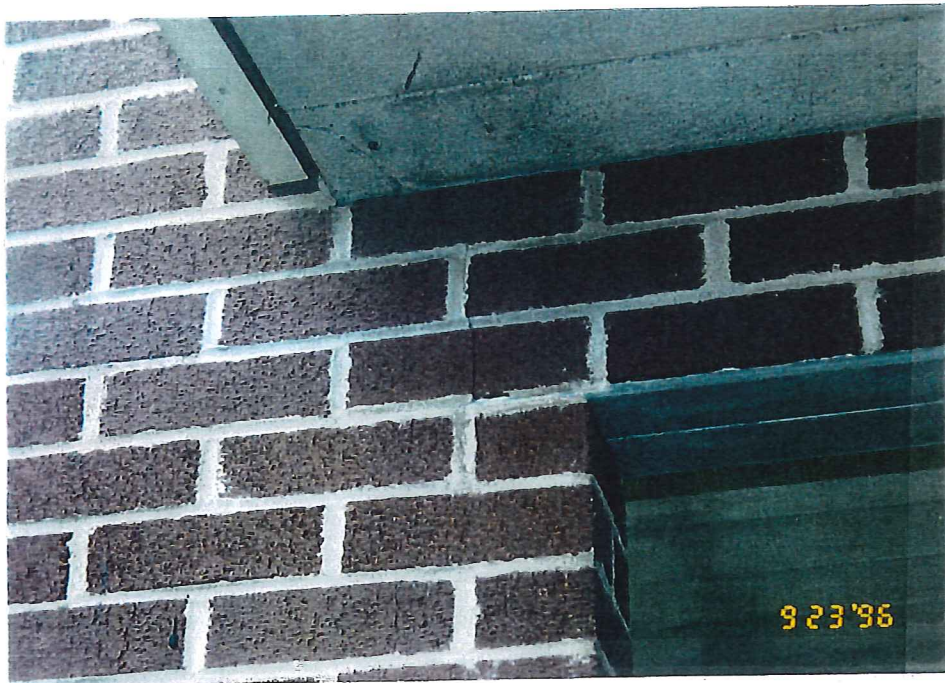
5. The second floor walkway decking is supported on masonry piers and masonry-steel lintel beams. The piers continue through the building as fire walls. The masonry is generally in good condition, but there are some cracks at the ends of the lintels. The probable causes are thermal movement and stress concentration. *I recommend sealing the cracks with small joint sealant. Recommended priority: low; estimated cost of remedial work: \$1,022.*

CRACK IN BRICK UNDER SECOND FLOOR WALKWAY, AT END  
OF STEEL LINTEL.

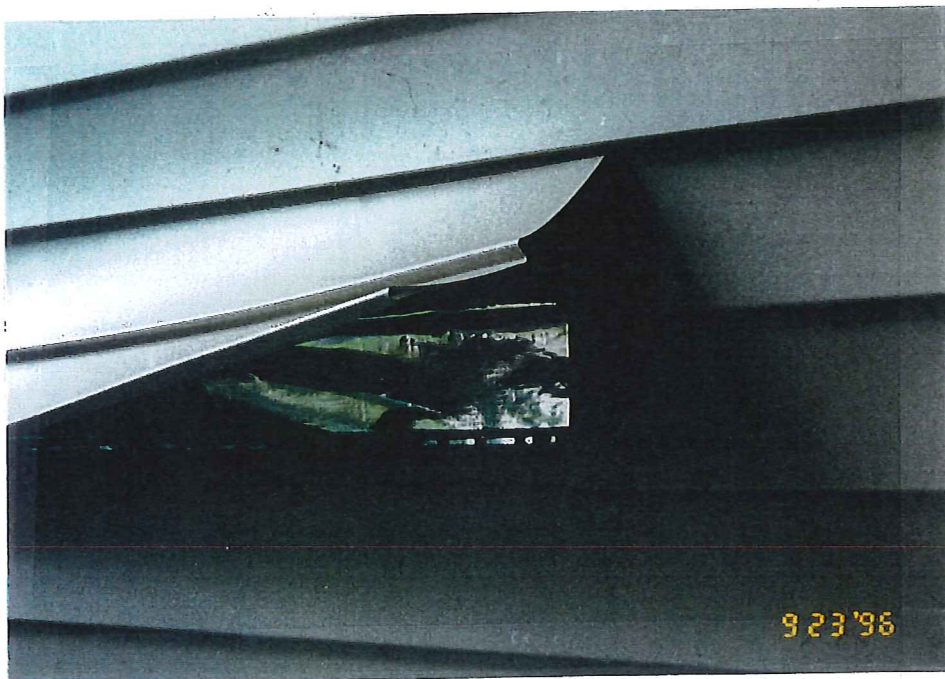
C. I loosened a portion of the vinyl siding on the A Building, using a vinyl siding tool. I observed aluminum foil under the siding. The material is almost certainly a vapor retarder. Standard good practice for heated buildings in this region is to apply vapor retarders on the warm side of the walls; this vapor retarder is on the cold side. Thus condensation may occur in the walls. I returned on October 1 and tested the moisture content of the wall behind the vinyl siding and aluminum foil, using insulated moisture meter probes so that the foil wouldn't change the reading. I found slightly elevated moisture content, about 12%. Moisture condensation is most likely in cold weather, however, and I shall return this winter to test again. In my opinion it was poor practice to install a vapor barrier under the vinyl siding.

CLAPBOARDS LIFTED TO SHOW ALUMINUM FOIL UNDERLAYMENT

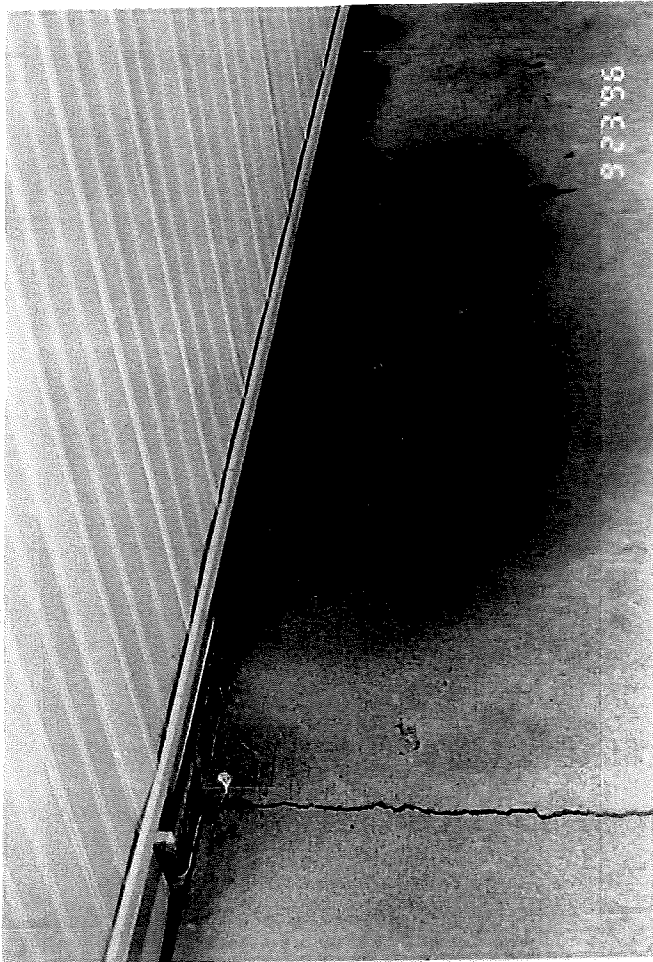
B. There are a number of cracks in the concrete topping over the precast decks, mostly perpendicular to the length of the walkways. The probable cause is thermal movement. I recommend cutting them out and sealing them with small joint sealant. Recommended priority: medium; estimated cost of remedial work: \$962.

CRACK IN WALKWAY TOPPING.

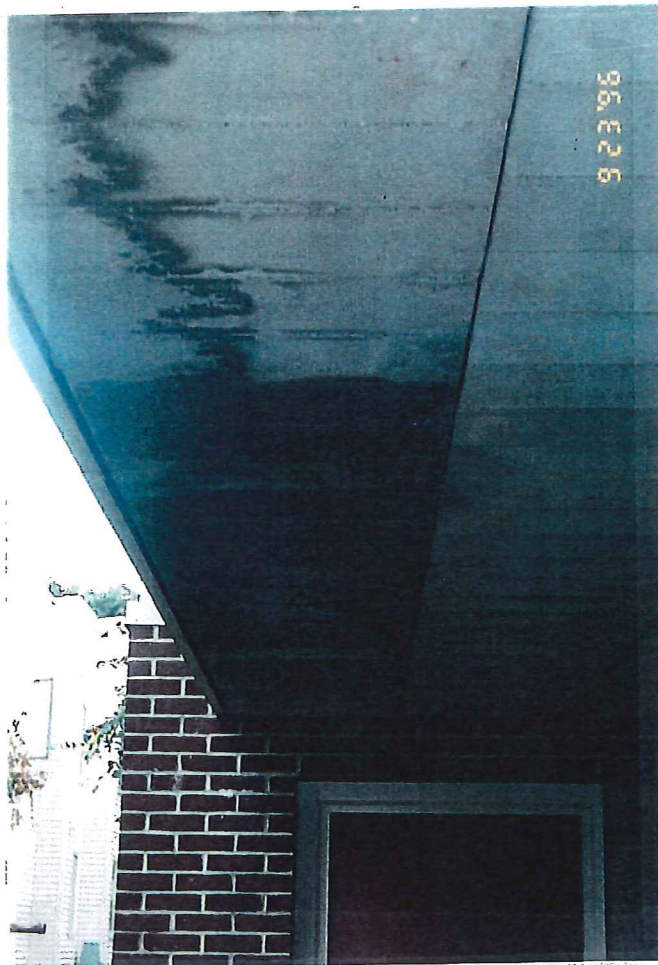
A. Because of the lack of a drip on the outer edge, water wicks back on the underside of the planks and creates an unsightly condition. I recommend adding a small metal drip fastened to the outer edge and set in a bed of nonhardening sealant. Recommended priority: low; estimated cost of remedial work: \$1,706.

STAINS ON WALKWAY SOFFIT,  
FROM WATER WHICH RUNS  
OVER EDGE.

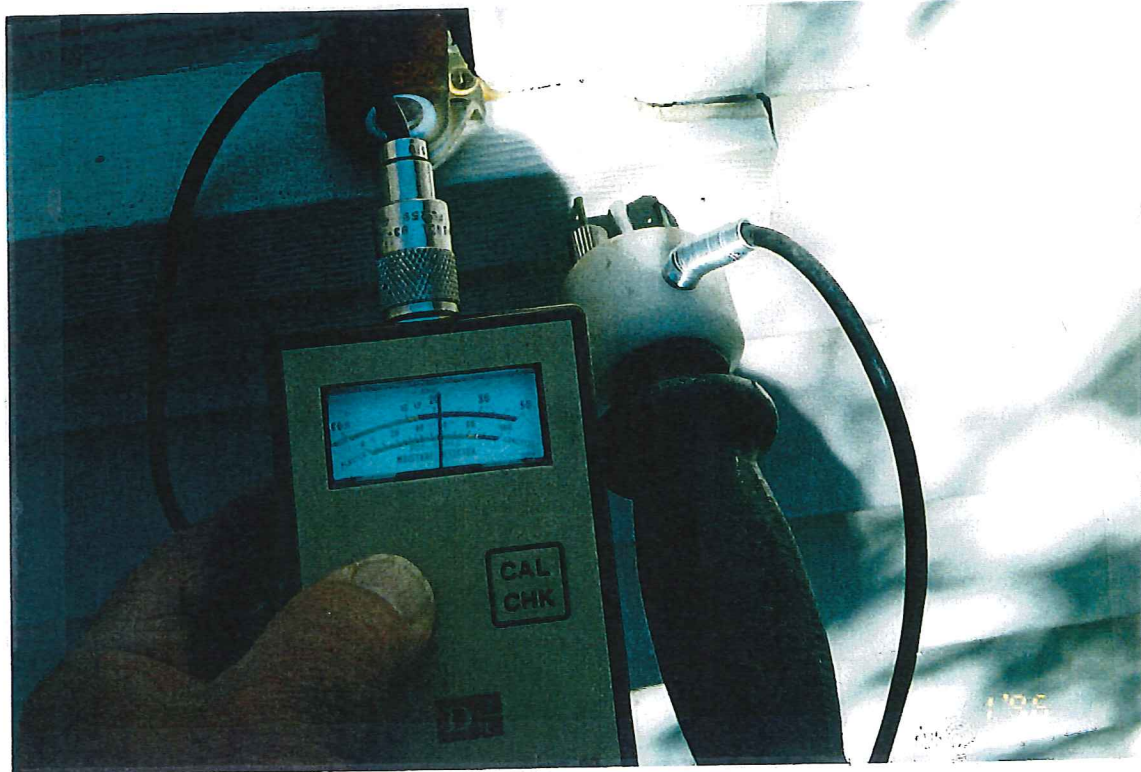
D. The prefinished aluminum trim, which is part of the vinyl siding system, covers window and door sills, jambs, etc. Although the workmanship appeared to be average or better, I am concerned that the wood covered with the metal trim cannot be inspected. I made a number of moisture tests, with insulated electrodes, into the wooden members covered with aluminum. I found high moisture content at most of them, especially near joints. I recommend inserting fungicidal rods, as specified above, where the wood is damp or exposed to dampness. Recommended priority: medium; estimated cost of remedial work: \$30 per unit. There are 168 windows, so the cost of treating every window would be \$5,040.

MOISTURE CONTENT 20% AT METAL-COVERED WINDOW SILL.

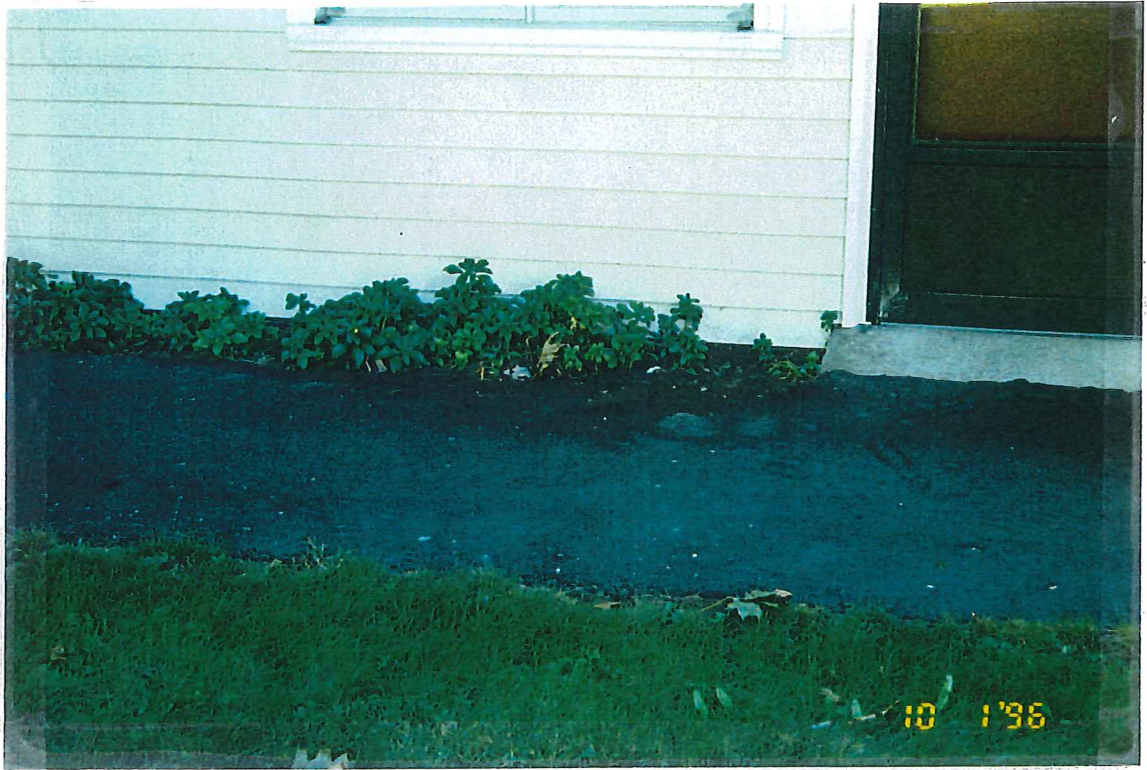
SIDING EXTENDS DOWN TO & BELOW GRADE.

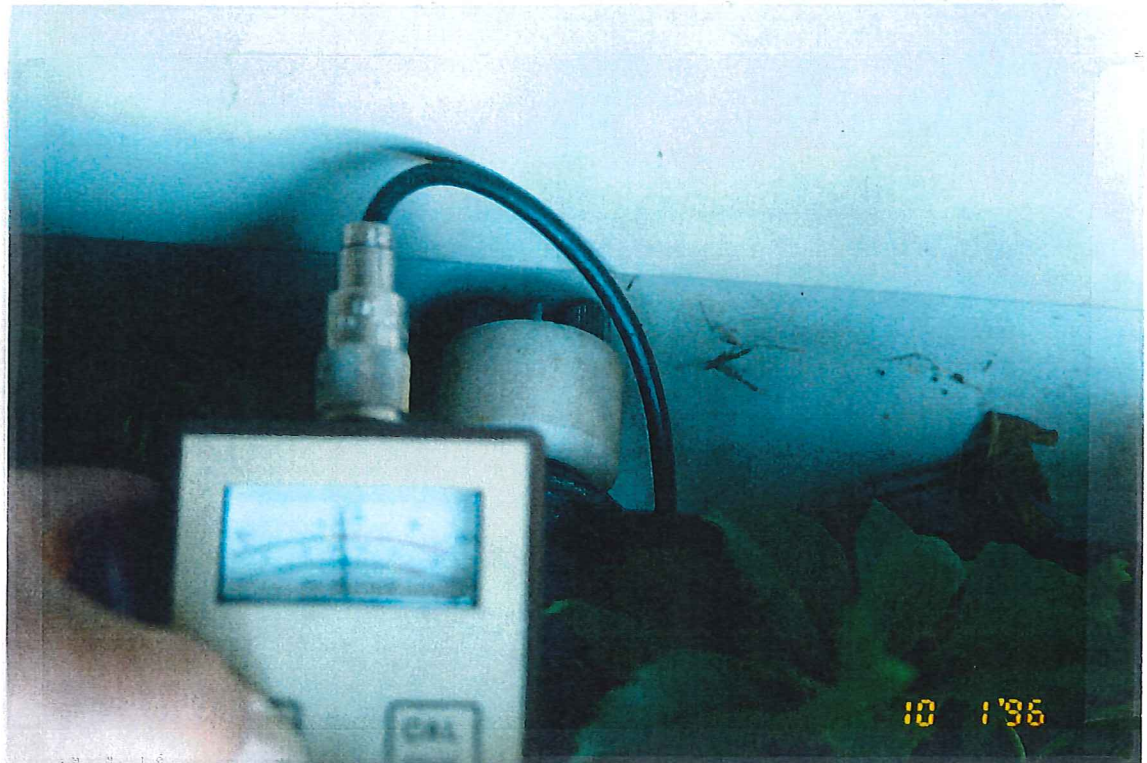
MOISTURE CONTENT IS 17% AT THIS AREA OF WALL NEAR GRADE.

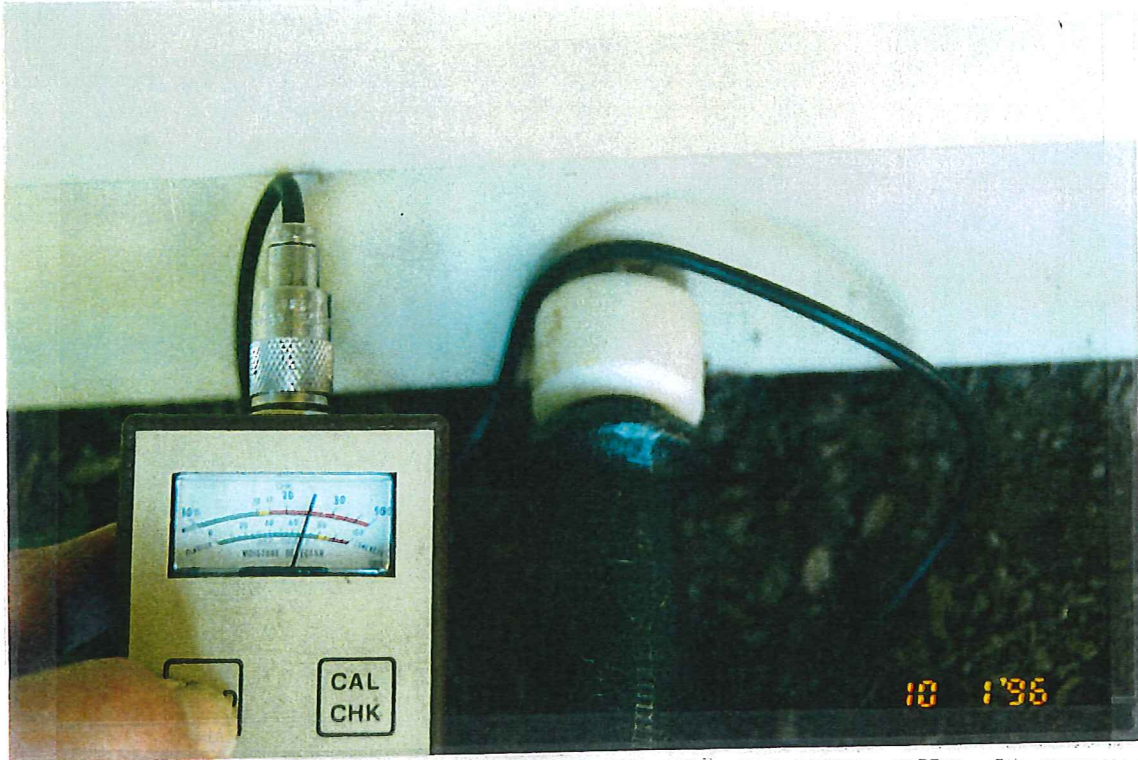
- B. I tested typical areas of the sills with the insulated probes on a Delmhorst moisture meter. I obtained readings of about 20%. A moisture content of 20% or higher promotes the growth of wood-destroying fungi. I expect the moisture problem to be worse in winter.

MOISTURE CONTENT IS 25% AT THIS AREA OF WALL NEAR GRADE.

- C. I recommend trying to lower the grade, even if only a little. Then loosen temporarily the vinyl siding to expose the sheathing and underlayment behind it. Drill through the sheathing into the framing, and install borate fungicidal

rods in the holes, in contact with the sills and also the sheathing. Then putty or tape over the holes, patch the underlayment, and reinstall the vinyl siding. The borate rods will slowly dissolve and kill the fungi. Specifications: Chemical Specialties, Inc., "Impel" rods, 1/3" x 1". Phone: (704) 522-0825. Rods can also be purchased from PRG, P.O. Box 1768, Rockville, MD 20849-1768, (301) 309-2222. Note that state regulations may require certification to apply this or any such product. Assume one borate rod per foot of wall. Recommended priority: medium; estimated cost of remedial work: \$1,059.

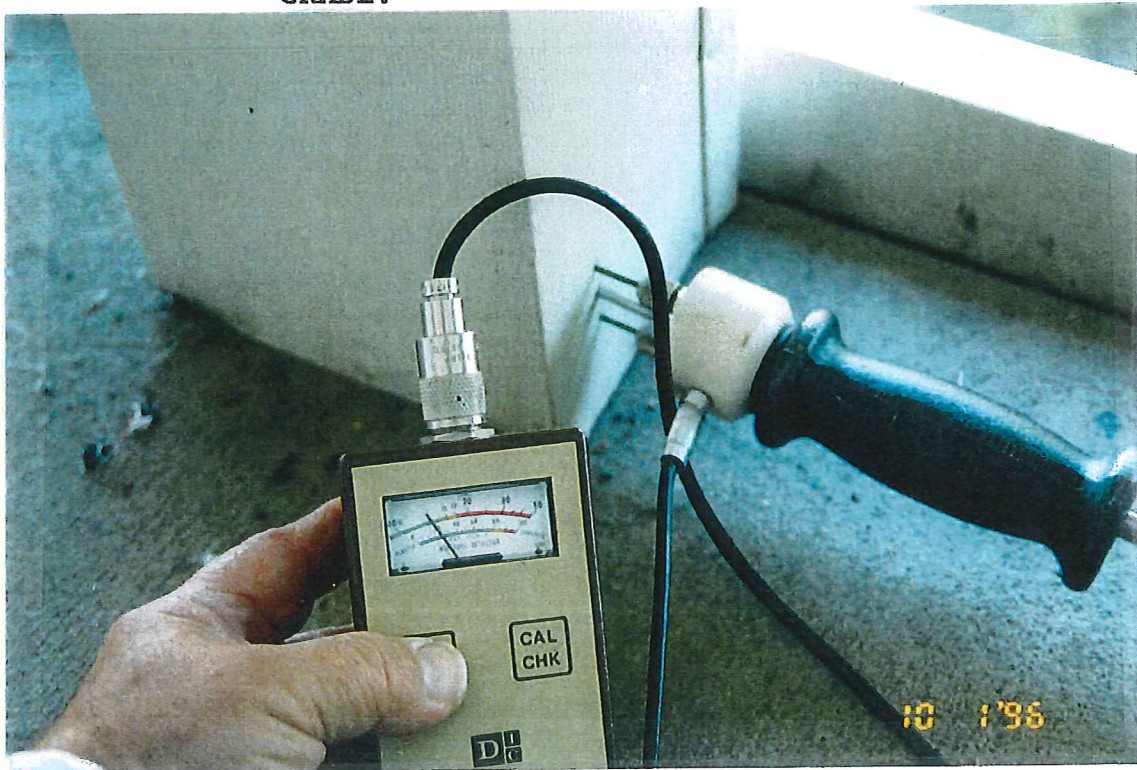
MOISTURE CONTENT IS 12% AT WALKWAY POST BASE.

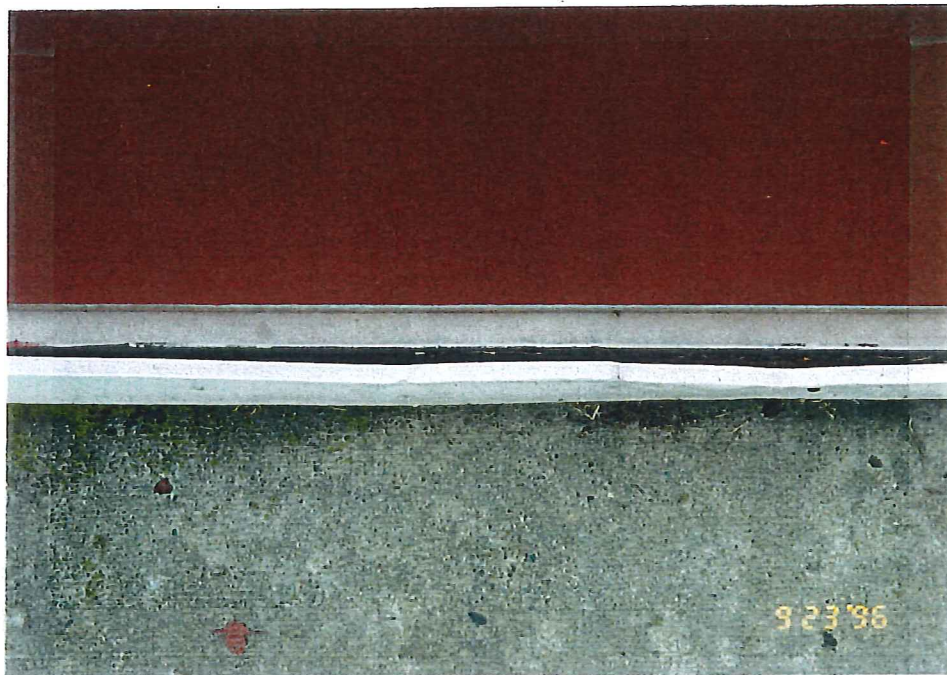
3. In many cases the thin aluminum cladding applied outside secondary exit door sills has bent and come loose. Recommendation: cover it with heavier-gauge aluminum. Recommended priority: high, since this condition could cause falls; estimated cost of remedial work: \$22 per door. There are 14 secondary exit doors, so the cost of treating all of them would be \$308.

THIN METAL TRIM BELOW SECONDARY EXIT DOOR IS  
LOOSE.

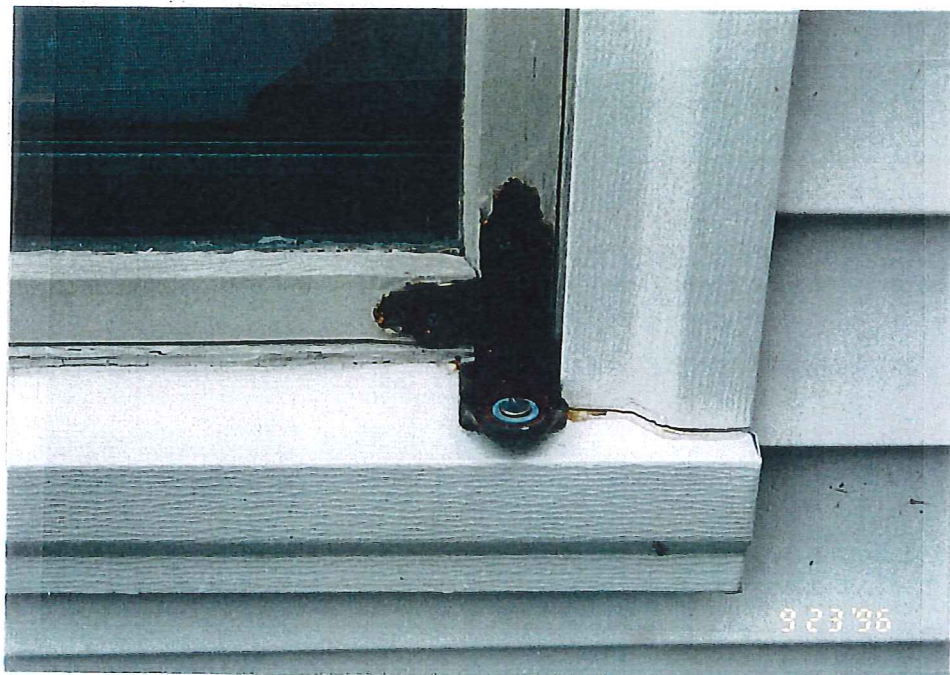
4. Most windows are wooden casement sash. There is some deterioration of the wood, and some of the hardware is rusty. Recommendation: The windows could be replaced, or most could be refurbished. Refurbishment would include demounting the windows, making minor repairs to the frames and sash, treating the wood with water-repellent preservative solution, priming and painting the sash and frames, cleaning and coating the hardware, and then reinstalling the windows. I recommend taking competitive bids for repairs vs. replacement. Recommended priority: medium; estimated cost of remedial work: \$138 per window for refurbishing existing windows and \$427 per window for new windows. There are 168 windows, so the total cost of restoring them would be \$23,184 and the total cost of repairing them would be \$71,736.   
replacing

RUSTY WINDOW HARDWARE.

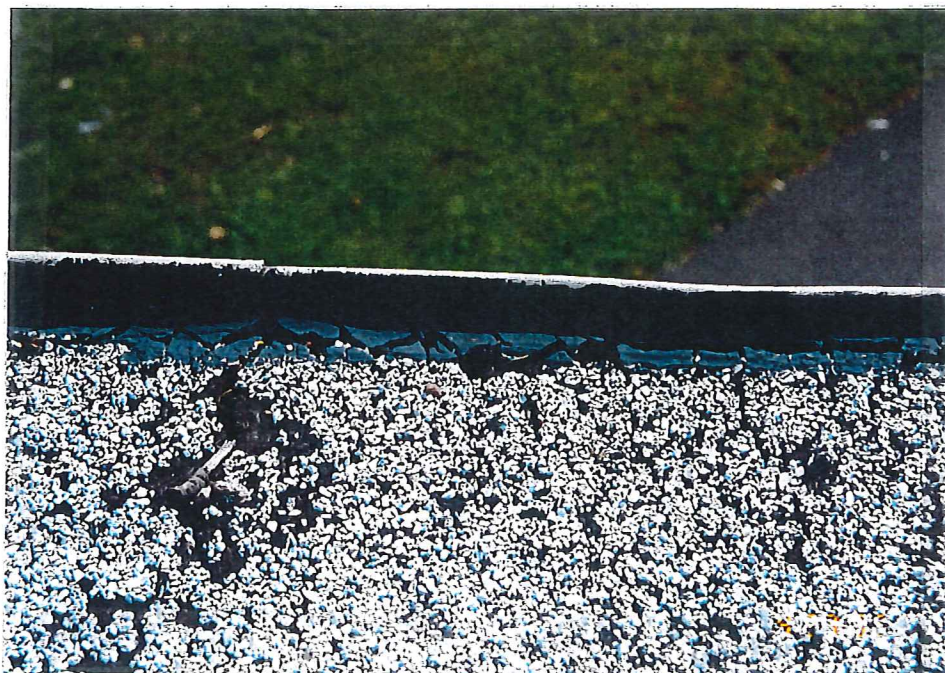
4. The edge details depend for waterproofing on a bead of mastic. The mastic has, in most places, turned hard and cracked. The detail at the eaves, where there are gutters, does not have adequate resistance to water entry during ice damming, in my opinion.

CRACKED ROOF EDGE SEAL; DISINTEGRATING ROOFING.

6. *I recommend replacement of the roofing system, starting with the C Building, where conditions are worst.*
  - A. *Remove the existing roof system, down to the structural sheathing. Inspect the structural sheathing for decay and other defects, repair such defects, and provide temporary weatherproof protection.*

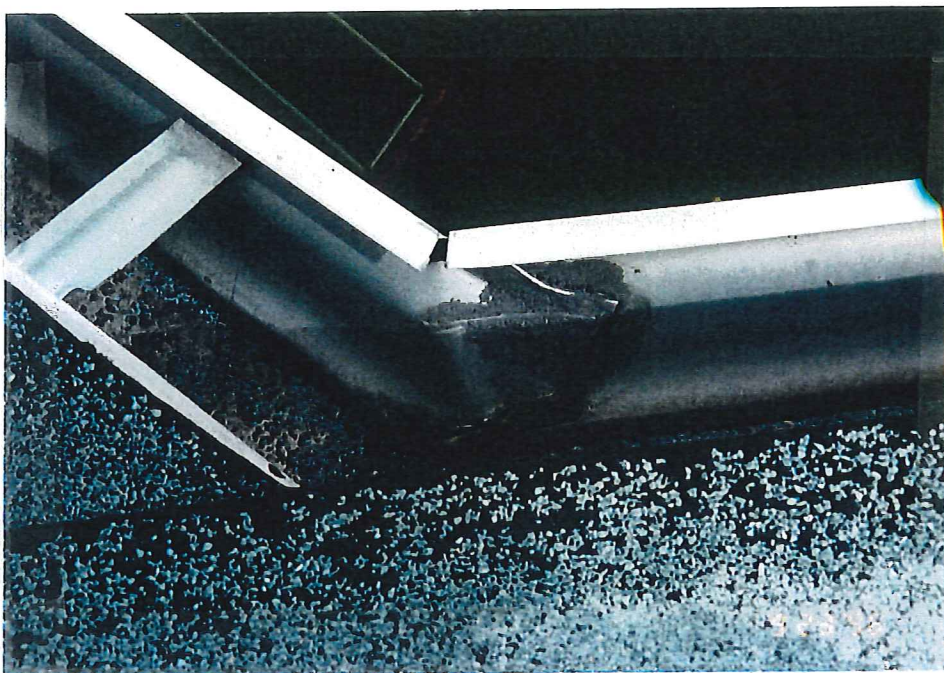
5. The existing aluminum gutters appear to be "seamless". At corners, however, the gutters were cut and folded, and sealant was applied (smeared) over the joint. Most of these joints have opened up, and water leaks from them. The proper detail would involve "buttering" the surfaces with nonhardening butyl sealant and then riveting the surfaces together.

POOR, LEAKING JOINT IN ROOF GUTTER.

*D. The gutters and other sheet metal work should conform to SMACNA recommendations. Corners and other joints should be set in PTI 404 nonhardening butyl sealant and then riveted.*

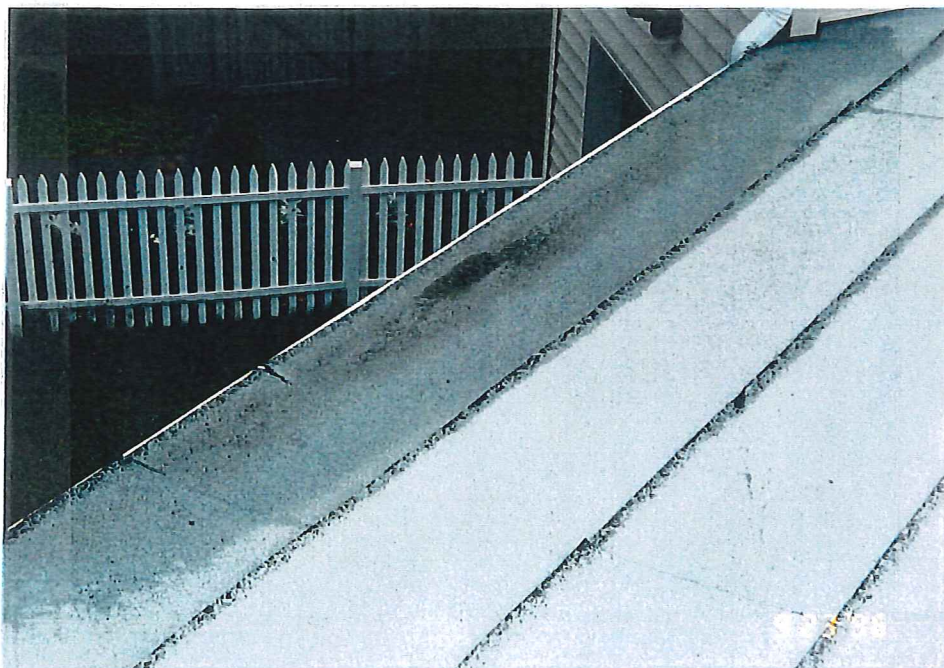
STANDING WATER ON ROOF.

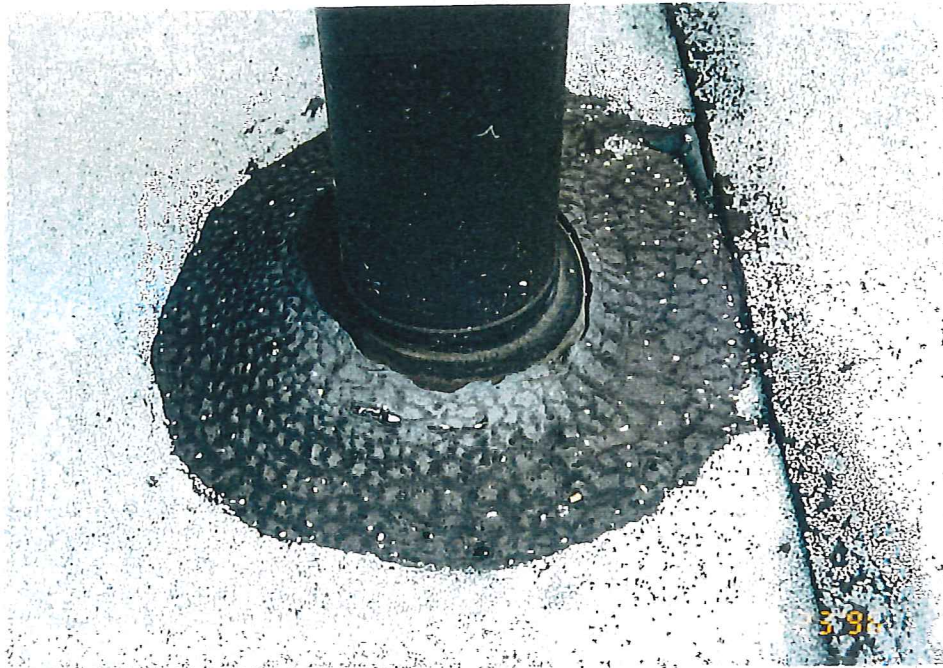
CRACKS IN ROOF PENETRATION FLASHING.

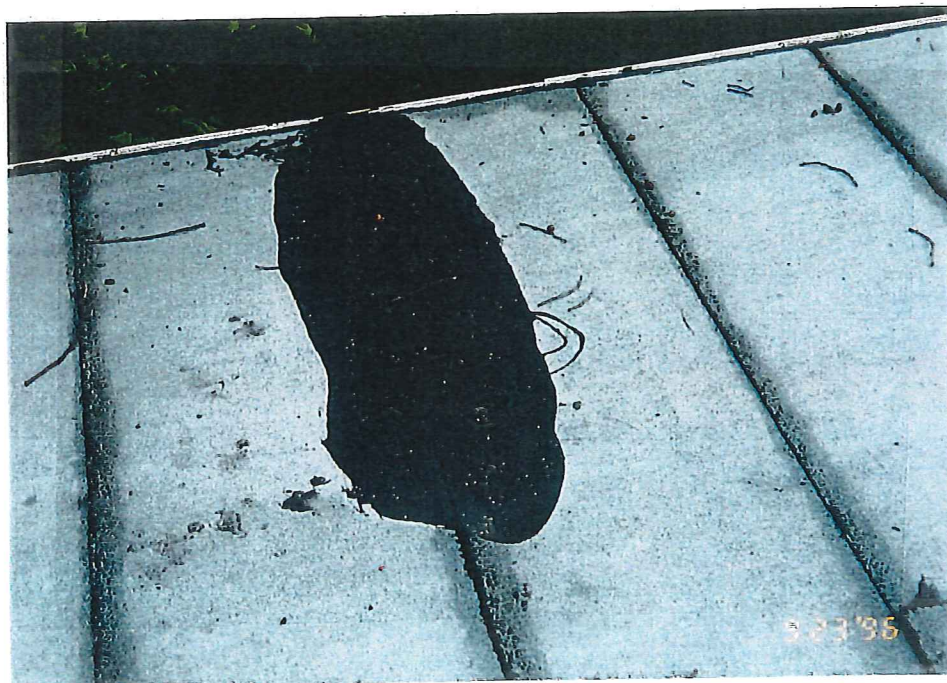
ROOF PATCH.

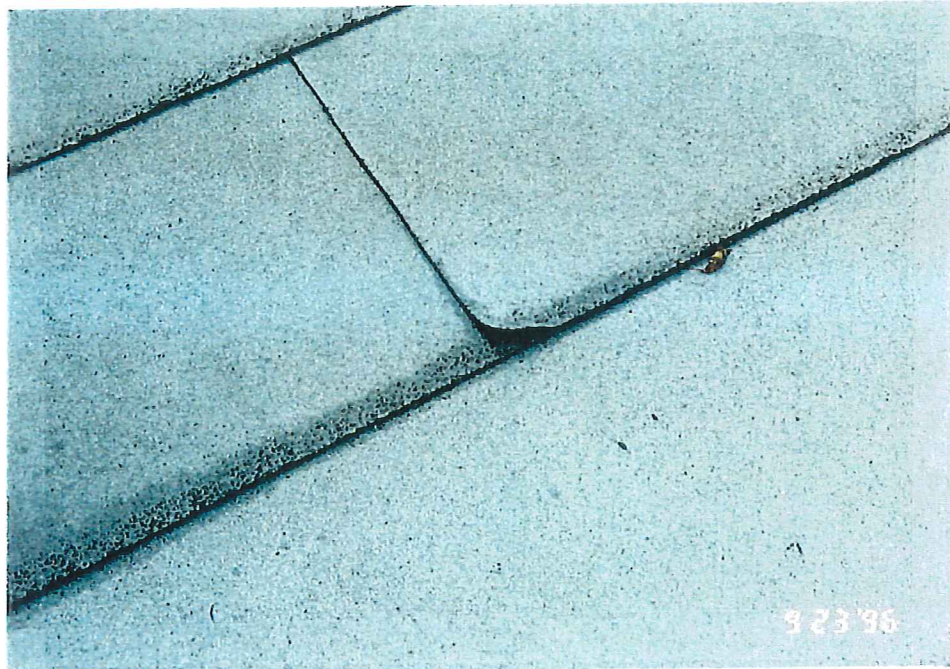
WARPED, LOOSE ROOFING CORNER.

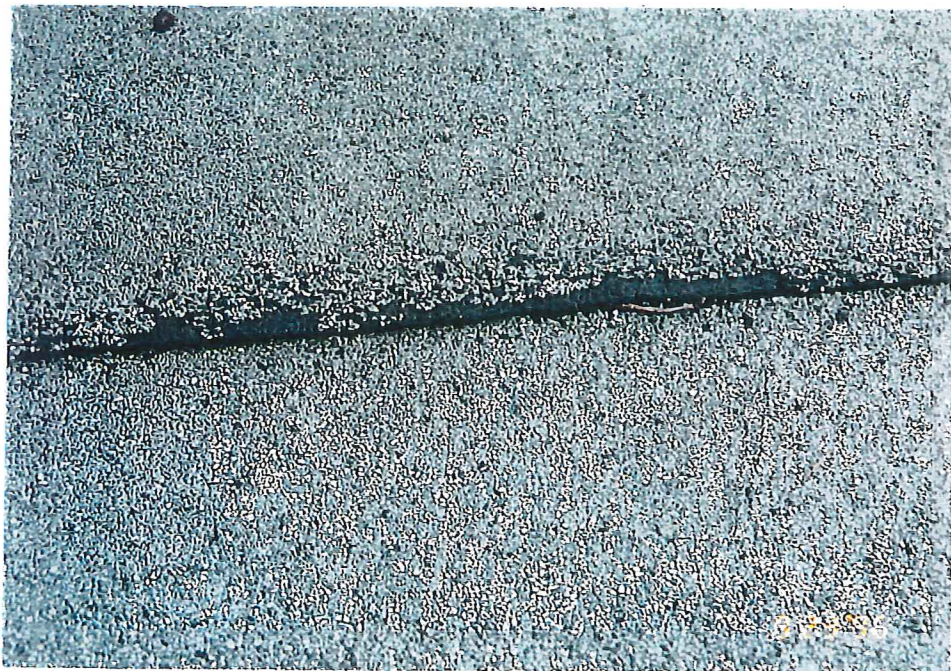
ERODED COATING ON ROOFING.

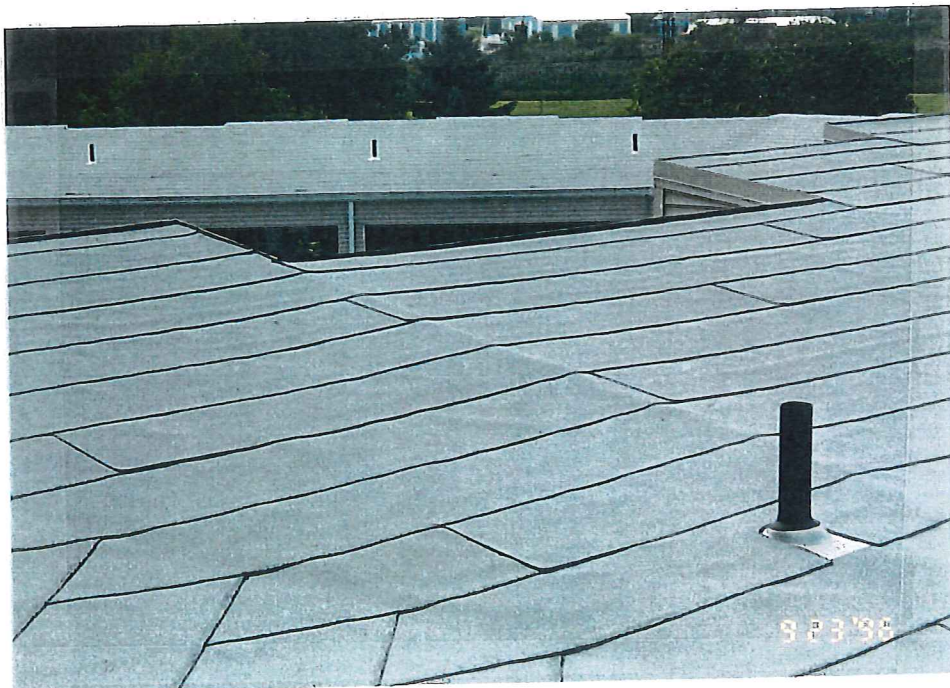
RIDGE IN ROOF; MR. BAERMAN DOES NOT KNOW THE CAUSE.

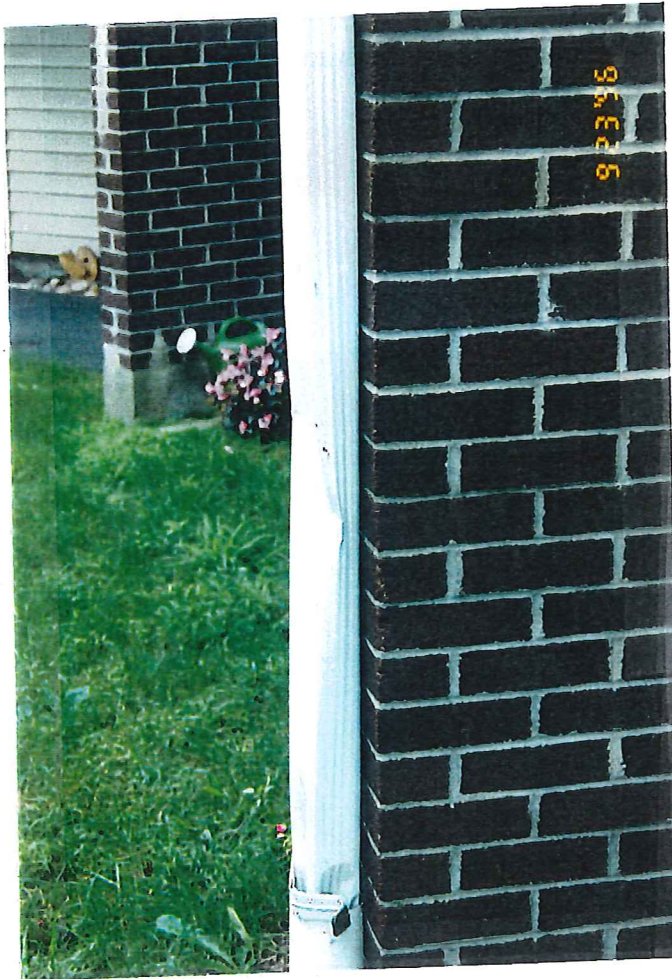
← MUNCHEDED RAIN WATER LEADER.

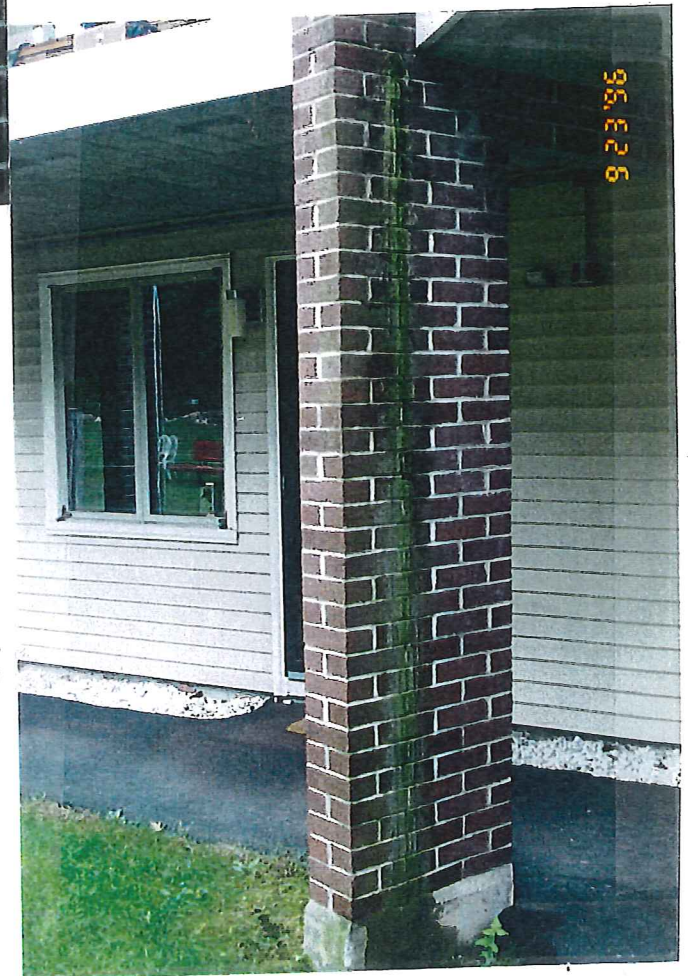
ALGAE ON PIER  
BELOW LEAKING JOINT  
IN RAIN WATER GUTTER. →

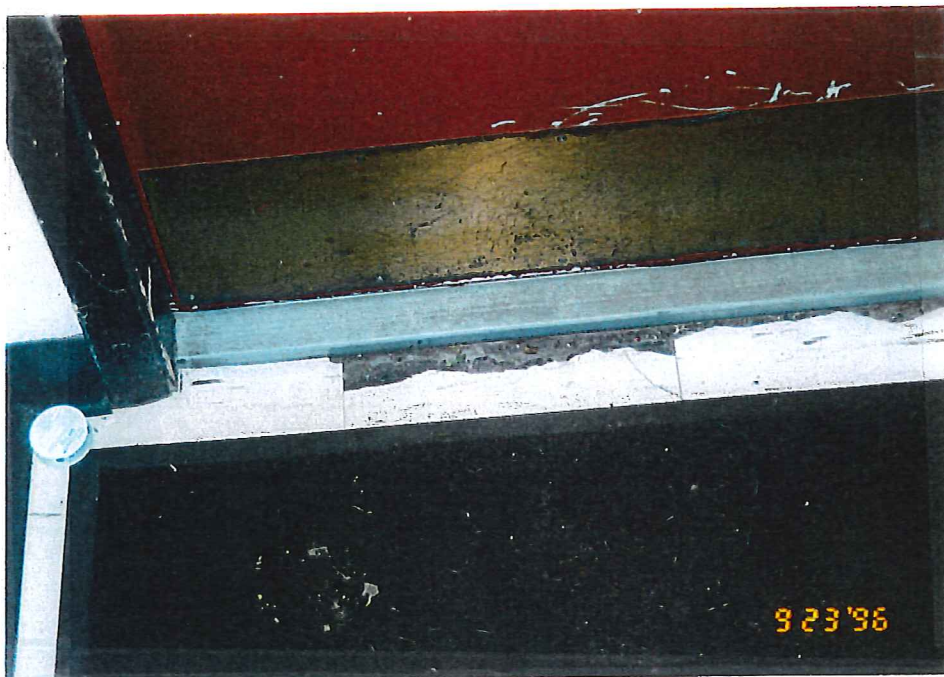
5. Resilient floor tile in stairways, next to the exterior door saddles, is chipped and broken. *I recommend removing the broken tiles (probably require special procedures; probably contain asbestos), levelling the slab, and installing new tiles. Recommended priority: low; I don't think this is a tripping hazard; estimated cost of remedial work: \$450 per opening. There are 12 such openings, so the total would be \$5,400.*

CHIPPED RESILIENT FLOORING IN PRIMARY STAIR ENCLOSURE.

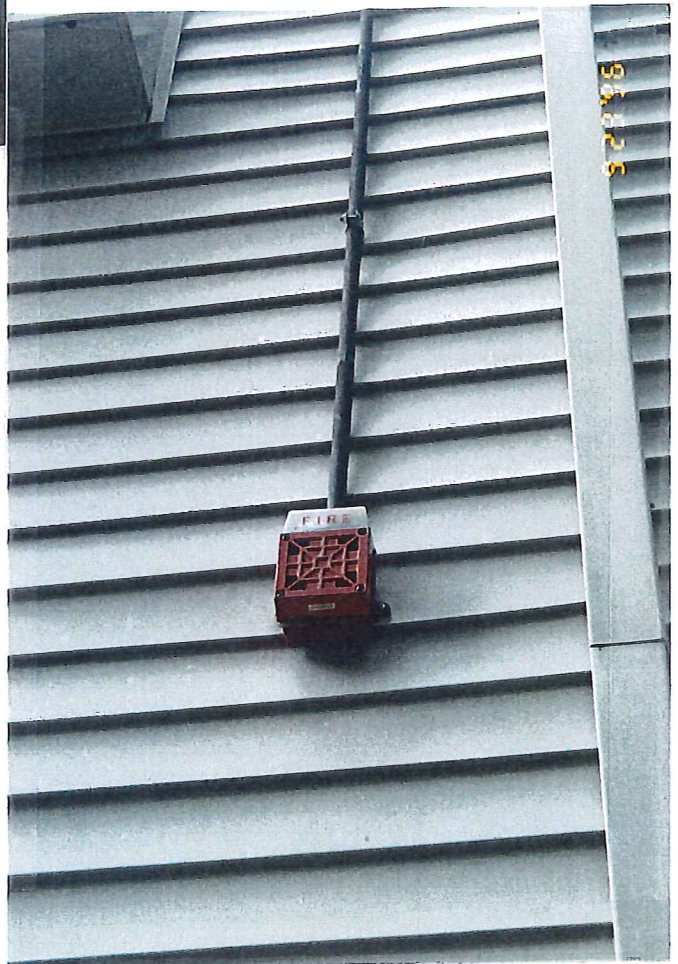
3. Electrical conduit on the exterior, to fire alarm boxes, is beginning to rust. *I recommend cleaning, priming, and painting it. Recommended priority: low; estimated cost of remedial work: \$22 each x 1 = \$22.*

SLIGHT RUST ON  
CONDUIT. →

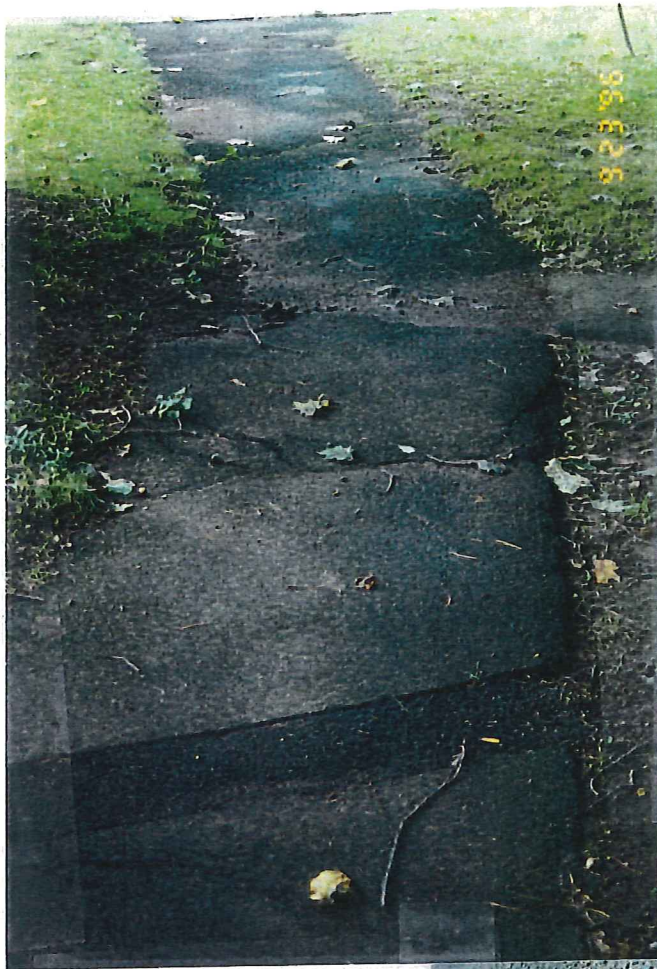
IRREGULAR SIDEWALK.

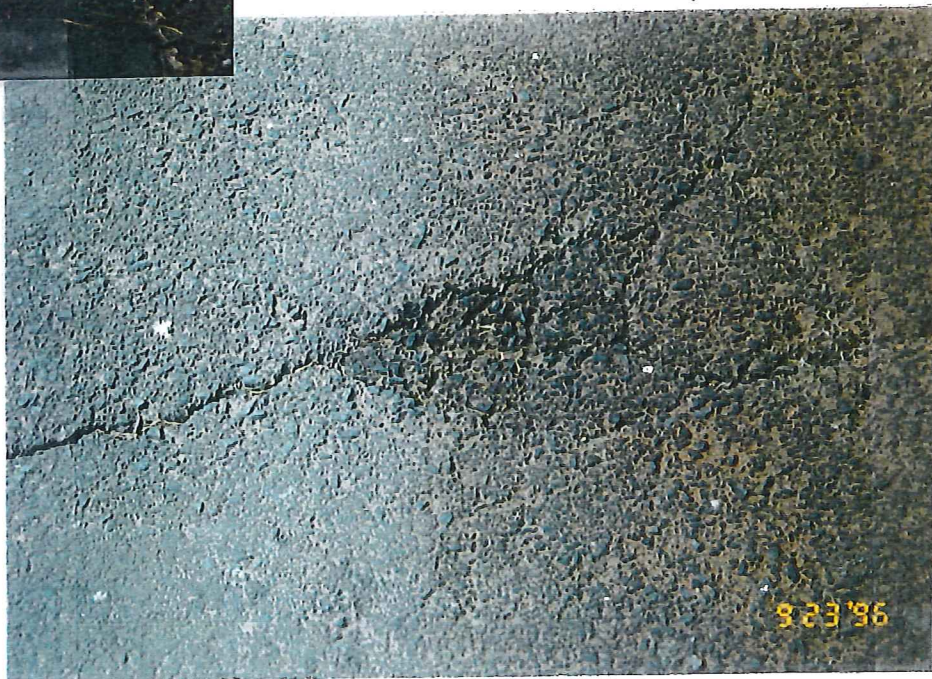
1. There are many cracks and irregularities in the paving, some of which could cause tripping. *I recommend patching of the worst areas soon and replacement of the paving, or major areas of it, when the budget will support that effort. Recommended priority:*

CRACKED PAVING.

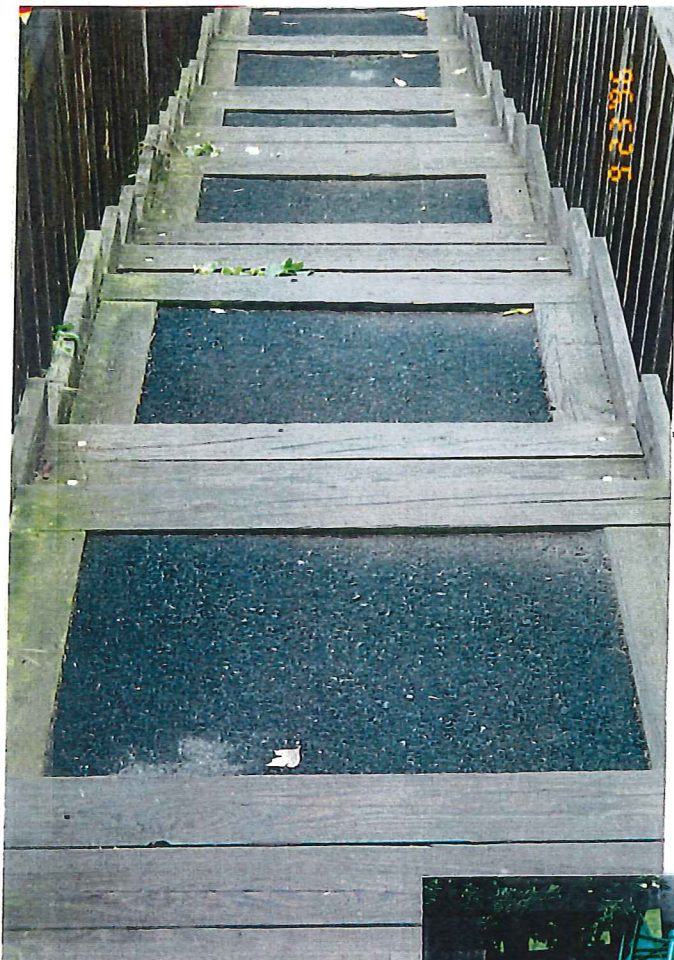
3. There are site stairs with low risers and broad treads. The construction is wooden timbers with asphalt paving in the middle. The wood protrudes above the asphalt paving. The handrails are not ergonomically correct. I think that the irregularity of the surfaces and the slipperiness of the wood when wet could cause, or be thought to have caused, falls. Therefore I recommend evening the surfaces, applying nonslip coating on the wood, and applying ergonomically correct handrails. Recommended priority: high; estimated cost of remedial work: \$1,646.

TRIP HAZARD AT SITE  
STEPS.
