## OBSERVATION REPORT

PARKSIDE I AND II, ELDERLY HOUSING

BRANFORD HOUSING AUTHORITY

DB FILE 9693

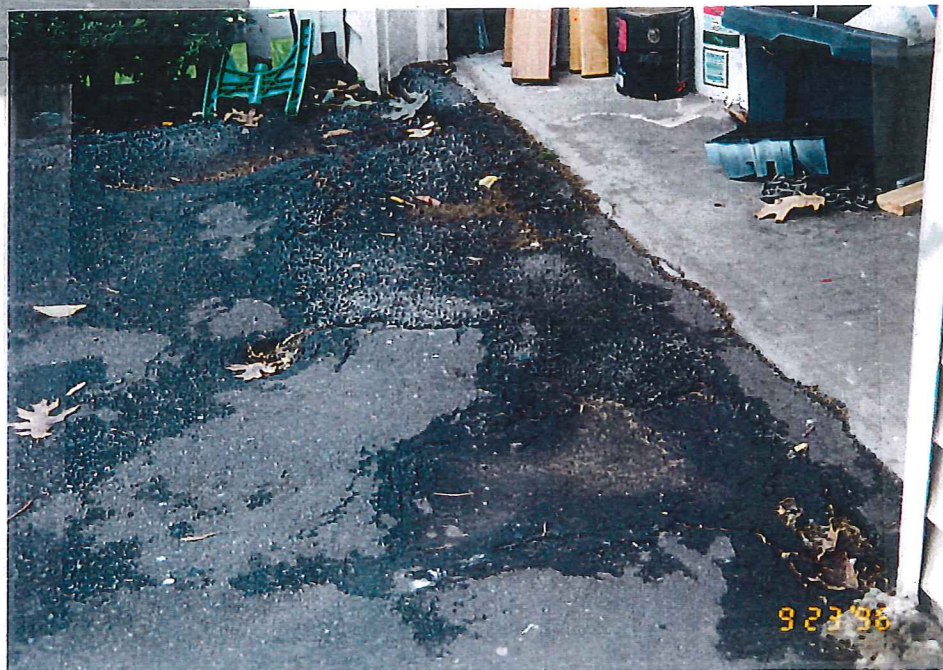
2. Outside the Community Building maintenance garage door the paving is sinking. I recommend excavating, compacting, filling with porous fill, and then patching the paving. Recommended priority: high, since a person could trip; estimated cost of remedial work: \$983.

CRACKED PAVING, SUBSIDING SOIL AT MAINTENANCE  
GARAGE.

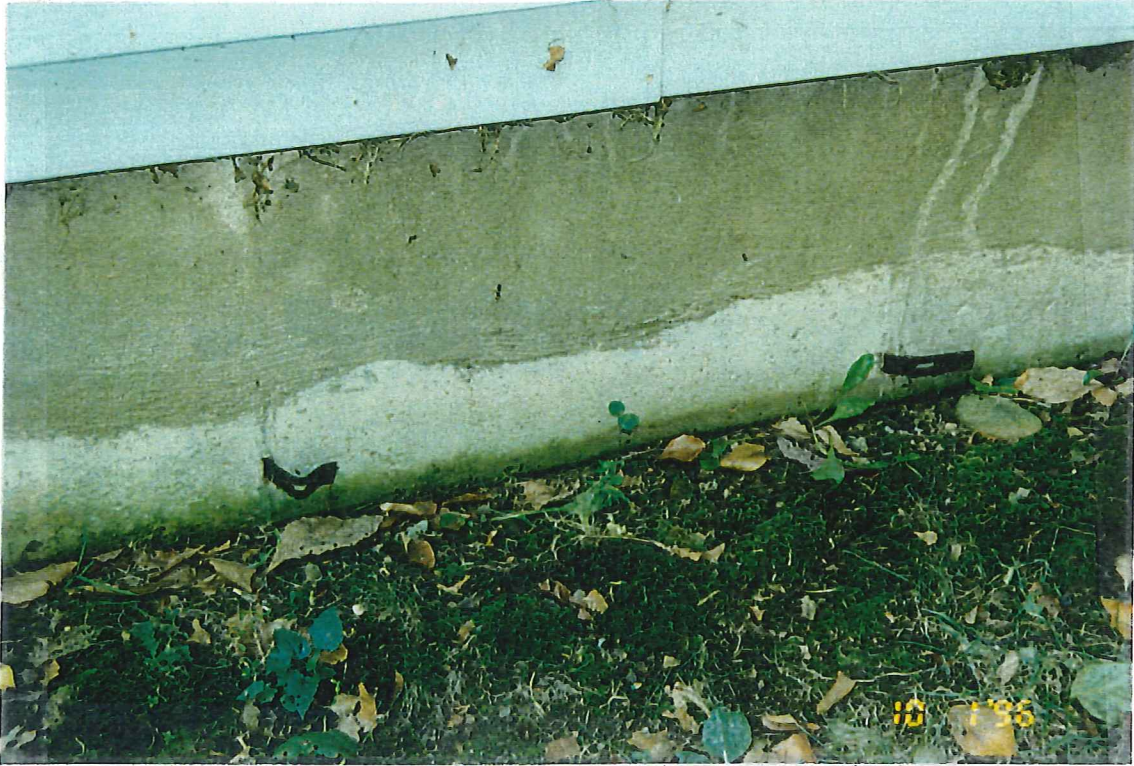
2. I observed, on the rear of one building, numerous rusty metal form ties sticking out from the concrete. These are intended to be snapped off inside the concrete, after which the hole in the concrete should be patched. The form ties that are bent over are unsightly, and the form ties which protrude straight could injure someone. I recommend removing all such ties and patching the concrete holes. Recommended priority: high for the straight ties, medium for the bent ones; estimated cost of remedial work: \$185.

PROTRUDING RUSTY FORM TIES BENT BACK.

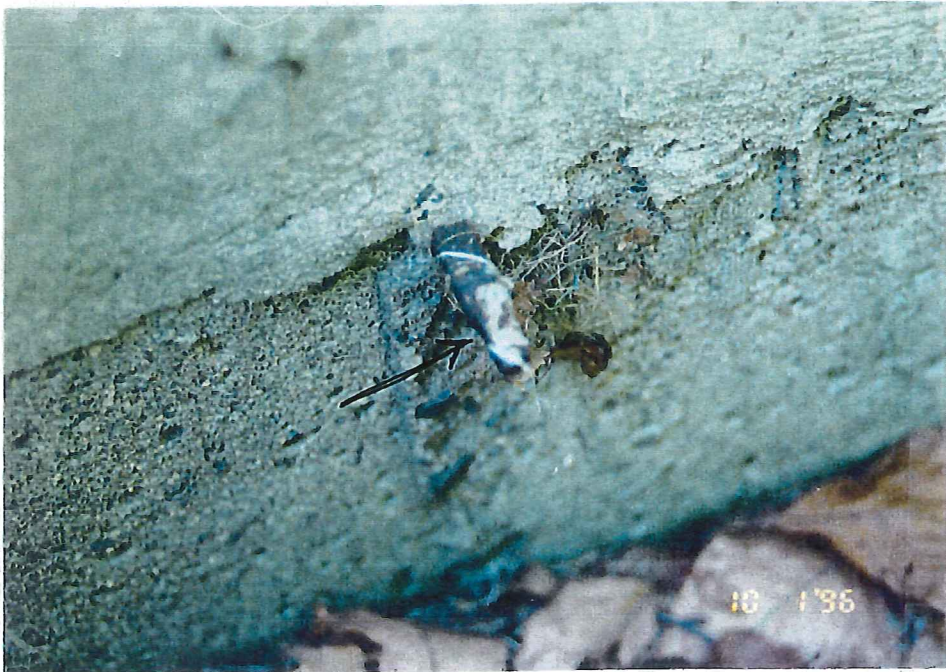
SHARP, PROTRUDING FORM TIE.

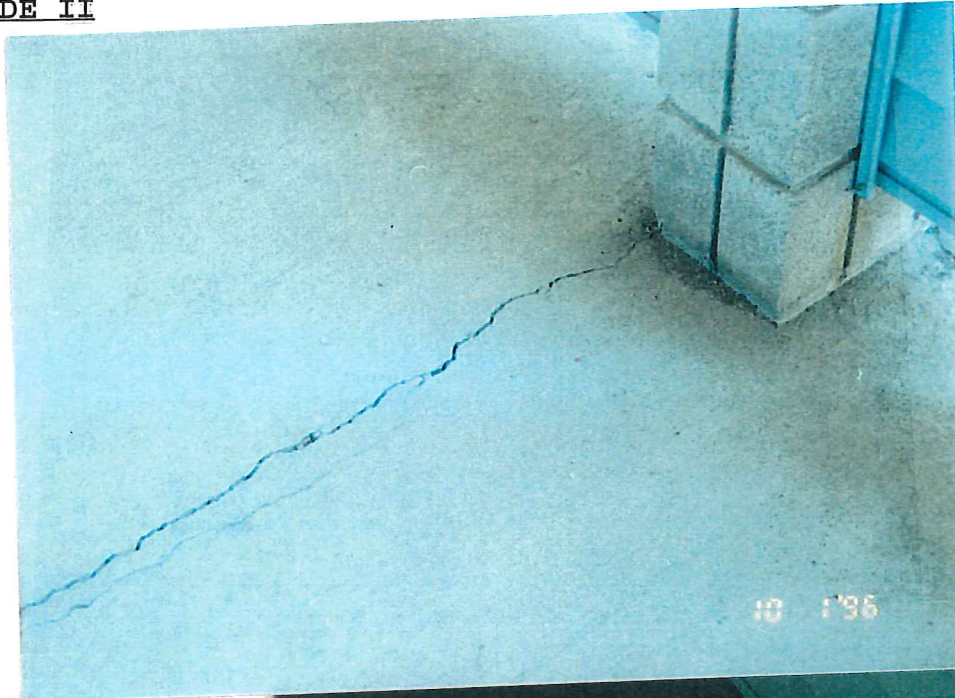
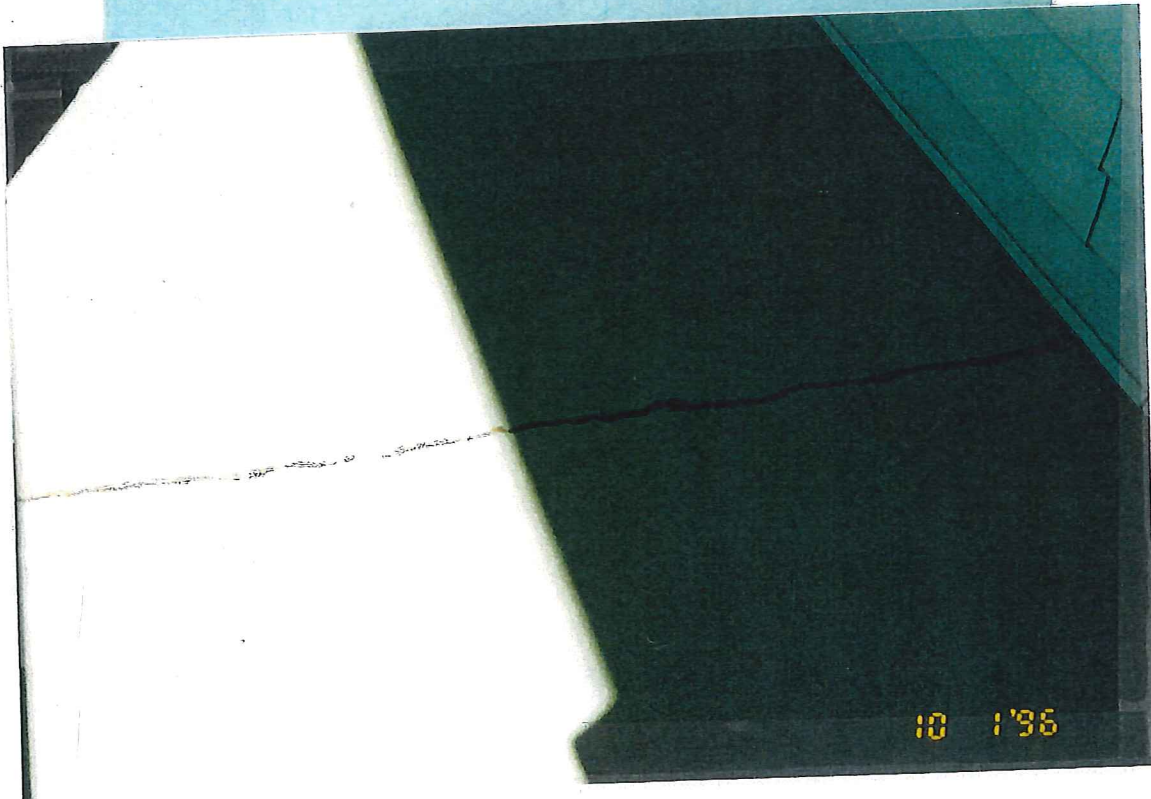
- A. There are a number of cracks in the concrete topping over the precast decks, mostly perpendicular to the length of the walkways. The probable cause is thermal movement. *I recommend cutting them out and sealing them with joint sealant. Recommended priority: medium; estimated cost of remedial work: \$962.*

WALKWAY CRACKS.

- B. To preserve the second floor walkway, *I recommend sealing the cracks and treating the upper surface with a penetrating water-repellent such as Hydrozo "Enviroseal Double 7". Recommended priority: medium; estimated cost of remedial work: \$1,876.*

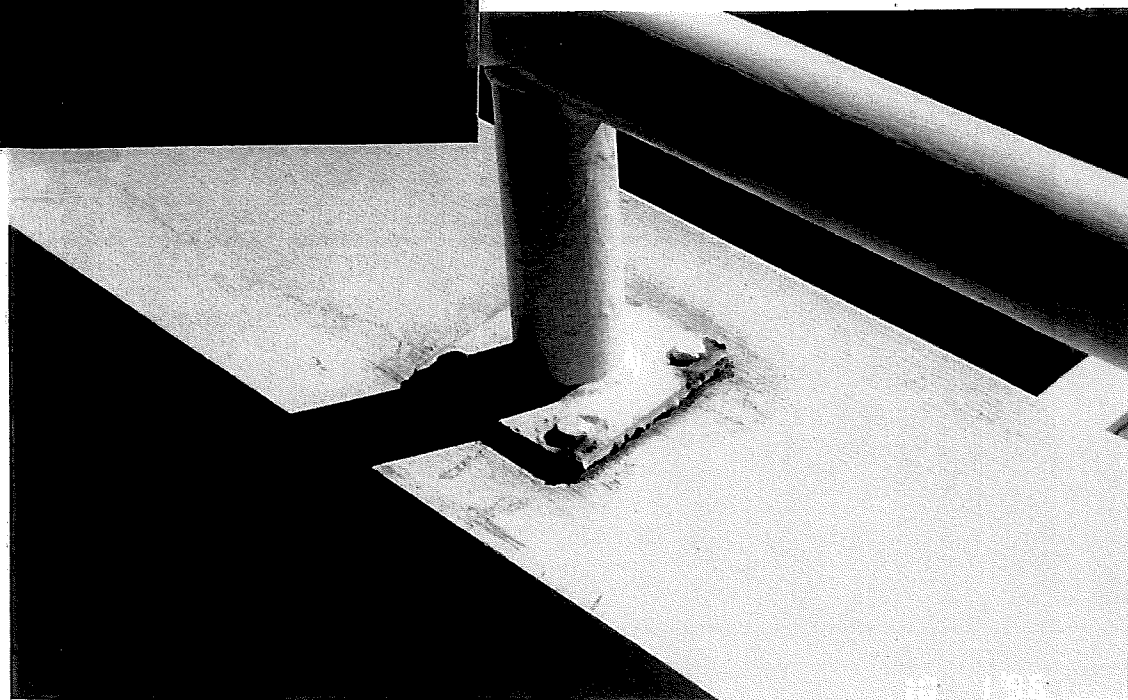
RUSTY RAIL BASE PLATE.

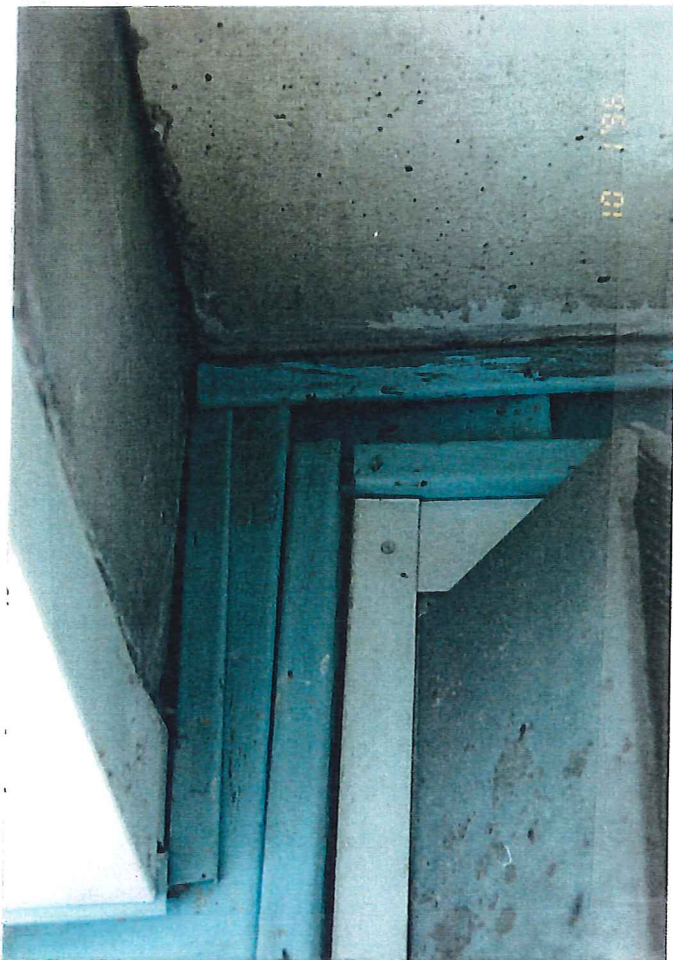
ALTHOUGH JOINTS ARE LOOSE  
UNDER END OF WALKWAY  
SLAB, NO MOISTURE WAS  
FOUND.

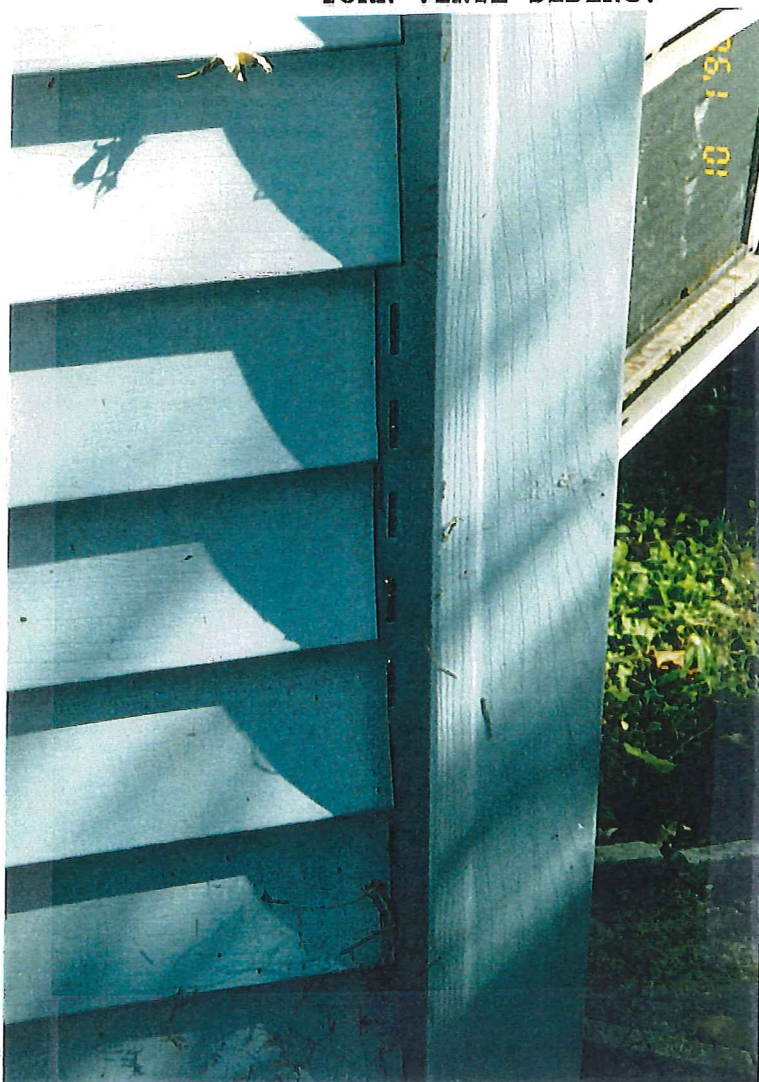
LOOSE VINYL CORNER TRIM.

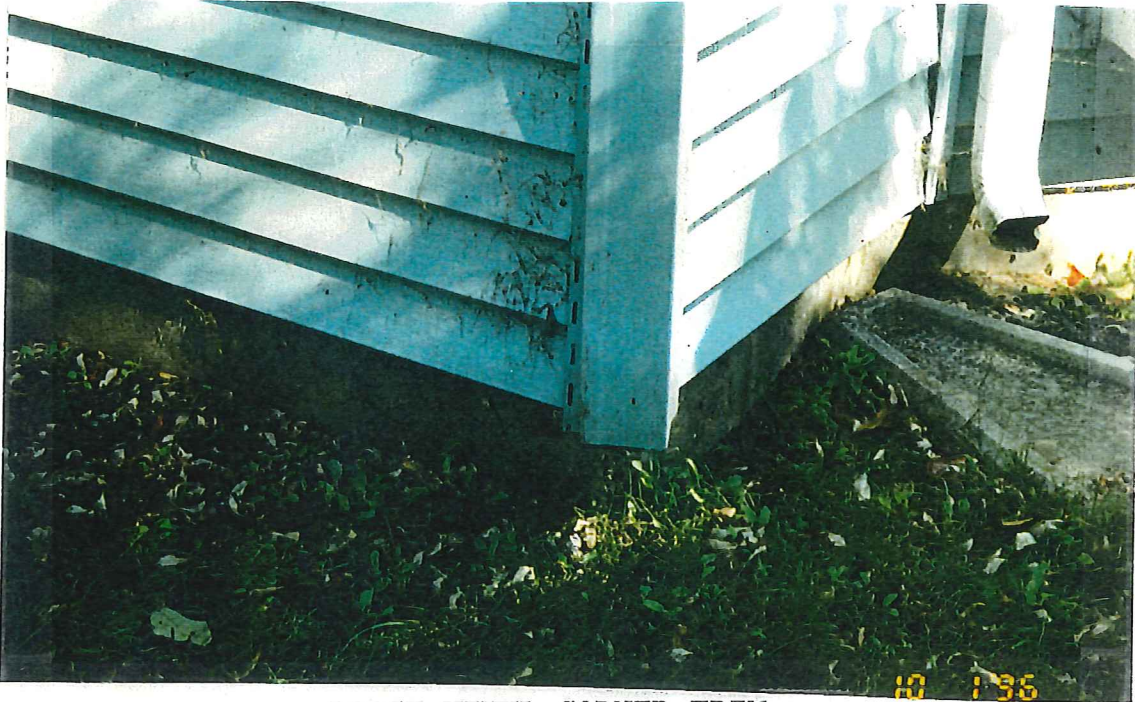
LOOSE VINYL CORNER TRIM.

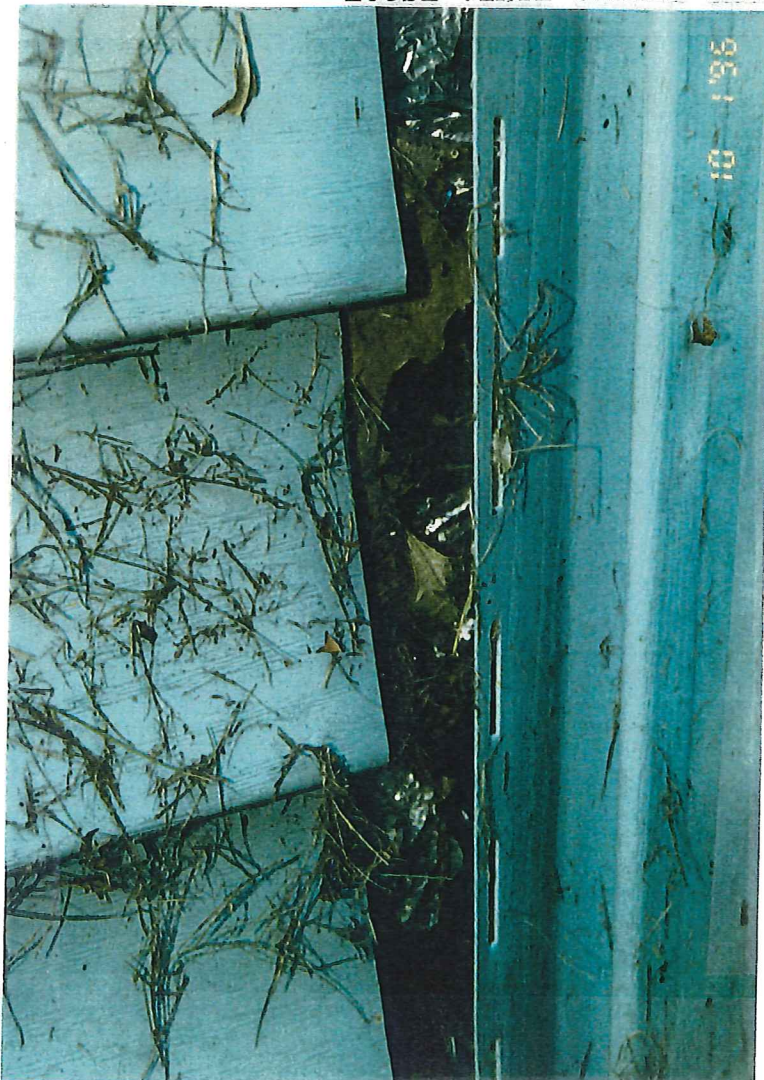
VINYL CORNER TRIM HAS  
COME OFF.

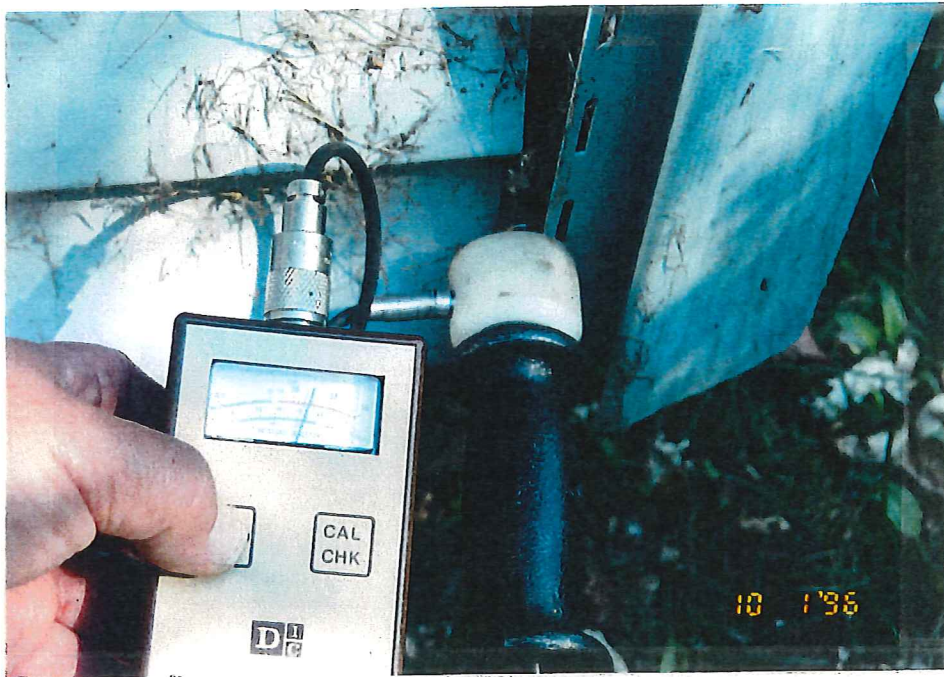
MOISTURE CONTENT 25% AT LOOSE CORNER TRIM.

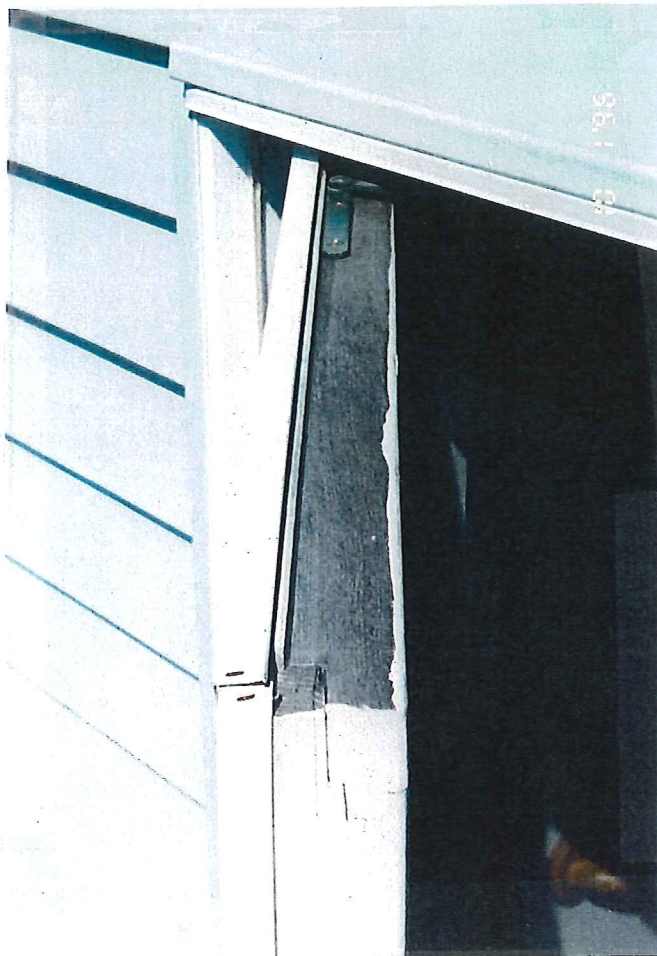
UNPAINTED TOP OF CASEMENT  
SASH.

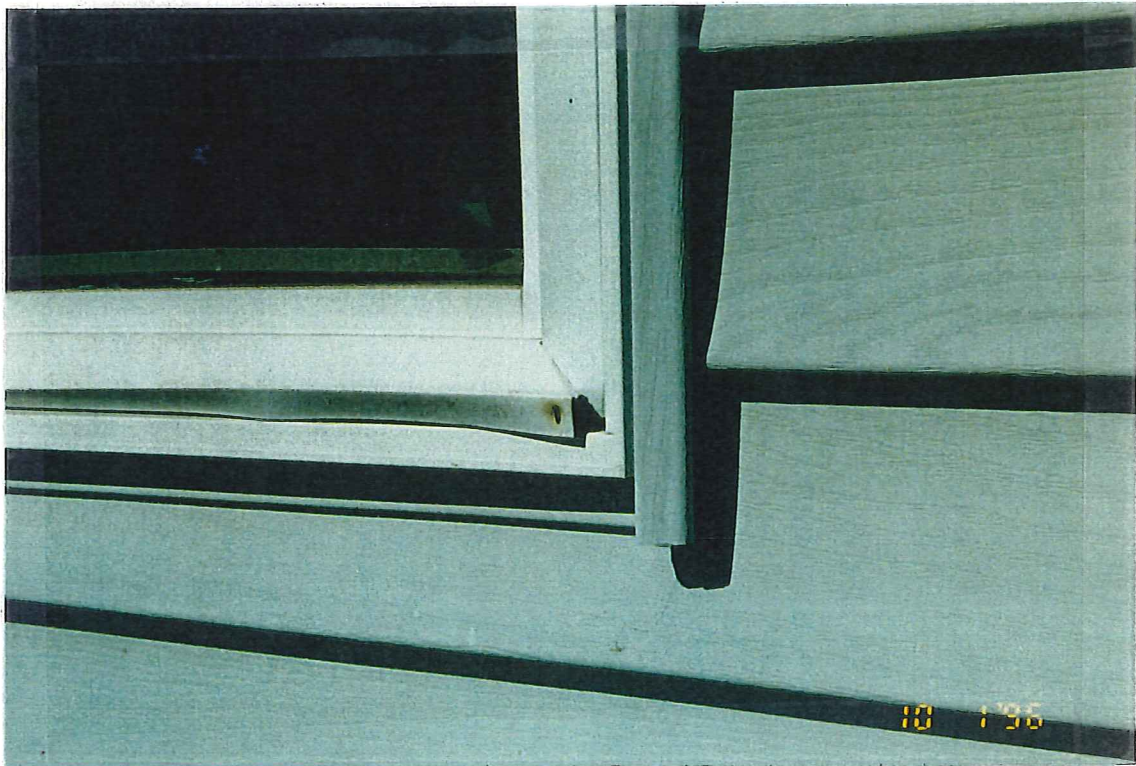
VINYL CLADDING LOOSE ON WINDOW.

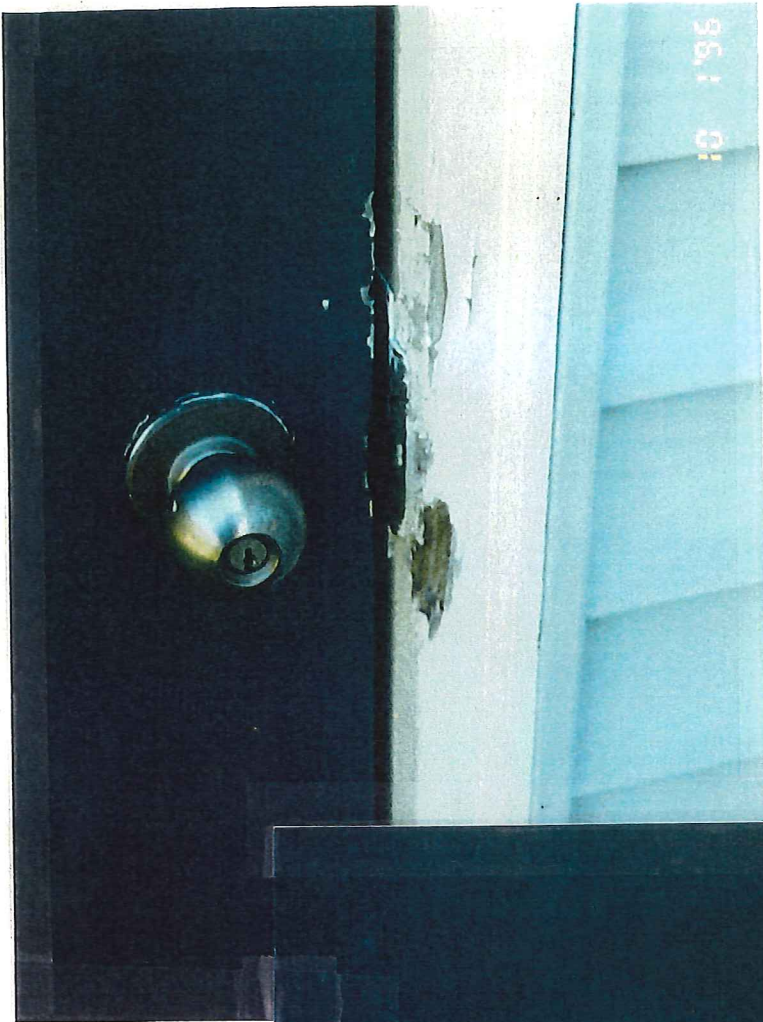
DAMAGED DOOR & FRAME TO  
ELECTRICAL ROOM.

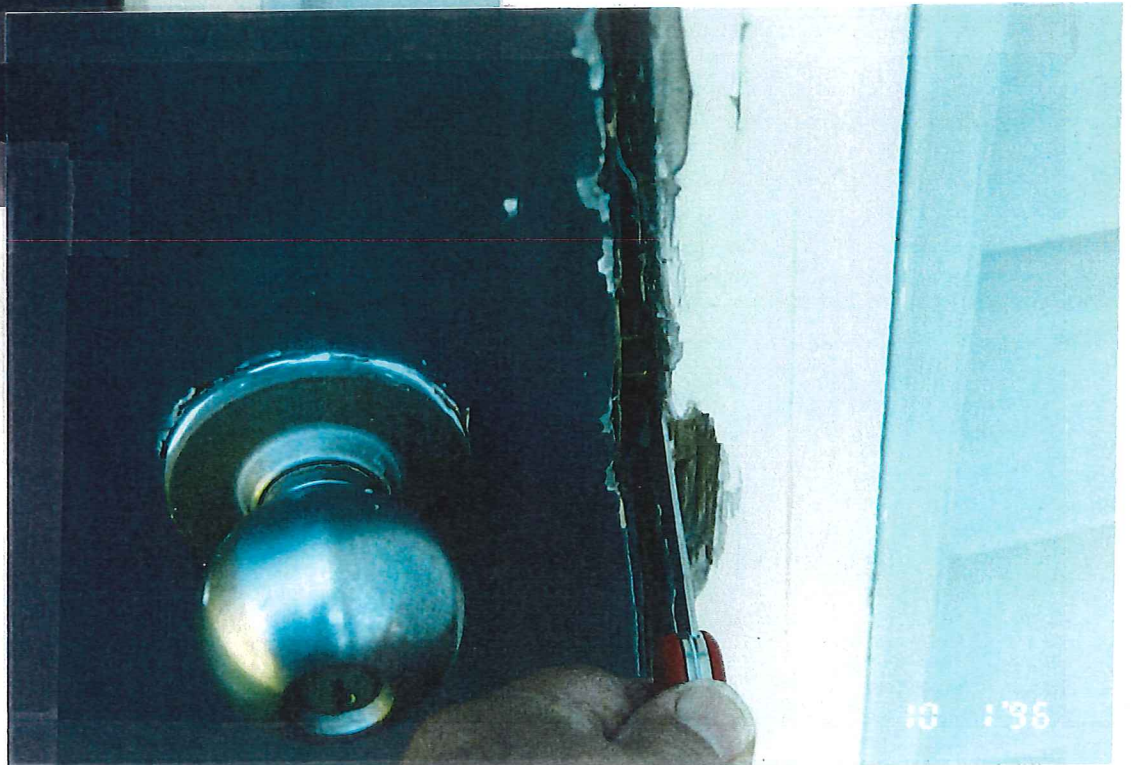
DOOR LOCK EASILY "LOIDED" WITH KNIFE.

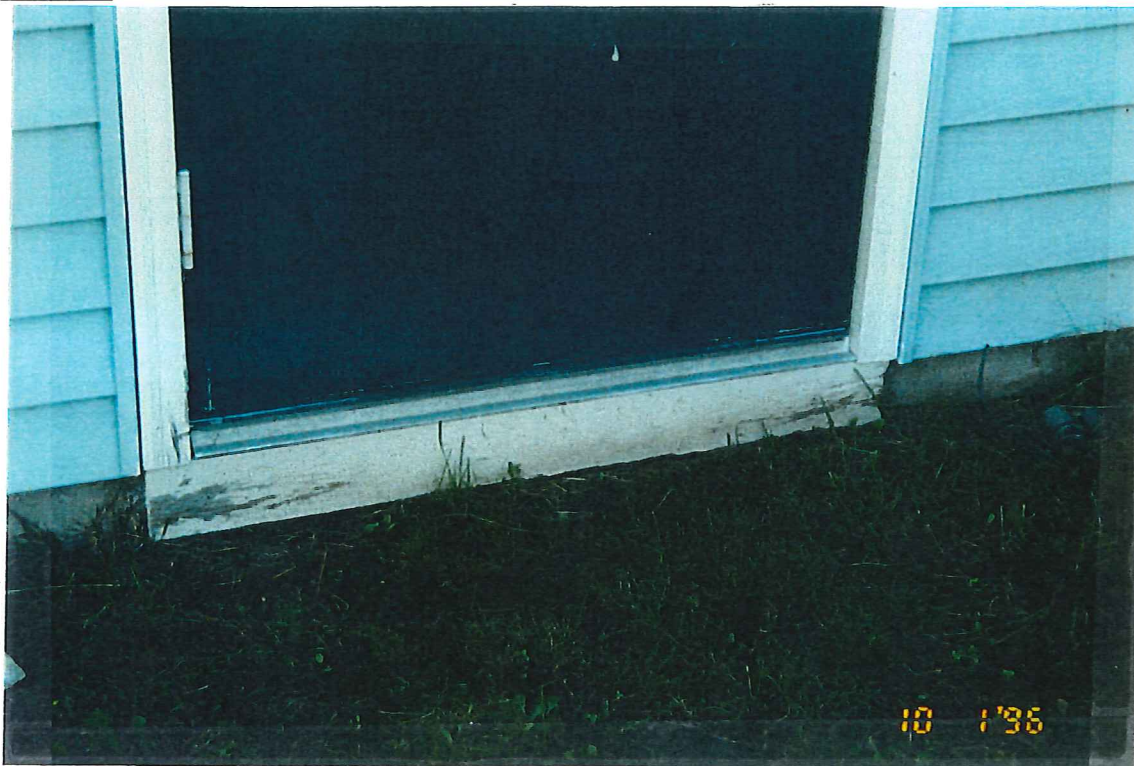
TRIM UNDER DOOR SILL IS NOT DECAYING.

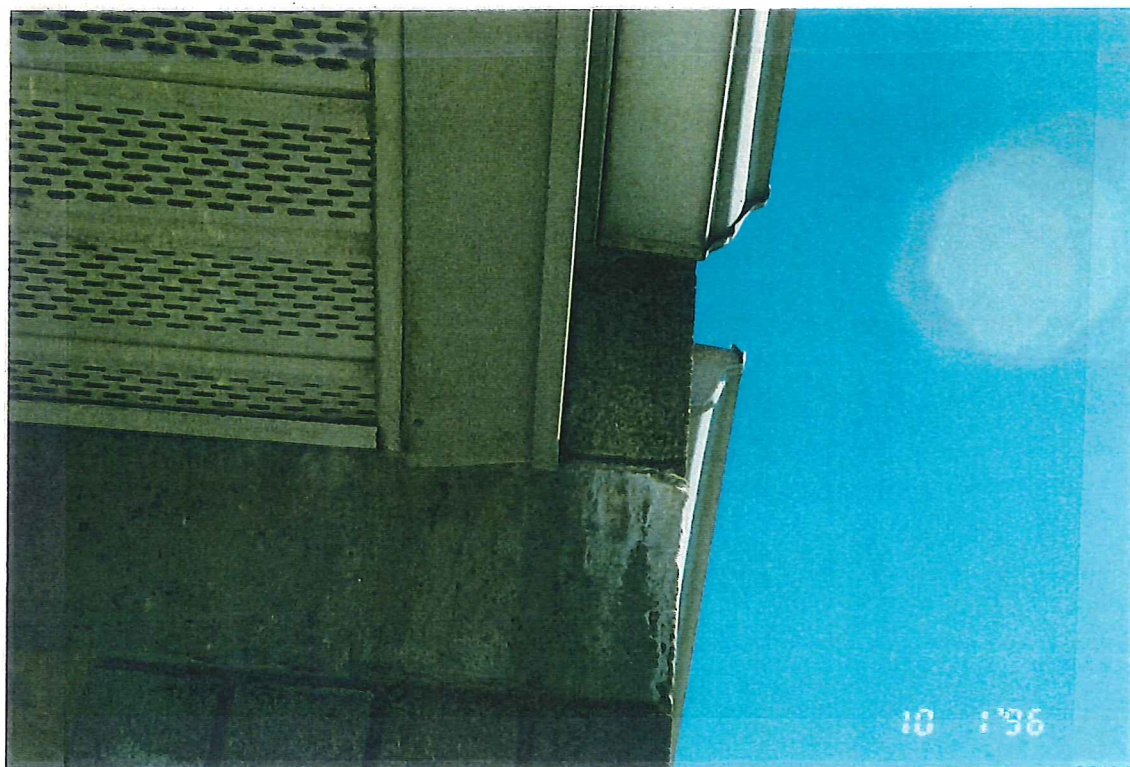
EFFLORESCENCE AT MASONRY PIER.

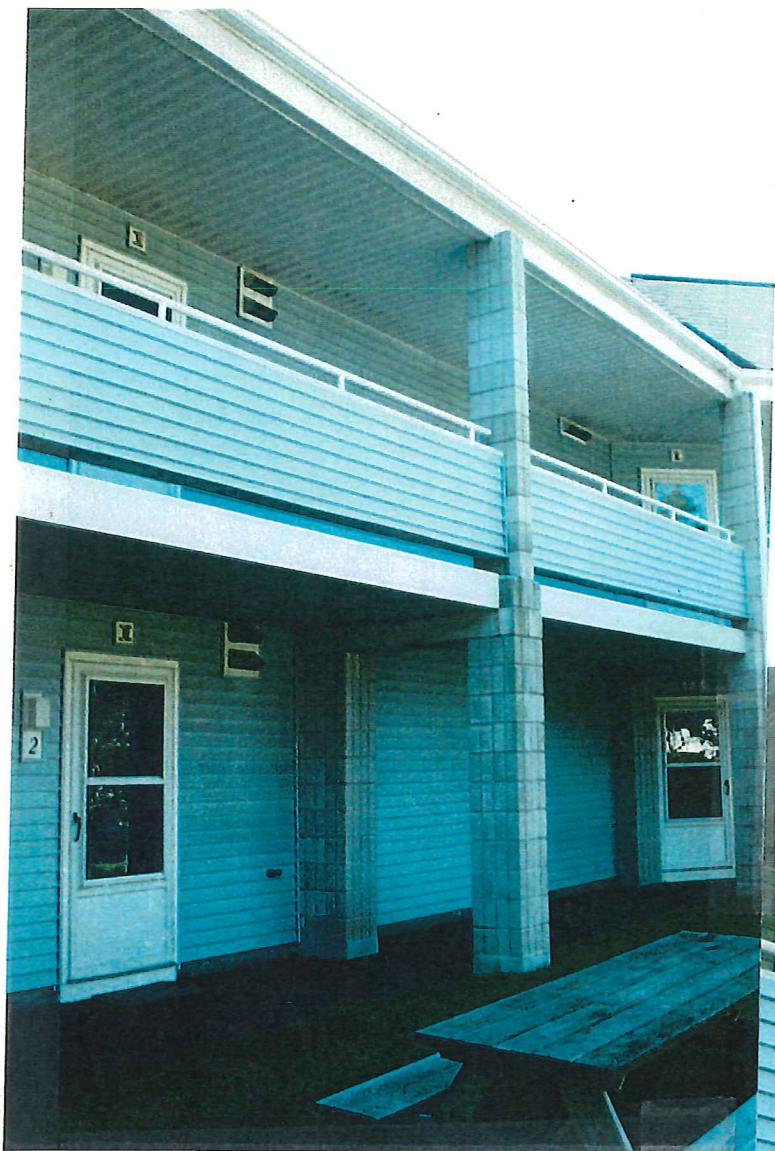
← MASONRY PIERS & BEAMS.  
THIS IS NOT PART OF A  
FIRE WALL & IS NOT

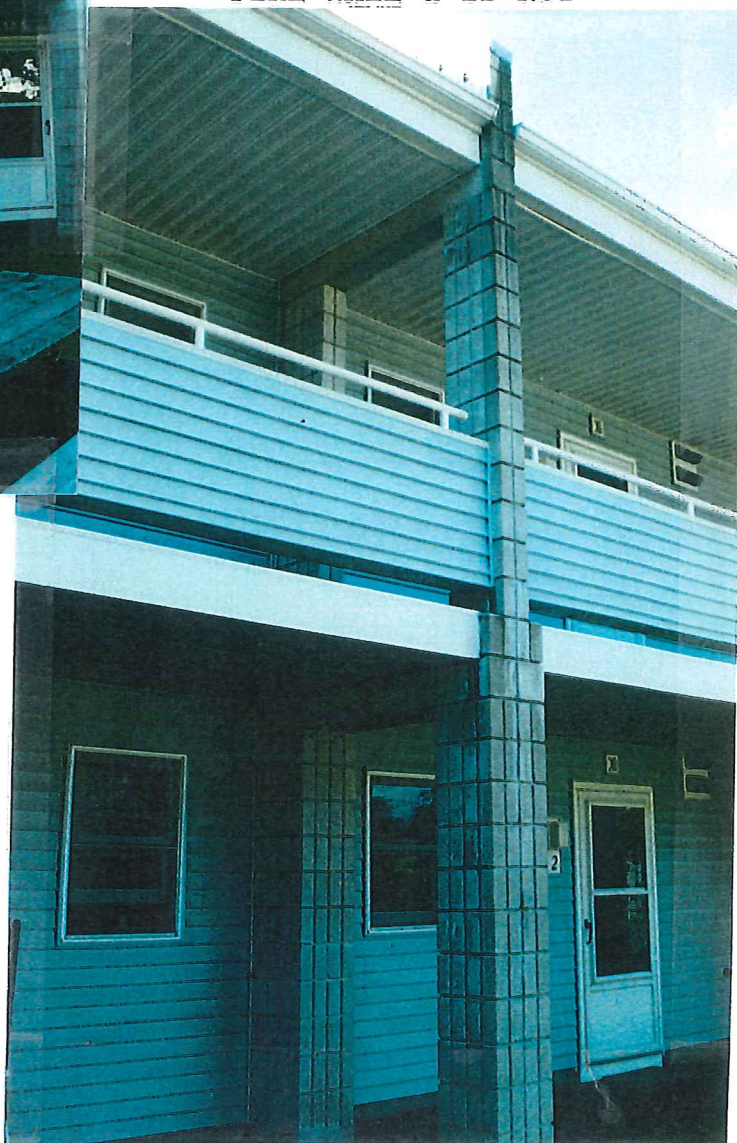
MASONRY PIERS & BEAMS.  
THIS IS PART OF A FIRE  
WALL & IS STAINED. →

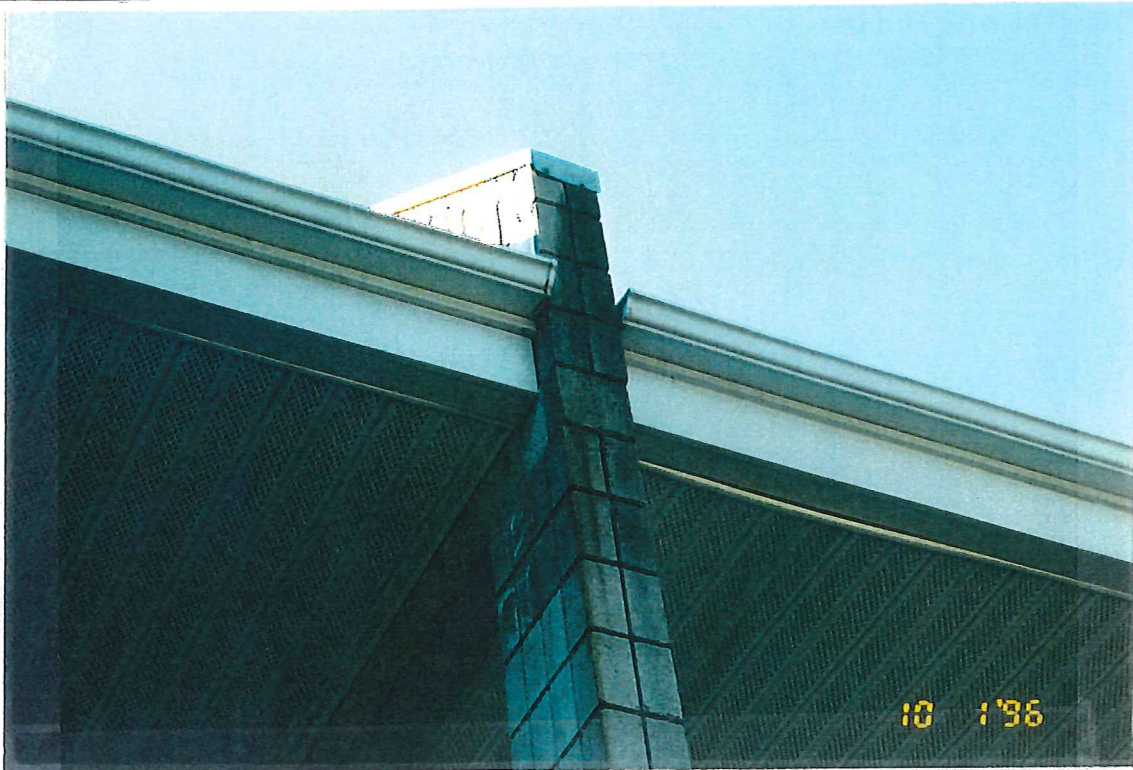
MASONRY PIERS & BEAMS. THIS IS PART OF A FIRE WALL  
& IS STAINED.

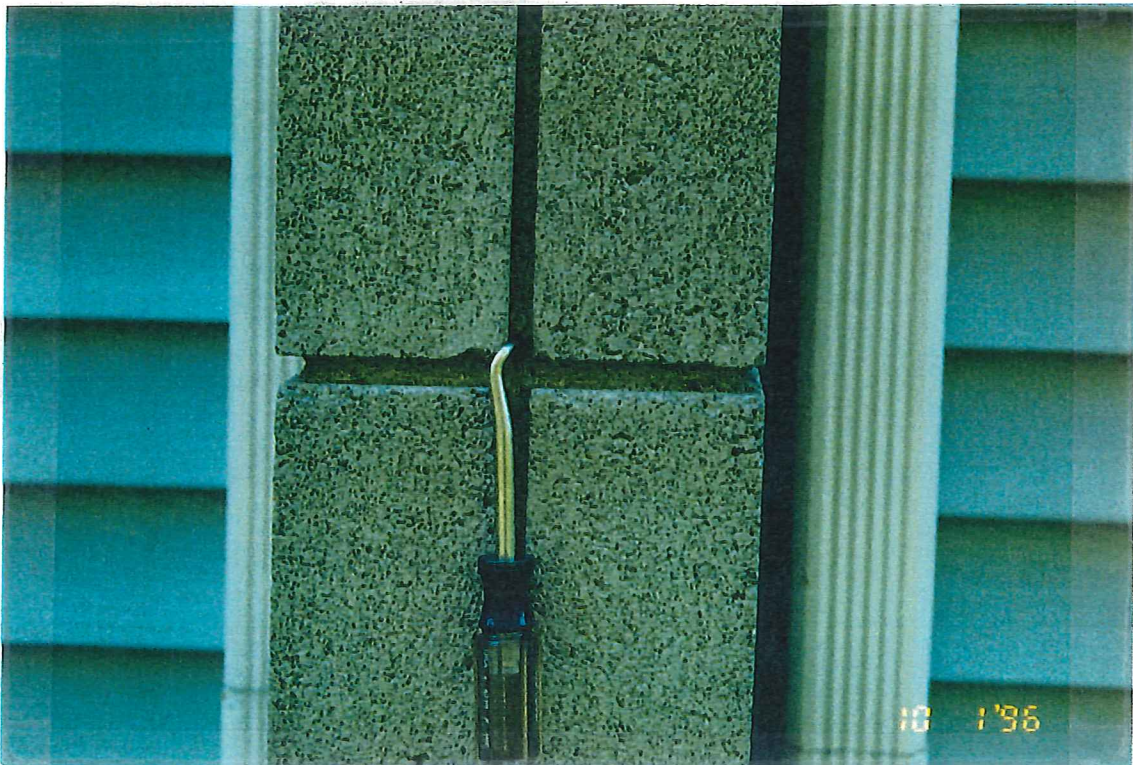
SMALL VOID IN MORTAR JOINT.

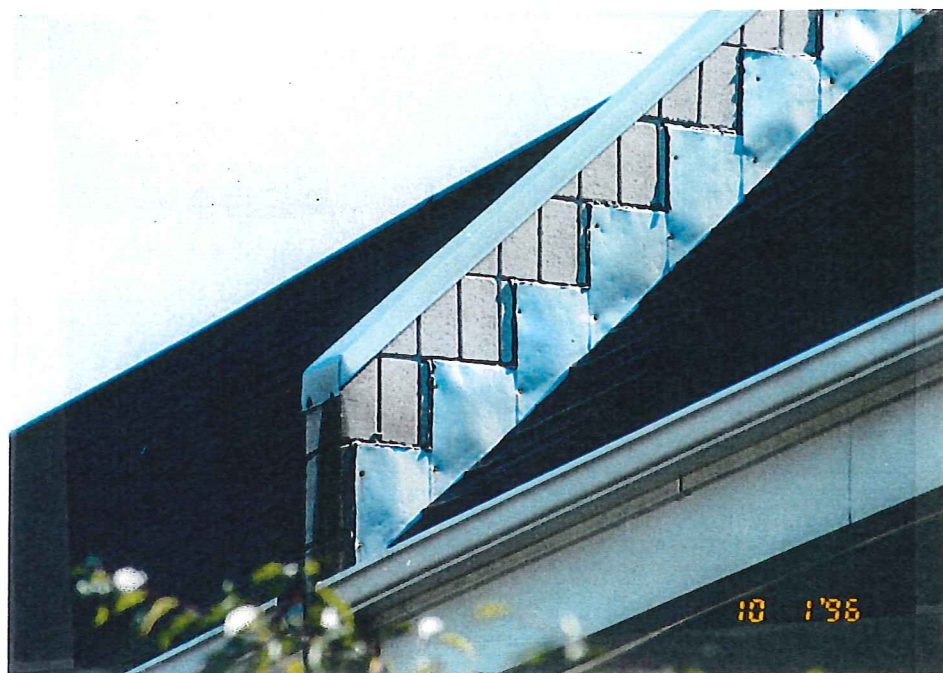
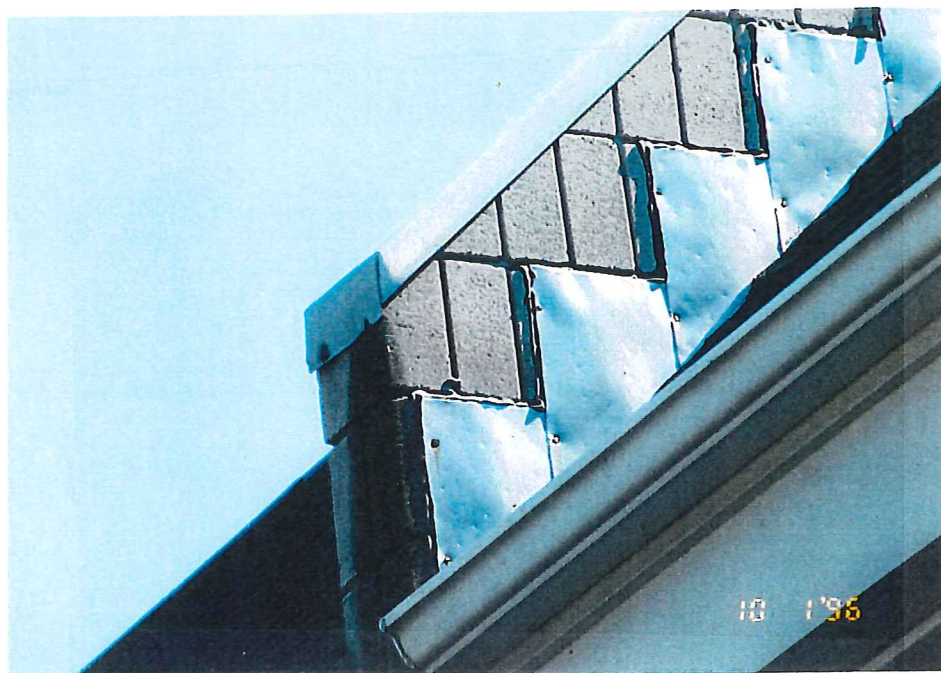
ROOF COUNTERFLASHINGS. NOTE STAINS ON LEFT FACE.

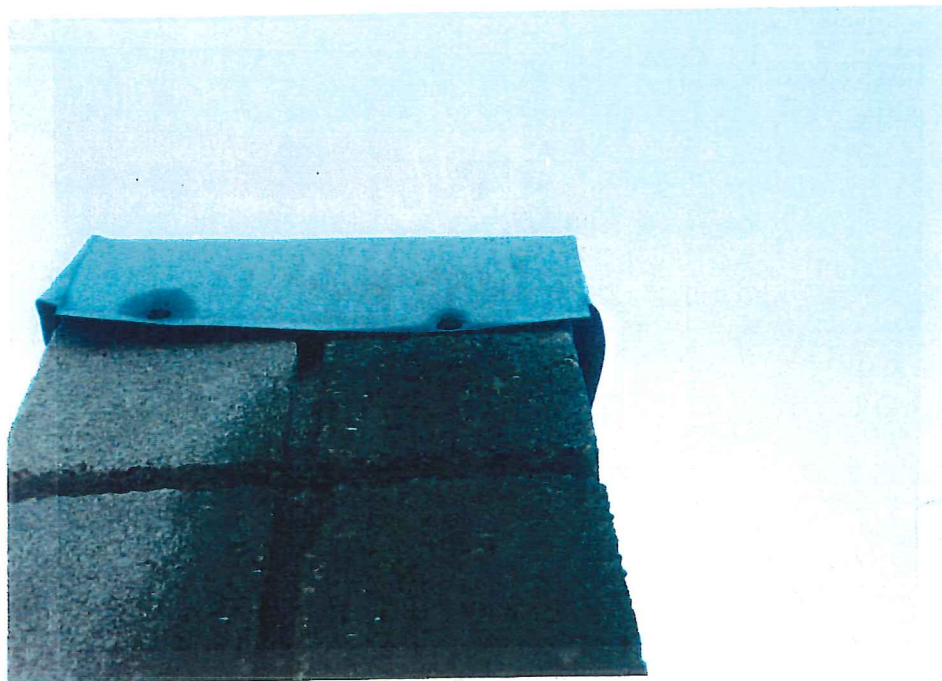
STAIN ON MASONRY PIER COMES FROM UNDER CAP.

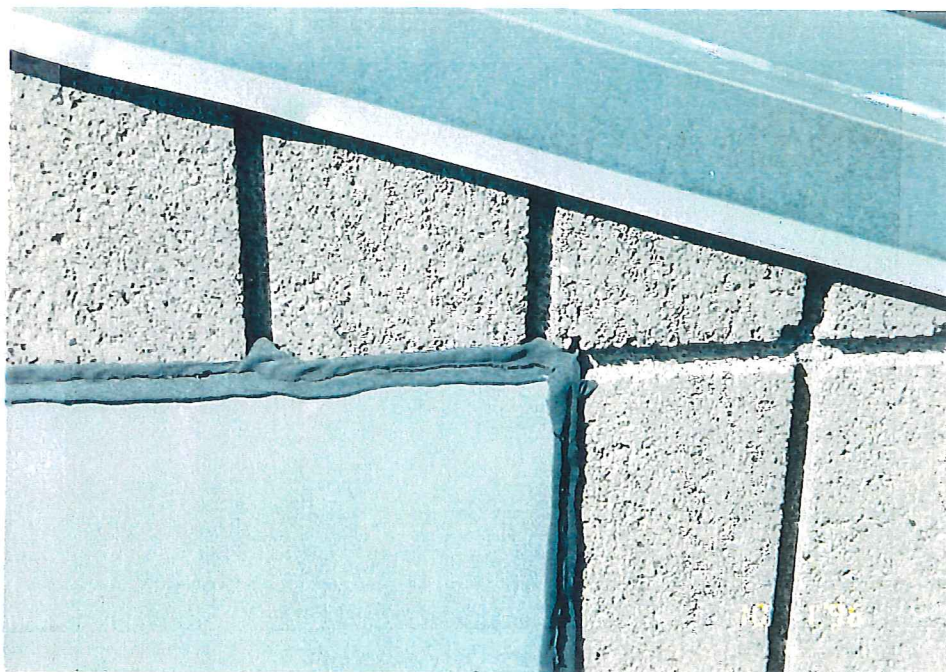
JOINTS AT COUNTERFLASHING.

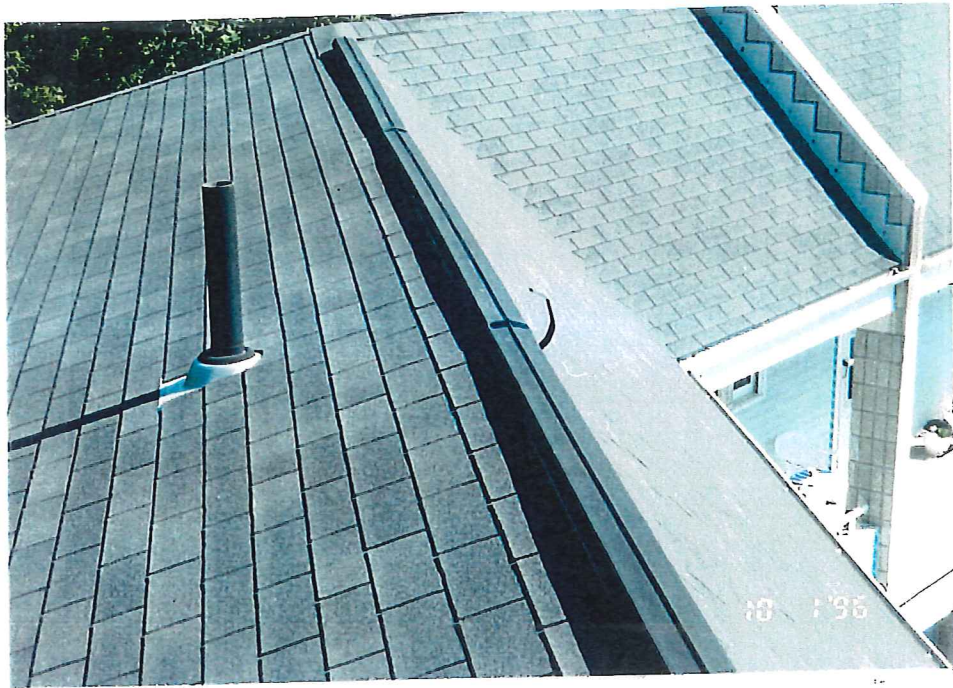
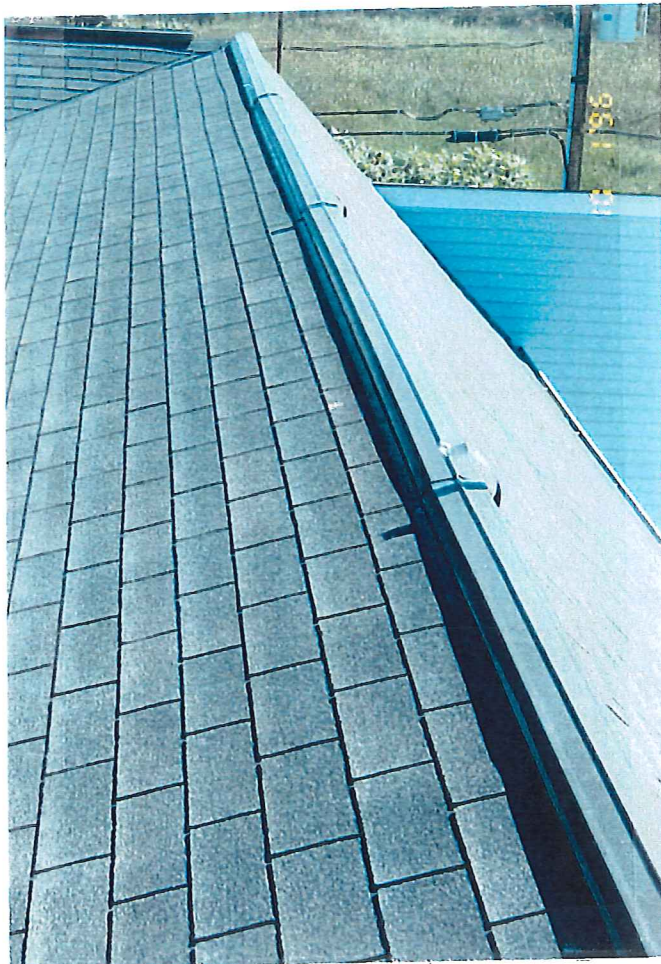
LOOSE JOINT COVERS AT  
ROOF RIDGE VENT.

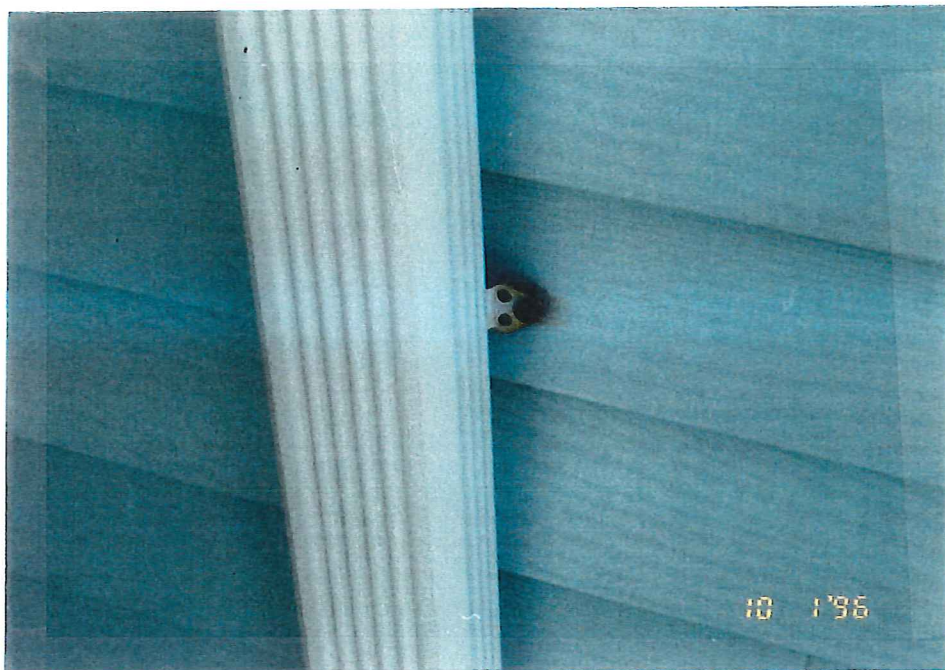
RUSTY GUTTER STRAP NAIL.

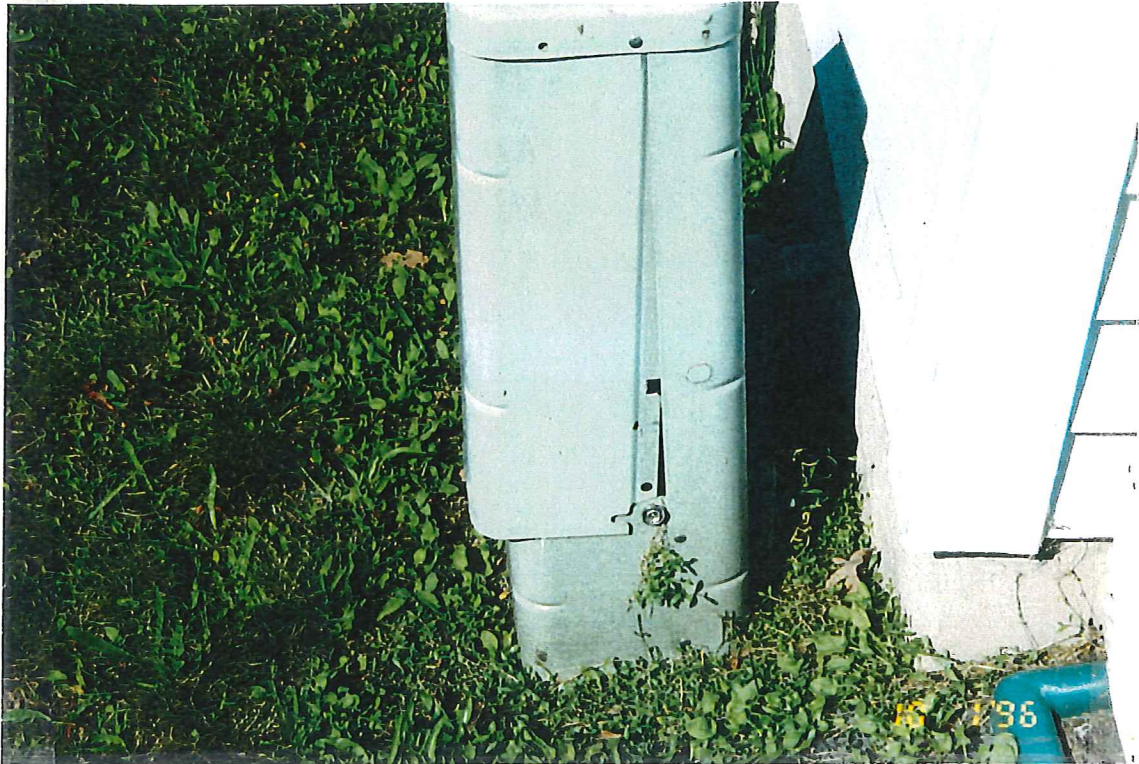
TRANSCLOSURE COVER LOOSE.
