## OBSERVATION REPORT

PARKSIDE I AND II, ELDERLY HOUSING

BRANFORD HOUSING AUTHORITY

DB FILE 9693

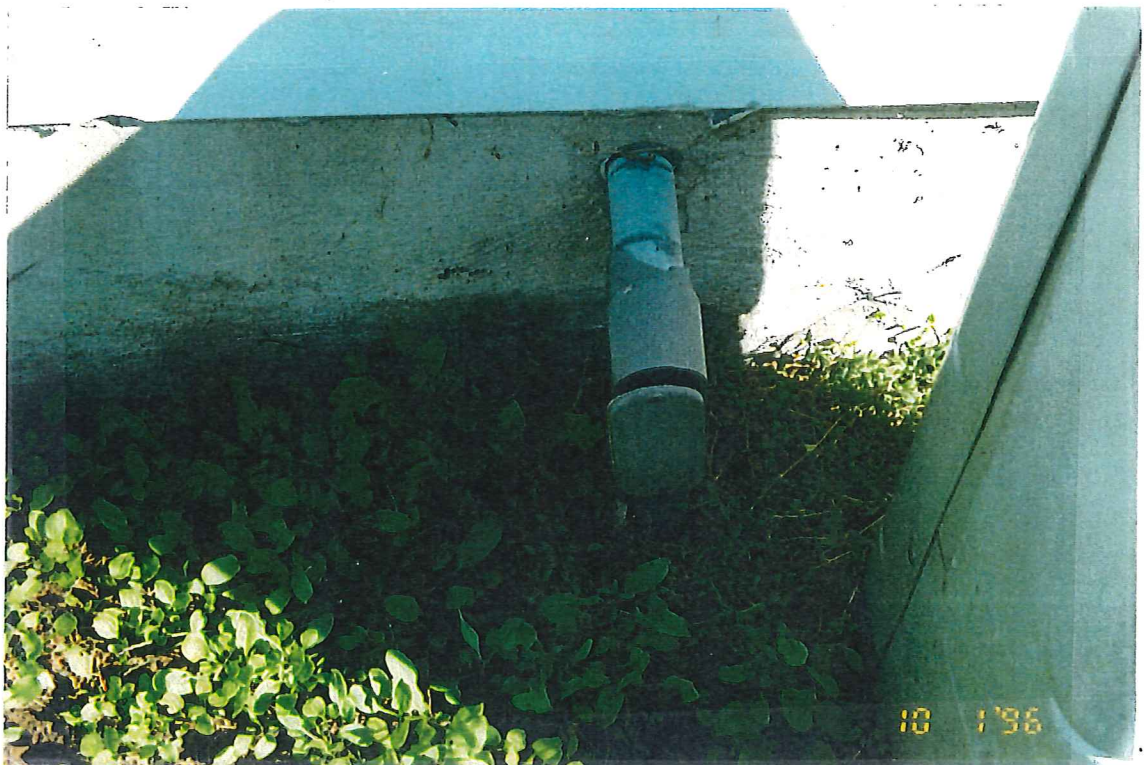
ELECTRICAL SERVICE COVER LOOSE.

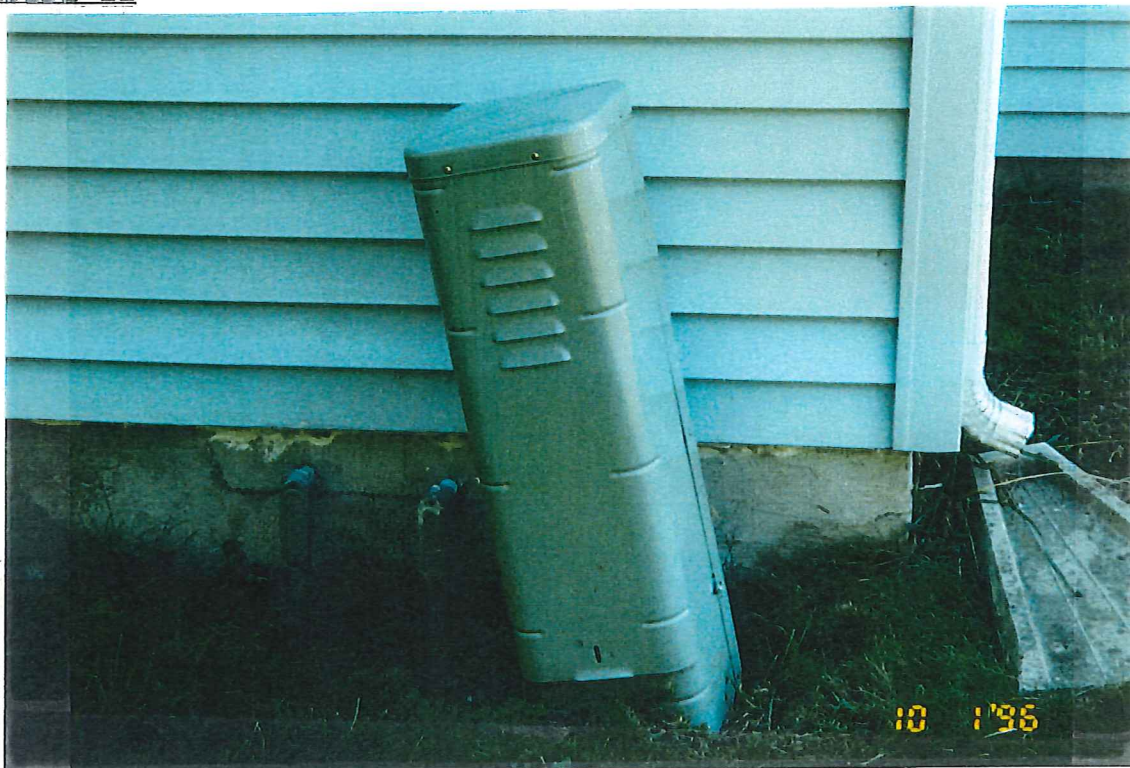
TRANSCLOSURE OFF PLUMB.

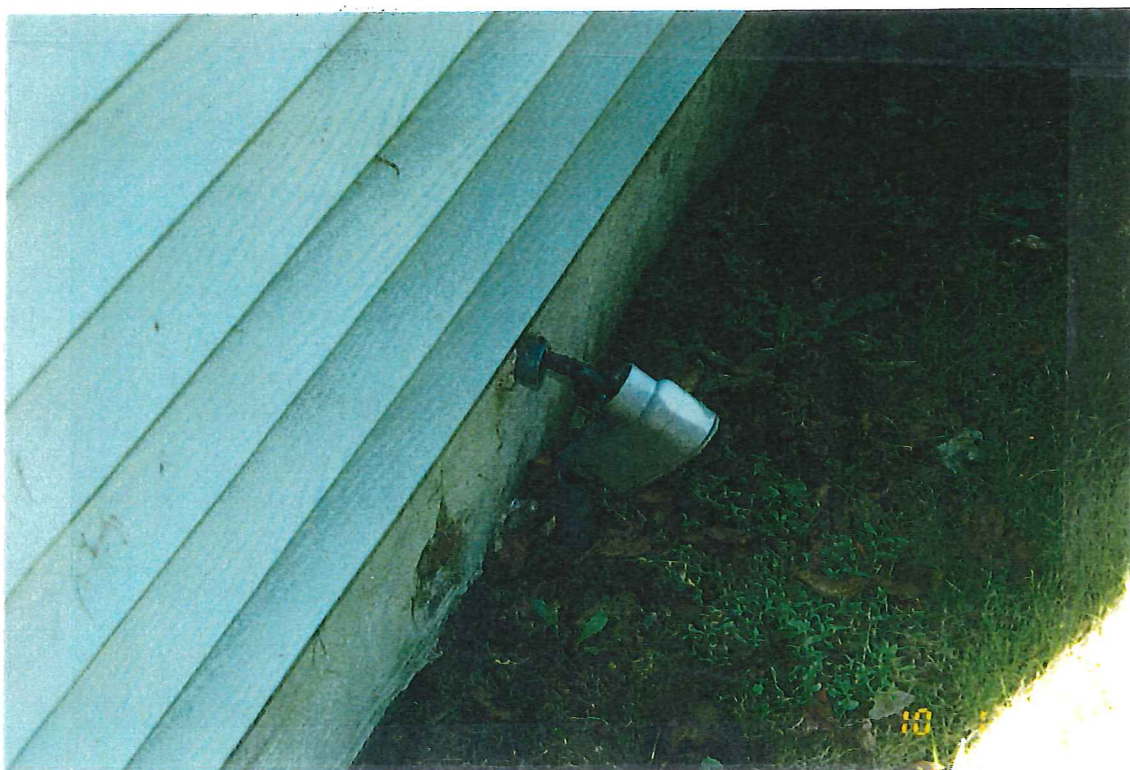
BROKEN ELECTRICAL ENTRANCE.

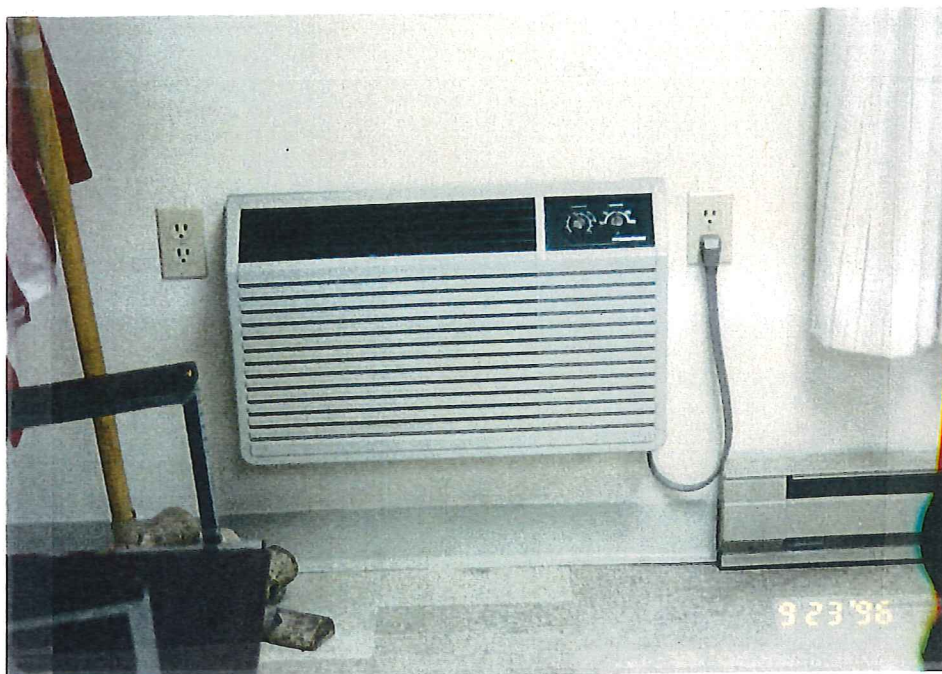
2. Mr. Bickford said that the Building Official had asked that those electrical outlets which are above heaters be moved. Mr. Murdock's electrician said that the National Electrical Code prohibits locating electrical outlets above heaters, since the wire insulation could melt from the heat and cause a short circuit. *Relocating the outlets away from the heaters using "Wiremold" would cost about \$155 per outlet, and I estimate that it would cost about \$250 if the wire were concealed.*

OUTLET TOO CLOSE TO BASEBOARD CONNECTOR.

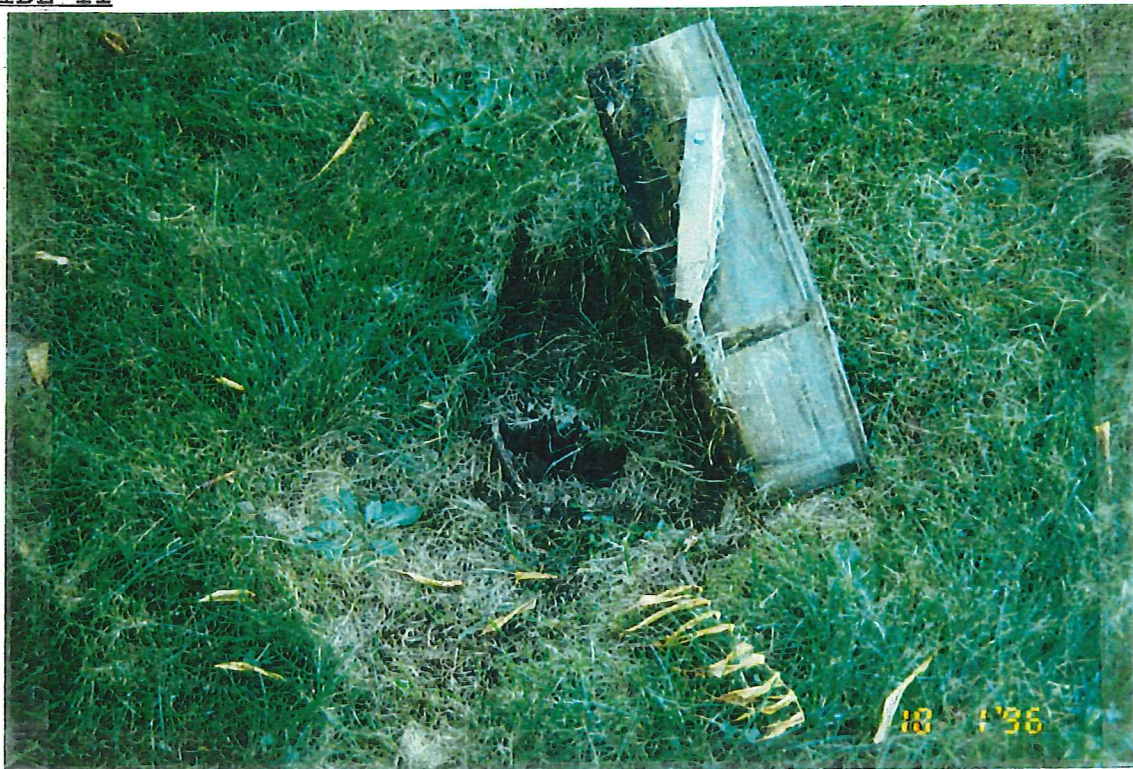
BROKEN PIPE COVERED WITH WOODEN BOX.
