# New Zealand Aluminium Smelters Limited

## SCL GROUNDWATER STATUS

2020

**Date:** 29 March 2021

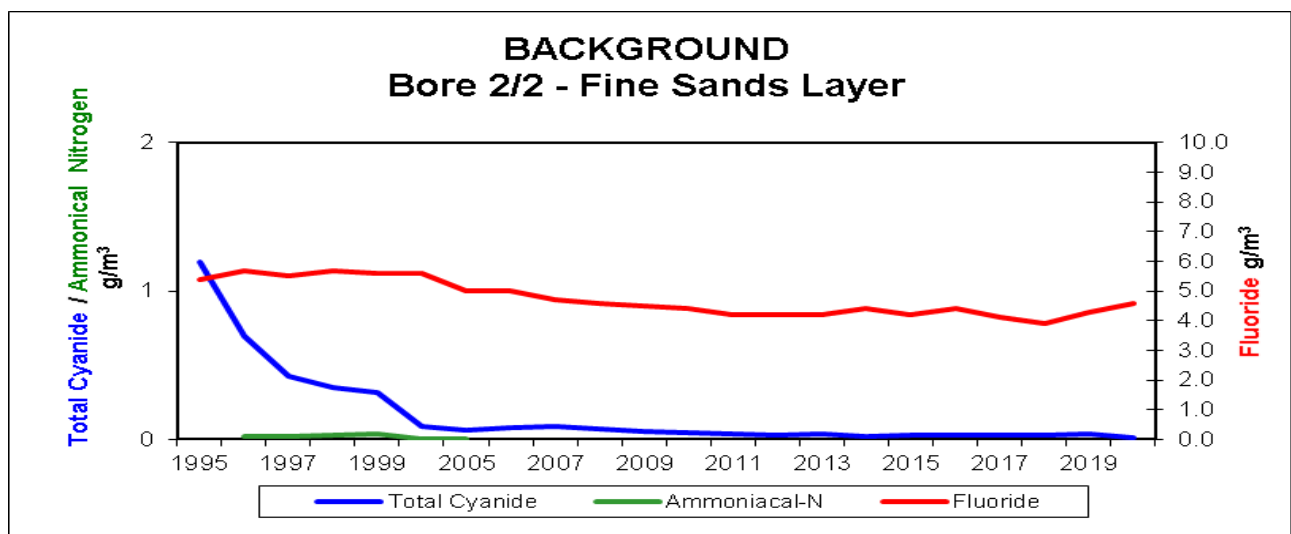
The elevated levels of total cyanide in the early 1990s were due to SCL leachate entering the groundwater around the pad. The SCL material was shifted to a temporary concrete pad to the north of the existing pad while the original location was reconstructed. The original SCL pad was covered in 1992 to stop any further leachate entering groundwater.

Conductivity measurements at Bore 2/2 indicate that the groundwater flowing into the SCL pad area has low levels of contamination. The conductivity is similar to values seen for groundwater in the vicinity of the sewage field and potable water supply.

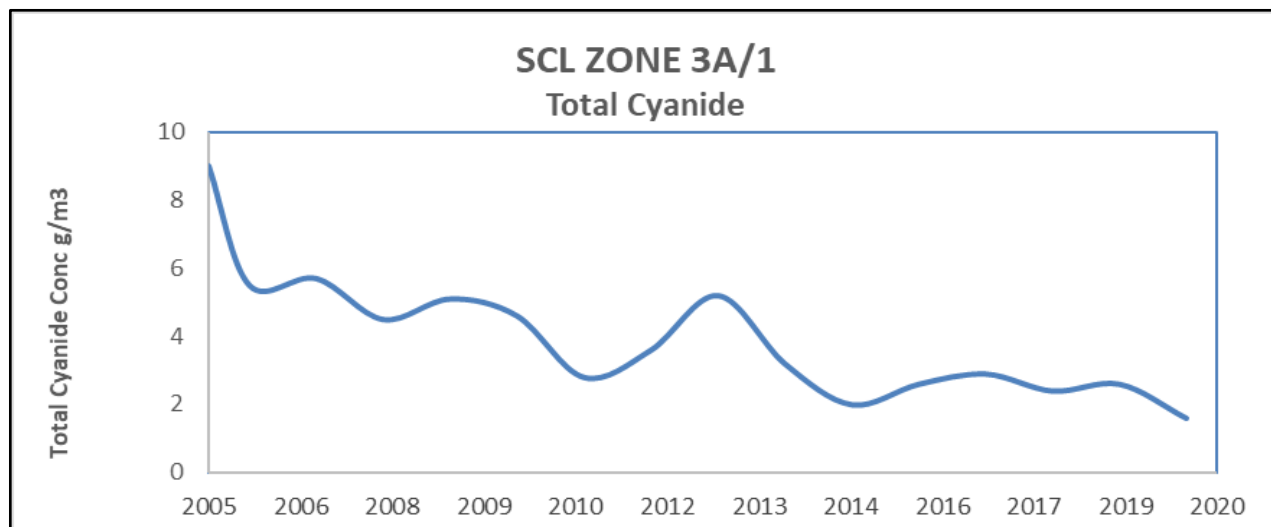
Free cyanide has ranged from  $< 0.01$  –  $0.32$  mg/L for bores 3/3; 3/2; 3/1 with bore 3/3 showing the lowest free cyanide concentrations typically below  $0.01$  mg/L. The following graph shows the annual average concentration of total cyanide since 1995 (Note –  $\text{g/m}^3 = \text{mg/L}$ ).

Cyanide concentrations have continued to decrease over time. A cyanide spike was observed in July 2011 for the shallow bores 3/1, 3/2 and 3/3 located close to the southern side of the SCL pad. Only one sample was collected in 2011 and when re-sampled 6 months later it had decreased to previous concentrations of approximately 1 mg/L. A similar spike was not detected in deep bore 3A/1 located just a few metres downstream of bore 3/3. An investigation into the elevated levels was conducted but no underlying root cause was found.

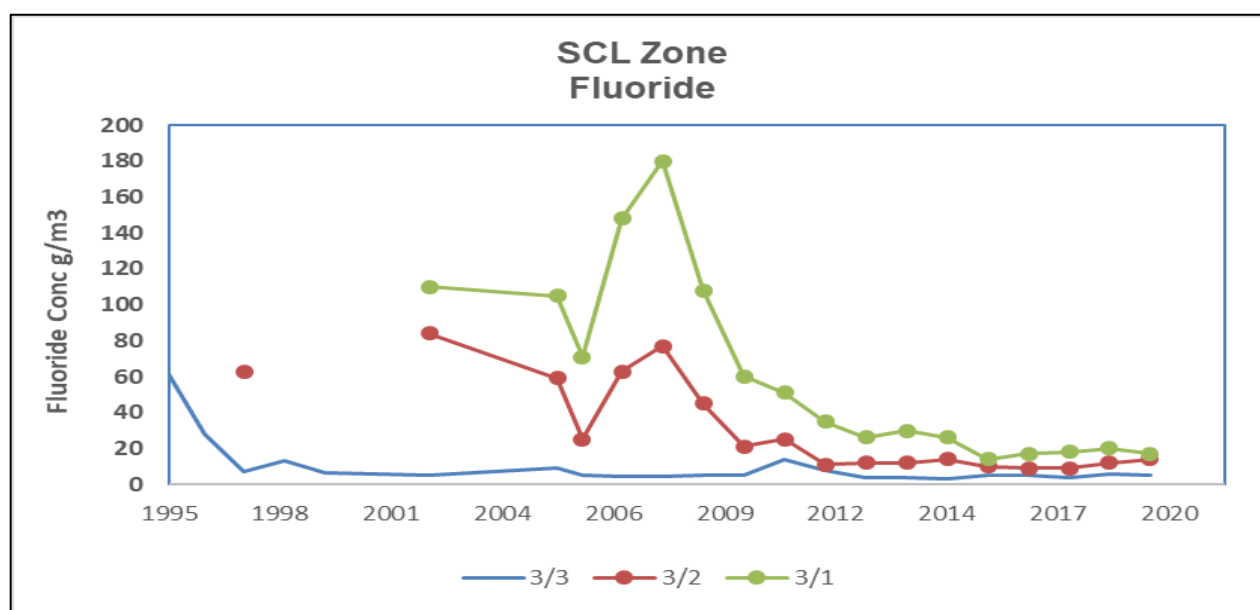
The fluoride concentrations in the SCL zone have significantly decreased from 2005 till 2020. The decreases in concentration in groundwater from east to west with deep bore 3/1A showing the lowest concentration. A fluoride spike was observed for bore 3/2 and 3/1 between 2007-2009. No spike in fluoride was detected for deep bore 3A-1. The root cause for the spike was never identified. The underground discharge pipe which was replaced in 2003/2004 but is unlikely to be the source of contamination. Since 2010 the fluoride concentration in bore 3A/1 is nearing background levels found in seawater surrounding the Peninsula.

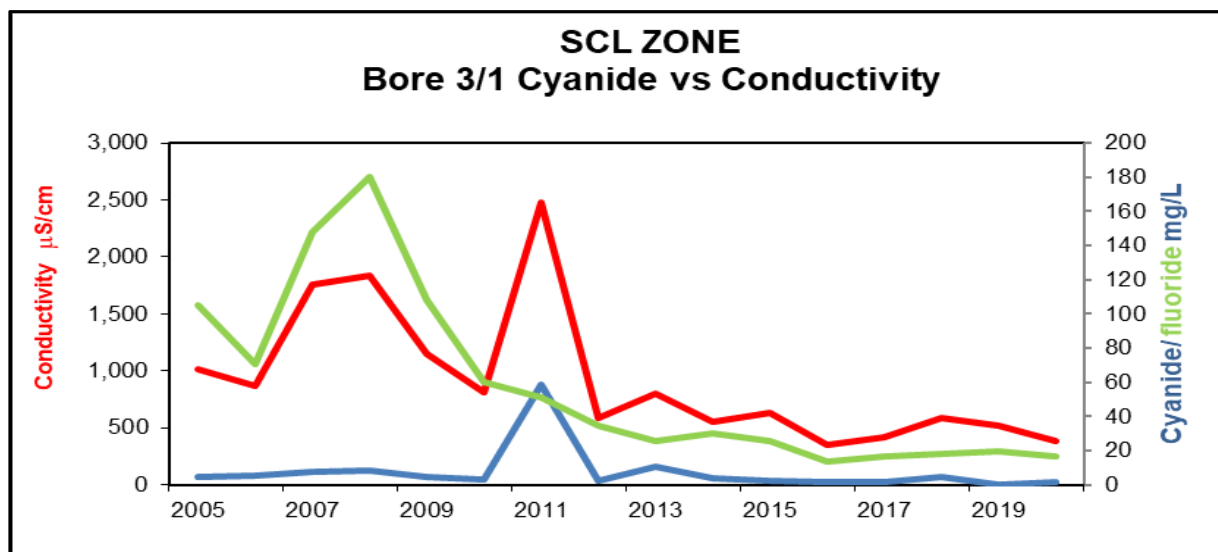
The cyanide concentrations track well with conductivity but not with fluoride for shallow bore 3/1 in the SCL Zone. See the graphs below for details. There appears to be limited or no correlation between total cyanide and fluoride concentrations for this bore.

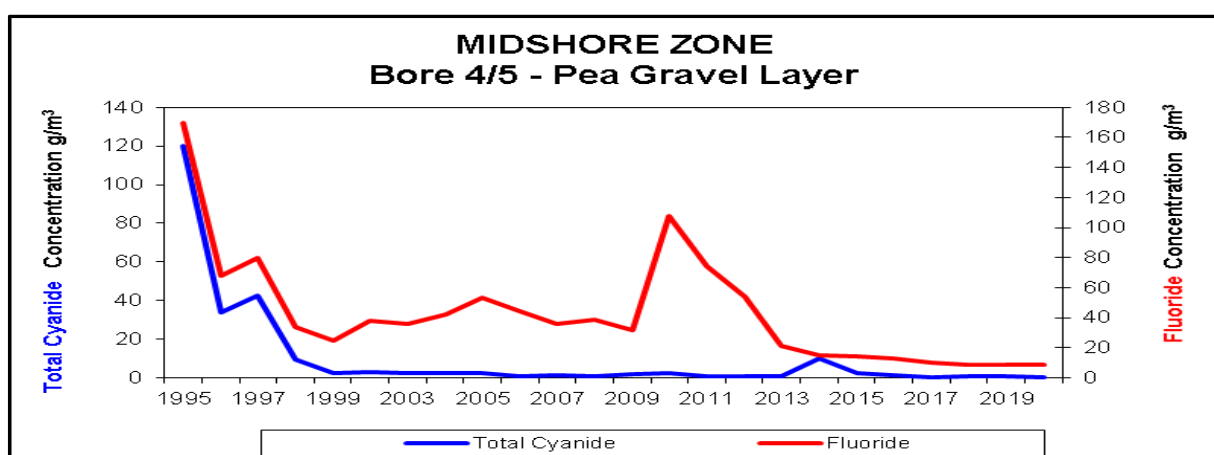
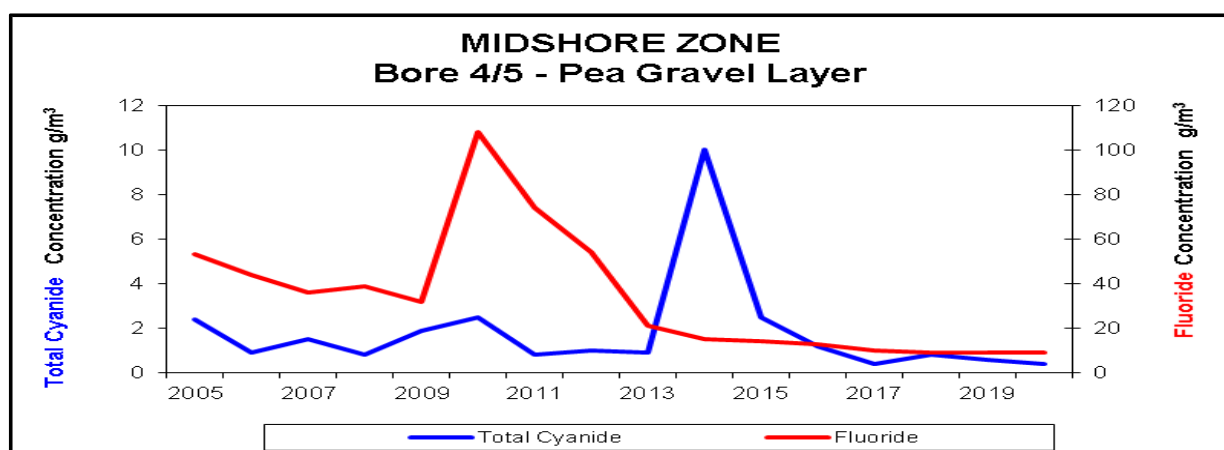
Both fluoride and cyanide levels have decreased significantly since monitoring began in 1995 and nearing the background values found in Bore 2/2. Total cyanide is higher than background but is much lower than that in the underlying fine sands layer. A spike in concentration for the analytes was observed for:

- fluoride in 2010/2011 which corresponds to a spike seen for bores in the SCL Zone occurring 3 years prior.
- cyanide in 2015 which corresponded to the spike observed for the SCL Zone bores in 2011. The underground discharge pipe was replaced in 2015 due to potential leakage.

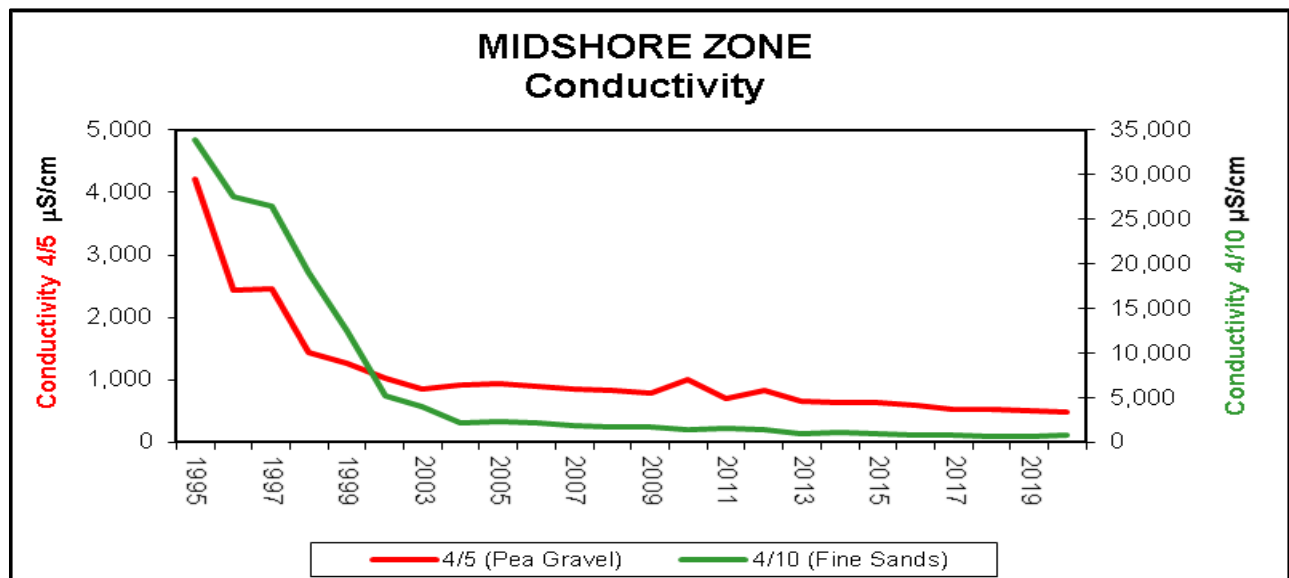
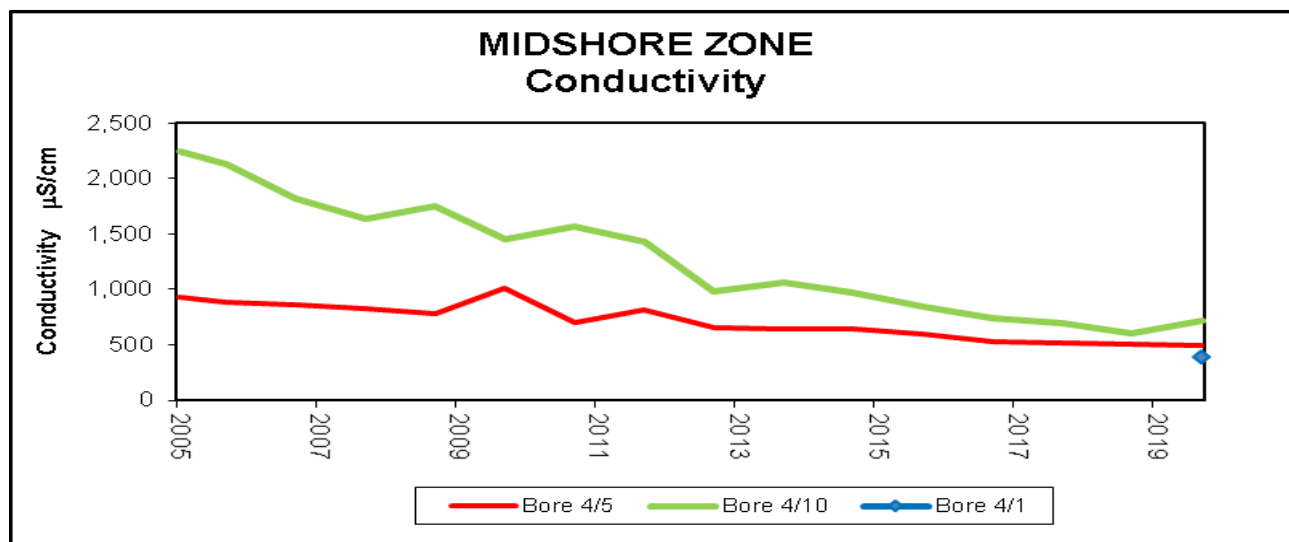
Contaminants are present in both layers, with the highest concentrations seen in the fine sands layer. The conductivity of the midshore bores 4/10 (deep) and 4/5 (shallow) have recovered significantly since monitoring began in 1995 and is approaching background levels, as are already seen in bore 4/1 (shallow). The conductivity in the midshore zone bores is 100-200 µS/cm above levels observed for the sewage field to the west of the pad.

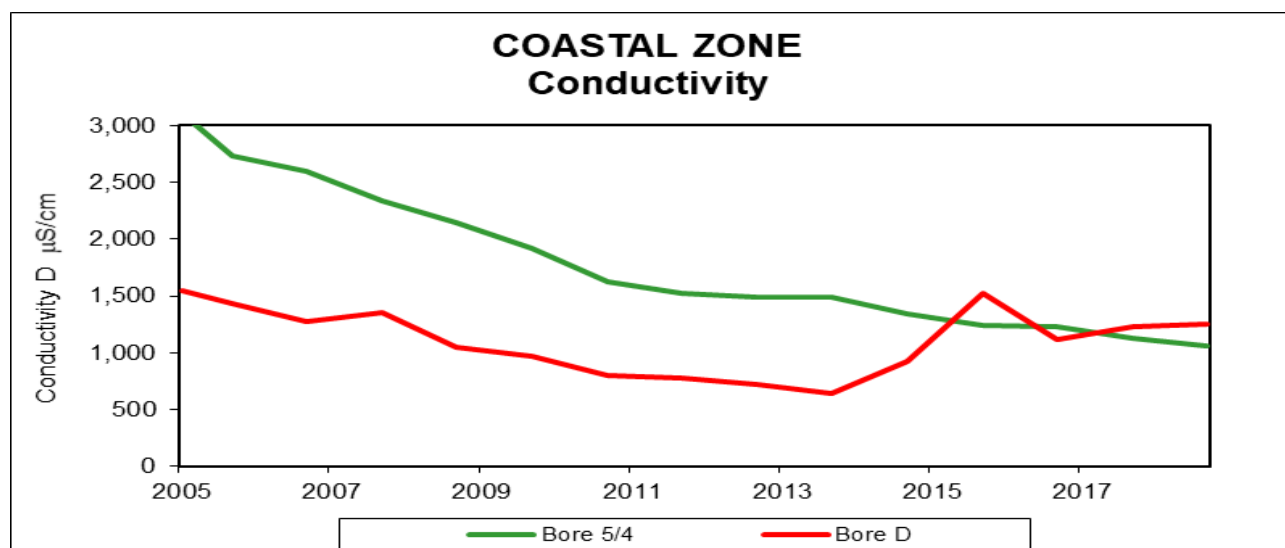
Monitoring at deep bore 5/4 in the fine sands layer demonstrates continued recovery over time. This bore is approximately 11 metres from the edge of the sand dunes to the beach. The conductivity is about 700  $\mu\text{S}/\text{cm}$  greater than levels observed in the background bore 2/2 and 500  $\mu\text{S}/\text{cm}$  above levels seen around the sewage field. This may be due to the start of sea water intrusion in this bore.

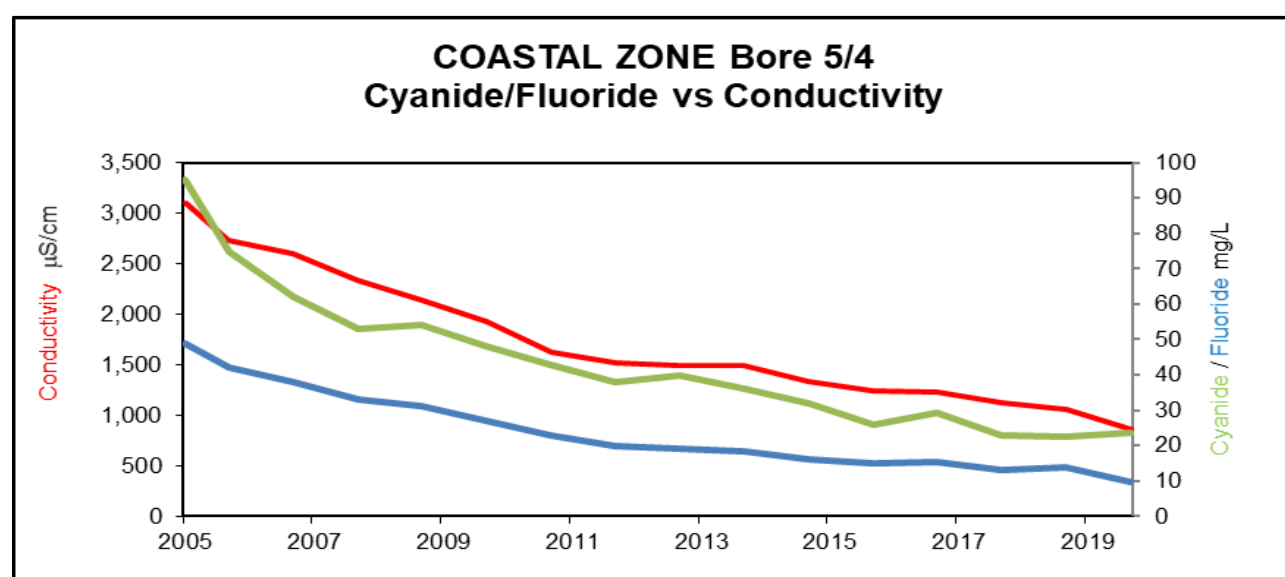
The cyanide and fluoride concentrations track reasonably well with conductivity for deep bore 5/4. Similar to what was observed for the SCL zone. See graphs below for detail.

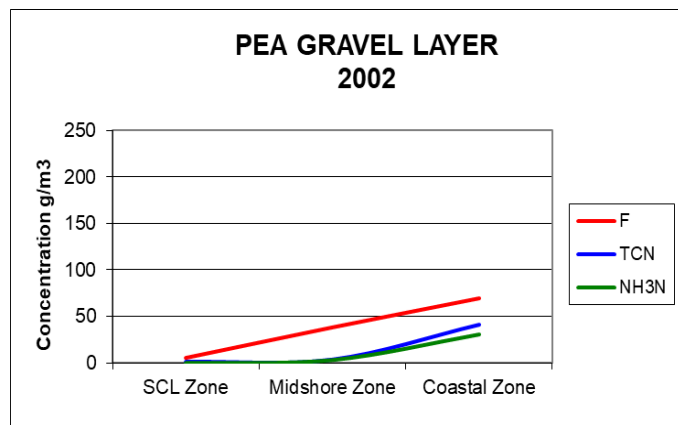
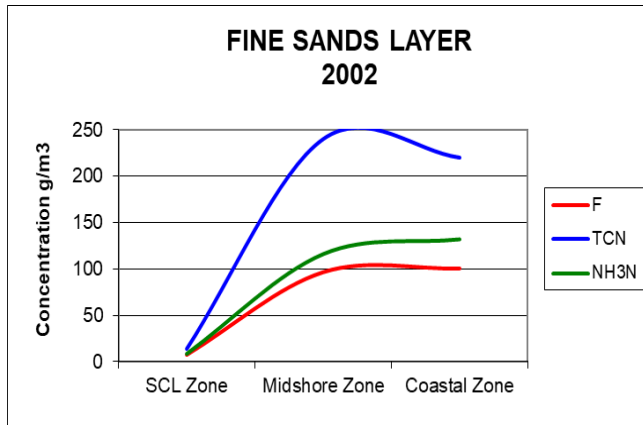
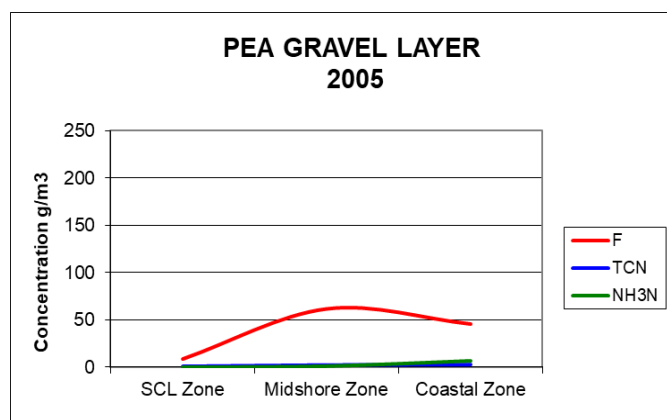
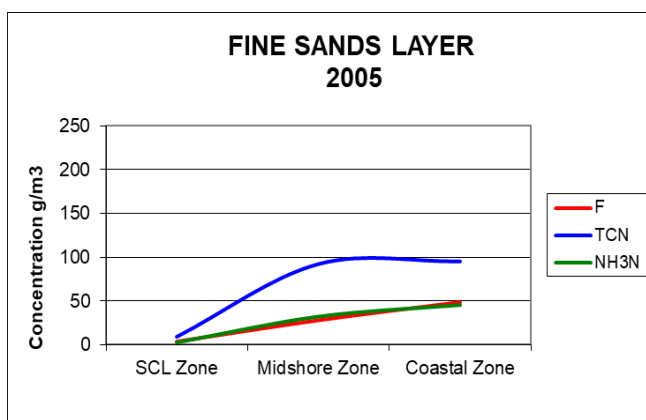
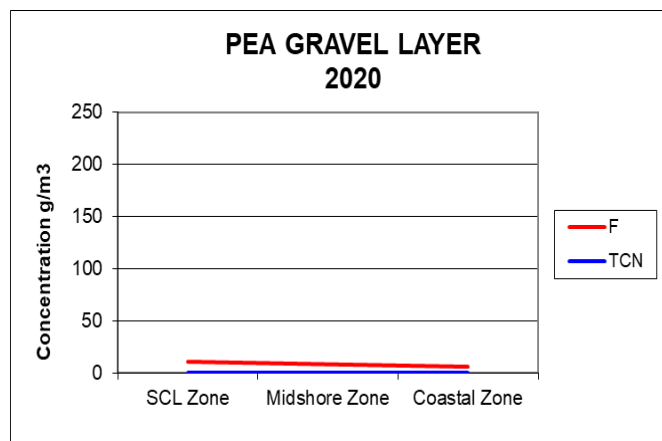
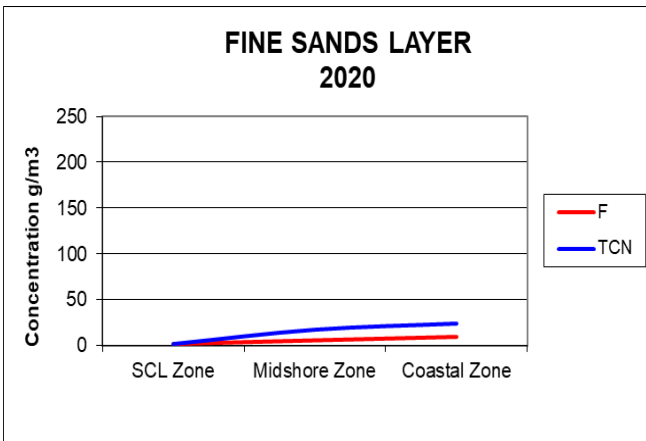
Both the pea gravel and find sand layers show great recovery from the 1990s groundwater contamination for all zones. The shallower pea gravel layers are showing less contamination than the fine sand layers which is expected due to the higher permeability in the pea gravel.
