CHFA Capital Needs Assessment

FINAL REPORT

Parkside Village I

November 10, 2020

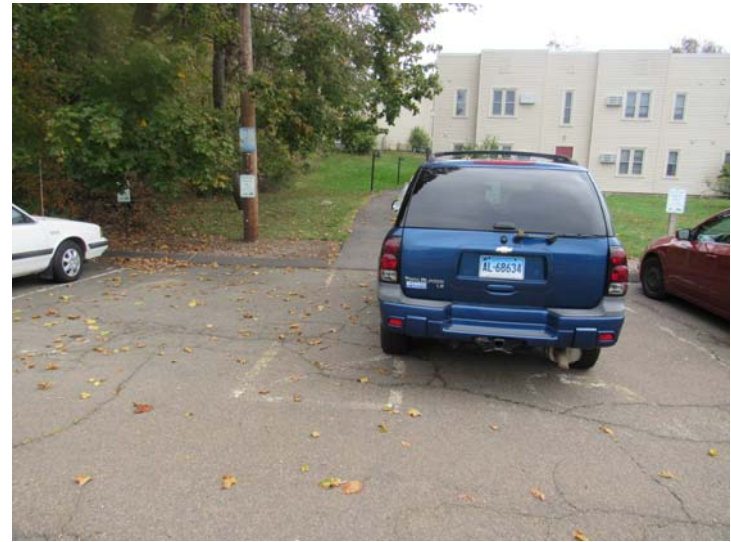
View of resident provided surface parking as seen towards west end of development –note cracking and faded/weathered striping

The front end asphalt pavement appears to have been resurfaced within the past several years and displays good overall conditions. Future resurfacing costs are shown in Year 14, based on estimated pavement age, observed conditions, and an expected useful service life of twenty years. The rear parking area is reportedly the responsibility of the development; the rear parking area exhibits cracking/evidence of fatigue. Resurfacing of the rear parking area is shown in Year 1. Future costs for preventative maintenance repairs in the form of crackfilling, sealcoating, and restriping are shown in Years 6, 11, and 19. The asphalt-paved walkways display good overall conditions and appear to have been

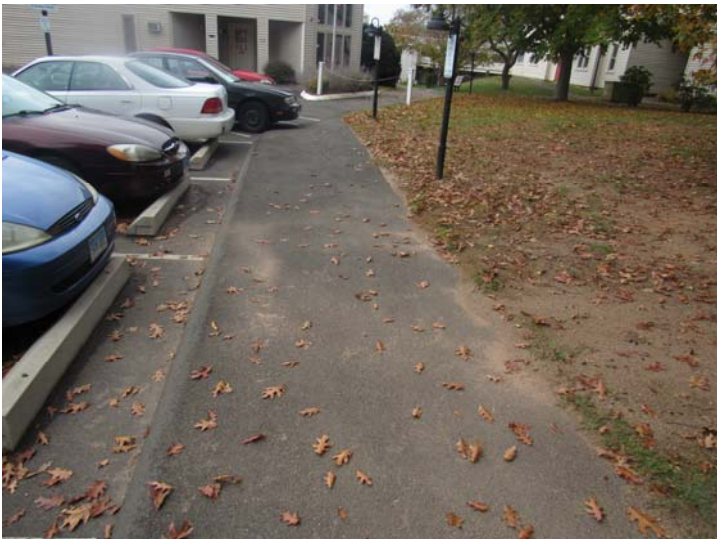
View of sample of asphalt walkway conditions – good overall conditions

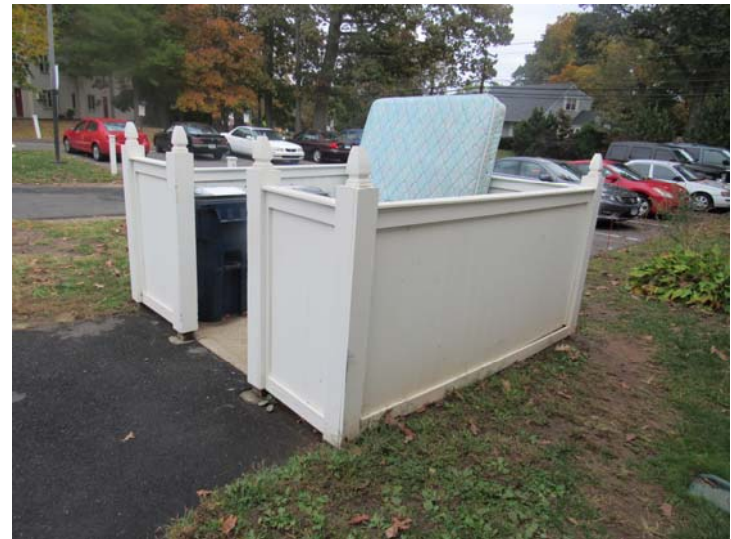
- The dumpster enclosures do not feature a 36-inch clearance at their entries. These conditions are shown being addressed as part of planned dumpster enclosure replacement.

The wood dumpster enclosures appear to be approaching the end of their normal expected useful service lives. Replacement costs are shown in Years 1 and 16 (including widening entrances to accommodate 36-inch minimum clearance for accessibility). Replacement of the development's wood entry signage is also shown in Year 1 (including addressing surrounding landscaping). No problems/concerns were reported with regards to the site lighting; future replacement costs are shown in Year 11. Localized areas of tree encroachment were observed along the building facades; periodic costs to carry out landscaping repairs/upgrades including tree pruning efforts are shown every five years starting in Year 1. Management reports the site distribution systems are in good condition at the present time. No instances of sewer line back-ups or breakage were reported; management also reports the development's stormwater system is functioning as originally designed. The site distribution systems are shown being maintained and monitored during the plan's timeframe.

View of dumpster enclosure conditions – 1 of 4 serving development

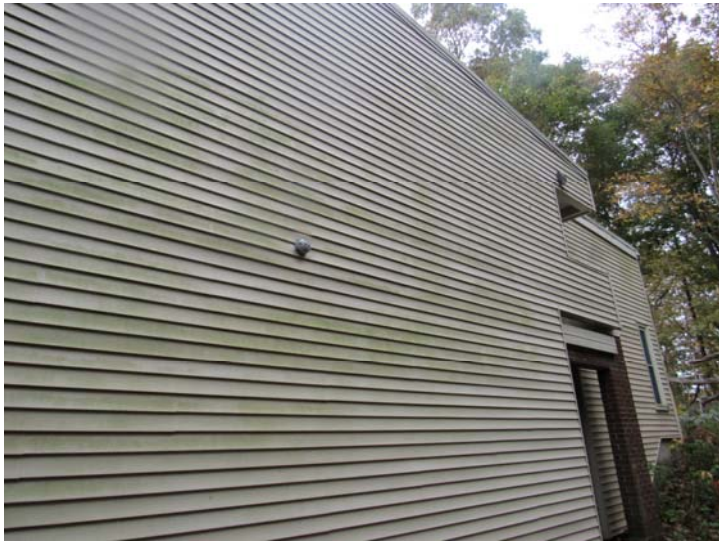
The vinyl siding is in serviceable condition at the present time. Localized damage and staining from water-runoff were observed, and costs for localized vinyl siding repairs and pressure washing efforts are shown in Year 1. Future replacement of the vinyl siding, based on estimated siding age and observed conditions, is shown in Year 11 (concurrent with exterior window replacement). The exterior doorways appear to date to the time of original construction and are therefore operating beyond the end of their normal expected useful service lives. Replacement of the exterior doors are shown in Year 1. The apartment unit exterior entries also contain an aluminum storm door; replacement of the storm doors is shown in Years 1 and 16. A metal overhead door serves the community building maintenance garage; future replacement costs are shown in Year 11. The electrical meter closet enclosures exhibit age related wear/weathering; repair/replacement costs are shown in Year 1.

Localized staining from water-runoff observed on vinyl siding at buildings

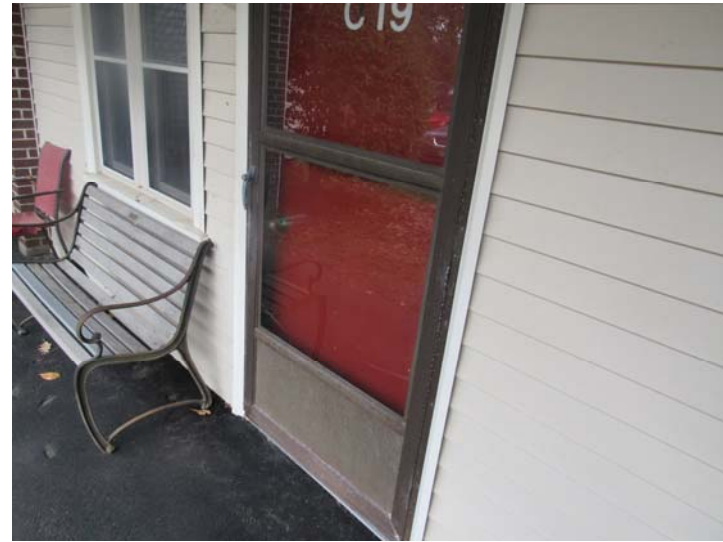
View of typical unit exterior entry doorway conditions – note oxidation on storm door

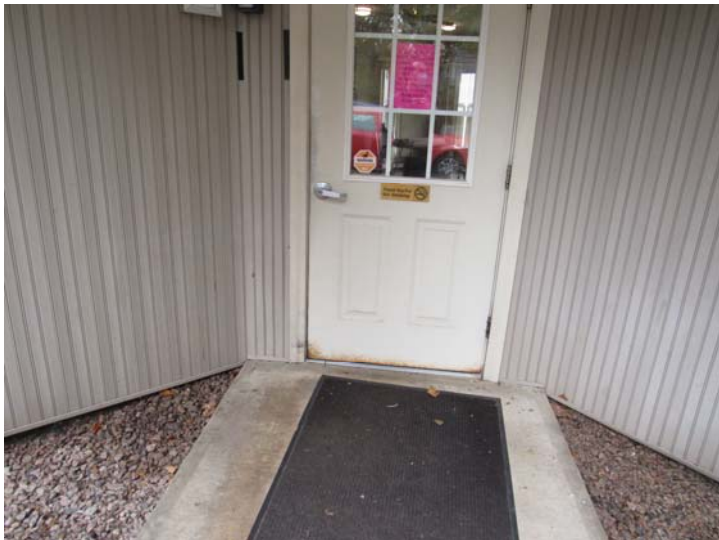
View of corrosion along base of community building main entry doorway

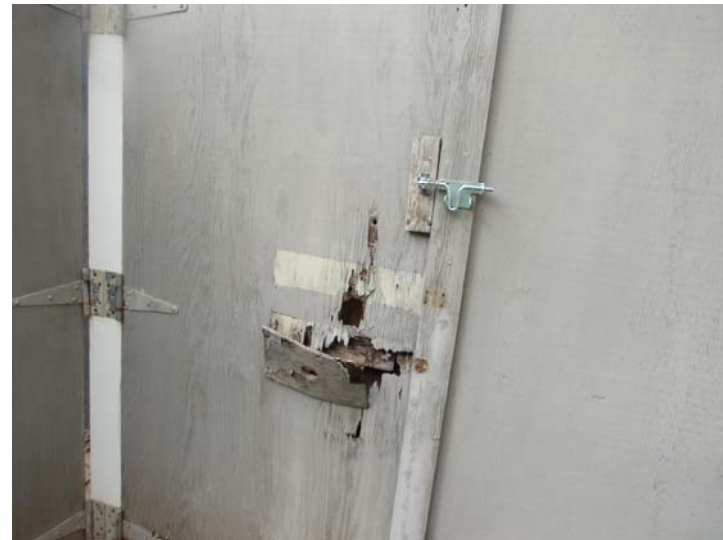
View of electrical closet wood doors exhibiting pronounced deterioration/weathering as seen at Building C

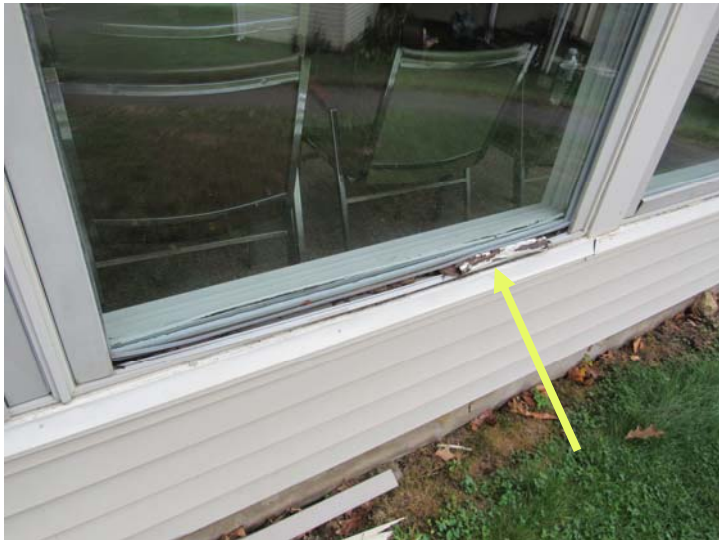
View of wood rot/deterioration as seen along base of community building exterior window

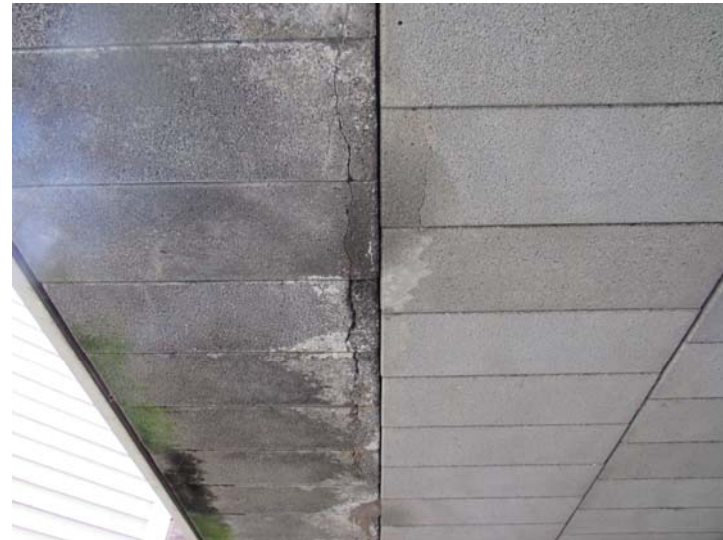
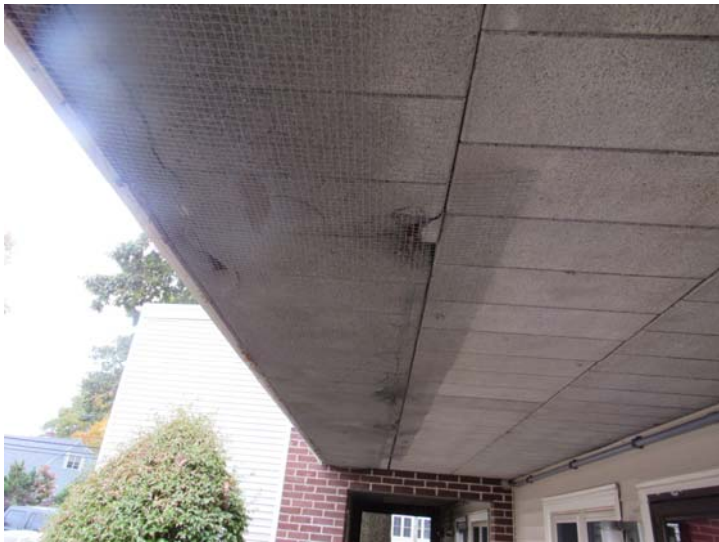
of cracking and spalling were observed on the soffit (i.e. underside) of the second floor level deck. Management has installed netting on the underside of the deck at deteriorated locations to mitigate any overhead risks to pedestrians below. The exact nature of the deterioration is unconfirmed, but appears to be related to moisture infiltration and potentially poor drainage. Several areas of cracking were also observed within the concrete topping. A place marker allowance to carry out repairs/replacement of the decks are shown as an immediate concern, however a detailed review by a qualified design professional is required to determine the full scope and cost(s) of the required repair/replacement work (potentially more invasive review/destructive testing required to determine full extent of required repair/replacement work). The building-mounted LED fixtures are in good condition, and future replacement costs are shown in Year 11. Replacement of the soffit-mounted light fixtures is shown in Years 1 and 16. The exterior light fixtures installed at the unit entries and common stairway doors are shown for replacement in Years 1 and 16.

View of underside of second floor deck – concrete soffit exhibits widespread cracking/deterioration

Additional view of concrete deterioration as seen at soffit/underside of second floor deck

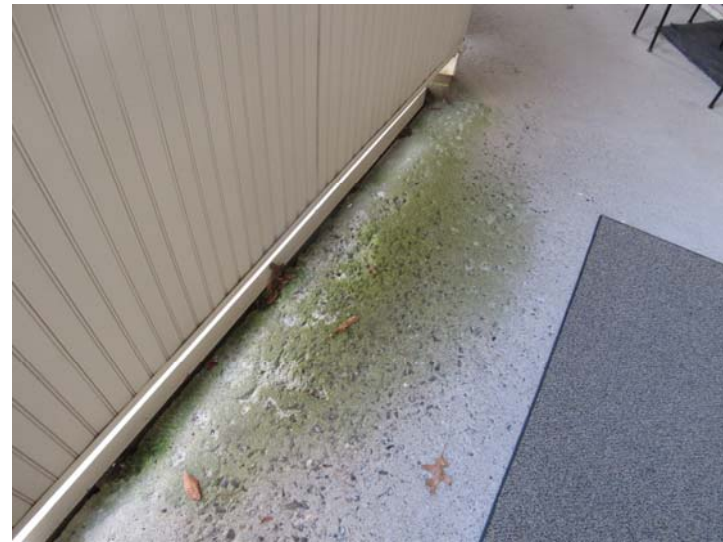
View of top surface of second floor concrete deck exhibiting surface scaling/deterioration – localized areas of cracking also observed

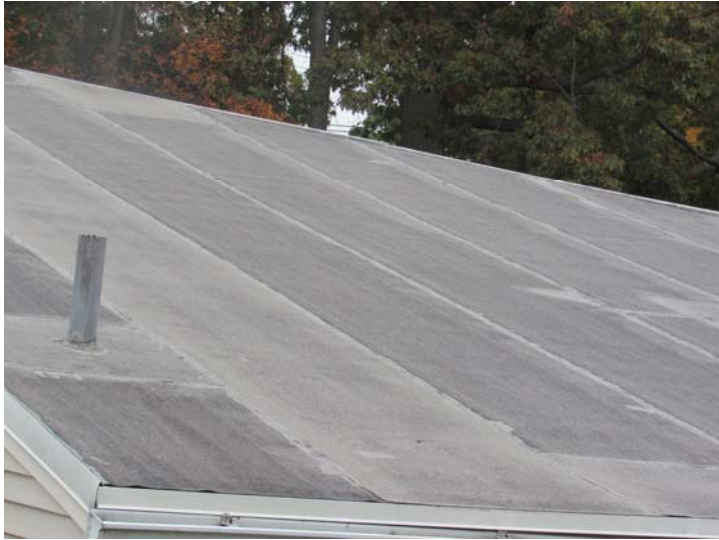
The buildings contain mildly sloped roof assemblies covered in modified bituminous sheet membranes. The exact age of the roof assemblies is unconfirmed at the present time, however from the available vantage points the sheet membrane appears to be exhibiting age related wear (e.g. deteriorated seams, degranulation, etc.). Costs to replace the roof assemblies are shown in Year 1. Concurrently, costs to replace the aluminum gutters and downspouts are shown in Year 1.

View of typical roofing system conditions – appears to be modified bituminous sheet membrane roof assembly from available vantage points

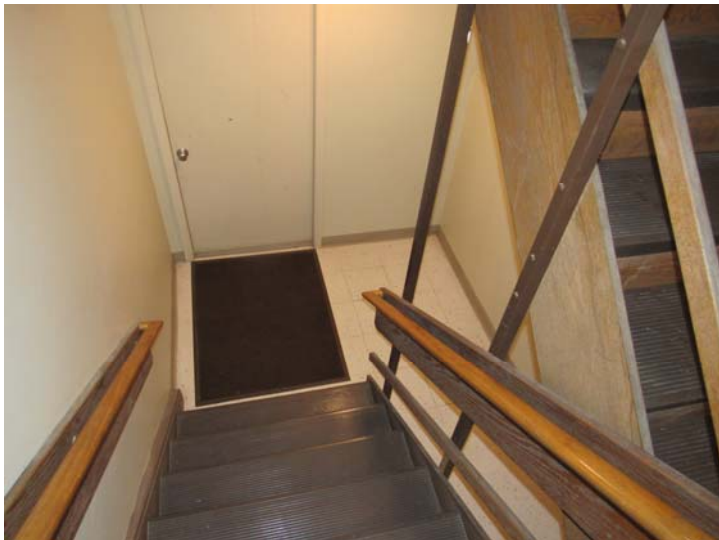
The common stairway finishes include painted wall and ceiling surfaces, vinyl stair treads, and vinyl composition tile (VCT) landings. Costs for repainting efforts are shown in Years 1 and 11. Replacement of the vinyl stair treads and VCT

View of typical common stairway finishes – note stairway railings do not meet current safety standards

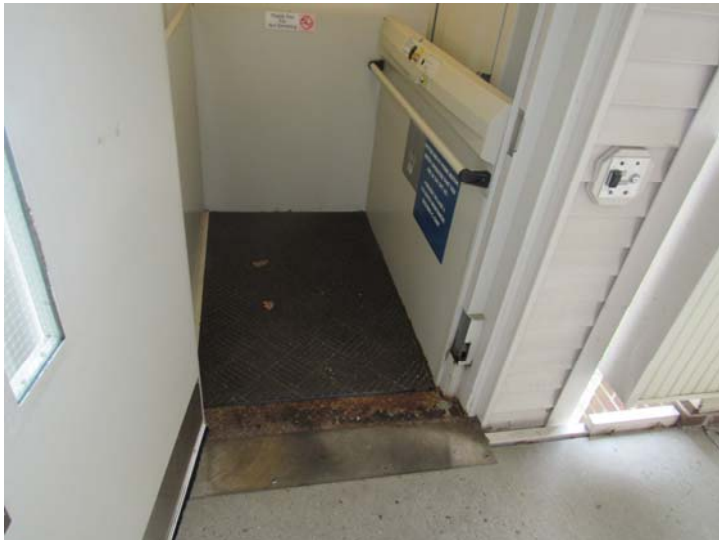
View of one of four vertical platform lifts serving residential buildings (i.e. 2 at Building C, and 1 each at Buildings A and B) – note corrosion at threshold

common stairways (including removal of existing lifts). An allowance per management request to carry out this work is shown in Year 1 (including costs associated with retaining a design professional); it should be noted that this modification/improvement work would require extensive modifications to the stairways to accommodate the size of the platform lifts (subsequently a detailed review would be required to determine full scope and cost(s) of this work).

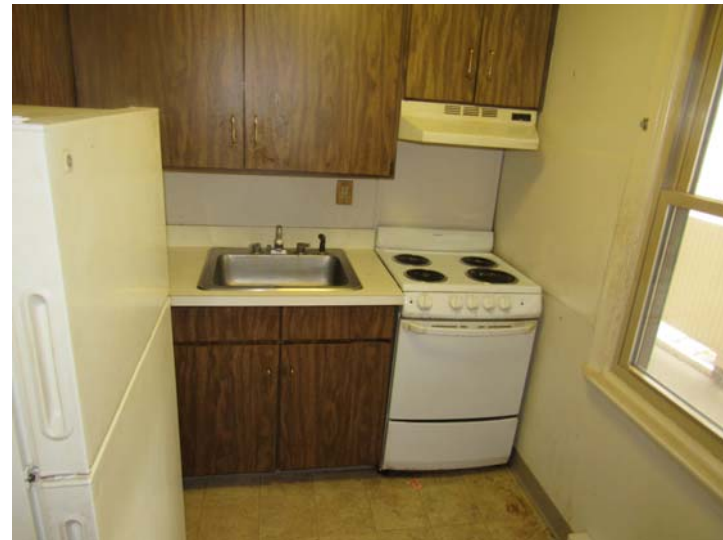
Unit kitchens contain either original or newer laminated particleboard cabinets, 30-inch electric ranges, frost-free refrigerators and recirculating rangehoods. Replacement of the original kitchen cabinets is shown in Year 1; the newer/replaced kitchen cabinets are shown for future replacement in Year 16. Replacement of the kitchen appliances is shown in Year 1 (concurrent with remaining unit renovation work); future replacement of the appliances is shown based on equipment expected useful lives. Costs to equip the rangehoods with fire stop canisters are shown in Year 1; future replacement costs are shown in Years 7, 13, and 19.

View of unit kitchen finishes and equipment – note original cabinet set

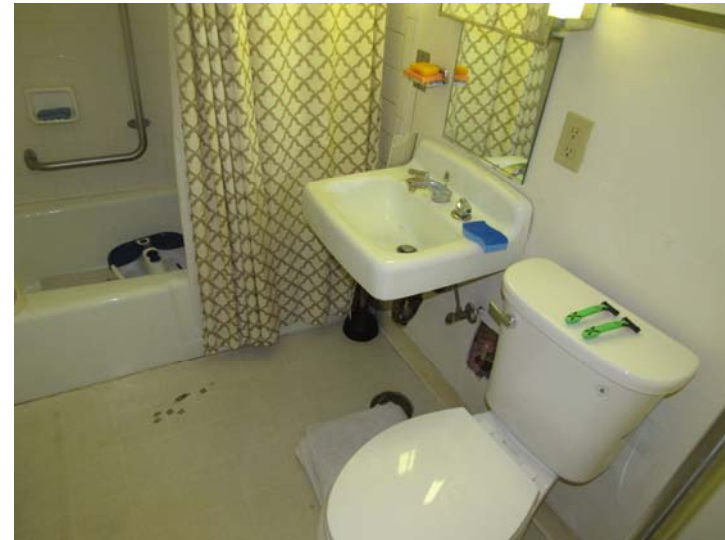
Units bathrooms predominantly contain cast-iron tubs with ceramic tile surrounds, wall-hung sinks, 2.0+ gallon per flush toilets, standard bathroom accessories, and ceiling-mounted exhaust fans. The majority of the bathroom fixtures date to the time of original construction; replacement of the original lavatories, tubs/surrounds, and toilets is shown in Year 1 (concurrent with remaining unit renovation work). The bathroom accessories, medicine cabinets, and exhaust fans are also shown for replacement in Year 1 (majority are dated where observed).

View of typical unit bathroom finishes and fixtures – isolated toilets appear to have been replaced in recent years

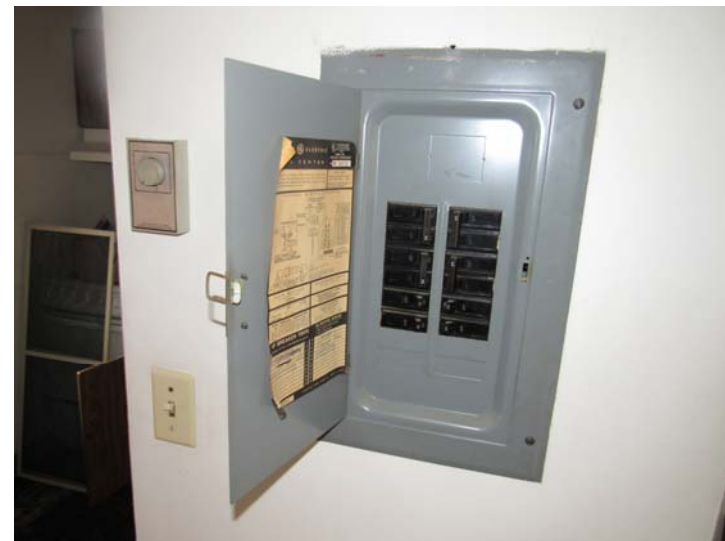
Units contain original electrical circuit breaker panels, hardwired, battery-backup local ring smoke detection devices, and thermostats. Replacement of the circuit breaker panels is shown in Year 1. The smoke detectors appear to be operating beyond the end of their normal expected useful service lives; replacement costs are shown in Years 1 and 11. The one-bedroom apartment units do not contain smoke detectors within the bedrooms; installation costs are shown in Year 1 (future replacement shown in Year 11). Costs to replace/upgrade the development's emergency call assistance pull cord system are shown in Year 1. Replacement of the electric baseboard heaters and thermostats is shown in Year 1. Electric domestic water heaters (40-gallon capacity each) facilitate domestic hot water generation for the apartment units. The water heaters vary in age; annual costs for as-needed replacement are shown starting in Year 1. Costs to refurbish the development's A/C unit sleeves are shown in Year 1.

View of General Electric unit-level circuit breaker panel
