Loudoun County Department of Fire, Rescue, and Emergency Management

SIGNIFICANT INJURY INVESTIGATIVE REPORT 43238 MEADOWOOD COURT MAY 25, 2008

September 2008

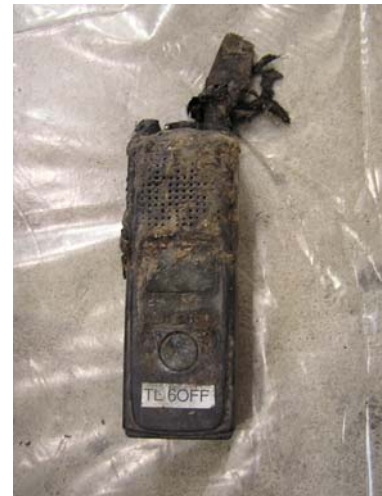
- The Tower Officer's radio was on 6-Charlie and was not on scan mode. The Officer carried the radio in a radio strap; both the portable radio and the radio strap sustained thermal damage (see Figure 38).
- The Reserve Engine Firefighter carried the portable in the radio pocket of the turnout coat. The portable was on 6-Charlie and was not on scan.
- The Tower Firefighter carried the radio in a radio strap. The portable was on 6-Delta and was not on scan. The Tower Firefighter's radio sustained thermal damage.

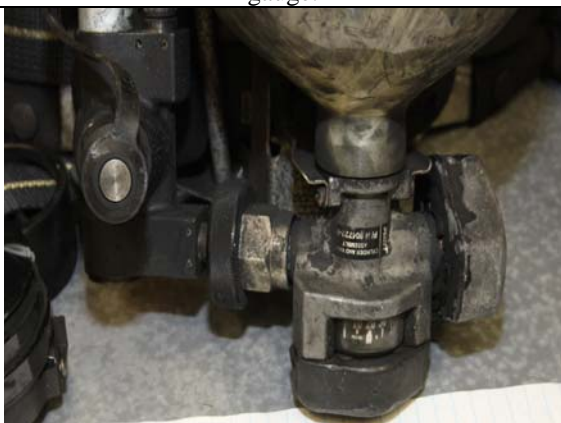
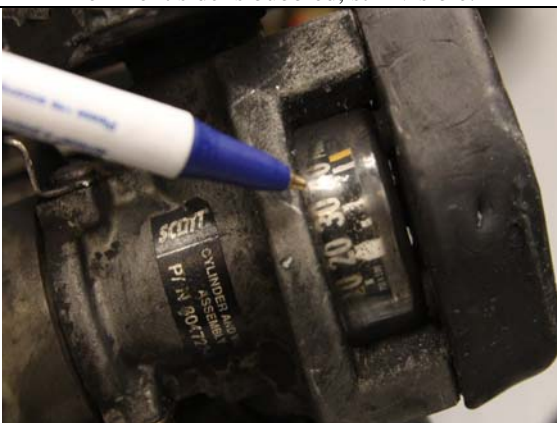
Cylinder:	
Cylinder received showing approximately 1900 psi on the gauge.	Cylinder is smoke stained, knob is missing some paint, gauge on front side is bubbled, still visible.

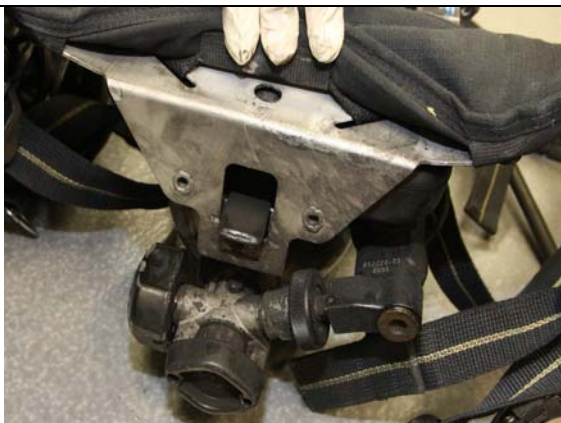
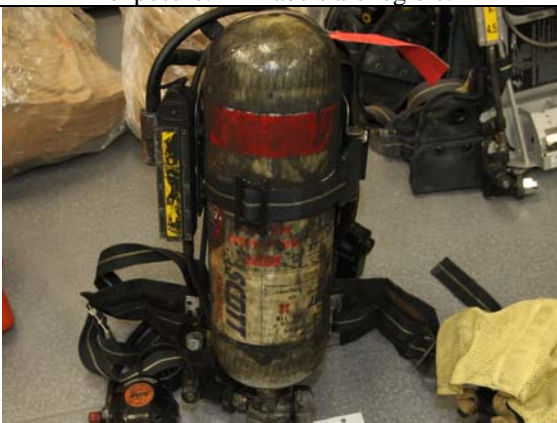
Gauge on backside is smoke stained, still slightly visible.	Red stripe at top of cylinder does not show signs of heat exposure. All labels are legible.

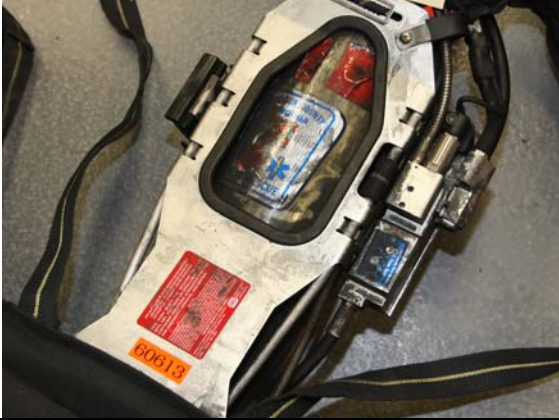
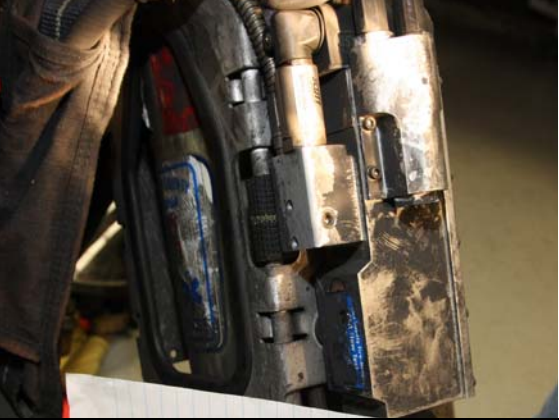
Reducer / Hoses: Smoke stained, Loudoun County Flow Test decal attached over the primary and secondary seat access is legible, has Apr 2008 holes punched out.	HUD driver has what appears to have a rusty color on the metal tube going to the gauge block

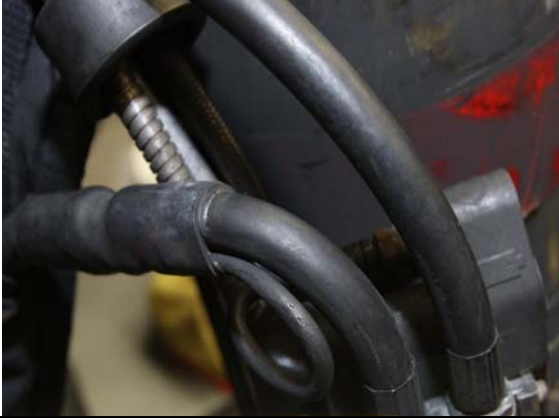
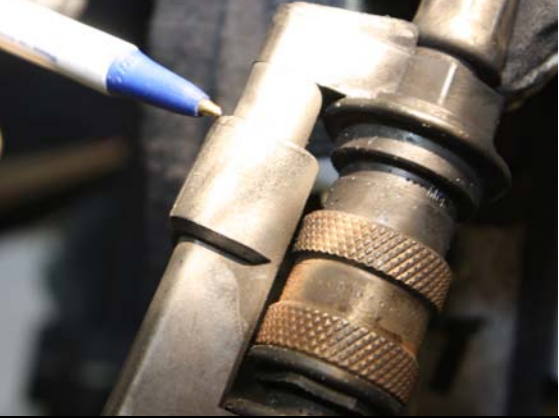
High pressure hose appears intact, UAC boot attached. Low pressure breathing line looks good, no apparent damage except for the HUD line coming off of it going to the HUD driver has what appears to be minor blistering.	Quick connect is discolored, rusty look. EBSS hose looks ok, no apparent damage, boot still attached to the quick connect.

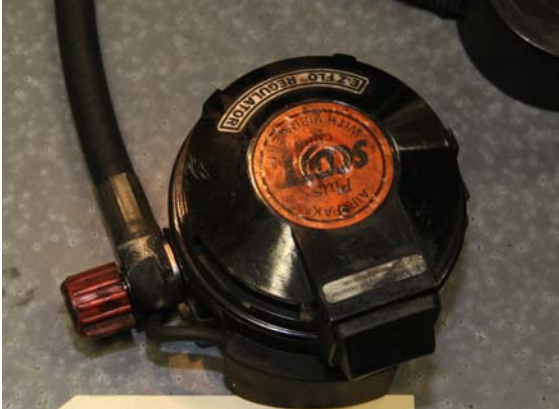
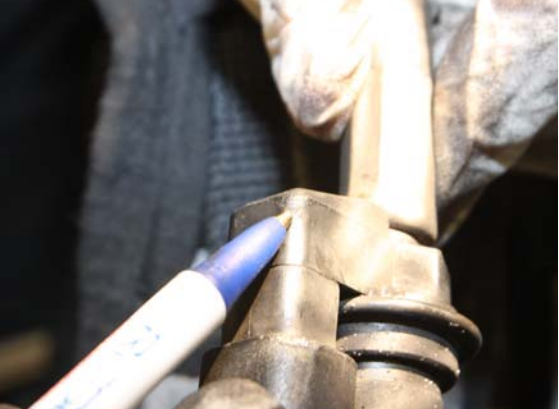
Regulator: Cover appears normal with minimal smoke stain. Bubbles on decal, one over the screw that attaches the air saver mechanism to cover and one below it in a U shape.	HUD socket worn on one edge.

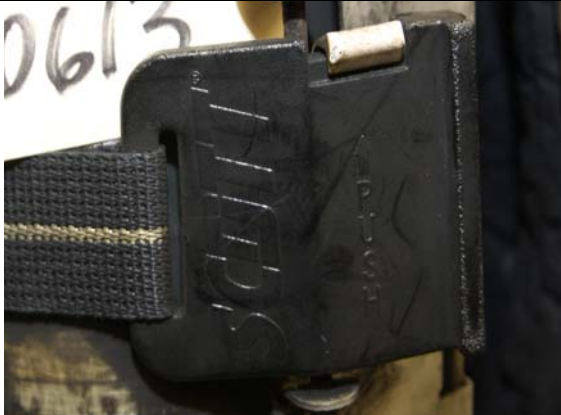
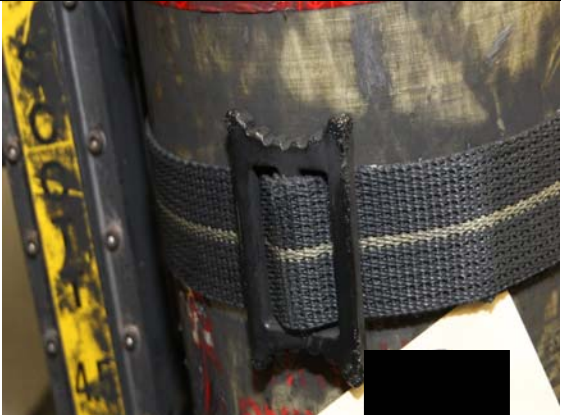
<p>Female waist strap has regulator holder attached, no apparent damage. Male waist strap no apparent damage, buckles operate normally and lock securely. Cylinder retention strap / buckle locked, no damage. Back part of latch plate slightly blistered.</p>	<p>Adjustable clip for retention strap blistered.</p>

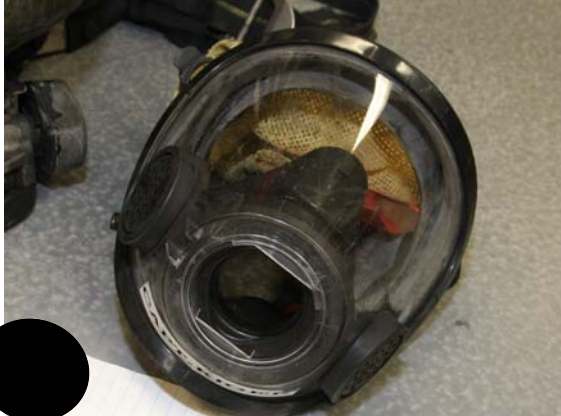
Mask:	
Mask lens crazed, no smoke stain, label at bottom of lens [name redacted] Harness clean, neck and temple straps clean and operational. All size dots in place, buckle pads are present. Faceseal, nosecup, voicemitter ducts, inhalation valves all intact with no visible damage.

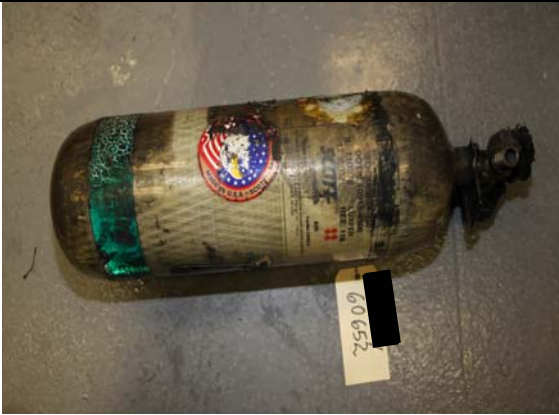
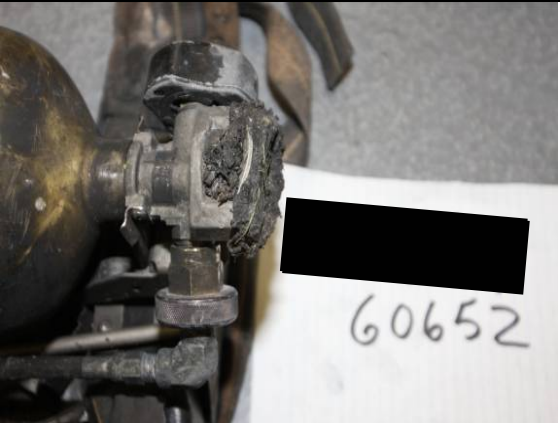
<p>Cylinder:</p> <p>Cylinder has signs of exposure to high heat or flame.</p>	<p>Bumper distorted and pushed down into gauge assembly. Front side of gauge lens not visible, covered by damaged bumper. There appears to be a hole in the gauge lens.</p>

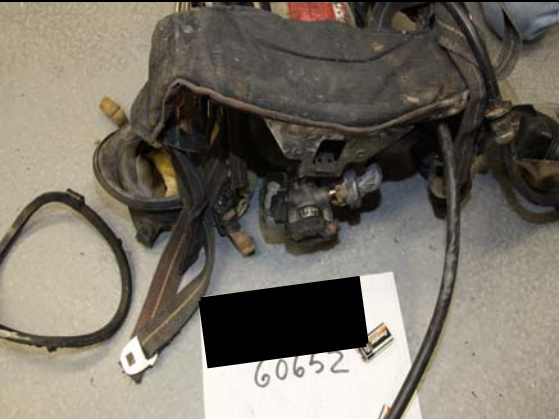
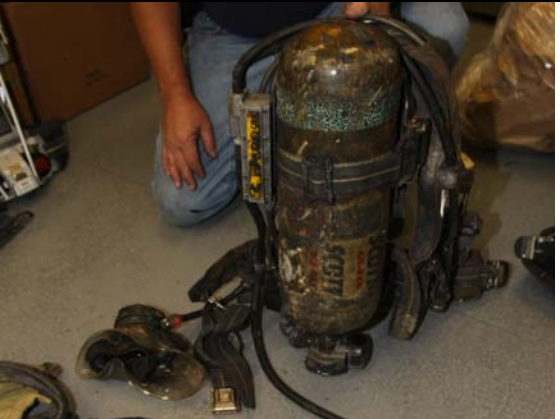
<p>The back side of the lens has no apparent damage; gauge is visible and showing 2000 psi. Gauge needle is not accurate, needle of gauge stuck due to front side damage. Actual air in cylinder is zero. Hand wheel is missing paint. Hydrostatic test label significantly damaged, date is slightly visible.</p>	<p>Green stripe around the top portion of cylinder blistered.</p>

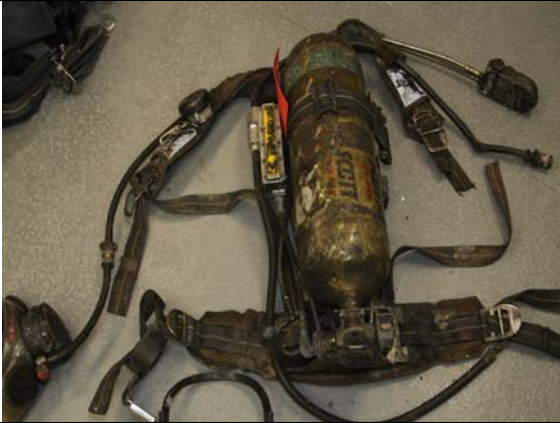
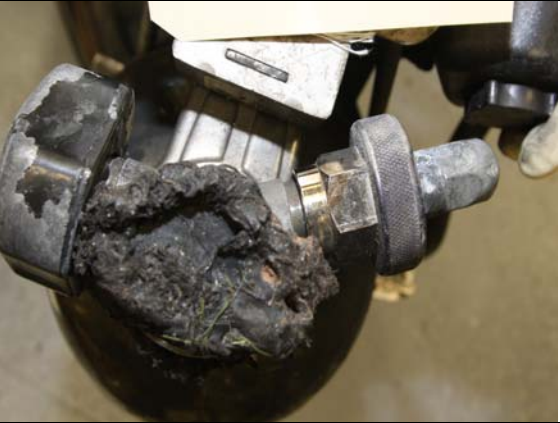
Reducer / Hoses:	
Reducer intact, smoke stained. Scott label on cover intact, no blistering.	High pressure connection still connected to cylinder. The coupling nut assembly appears to have a shiny brass look, possibly a sign of high heat exposure.

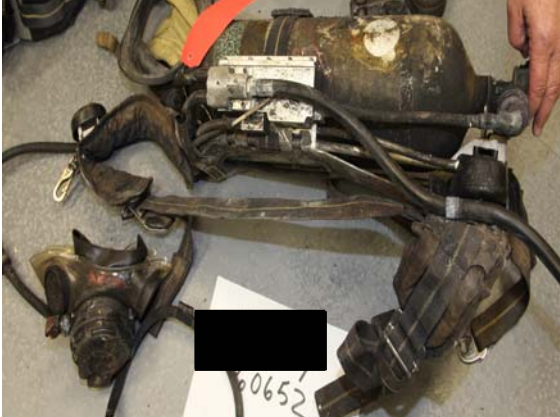
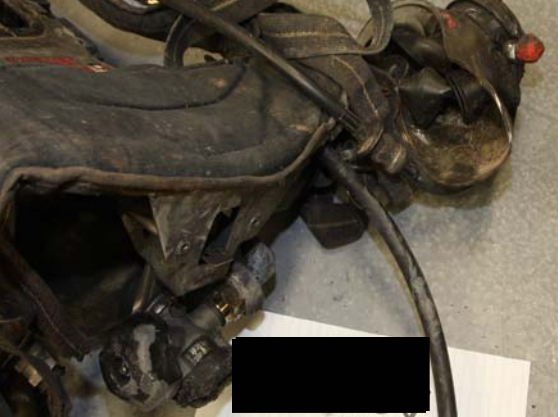
Hose is intact, feels stiff and possibly brittle.	The low pressure breathing line is intact, no visible defects.

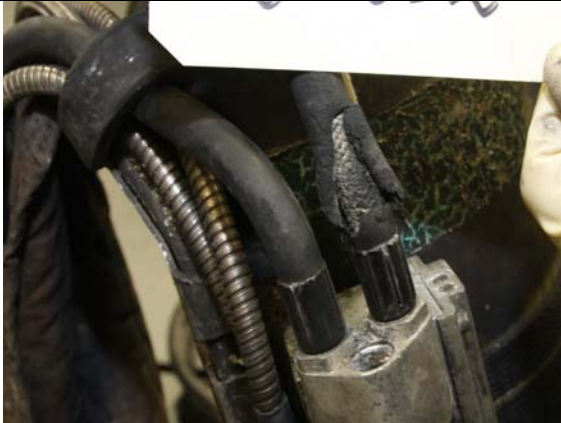
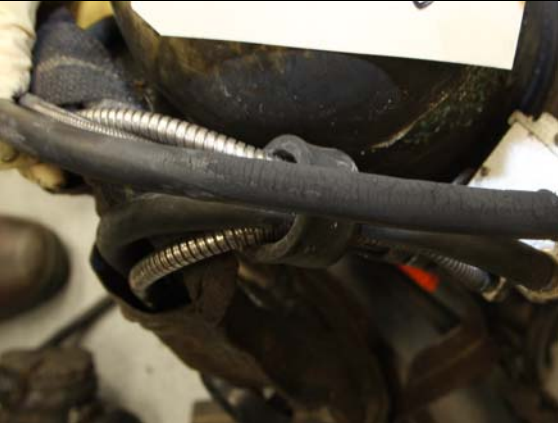
<p>EBSS hose has a tear in the outer cover at the reducer, some damage to inner weave.</p>	<p>The top portion of the EBSS hose where it would curve at the top portion of the cylinder appears to have heat damage.</p>

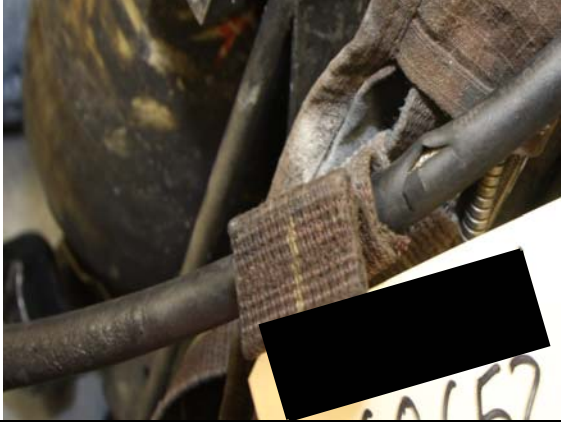
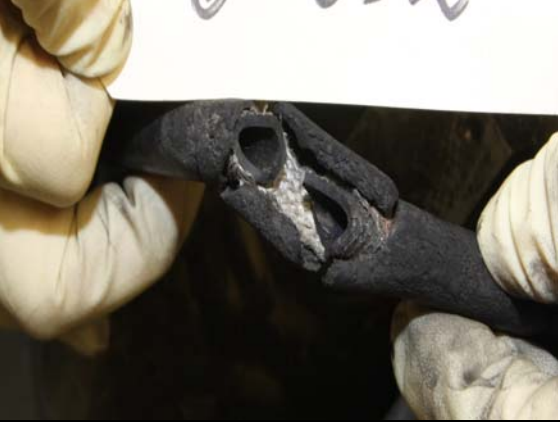
<p>There is a tear on the outer cover adjacent to where it is in position next to the cylinder retaining strap.</p>	<p>Appears the hose was cut just below the EBSS retaining strap. Quick connect coupling looks ok, boot is missing.</p>

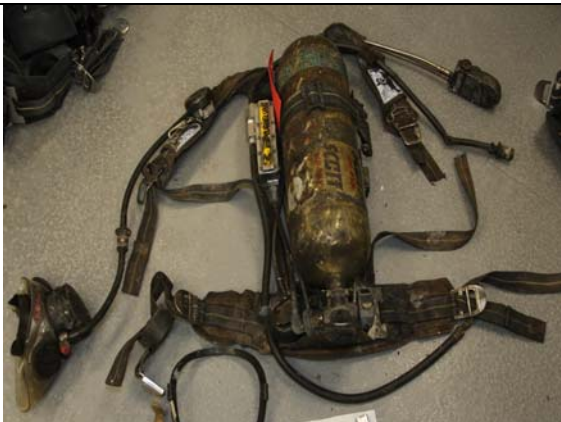
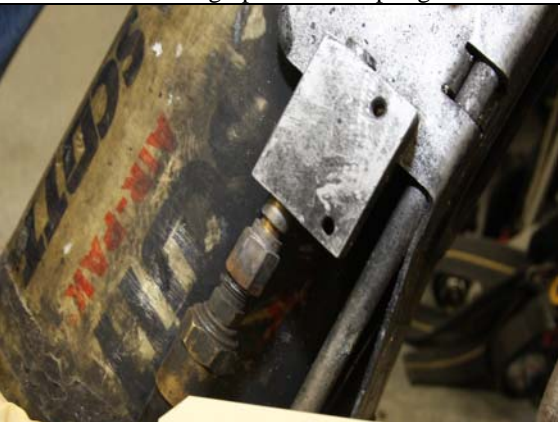
<p>This SCBA also has a supplied air hose connected to the bottom side of air manifold.</p>	<p>Hose was loose, not secured into catch that holds the coupling. The loose end is a Schrader connection that has a brassy look as did the high pressure coupling nut.</p>

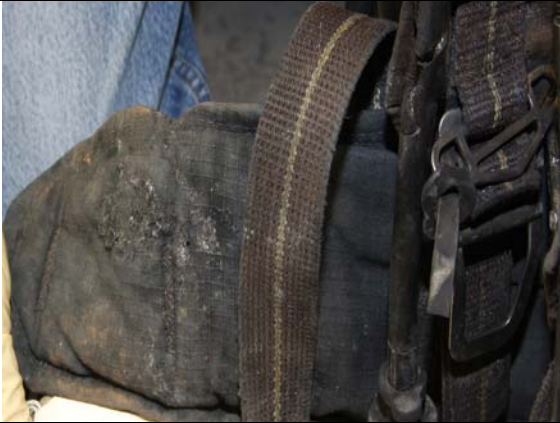
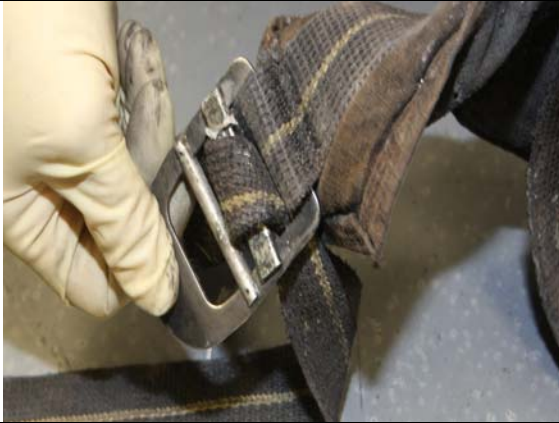
<p>Waist pad assembly has discoloration; right side has some debris melted on it.</p>	<p>Male waist strap twisted in buckle, no discoloration.</p>

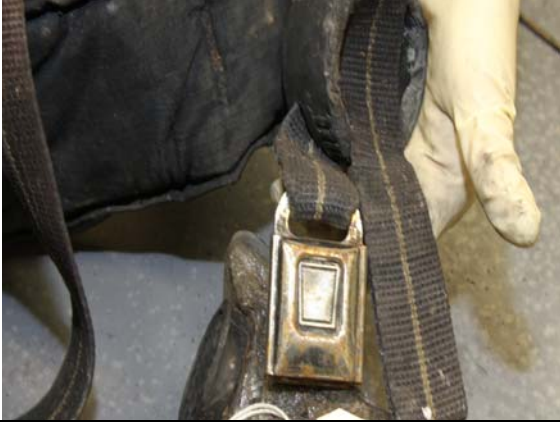
<p>Female waist strap exposed to high heat, regulator holder was melted into the strap. The female buckle showed some signs of rust. The frame itself is in good condition, some discoloration but no deformities noted.</p>

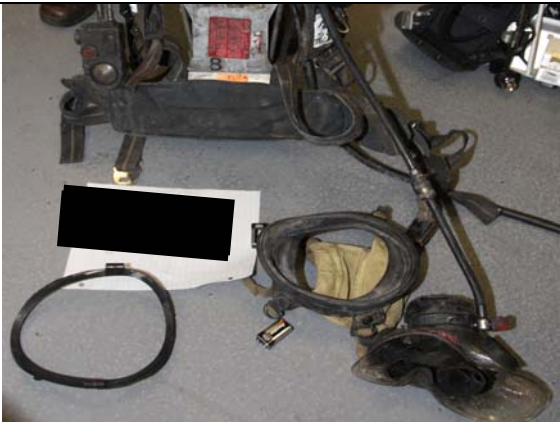
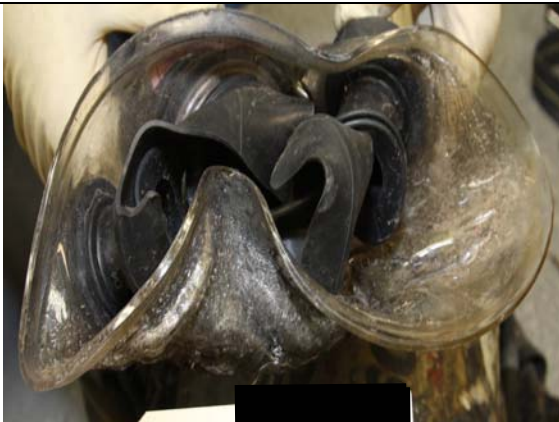
<p>Mask:</p> <p>Mask was not intact. The lens was separated from the upper and lower bezel. The upper and lower bezels were attached to each other but separated from the face seal. Face seal and harness still intact together.</p>	<p>The mask is an AV3000 size medium face seal. The lens was grossly disfigured from high heat or flame exposure. Appears grass was embedded into the front of the lens. The nose cup, both voicemitter ducts with inhalation valves surrounded by the melted deformed lens.</p>

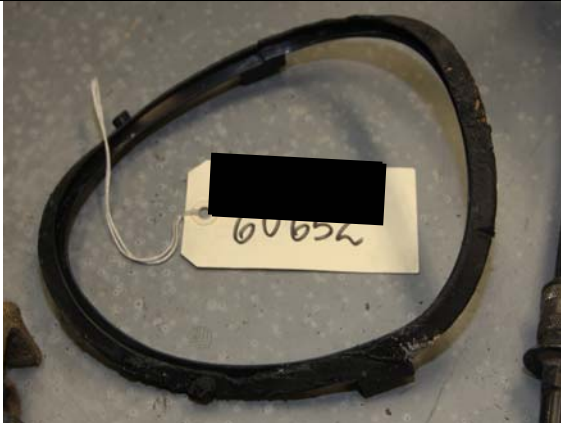
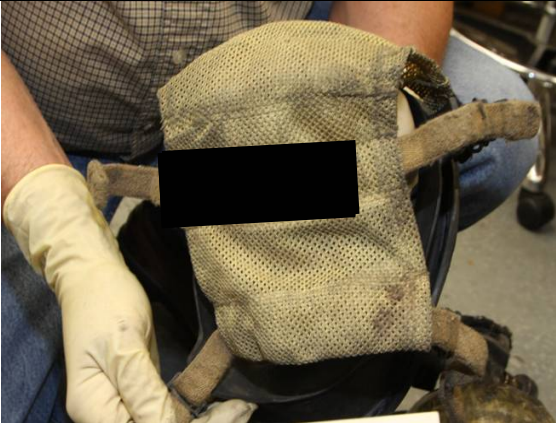
<p>Outer portion of voicemitters show some signs of heat exposure. Upper and lower bezels showed signs of heat damage on the front surfaces, mostly to the top right and bottom left.</p>	<p>The harness and both neck and temple straps look good, no apparent damage. All 4 size dots present both buckle pads in place.</p>

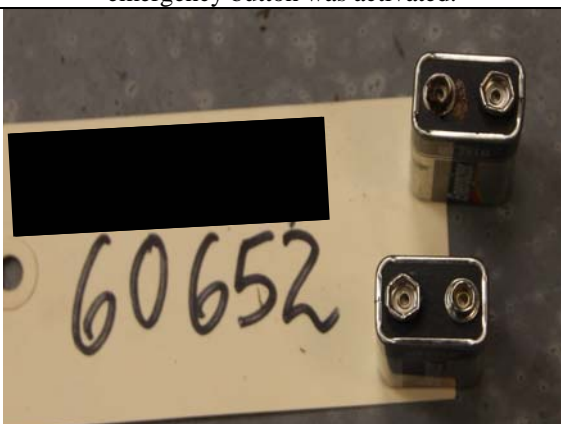
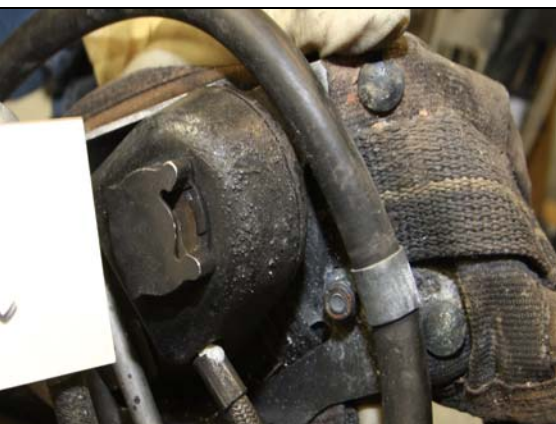
<p>P.A.S.S. / Console:</p> <p>Pak-alert was intact. Two energizer batteries were out of unit loose with the gear. One of the batteries showed significant corrosion damage on the positive terminal. The battery cover was missing 1 screw. Original batteries placed in pak-alert and did supply power to it allowing it to go into alarm when emergency button was activated.</p>	<p>Left side of housing showed signs of heat exposure.</p>

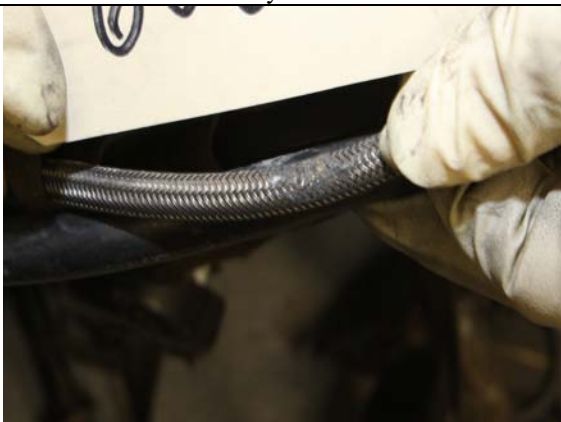
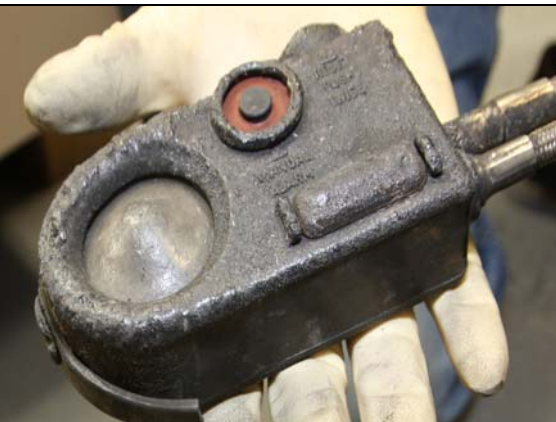
<p>Wire enclosure going to console in good shape, some debris melted on top portion of it where it curves down near the top of the cylinder.</p>	<p>The console showed signs of high heat exposure. Gauge lens was distorted, gauge not visible. Cover for indicator lights distorted.</p>

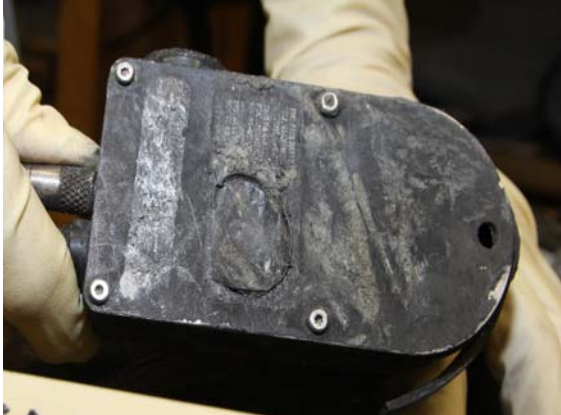
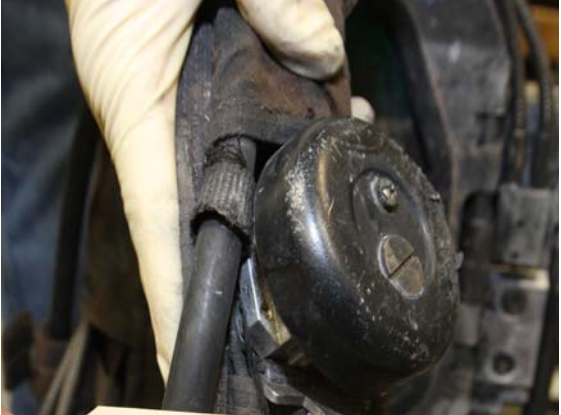
<p>The red and yellow on the emergency and reset buttons visible, some smoke stain. Gauge retaining strap was cut. Gasket appears intact, back cover labels illegible from possible heat damage.</p>	<p>Bell assembly intact, retaining strap still connected to low pressure breathing hose. Cricket line is intact, no visible damage.</p>
