EXISTING FACILITY ASSESSMENT

at THE ALFRED C. PRIESTLEY SCHOOL New Orleans, Louisiana

Waggonner & Ball *Architects* New Orleans, Louisiana

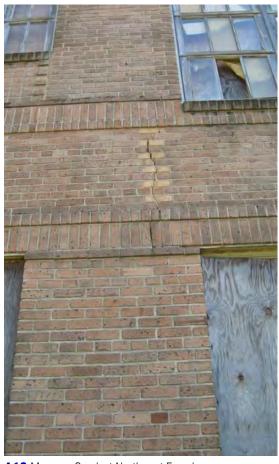
The exterior masonry walls are three wythes thick. There are no expansion or control joints in the masonry walls, which was typical for this era of construction. However, masonry cracking was observed in approximately forty locations. At the front parapet along Leonidas Street, approximately 240 SF of masonry had been replaced at some time in the past, but has again cracked. It also appears that the masonry parapet has been replaced (or repointed) on the Birch Street side.

A12 Masonry Crack at Northwest Façade

3. Remove and replace cracked bricks on each side of the 40 cracks in the main building and four cracks in the gymnasium. Place $\frac{1}{4}$ " stainless steel rod x 2'-6" at every third brick course across the repaired crack. We are recommending to repair the masonry cracks, but recognize that masonry cracking will continue because of the lack of masonry control joints and the differential settlement.

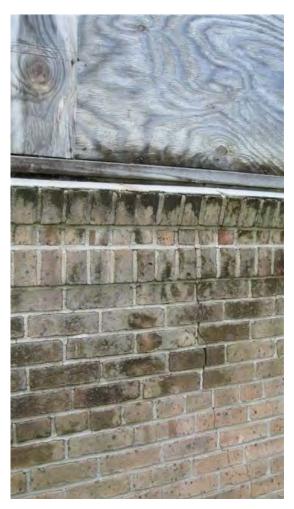
A24 Exterior- Crack Below Sill

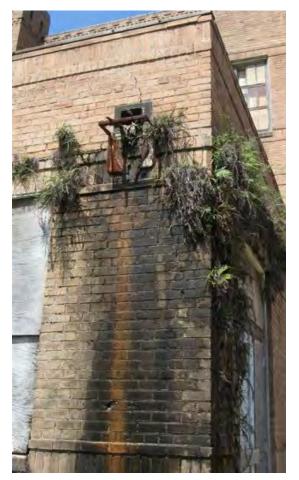
A28 Plant Growth in Masonry at Boiler Room

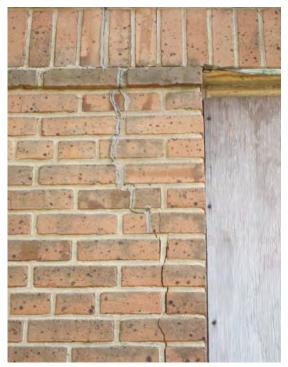
A36 Masonry Crack Adjacent to Window

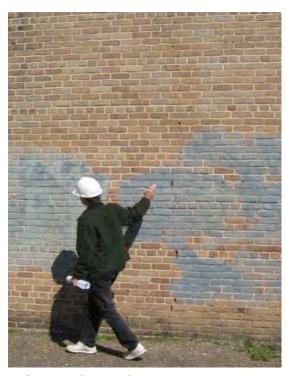
It was noted that the top members of the two end trusses have rusted. The other framing members appear to be in good condition. Elevations were taken by Gandolfo Kuhn, LLC, on the finished floor. The readings indicated that the slab has settled differentially $2\frac{1}{2}$ ", and like the classroom building, the high side is along Green Street and the low side along Birch Street. Masonry wall cracking was noted in four locations.

A42 Masonry Cracks in Gym Wall

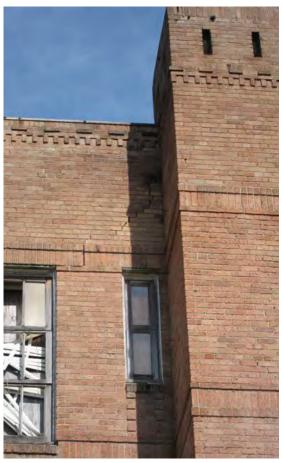
A51 Masonry Cracking Adjacent to Boiler Stack

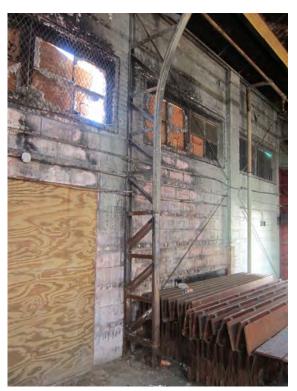
A305 Steel Framing at Gym

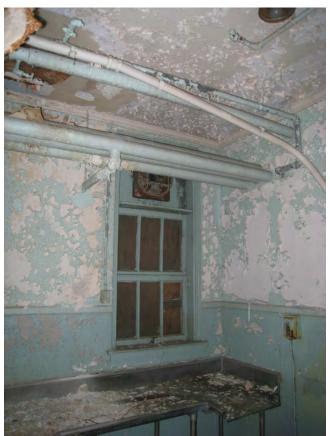
M04 Non-Functioning Piping

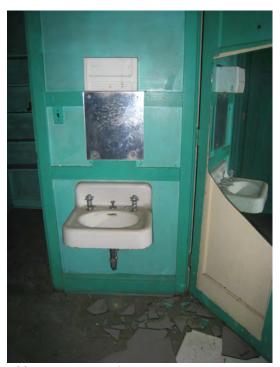
P02 Non-Functioning Sink

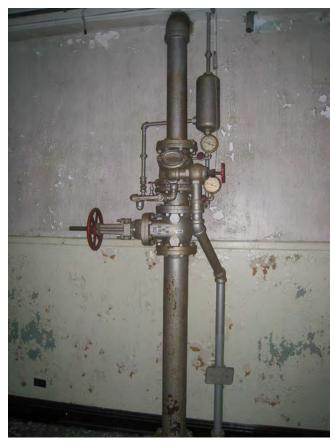
FP01 Non-Functioning Sprinkler Rig

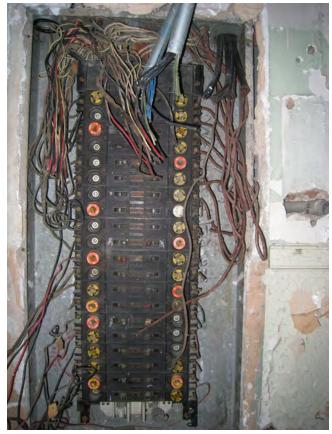
E02 Non-Functional Components

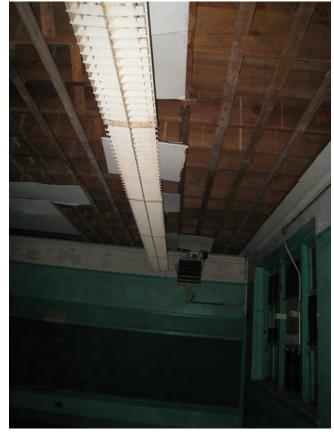
E03 Non-Functioning Lighting
