Lessons Learned From the Loma Prieta Earthquake

Mark A. Pickett, Gordon L. Laverty, Omar A. Abu-Yasein, and Chenwun Lay

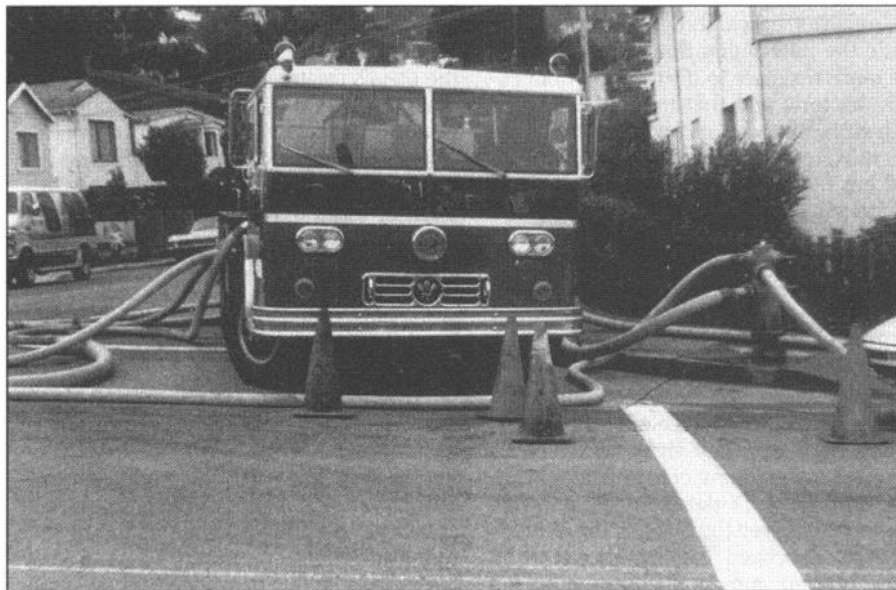
San Francisco Fire Department pumper trucks acted as makeshift booster pumps to get water to those supply areas in which numerous main breaks occurred after the earthquake Oct. 17, 1990.

- Obtain prior authorization from fire department officials to use fire engines as booster pumping equipment. This will require cooperation between the water utility and the fire department for the provision of between-zone hydrants and portable hydrant assemblages. Both organizations may need to share the cost of procuring these portable assemblies, which are made up of pipe crosses, regu-

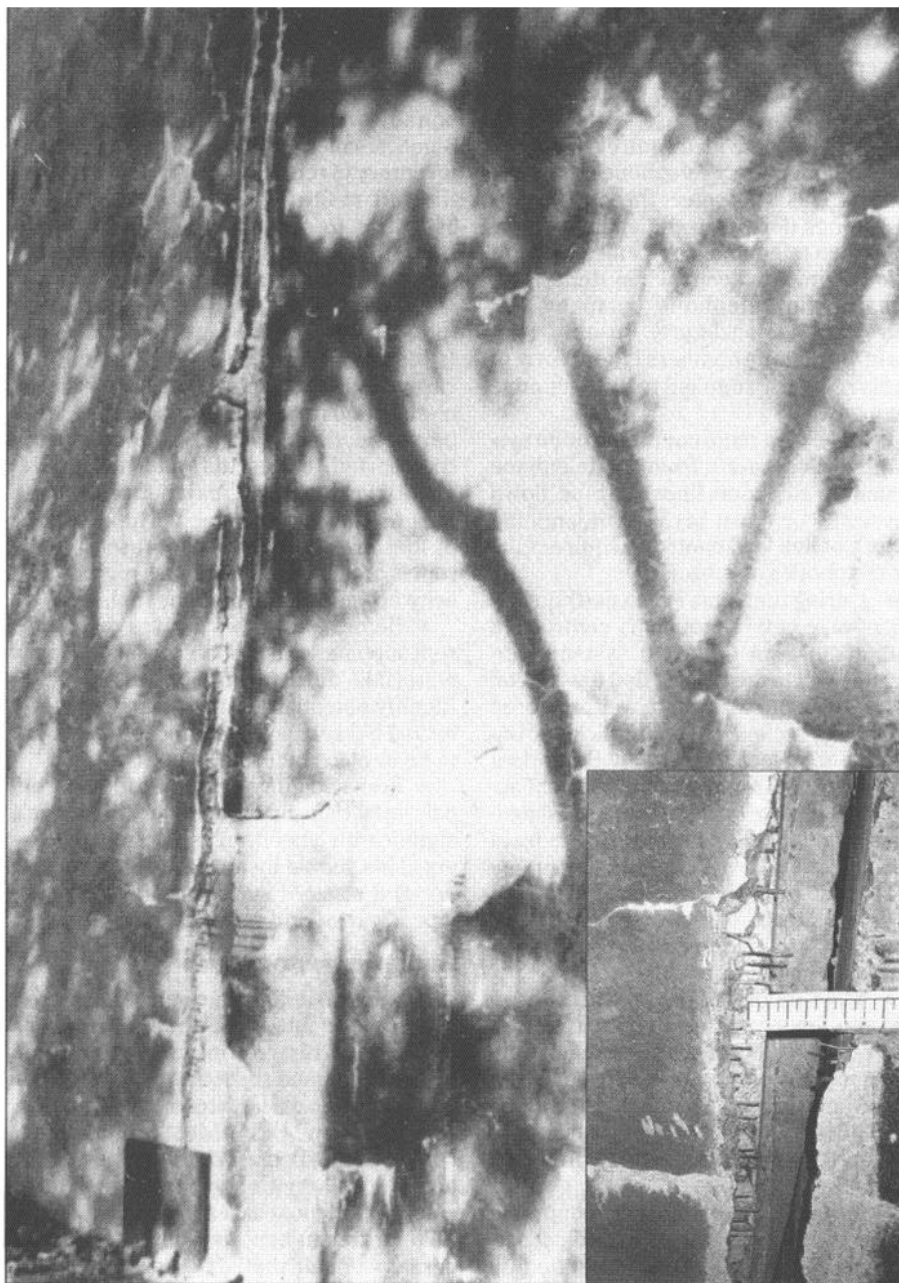
A wire-wound posttensioned concrete tank, constructed in 1964 by alternate pours of the vertical panels, in the La Purissima Water District emptied because of the collapse of its column-supported roof slab and the opening of one of the vertical panel joints (inset) after the earthquake.

Tanks. An earthquake's ground motion causes significant water motion. (During the Loma Prieta earthquake, the water motion in a Hollister pool was so severe that swimmers were swept out of the pool.) Earthquake-induced ground and water motion caused significant damage to a concrete tank in the La Purissima Water District. The wire-wound post-tensioned concrete tank was built in 1964 by alternate pours of the vertical panels. The earthquake caused the collapse of the column-supported roof slab and the rupture of a panel joint that appeared to have had a corrosion problem in the post-tensioning wires. The entire 1.1 mil gal of water in the tank were lost.

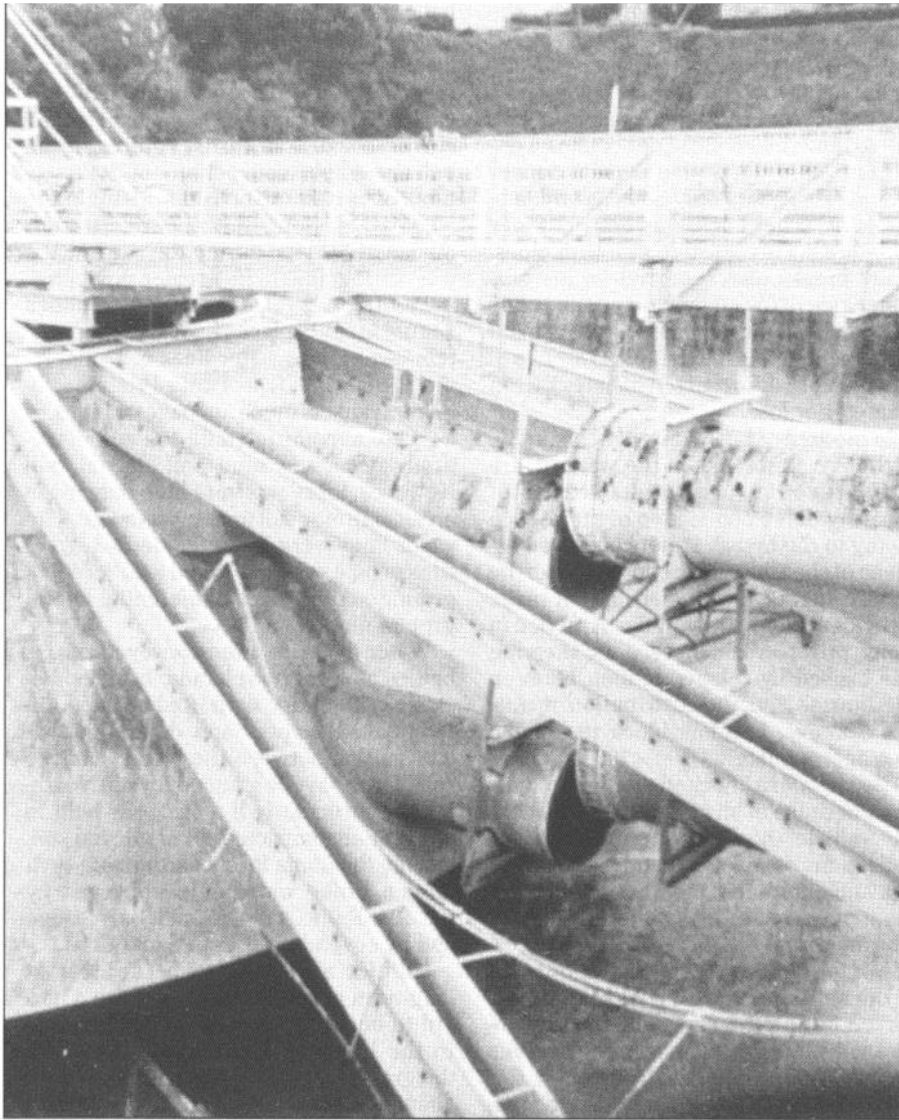
At the Rinconada Water Treatment Plant, which is located about 6 miles from the epicenter of the Loma Prieta quake, pretreatment equipment was badly damaged as a result of wave action and the lack of lateral support at the top of the equipment.

Wave action also significantly damaged the pretreatment equipment at the Rinconada Water Treatment Plant near Los Gatos, about 6 mi from the epicenter. To prevent this type of damage, support such equipment at the top.
