Collision Reconstruction Report

COLLISION RECONSTRUCTION

HR No. HR-2016-055

Case No. 16-005442

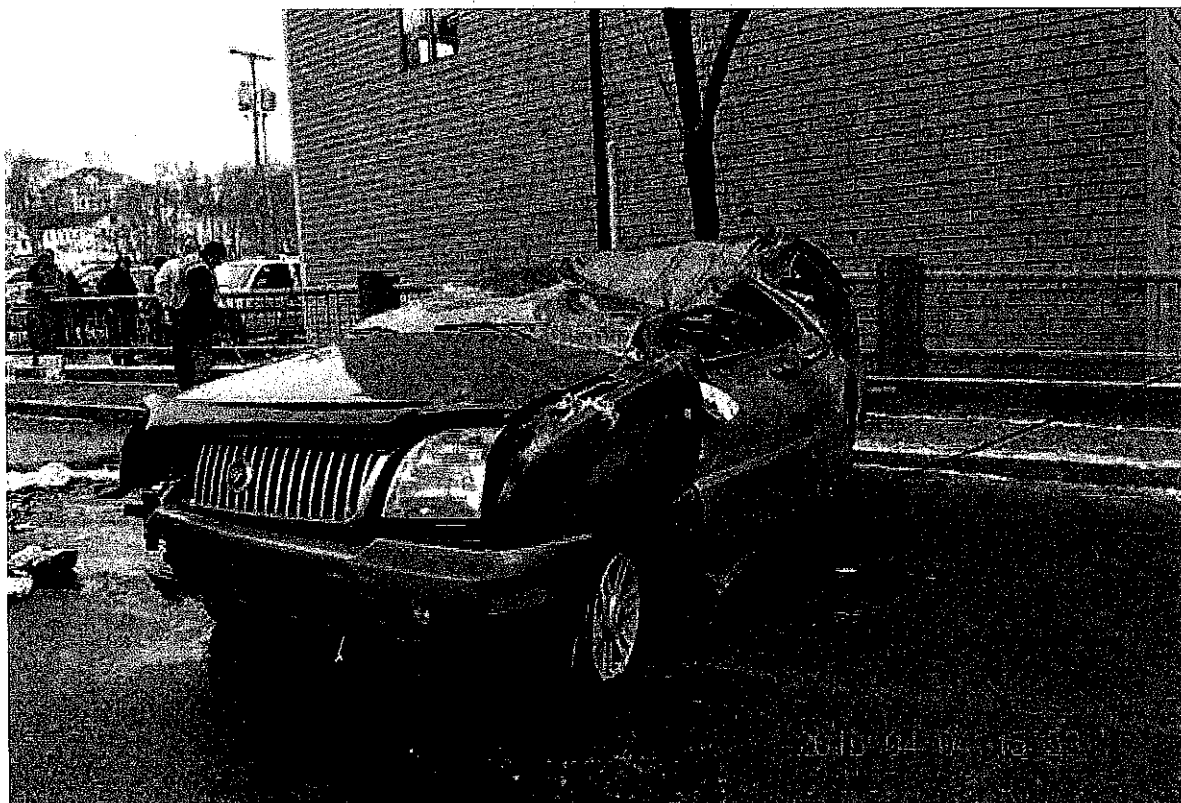
Unit 1: Green 2003 Mercury Mountaineer ME PC 8227VC, VIN 4M2ZU66K23UJ03967 (RWD only, no AWD/4WD)

Noted Damage: Total loss. Damage centered on roof due to impact with Unit 2 (roof-down impact)

Tire	Make	Type		Maine State Police		Air Pressure (psi)	Tread Depth (32's)	Comments
				Size Approved				
				April 14, 2016				
LF	Mirada	Crosstour SLX	245/70R16	107S M&S		flat	6/32	Rim damage, puncture
RF	Mirada	Crosstour SLX	245/70R16	107S M&S		flat	6/32	Rim damage, puncture
RR	Mirada	Crosstour SLX	245/70R16	107S M&S		full	6/32	good condition
LR	Mirada	Crosstour SLX	245/70R16	107S M&S		full	6/32	Good condition

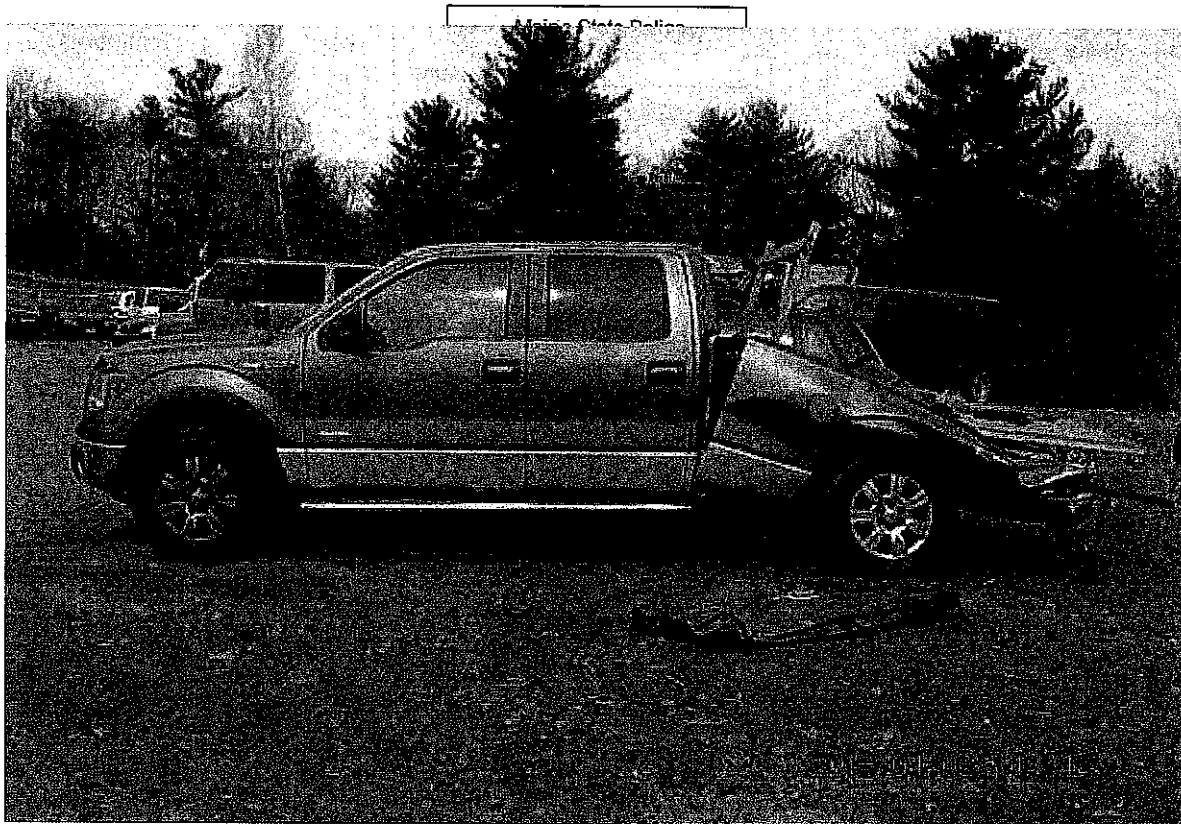
Unit 2: Gray 2011 Ford F-150, ME PC 5291TQ, VIN 1FTFW1ET1BFL68704

Noted Damage: vertical crush damage to pickup bed

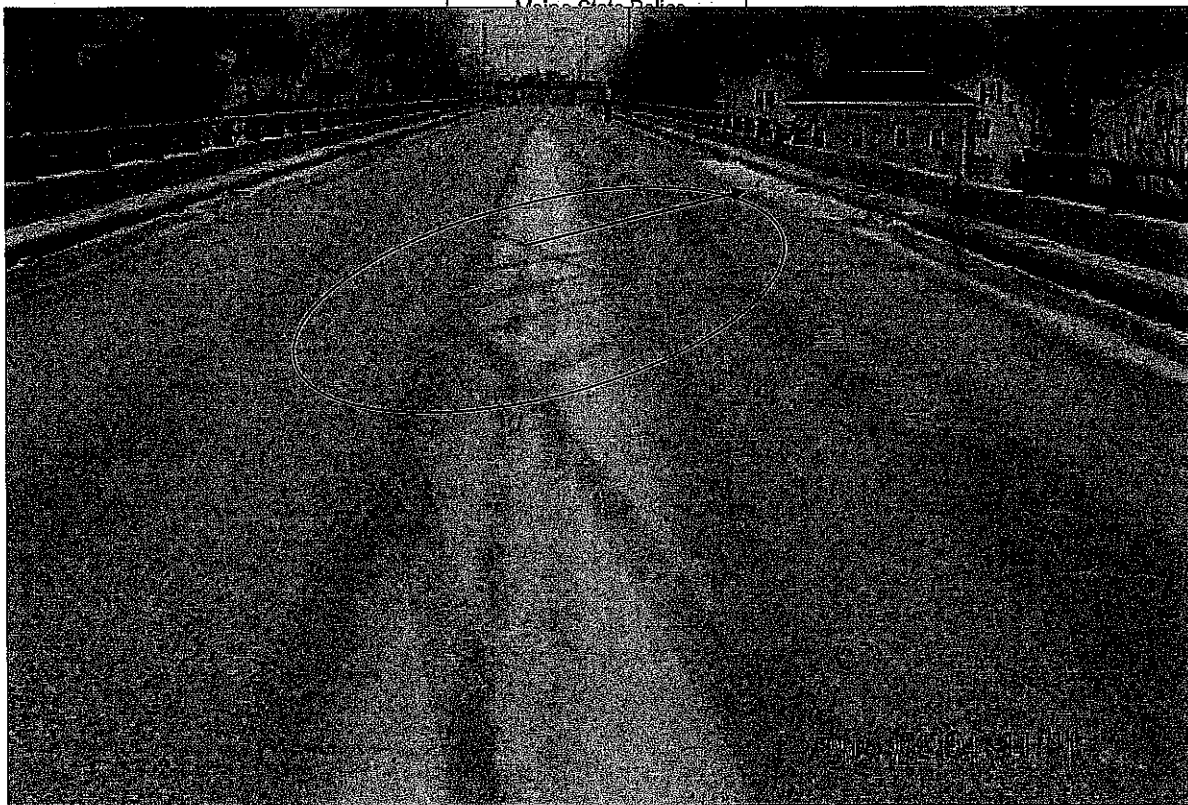
Looking southbound. Tire marks indicate Unit 1 had been swerving in both lanes, then off right shoulder (north side of viaduct).

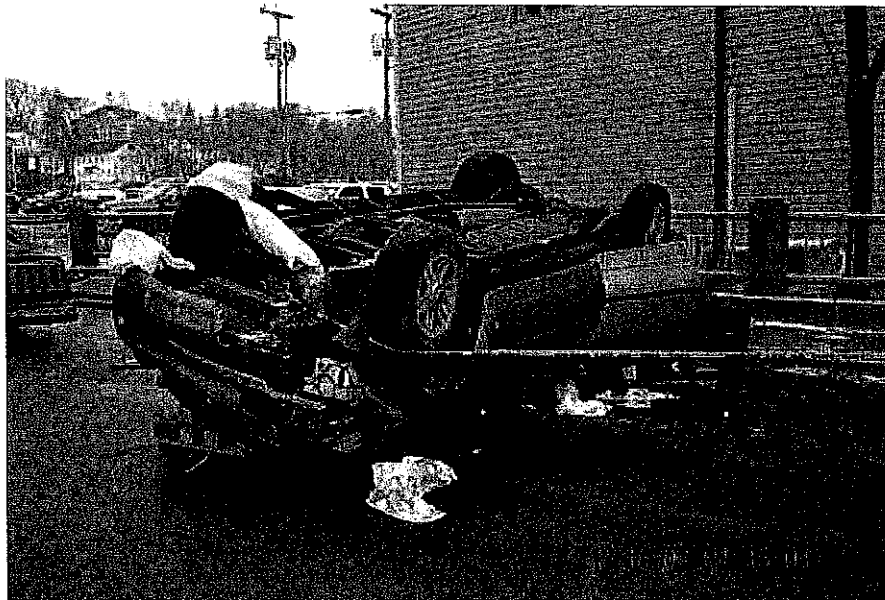
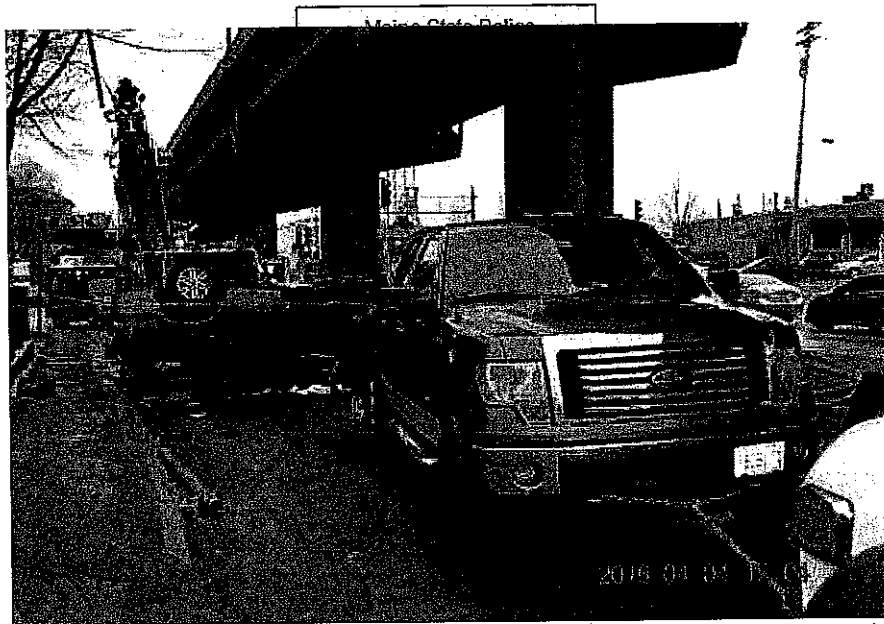
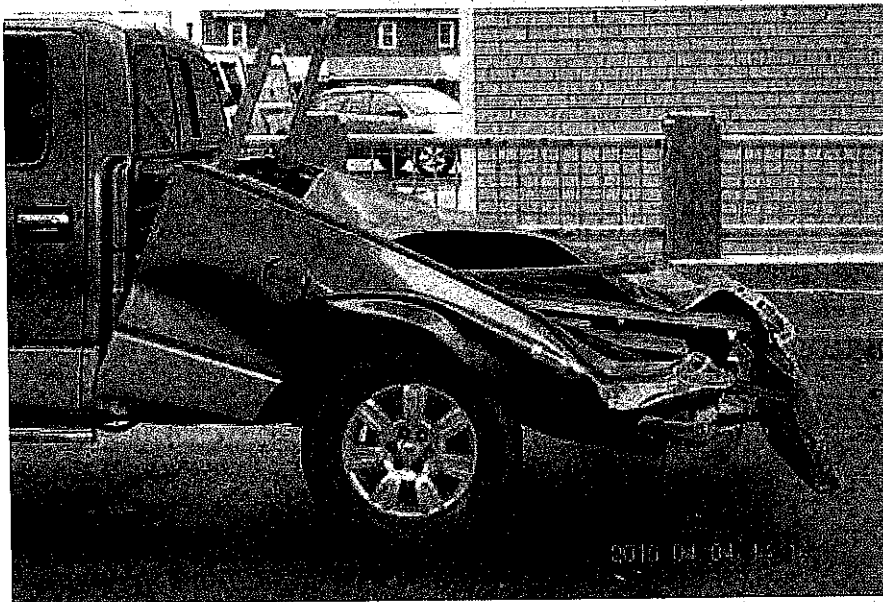
The top half of Unit 1 been flattened. I did see fresh scrapes and gouges in both of the front tire rims of Unit 1, indicating that they at some point hit a curb. There appeared to be some damage to the front right corner, but most of the damage was centered on a direct upside down fall, landing on its roof. Airbags had been deployed. Unit 2's rear half portion, the bed portion, also indicated a downward crush.
