Oakland Sewer Department Inflow & Infiltration Study Update

November 9, 2016

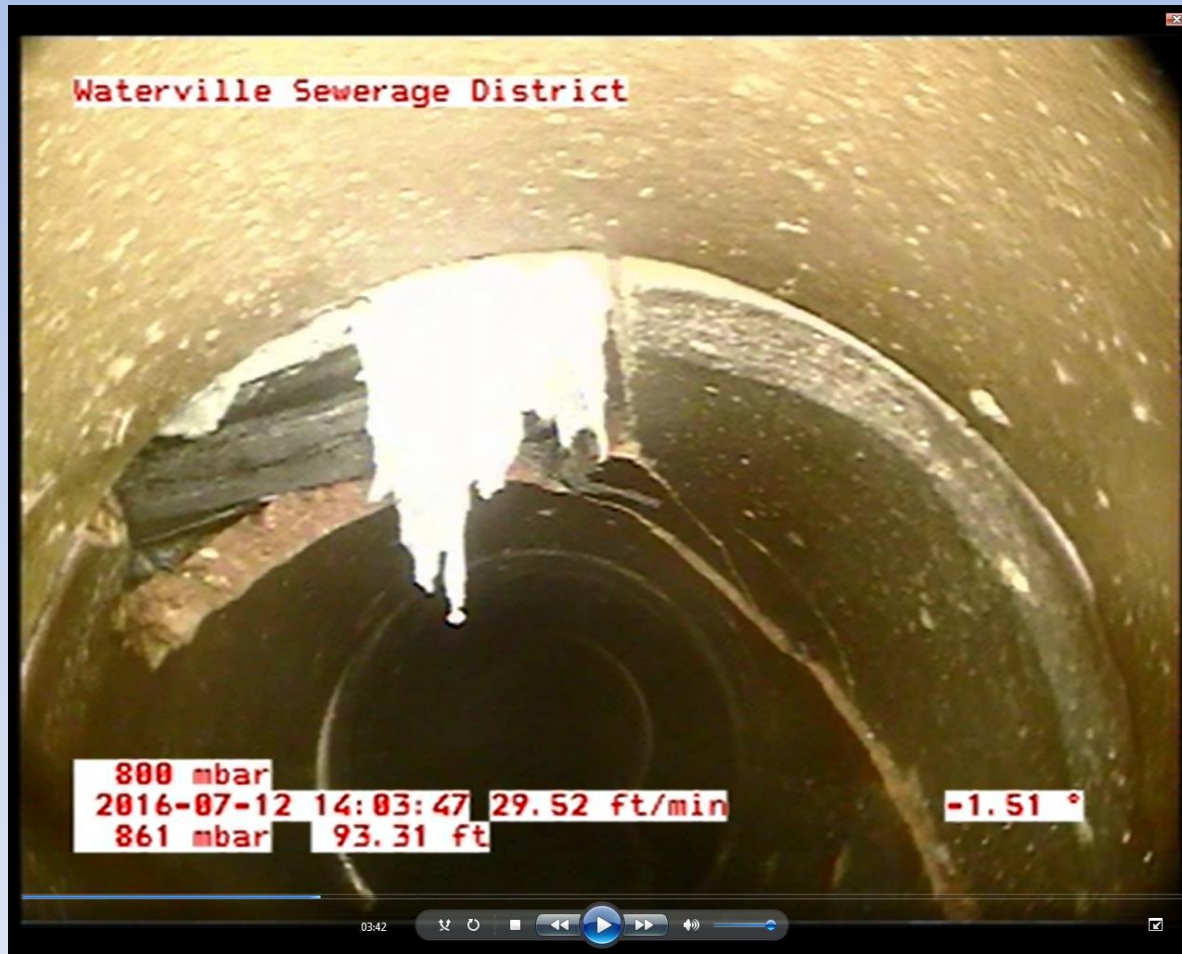
Lower Oak Street Broken Pipe Section with Previous Repair

- Pipe section is a contributor of Inflow & Infiltration.
- Pipe section recommended for lining ..
- Currently obtaining prices to have this section lined from manhole to manhole.

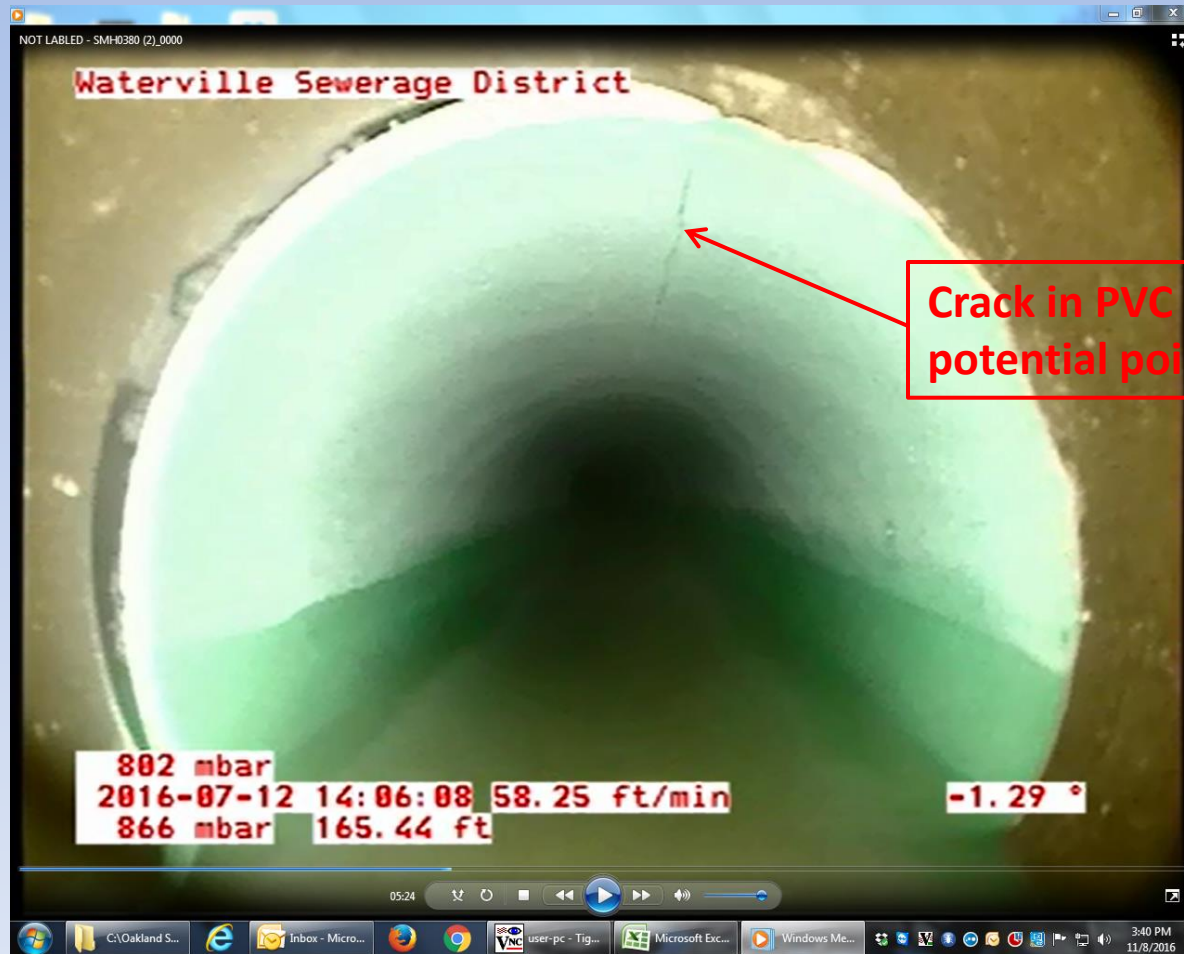
Pipe Material change from Clay to PVC Pipe

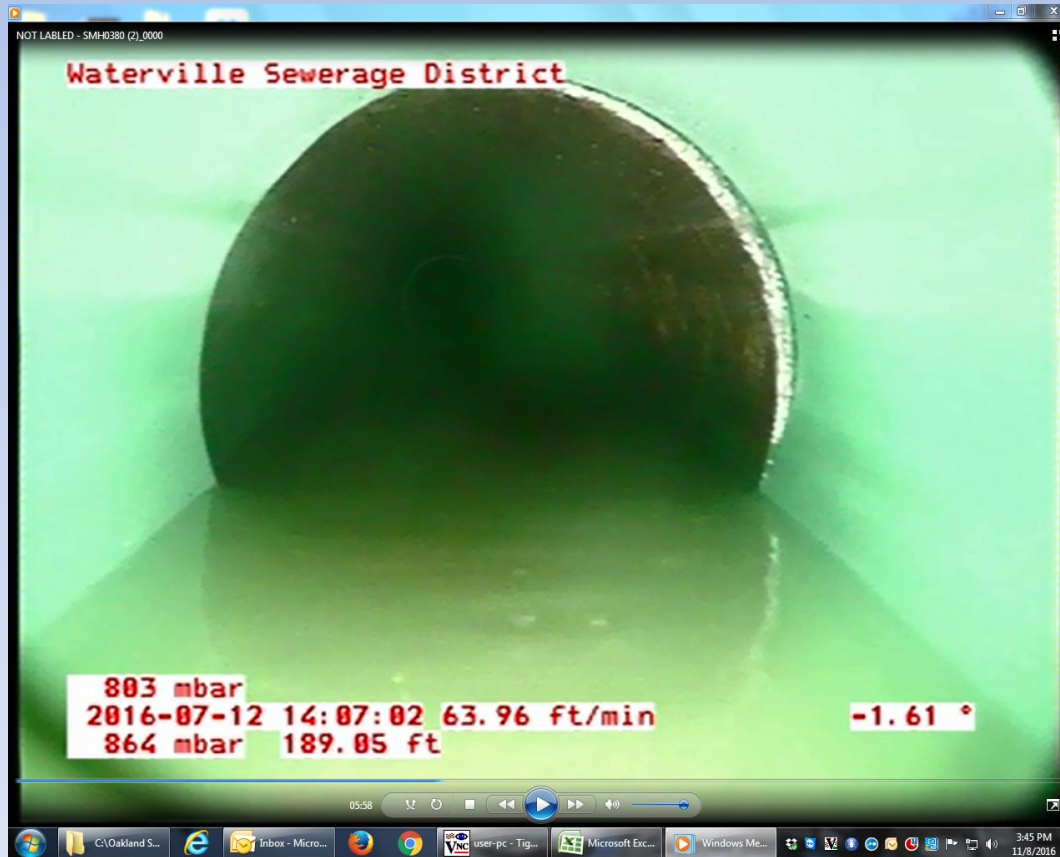
Pipe Material Change from PVC to Cast Iron (believed to be at granite box culvert crossing)

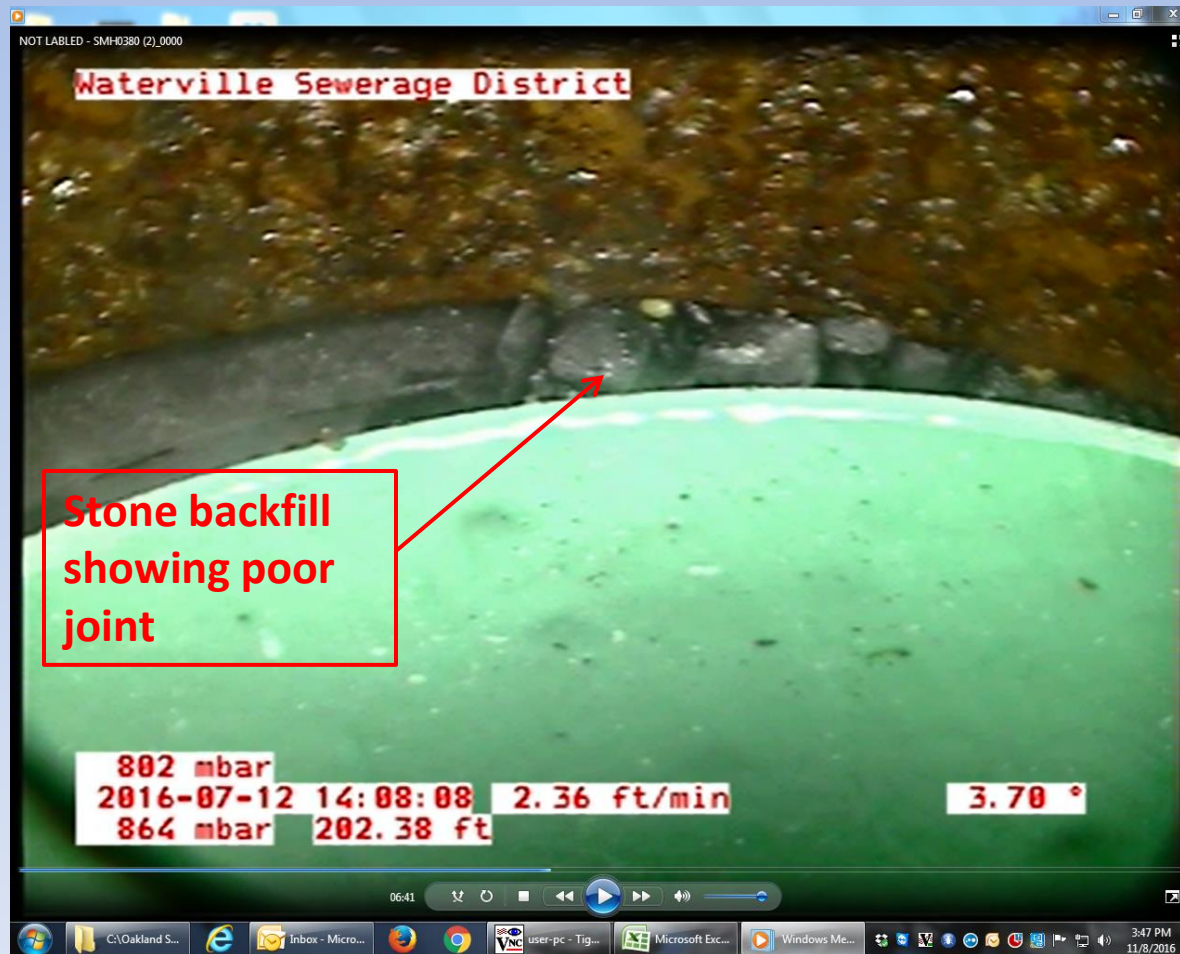
Shows open joint with stone backfill present in joint

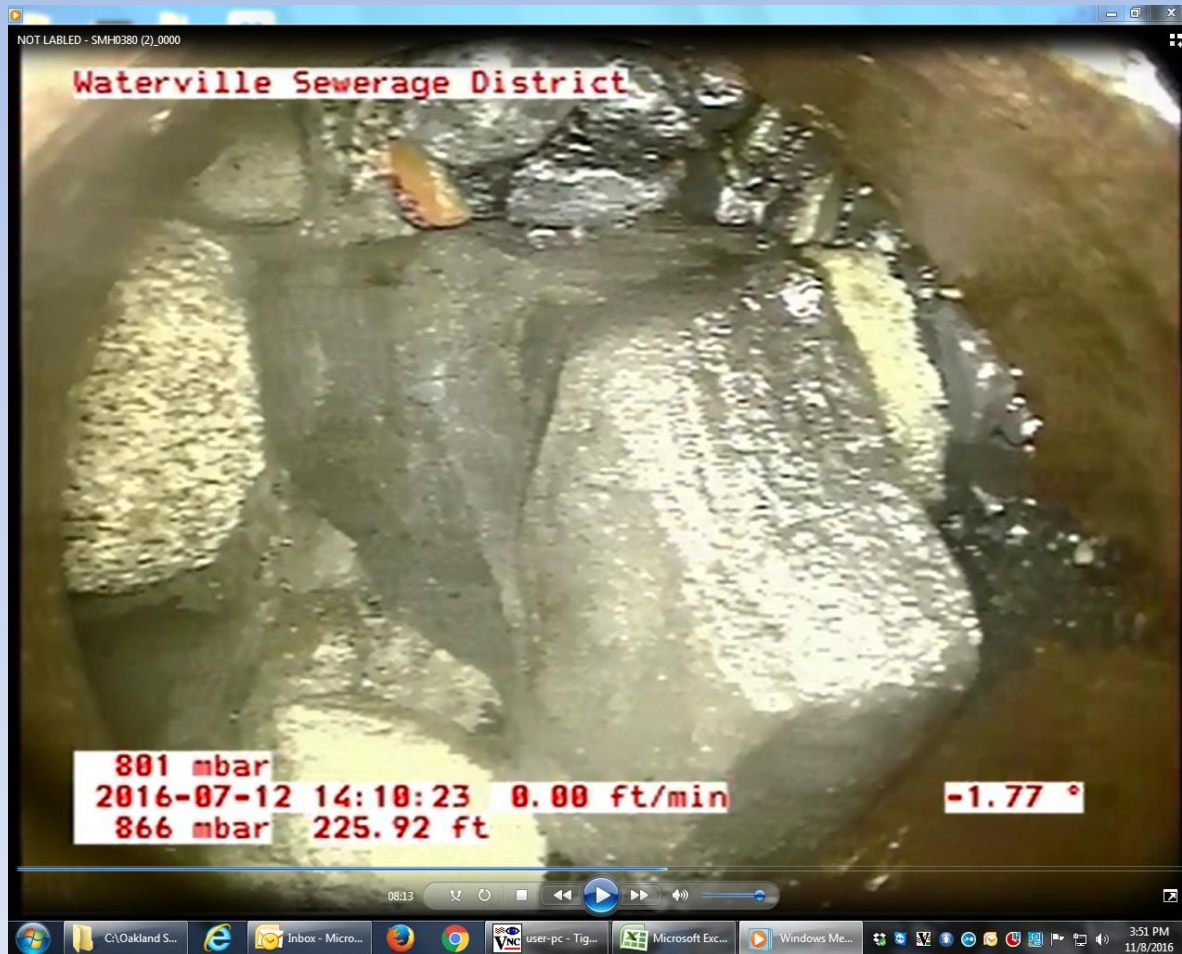
Abandoned Sewer Service not capped. Stone showing for backfill

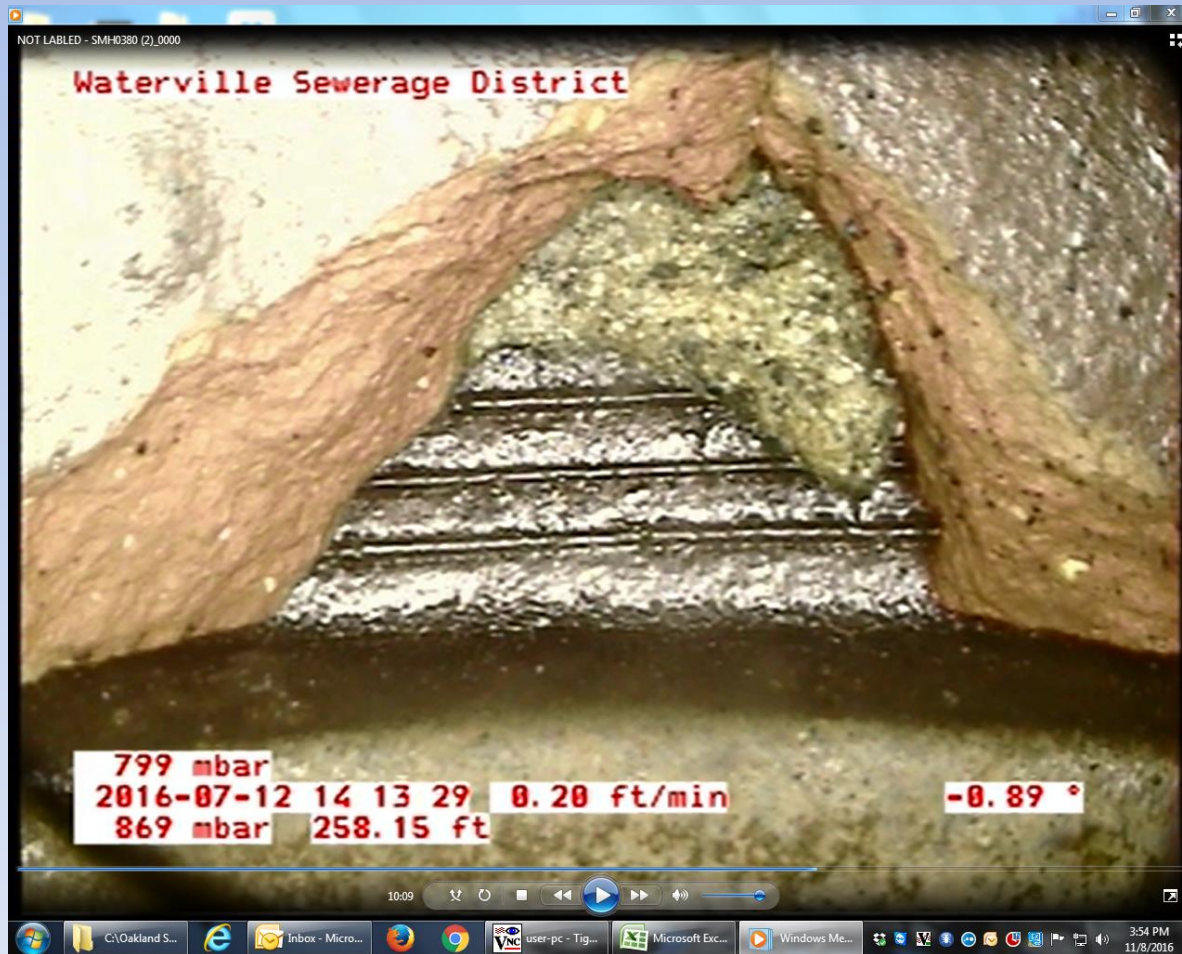
Broken joint leak point

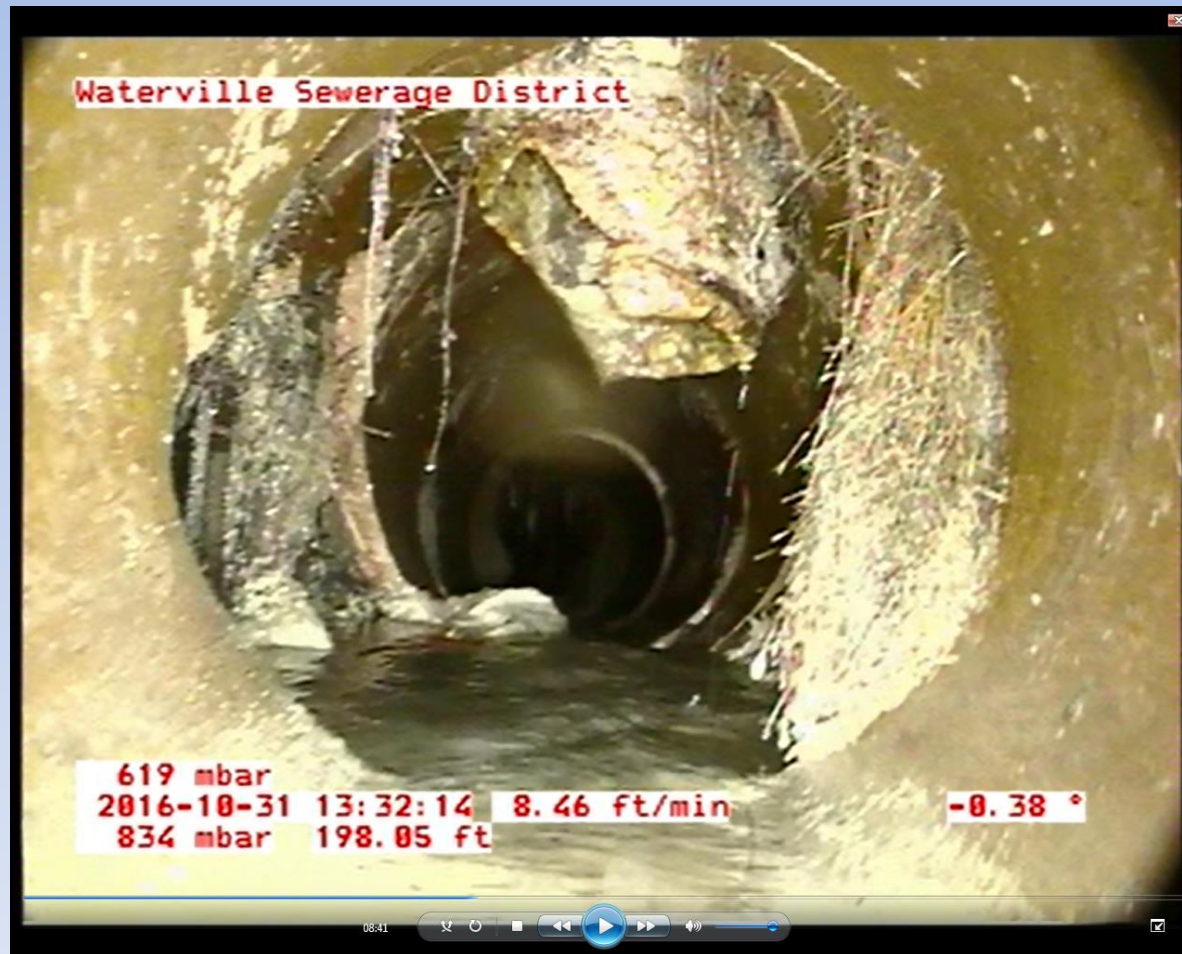
Broken Pipe Section with roots throughout

- Pipe section is a contributor of Inflow & Infiltration.
- Pipe section is priority due to the collapsed pipe section.
- Pipe section recommended for lining immediately to avoid potential for sewer backup issues.
- Currently obtaining prices to have this section lined from manhole to manhole.

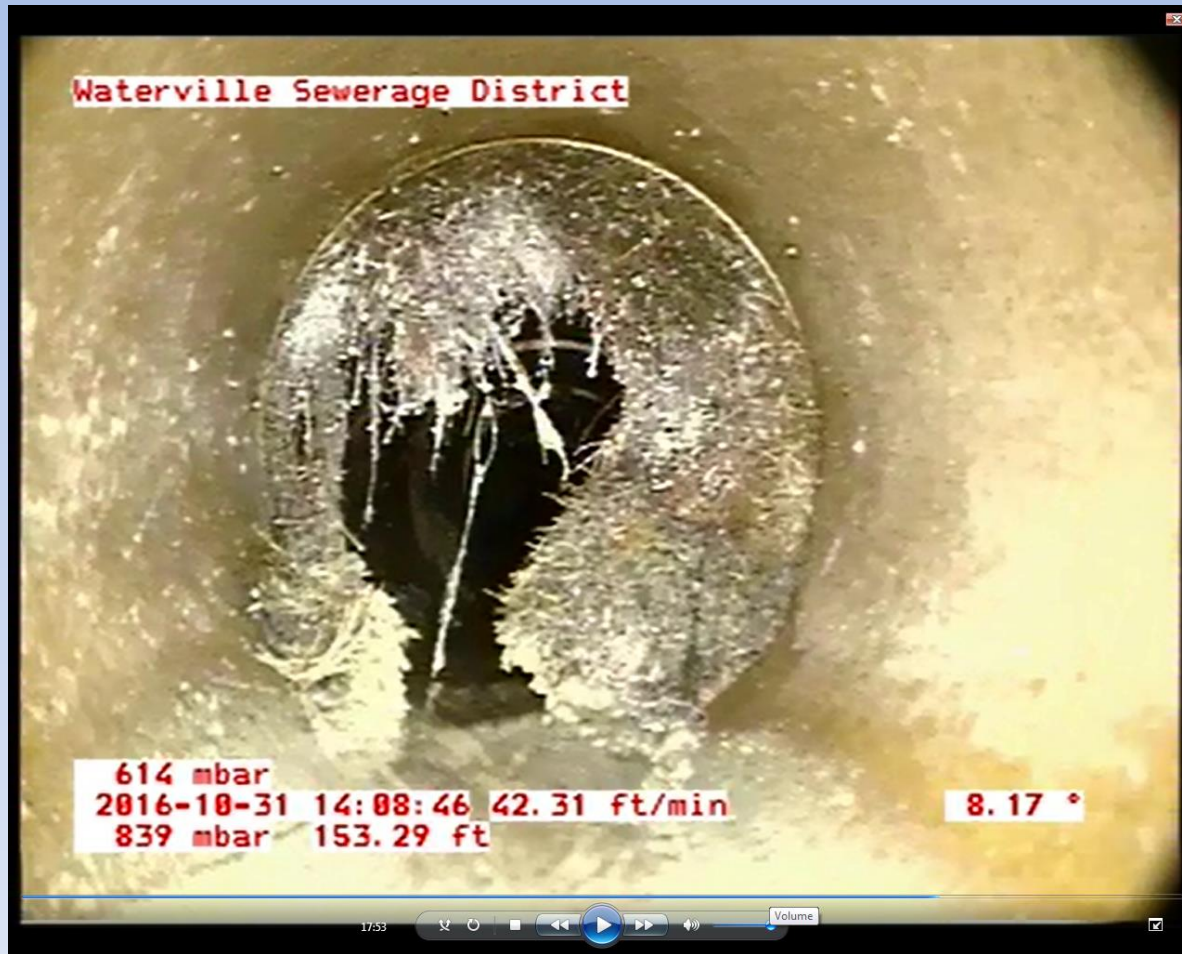
Major Root Issues along Pipe run

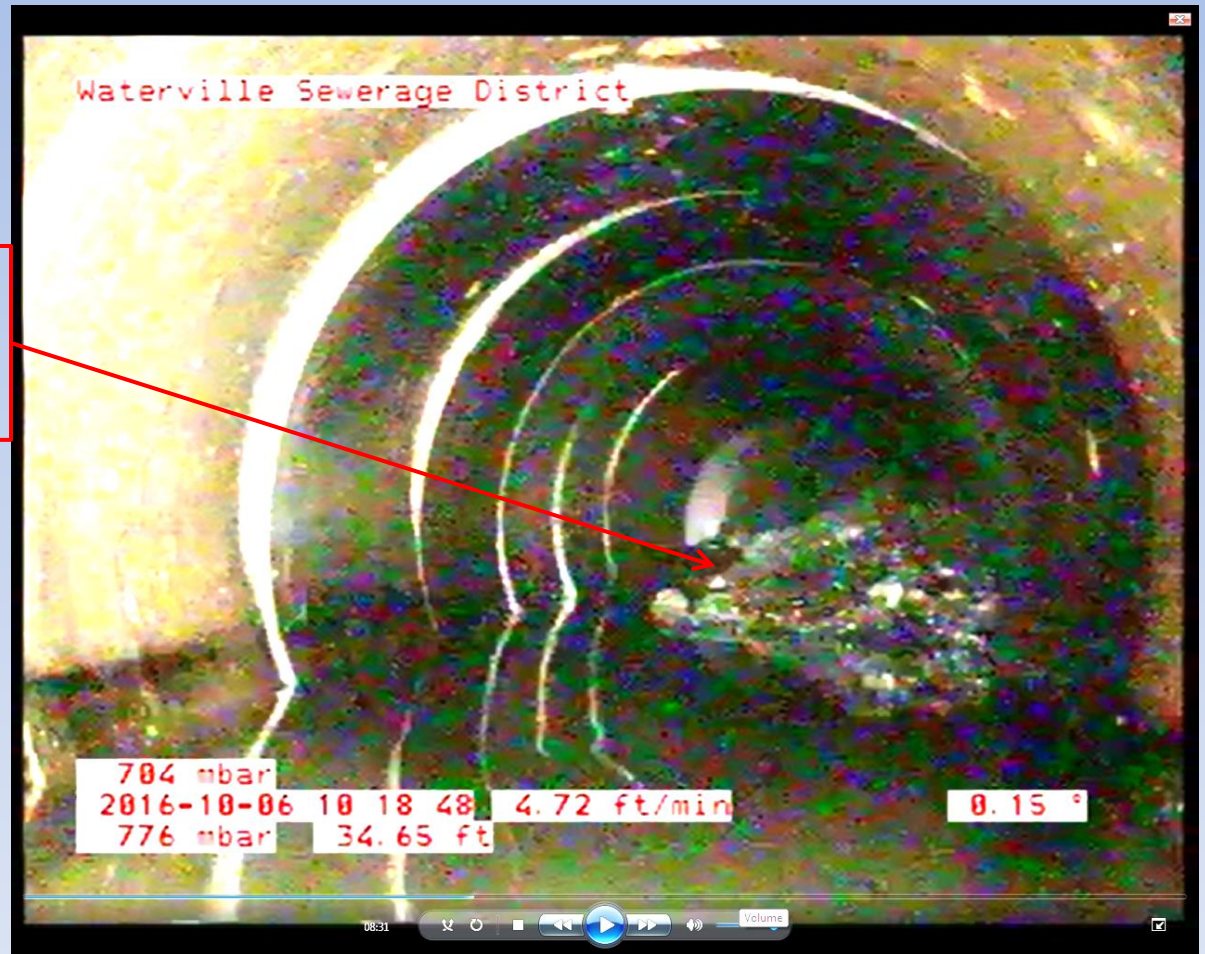
Rocks, bricks, sand and debris full length of pipe section

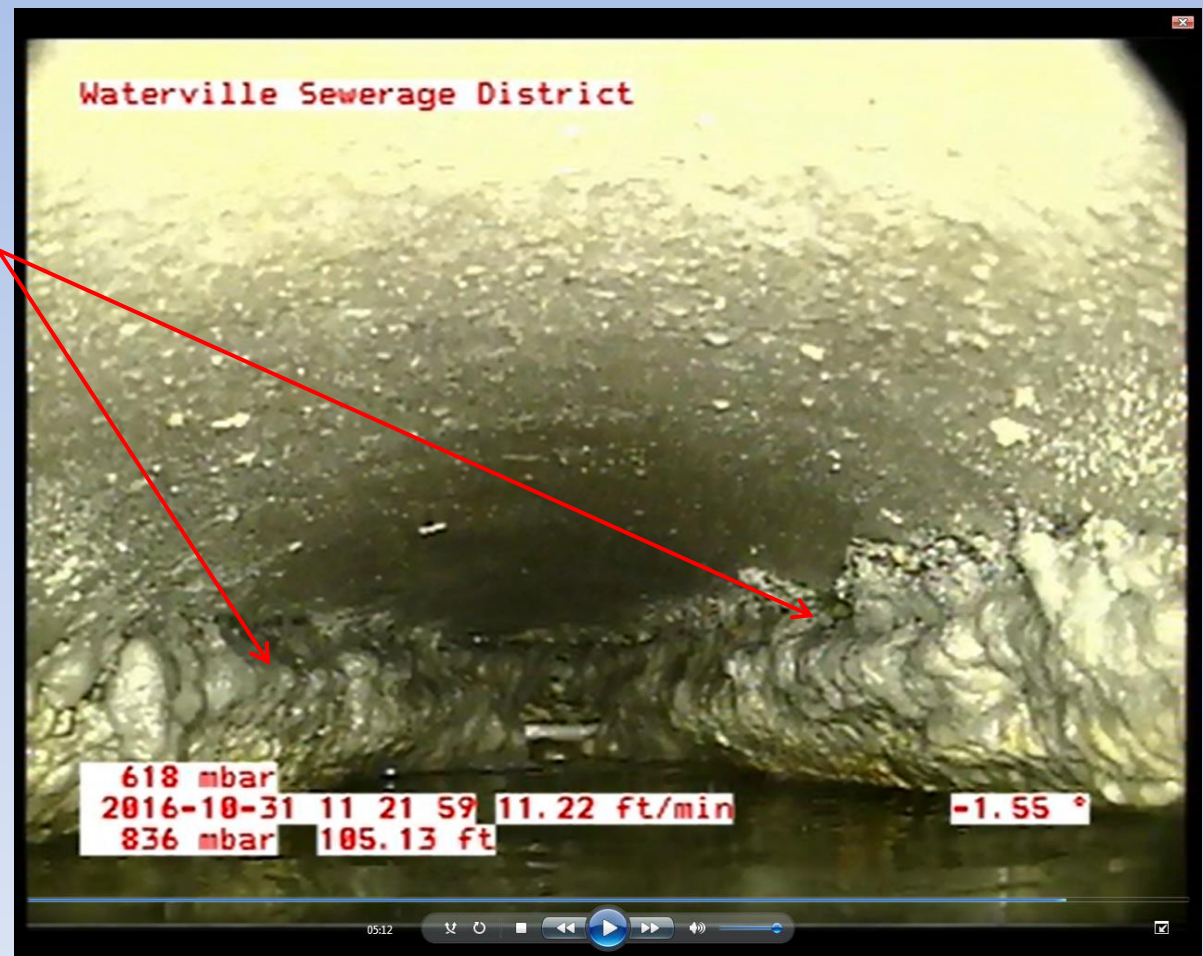
Grease buildup in sewer main between Fairfield Street and Main Pump Station

Grease build-up on sides of the existing sewer main prior to plant

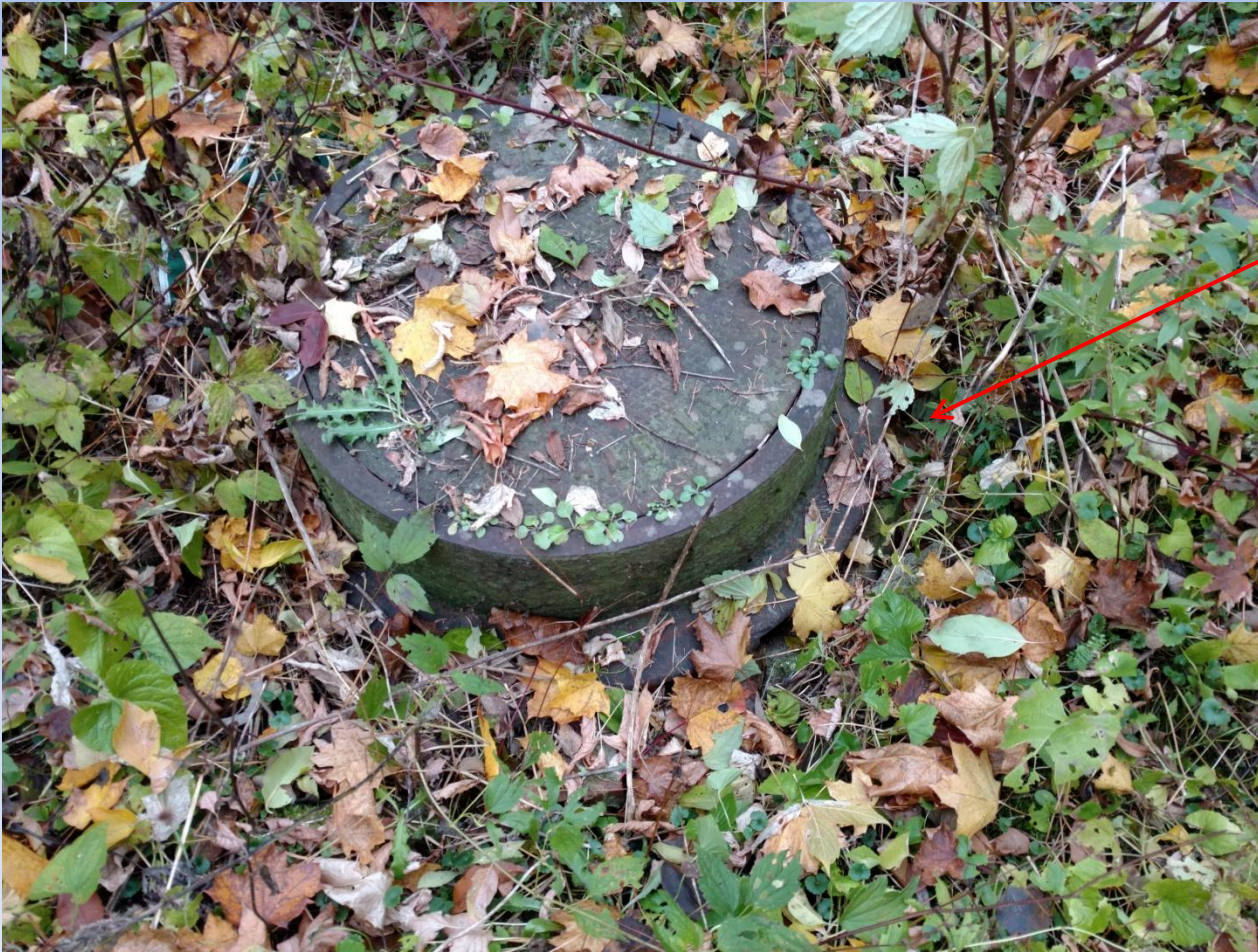
Fairfield Street Manhole to be repaired likely I&I Source

Manhole is located in drainage low spot, open areas below rim allow water runoff entry
