EVALUATION REPORT

PORTLAND PUBLIC SCHOOLS

BUILDINGS FOR OUR FUTURE

July 25, 2013

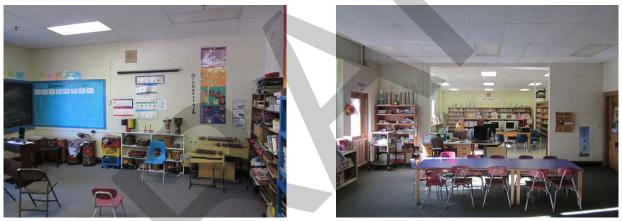
The music room is located to the west of the raised platform. At 495 square feet, it is undersized for the program and has major acoustical issues. The space does not have storage closets for instruments or equipment. Longfellow has three music programs (band, strings and general music) and currently uses the music room, the multi-purpose room and a fifth grade classroom to accommodate the program.

Music room

Library

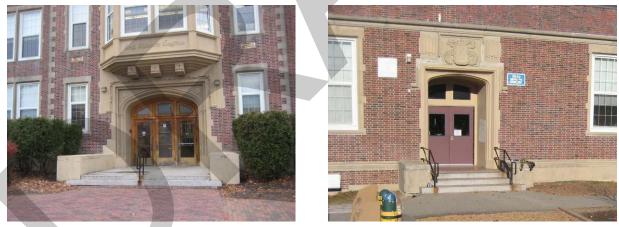
the building is approximately four feet above grade at the main entrance. An accessible entrance is provided by way of a metal ramp on the north face of the building that leads to a door on the backside of the multi-purpose room. There is no camera or buzzer system to control this entry and access is by knocking and hoping someone is there to open the door. This is the only route into the building that is accessible to persons with disabilities. There are no accessible routes to the outdoor learning garden space. Classrooms are located on all three floors of the building and two stairwells provide the only means of access between the floors. There is no elevator in the building.

Main Entrance

Entrance from Upper Playground

Reconfiguration of the main entrance is proposed to allow for handicapped access into the building. Construction of a ramp within the expanded entrance lobby would provide an accessible means to the first floor. Provision of an at-grade or ramped entrance at the new gymnasium lobby would also make that entrance accessible. A ramp adjacent to the gym lobby will allow for handicapped access to the remainder of the first floor. The installation of an elevator is recommended to provide access between the basement, first and second floors.

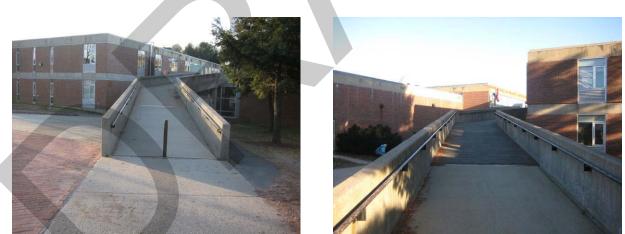
The existing second floor access ramps on both the Brackett Street and Clark Street sides of the building do not conform to current ADA guidelines. It was also noted by both staff and the public that the ramps tend to be icy in the winter.

Second floor access ramp (Brackett Street side)

Second floor access ramp (Clark Street side)

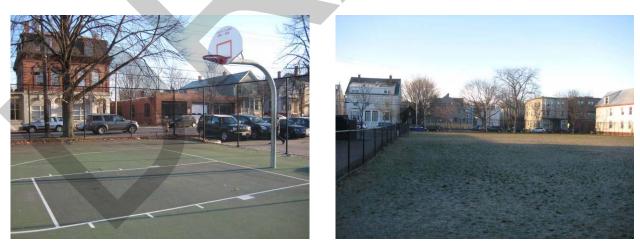
The open space to the west of the building (toward Pine Street) is adjacent to the Community Center portion of the building, and the site is dedicated to a recreational play field and full-size basketball court which are used by Reiche School for physical education classes, but not used for recess. The (approximately 0.7 acre) multi-purpose play field is very heavily utilized by the school and community sports during the fall, spring and summer months. Under-drainage appears to have been installed in 1984. The basketball court was reconstructed circa 2005. There is a water fountain near the gated entrance to the field. There is a chain link fence at the perimeter of both the field and the basketball court, restricting public use.

Basketball court

Recreational play field

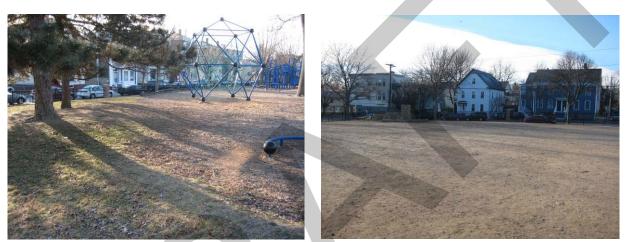
feet in diameter that is striped with four square, hopscotch, and a large map of the United States; and also has a ball toss. There are three brick seat walls on one side of the hard court area. Separate play equipment is provided for younger and older children. A composite play structure and small swing set (2 belt seats, 2 toddler bucket seats) are located at the north end of the playground. At the northeast corner of the playground is a curvy balance beam and a cable net climber. At the lower (southeast) side of the playground, there is a larger composite structure and 4-bay (8 belt seats) swing set intended for the older child. These areas are linked with a continuous, wood chip safe playground surface. Boulders around mature trees provide seating, and the trees provide a good balance of sunny and shady areas. There is a water fountain near the hard court area of the playground, which reportedly doesn't function well.

Playground equipment

Playground play field
