FLORIDA FISH AND WILDLIFE CONSERVATION COMMISSION
DIVISION OF LAW ENFORCEMENT
INCIDENT NUMBER FWSB-16-OFF-12502

**FLORIDA FISH AND WILDLIFE CONSERVATION COMMISSION
DIVISION OF LAW ENFORCEMENT
INCIDENT SUMMARY REPORT**

REPORT #: FWSB-16-OFF-12052

Synopsis

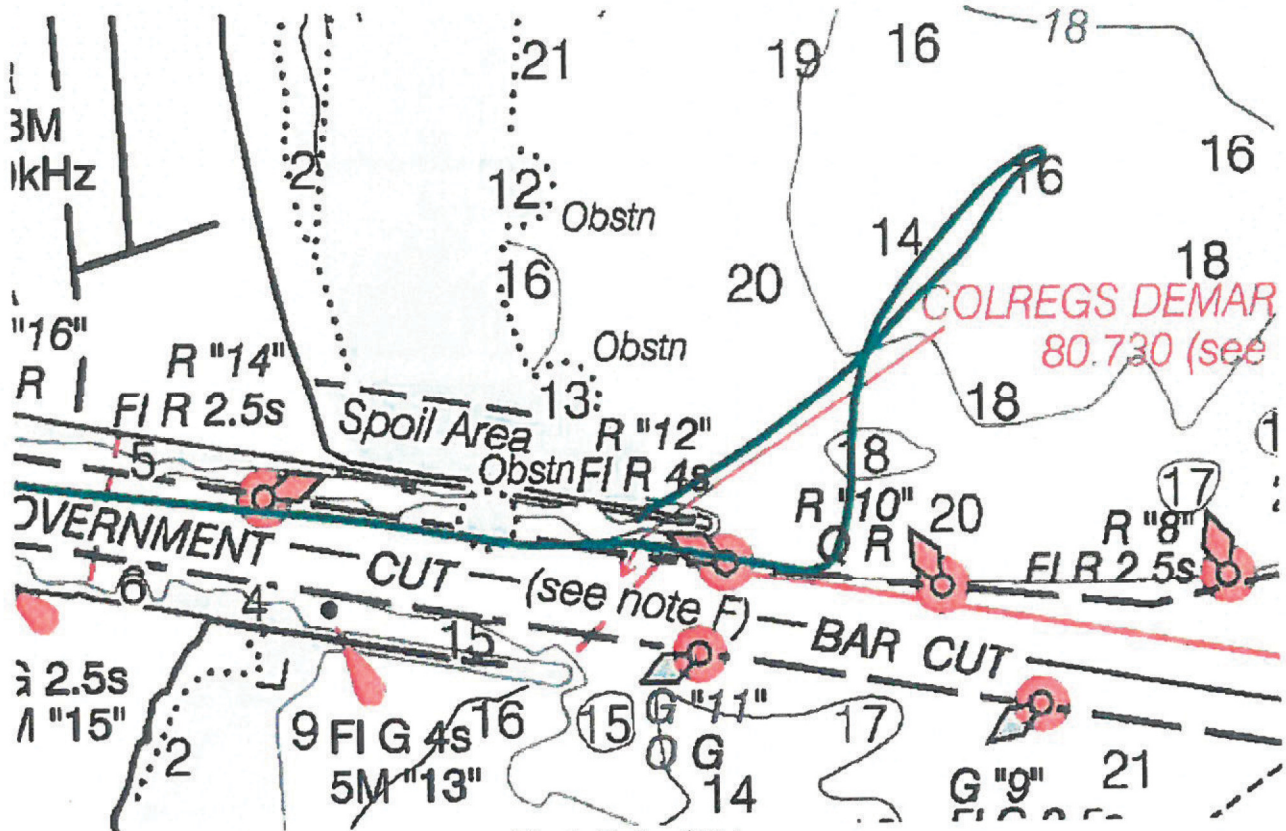
At 0302 hours, V-1 allided with the north side of the north jetty at 65.7 mph; V-1 was stopped almost instantly. As V-1's port bow (left front) struck the initial impact boulder, V-1 began to elevate at the bow. This upward motion caused damage to the starboard bow (right front) as it struck another boulder on the jetty. As the initial impact boulder deeply penetrated the hull, it stopped the port (left) sides forward motion at a much faster rate than its starboard (right) side. V-1's stern (rear) yawed immediately to the starboard (right) as the front left stopped. These dynamics resulted in V-1's starboard chine at midship to strike another boulder which caused its starboard yaw to stop abruptly. V-1's sideways and rolling motion ejected all on board. These crash dynamics caused V-1 to completely roll over and come to rest on its t-top on top of the jetty in a matter of seconds.

Fig. 1. Path of V-1

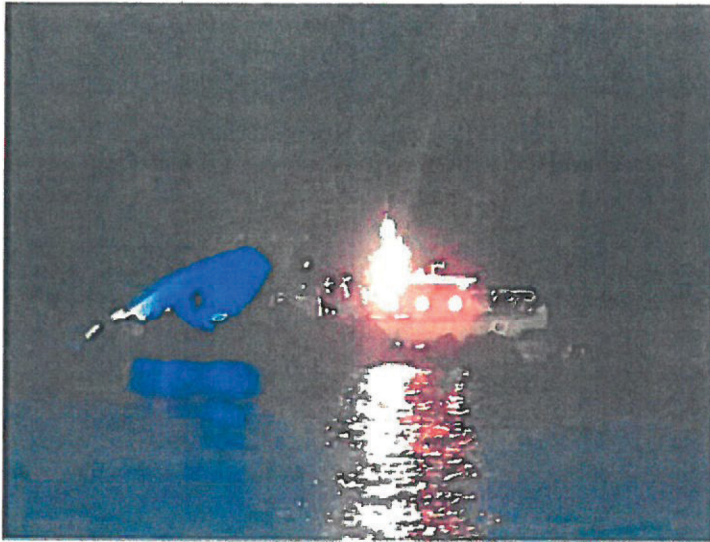
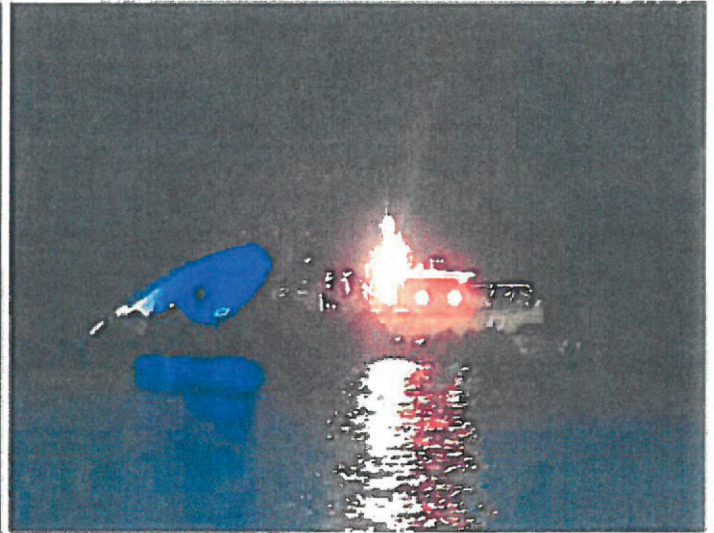
Fig. 2. V-1 view from south side of north jetty

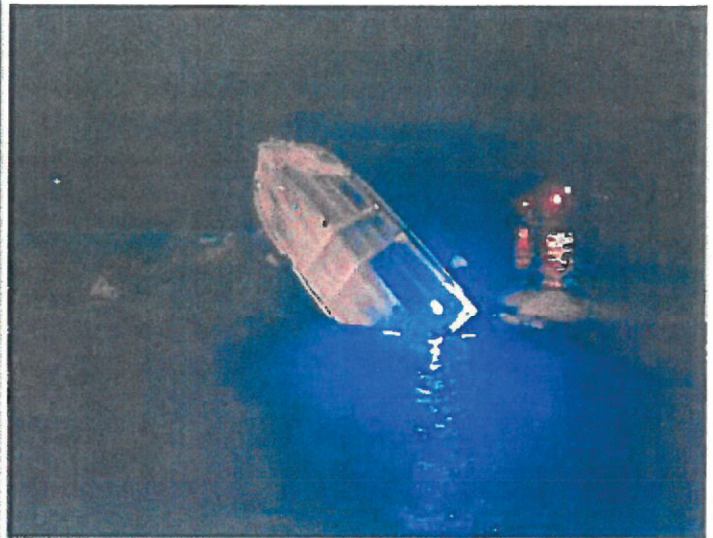
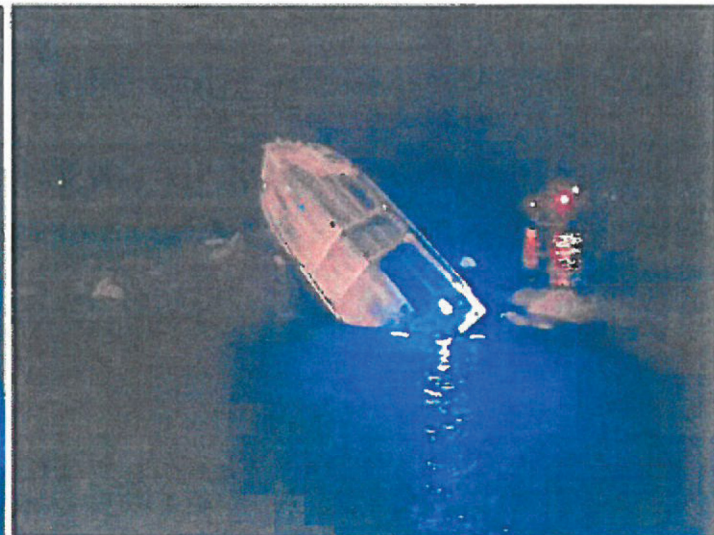
Fig. 3. V-1 view from the north side of north jetty

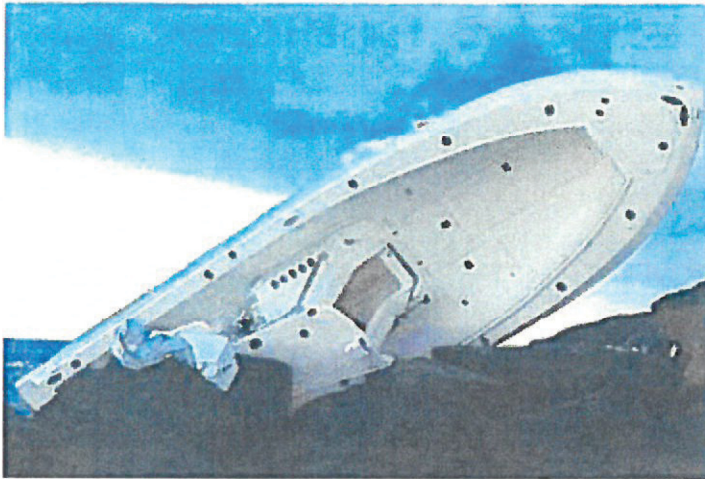
Fig. 4. V-1 red navigation and blue interior deck lights illuminated.

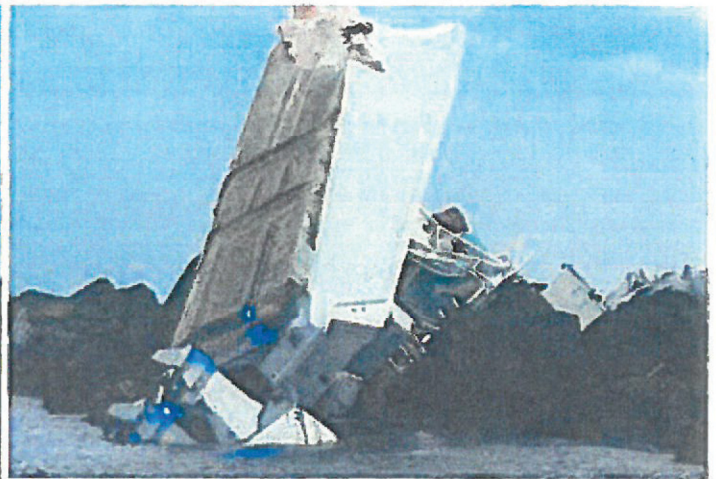
Fig. 5. V-1 blue transom lights illuminated.

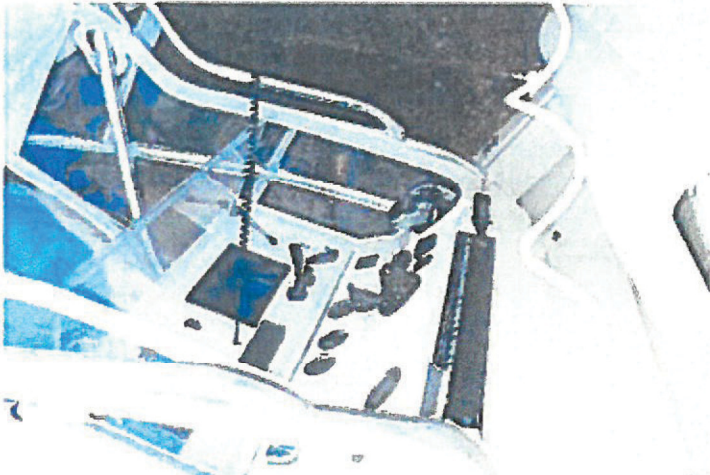
hull. At the helm of V-1, I observed the throttles to be in the forward, full throttle position, the steering column had been broken off and the steering wheel was missing, two of the gauges were gone and a portion of the Plexiglas above the switch panel was broken off and missing. The steering wheel had been placed on top of the T-top after it was located by the MDFRD boat #73 divers for evidence recovery. There was a white cooler and two light blue bean bags belonging to V-1 on top of the jetty, west of V-1. Inside this cooler I located Eduardo Rivero's wallet, one gold chain, one set of keys and one black pair of pants.

Fig. 6. V-1 center console: missing steering wheel, broken lower switch panel, throttles in full Throttle forward position.

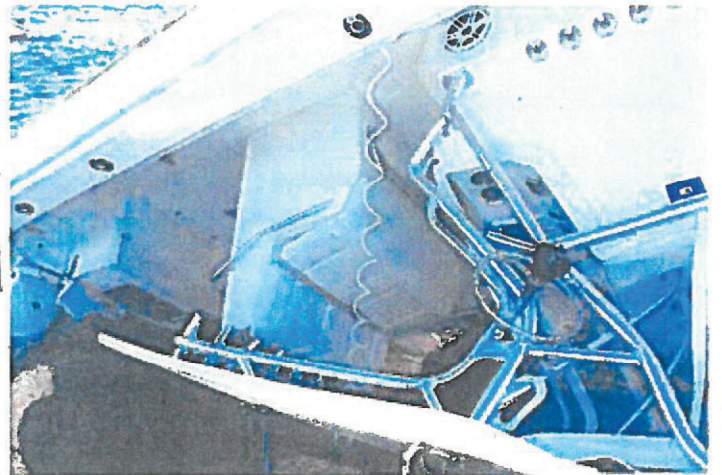
Fig. 7. V-1 upside down on jetty, steering wheel on t-top structure.

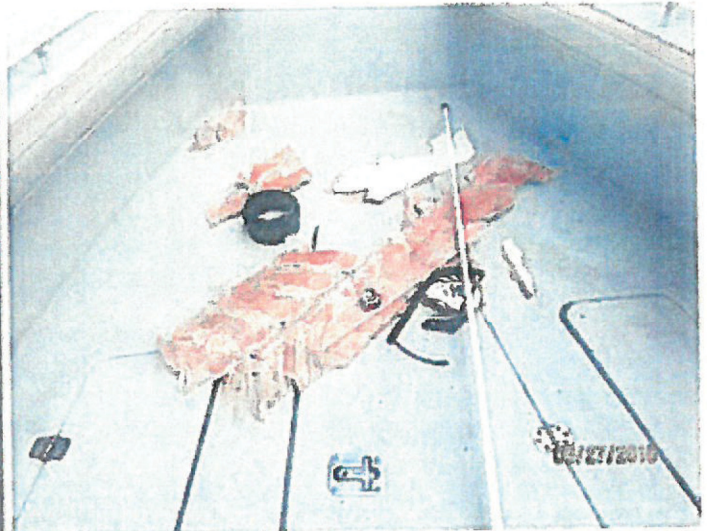
Fig. 13. Two recovered pieces of fiberglass.

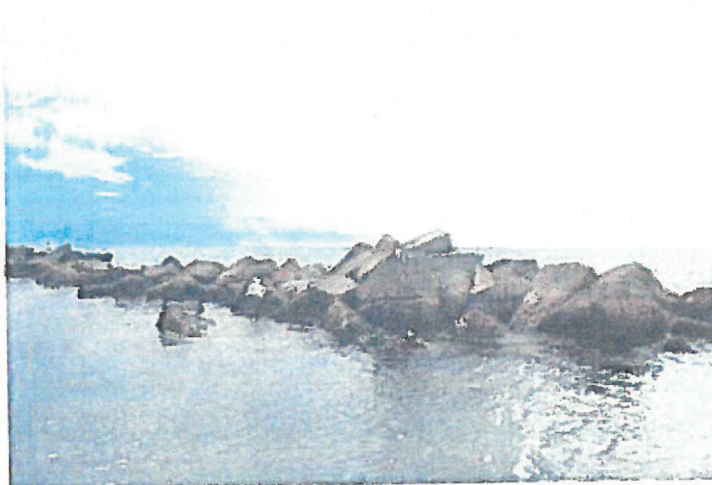
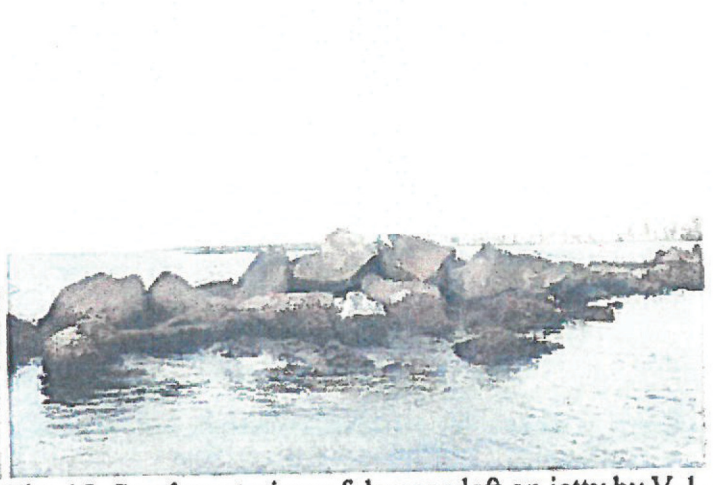
Fig. 14. Southeast view of damage left on jetty by V-1. Fig. 15. Southwest view of damage left on jetty by V-1.

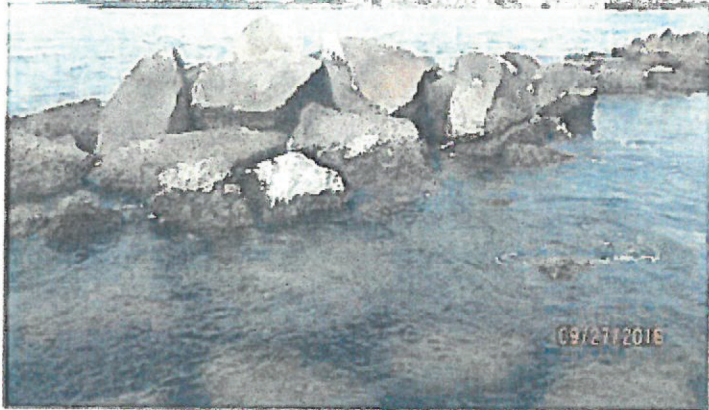
Ofc. Yanez and I dropped off Lt. Pomares on the north jetty. He took several pictures of the boulders and the damage the boulders sustained from the impact at the crash site. The force at which V-1 impacted the jetty's boulders caused them to shift and collide into each other. This was evident from the damage sustained on the edges of the boulders, where they moved and ground against each other.

Fig. 19. View from estimated angle of impact.
Boulder with most white transfer is initial impact point.

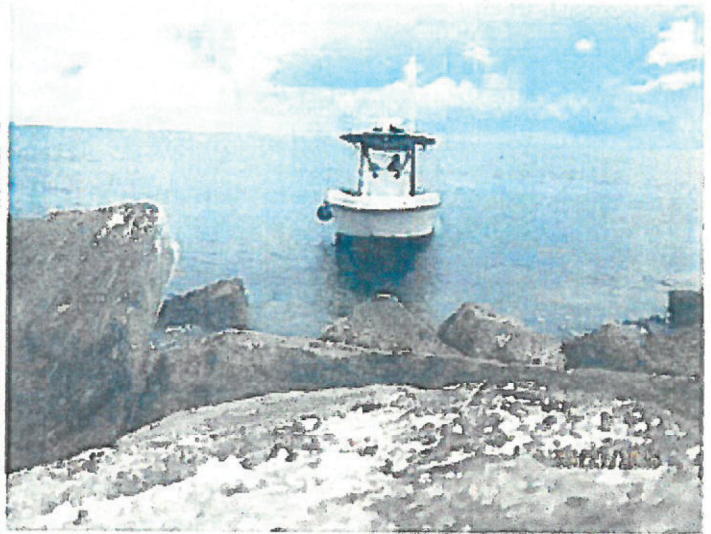
Fig. 20. View from estimated angle of impact

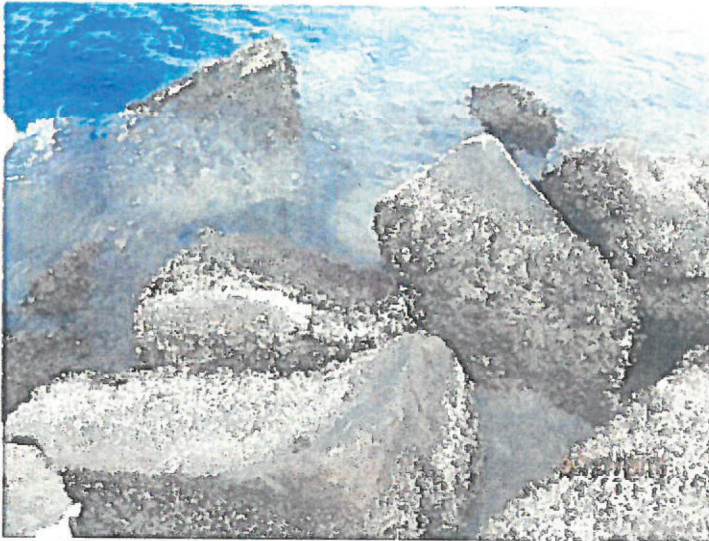
Fig. 21. View of back side of initial impact boulder.

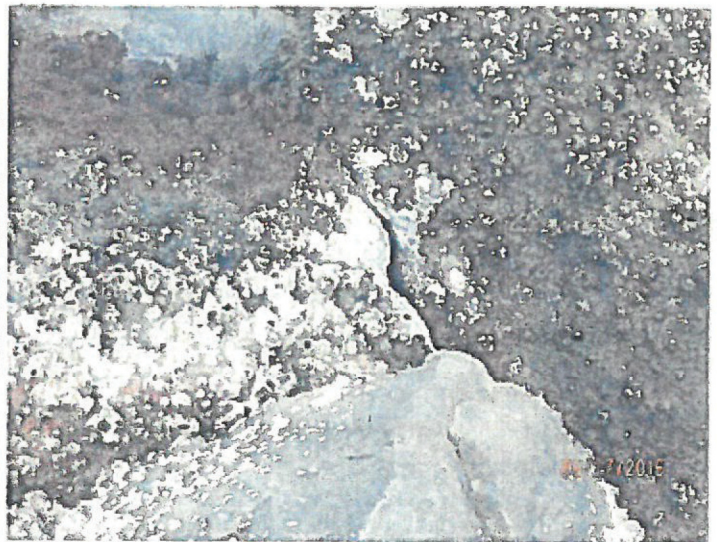
Fig. 22. Damage to west edge of impact boulder

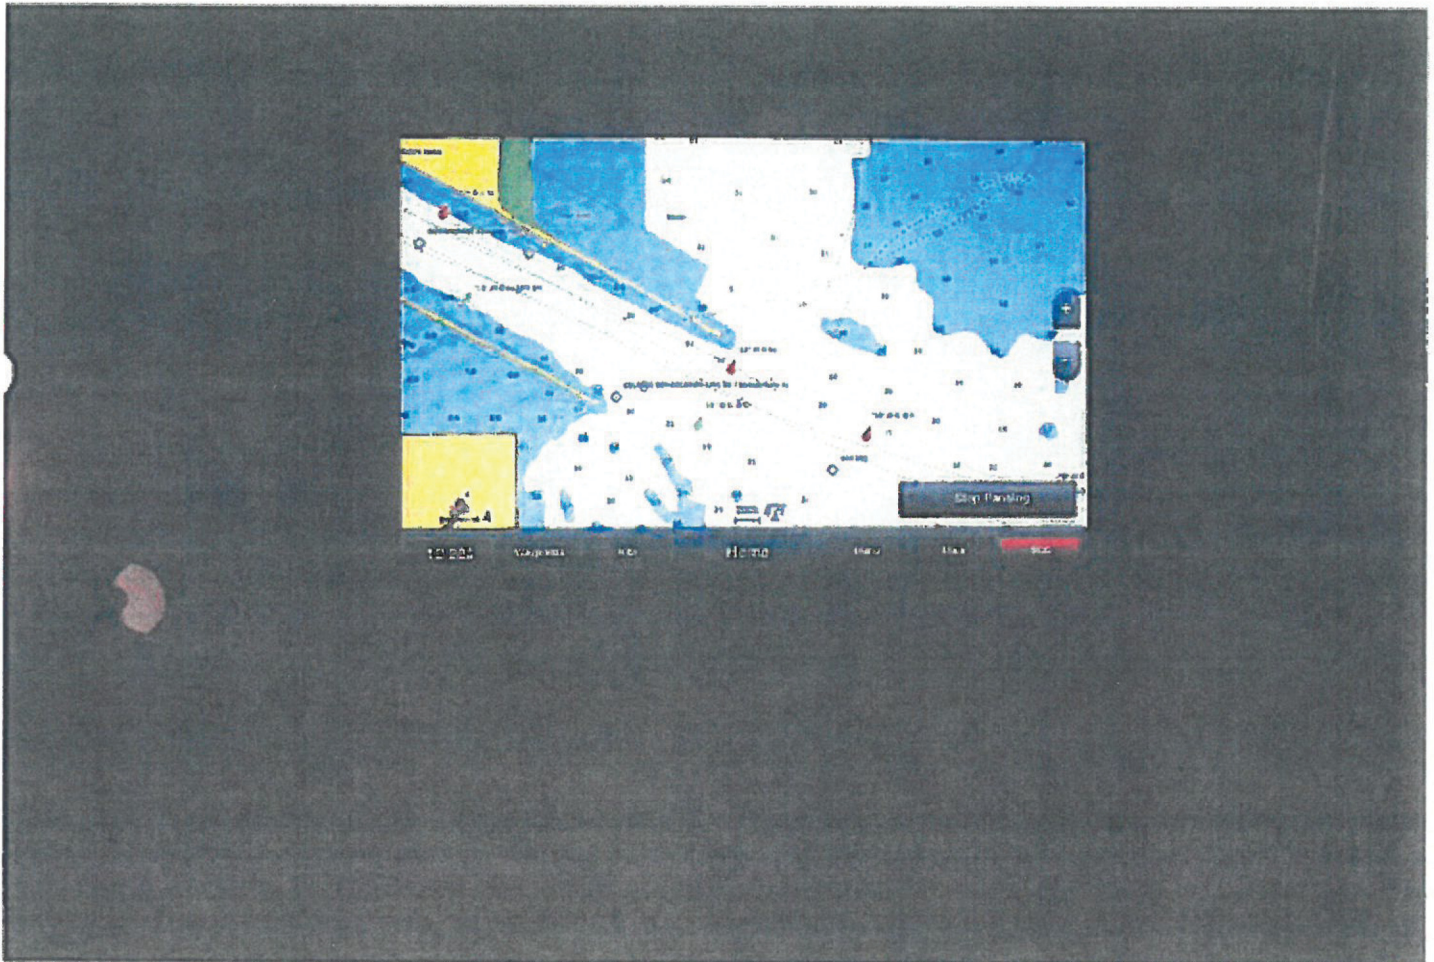
Fig. 23. V-1 GPS unit (right screen) showing the Government Cut jetty and track line from night of accident.

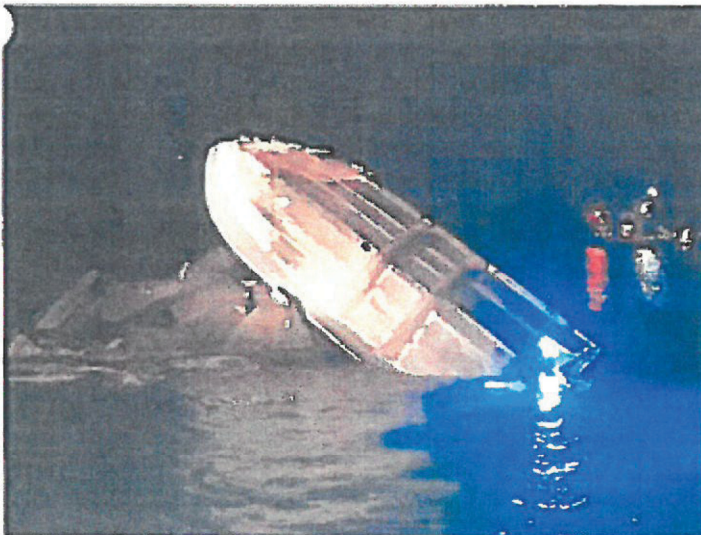
Fig. 25. V-1 on top of north jetty.

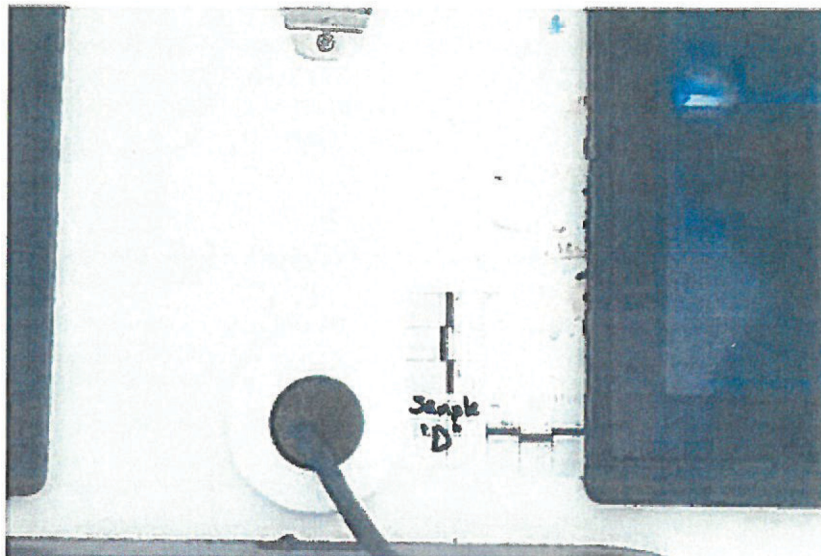
Fig. 28. Damage cause by MDFRD Halligan tool.

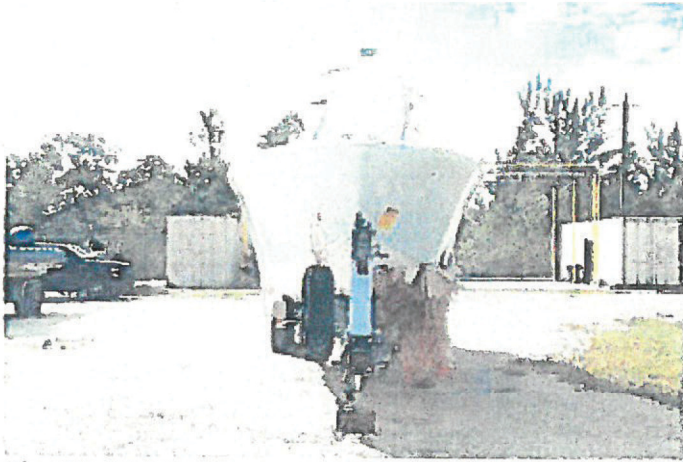
Fig. 29. V-1 bow.

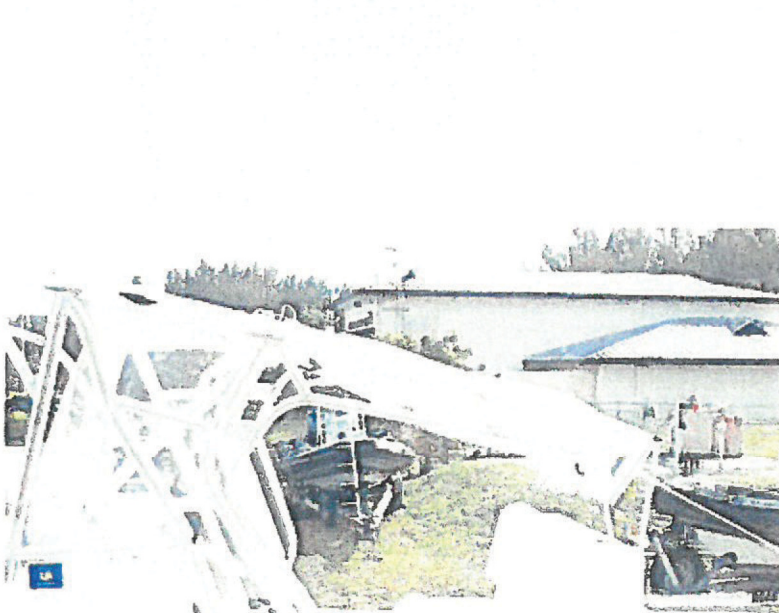
Fig. 31. View of t-top from port (left) side

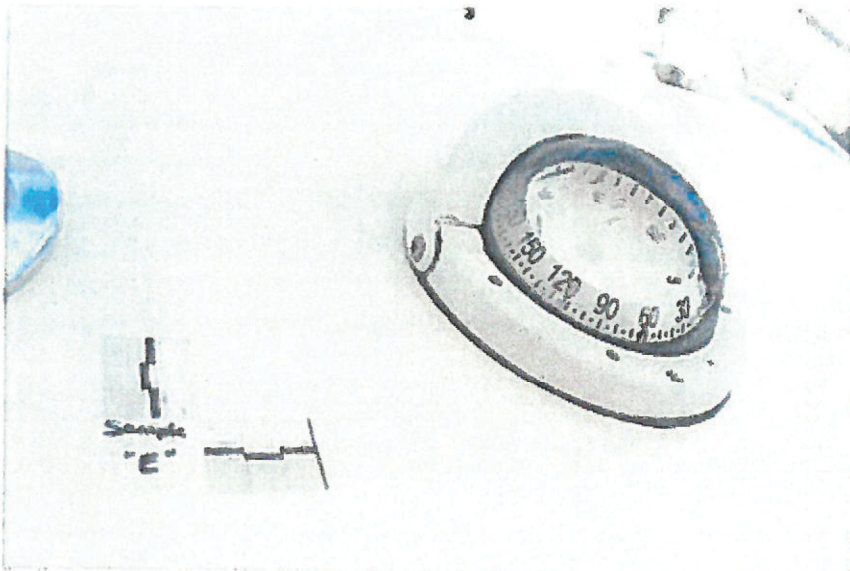
Fig. 35. Chips on compass of center console.

While reviewing evidence in this case, including autopsy photographs, we noticed a circular wound on the forehead of Rivero. Further examination of this wound matches the shape of the bottom of the rod holders located at the back of the V-1 t-top. The rod holders are the only items on V-1 that could have made this type of injury.

I spoke with Miami Dade Medical Examiner's Office Investigator Mendoza, who conferred with MDME Doctor Hutchins, that the material and impressions on the compass would not be able to be analyzed as a tooth material. They suspected it to be only a surface composite, not the pulp of a tooth, based on the autopsy photos and damage to Fernandez's teeth.

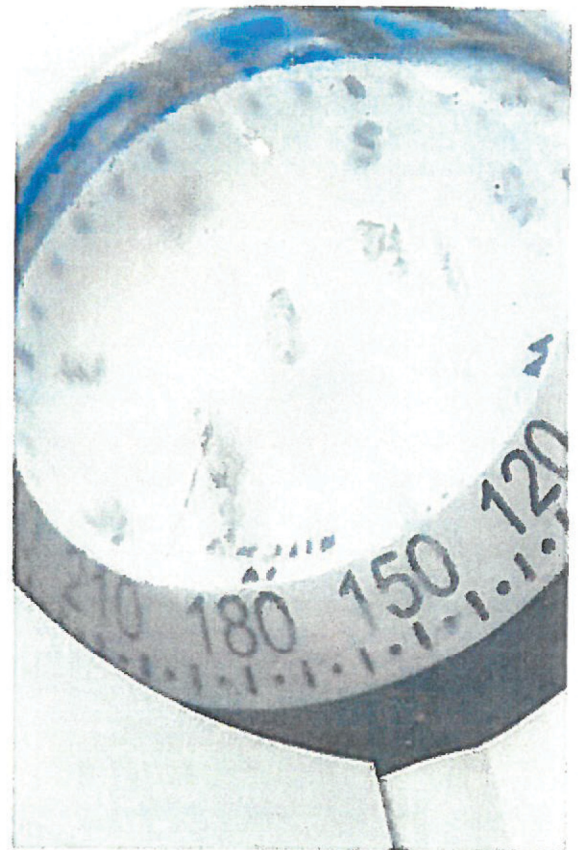
Fig. 36. Close up of chips.

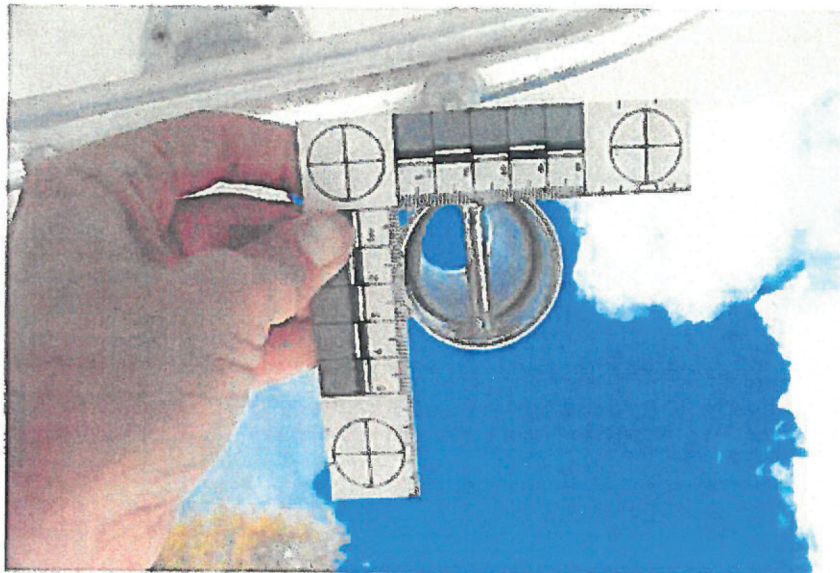
Fig. 40. Diameter of base of V-1 rod holder approximately 4 cm.
