A report from the NIOSH Fire Fighter Fatality Investigation and Prevention Program

March 21, 2017

Career Female Fire Fighter Dies After Becoming Lost and Running Out of Air in a Residential Structure Fire—Pennsylvania

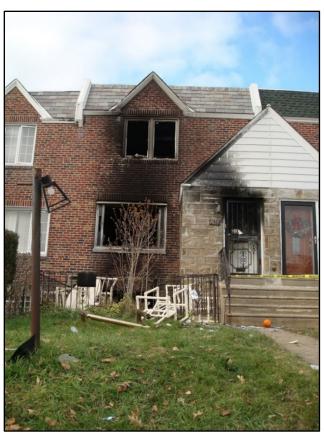
Photo 1. Front of row house. (NIOSH photo.)

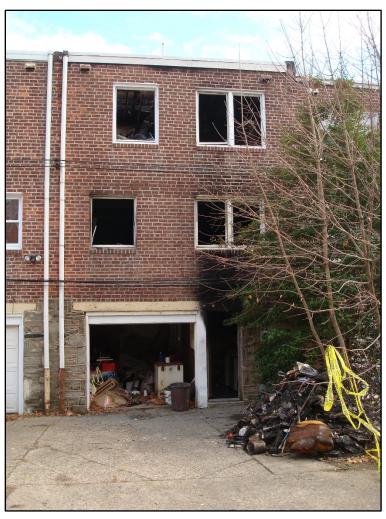
Diagram 2). The basement could be accessed either by an interior door leading to stairs off the right side of the kitchen or an exterior door at the rear (see Photo 2) of the house via an alley. The basement had a recreation room with half bath in the front half of the house, utility area on the left rear, and a garage on the right rear area (see Diagram 3). The garage was accessed by a standard aluminum garage door and had no interior access to the utility or recreation area and was formed by concrete block walls. The garage area was used for storage.

Photo 2. Rear of row house. (NIOSH photo.)

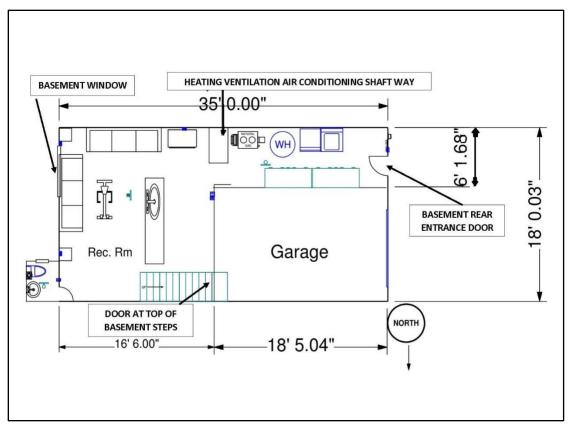
Diagram 3. Basement floor plan. (Courtesy of the fire department.)

Fire conditions were floor-to-ceiling in the basement recreation room and venting from the front basement window. Fire extended into the cockloft and throughout kitchen from the basement door.

According to the city fire marshal's office, the cause of the fire was "undetermined." The origin of the fire was in the basement recreation room where combustible material was ignited by an undetermined source.

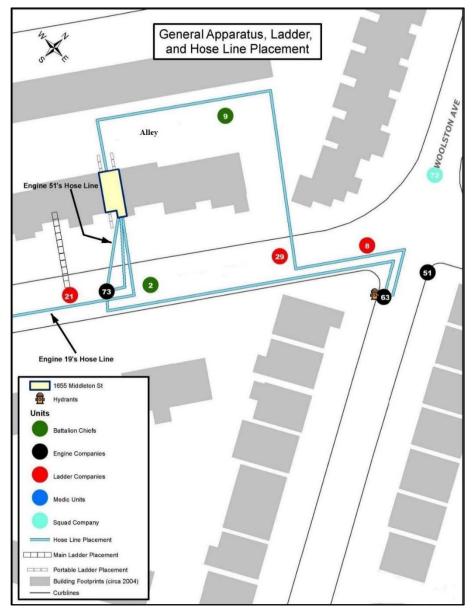
At 02:55 hours, Engine 63 arrived on-scene and proceeded to the rear of the structure, via the rear alley (see Diagram 4). The Engine 73 officer and nozzle operator were donning their facepieces in the dining room while the fire fighter/EMT was flaking out the hoseline outside the front door. At 02:56 hours, the Engine 73 officer radioed the Engine 73 driver to give them water. Looking through a 2-foot by 2-foot decorative cutout in the wall between the dining room and kitchen, the officer could see fire beginning to vent from the top of the basement doorway. A minute later, the Engine 63 officer reported nothing showing in the rear but immediately changed that to seeing fire through the window in the first-floor kitchen area with smoke conditions getting heavier from the first-and second-floor windows.

Diagram 4. Apparatus and hoseline placement. (Courtesy of the fire department.)

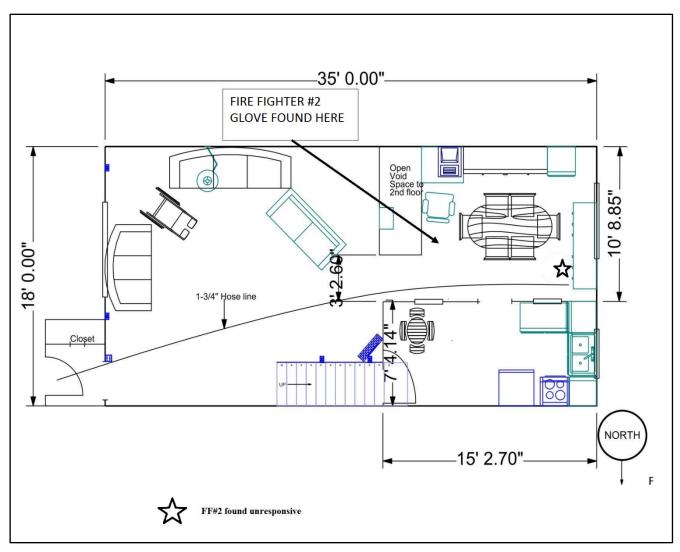
Ladder 29 fire fighter entered dining room through window from ground ladder. Squad 72 officer followed the Engine 73 hoseline, removed an office chair in the way, and found Engine 73 fire fighter/EMT slumped over against a buffet under the dining room window. Squad 72 reported bringing out the fire fighter/EMT. Squad 72, Ladder 29, and Ladder 8 carried the fire fighter/EMT out.

Diagram 5. Location of missing fire fighter. (Courtesy of fire department.)
