# **Preliminary Root Causes Analysis of Failures of the Oroville Dam Gated Spillway**

R. G. Bea

Center for Catastrophic Risk Management  
University of California Berkeley  
April 17, 2017

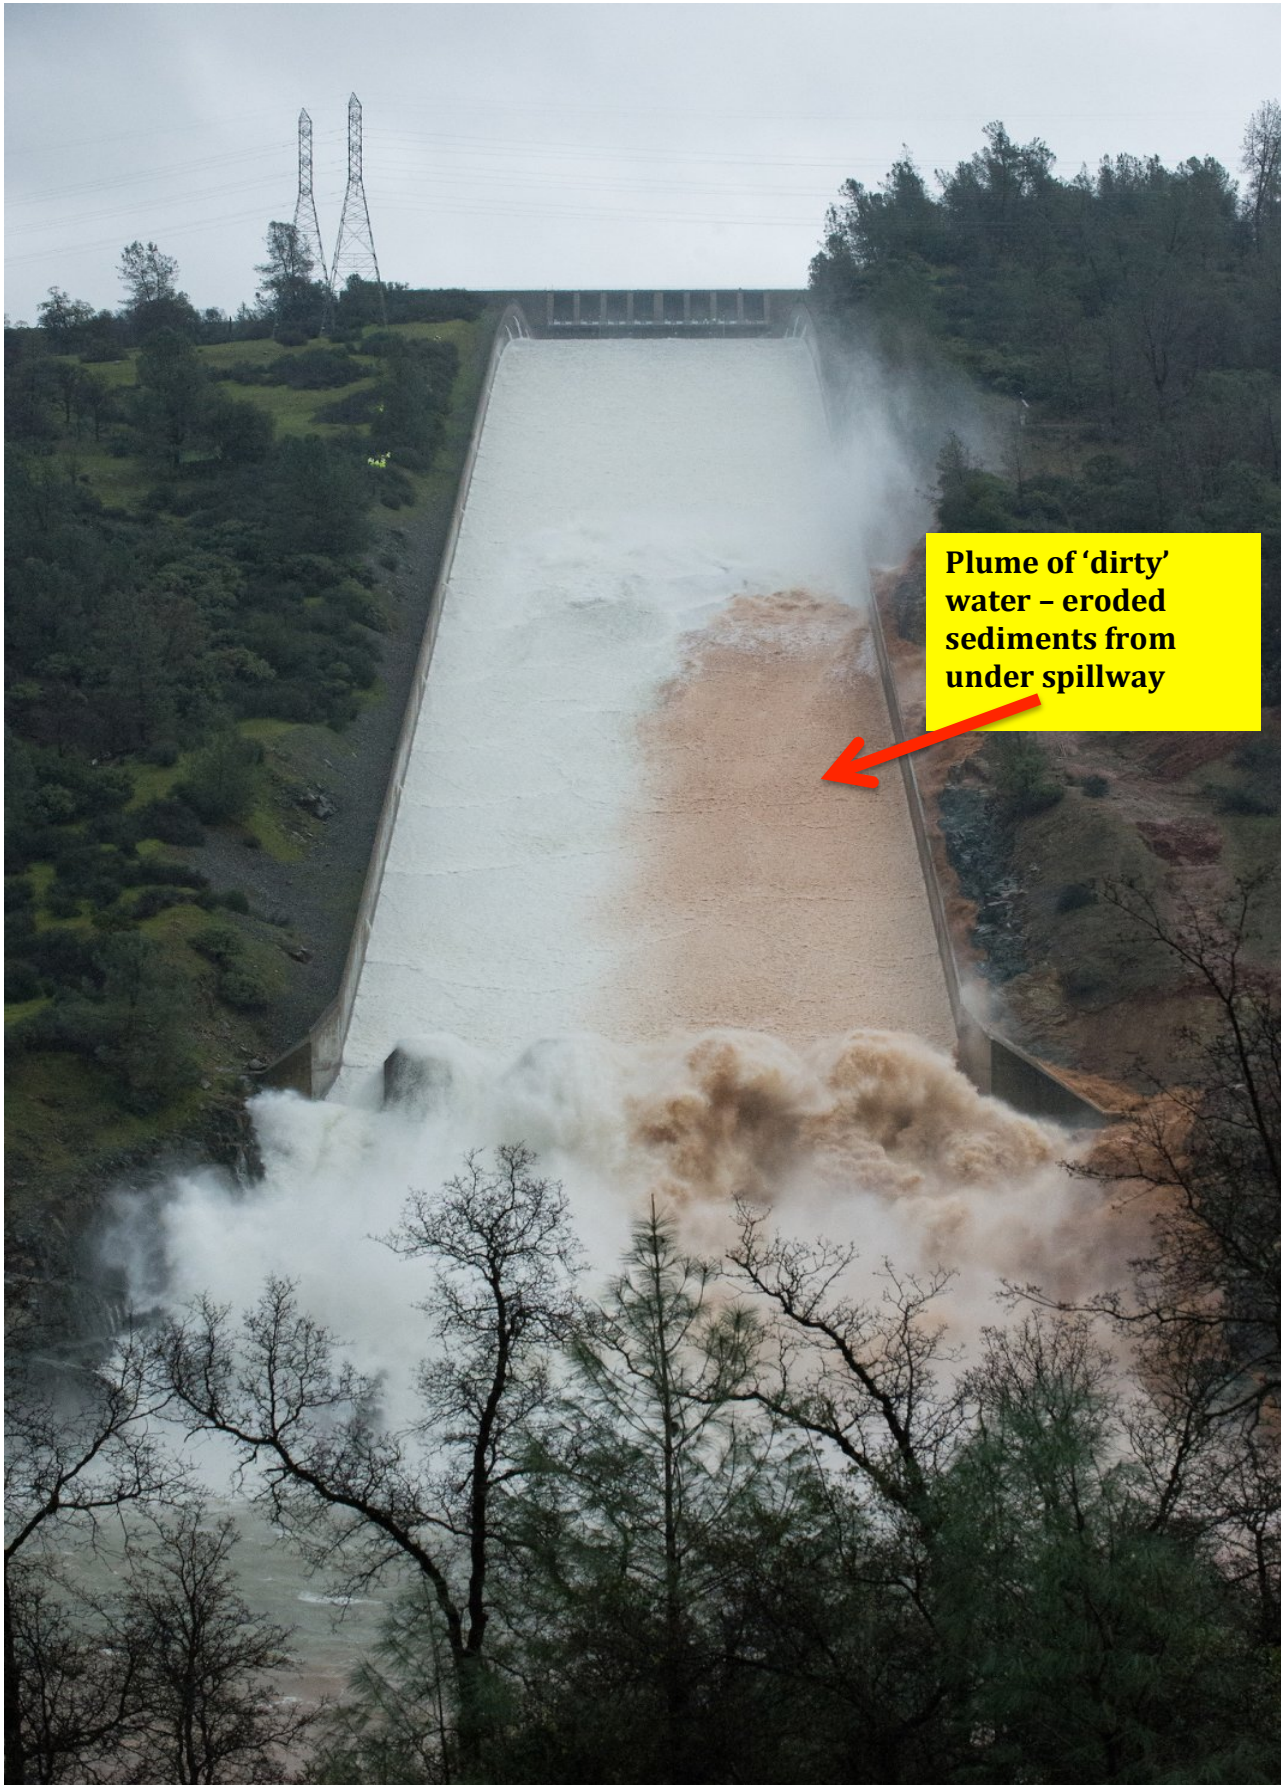
**February 7, 2017 - Stage #1**

**Plume of 'dirty' water - eroded sediments from under spillway**

**Exposed rock and erodible sediments under spillway**

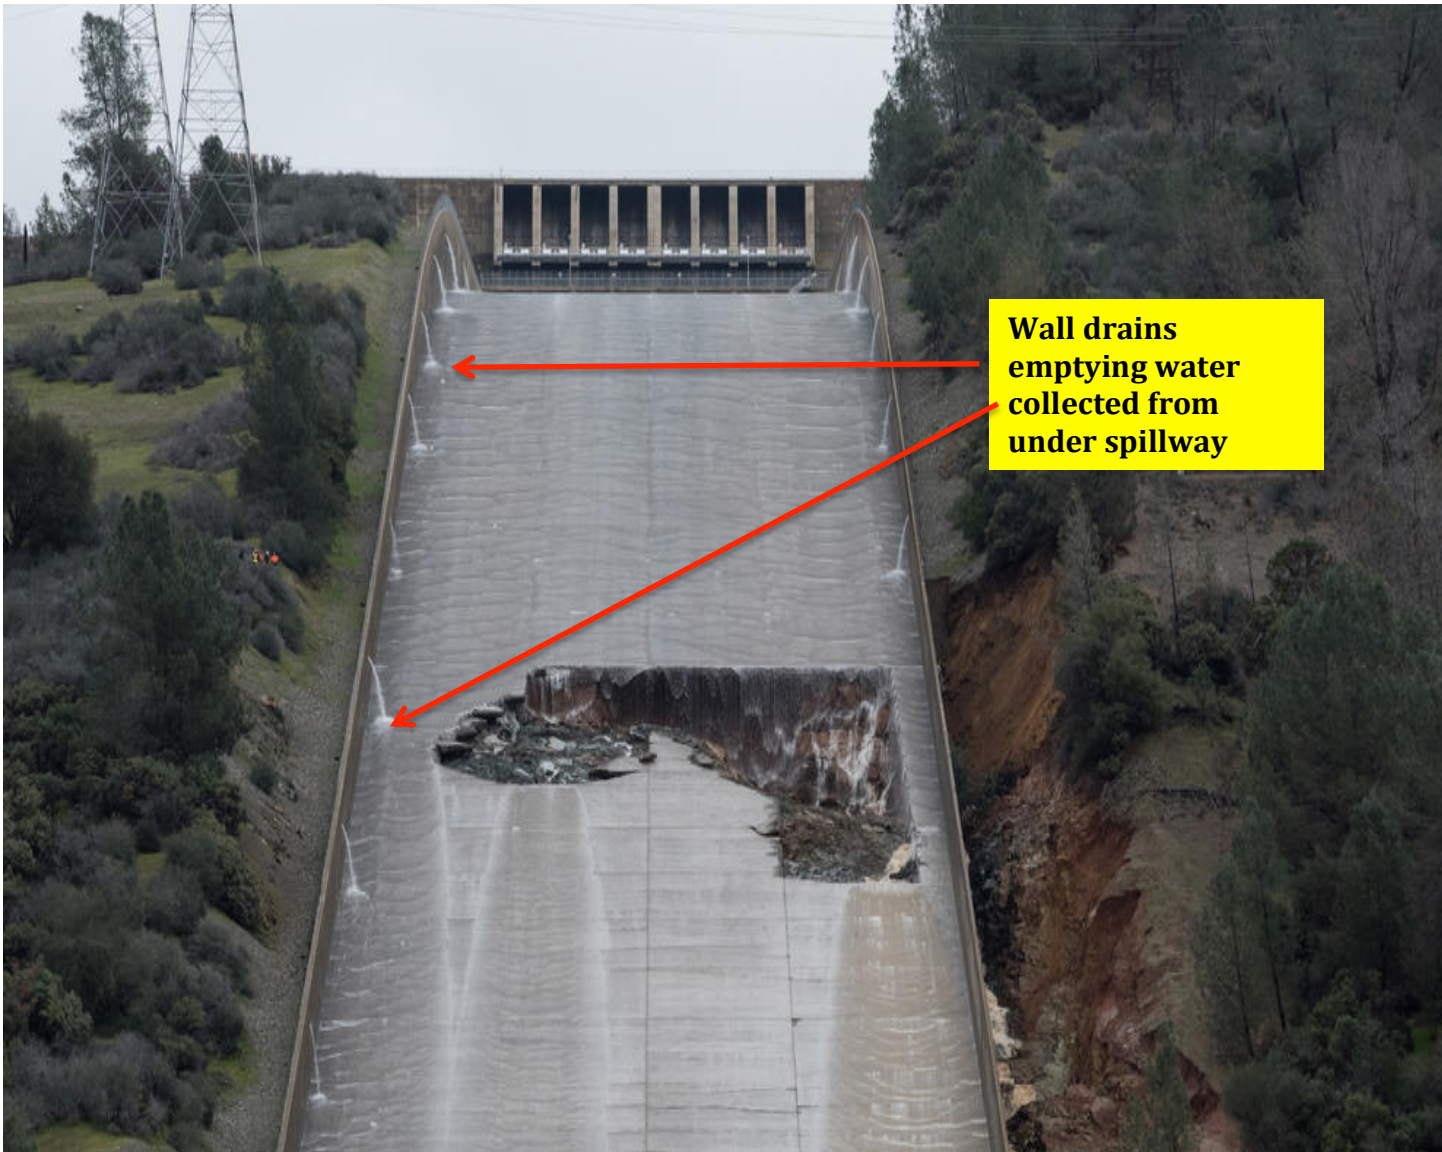
**Wall drains  
emptying water  
collected from  
under spillway**

**Wall drains on  
upper part of  
spillway indicate A  
Lot Of Water  
coming from under  
the spillway**

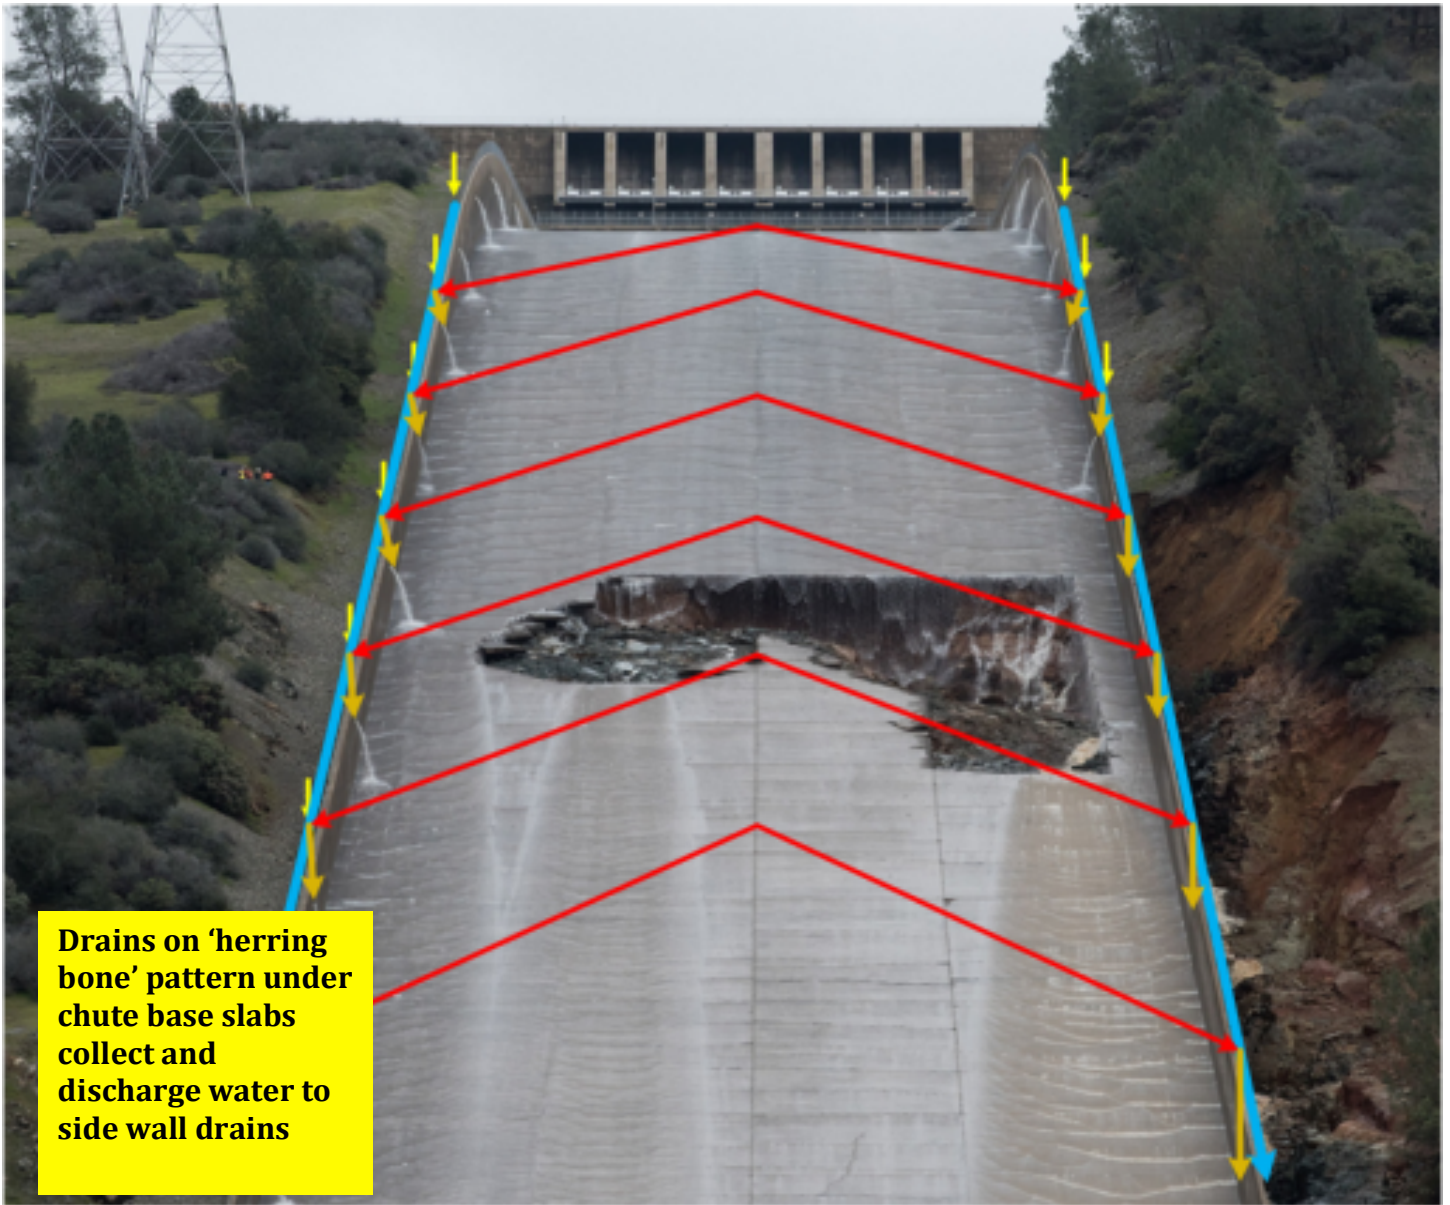
**Drains on 'herring bone' pattern under chute base slabs collect and discharge water to side wall drains**

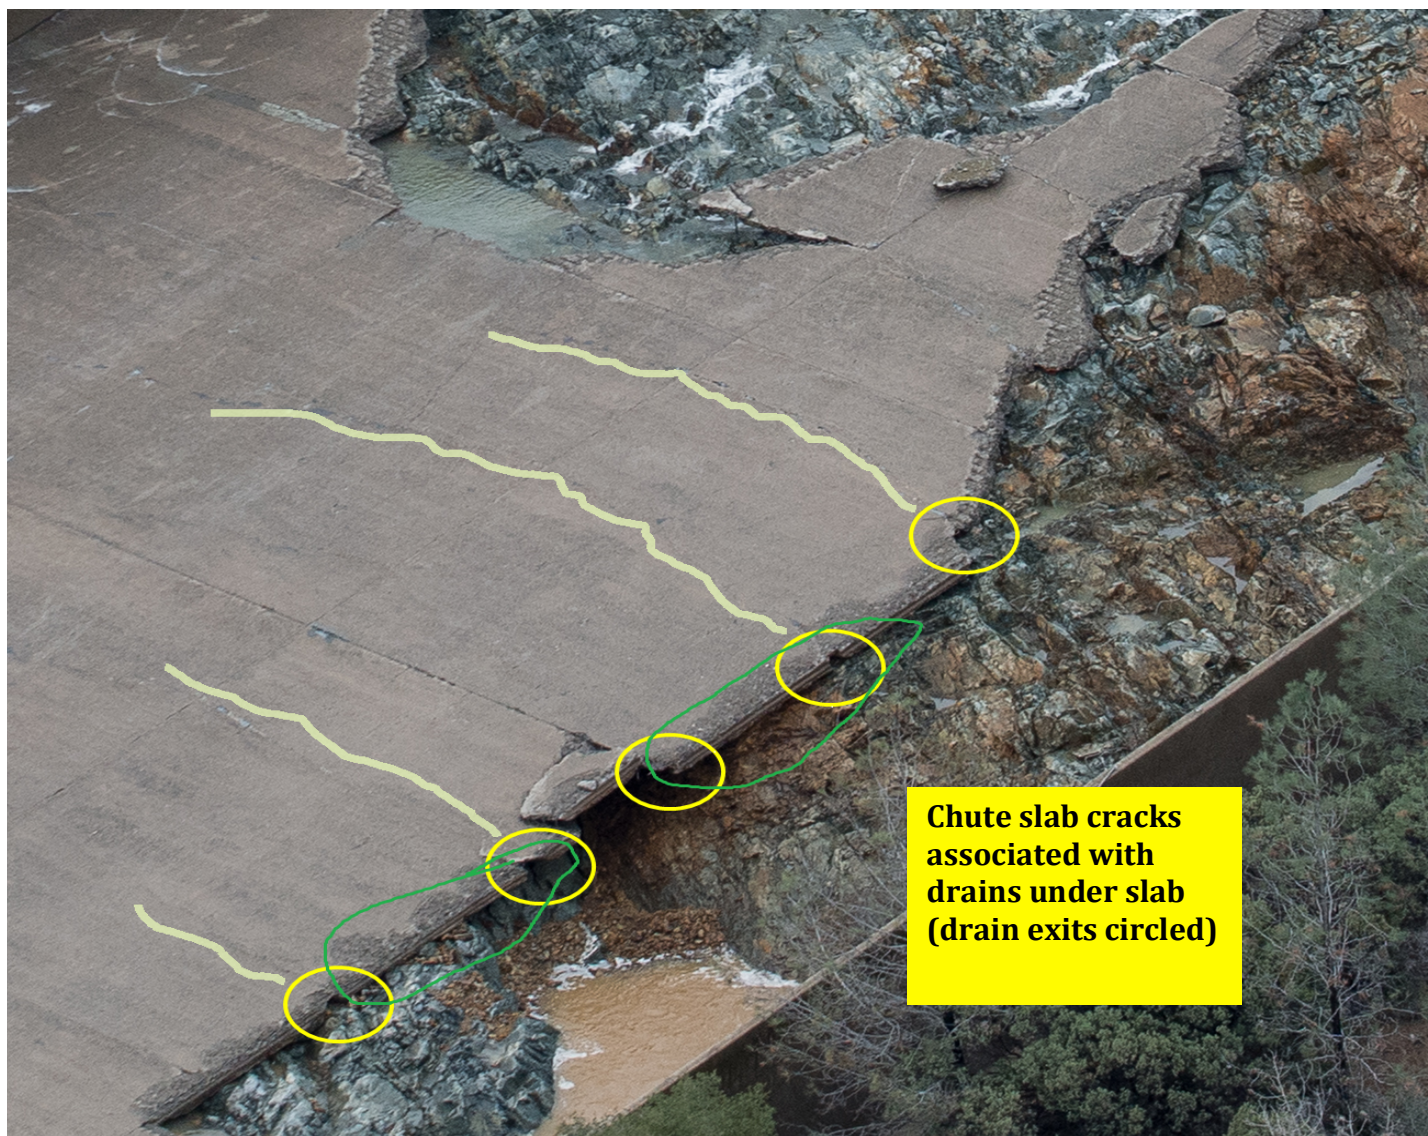
Chute slab cracks associated with drains under slab (drain exits circled)

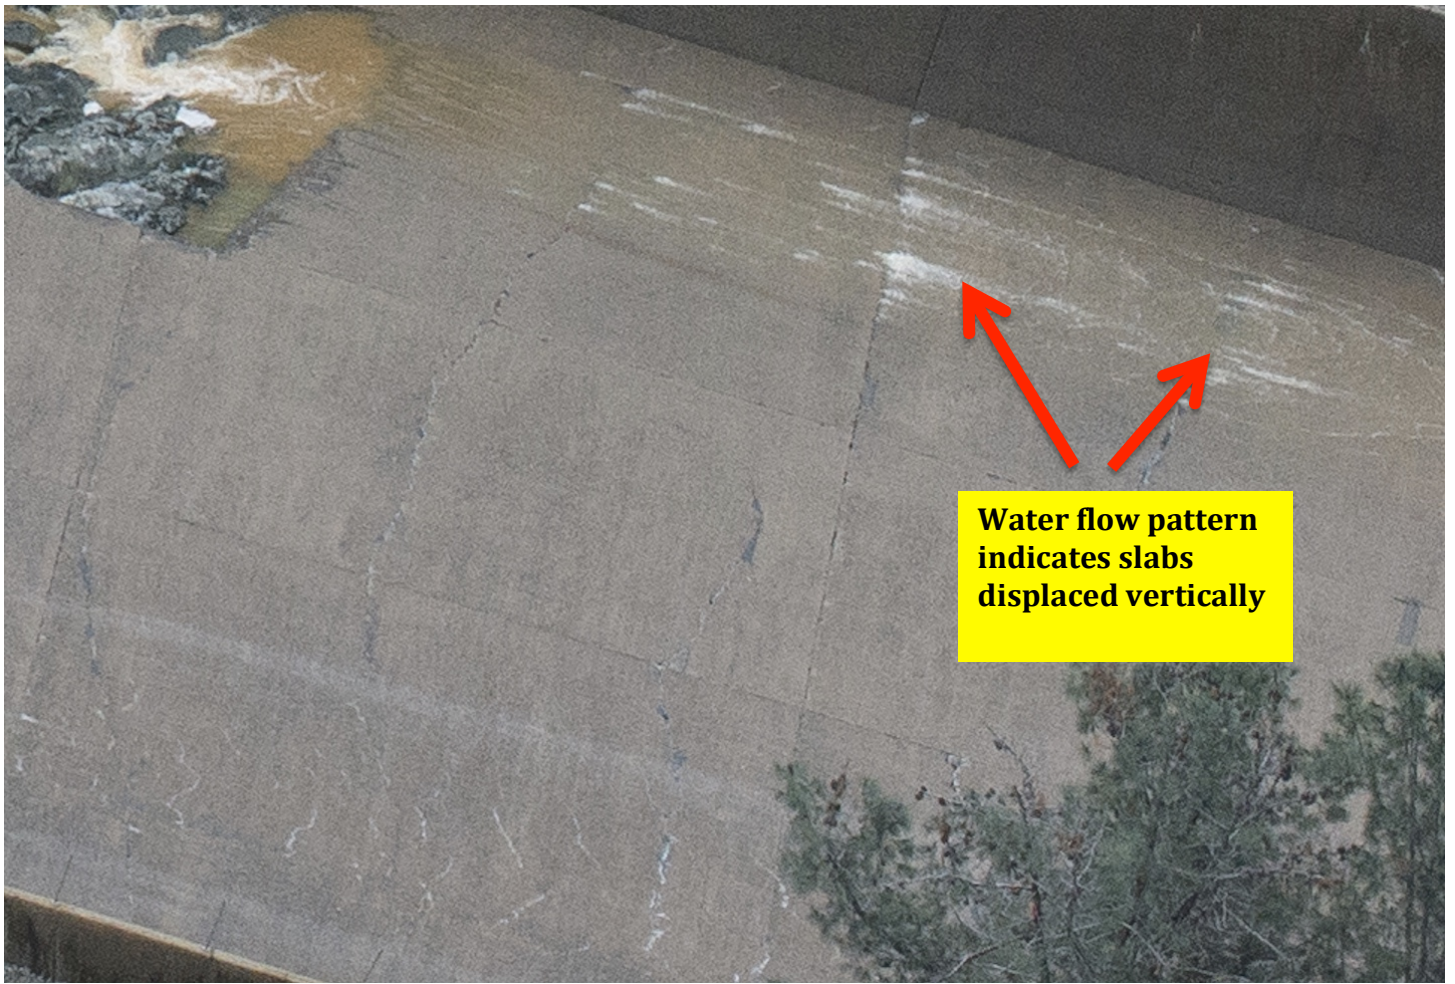
**Water flow pattern  
indicates slabs  
displaced vertically**

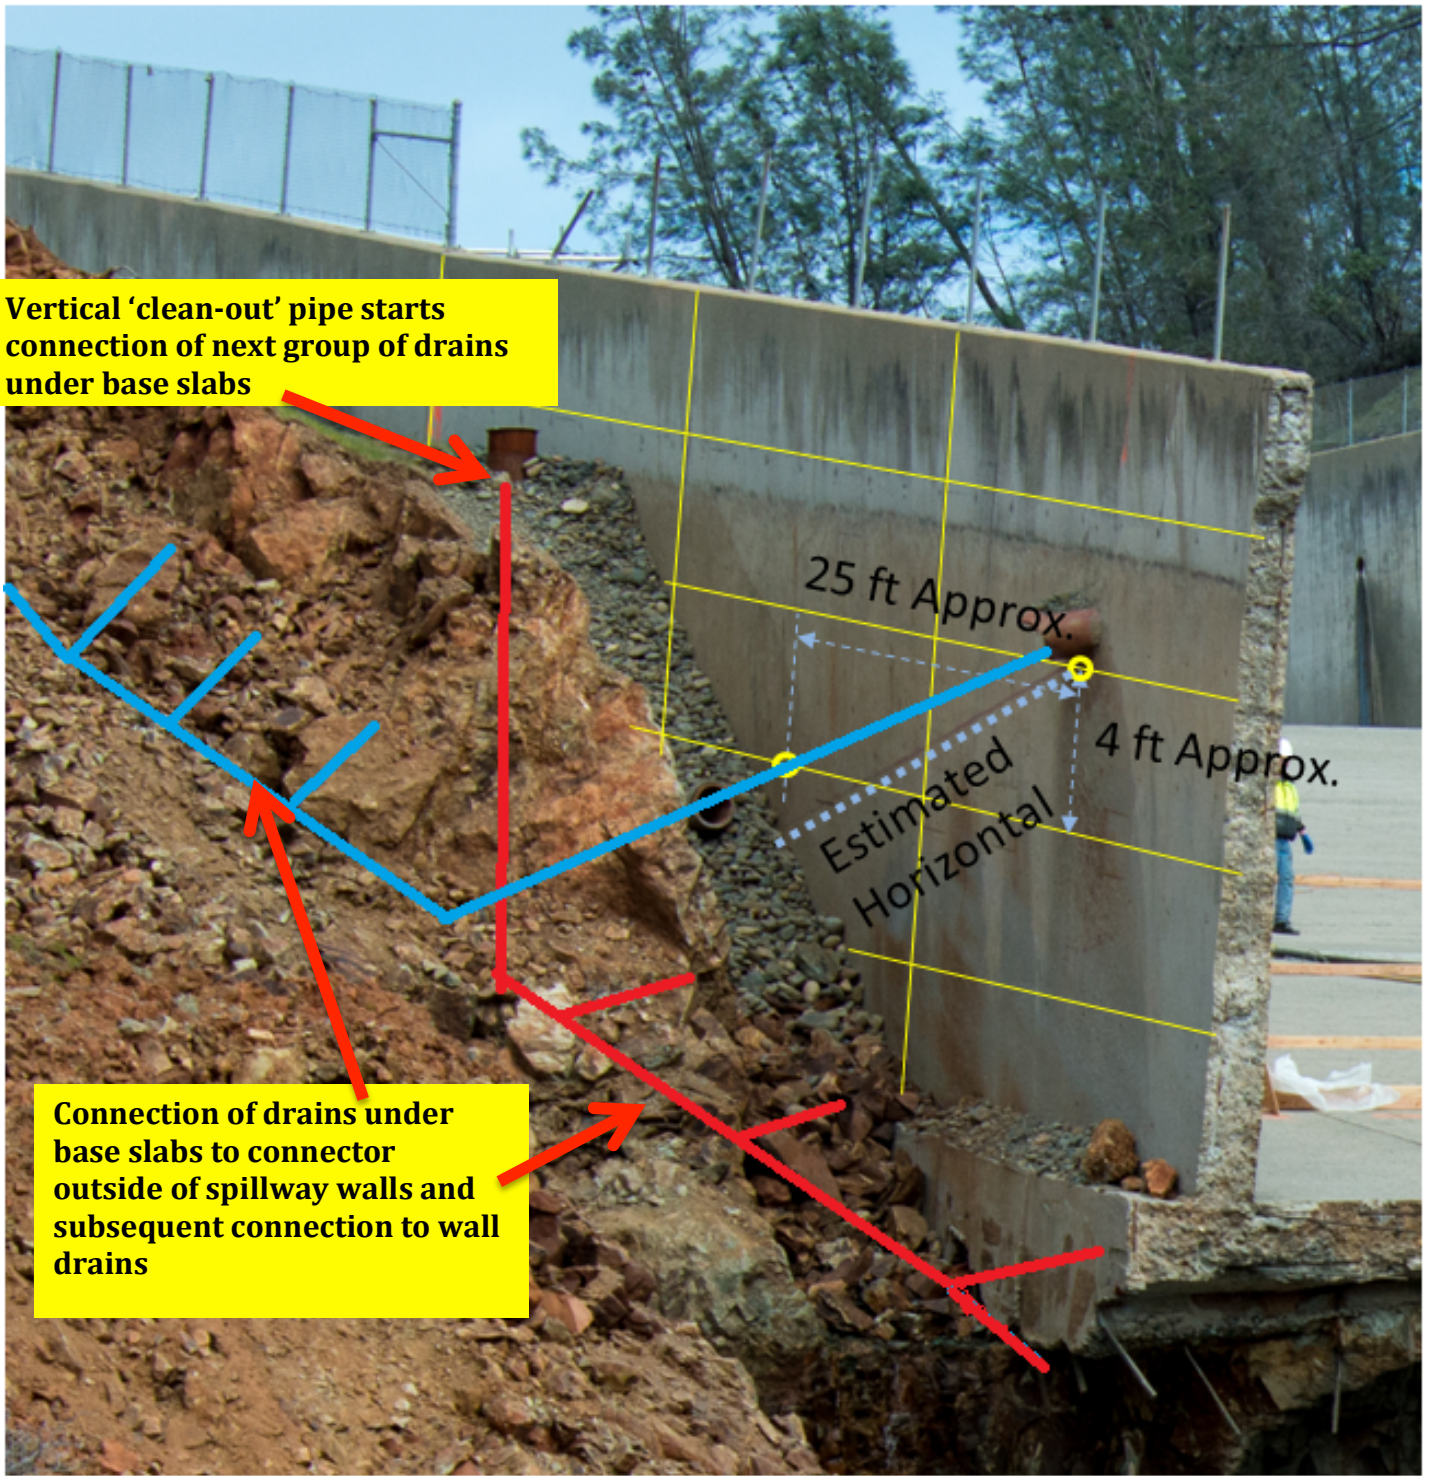
**Vertical 'clean-out' pipe starts connection of next group of drains under base slabs**

**Connection of drains under base slabs to connector outside of spillway walls and subsequent connection to wall drains**

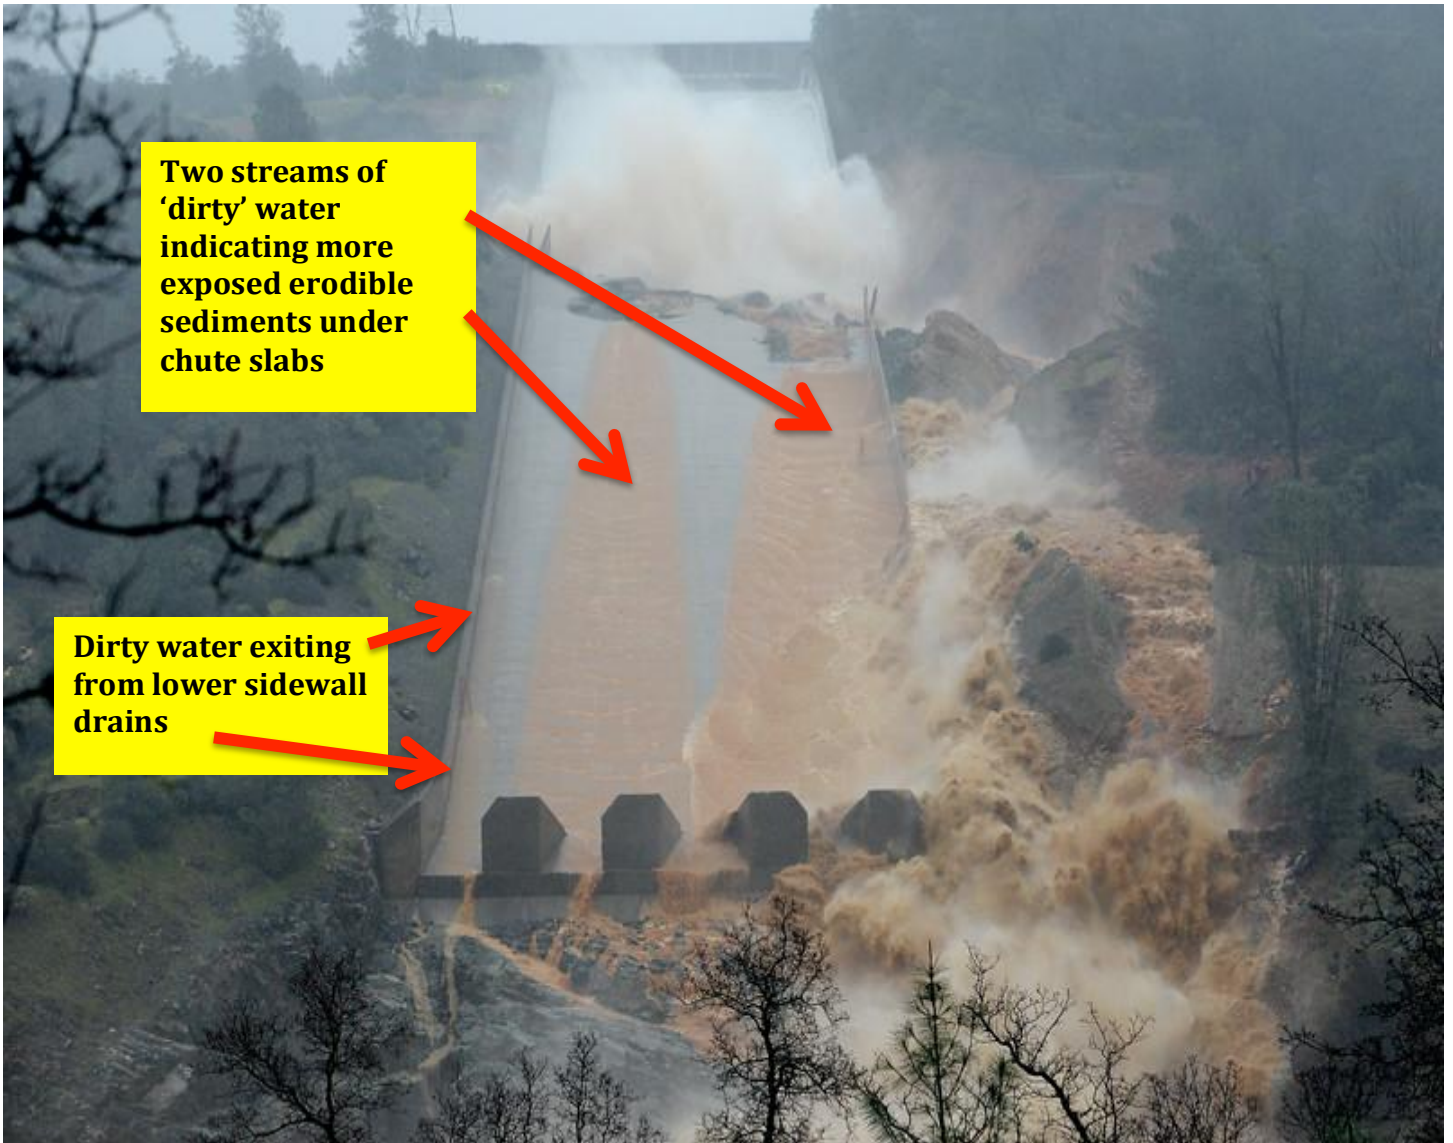
**February 9, 2017 - Stage #2**

**Two streams of 'dirty' water indicating more exposed erodible sediments under chute slabs**

**Dirty water exiting from lower sidewall drains**

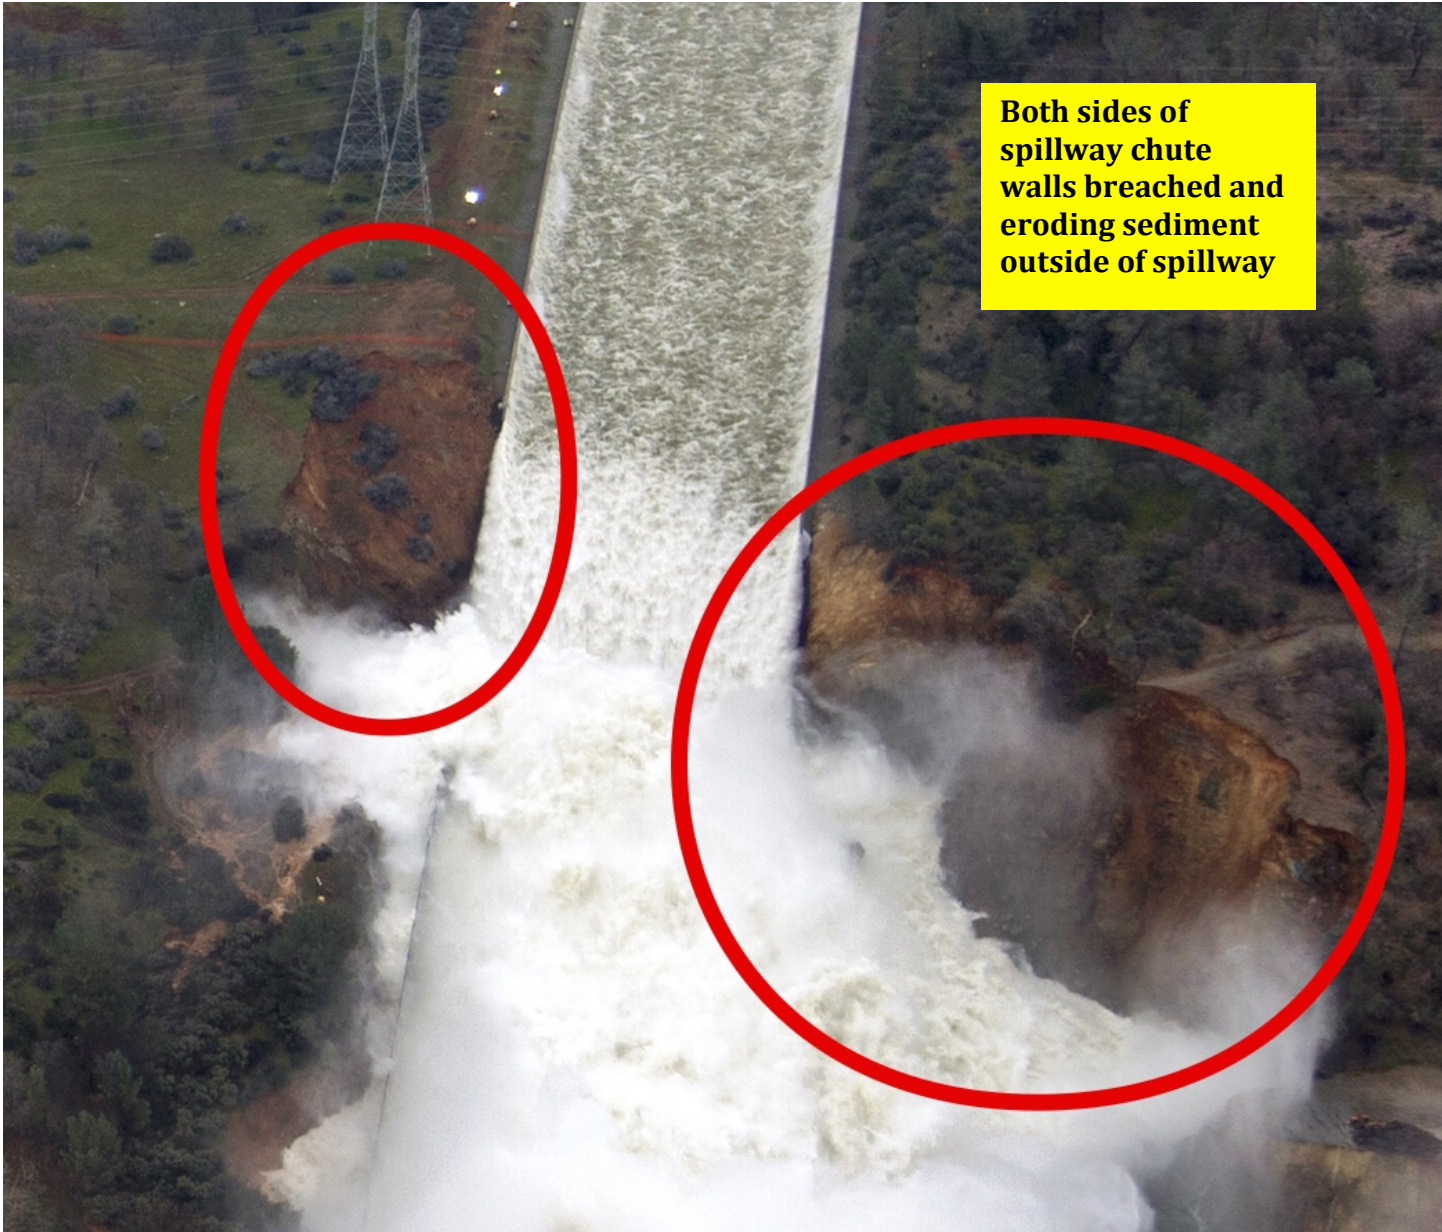
**Both sides of  
spillway chute  
walls breached and  
eroding sediment  
outside of spillway**

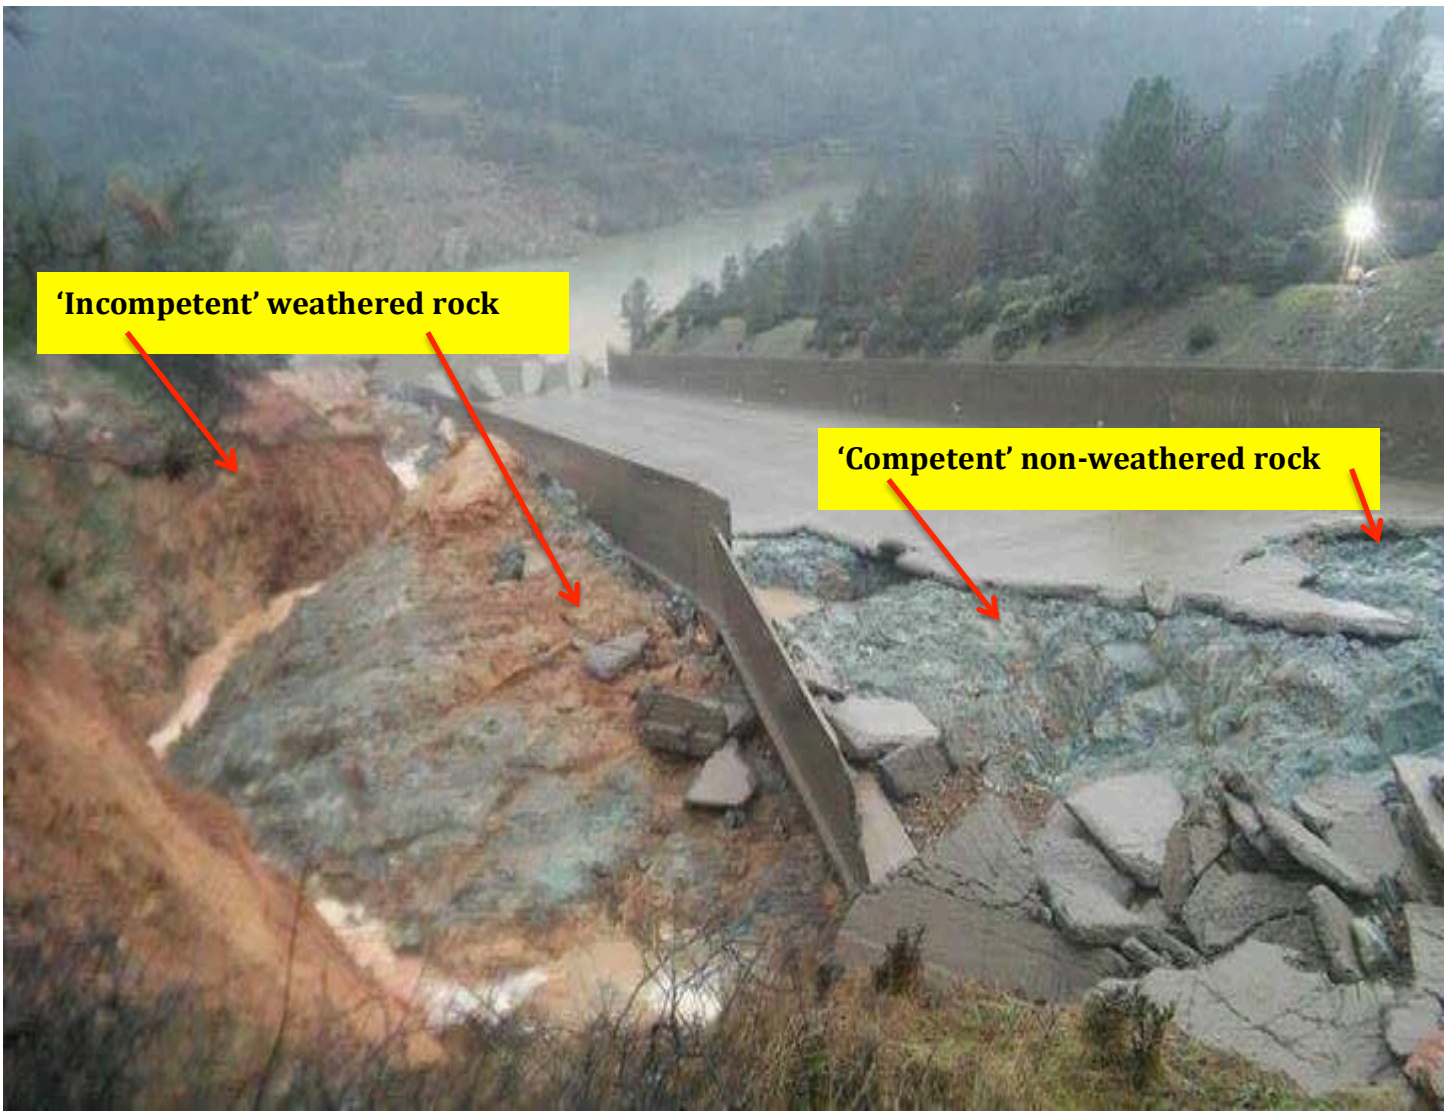
**'Incompetent' weathered rock**

**'Competent' non-weathered rock**

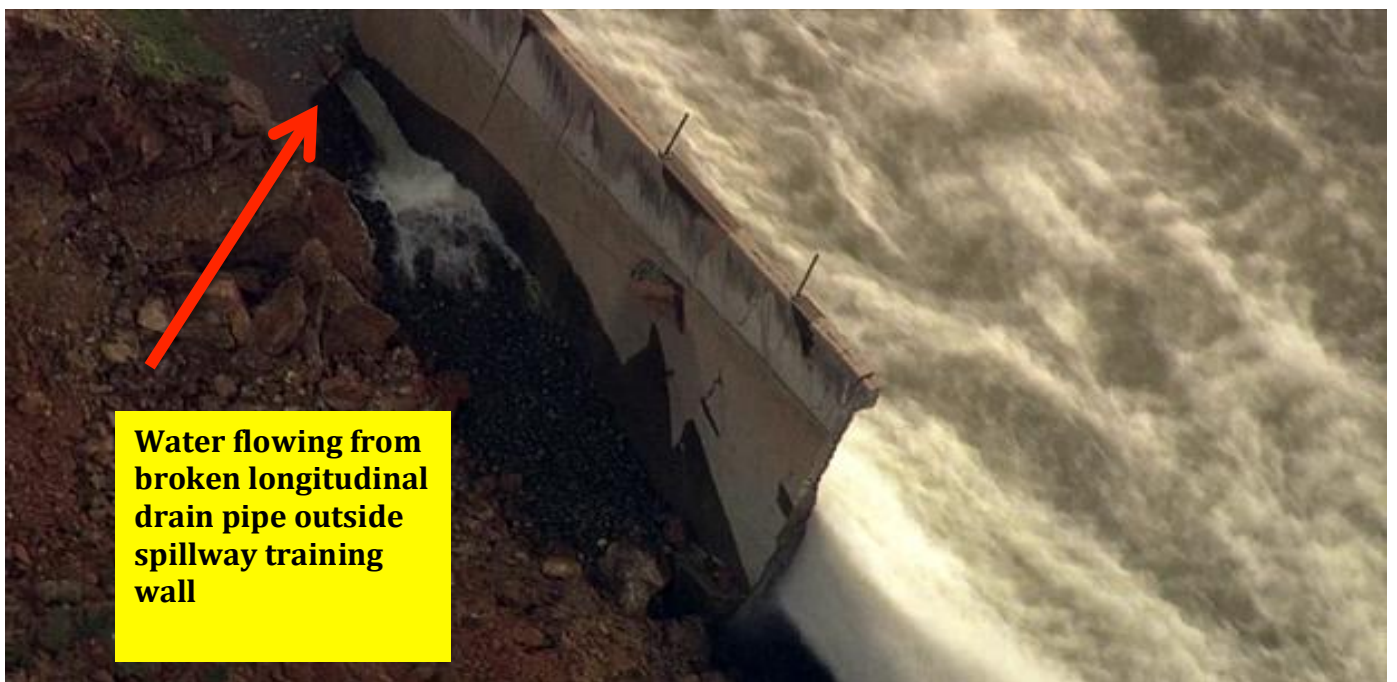
Stage 3 - February 16, 2017

**Water flowing from broken longitudinal drain pipe outside spillway training wall**

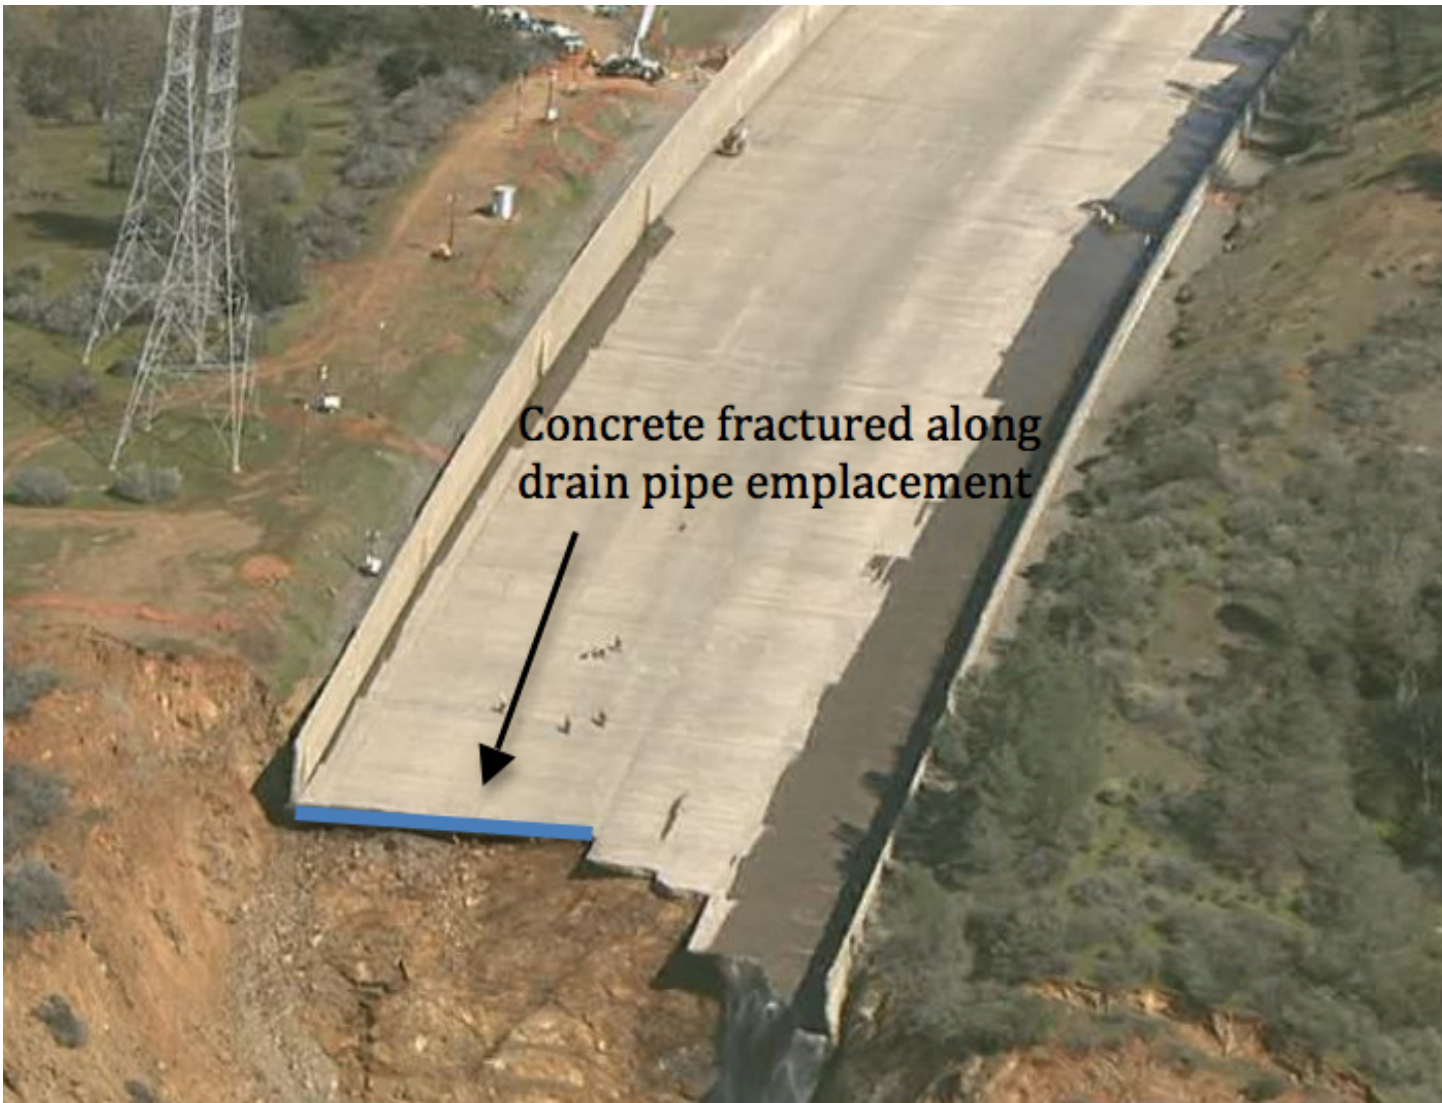
Concrete fractured along  
drain pipe emplacement

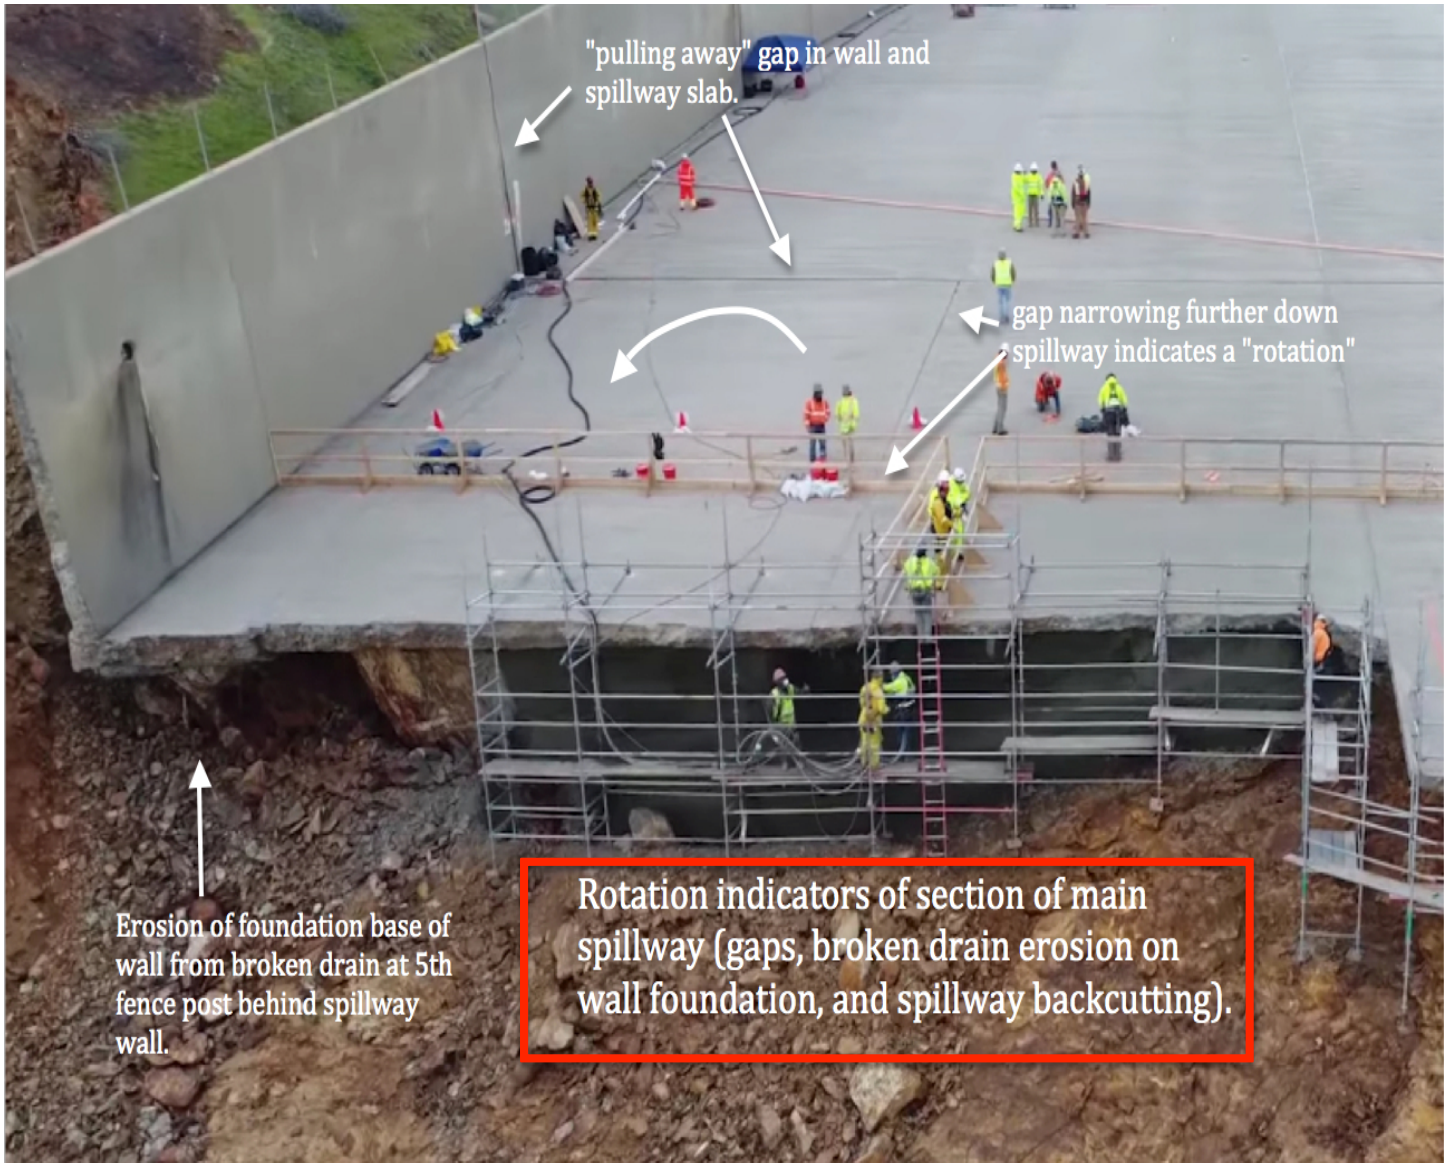
"pulling away" gap in wall and spillway slab.

gap narrowing further down spillway indicates a "rotation"

Erosion of foundation base of wall from broken drain at 5th fence post behind spillway wall.

Rotation indicators of section of main spillway (gaps, broken drain erosion on wall foundation, and spillway backcutting).

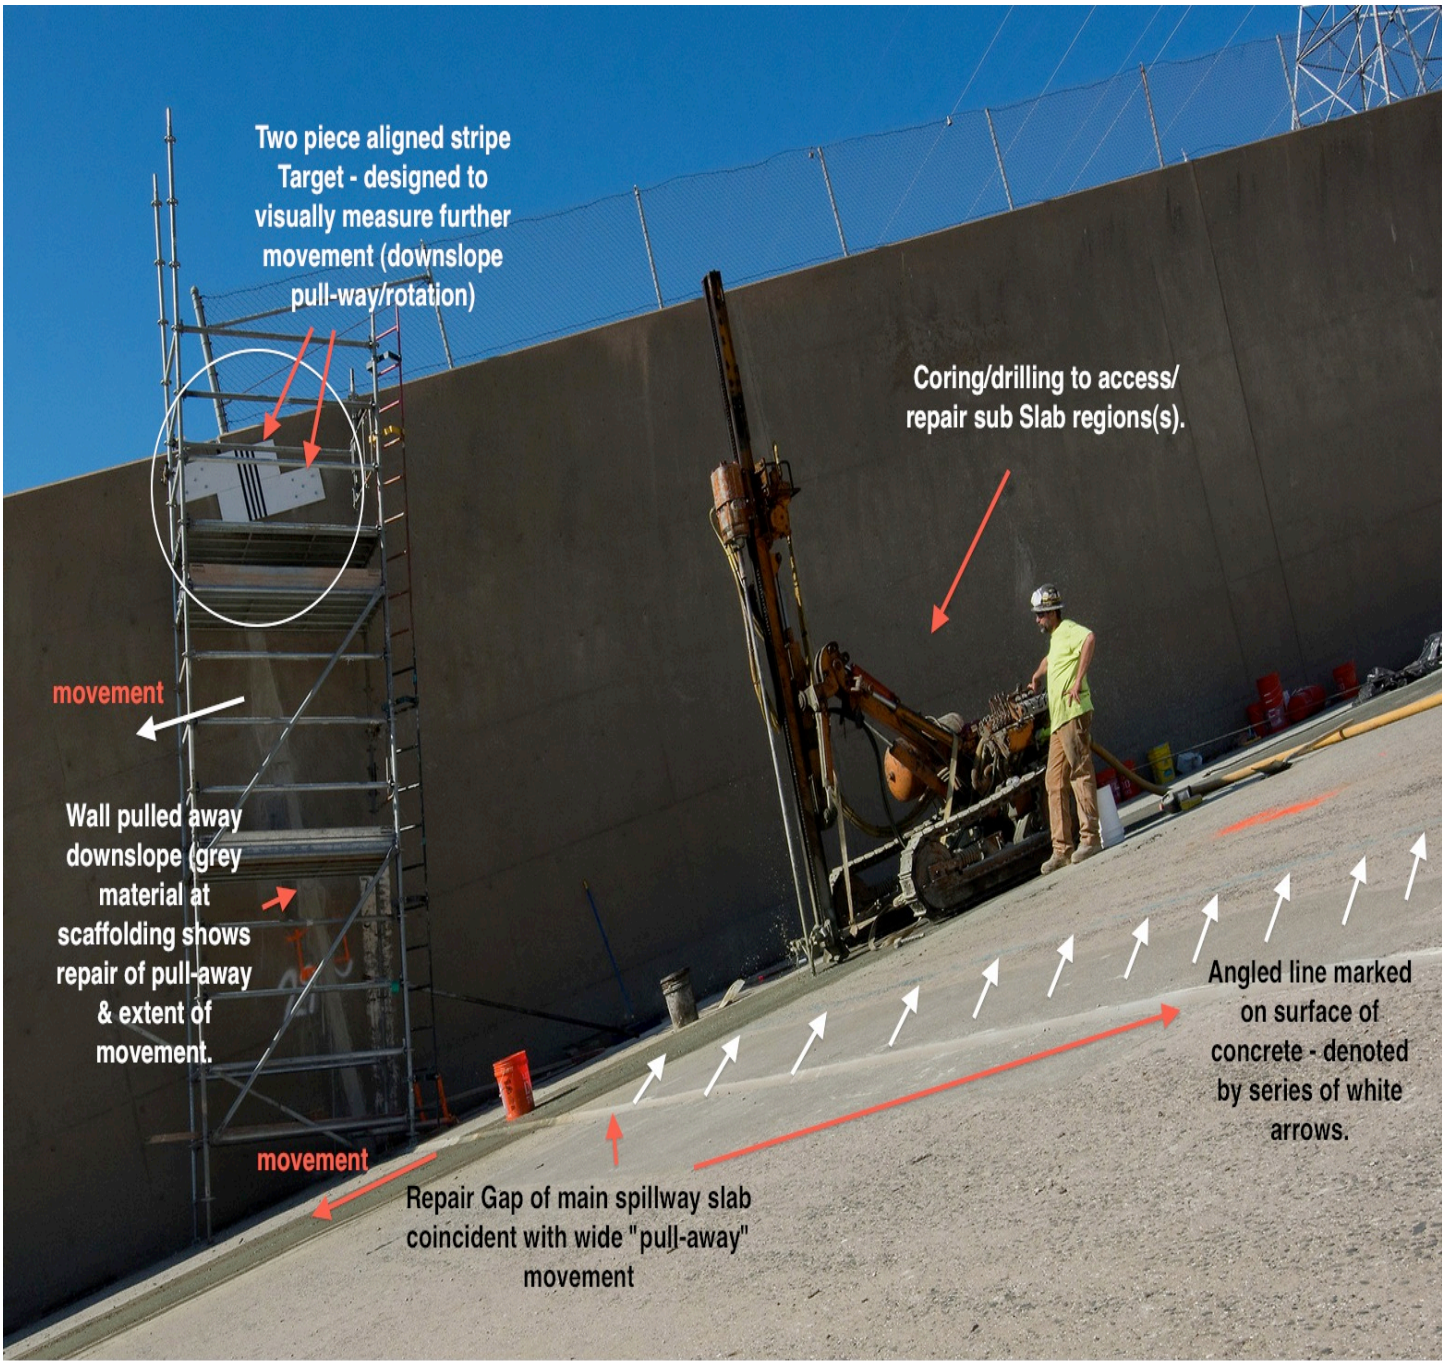
Two piece aligned stripe  
Target - designed to  
visually measure further  
movement (downslope  
pull-way/rotation)

Wall pulled away  
downslope (grey  
material at  
scaffolding shows  
repair of pull-away  
& extent of  
movement.

Repair Gap of main spillway slab  
coincident with wide "pull-away"  
movement

Angled line marked  
on surface of  
concrete - denoted  
by series of white  
arrows.

Coring/drilling to access/  
repair sub Slab regions(s).

**Spillway Repair - Drilled & emplaced "rock bolts" to secure concrete slabs**
