# **Preliminary Root Causes Analysis of Failures of the Oroville Dam Gated Spillway**

R. G. Bea

Center for Catastrophic Risk Management  
University of California Berkeley  
April 17, 2017

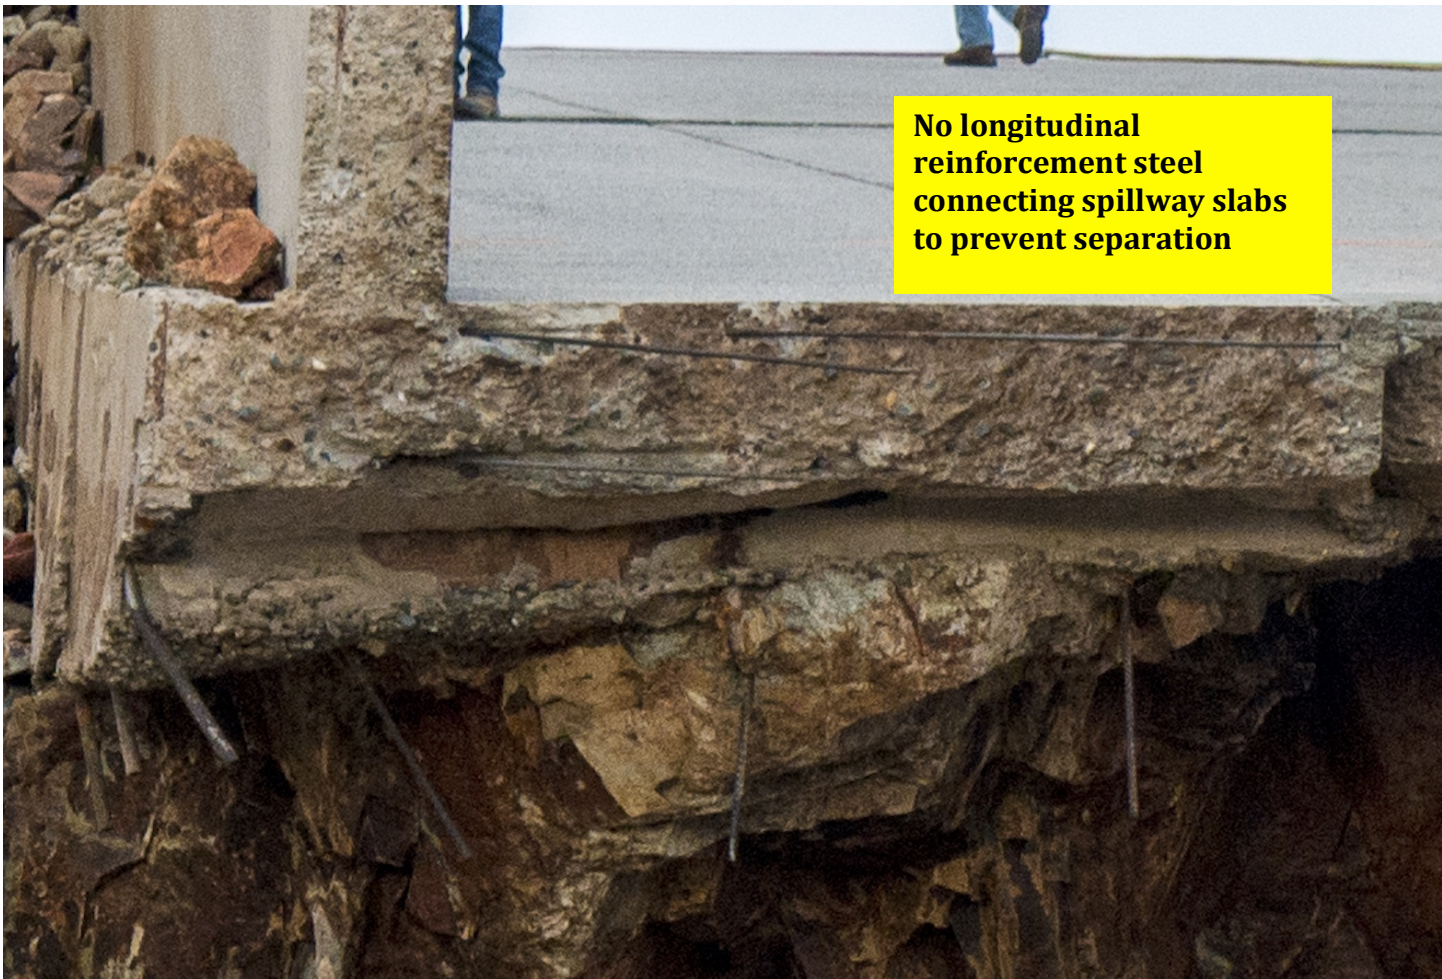
**No longitudinal reinforcement steel connecting spillway slabs to prevent separation**

**No longitudinal reinforcement steel connecting spillway slabs**

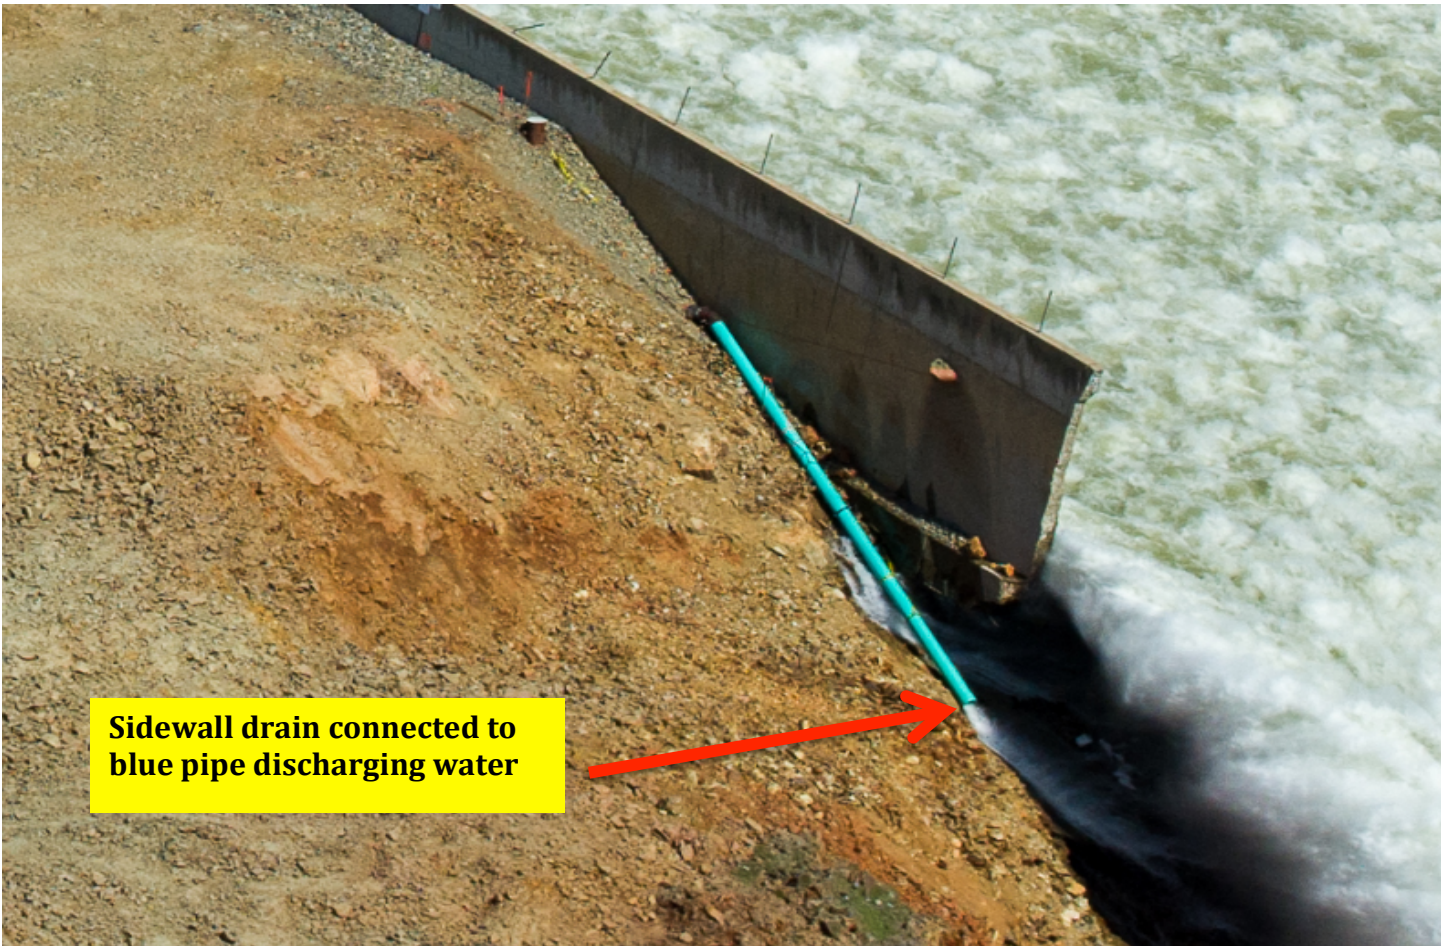
**Sidewall drain connected to blue pipe discharging water**

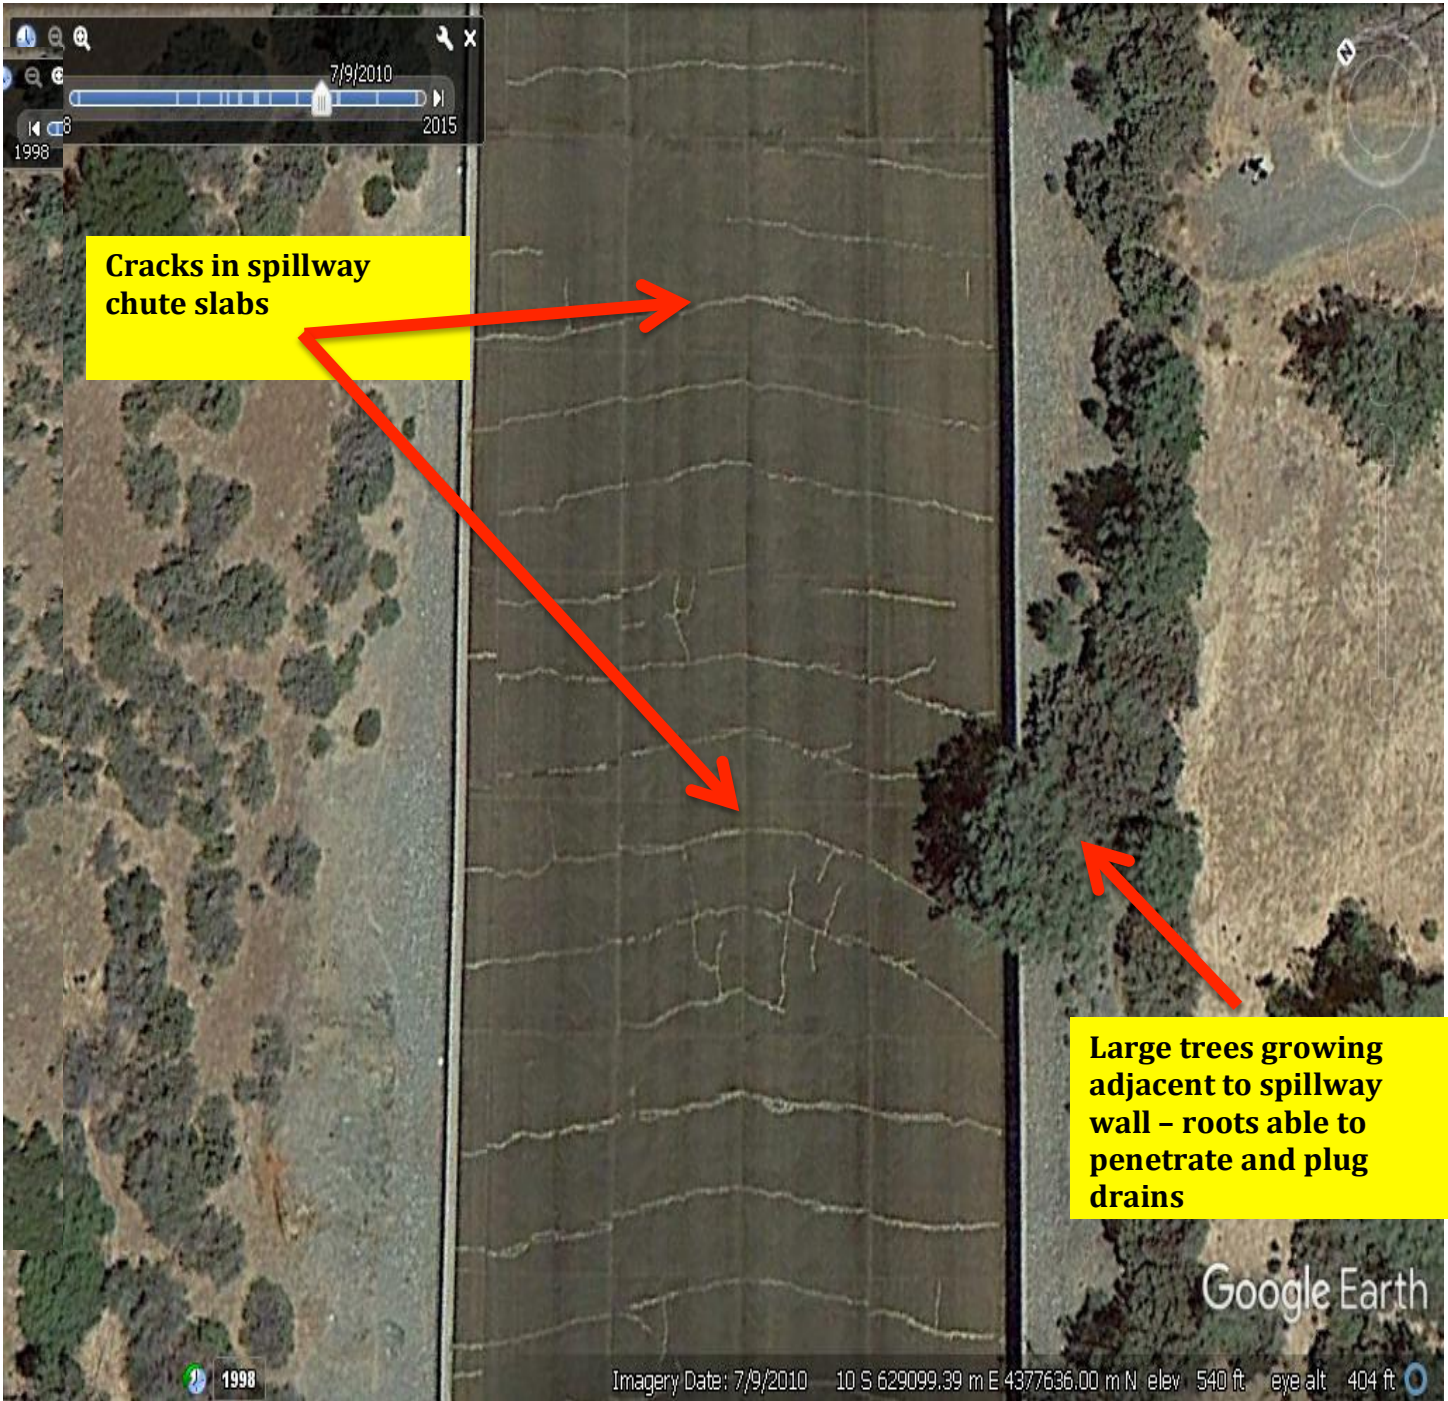
July 9 - 10, 2010

**Cracks in spillway chute slabs**

**Large trees growing adjacent to spillway wall - roots able to penetrate and plug drains**

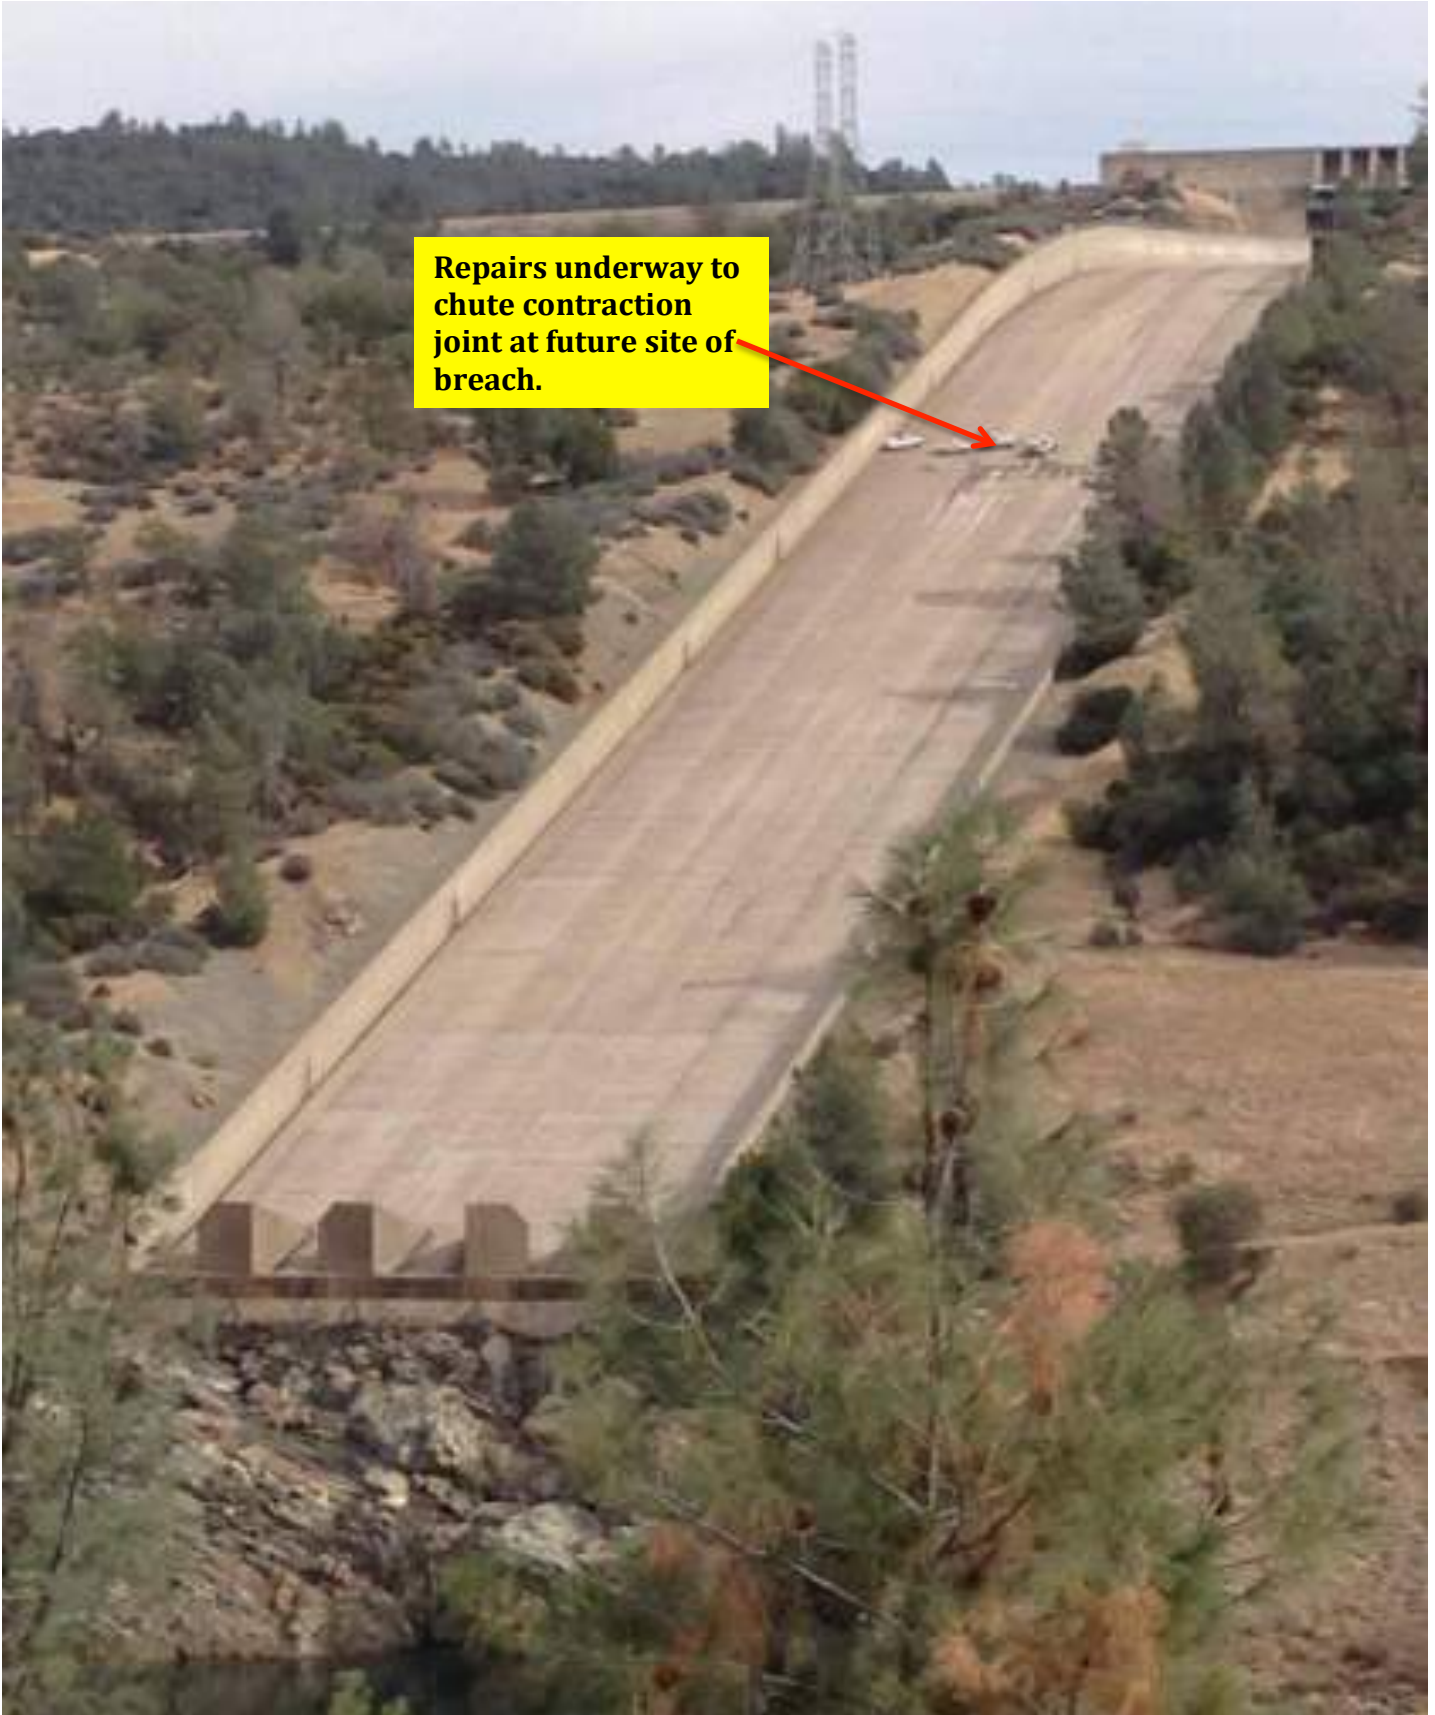
**2013**

**Repairs underway on chute contraction joint at future site of breach.**

**Water seeping through joints from under chute slabs.**

**Large trees growing adjacent to spillway wall - roots able to penetrate drains**

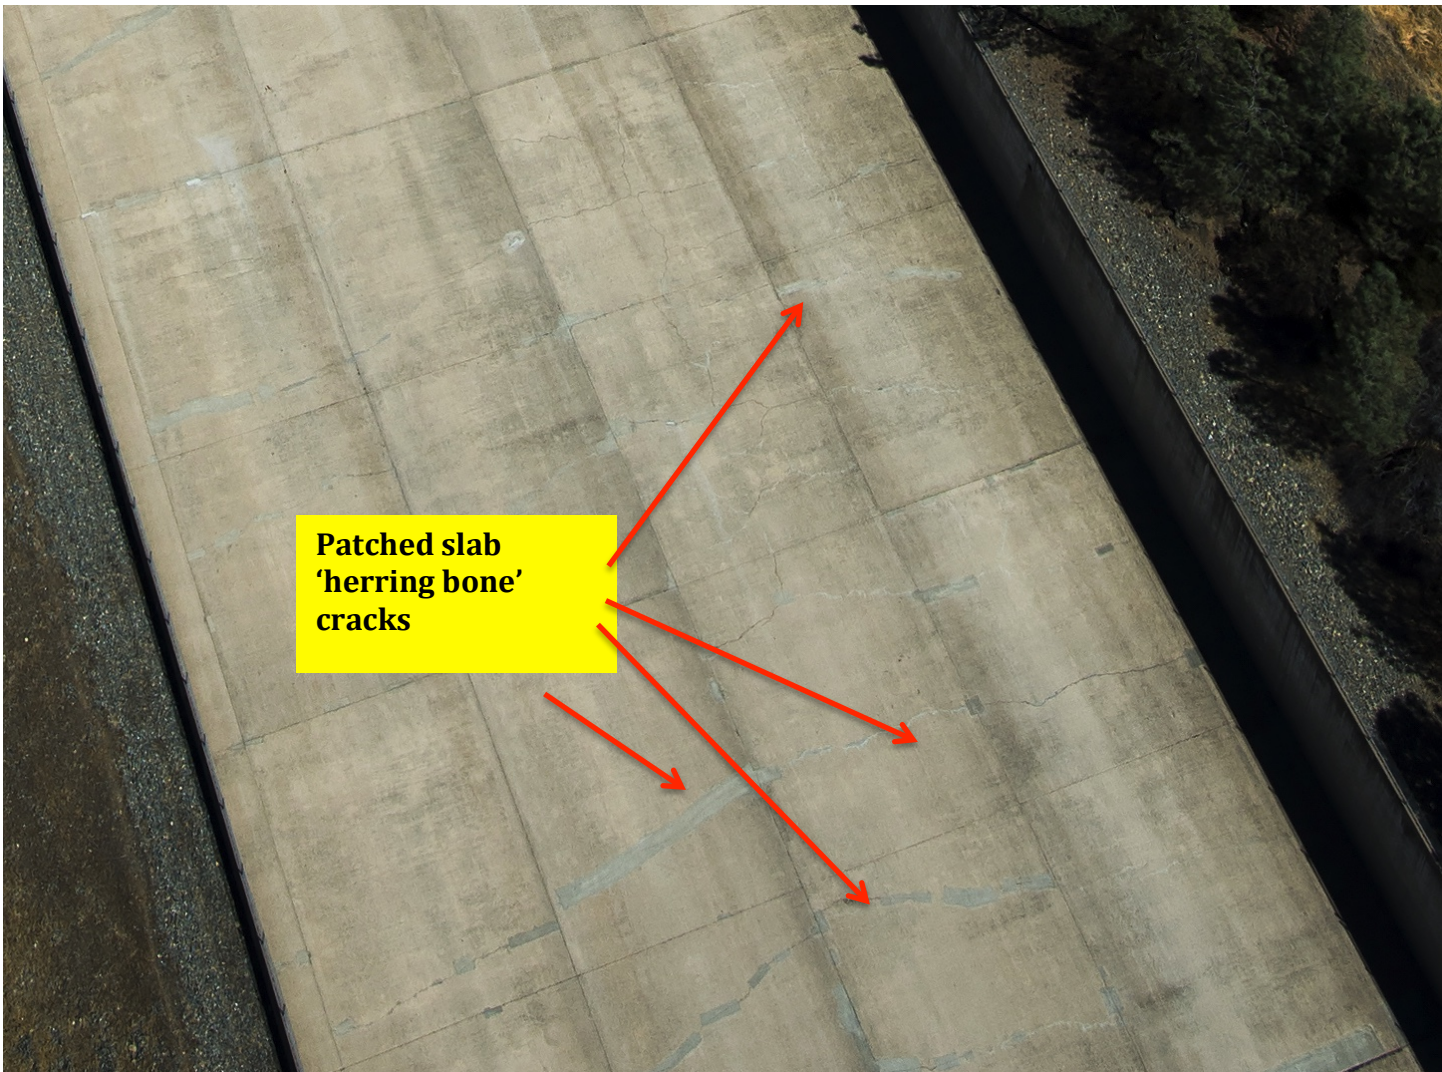
**Patched slab  
'herring bone'  
cracks**

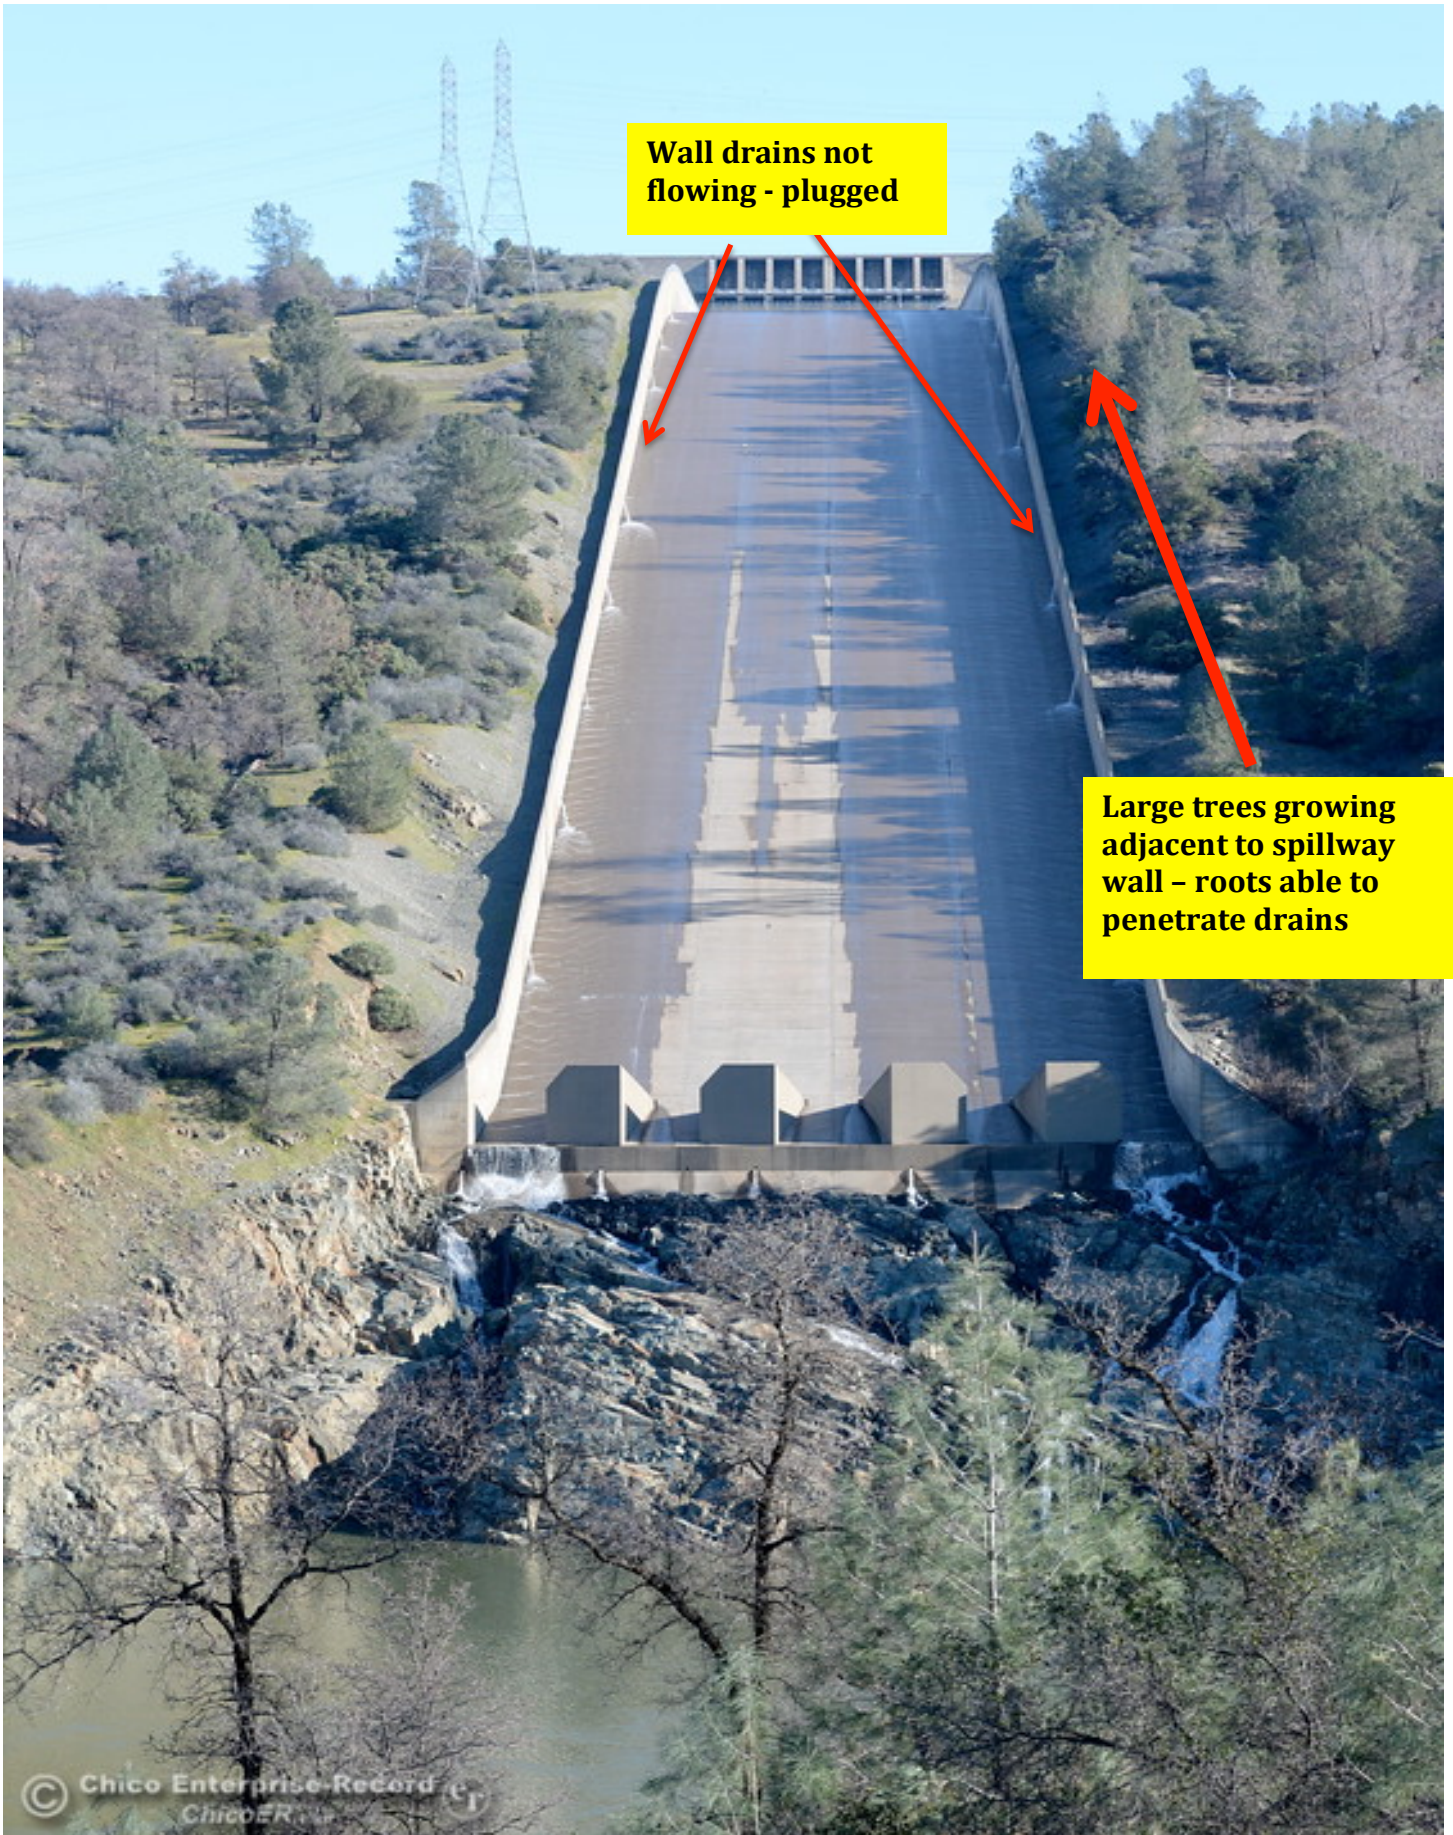
January 27, 2017

**Wall drains not  
flowing - plugged**

**Large trees growing  
adjacent to spillway  
wall - roots able to  
penetrate drains**

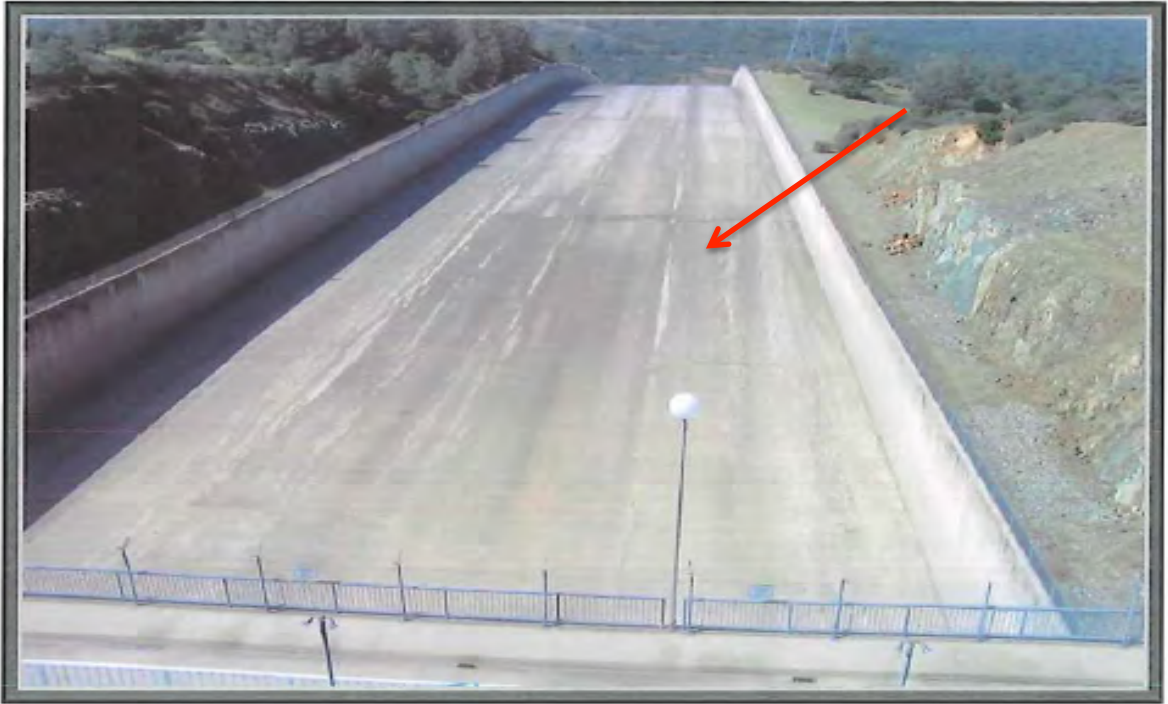
5/6/08 Inspection Report

11. The spillway at the flood control outlet remains in satisfactory condition.

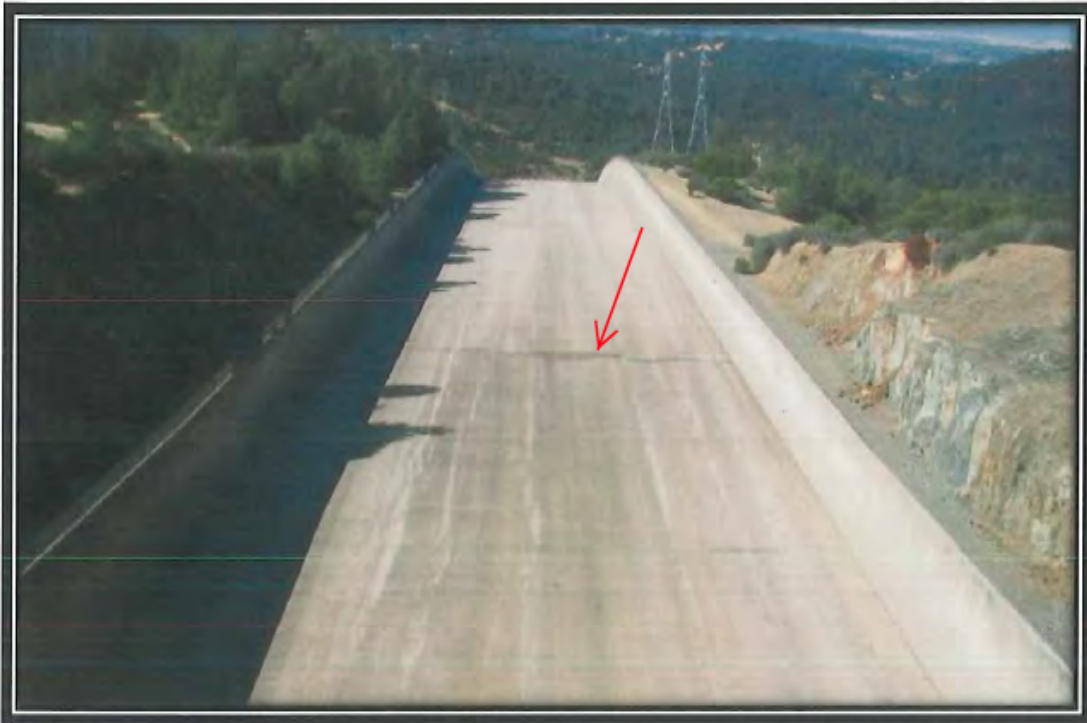
12/14/09 Inspection Report

20. This view shows the flood control outlet chute as seen from the upper deck. The walls and chute appeared to be stable and in satisfactory condition. Minor repairs along the chute floor will be completed this year.

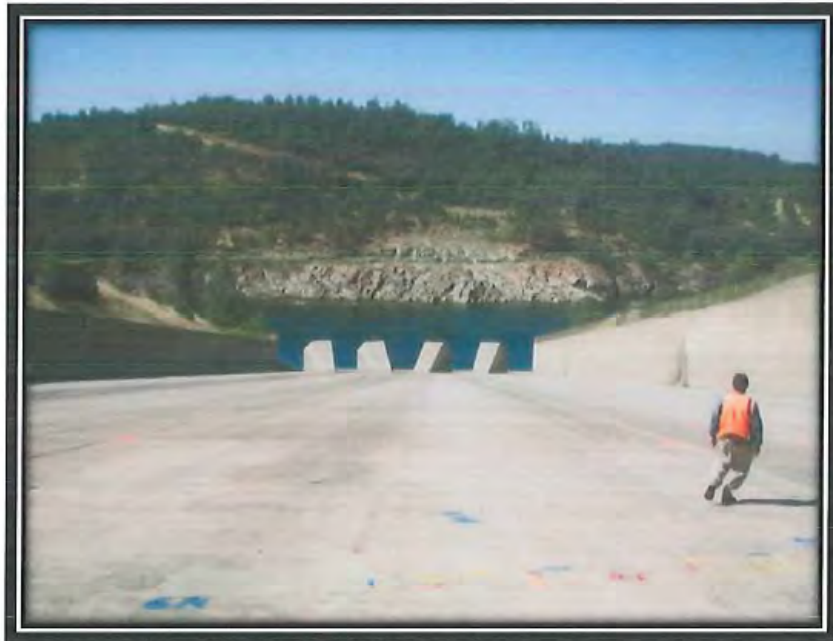
21. The lower flood control outlet chute is shown. Not the markings for the upcoming chute repairs.  
**6/25/10 Inspection Report**

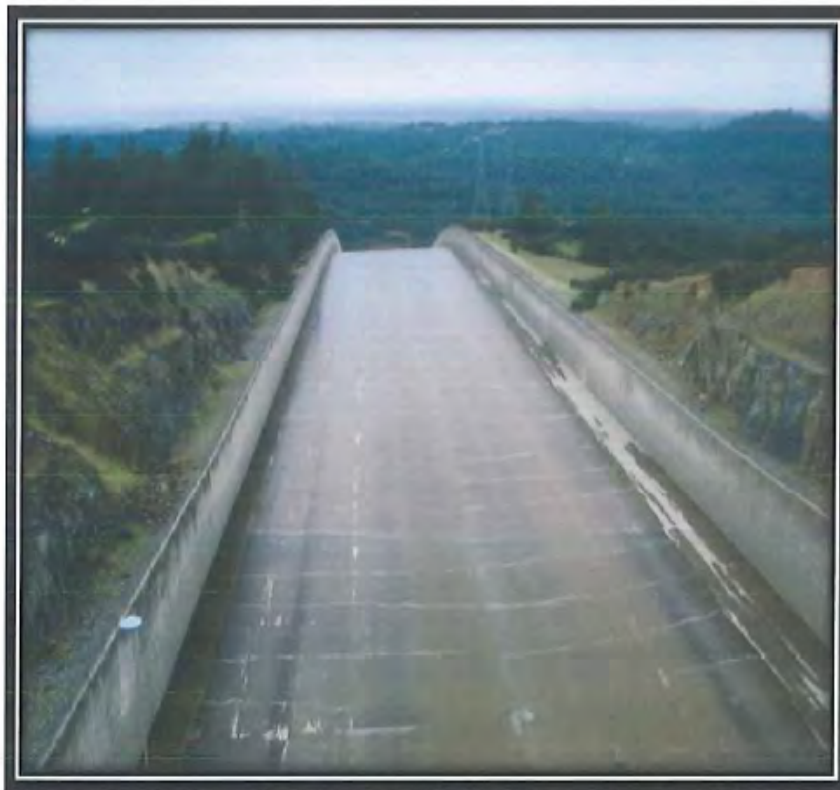
12. The concrete along the spillway chute has been repaired. The repaired herringbone crack pattern is said to reflect the underlying drain system.

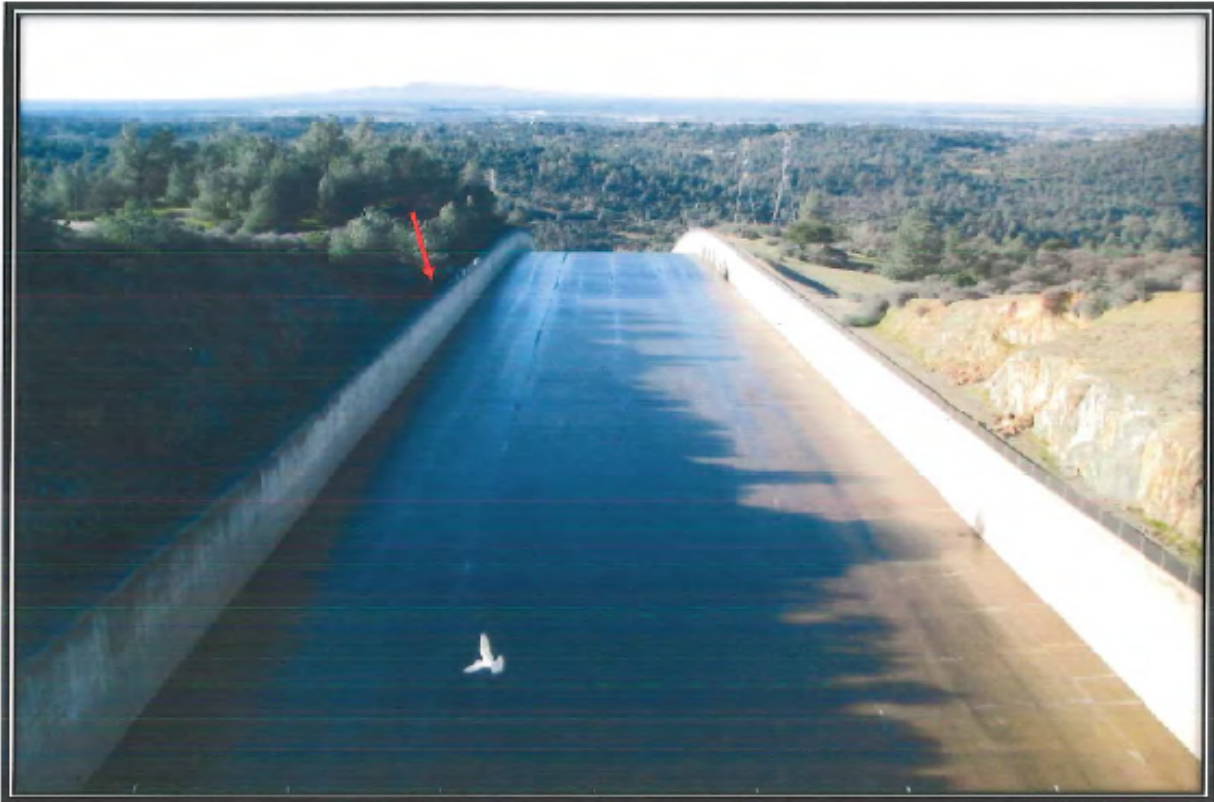
## 2/8/11 Inspection Report

9. The gates seals were leaking enough to keep the chute floor wet. The repaired lateral cracks in the chute floor are visible as light streaks. The brush at the arrow should be removed to prevent root invasion of the wall drain. No signs of instability were noted along the chute walls or floor. The drain holes at the end of the chute were flowing.

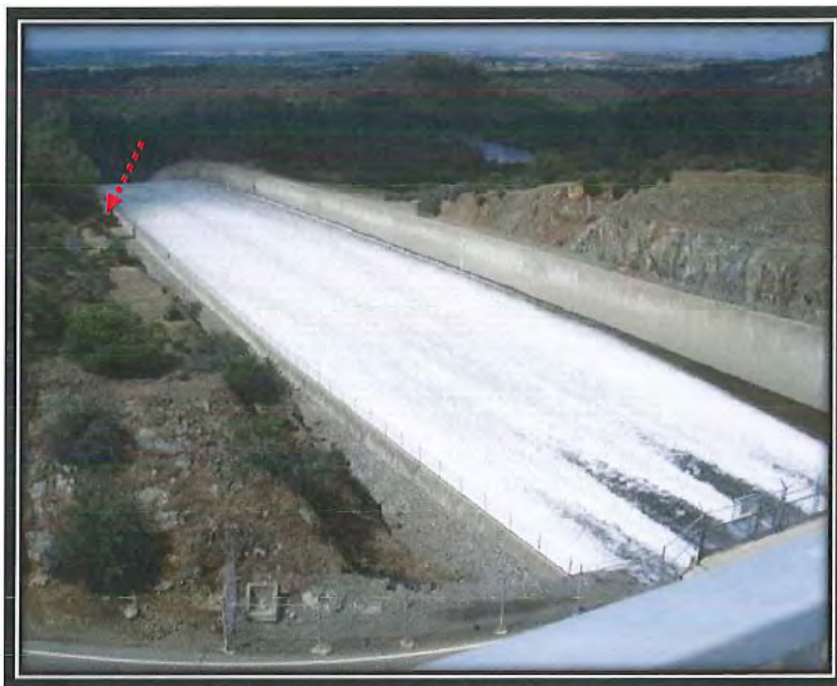
## 2/16/11 Inspection Report

11. The flood control outlet flow pattern was normal. The walls were well aligned and stable appearing. The drains at the vertical curve along the chute were flowing as expected. The brush growing in the backfill gravel adjacent to the left wall should be removed as previously requested. See arrow at left.

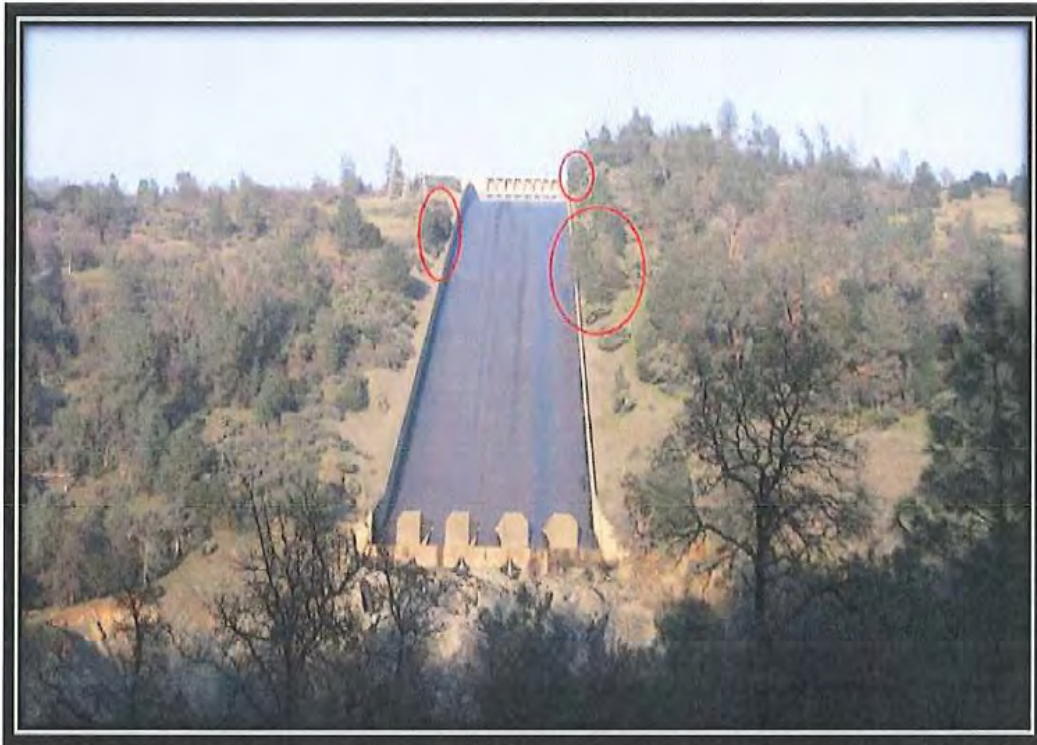
## 2/5/13 Inspection Report

14. The flood control outlet gate seal leakage and drain flow are visible. The trees and brush shown within the ovals should be removed by November 1, 2013. Oroville Dam, No. 1-48

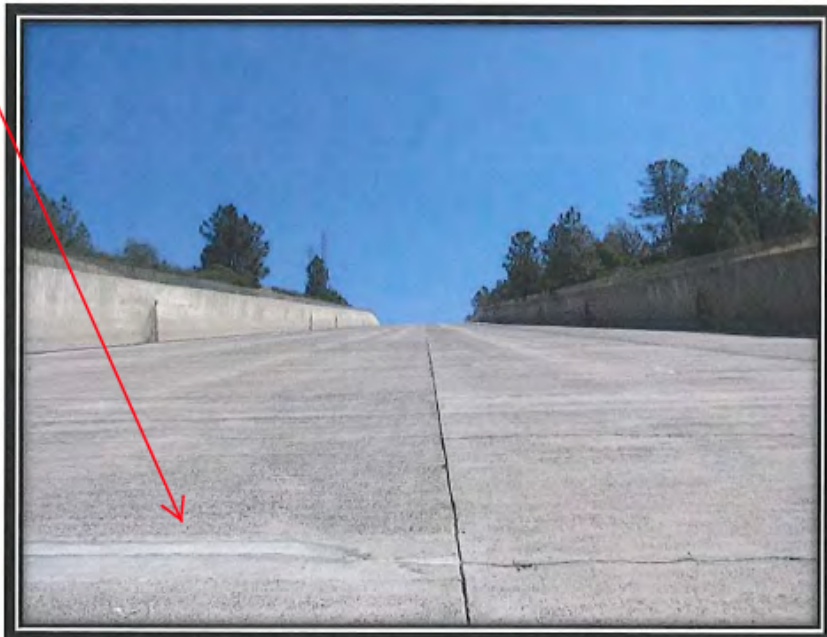
13. This view is looking upstream along the FCO channel from the dentates. Dark, vertical stains along the walls indicate the location of the drain outfalls.

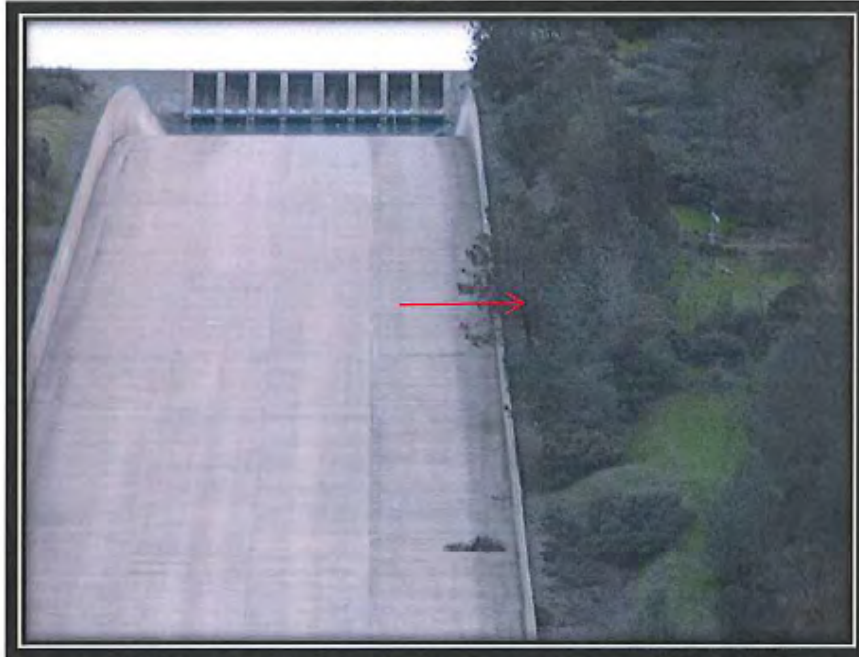
2/3/15 inspection report

9. This view looking upstream along the FCO discharge chute shows one tree (arrow) that needs to be removed following a significant effort to remove brush along the outside of the wall.

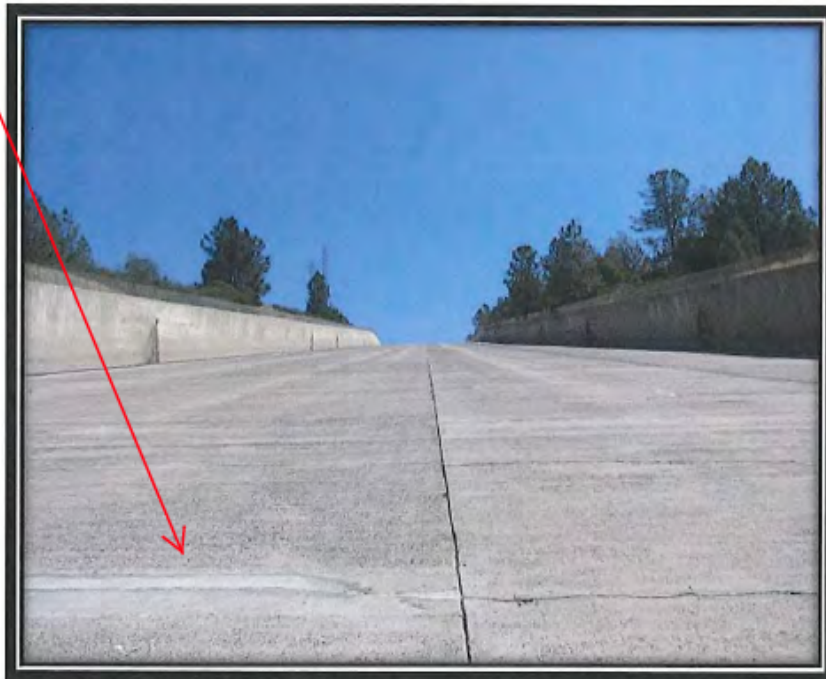
13. This view is looking upstream along the FCO channel from the dentates. Dark, vertical stains along the walls indicate the location of the drain outfalls.

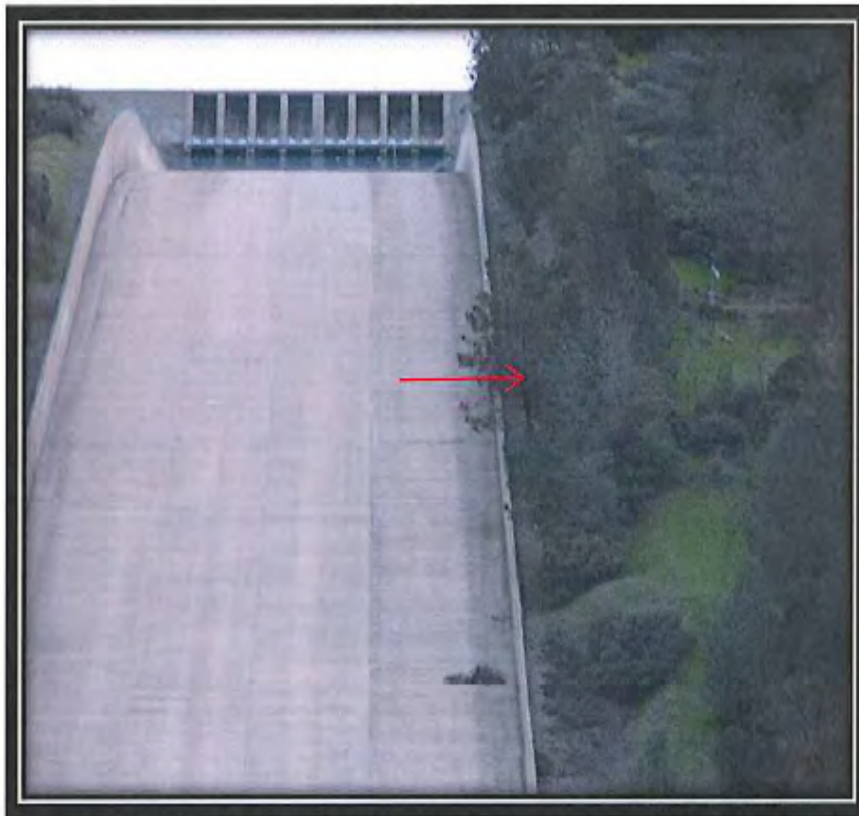
9. This view looking upstream along the FCO discharge chute shows one tree (arrow) that needs to be removed following a significant effort to remove brush along the outside of the wall.
