**Assessments of streams and riparian plantings
within Carter Holt Harvey Forests
at
Mangakahia and neighbouring sites**

**- Bruce Alexander
October 2002**

An assessment of streams and riparian plantings within Carter Holt Harvey's Forest at Mangakahia and neighbouring sites.

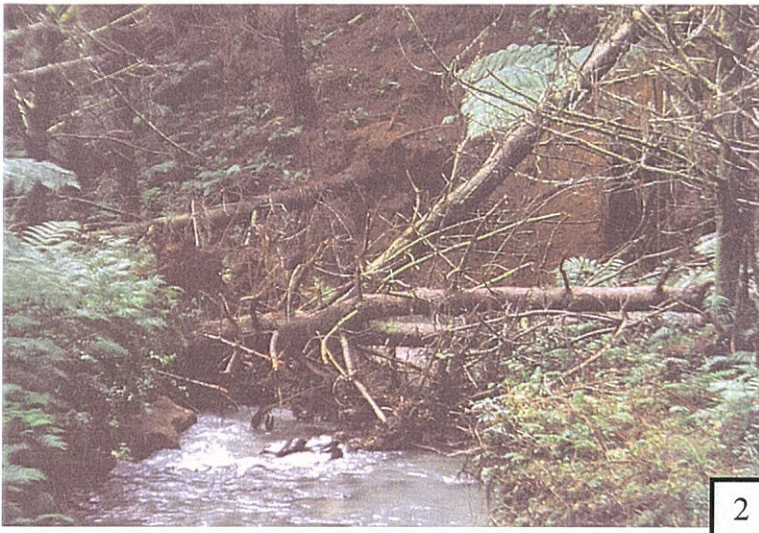
A considerable amount of soil has been released into the water. This photo shows silt build-up where Noall's 1 enters the Waitotekumerau river.

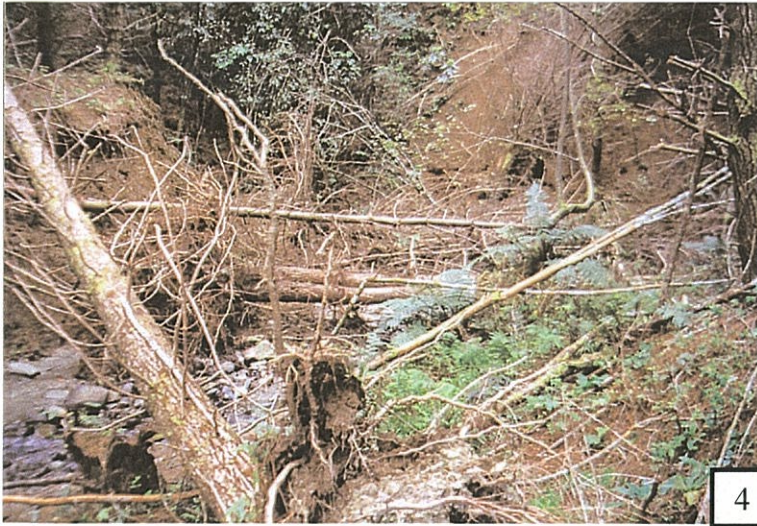
This demonstrates streambank erosion due to a blockage by pine trees.

Stream is being diverted and cutting away the bank.

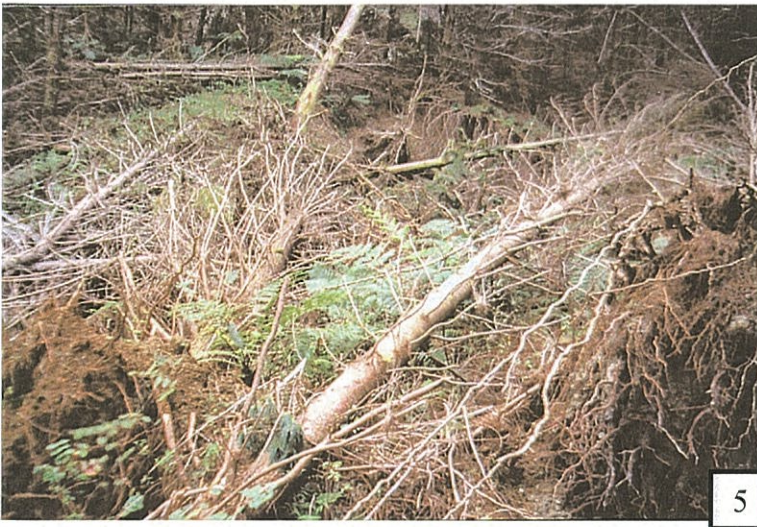
4

Fifty metres from the beginning of a gorge there is a total collapse of trees, waterways and streambanks making a terrible mess.

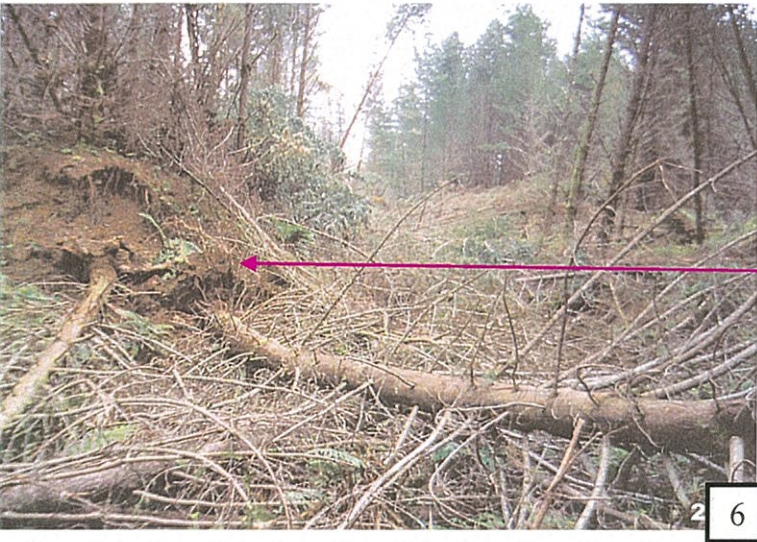
5

The pines are too tall and heavy for the soft soils. The restricted root growth and action of toppling close to streams is depositing large amounts of soil in the water..

There is very bad erosion and this would appear to have been ongoing for several years. This general area could be the cause of a major adverse effect.

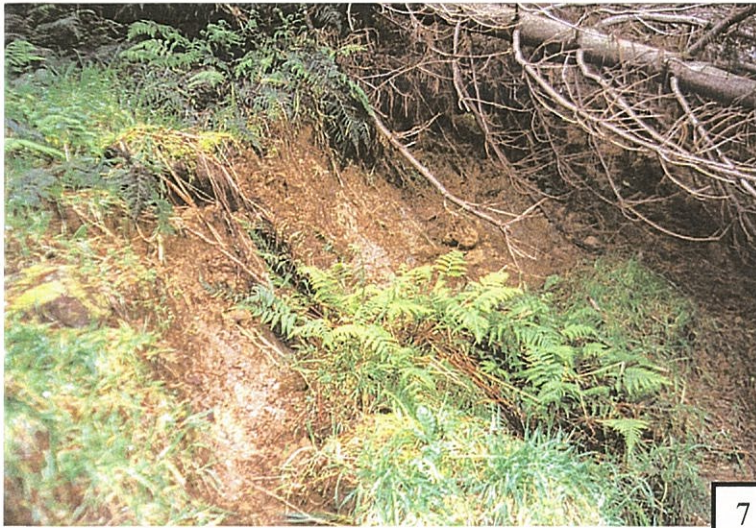
6

A better idea of the extent of toppling.

Note the small root system.

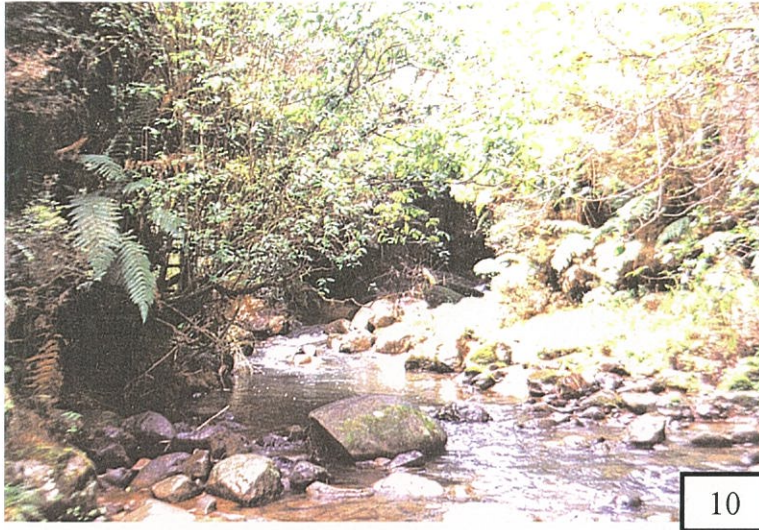
Shows the upper end of Noall's 6 stream undamaged where a planting setback has occurred

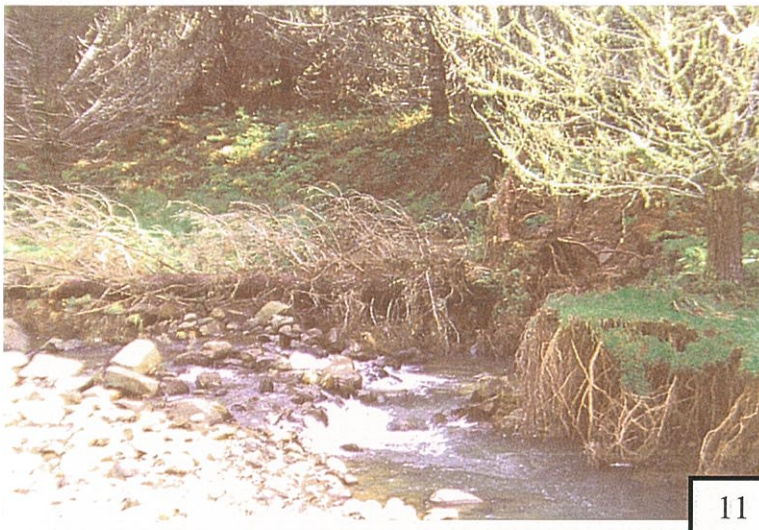
Bottom end of the stream walking 1 Km upstream from the Mangakahia river.

Six trees have fallen here, and a further eight will topple shortly, due to the lean they are on in the soft ground. Large volumes of water appear to flow here to a depth of 3 metres.

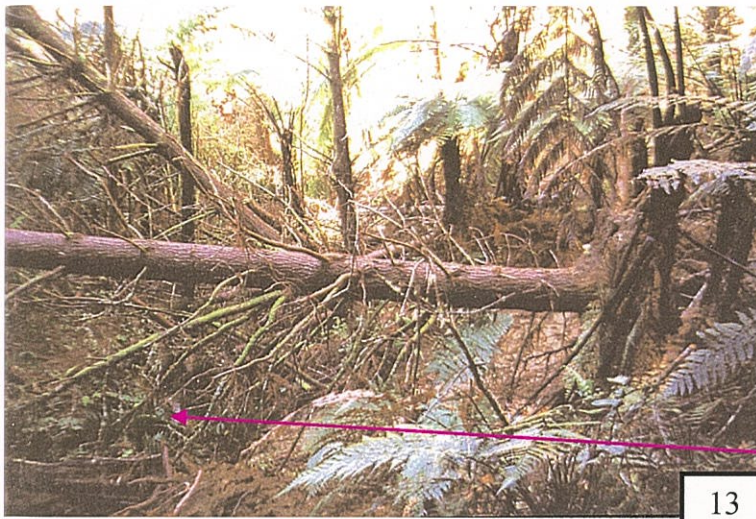
Typical of what is occurring when the trees develop size and weight --- they fall over and the remainder left standing is mainly native.

Further up blockage material is forming and showing continued streambank erosion.

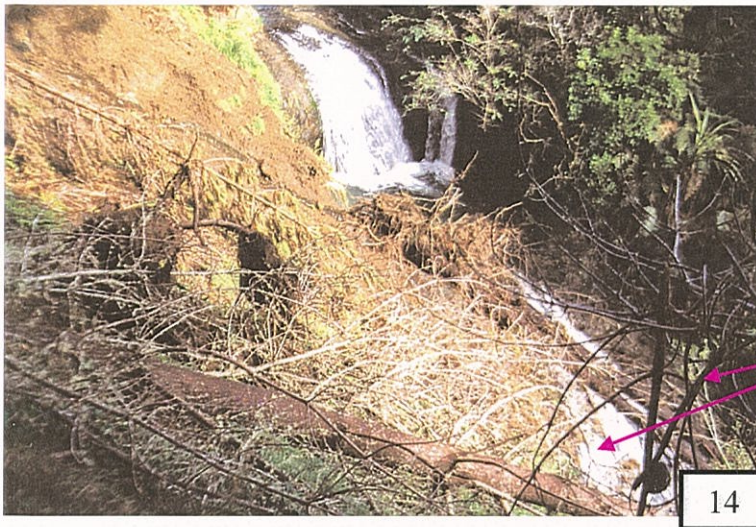
This waterfall is about half way up and next photo shows a slip where seven trees have slid down to the stream. There are about thirty others ready to follow.

Note the trees here. Some have slid 30 metres.

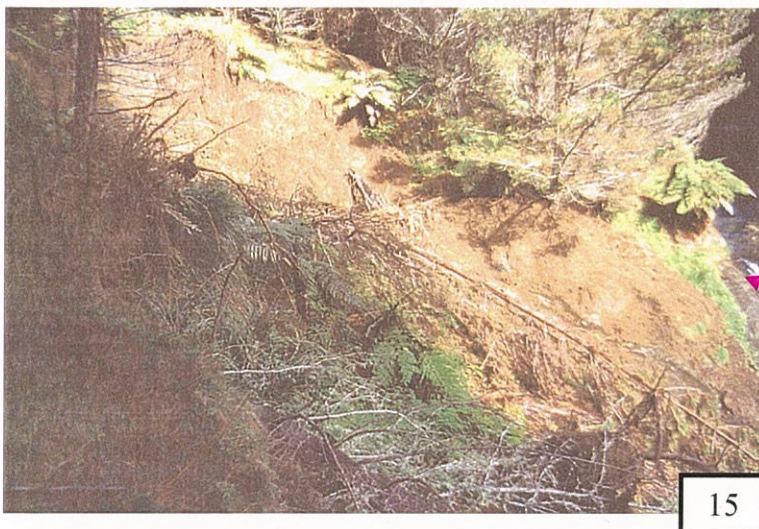
Close-up of slip referred to above. A huge amount of soil disappeared downstream here.

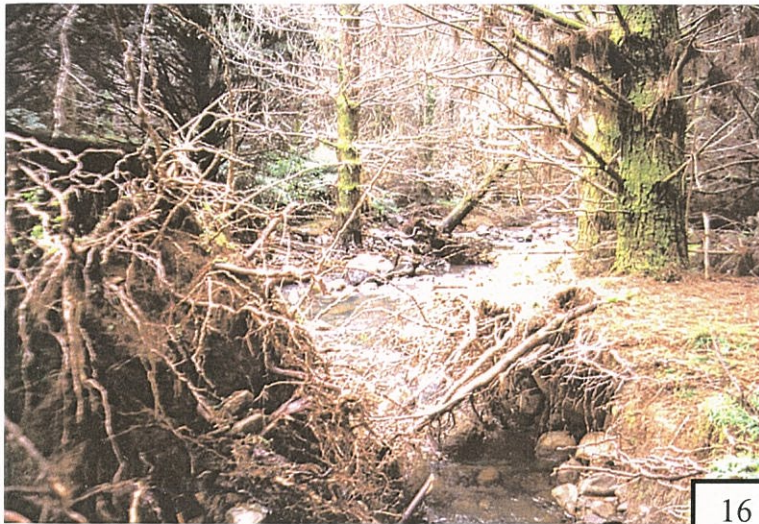
16

There are nine trees in this immediate area above the waterfall lying down with the two on the right of photo at risk from scouring of the bank when water is deflected sideways by the trees lying in the streambed. There is the possibility of a large buildup or dam occurring here. Access is handy for machinery.

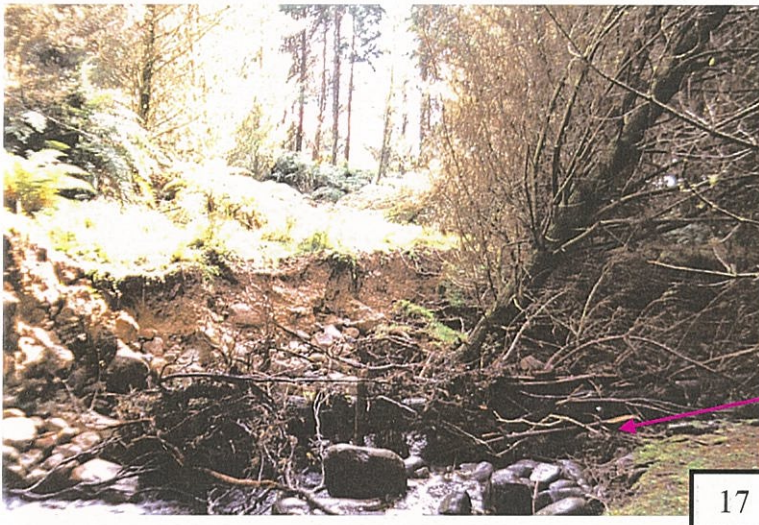
17

Shows another section of the streambank eroding due to blockages within the streambed.

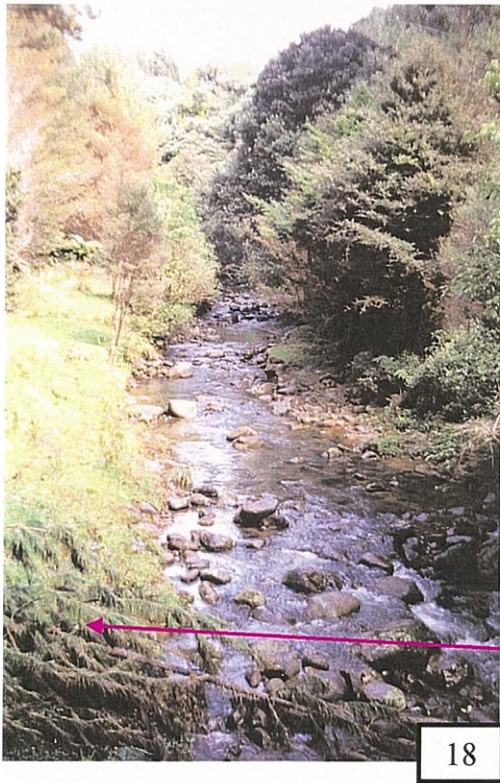
18

This is a classic example showing the same stream without damage immediately above the fallen pine in the foreground, simply because at the time of planting it was left clear due to the ground being extra wet. There is minimal leverage on the soil structure with this type of vegetation as compared with the above scenarios.

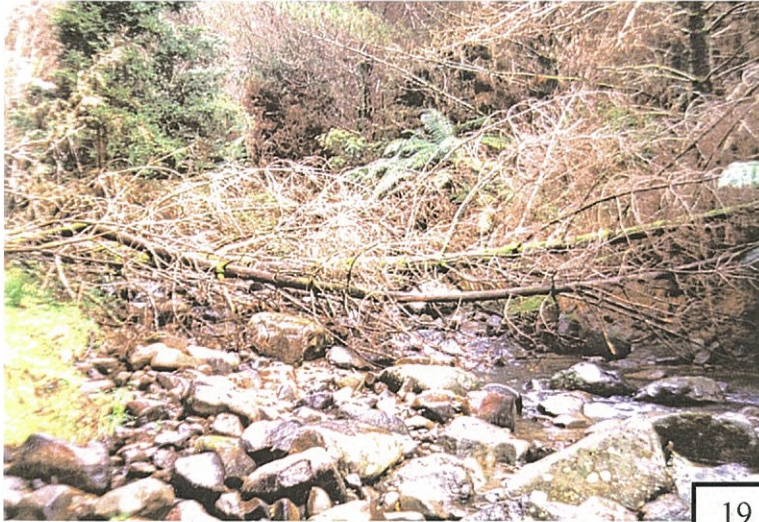
19

Trees that have been fallen for 2 to 3 years with many more on the edges ready to follow.

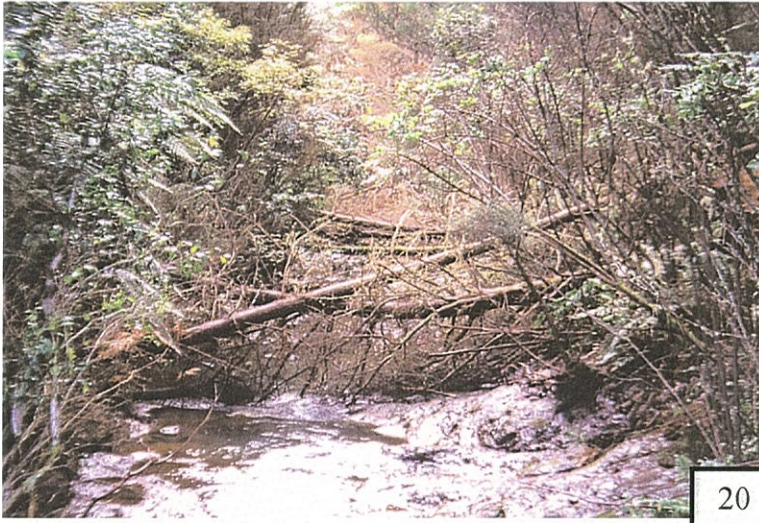
20

These also, have been down for about 2 to 3 years with many more on the edges ready to follow.

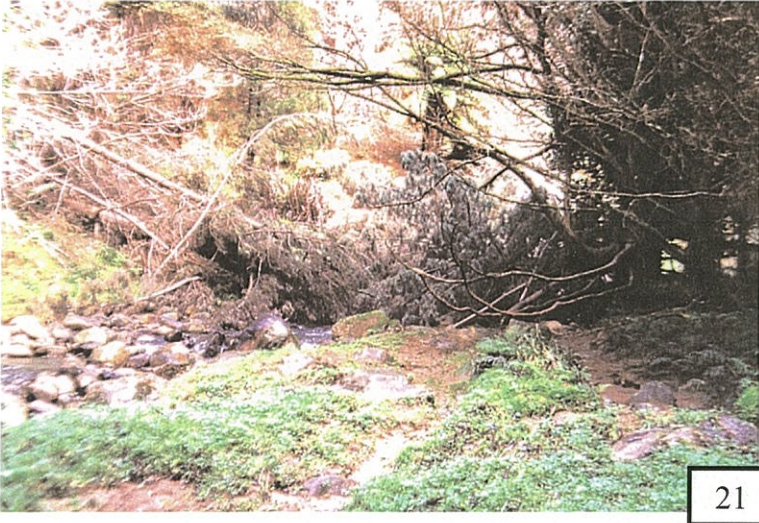
21 & 22 are in an area upstream where the flooding varies between 2 to 3 metres. Water flow has been diverted outside of streambed . There are signs of decay amongst the older toppling in this forest which is of concern. As they break, they provide a ready source of smaller branches and fragments which when combined with tree trunks already in the stream make very effective dams.

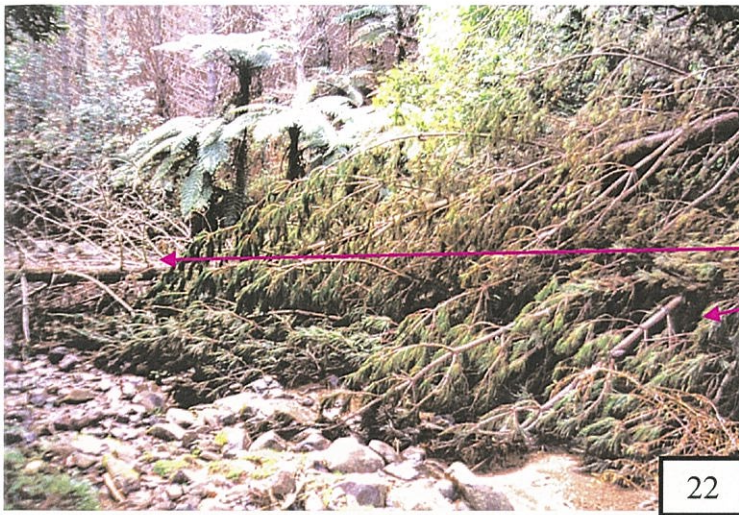
Further effects of damming.

*Older toppling in place.
Recent toppling builds up
against it.*

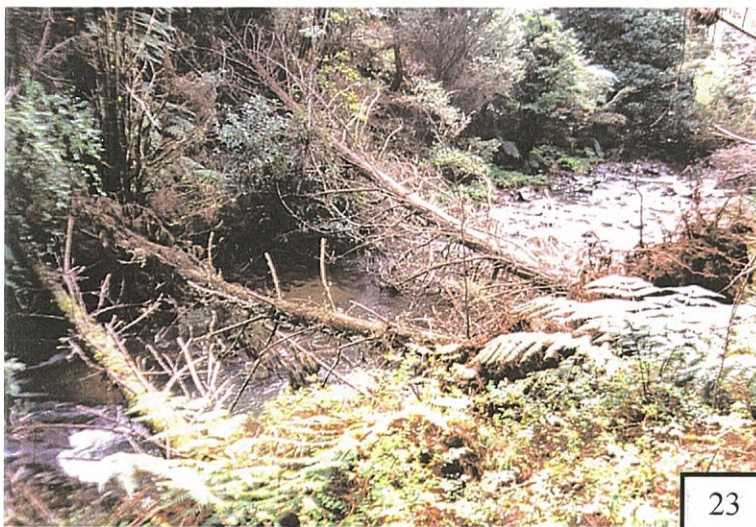
Here we have an example showing four pine trees that have toppled periodically, over something like five years. The tree on the left is starting to break up. Take note that all other vegetation is intact as it is more suited to the environment of soft wet clay soils.

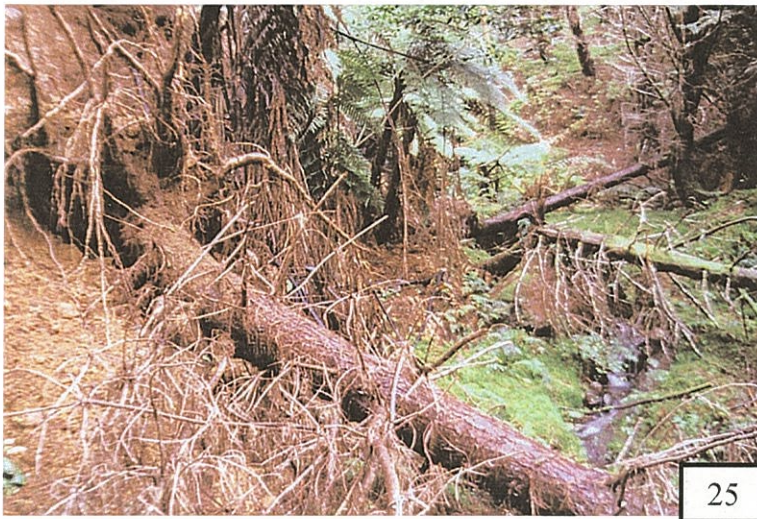
25

A smaller perennial stream not likely to have a large flow but there are trees down in this watershed also.

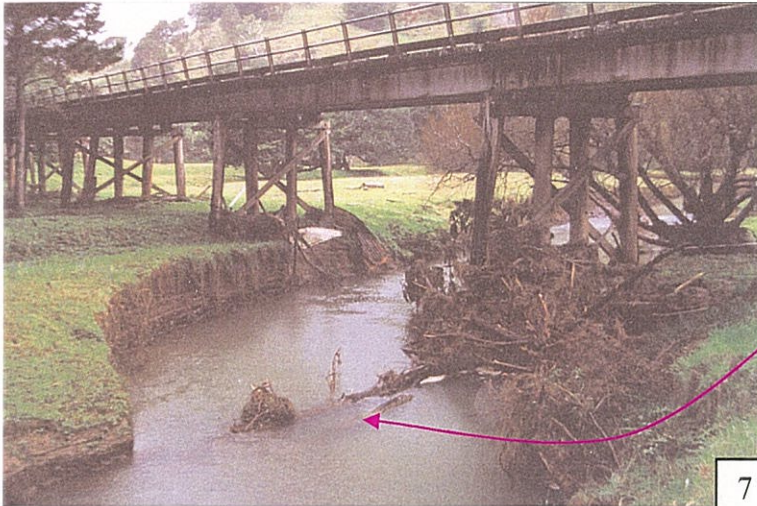
Note submerged logs midstream.

Hue Hue River bridge showing the remains of a blockage which caused scouring of the opposite bank.

This stream needs monitoring as it is subject to blockages. The top end has toppling. Numerous streams feed it with additional debris.

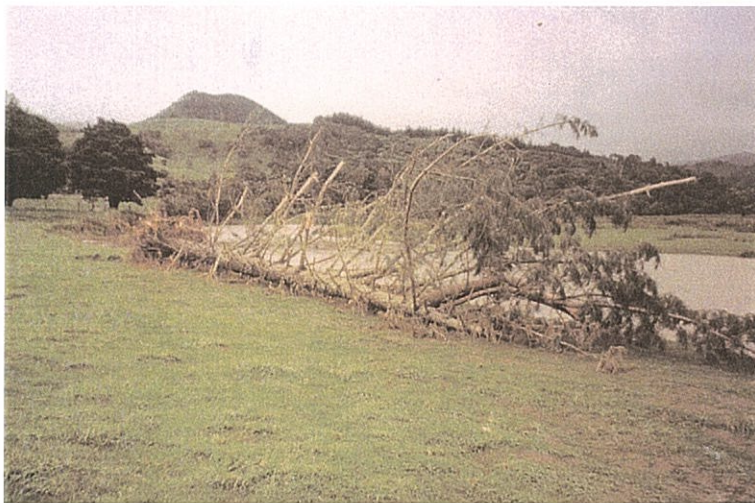
A tree like this makes an excellent battering ram!
Stream banks, native trees and fences do not stand a chance.

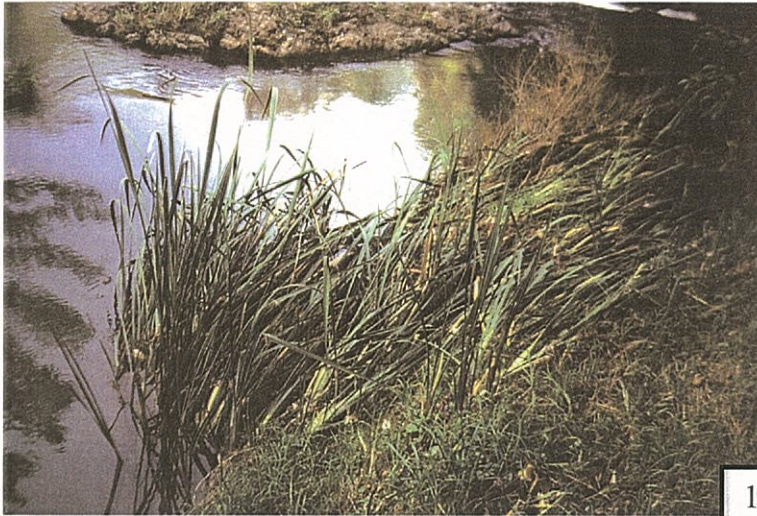
This stream is a source of Manchurian ricegrass. It would appear that debris and logs that break and loosen the root system are transporting this noxious weed downstream. There is an important issue here that needs addressing. When the forest was established some contractors came from the Northern Wairoa area where the noxious weed is prevalent.

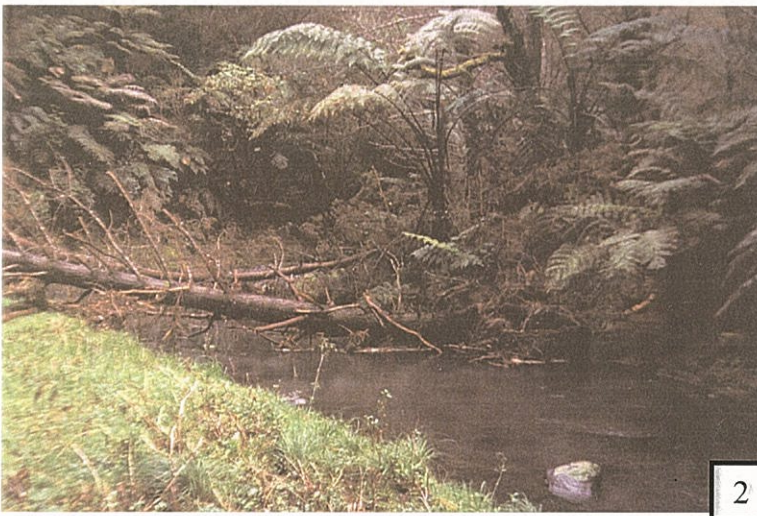
While these remain they will collect debris and erosion will proceed on the opposite bank.

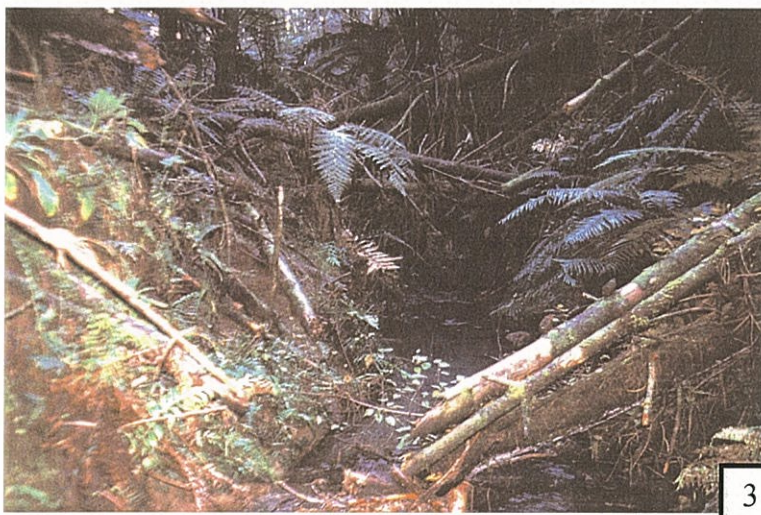
A small side stream shows decaying logs, indicating that toppling has existed for some time.

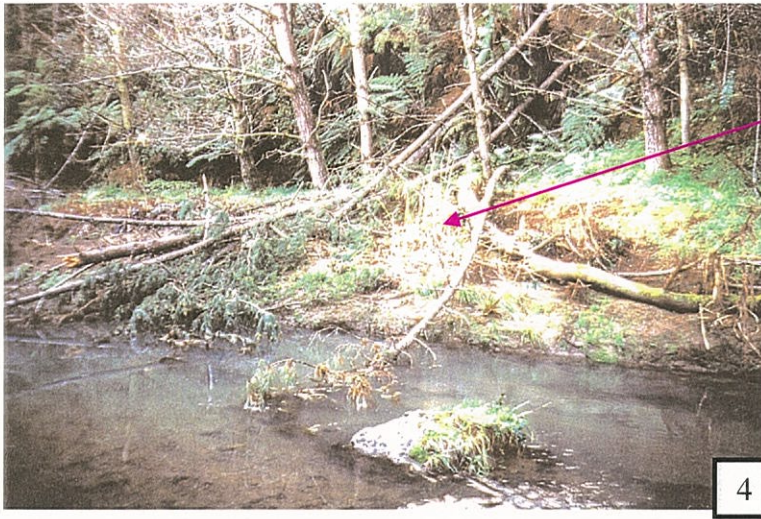
Manchurian Ricegrass

Further bank damage will cause this noxious weed to spread downstream.

Two clumps have completely disappeared from nearby and plants have been detected 10 kilometres further down the Opouteke stream.

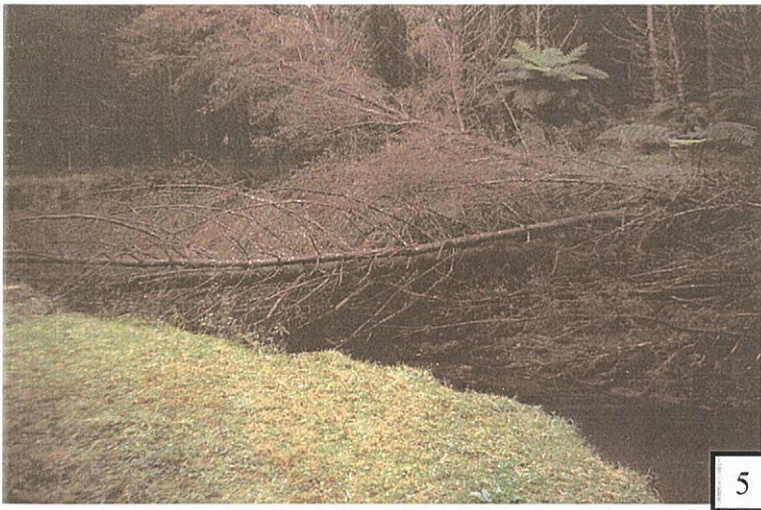
This scene is common. Water will be deflected into the opposite bank until the tree is washed away.

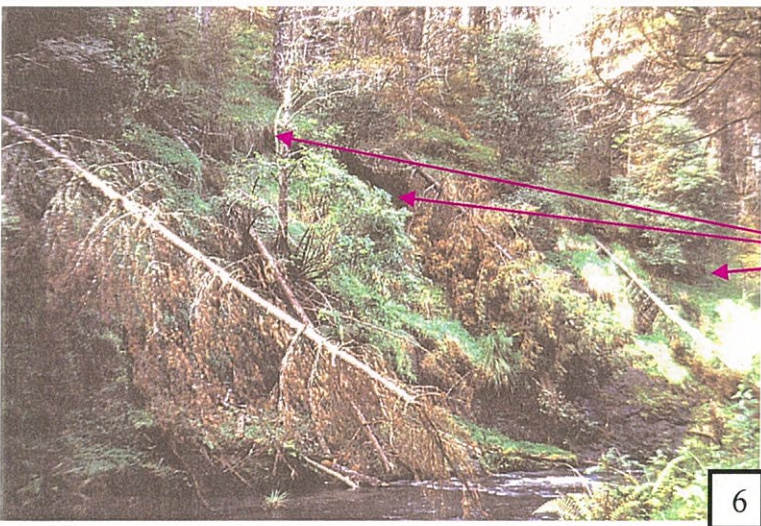
Further damage extending fifty metres from the streambank

The whole bank has ruptured.

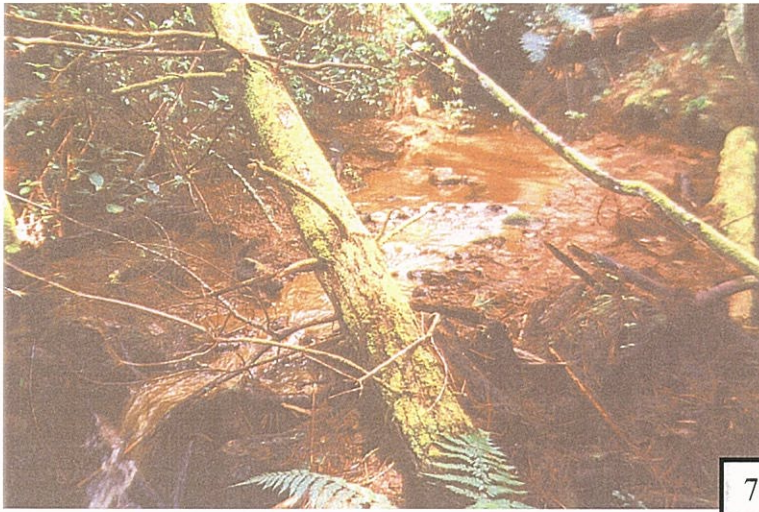
7

Taken at the top of stream. A pool no longer exists and is filled with mud.

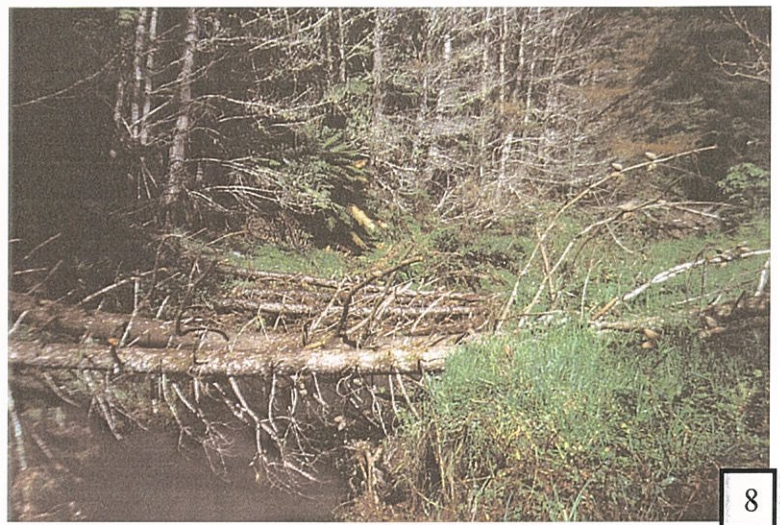
8

A bit more debris from upstream and this would make a good dam. (or damn!!.)

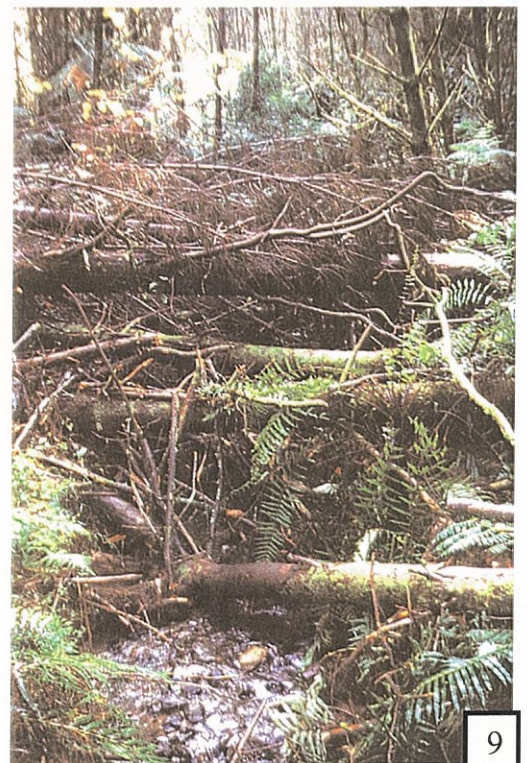
9

Judging by the moss and decay of trees, damage here in the wet fragile soil has been continuing for a lengthy period and has caused a lot of erosion and silt.

Twenty trees are down, fifty metres from the Takitu road.

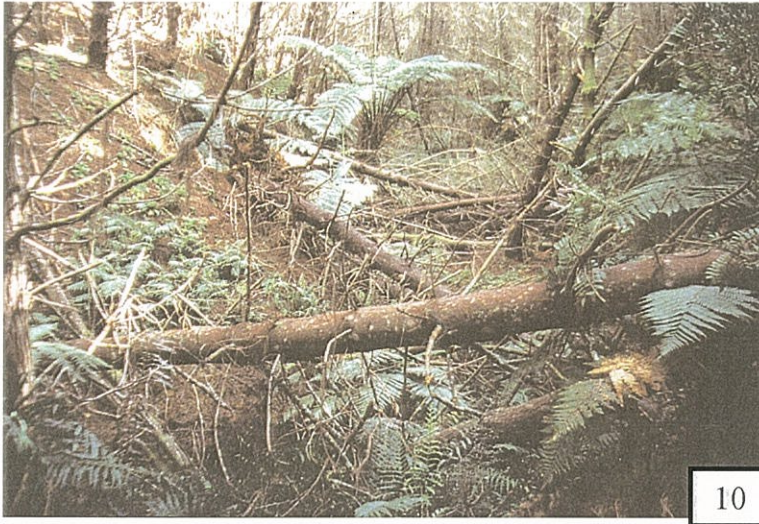
10

Takitu 3 - Extensive old and new toppling in stream.

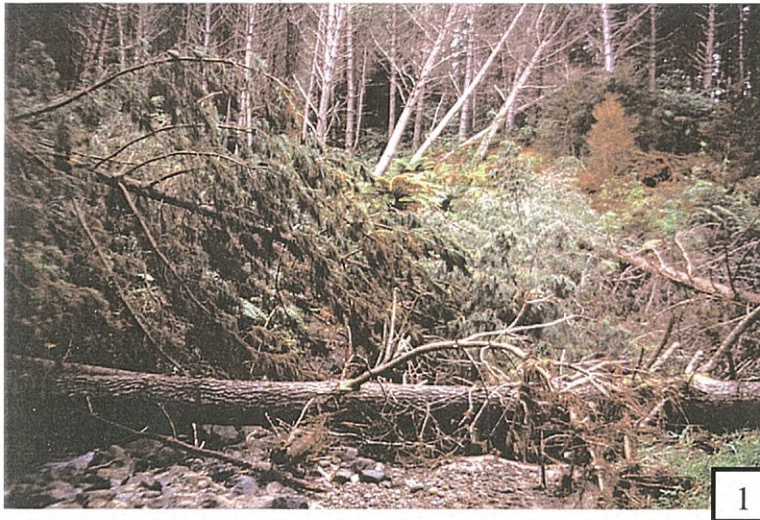
This blockage occurs below the Tararua road and gives a good indication of the size of material involved. There are more trees, twenty and thirty metres from the banks that are leaning and will topple eventually. Sixty toppled trees can be seen by standing in one spot. Water flow here reaches a height of two metres and is thirty metres wide.

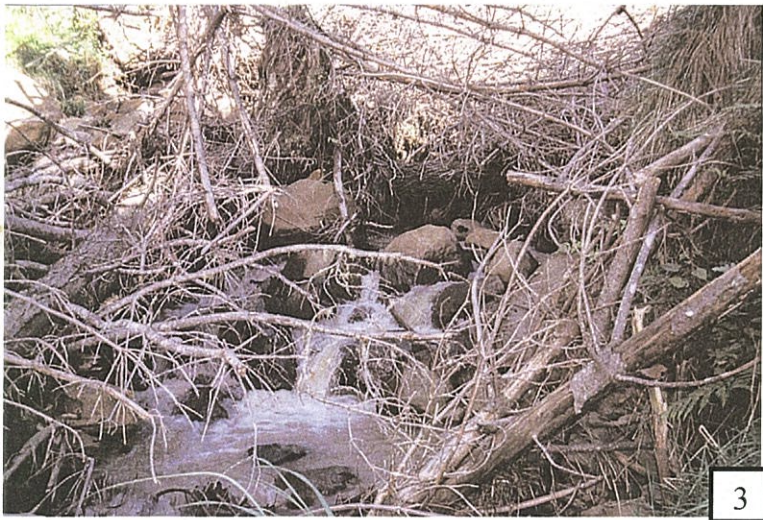
Older trees starting to break.

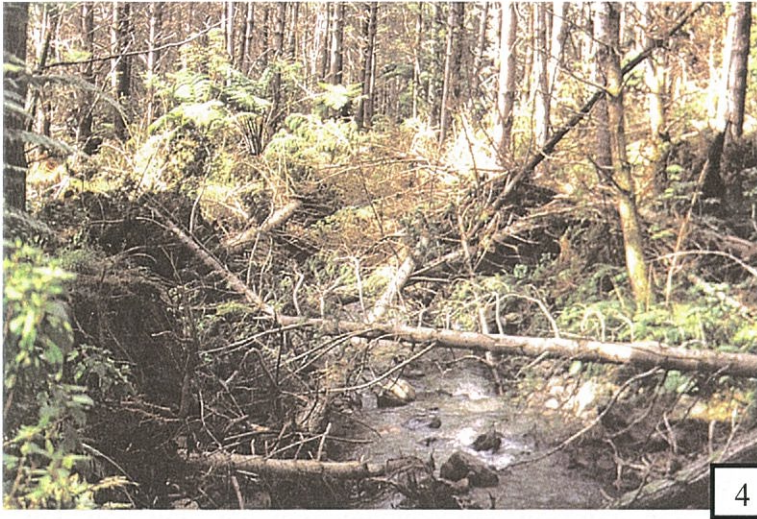
4

These trees could not stay upright and fell in all directions.

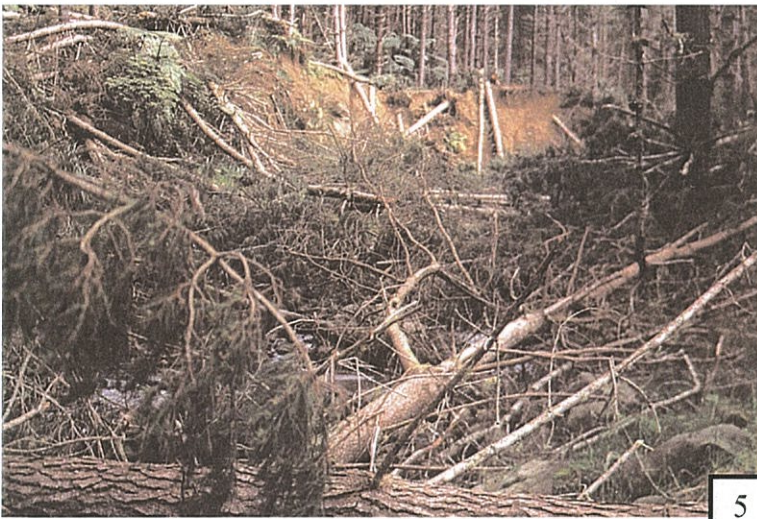
5

This twenty metre wide streambed is smothered. Some trees have been down for a considerable time and more trees appear ready to follow as slumping takes place and banks erode.

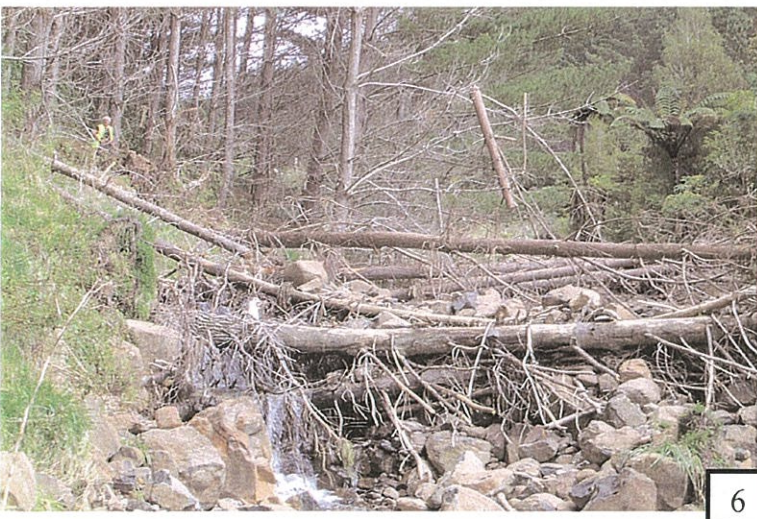
6

This blockage was present in 2001 and has now been washed downstream.

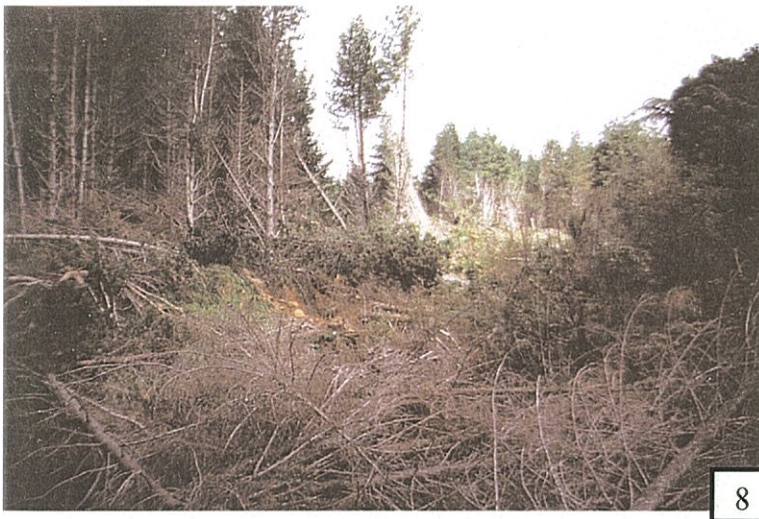
This swampy area has most of its trees lying down. The weight of timber has caused its level to drop about three metres since planting. It has subsided more recently as shown in photo 8.

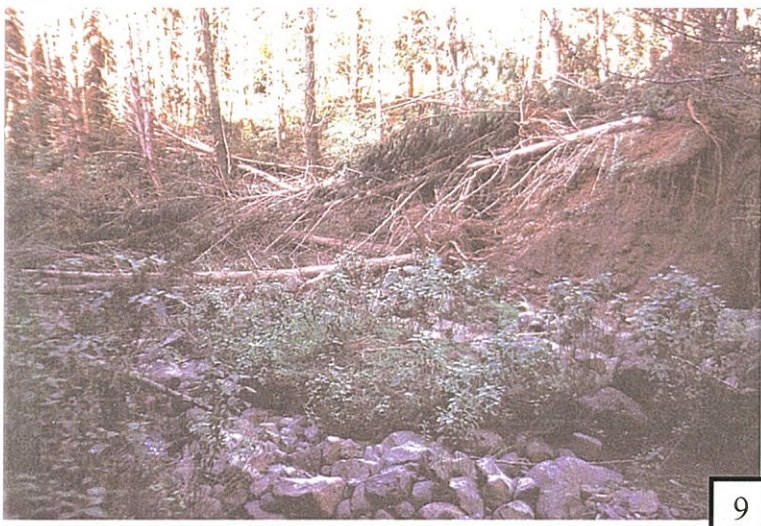
This area is just below Travers road

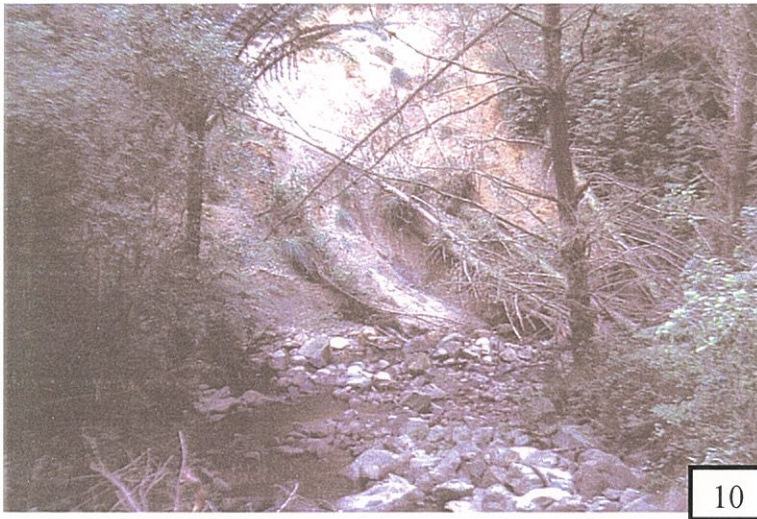
Also below Travers road.

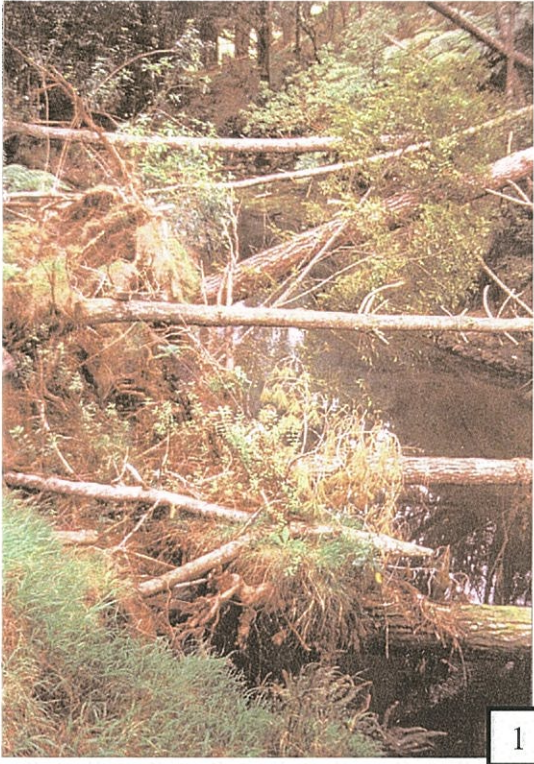
This toppling is just up stream from the Kaimaro – Ha Ha road junction by Froggetts property. The condition of this is disheartening.

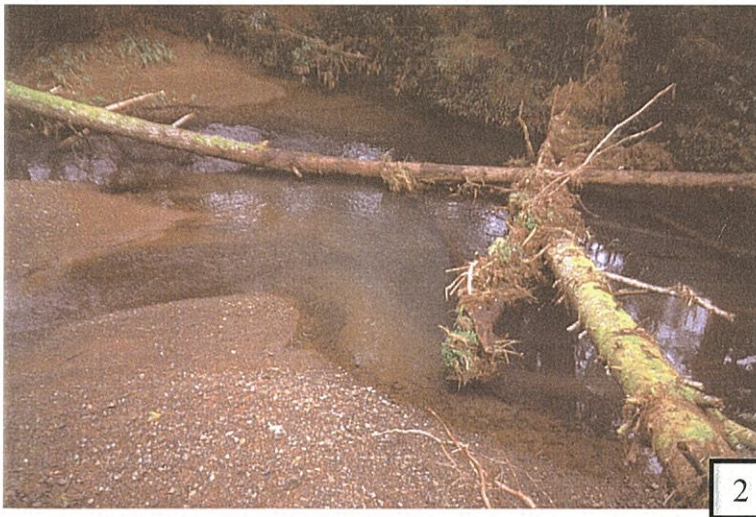
A lot of silt and older damage is working its way downstream. Even light rain makes the water cloudy.

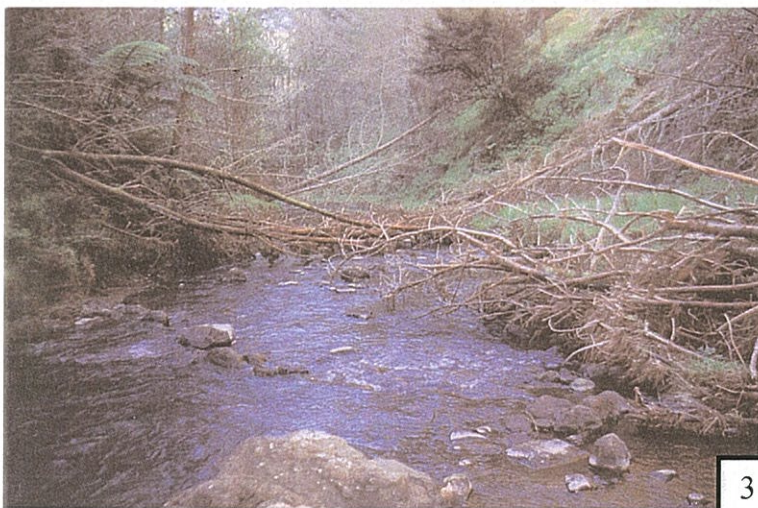
This blockage just below the gorge is one of many in the stream. Floodwater here is two metres high by about twenty metres wide. Machinery can come to here.

GPS
E 2583222 – N 6613820

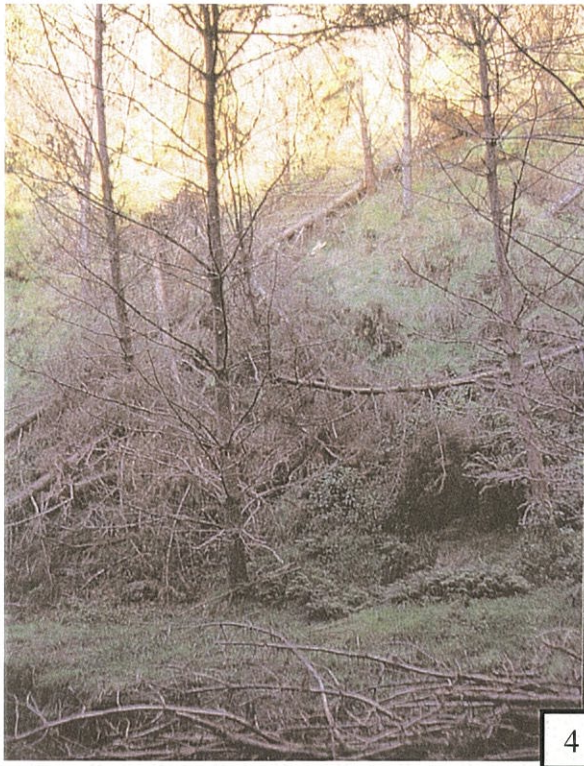
These trees have been toppling for a number of years. (From about 15 yrs. age onwards.) The catchment is noted for its high rainfall and soft wet conditions.

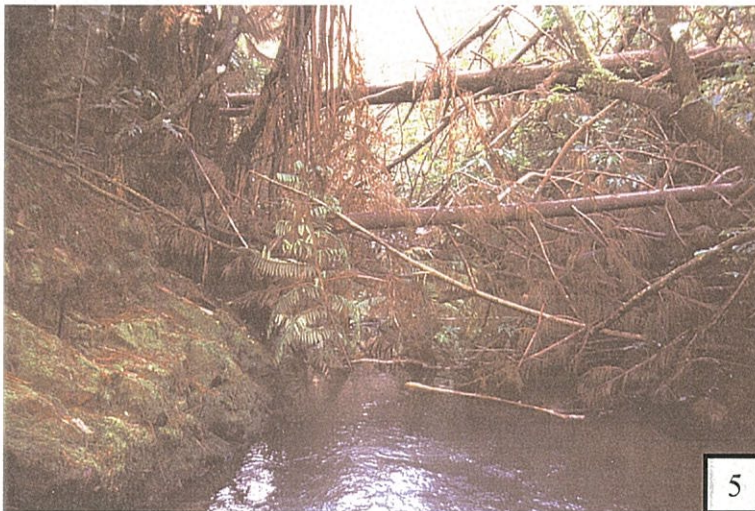
A typical scene where this and many other streams narrow down.

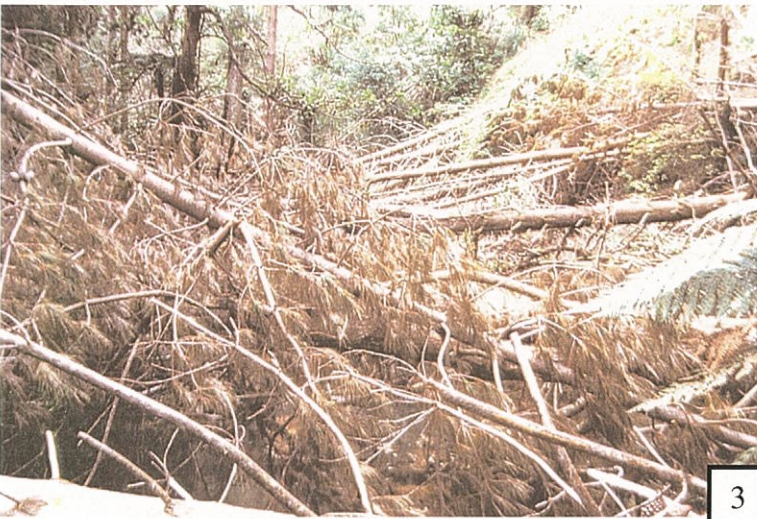
This mess should not be left lying here.

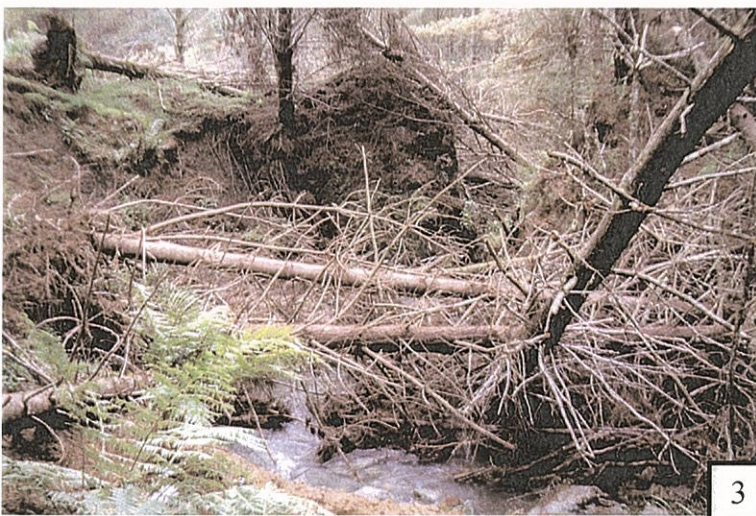
Damage is prevalent in this catchment also, with plenty of soil disturbance occurring.

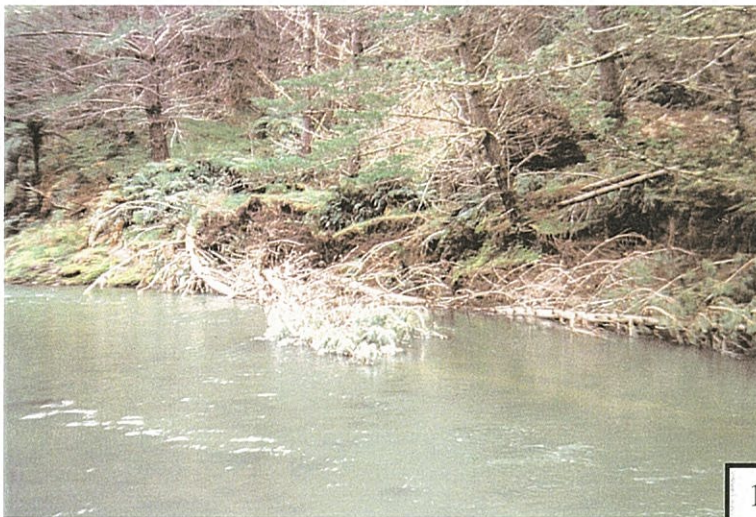
At the lower end of the river the soft banks have allowed this to happen to twelve trees in this area.

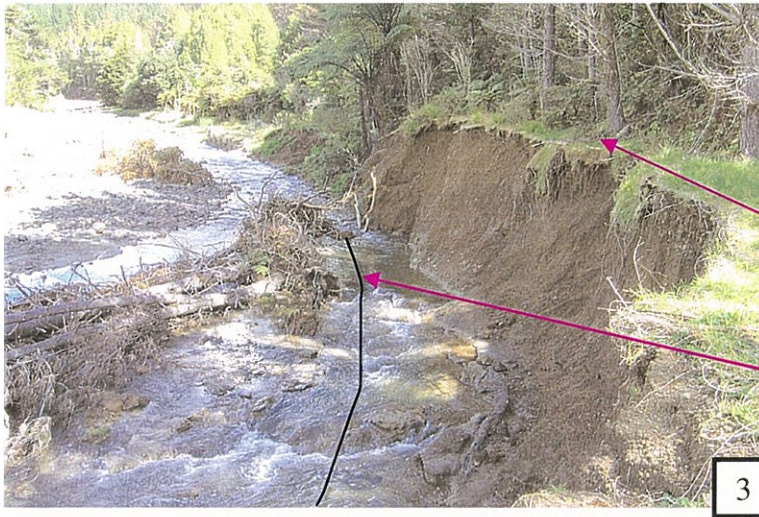
There are more trees here ready to topple if the bank does not undermine first

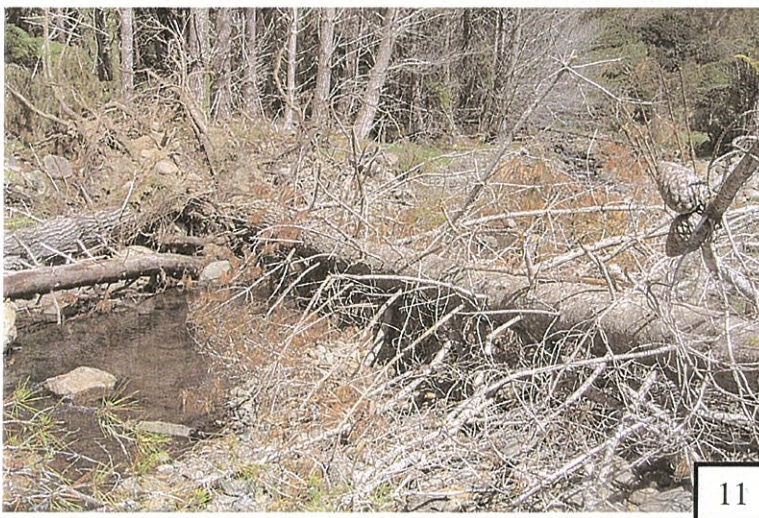
This blockage in the main river is about two hundred metres below Gibraltar road. It will readily wash downstream if left here.

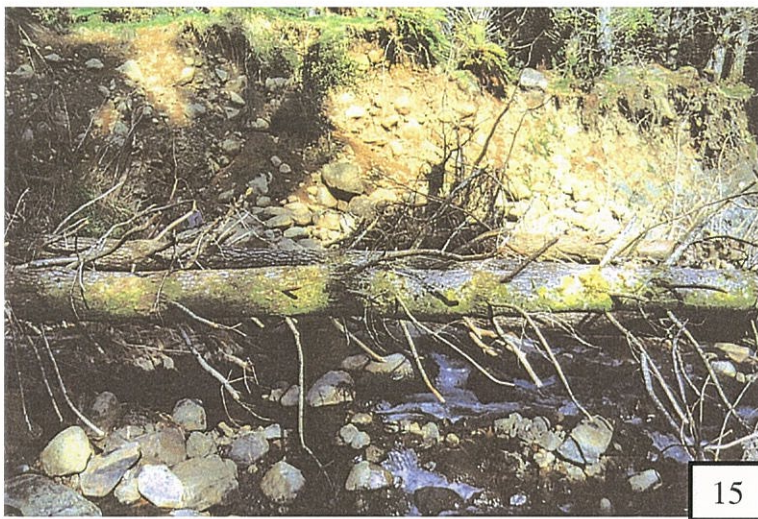
There is major scouring of banks and riverbeds at places. It is disgusting that planters showed no regard for stream protection. The build up of debris deflecting water to the left has undermined the bank. This mess should not be allowed to happen again.
GPS
E 2578822 – N 6609677

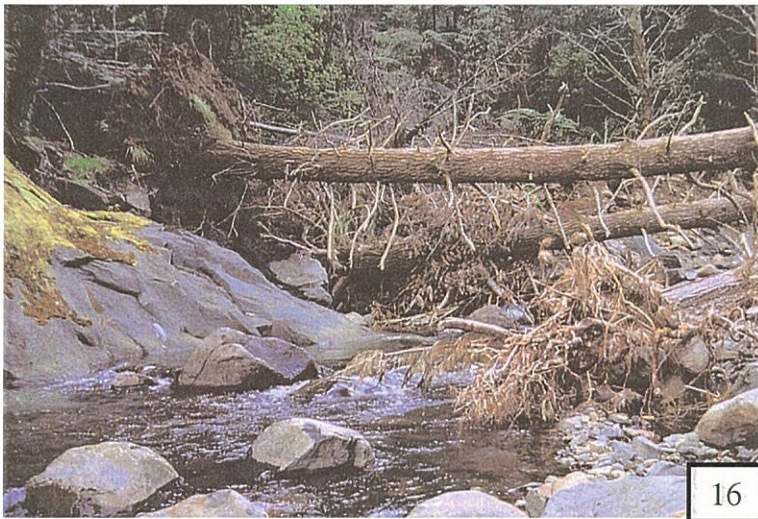
There are many blockages, and if trees like this are left in flood paths, everything will get a thrashing.

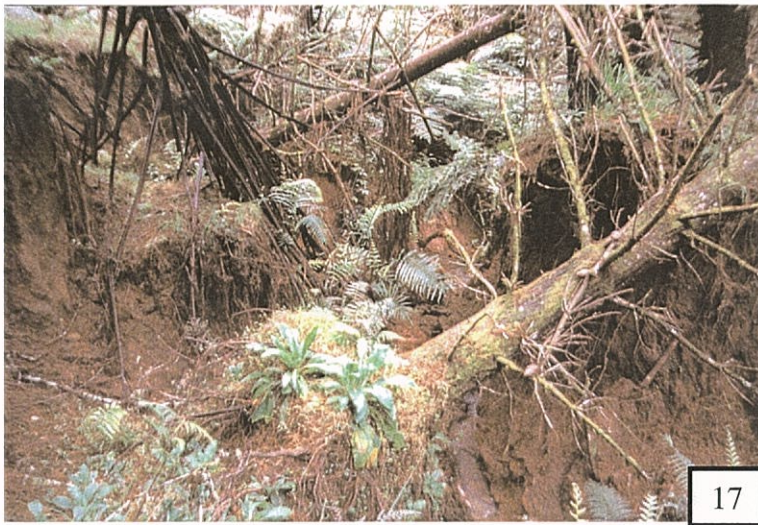
This is a tributary just above the Opouteke river bridge.
