**Assessments of streams and riparian plantings
within Carter Holt Harvey Forests
at
Mangakahia and neighbouring sites**

**- Bruce Alexander
October 2002**

An assessment of streams and riparian plantings within Carter Holt Harvey's Forest at Mangakahia and neighbouring sites.

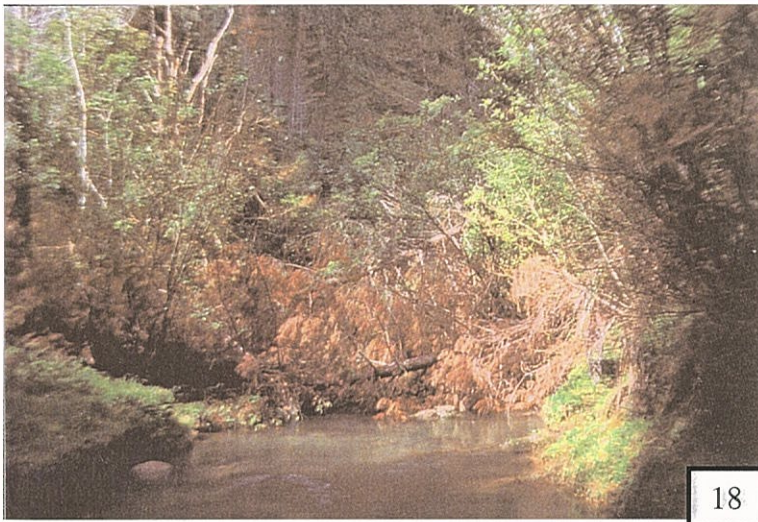
This is a tributary in the McKenzie basin which had excellent setback for the first 1Km going up. The trees were planted back at least a full length due to the awkwardness of the terrain.

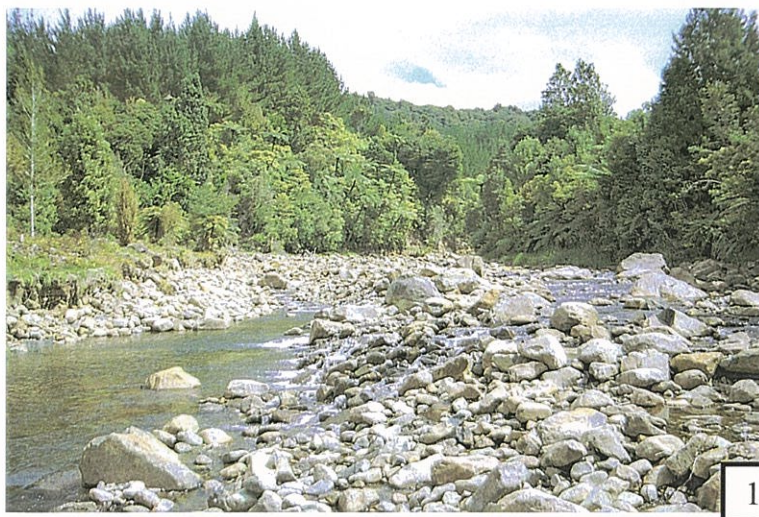
Just downstream from the top end by Danube road a large presence of invertabrates was noticed. Water quality is excellent here.

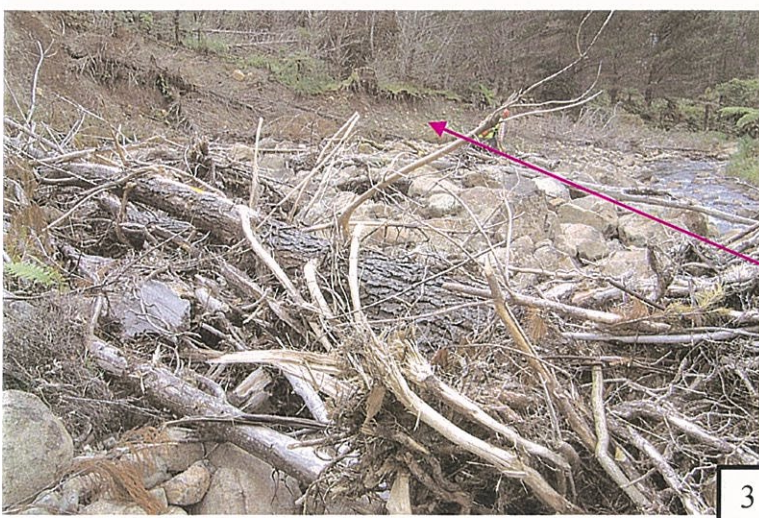
Debris is to be found dumped like this in many places.

Damaged bank with further potential of toppling.

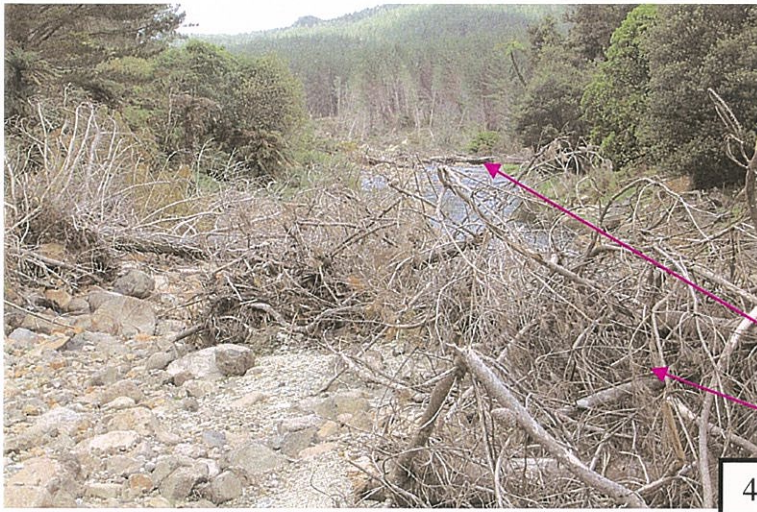
These blockages have increased in the last six months.
