December 2016 Quick Draw Express Lift (SC-008) Incident

Report of Investigation

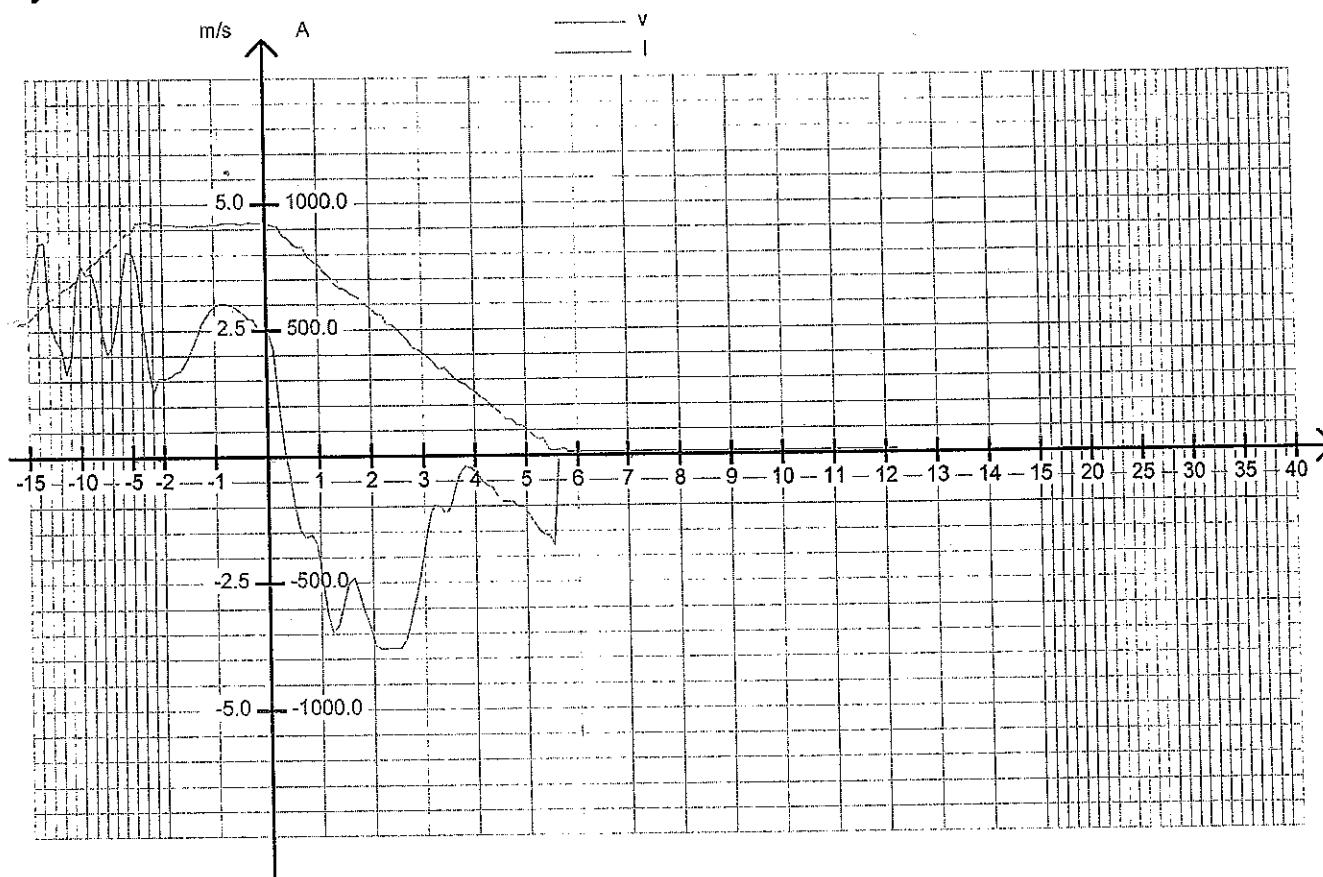
Record Nr.: 38, Registered on STOP at 09:30:28

09:30:28,40 : DA 91.29 *Stop ch. 1 from return
09:30:28,40 : DA 91.30 *Stop ch. 2 from return
09:30:28,40 : DA 95.14 *Tower circuit 1
09:30:28,40 : RA 95.20 *TOWER 5 FAULT
09:30:35,90 : RA 91.06 *Checkback direction signal parity
