DEPARTMENT OF THE NAVY
COMMANDER BATTLE FORCE SEVENTH FLEET
COMMANDER CARRIER STRIKE GROUP FIVE
UNIT 200218 BOX 1
FPO AP 96602

5830
Ser N00/328
11 Aug 17

Subj: SUPPLEMENTAL PRELIMINARY INQUIRY AND LINE OF DUTY
DETERMINATION REGARDING INJURIES AND THE DEATHS OF SEVEN
SAILORS ABOARD USS FITZGERALD (DDG 62) ON OR ABOUT 17 JUNE 2017

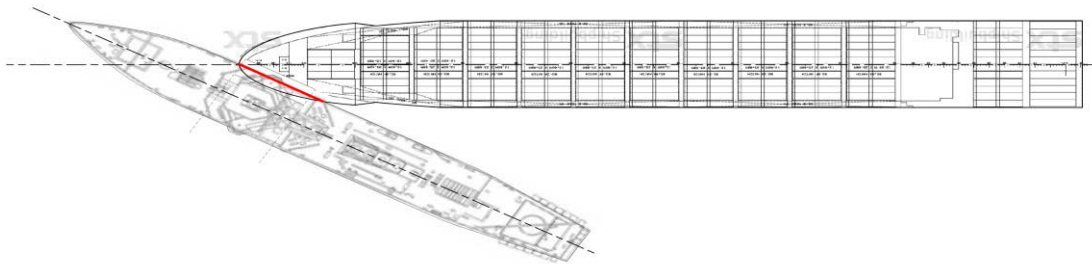
Figure 4 - Diagram of Collision points

10. The port (left) side of CRYSTAL’s bow, near the top where the anchor hangs, struck FITZGERALD’s starboard (right) side above the waterline. CRYSTAL’s bulbous bow, under the water, struck FITZGERALD on the starboard side just forward of the middle part of the ship. Figure 5 provides a representation of a bulbous bow. CRYSTAL’s bulbous bow struck the starboard access trunk, an entry space that opens into Berthing 2 through a non-watertight door.

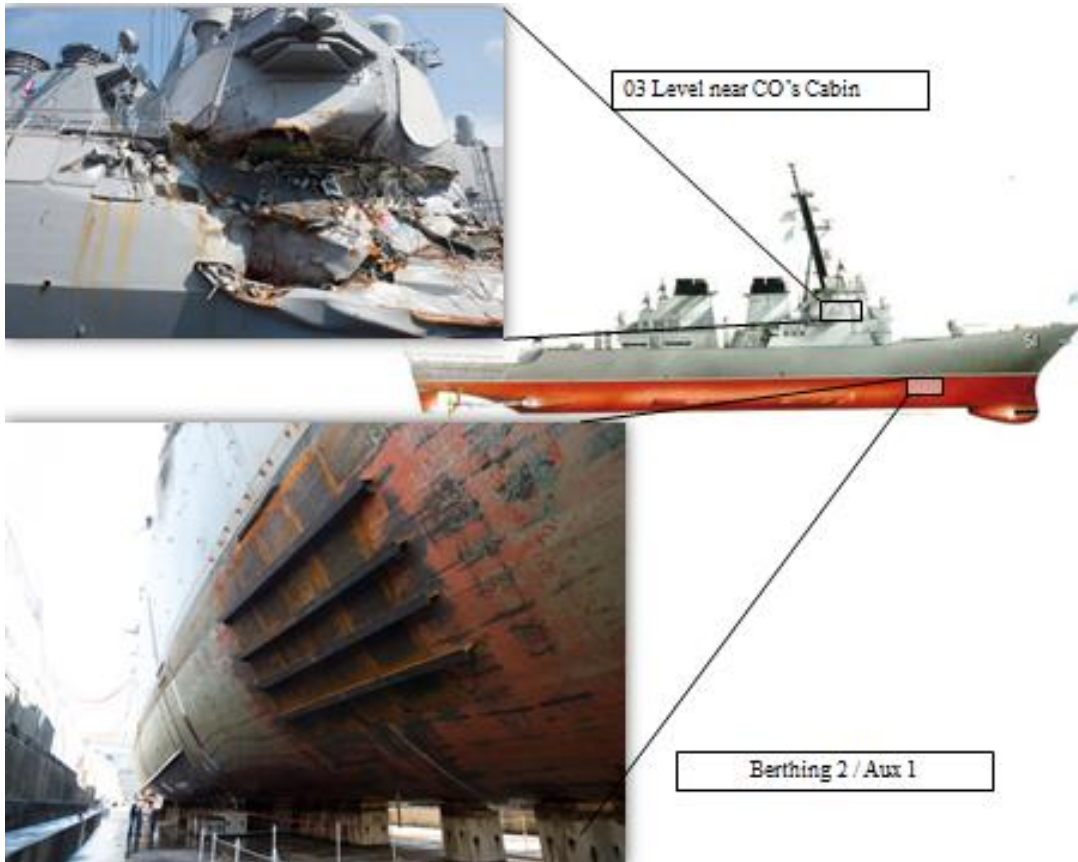
Figure 6 – Starboard side of FITZGERALD
Inset Above: Damage to FITZGERALD above the waterline at the 03 Level near CO's Cabin
Inset below: FITZGERALD in drydock with patch over the 13ft x 17ft hole at Berthing 2/AUX 1

12. The impact of CRYSTAL's bulbous bow below the waterline punctured the side of FITZGERALD, creating a hole measuring approximately 13ft by 17ft, spanning the second and third decks below the main deck. The hole allowed water to flow directly into Auxiliary Machinery Room 1 (AUX 1) and the Berthing 2 starboard access trunk. The force of impact from CRYSTAL's bulbous bow and resulting flood of water pushed the non-water tight door between the starboard access trunk and Berthing 2 inward. The wall supporting this door pulled away from the ceiling and bent to a near-90 degree angle. As a result, nothing separated Berthing 2 from the onrushing sea, allowing a great volume of water to enter Berthing 2 very quickly.

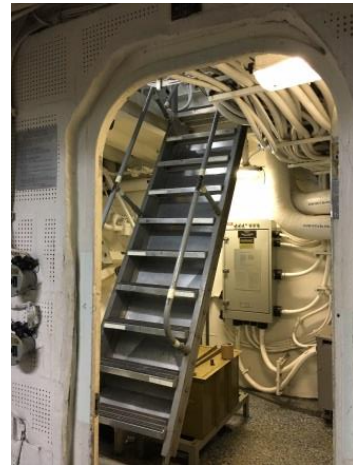
54. Berthing 1 was partially flooded to five feet by water entering from the hole created by the impact in Berthing 2 and AUX 1. Damage control parties tried to limit and reduce the flooding with eductors, but with no watertight hatch or door between Berthing 2 and Berthing 1 on the starboard side to act as a barrier against the progressive flooding, water passed freely into Berthing 1 and undermined dewatering efforts. Berthing 1 had water in the space until after the ship returned to Yokosuka and entered dry-dock (a place where water is drained from around the ship to allow for repairs).

Figure 16 - Non-watertight door frame from Berthing 2 to the ladder going up to Berthing 1 Access Trunk. There is no hatch at the top of this ladder to prevent water from flooding up into Berthing 1.

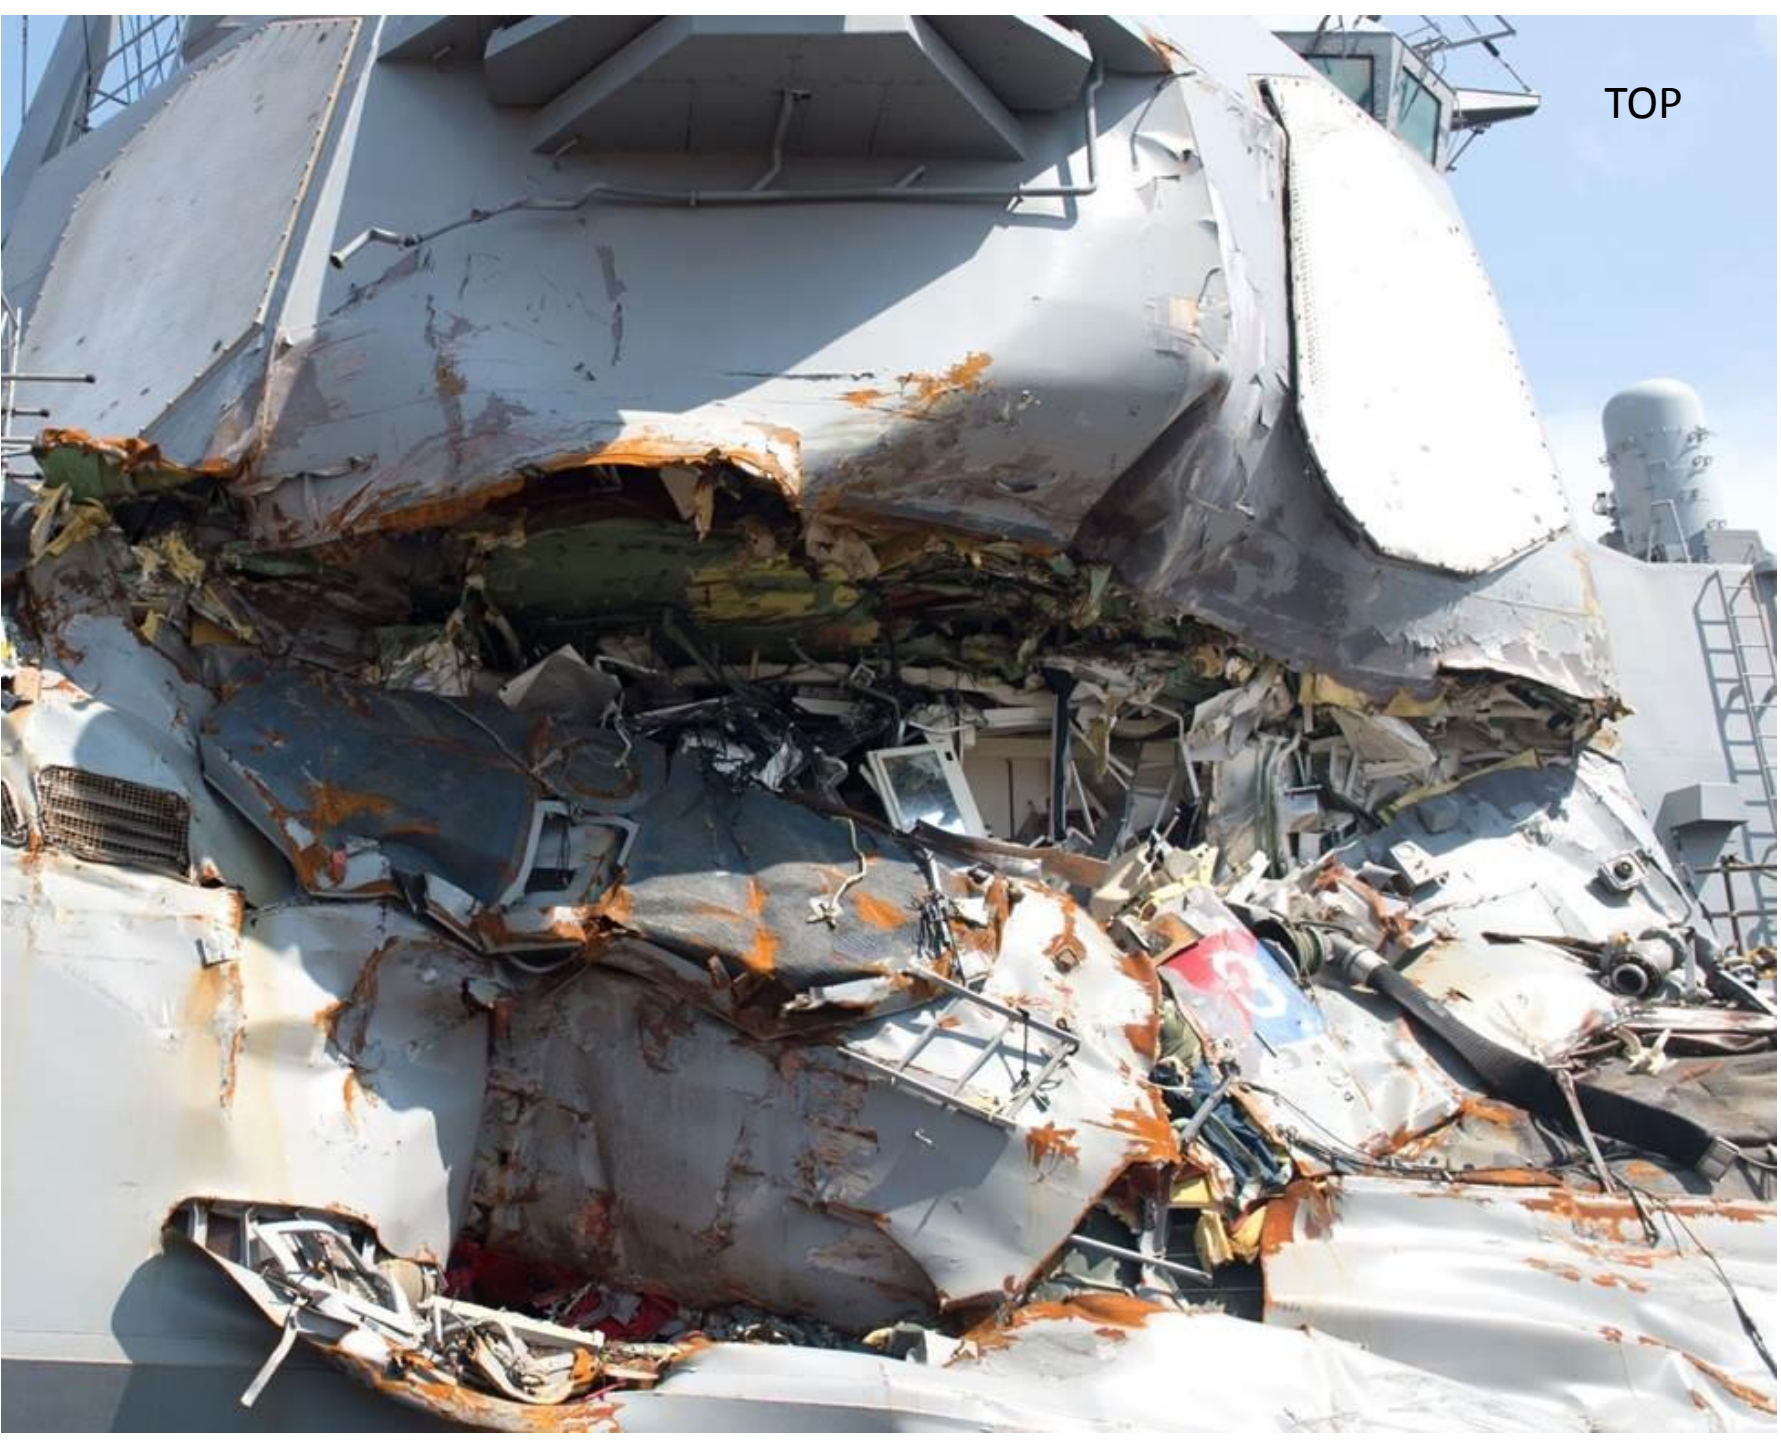
A1 : Commanding Officer's Stateroom on FTZ - Exterior View

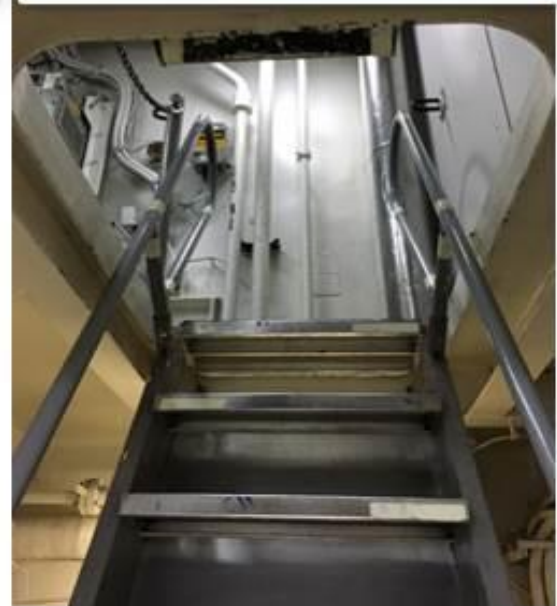
USS FITZGERALD Starboard Access Trunk as seen from Berthing 2

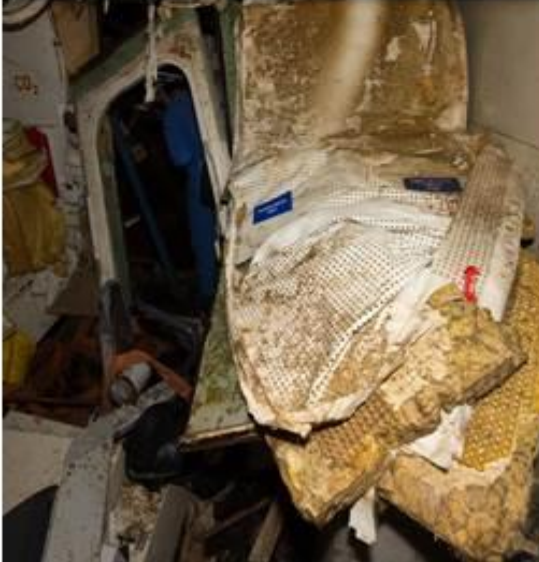
USS FITZGERALD Starboard Access Trunk - Hatch & Scuttle to Forward Interior Communications Room Below

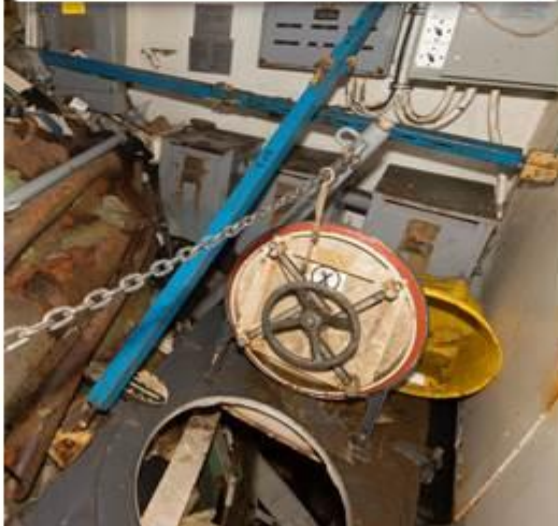
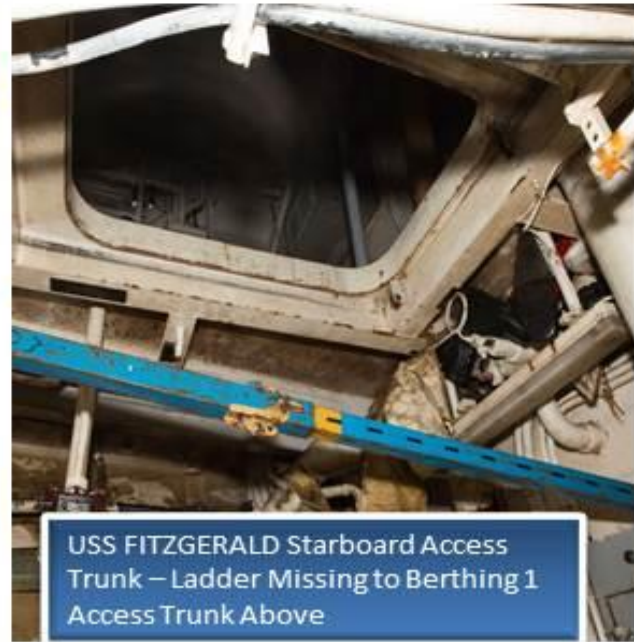
USS FITZGERALD Starboard Access Trunk - Ladder Missing to Berthing 1 Access Trunk Above

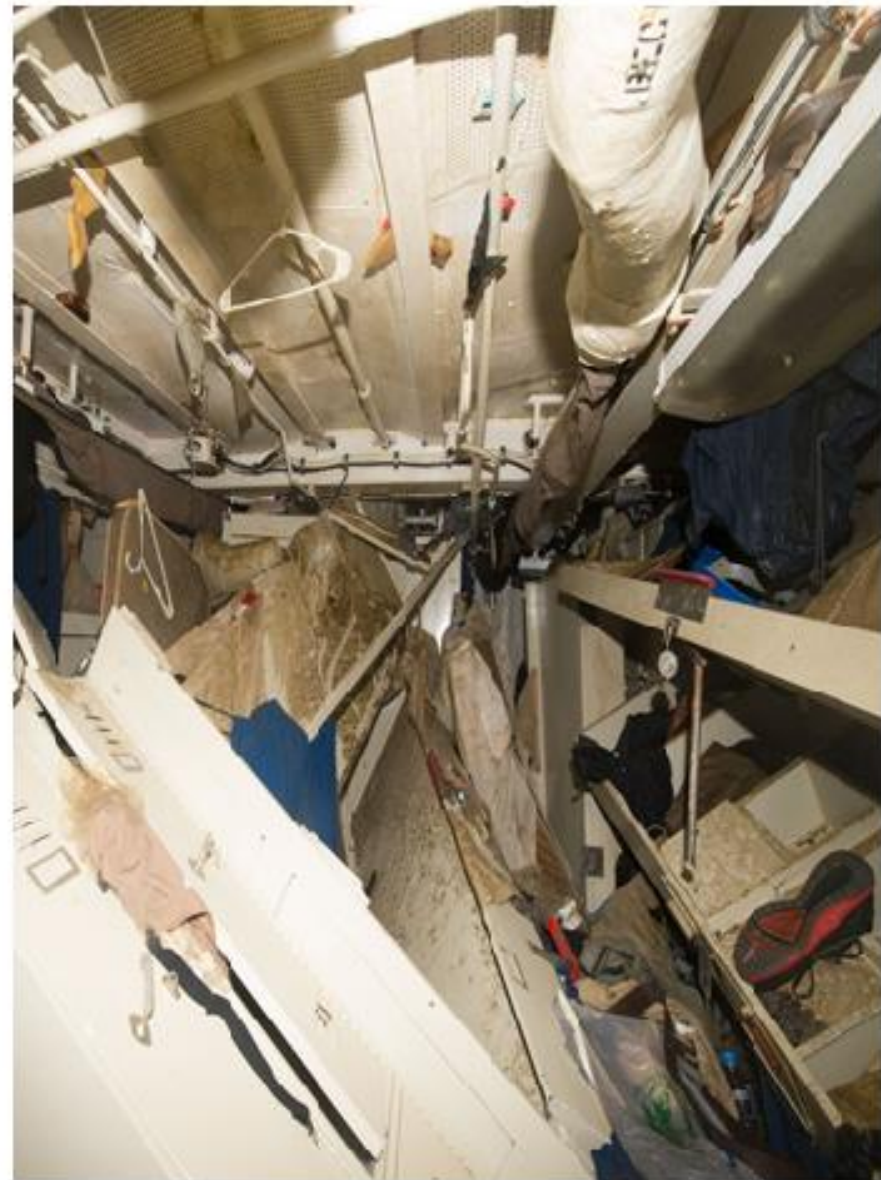
FITZGERALD Berthing 2 Racks Post-Deflooding

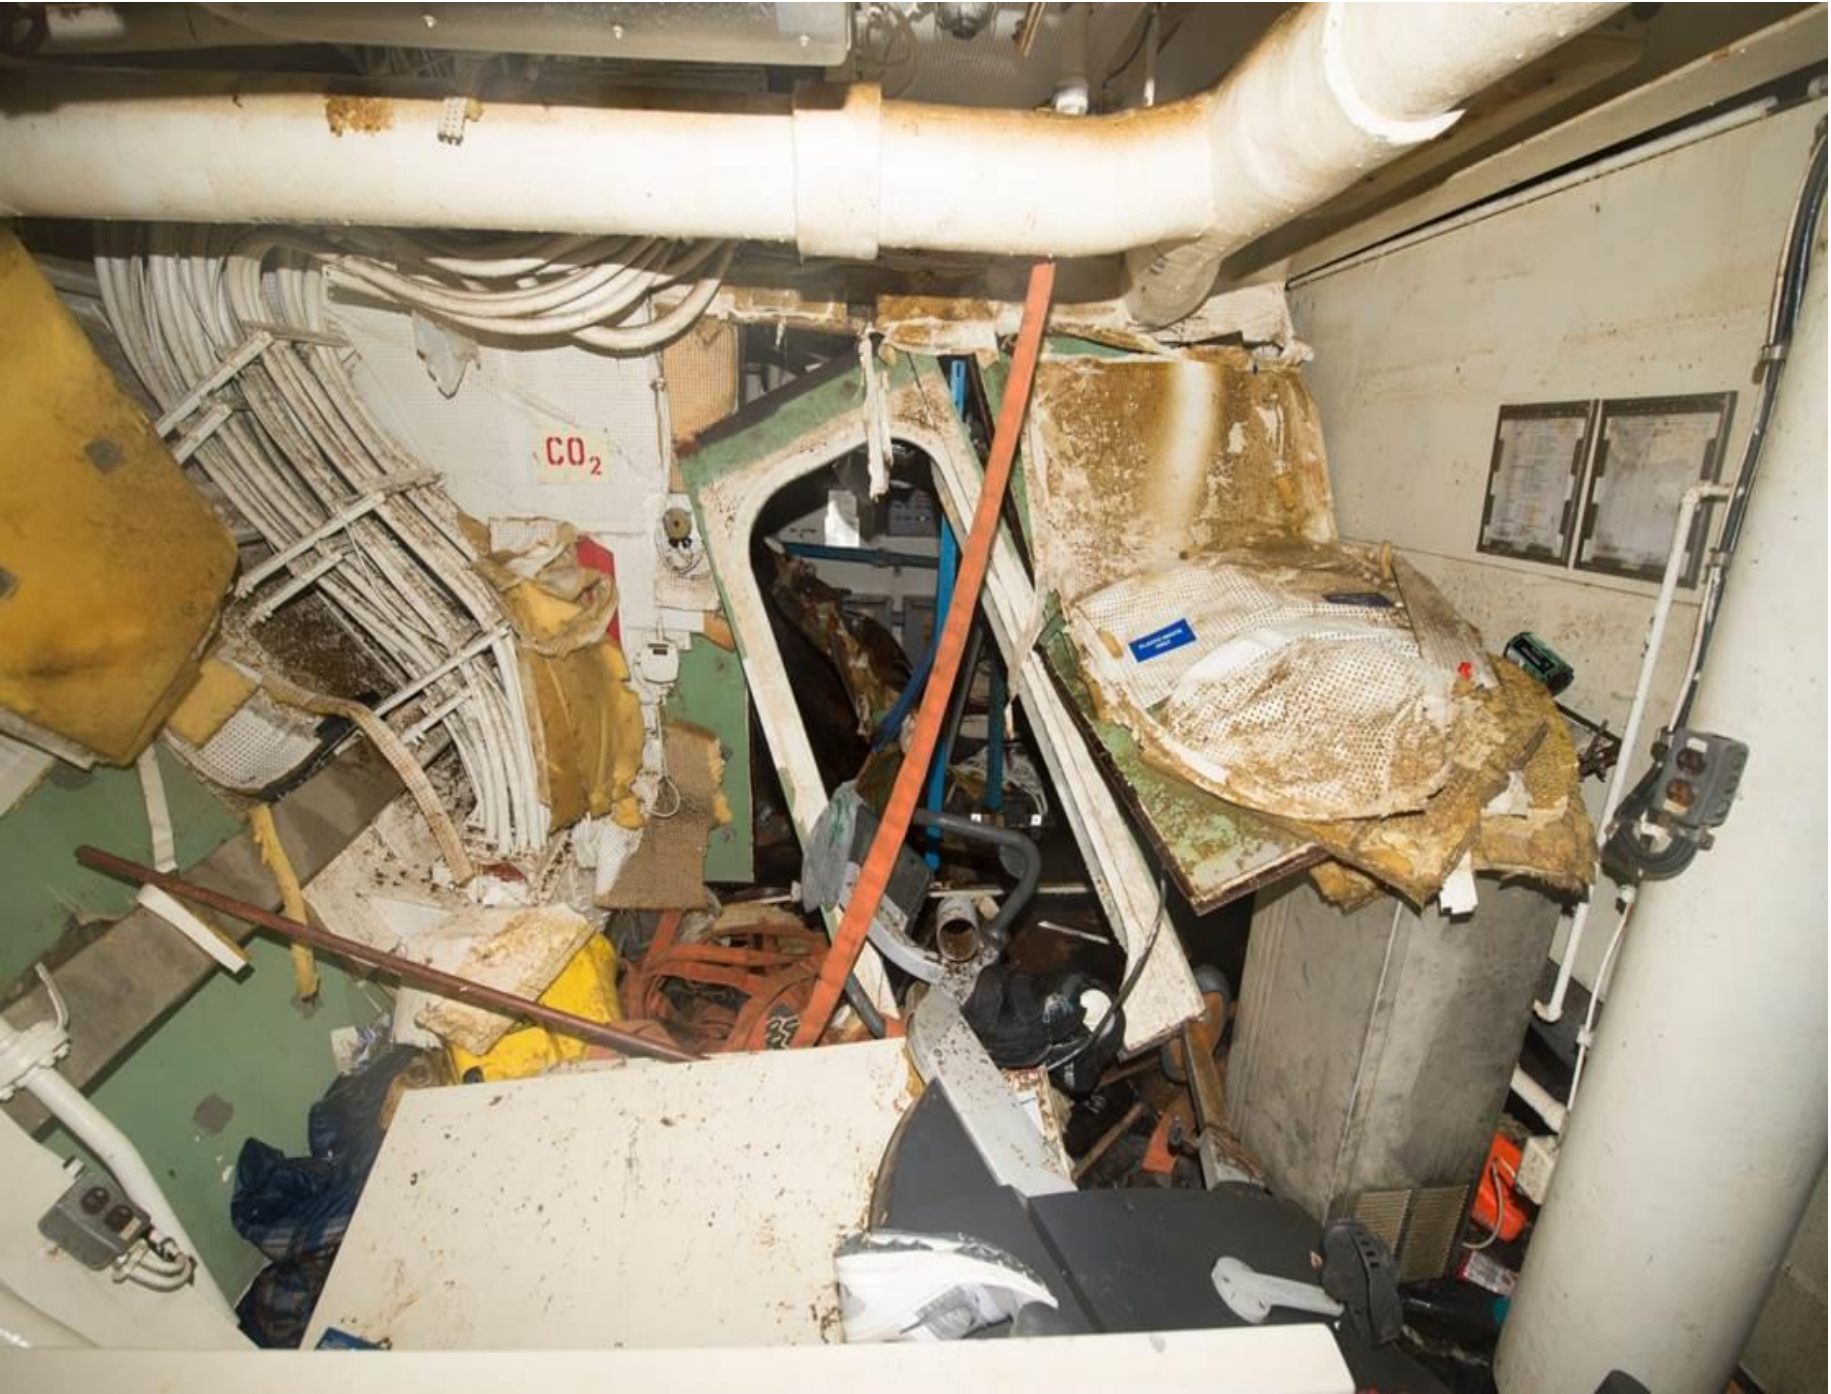
A5: Lounge in Berthing 2 - View from lounge facing egress

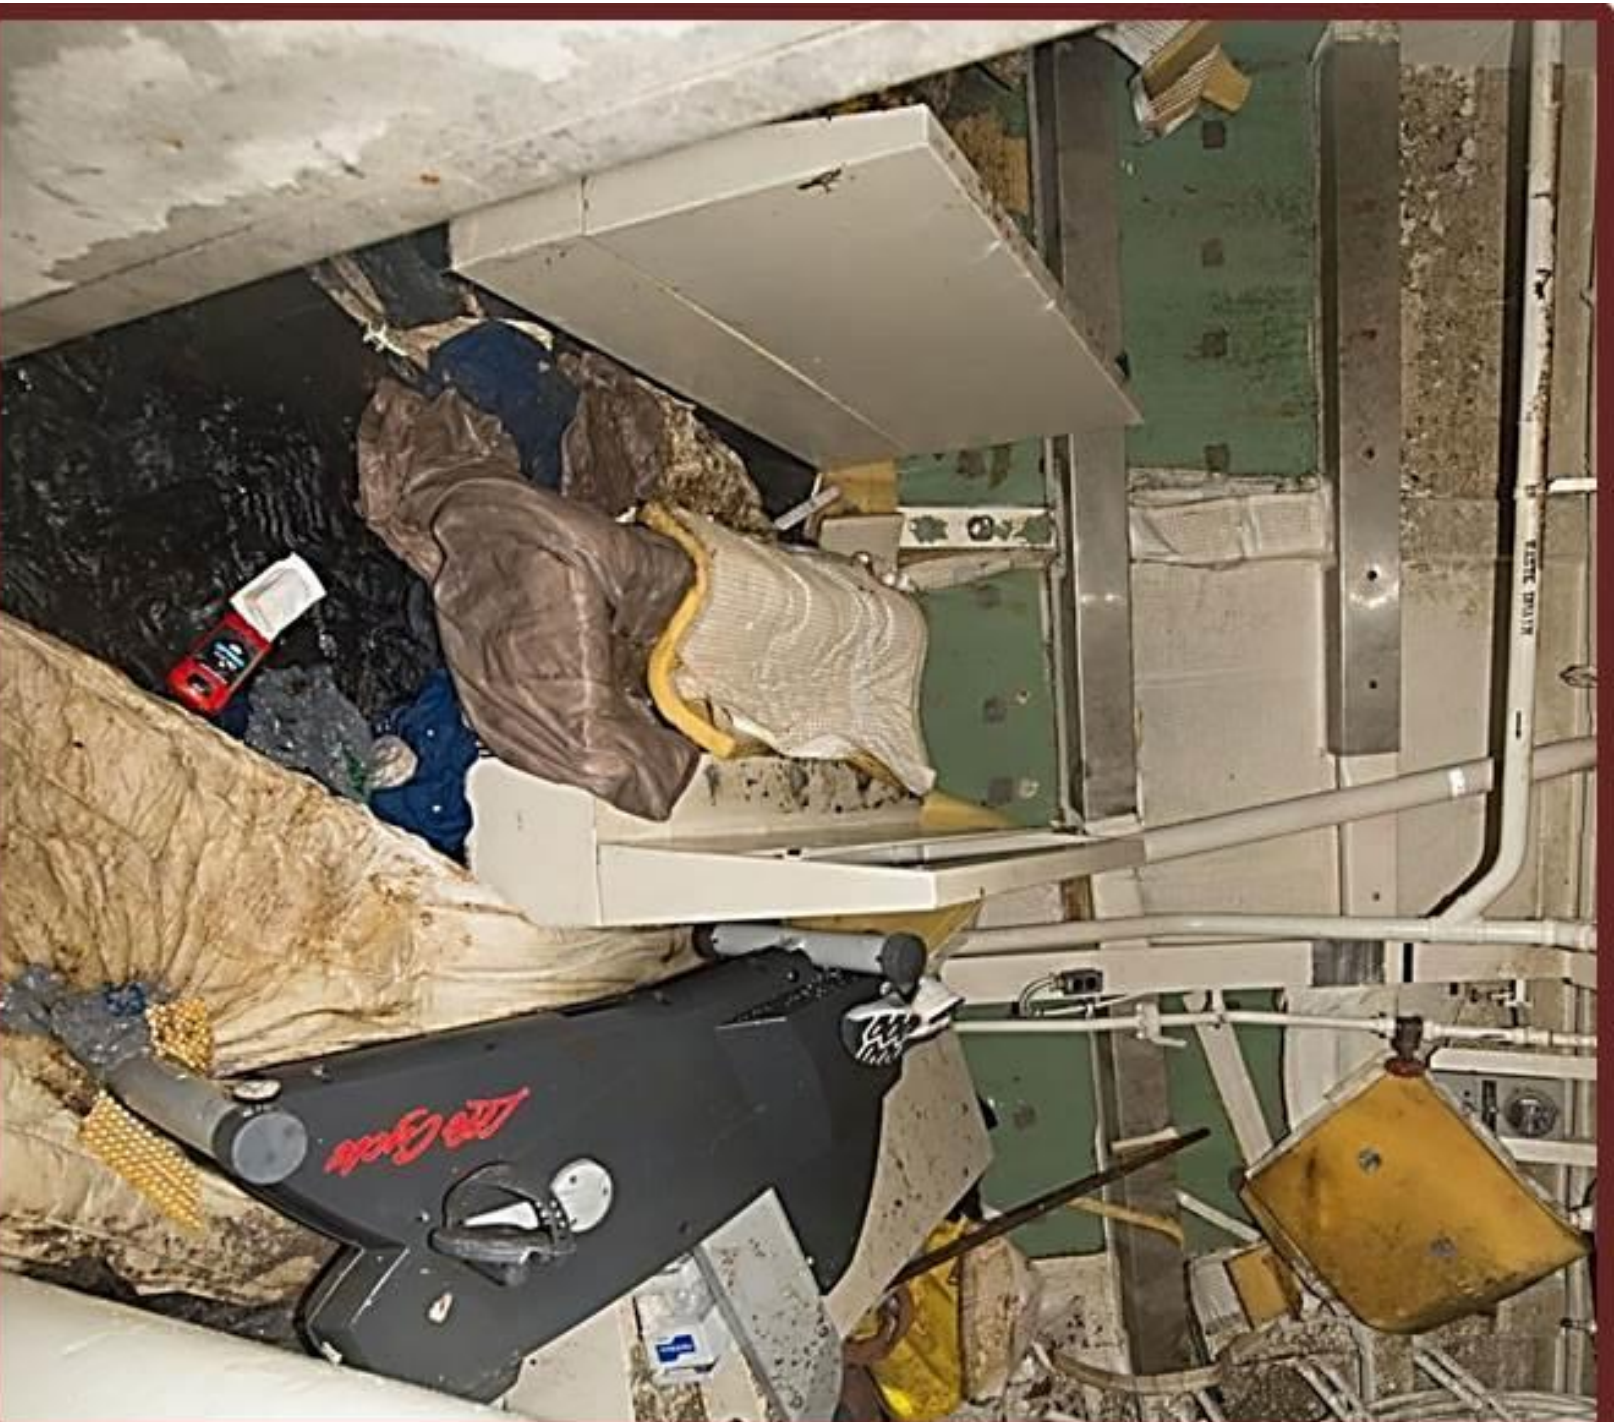
A6: Lounge in Berthing 2 - View from racks
