Subject: Limited Visual Structural Evaluation – Hurricane Irma

Catapult
2.0

Cash Feed Building Renovation
502 E Main Street, Lakeland, FL

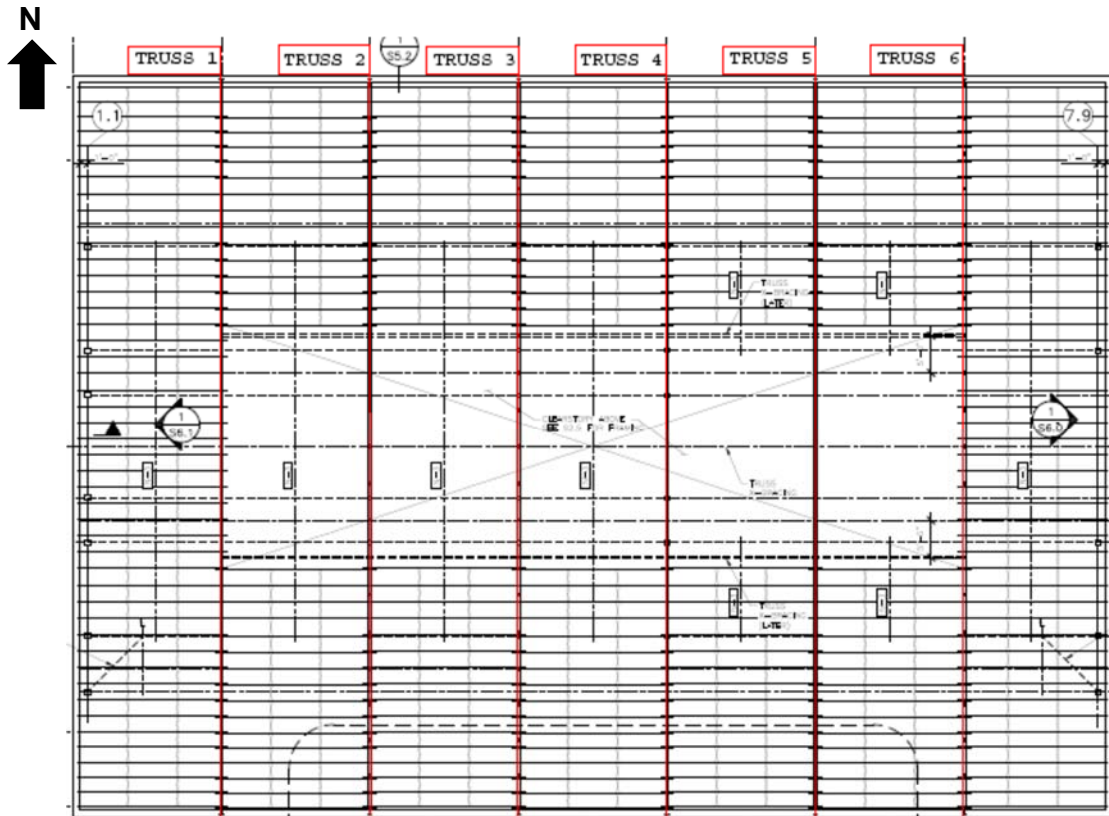
ROOF REFERENCE PLAN: MAIN ROOF TRUSS DESIGNATIONS

For the purposes of this letter, the main roof trusses spanning between the north and south main building walls are designated as TRUSSES 1 through 6 from the west end. See *ROOF REFERENCE PLAN* below.

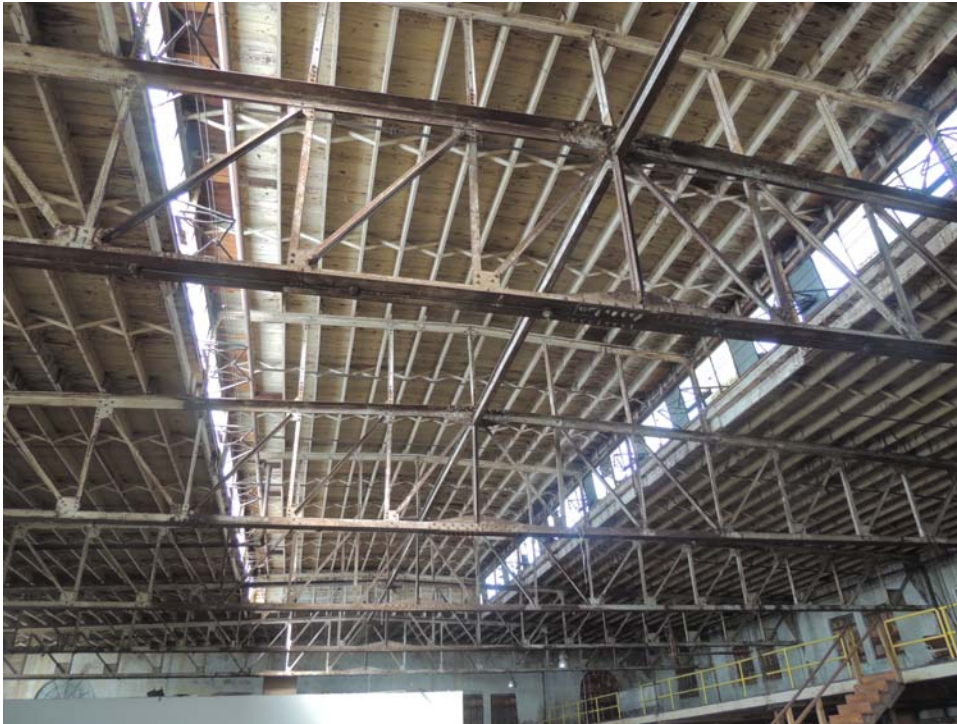
1. Steel girder trusses of main roof framing. Refer to *Figure 1*.
2. West steel girder truss (first truss from west end) exhibited visible lateral displacement. Refer to *Figure 2*, *Figure 3* and *Figure 4*.
3. Second truss from west end exhibited minimal lateral displacement. Refer to *Figure 5*.
4. Third, fourth and fifth trusses from west end exhibited slight lateral displacement. Refer to *Figure 6*.
5. West wall exhibited inward bowing. Roof rafters exhibited some discernible movement relative to the west wall. Refer to *Figure 7*.

Figure 1: Roof Trusses 09-14-2015

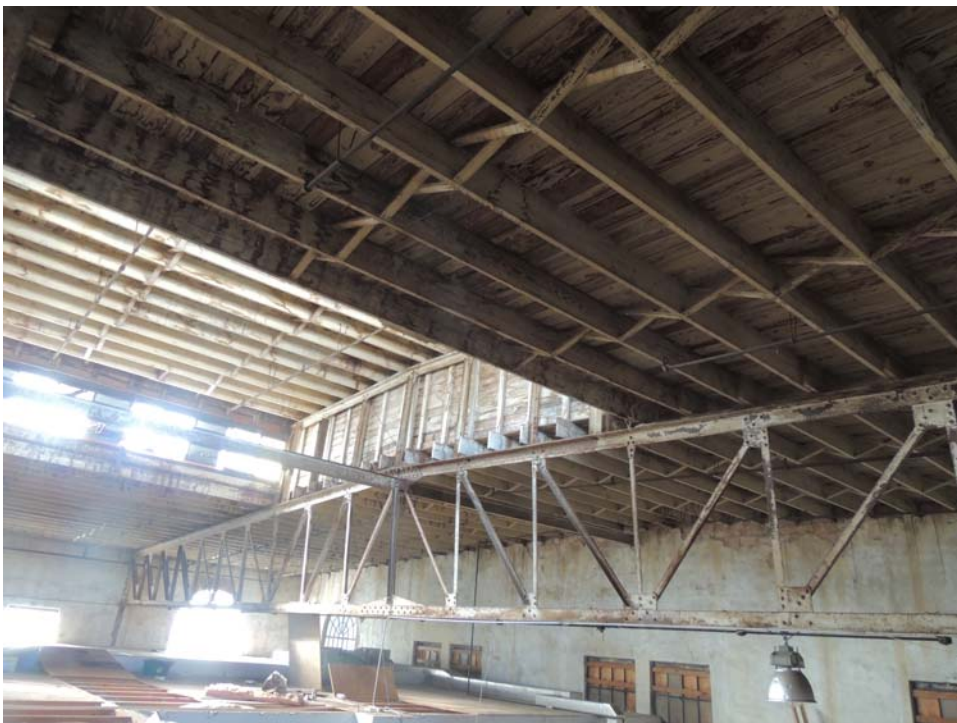
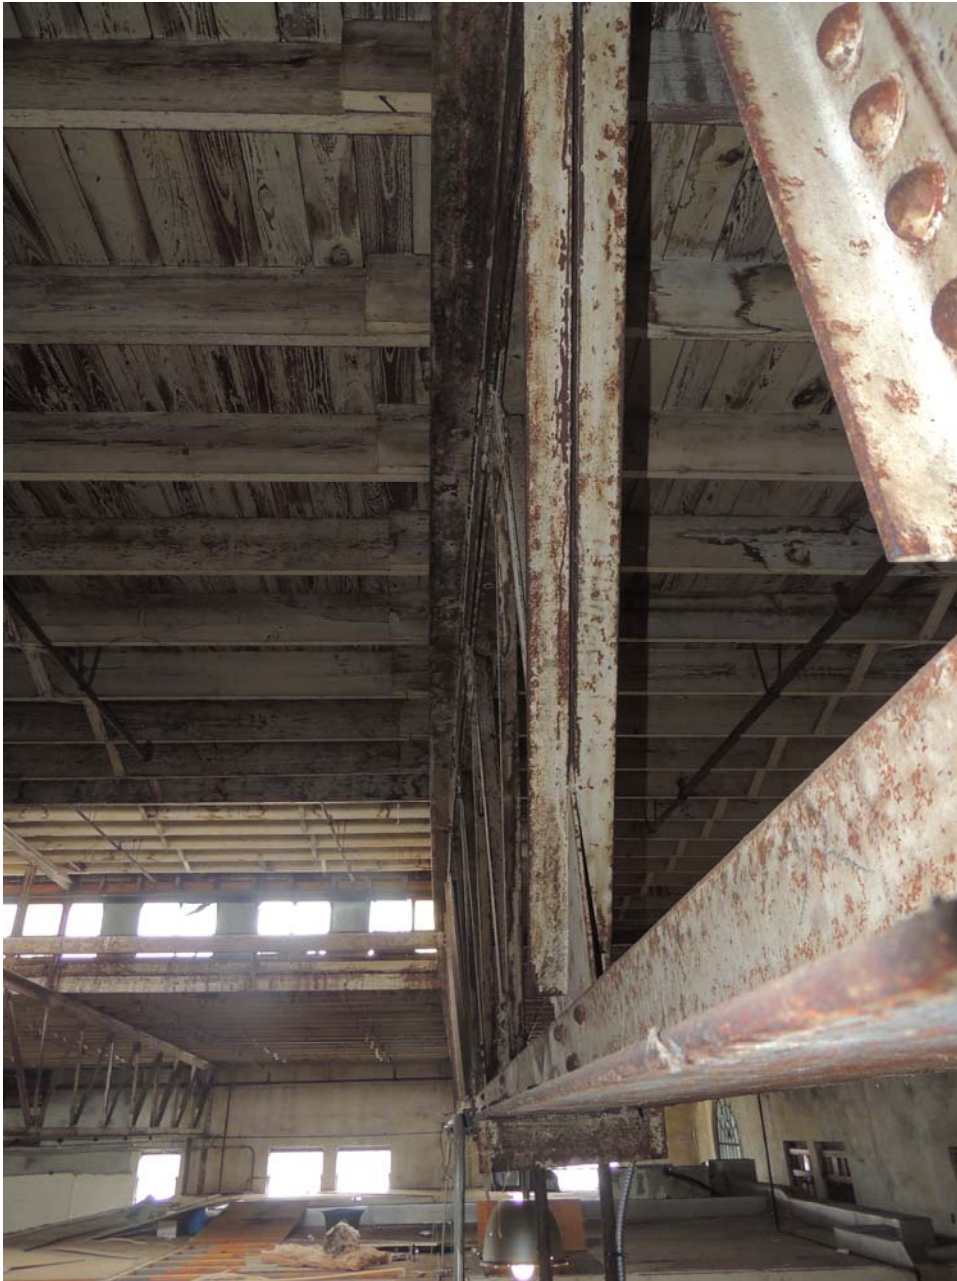
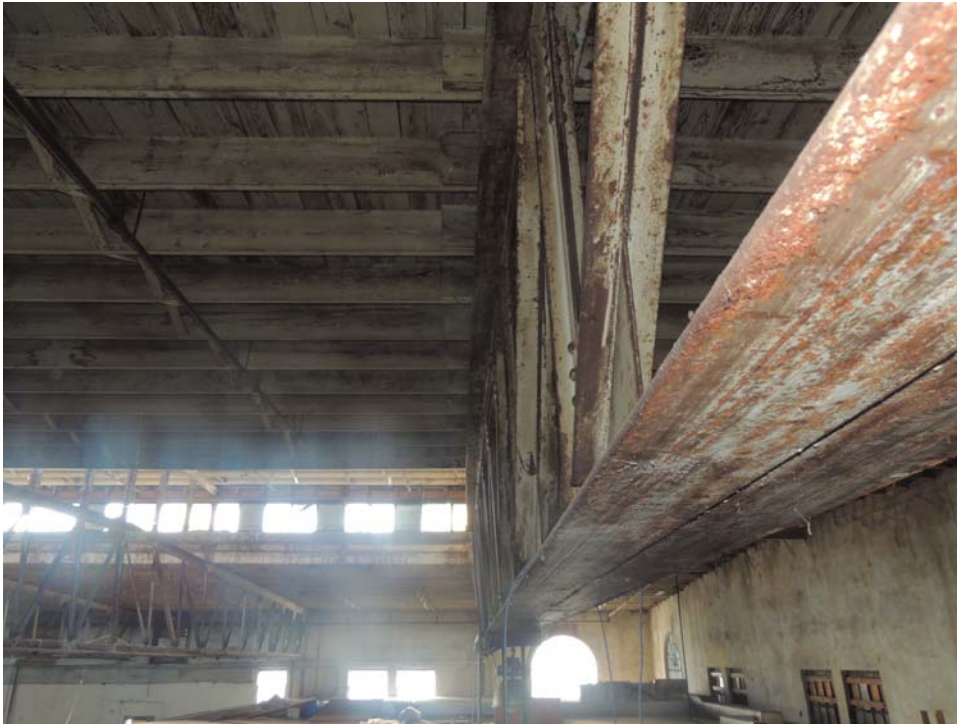
Figure 2: First Truss from West End 09-14-2015

Figure 3: First Truss from West End 10-27-2015

Figure 4: First Truss from West End 09-14-2015

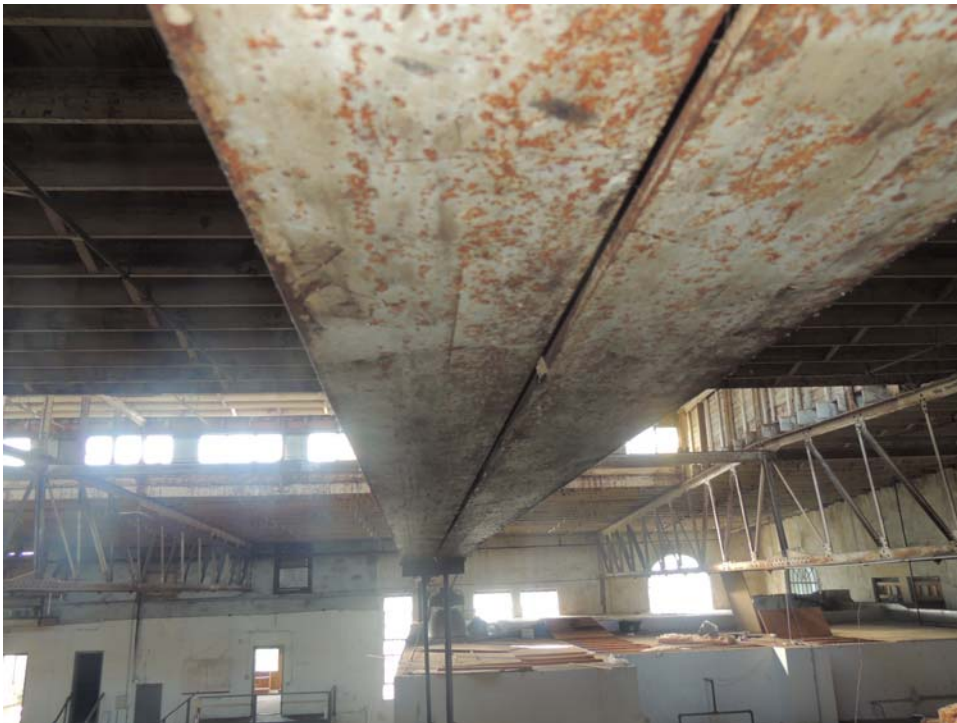
Figure 5: Second Truss from West End 09-14-2015

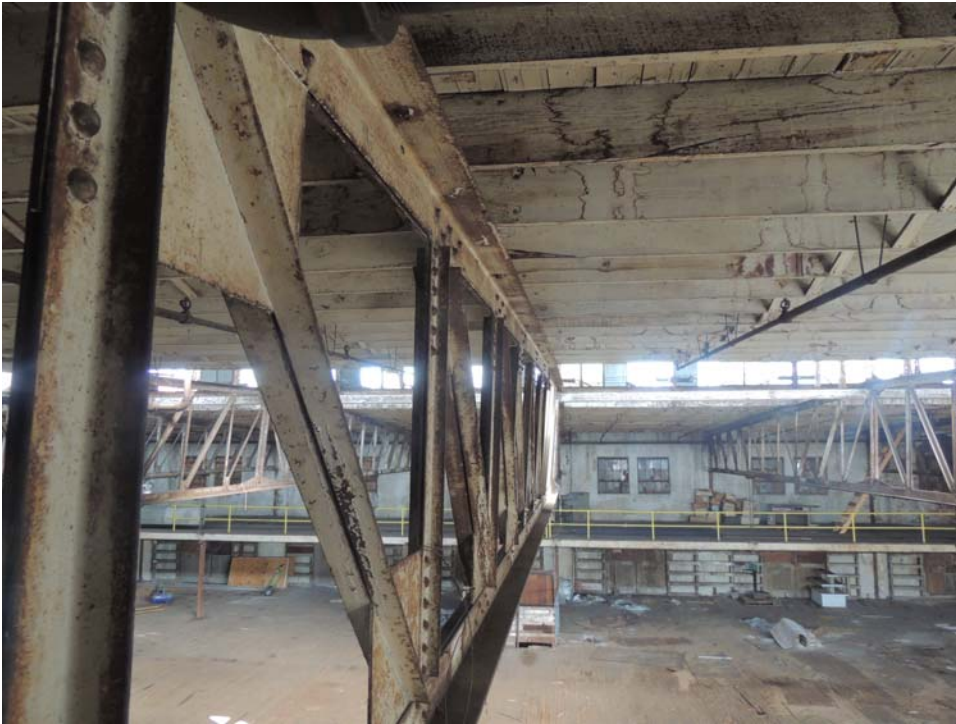
Figure 6: Third, Fourth & Fifth Truss from West End Looking N 09-14-2015

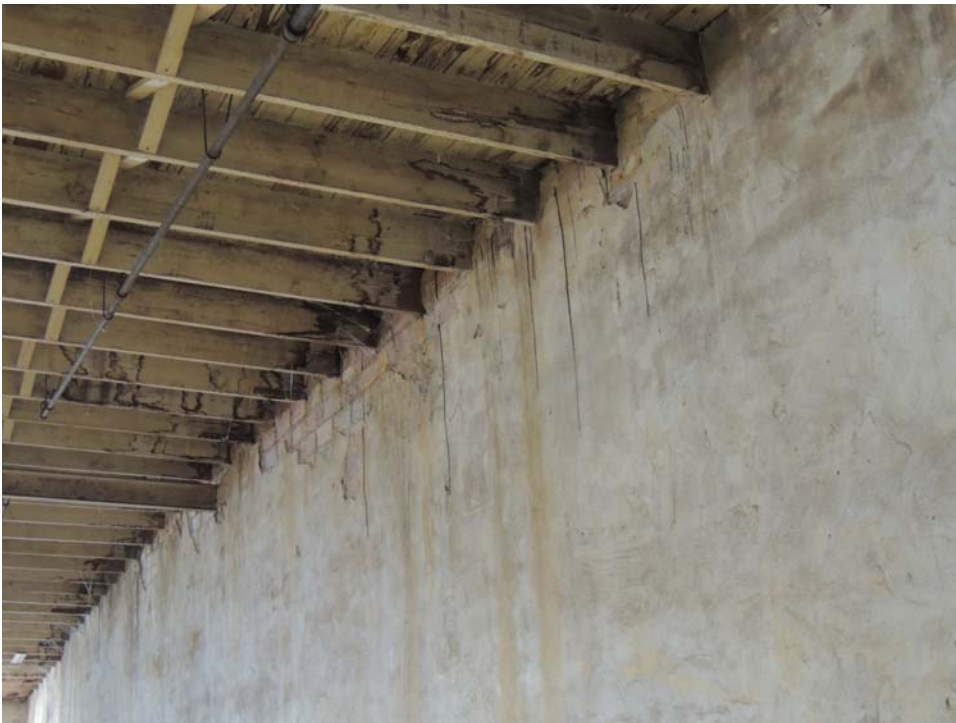
Figure 7: West Wall 10-27-2015

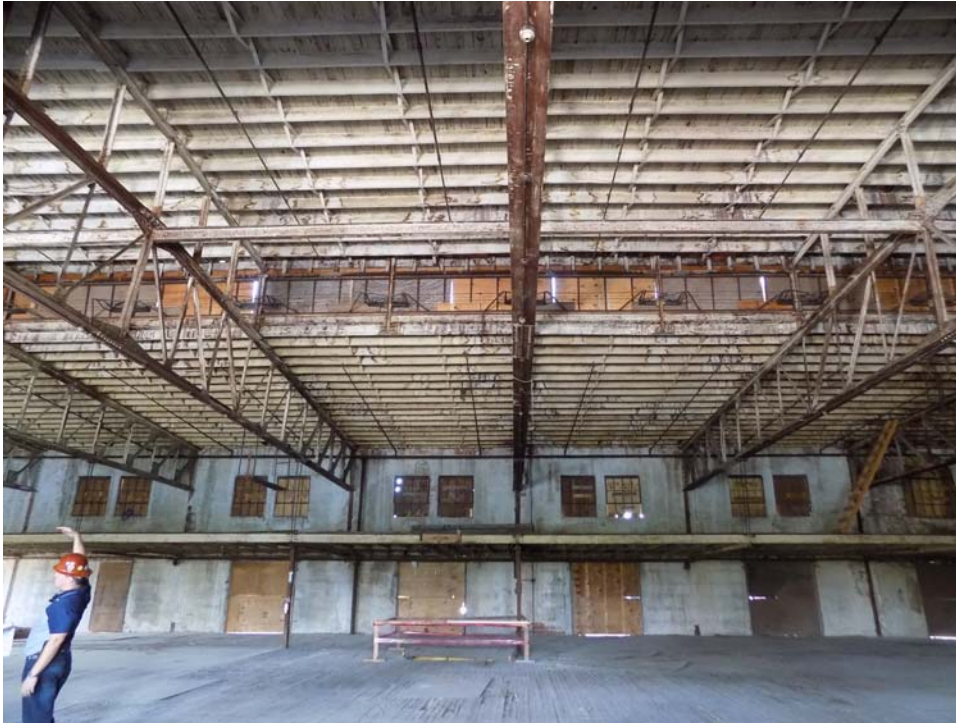
6. Steel girder trusses viewed with little visible discernible lateral displacement as of July 25, 2017. See *Figure 8*.

Figure 8: Second, Third, Fourth, Fifth and Sixth Roof Trusses from West End Looking North 07-25-2017

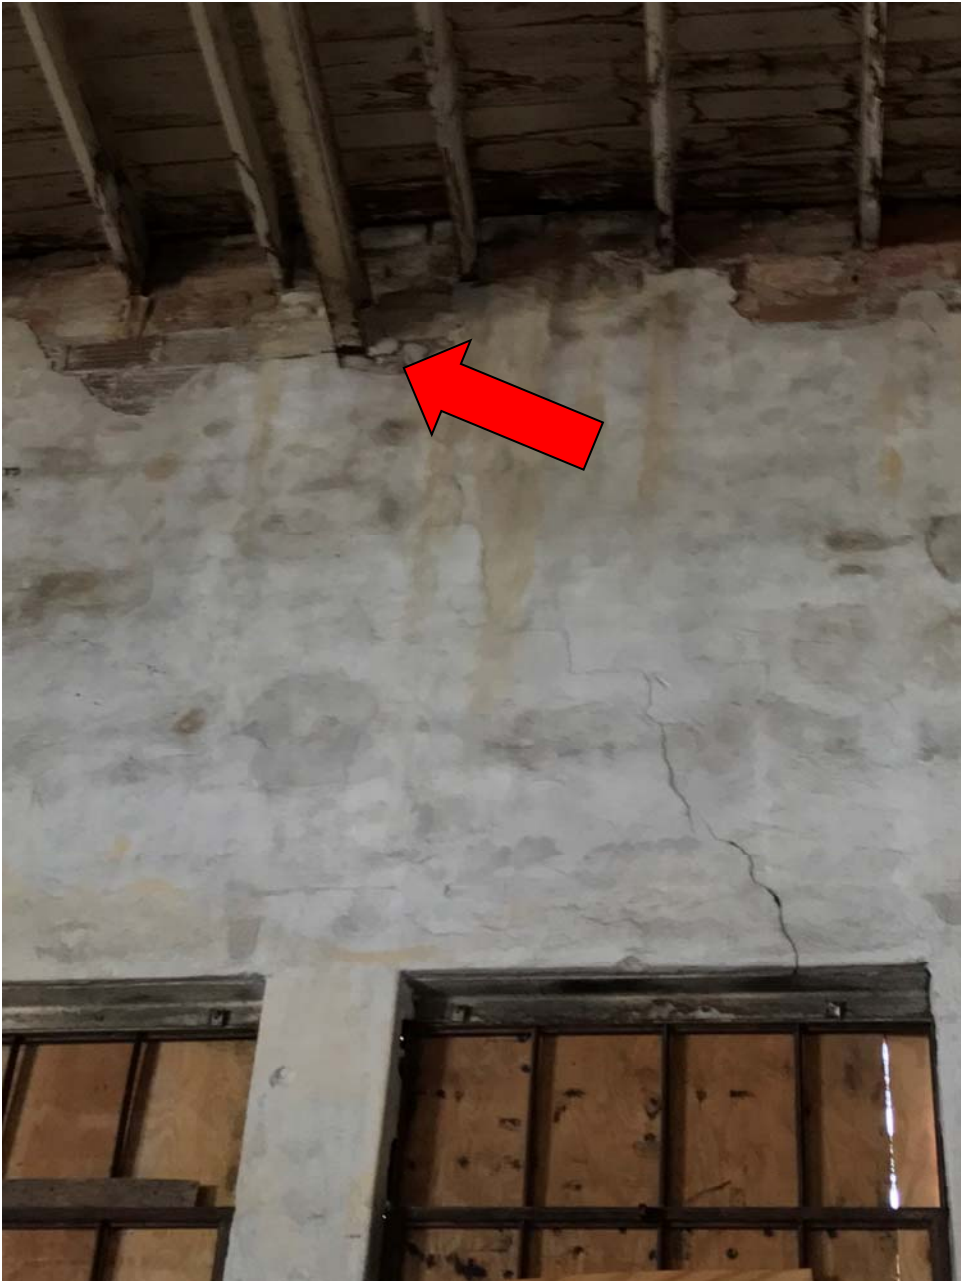
1. The single steel beam spanning east-west across the top chords of the trusses was observed to still bear on east and west walls. Some minor displacement may have occurred. See *Figure 1*.

Figure 1: West Wall interface at single top chord truss brace 09-25-2017

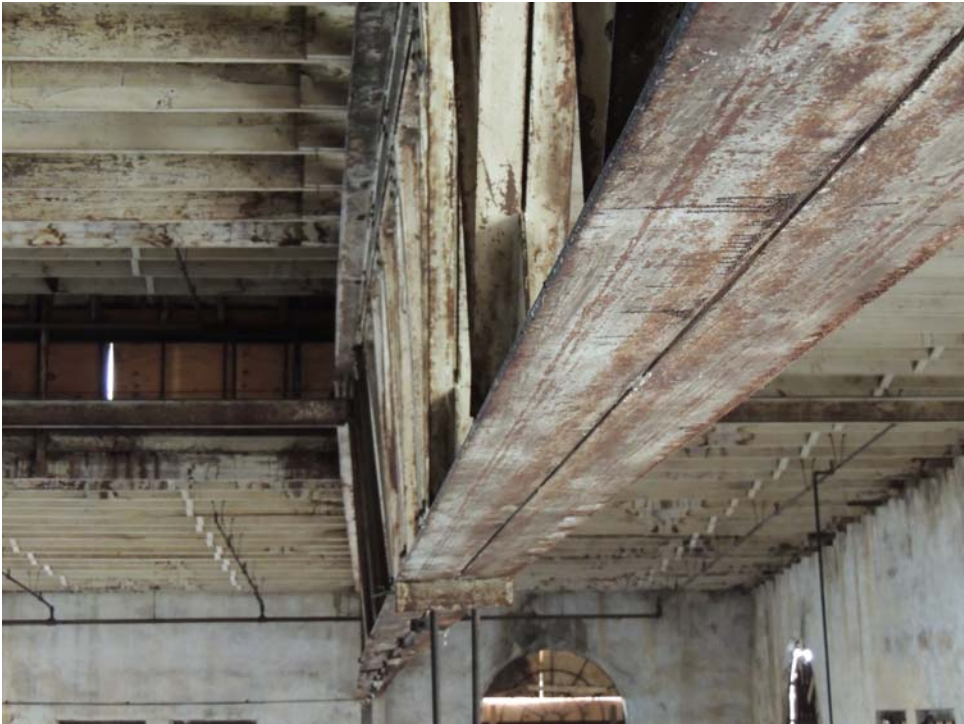
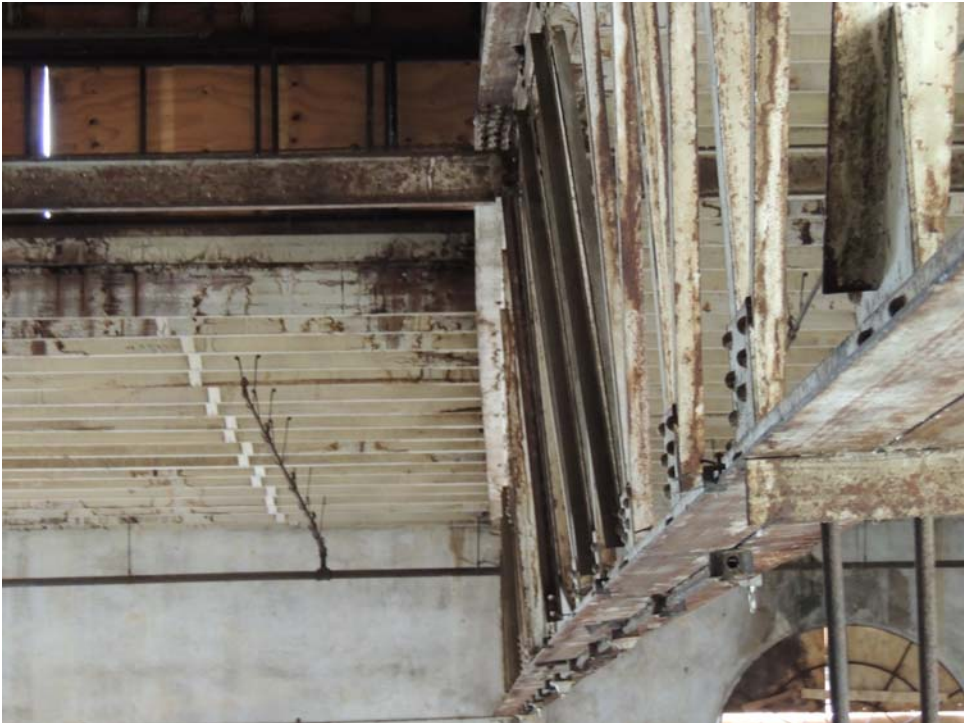
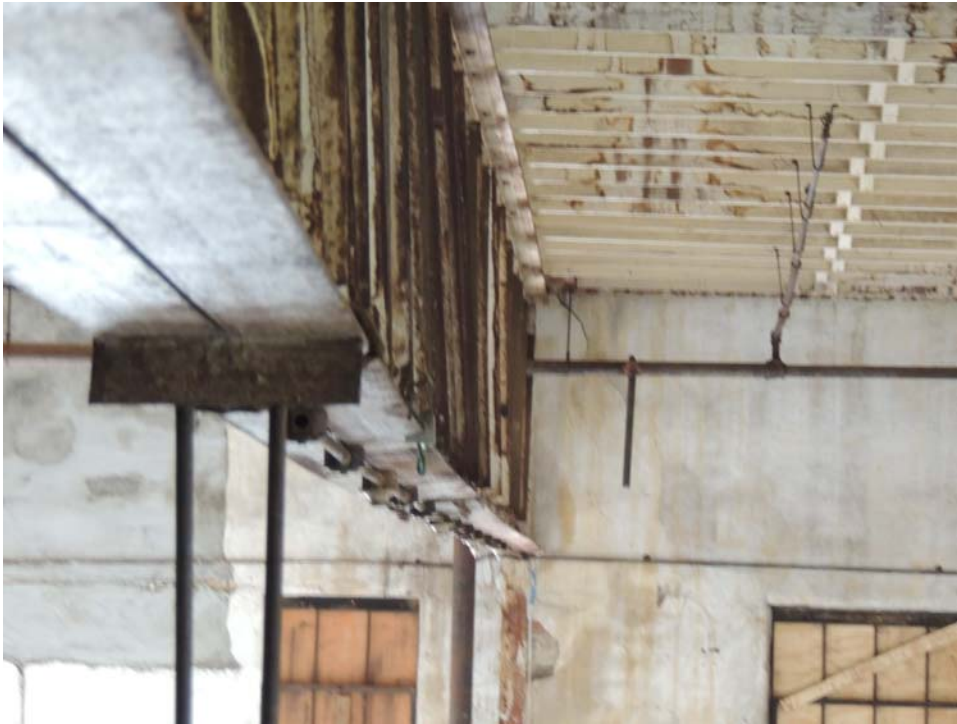
2. The west steel girder truss (first truss from west end) exhibited significant visible lateral displacement and lateral-torsional displacement (twisting of bottom truss chord). The lateral displacement appeared to be greater than previous observations. The later-torsional displacement was not exhibited in previous observations. Refer to *Figure 2, Figure 3 and Figure 4*.

Based on the visual observations made before Hurricane Irma event compared to those after, BillerReinhart believes the structural capacity of the main steel roof truss girders have been substantially compromised, particularly considering the increased degree of lateral displacement and the introduction of lateral-torsional (twisting) displacement.

BillerReinhart believes the significant wind event of Hurricane Irma was the primary cause of the increased degree of lateral displacement and the introduction of lateral-torsional (twisting) displacement of the main steel roof truss girders. Wind forces (lateral, suction and pressures) act simultaneously on all wall, main roof, parapet and clearstory surfaces. This wind event is considered to be a cause for the window dislodgement.

Figure 2: First Truss from West End 09-25-2017

Figure 3: First Truss from West End 09-25-2017

Figure 4: First Truss from West End 09-25-2017

Any remedial efforts would likely be an iterative process and include, but not be limited to:

1. A significant shoring effort to un-load the roof trusses. The existing second floor system would need to be considered and factored into the shoring system.

2. Likely complete removal of the timber roof rafters and deck.
3. Installation of new steel girder roof trusses to each side of the existing trusses should they be desired to remain. Permanent supporting structure for the new trusses would be required, i.e., foundations, steel columns and/or integral concrete wall columns and lateral support for the existing trusses should they be desired to remain.

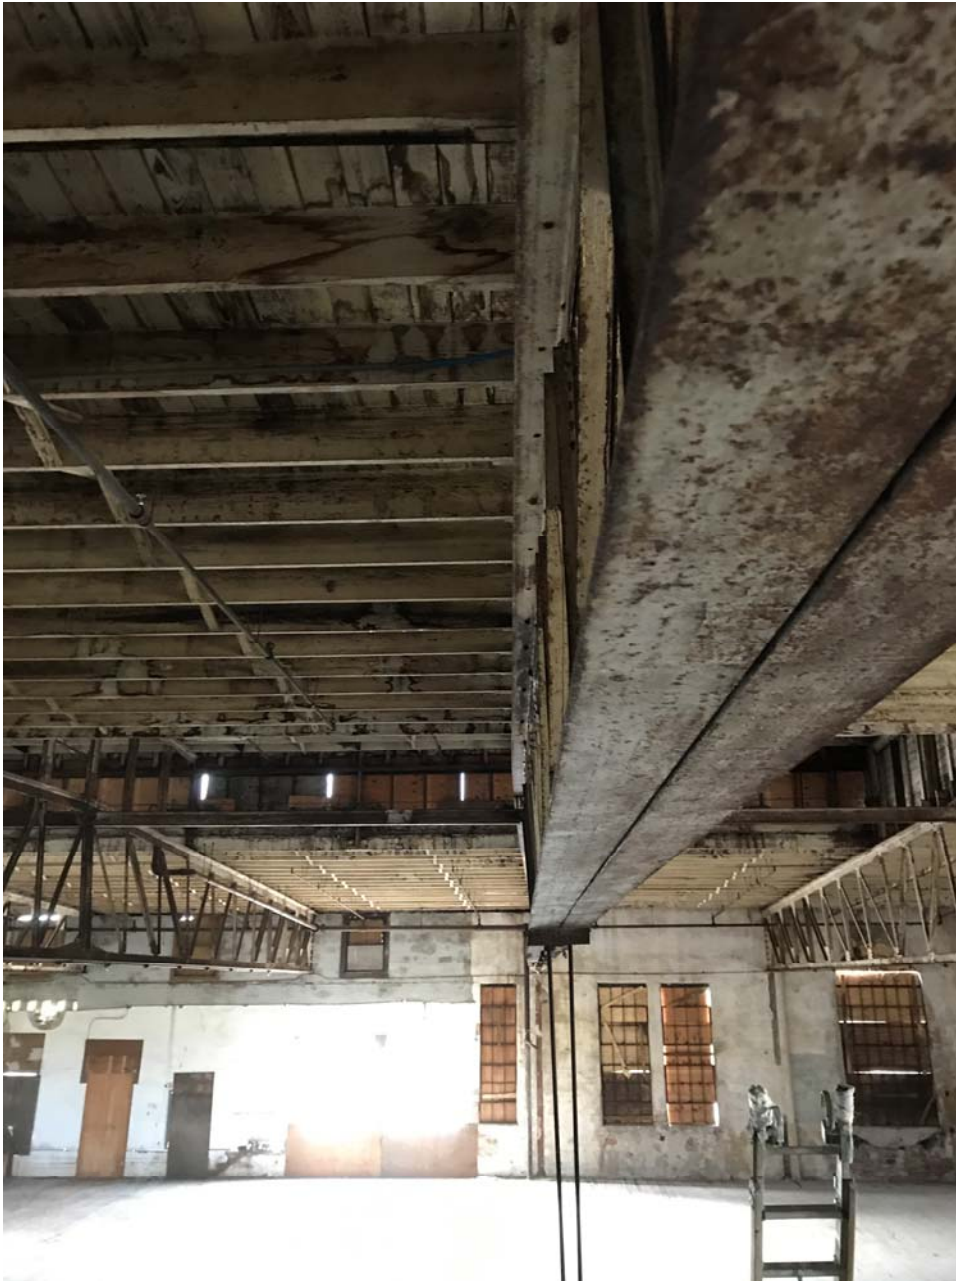
3. The second steel girder truss from the west end exhibited visible lateral displacement and lateral-torsional displacement (twisting). The lateral displacement appeared to be greater than previous observations. The later-torsional displacement was not exhibited in previous observations. Refer to *Figure 5*.

Figure 5: Second Truss from West End 09-25-2017

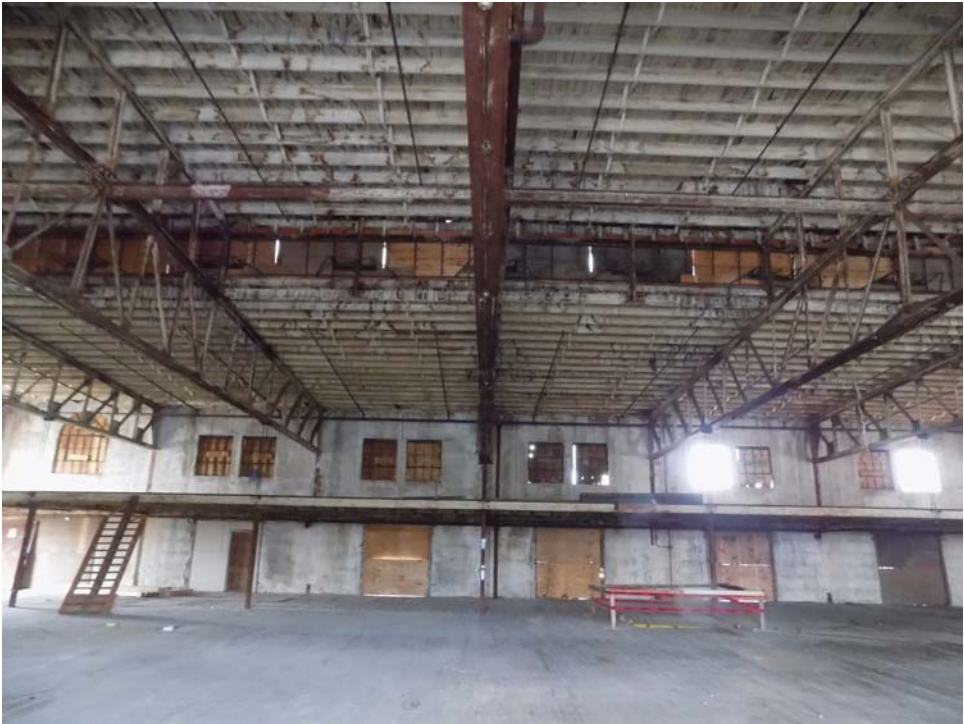
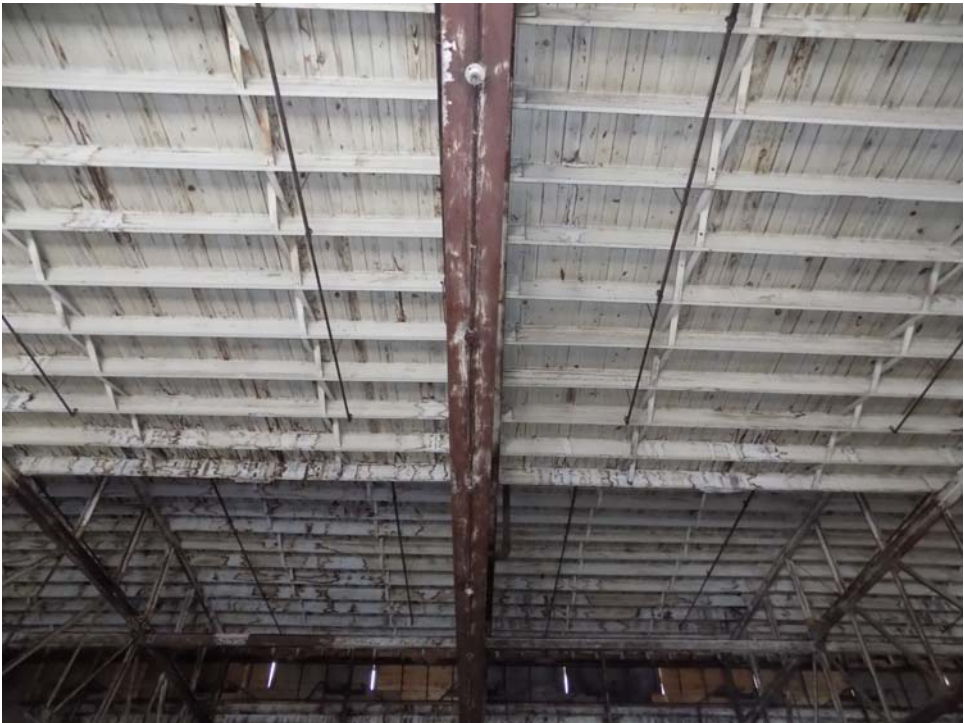
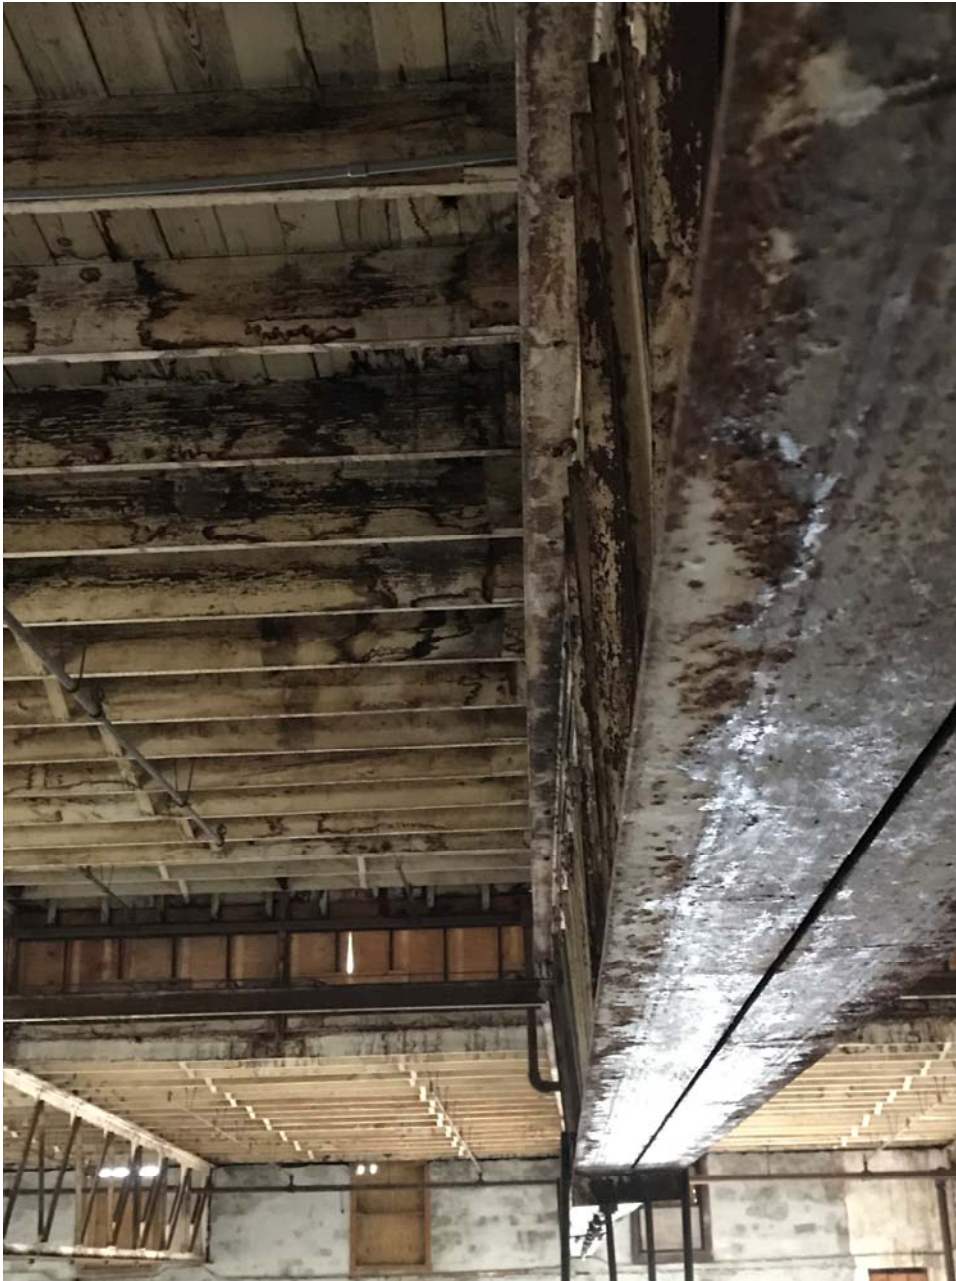
4. The third steel girder truss from west end exhibited significant visible lateral displacement and lateral-torsional displacement (twisting of bottom truss chord). The lateral displacement appeared to be greater than previous observations. The later-torsional displacement was not exhibited in previous observations. Refer to *Figure 6, Figure 7 and Figure 8*.

Figure 6: Third Truss from West End 09-25-2017

Figure 7: Third Truss from West End 09-25-2017

Figure 8: Third Truss from West End 09-25-2017

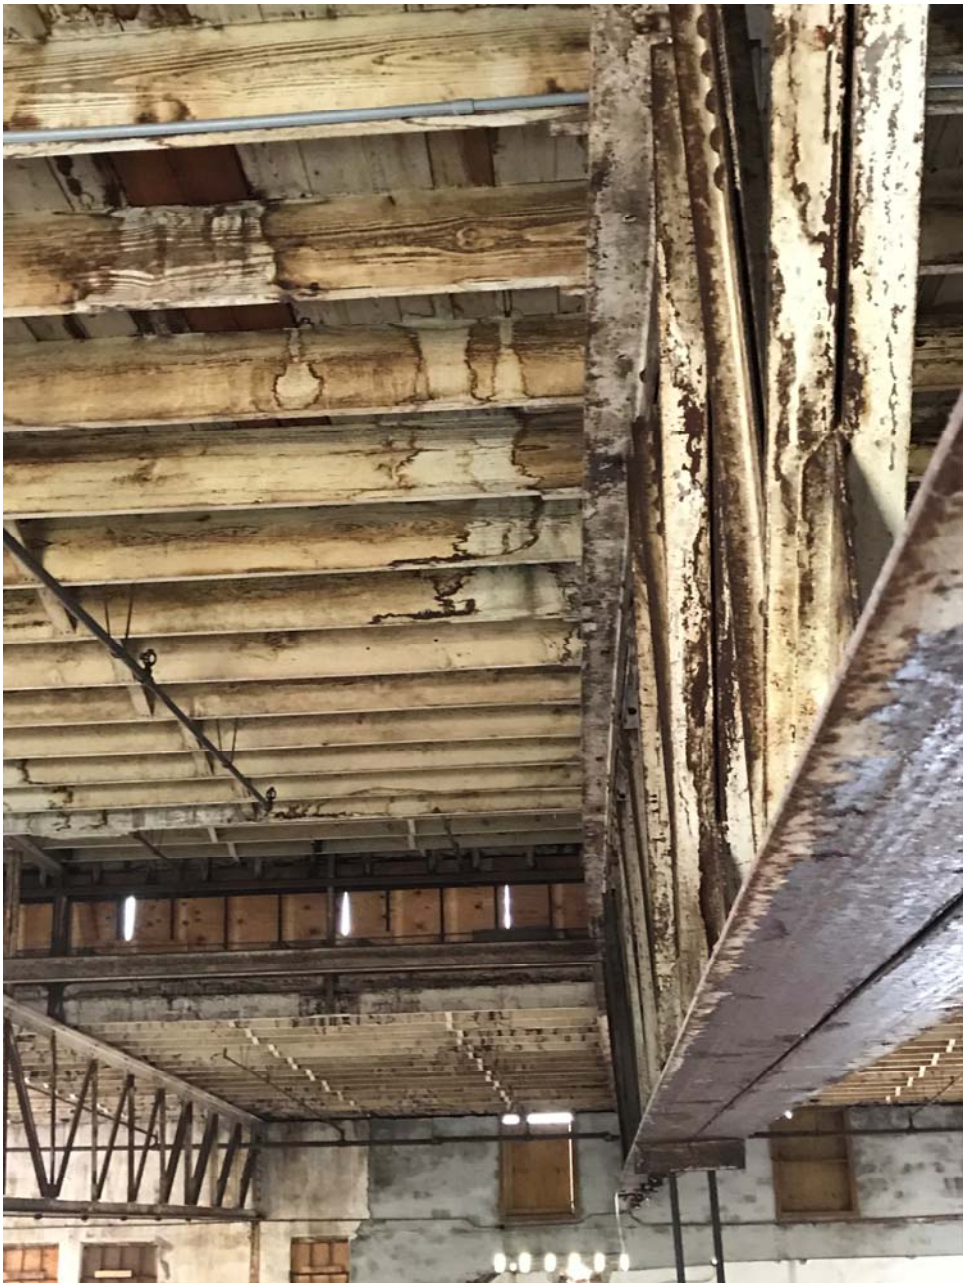
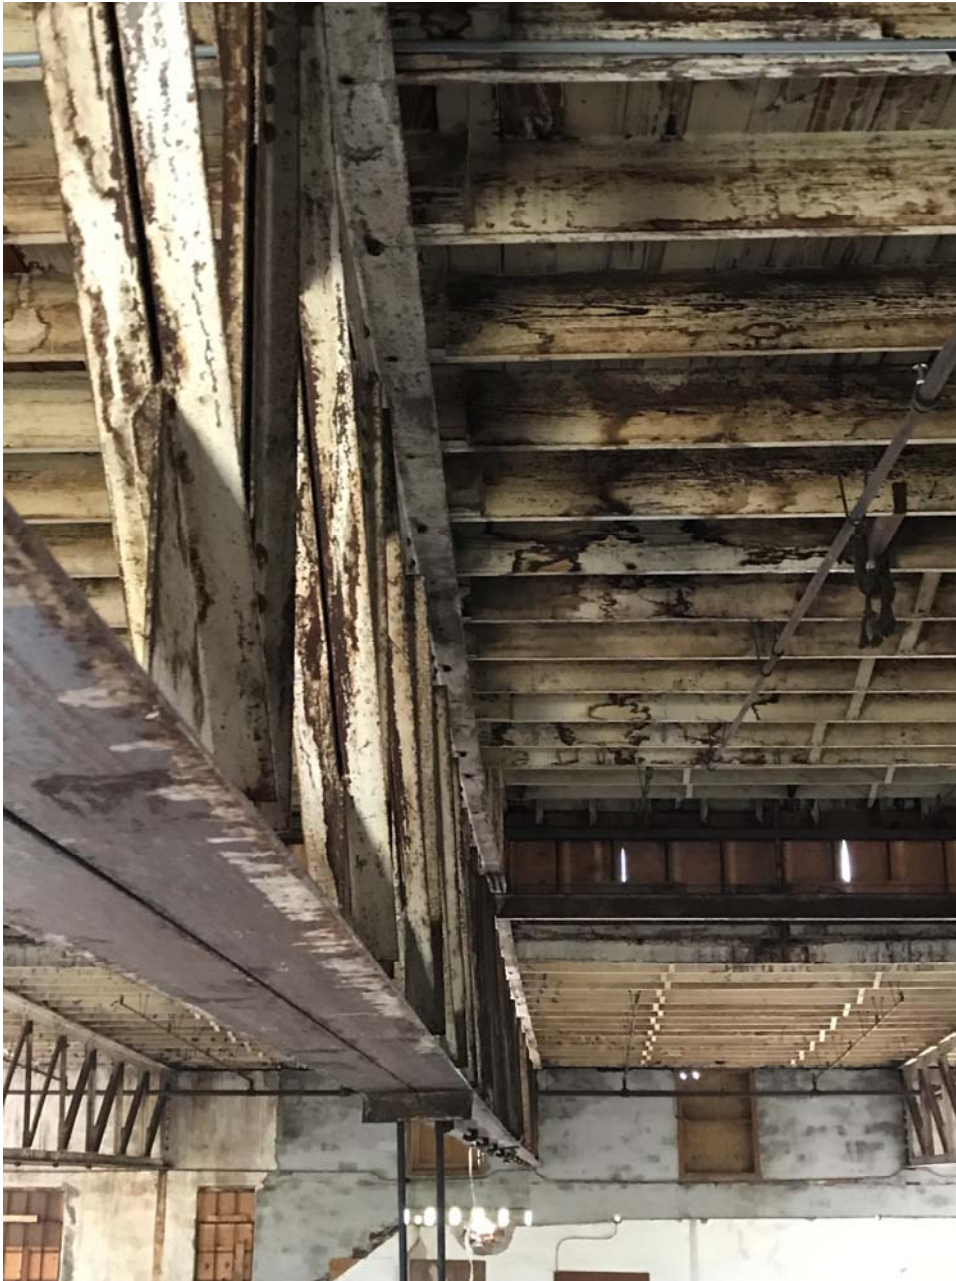
5. The fourth steel girder truss from the west end exhibited visible lateral displacement and lateral-torsional displacement (twisting). The lateral displacement appeared to be greater than previous observations. The later-torsional displacement was not exhibited in previous observations. Refer to *Figure 9 and Figure 10*.

Figure 9: Fourth Truss from West End 09-25-2017

Figure 10: Fourth Truss from West End 09-25-2017

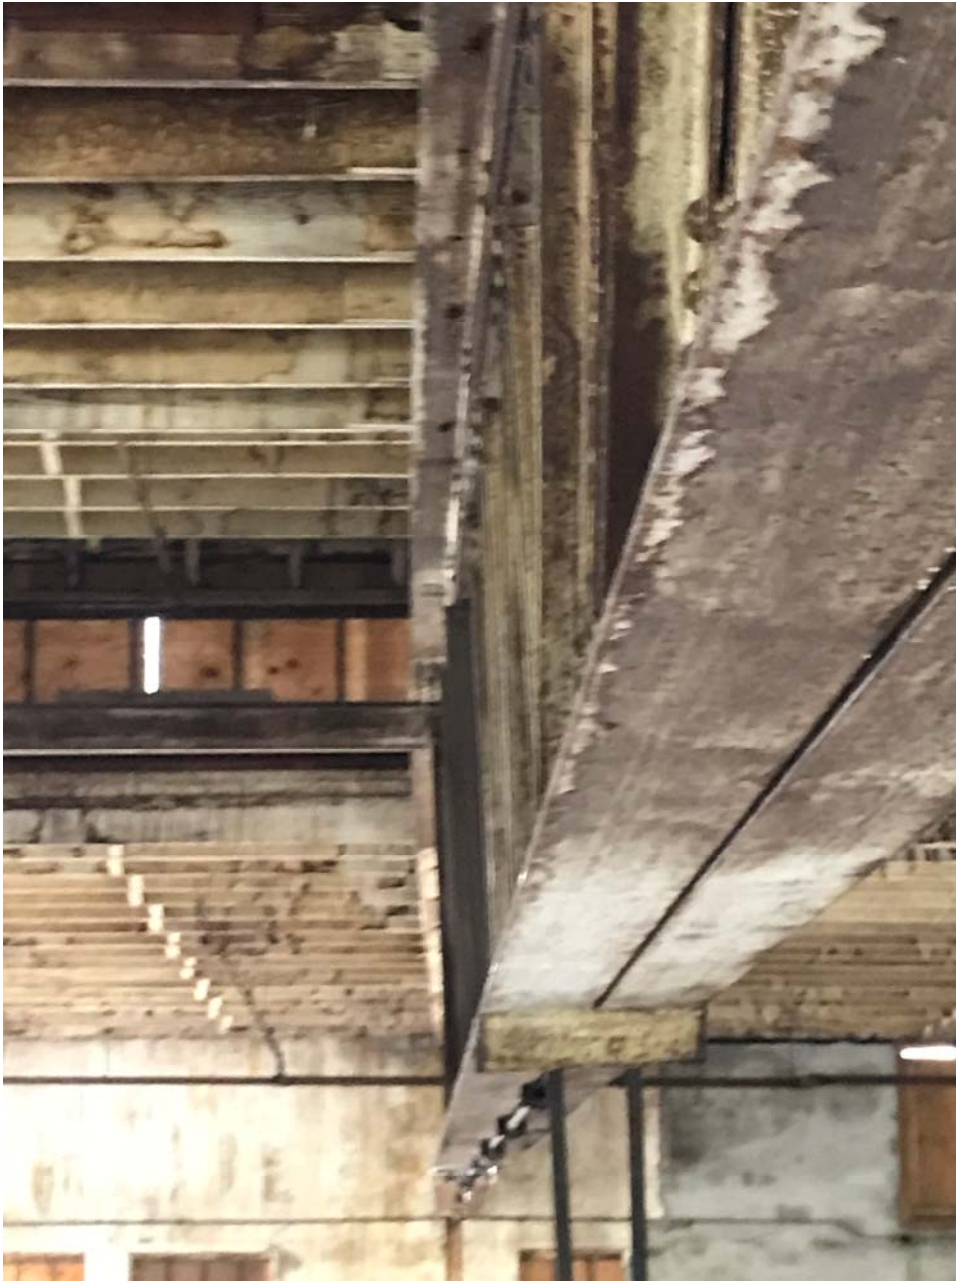
6. The fifth steel girder truss from the west end exhibited visible lateral displacement and minor lateral-torsional displacement (twisting). The lateral displacement appeared to be greater than previous observations. The later-torsional displacement was not exhibited in previous observations. Refer to *Figure 11*.

Figure 11: Fifth Truss from West End 09-25-2017

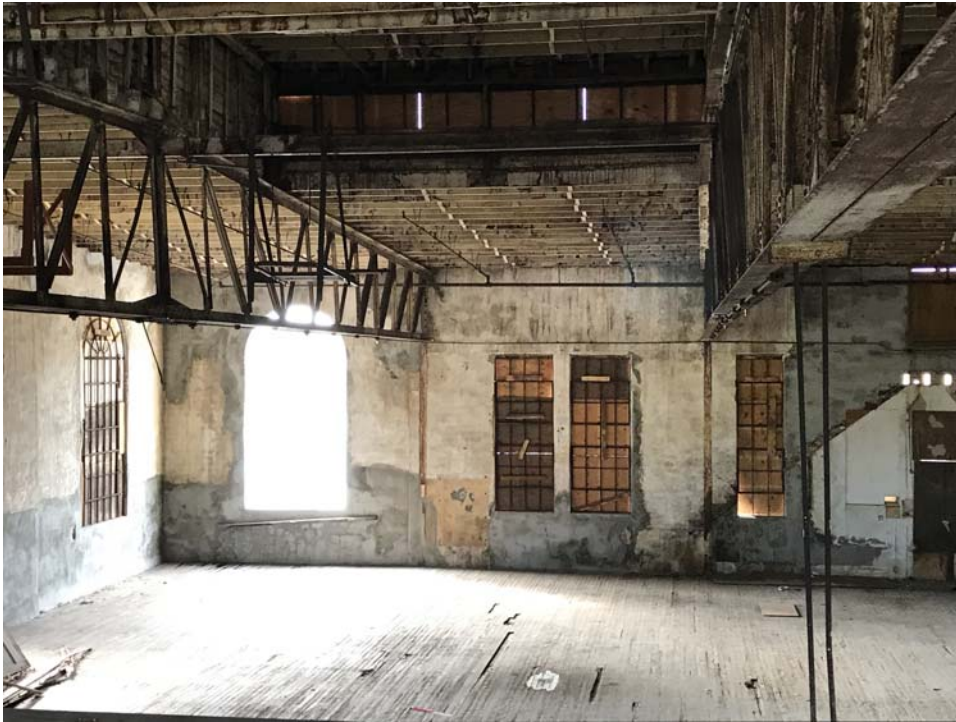
7. The sixth steel girder truss from the west end exhibited visible lateral displacement and minimal lateral-torsional displacement (twisting). The lateral displacement appeared to be greater than previous observations. The later-torsional displacement was not exhibited in previous observations. Refer to *Figure 12*.

8. The west window on the south building elevation has been dislodged. Refer to *Figure 12*.
9. The main roof was accessed during the site visit. The items noted may be related to the condition of the steel girder trusses.

Figure 12: Sixth Truss from West End and dislodged window 09-25-2017

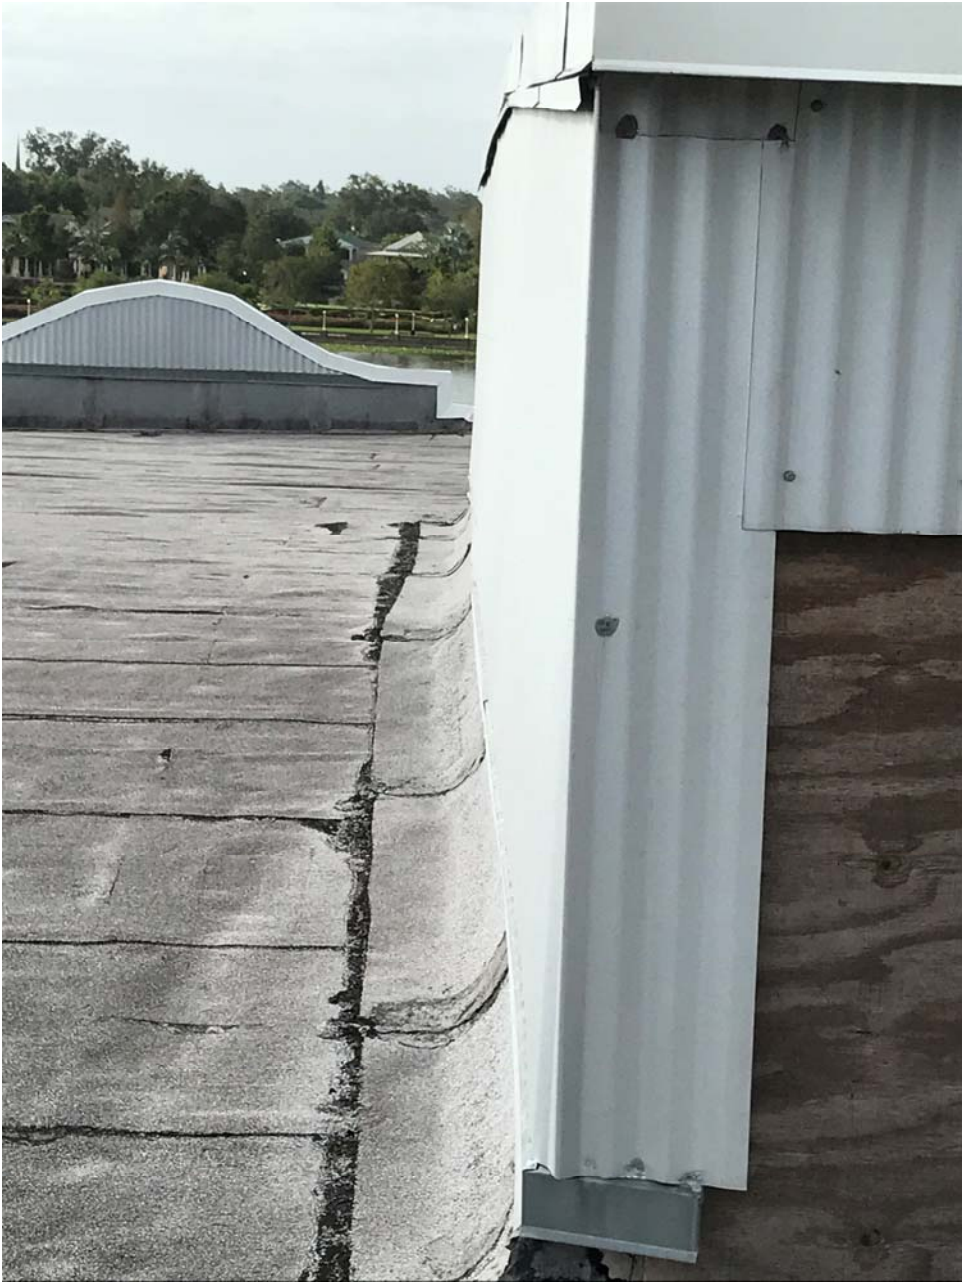
- a. The east end of the clearstory appeared to be bowing outward toward the west. Roof system exhibited minor buckling. Refer to *Figure 13*.
 - b. The east wall parapet exhibited displacement toward the west. Refer to *Figure 14*.

Figure 13: East end of Clearstory 09-25-2017

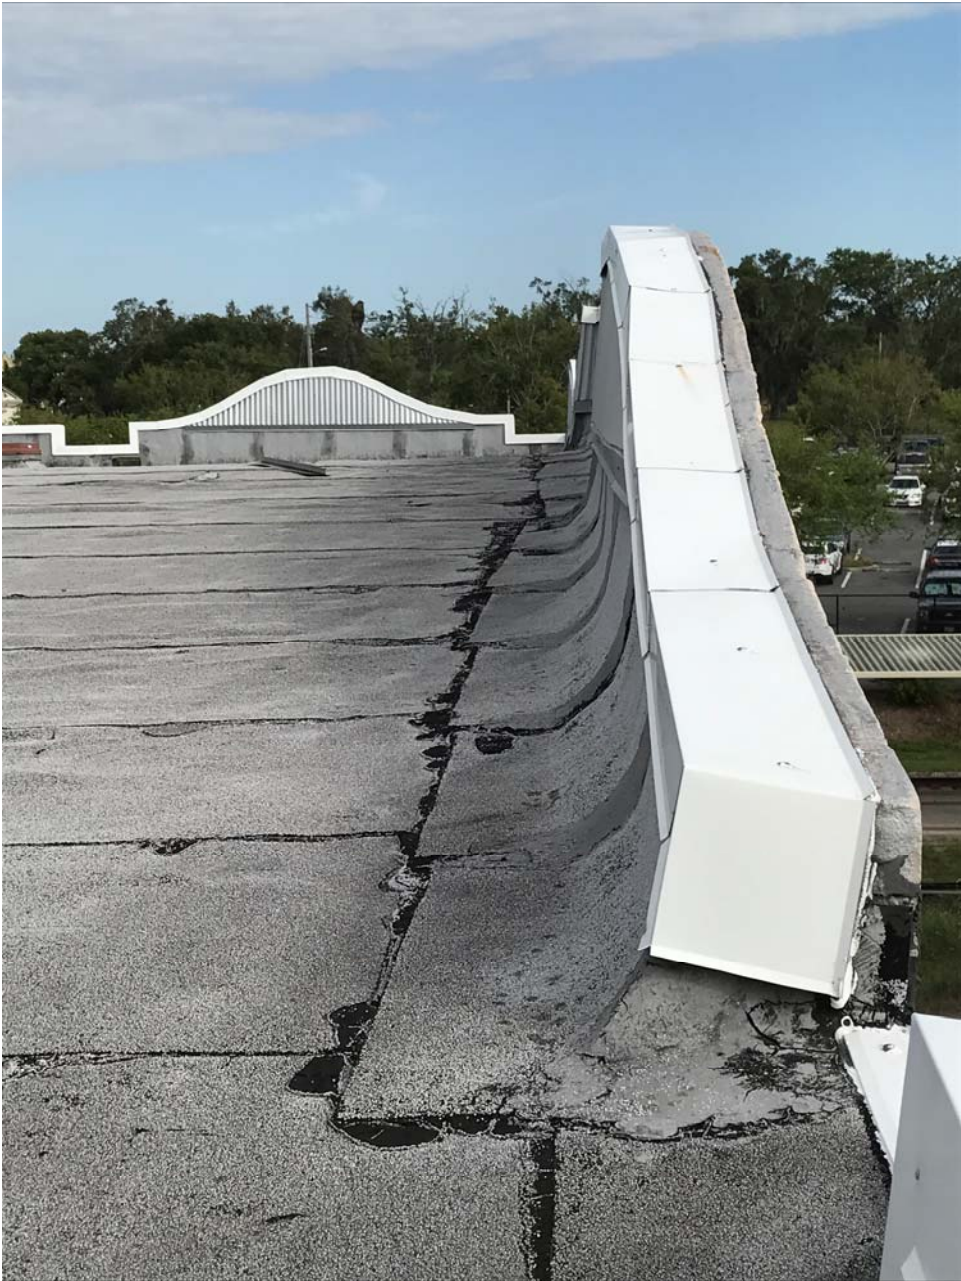
Figure 14: East Parapet 09-25-2017
