Subject: Limited Visual Structural Evaluation – Hurricane Irma

Catapult
2.0

Cash Feed Building Renovation
502 E Main Street, Lakeland, FL

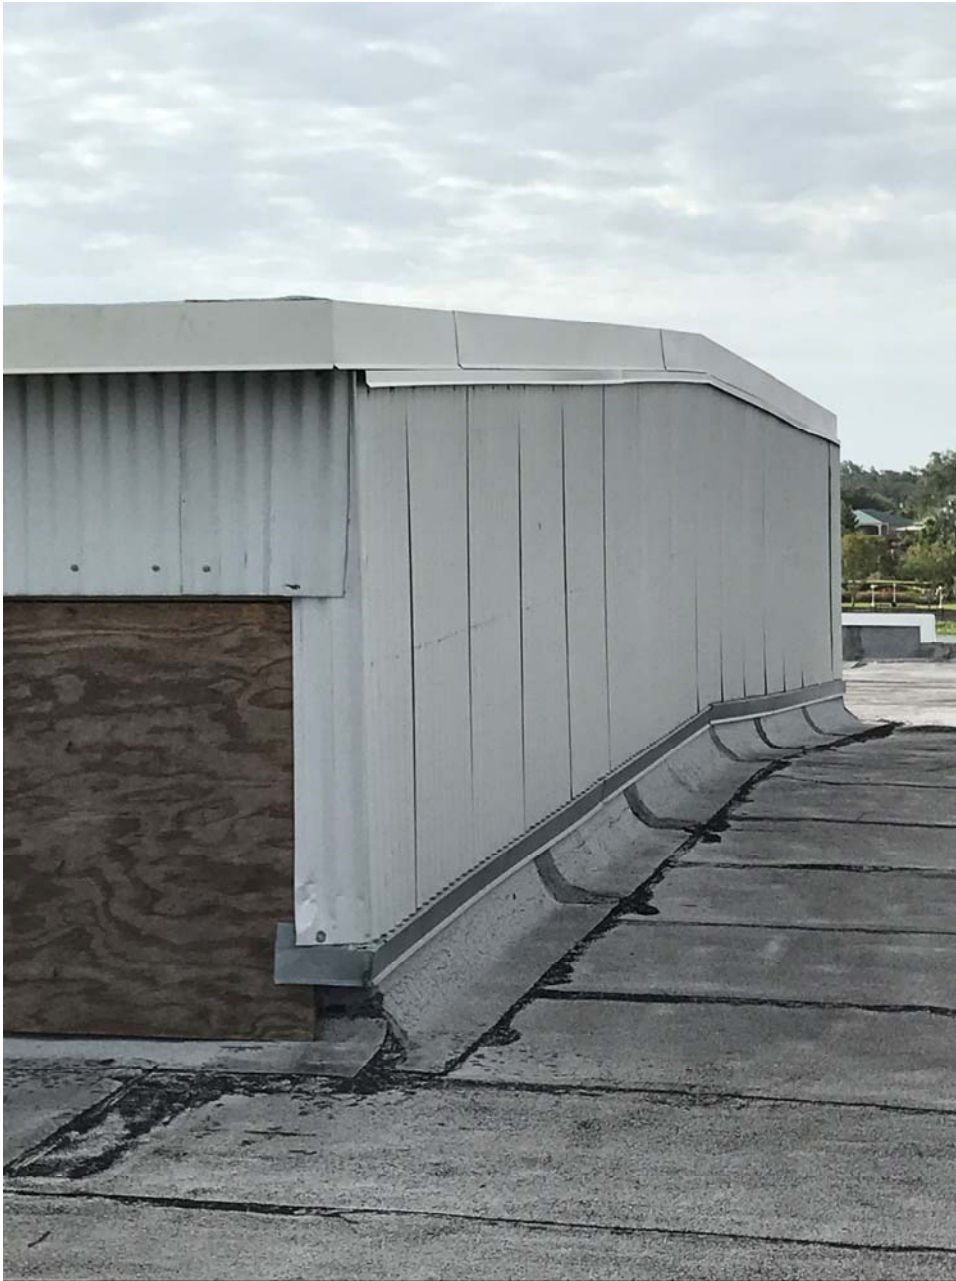
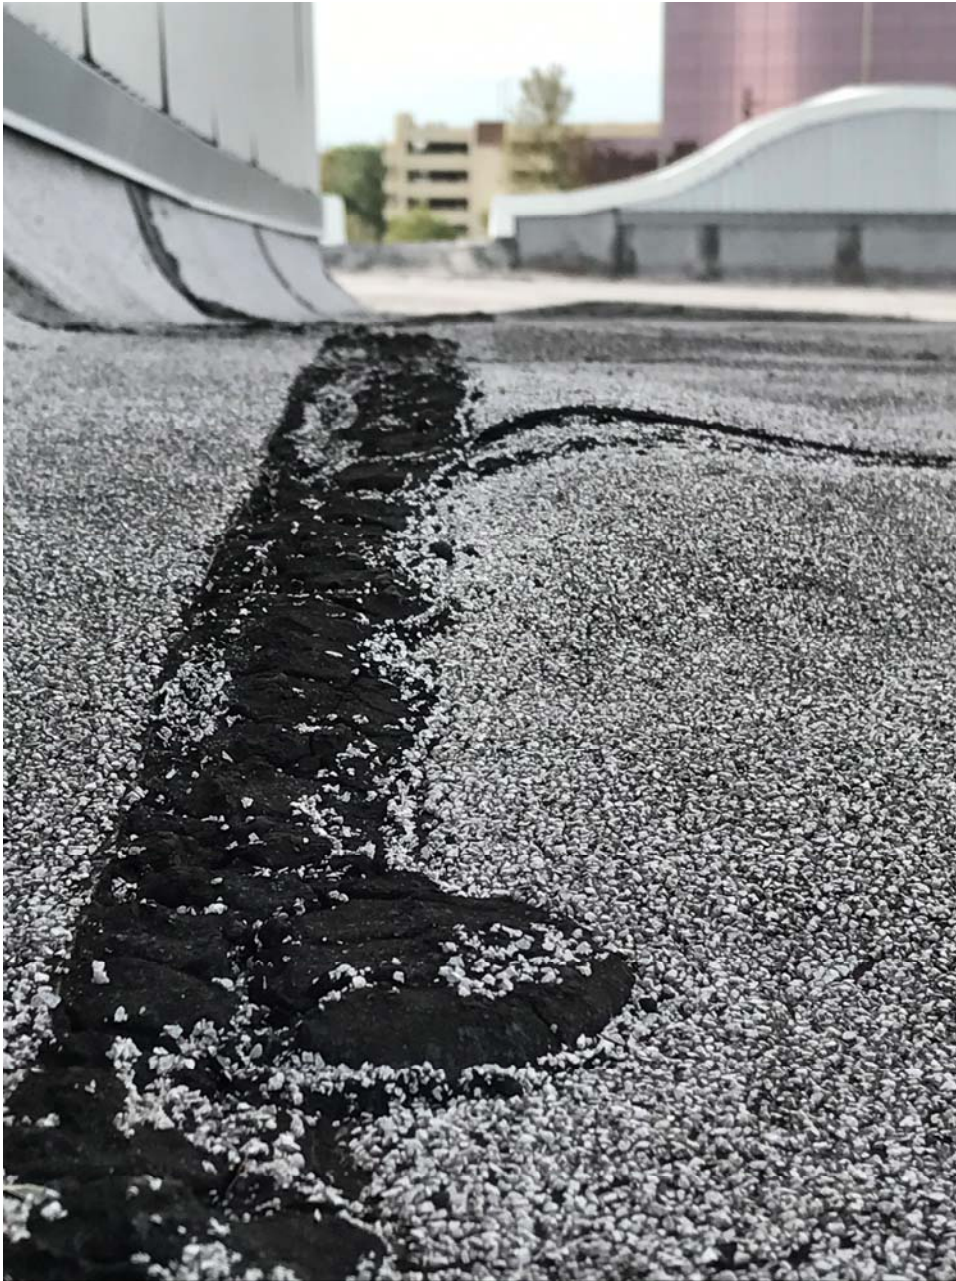
- c. The west end of the clearstory appeared to be displaced – differential movement between top eave and bottom interface with main roof. Roof system exhibited minor buckling. Refer to *Figure 15* and *Figure 16*.

Figure 15: West end of Clearstory 09-25-2017

Figure 16: West end of Clearstory – roof system buckling 09-25-2017

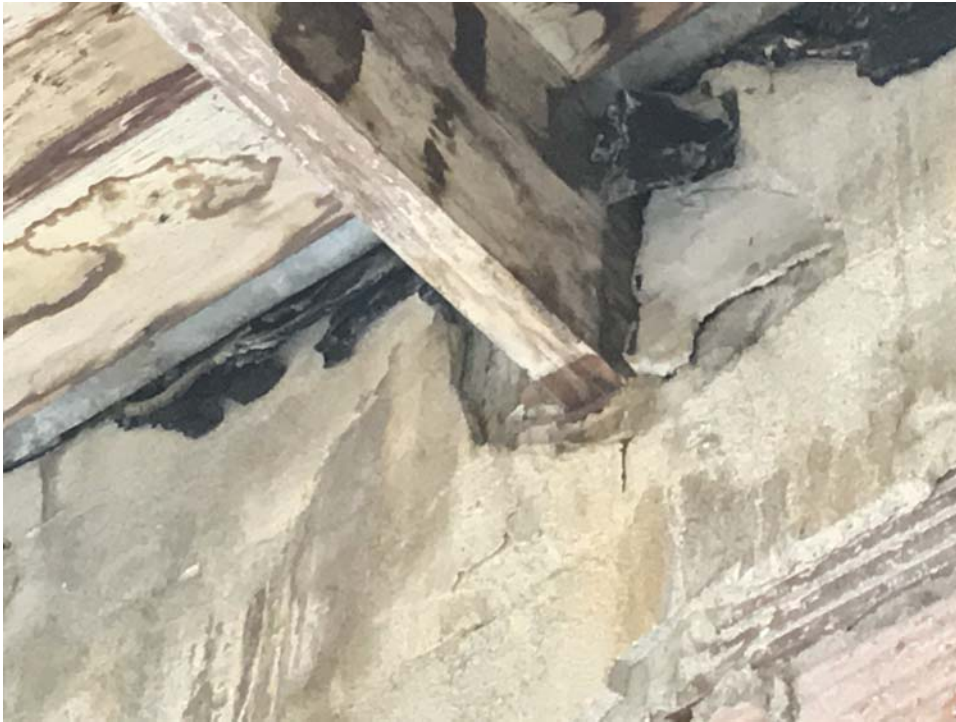
10. Timber roof rafters bearing on the west wall appear to have been displaced. Some of the displacement was exhibited in previous observations. Some minor additional displacement may have occurred. See *Figure 17*.

Figure 17: Timber roof rafter bearing at West Wall 09-25-2017

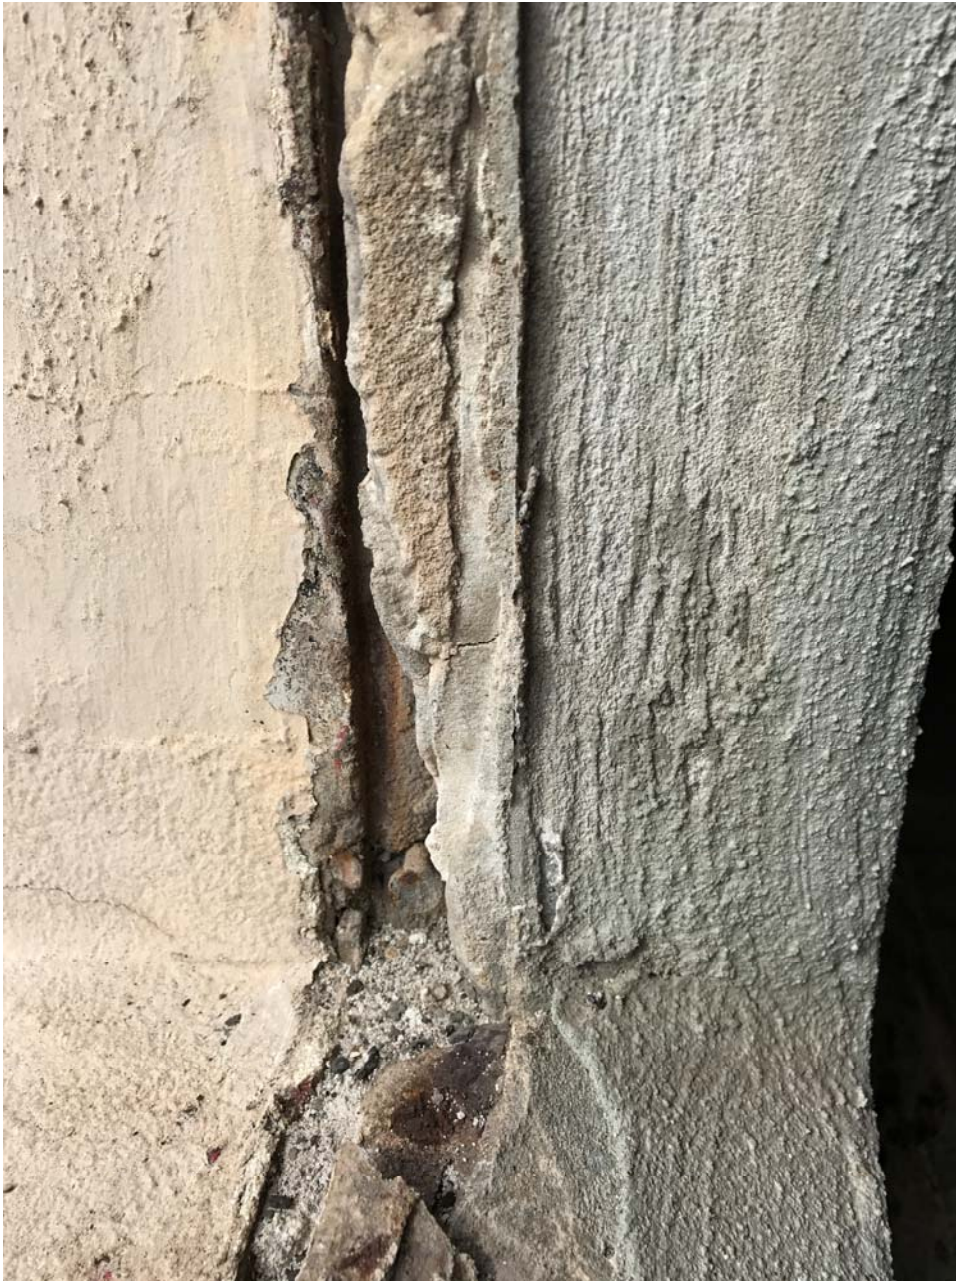
11. Anchorages and window frame failed at the west window on the south building elevation. See *Figure 18*. This occurrence now elevates the concern that all existing windows and window and door openings are compromised from the storm event.

Figure 18: Sill and jamb of dislodged window

8. Window and door openings (sills, headers, jambs) fully evaluated and supplemented with integral grouting as required. Develop window and door fastening protocol.
