MEMORIAL FIELD TENNIS BUBBLE

Post Installation Report

December 16, 2016

Arcadis of New York, Inc.

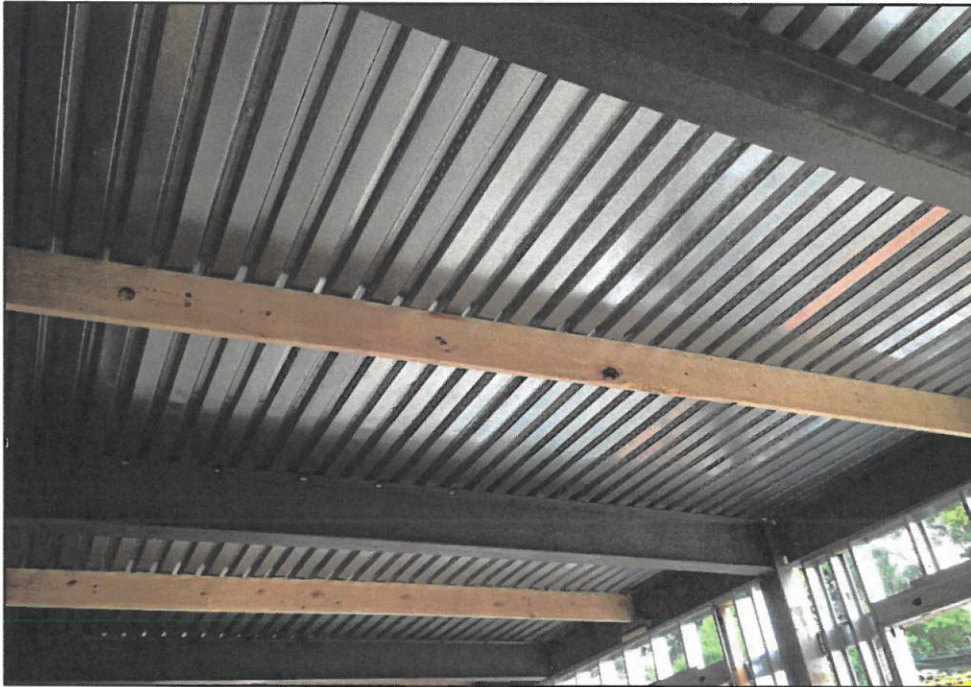
Photo: 1

- The metal decking that supports the concrete on the second floor was accepted by the City as 22-gauge thick steel. The design drawings call for 18-gauge thick steel, a much stronger decking. The installation of the thinner material required temporary shoring to be designed, and installed while the concrete cured and developed strength.
- Connection plate at the top of the building was modified to allow the bubble fabric to connect to the top steel box beam. The original design had fabrication and installation design deficiencies preventing that connection. Arcadis developed four alternative attachment scenarios and sent them to Arizon for their comment and approval.

Metal decking was too thin requiring additional support to hold concrete during placement.

Underside of second floor metal decking.

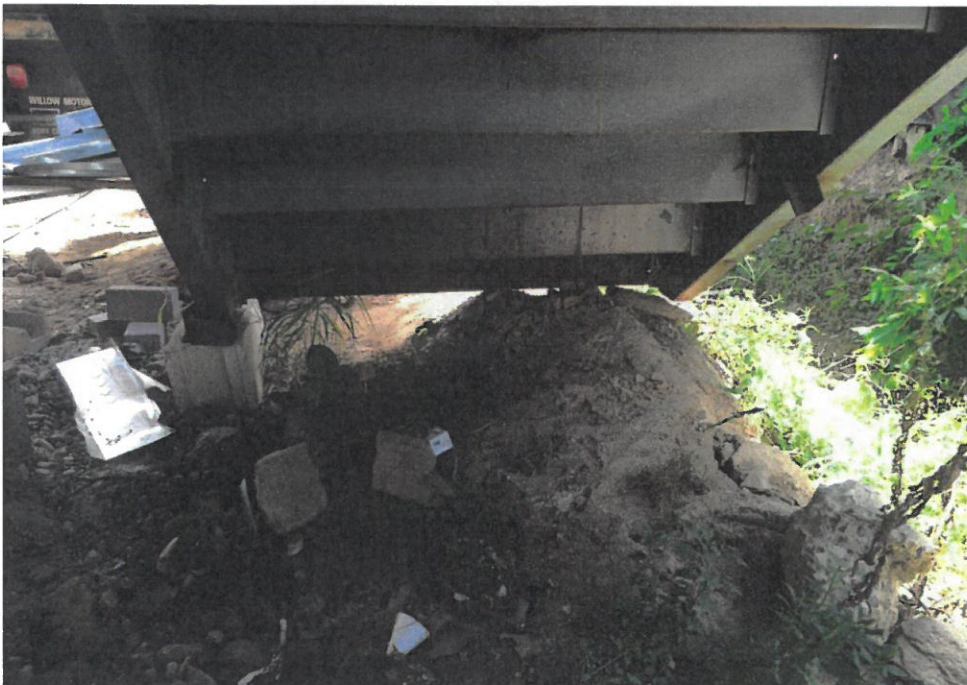
Photo: 2

Steel stairs fabricated incorrectly and improperly supported due to there being no floor slab.

First floor south stair.

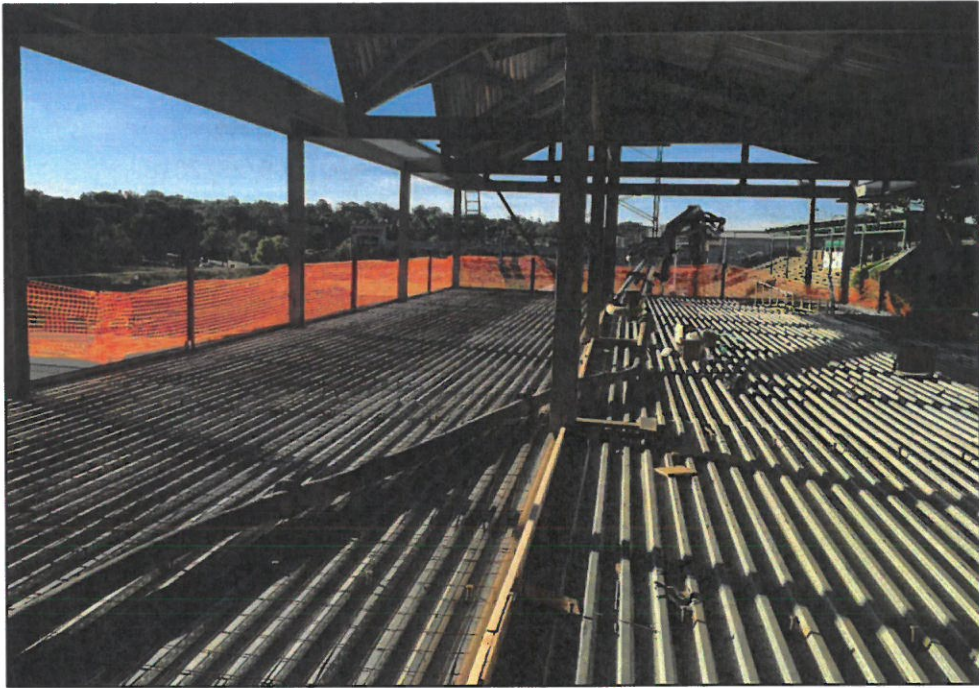
Photo: 3

- East half of the building's second floor concrete slab is poured by Landi, after wood shoring is installed below to compensate for deficient structural conditions there were present at the time of the first Arcadis construction oversight engagement. Sept. 26, 2016. (Photo 3)

Description:
Slab reinforcing only added
after Arcadis inspection.

Location:
Second floor slab.

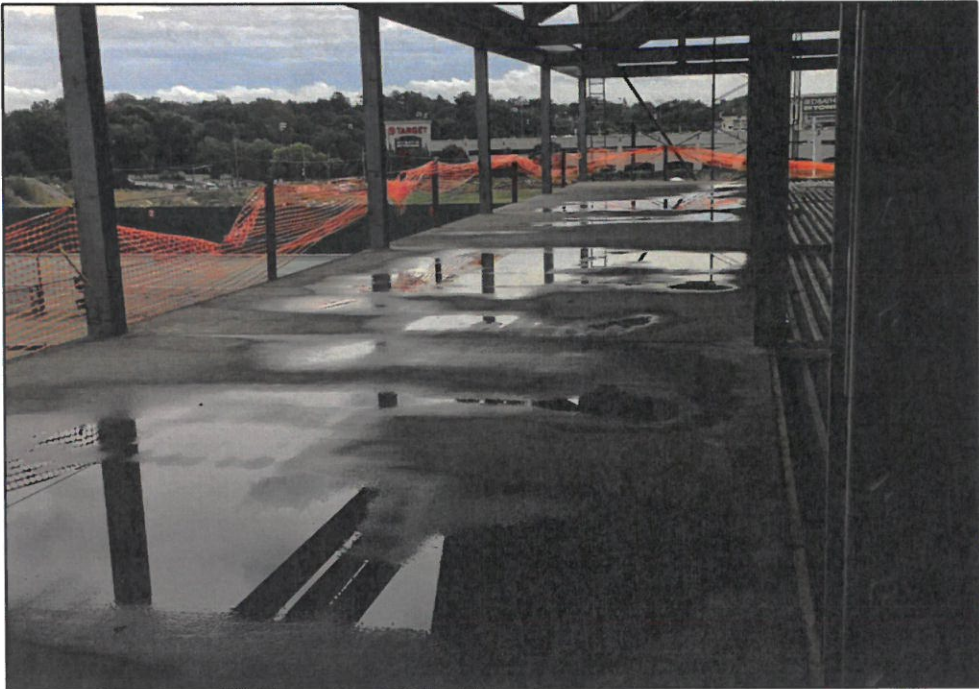
Photo: 4

Description:
First concrete pour in 2016.
Second floor eastern side.
Post rain event

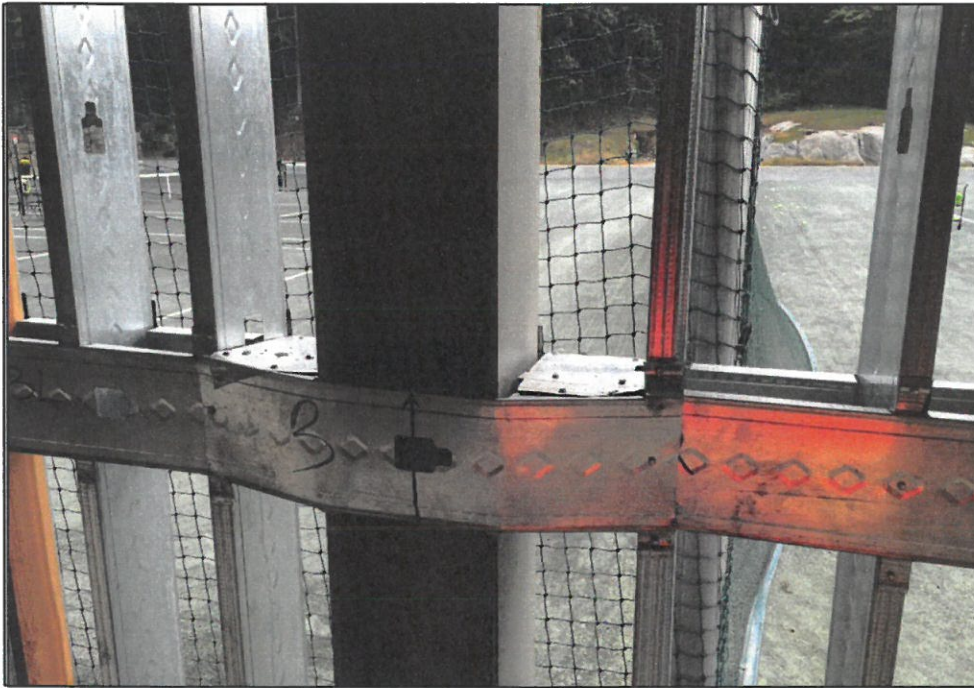
Photo: 5

Description:
First floor walls improperly built: metal gauge is too thin, strapping at column is incorrect detail, wall is reinforced with wood.

Location:
First floor east wall.

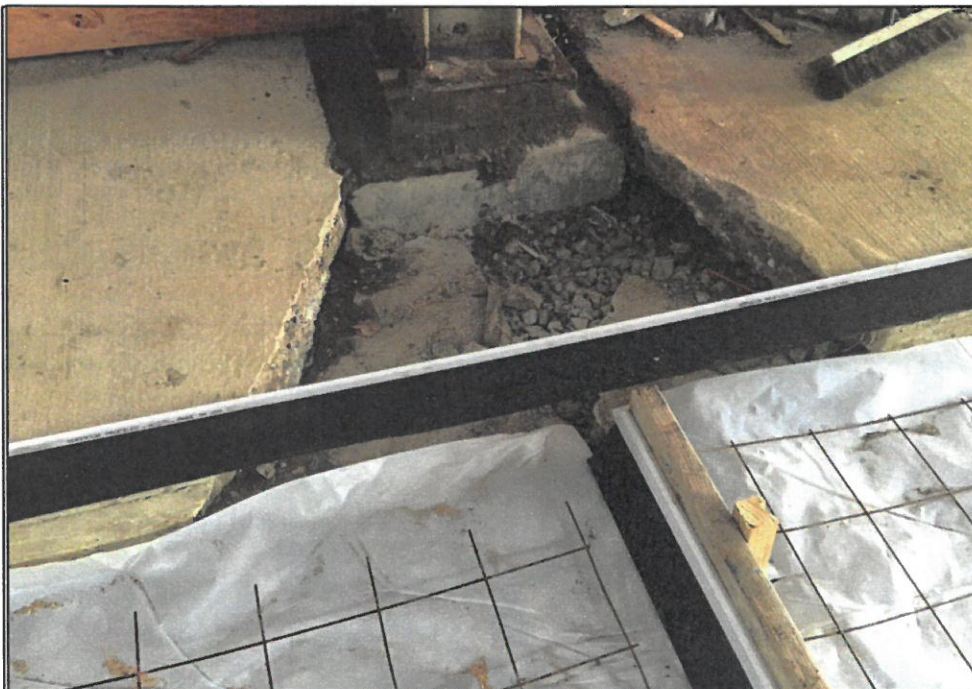
Photo: 6

Description:
Initial concrete poured without reinforcing or vapor barrier

Location:
First Floor Slab.

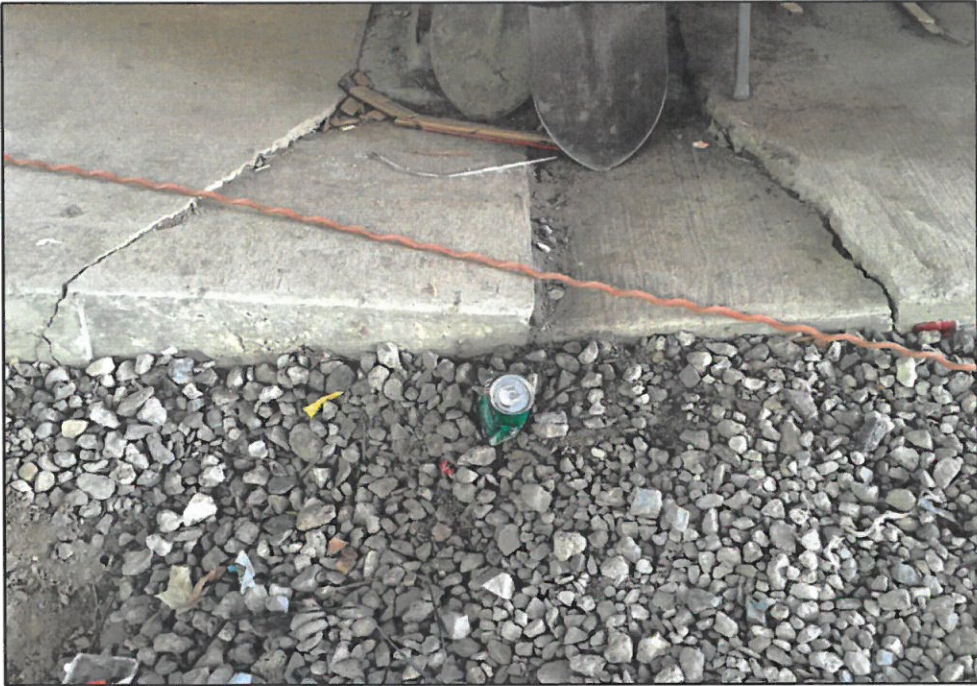
Photo: 7

Description:
Improper first floor slab
resulted in severe cracking
and settling.

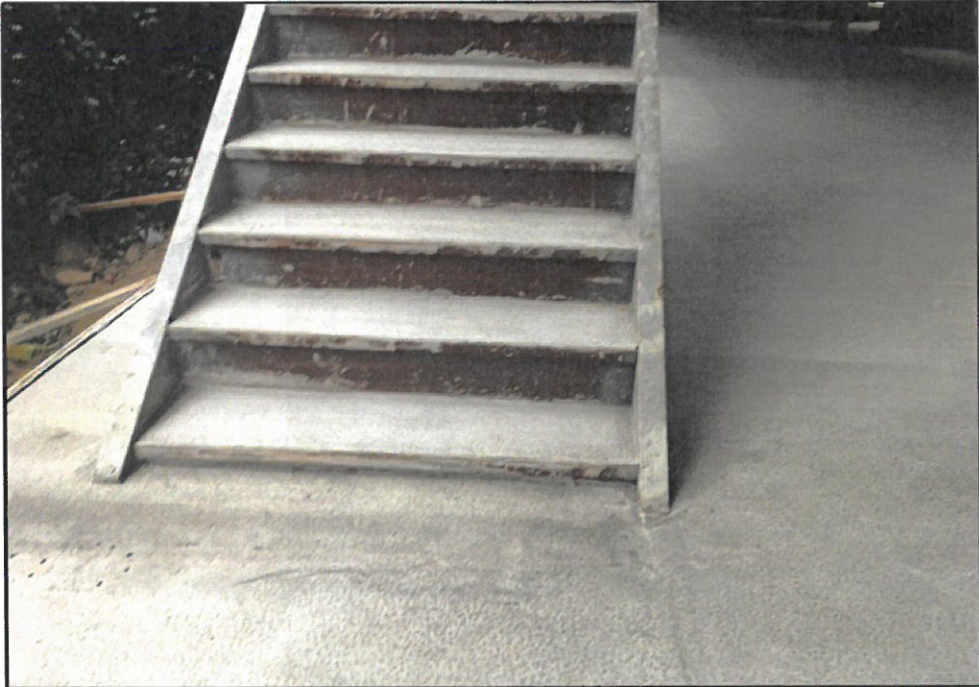
Photo: 8

Description:
Metal stair runners were not
set correctly and create a half
step on first step. Remedy has
been identified

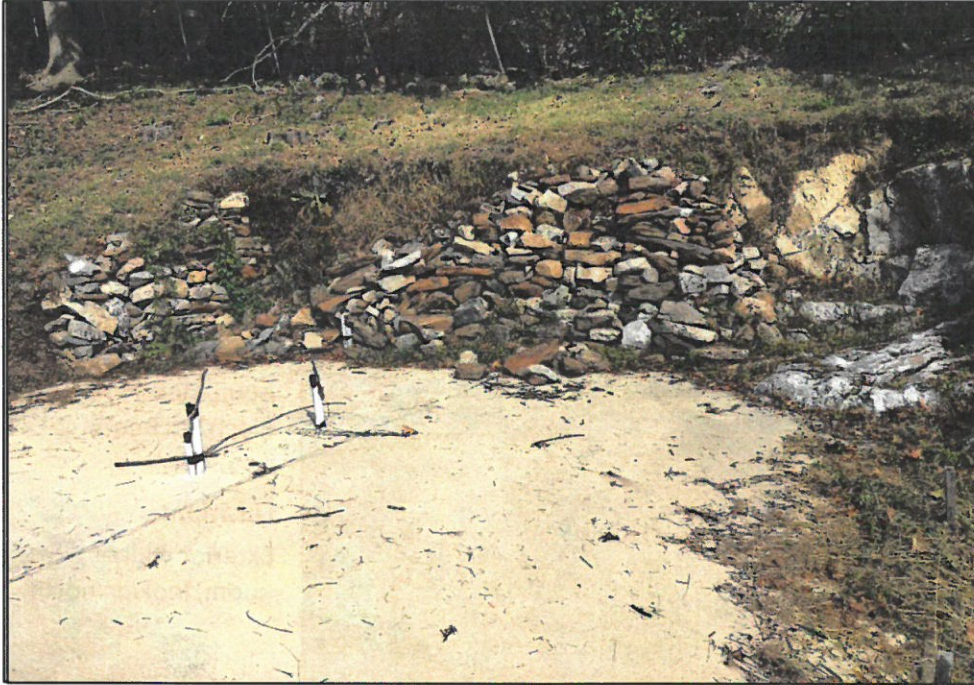
Photo: 9

Description:
Mechanical equipment pad. Electrical conduits are in the wrong location and the retaining wall in the rear has failed.

Location:
East side of courts

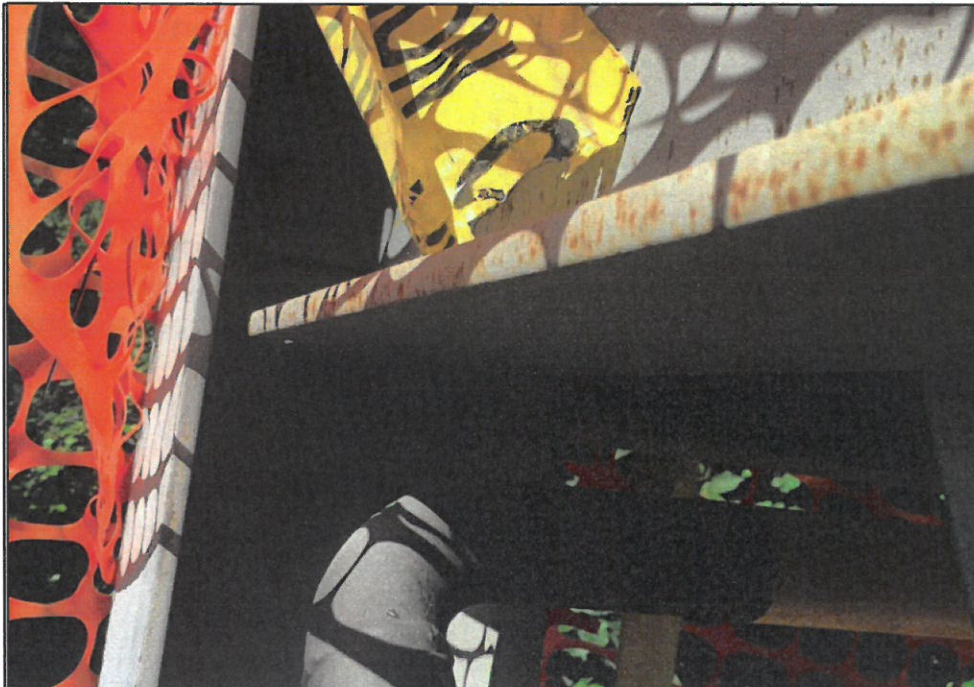
Photo: 10

Description:
Steel beam placed 1-1/2" out of level.

Location:
South second floor.

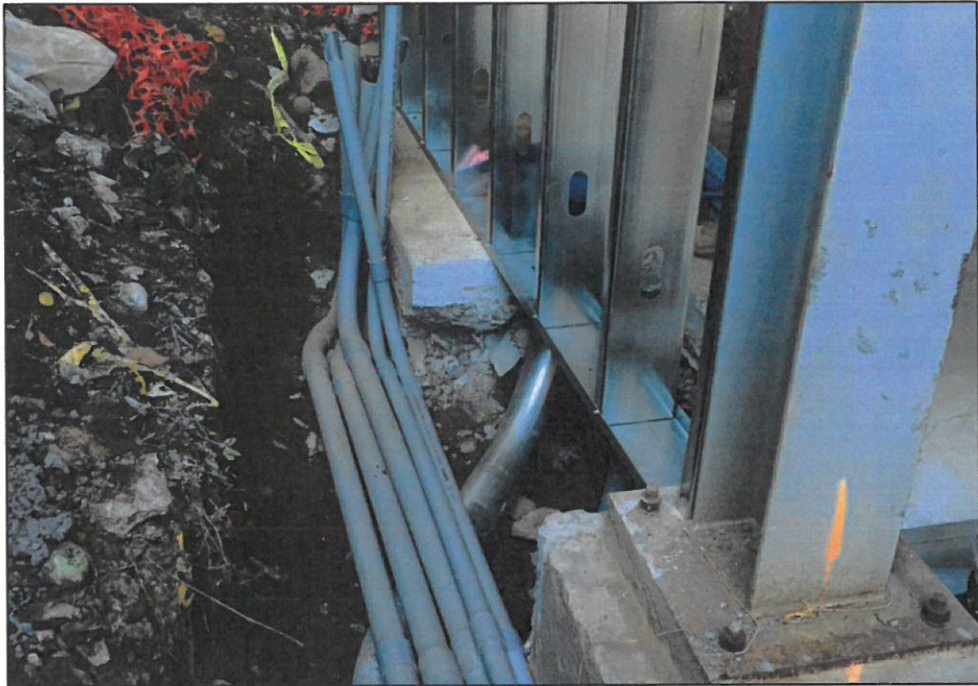
Photo: 11

- C. Williams starts the installation of the electrical service from the existing power pole via an earthen trench on the west side of the building to the proposed electrical room. (Photo 11 & 12) Oct. 11, 2016

Description:
Underground service conduit from Con Ed utility pole and feeder conduits from field equipment, routing to Electrical Room.

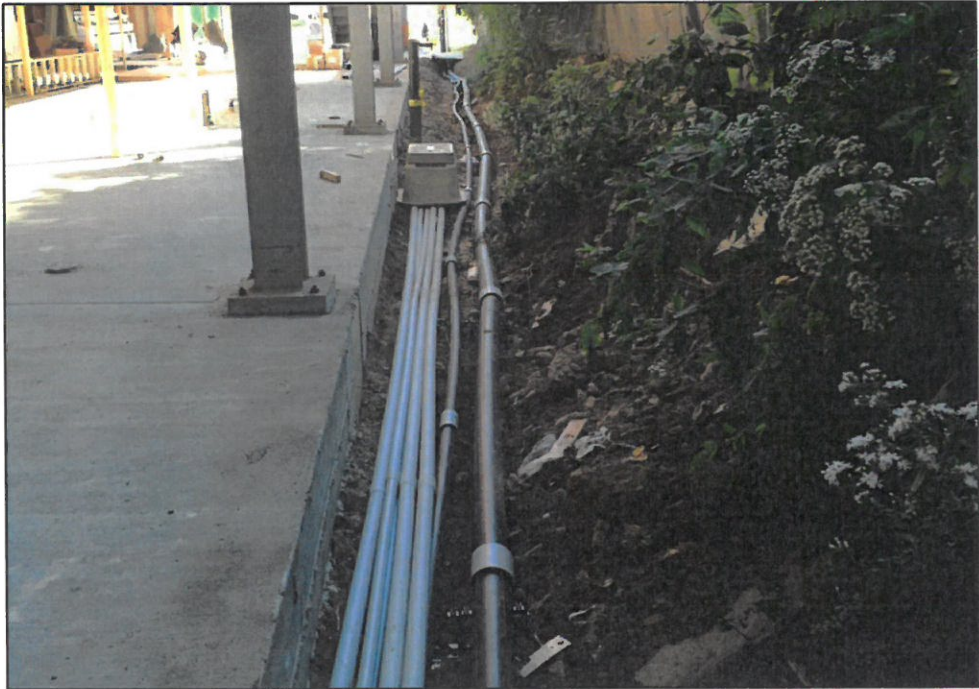
Photo: 12

Description:
Underground conduits laid in trench before ductbank installation

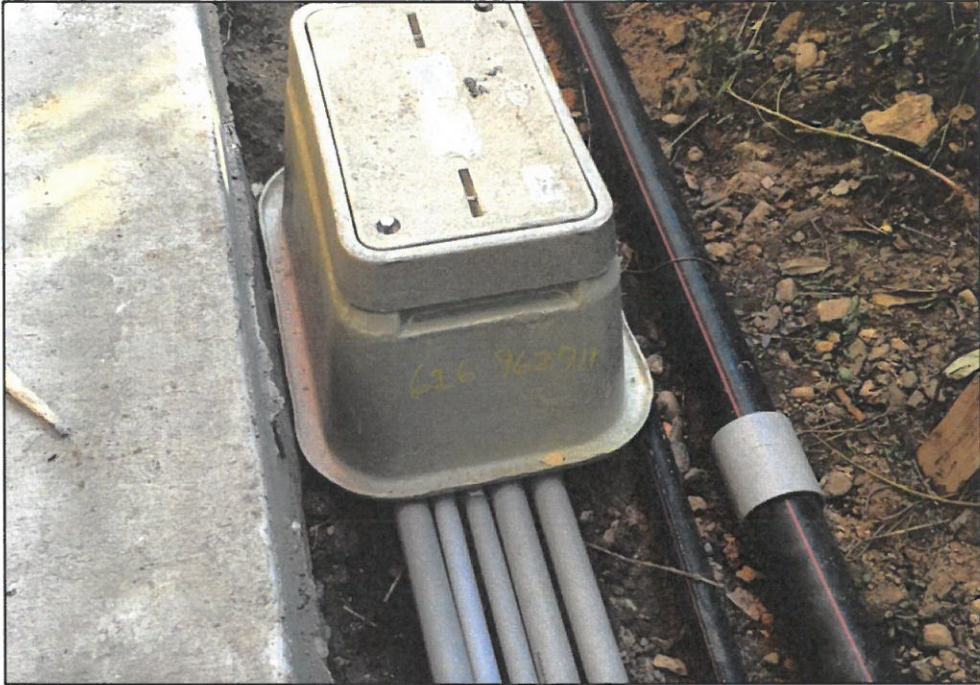
Photo: 13

- Con Ed underground electrical service conduit is, sketched, formed and encased in a concrete ductbank and backfilled. Oct. 26, 2016
- Arcadis oversees Arizon's air handling unit (AHU-2500) placement and coordinated electrical connection utilizing the existing conduits crossing the tennis courts. (Photo 13) Oct. 28, 2016

Description:
Underground pull box,
intercepting existing conduits
to route to Electrical Room

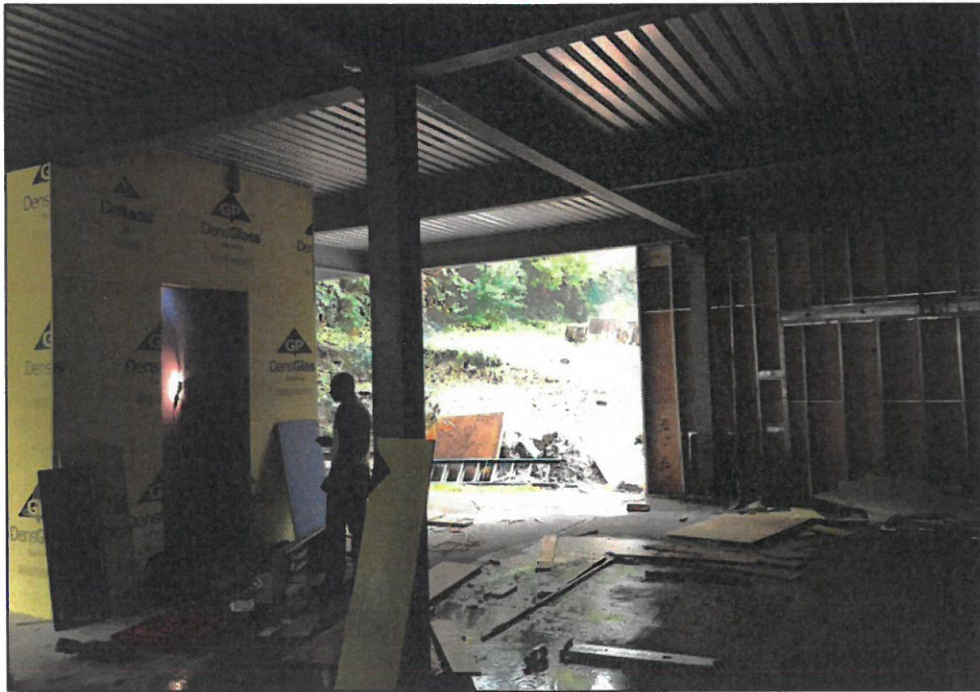
Photo: 14

- Guy wire on the existing electrical pole is installed to provide additional support, conforming to Con Ed specification. Con Ed overhead service cable is connected to new underground service cable. Electrical equipment in the electrical room is energized and tested. (Photo 14) Nov. 7, 2016.

Description:
Electrical Room under
construction

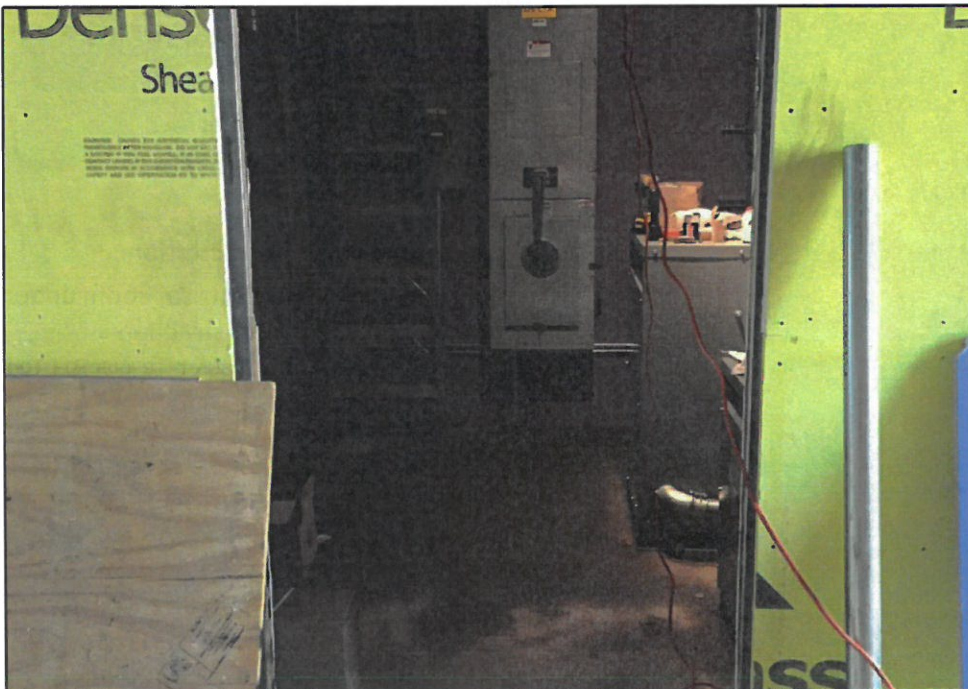
Photo: 16

- Electrical equipment in the electrical room is finished and inspected. Con Ed inspects the underground feeder conduit for the main service. (Photo 16) Oct. 31, 2016.

Electrical Room

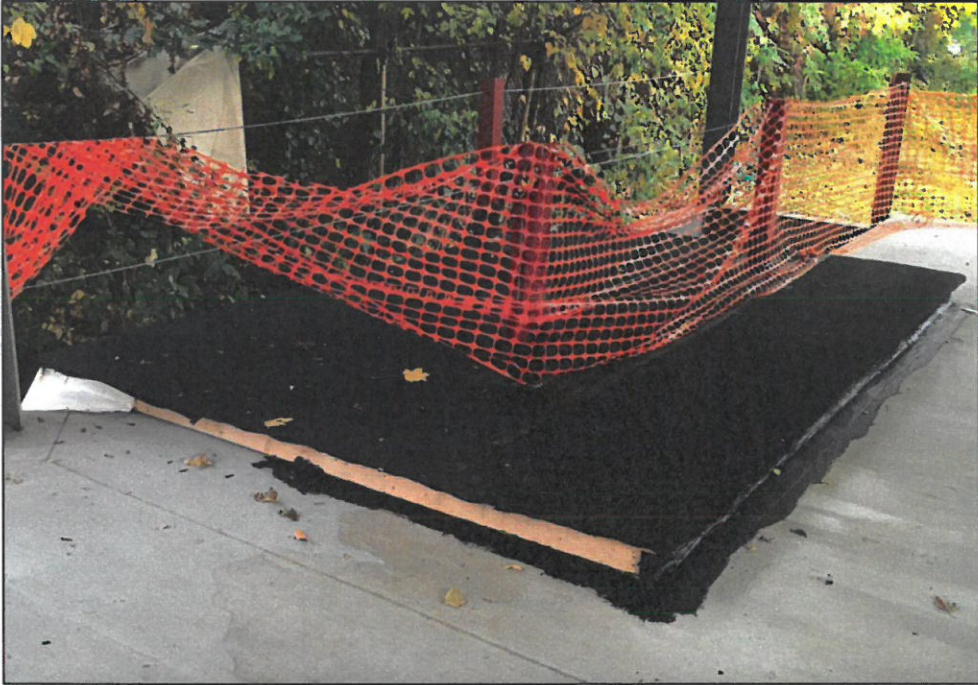
Photo: 17

Description:
Temporary roof built on the second floor slab to protection the first floor electrical room from rain

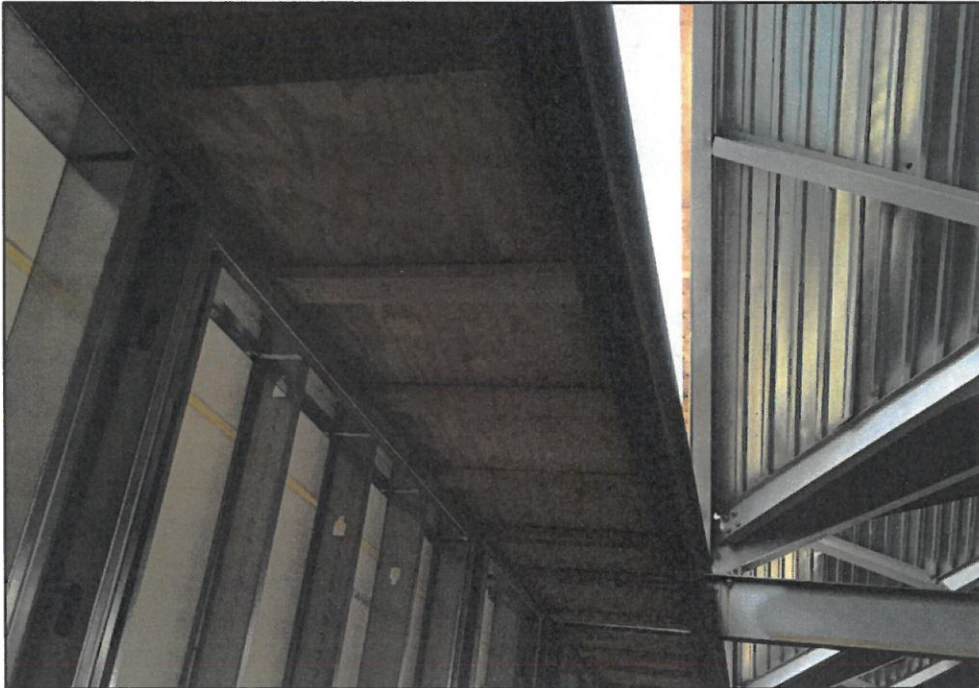
Photo: 18

- Concrete pads were designed outside of each emergency exit door.
- Rain gutter details were designed, partially installed. (photo 18)

Description:
Top of building's east wall. Plywood acting as a walkway for fabric installation and as gutter for rain drainage.

- Installation of a temporary gutter system and storm water piping to drain rain water and snow melt that comes off the west side of the tennis bubble and the east side of the building's roof. (Photo 18)

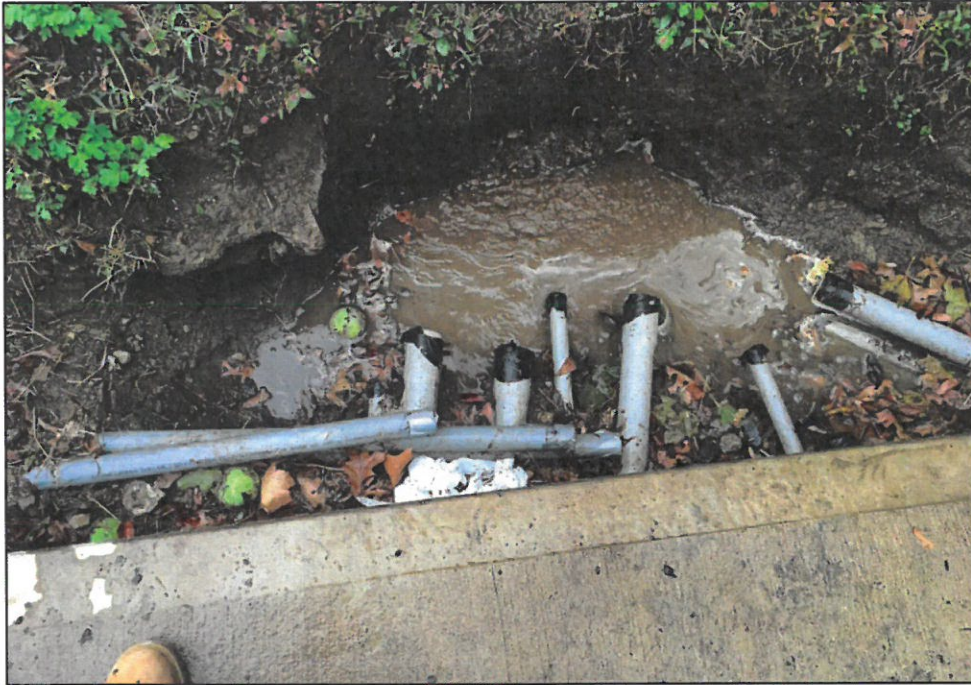
Photo: 19

- Existing conduits are cleaned with assistance from the City. Feeder cables for AHU and ATS are installed in existing conduits between the main building and the field equipment pad. (Photo 19 & 20) Nov. 3, 2016

- The electrical design had not been started.
- The electrical conduits that were installed underneath the tennis courts, by the City, were not documented on the drawings or in any written form. This caused a significant amount of investigation time and rework to remedy this situation. The mechanical equipment pad was not coordinate with Arizon's equipment layout and a work-around had to be developed to accommodate this situation. (Photo 19)

Description:
Undocumented electrical
conduit. Field testing proved
them connected to building's
west side

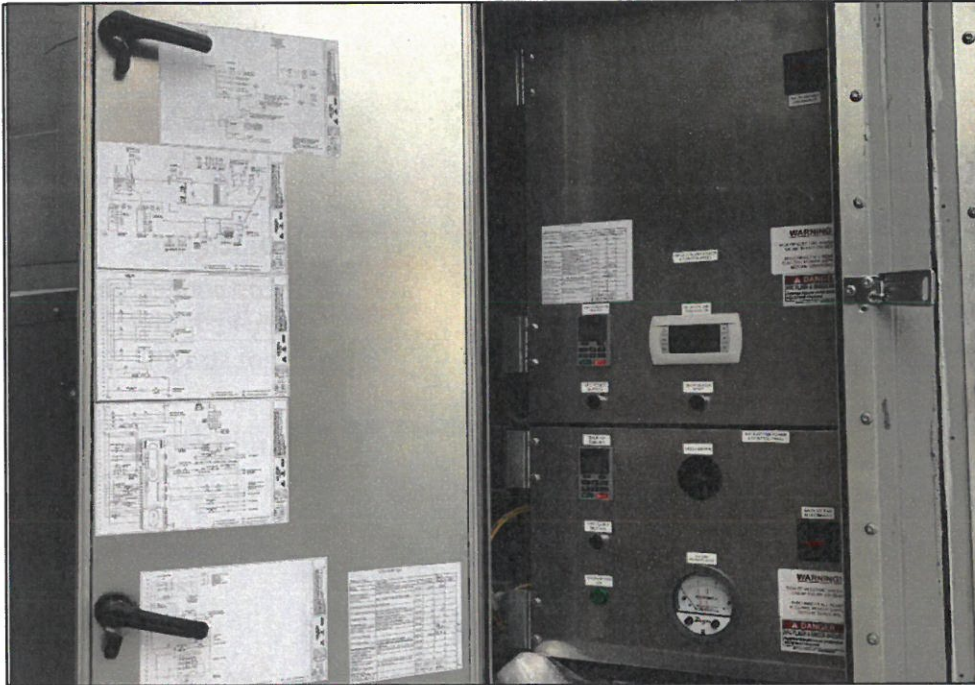
Photo: 21

- Electrical installation of AHU is finished and tested. (Photo 21) Nov. 10, 2016
- Coordinated the steel plate locations on the roof, the steel angles on the perimeter wall, directed the installation and connection of the standby generator to the AHU, and verified that the doors and locks were installed at the entrance hallway and electrical room. Nov. 14, 2016

Description:
Power/Control Cabinet of Air
Handling unit

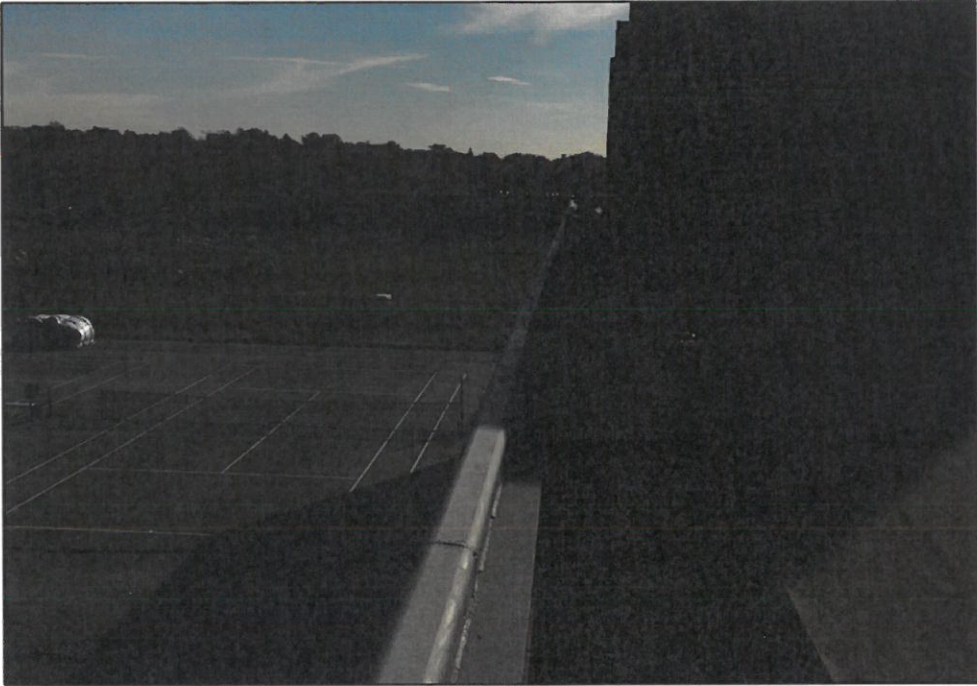
Photo: 23

Description:
Top connection box beam.
Building steel members are
not straight

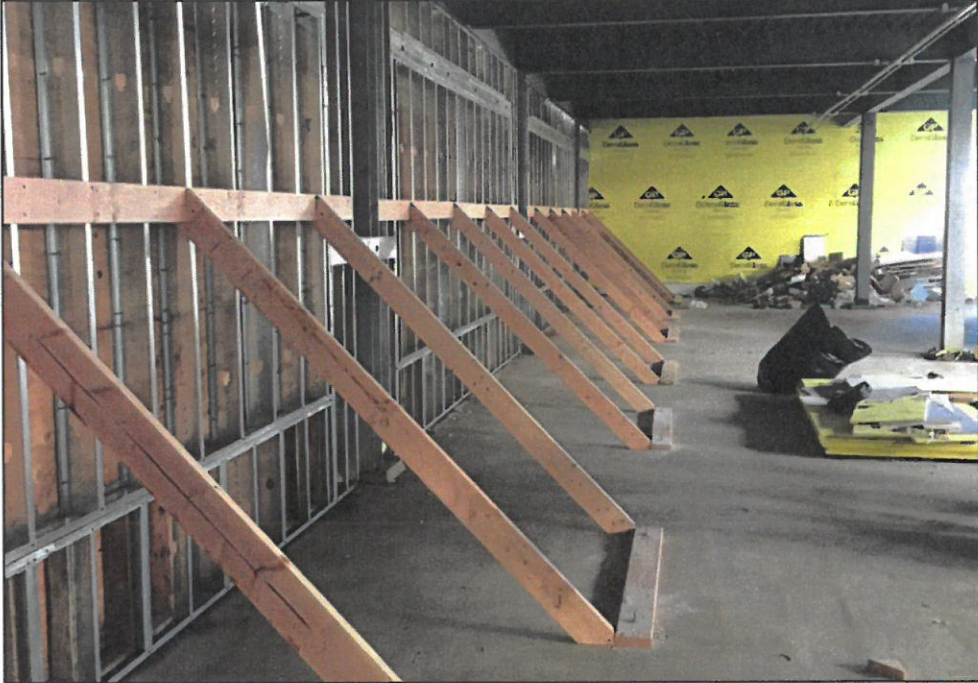
Photo: 25

- The building's first floor exterior wall was partially installed when Arcadis visited the site for the first time. It was noticed that the wall was not being fabricated with structural materials, and the structural capacity of this wall was deemed structurally suspect. Due to the accelerated pace of the project it was decided to clad this work with plywood and brace it from behind to provide additional structural capacity. In the spring of 2017 when the bubble is taken down, we recommend that the plywood be removed and repurposed and that the metal wall framing be removed and recycled. (Photo 25)

Description:
Wooden bracing. Bracing first floor non-structural steel wall framing. This wall will require replacement
