Shoreline Structural Classifications & Design Water Levels, Lake Ontario

Prepared By Todd Monson

AECOM

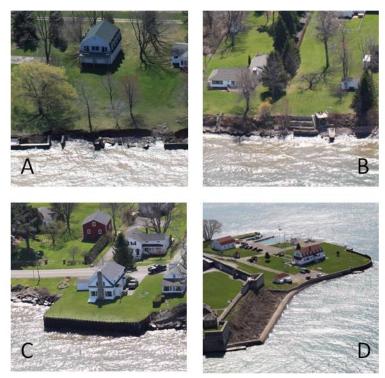
Figure 2-2 Examples of structural condition classifications: A. poor condition seawall in Yates, B. moderate condition seawall in Ontario, C. good condition in seawall in Williamson, D. high condition seawall in Porter (Oblique Imagery, USACE 2012)

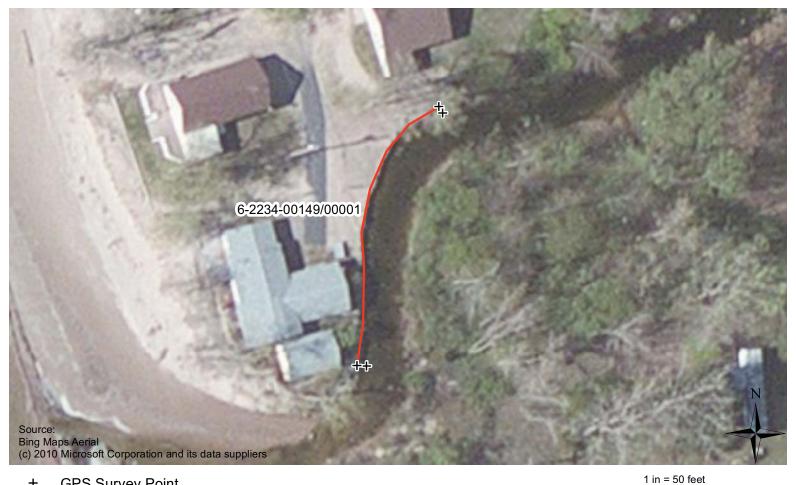
Page: 2 of 11

Condition: Good Quality

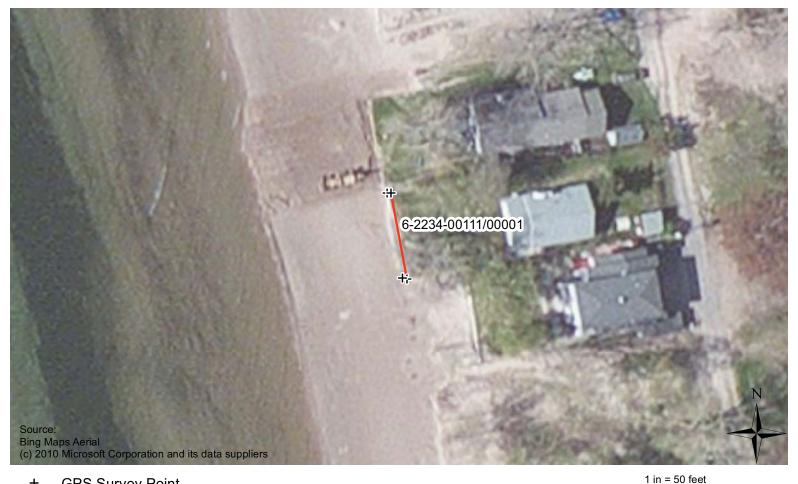
Page: 3 of 11

Condition: Moderate Quality

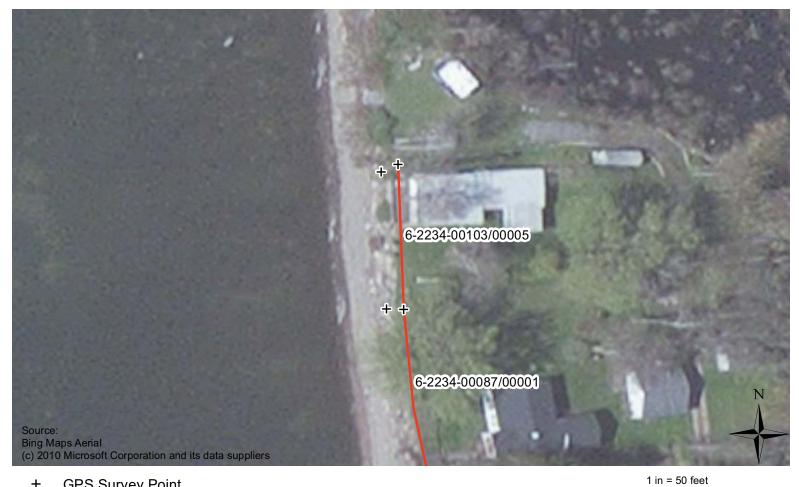
Page: 8 of 11

Condition: **Poor Quality**

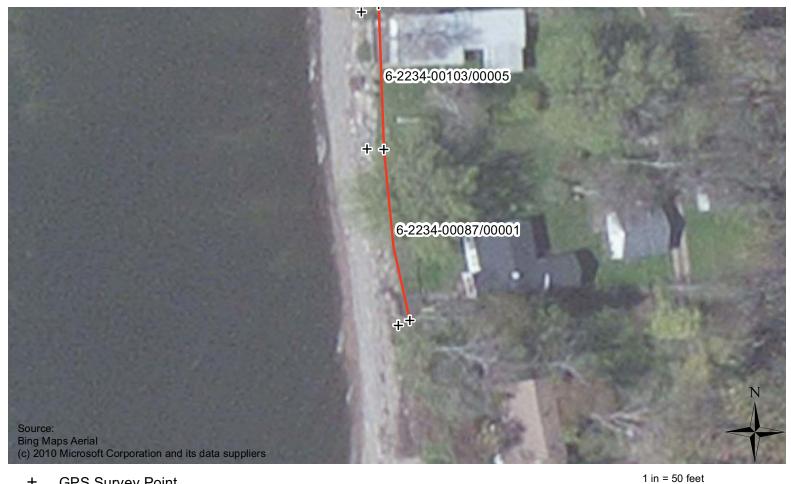
Page: 9 of 11

Condition: **Poor Quality**

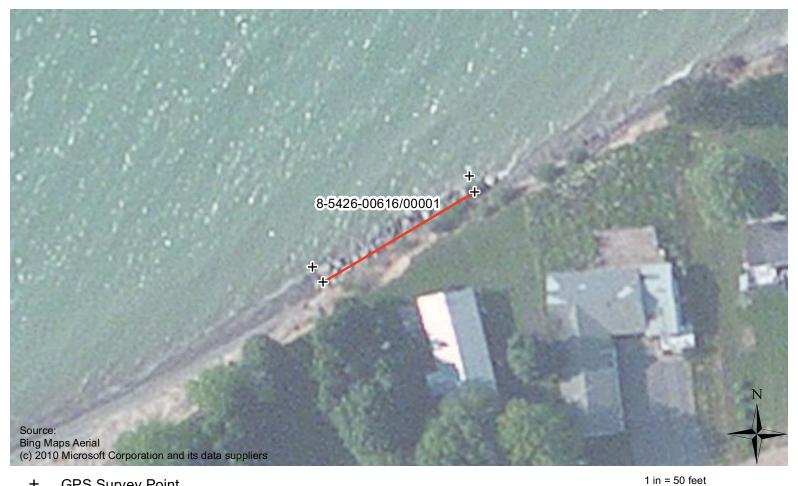
Page: 8 of 14

Condition: Poor Quality

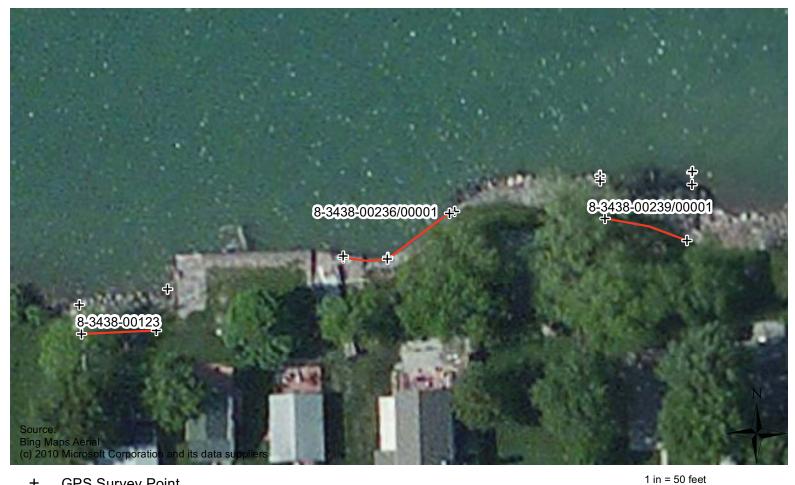
Page: 31 of 49

Condition: Poor Quality

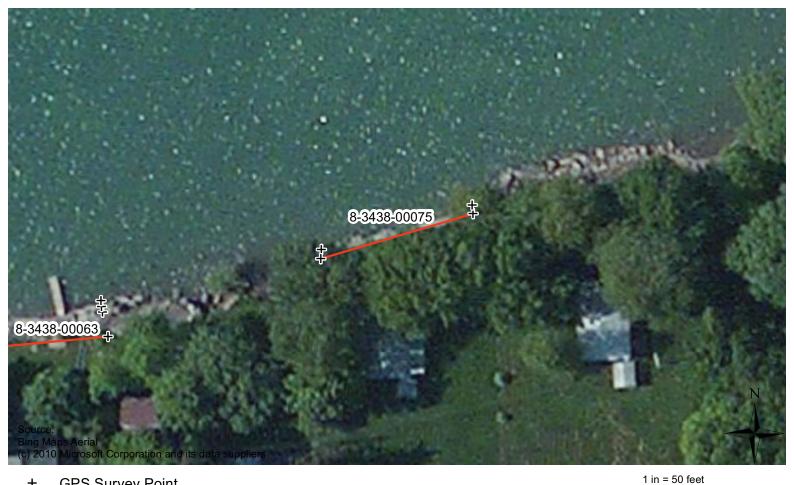
Page: 32 of 49

Condition: Poor Quality

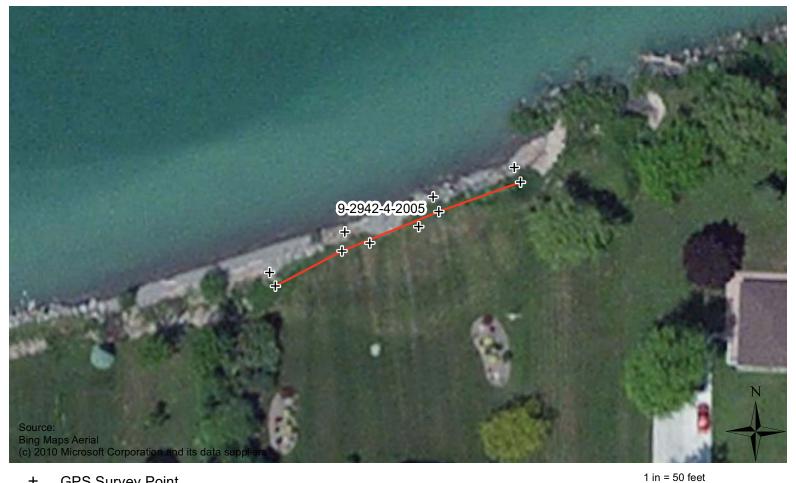
Condition: Poor Quality
