INDEPENDENT FORENSIC TEAM REPORT OROVILLE DAM SPILLWAY INCIDENT

JANUARY 5, 2018

SUMMARY

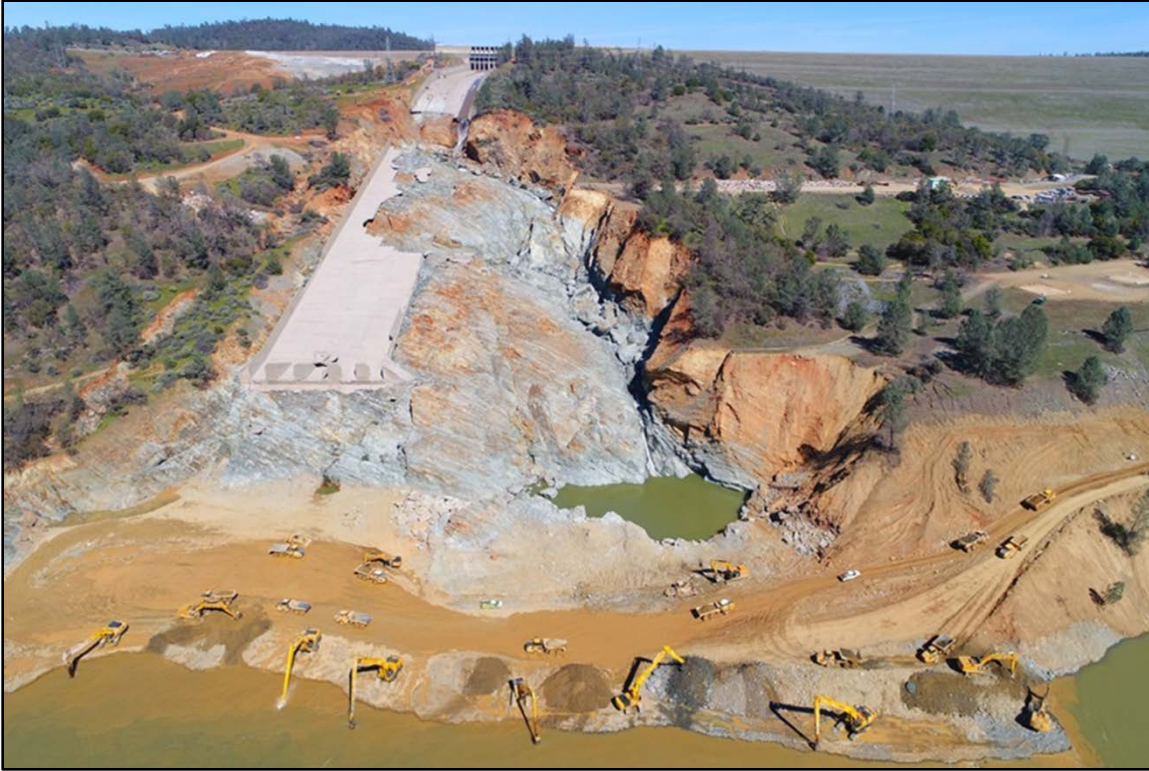
During service spillway operations between February 8, 2017 and May 19, 2017, additional spillway chute slab sections were lost and the erosion at the service spillway enlarged significantly, as shown in Figure 3-20.

Figure 3-20: Ultimate damage at the service spillway (from DWR)

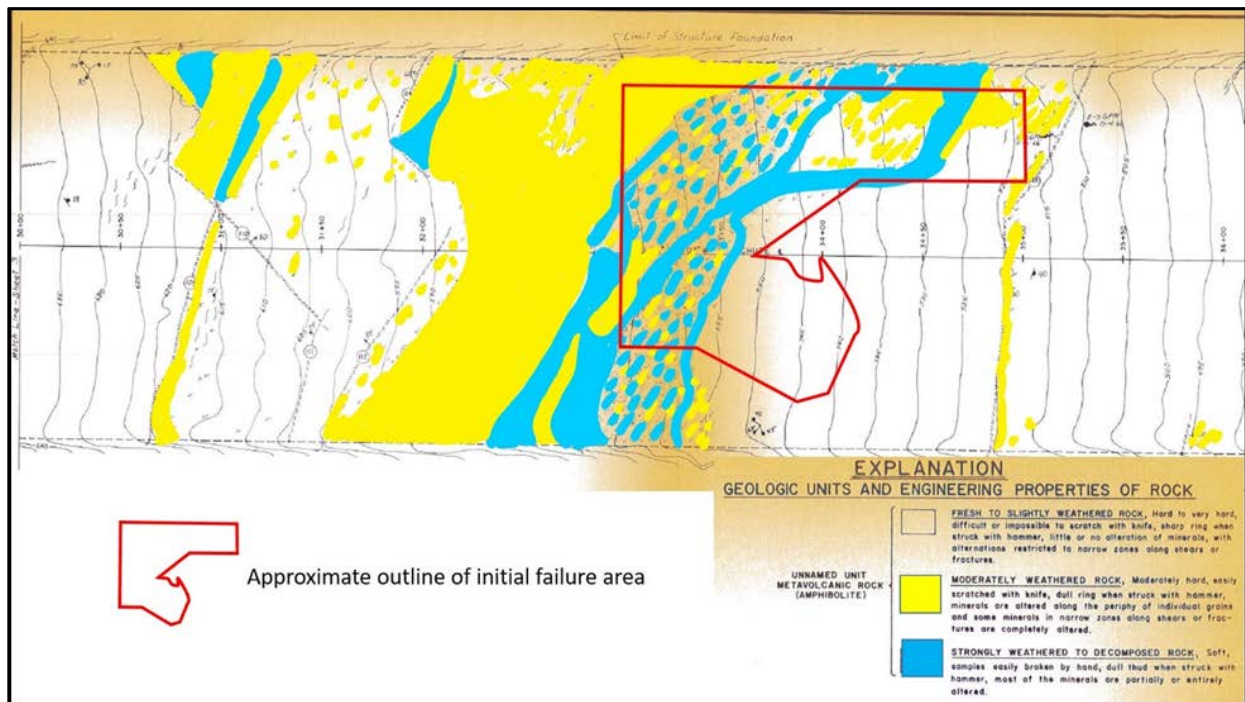
prevalent in the area of the chute slab failure. With the large amount of water that has been observed flowing through the underdrain system and the lack of filter compatibility between the drain system gravel and the erodible materials, it is conceivable that voids beneath the slab could have been created by piping (internal erosion) of the underlying materials by water flowing under the slab. As noted in Section 4.1.1, the IFT believes that any voids that would have formed would have been shallow (perhaps a few inches at most), rather than deep. With extended periods of underdrain flows, areas of voids could expand laterally beneath the chute. This would increase the size of areas of uplift pressure beneath the slab and also more readily transmit stagnation pressures over greater distances, resulting in an increase in the net uplift force on the slab. With the thickness of the chute slab and the anchors which would support the chute slab, voids beneath the slab would be difficult to detect.

Figure 4-6: Extents of moderately and strongly weathered rock.
Geologic mapping from Final Geologic Report [9]

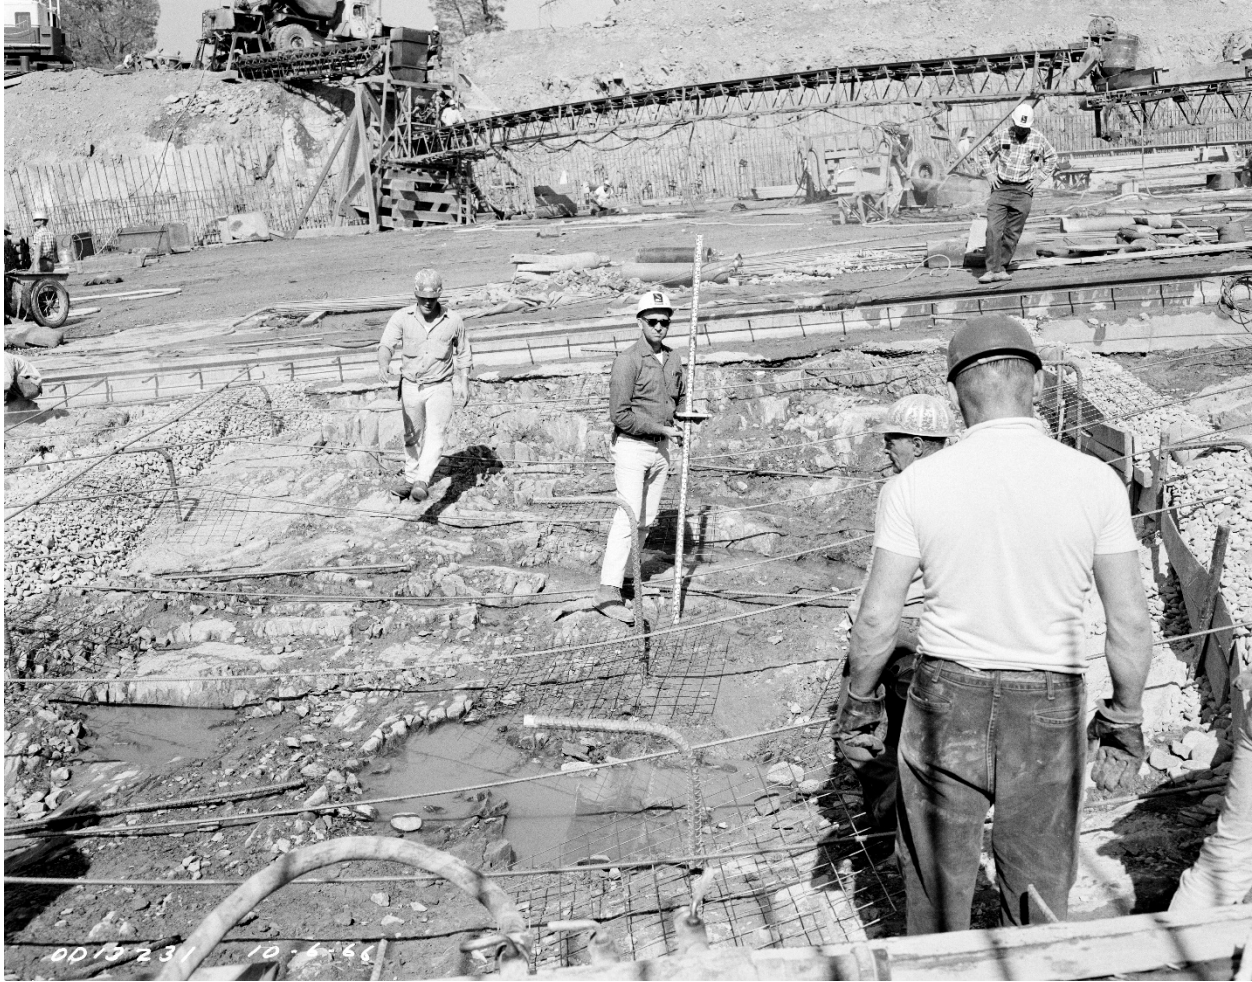
As with the chute concrete, no details of the anchor bar designs for the spillway chute were provided, and it is possible that none exist. Therefore, it is not known why the designers chose to install anchor bars in the spillway chute. Although no design calculations were provided for the spillway chute, the wall design calculations had load cases where there was water both inside the chute (up to the PMF condition), and outside the chute. These water loads were used for the design of the reinforced concrete wall stem and base. Although stability calculations were also performed, it appears that uplift was not generally considered in the chute wall calculations, except for the walls at the terminal structure at the downstream end. The design of anchor bars for the chute walls was not documented in the design calculations provided by DWR.

Figure A-13: Anchor Bars Installed on Uneven Rock Surface (Photo OD_13231_10_06_1966)

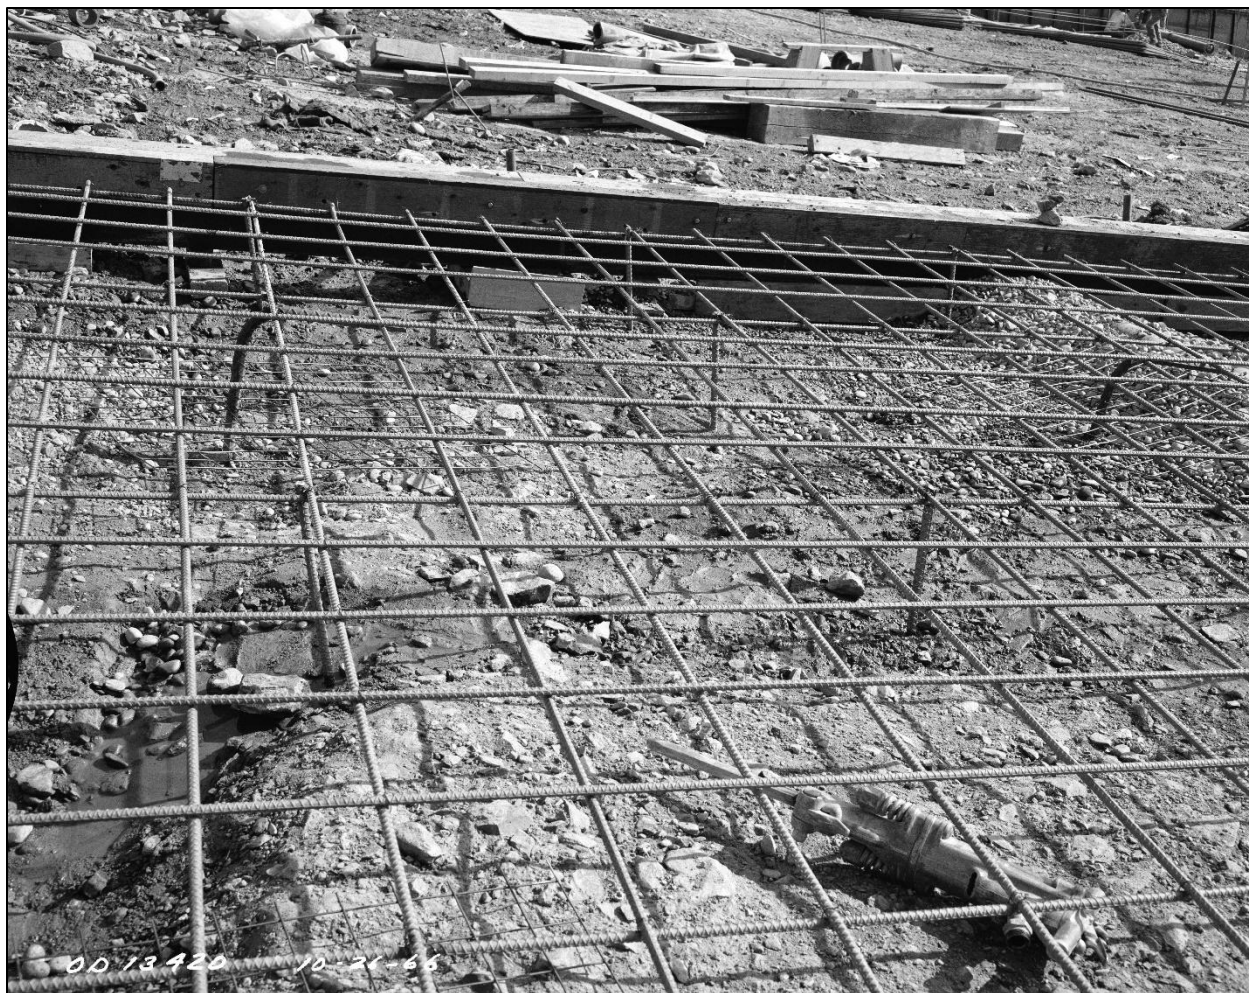
Figure A-16: Clean-up effort for the spillway chute prior to placement. Note that foot prints appear in the material left in place, and numerous rock fragments are present. This is believed to be in an area that required additional cleanup just upstream from Sta. 33+00. (Photo OD_13420_10_26_1966)

Figure A-16, which is believed to be just upstream from the initial 2017 damage area also shows poor cleanup effort. The poor cleanup effort is also mentioned in the Engineer's Daily Report on the day after the photo was taken, presumably when this foundation was being accepted for placement. However, at the time the photo was taken, the anchor bars had already been installed.

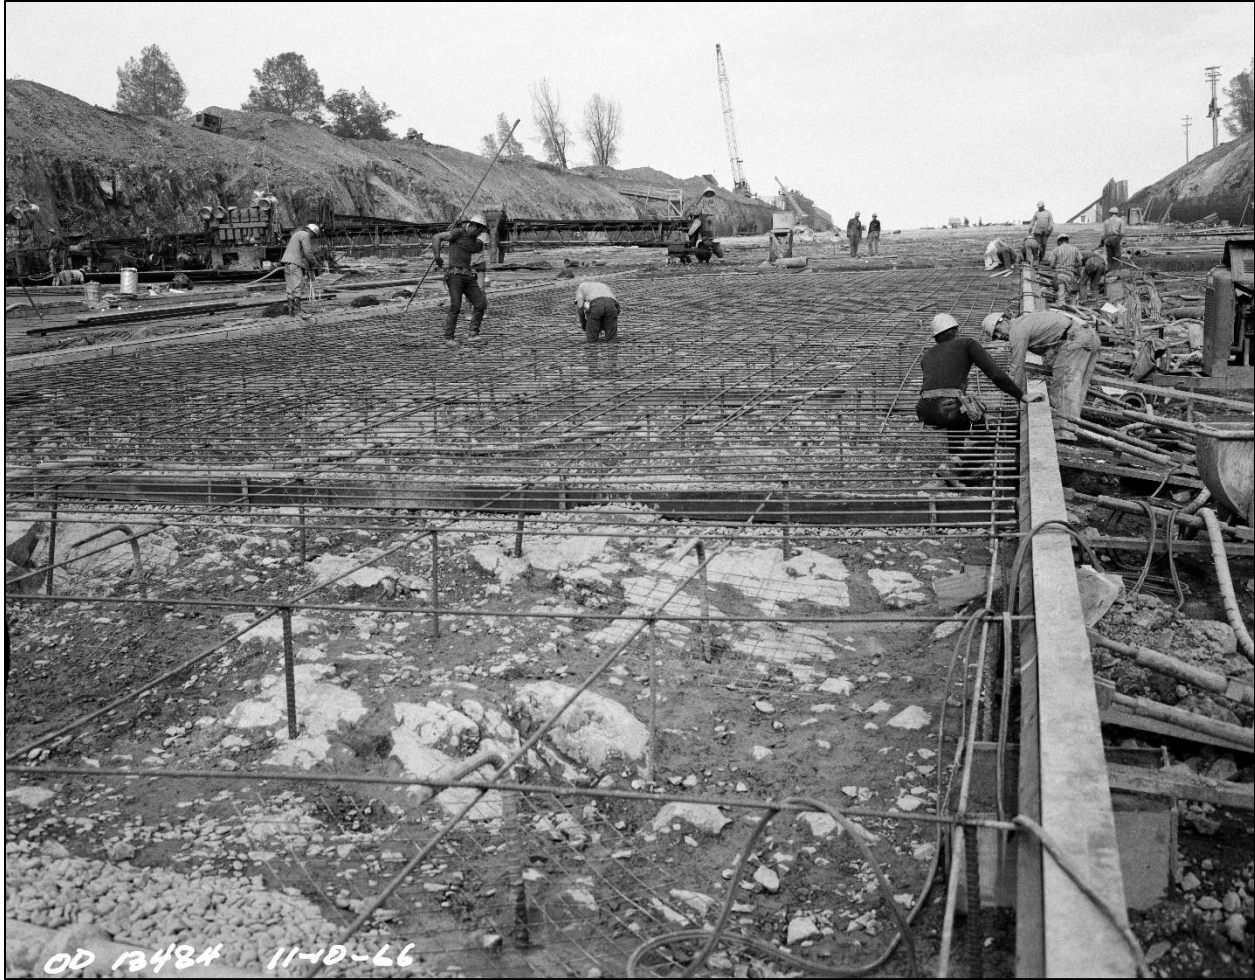
Figure A-17: Another example of the clean-up effort for the spillway chute prior to placement. Note what appears to be “compacted clayey fines” between the rock outcrops. (Photo OD_13484_11_10_1966)

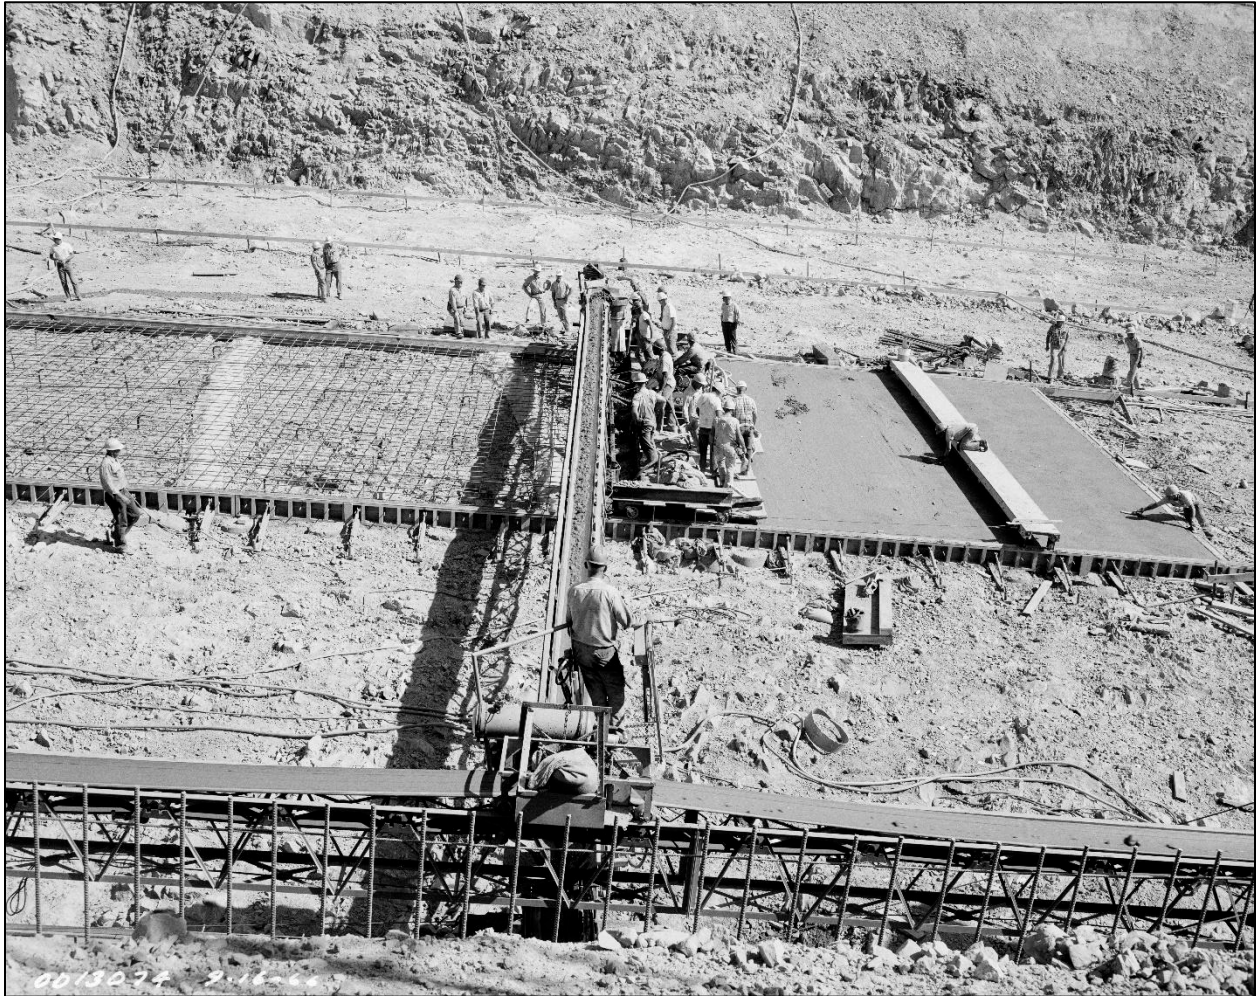
assumed that the bars were oversized, possibly to add greater bar area to counteract minor erosion. Figure A-18 is believed to show the area near where the anchor bar pull tests were performed (10 days after the pull tests), based on the date of the photo compared to the construction activities as reported in the daily reports from construction. Note that in Figure A-18 it would be difficult to determine where there were worst case conditions having clay seams, unless there was a special cleanup for the anchor bar pull tests.

Figure A-18: Typical concrete placement in the spillway chute (believed to be Lane 3, Sta. 26+00 to 27+00) using slip-forming. Note that the foundation ahead of the slip-form shows very few distinct rocky outcrops. (Photo OD_13074_09_16_1966)

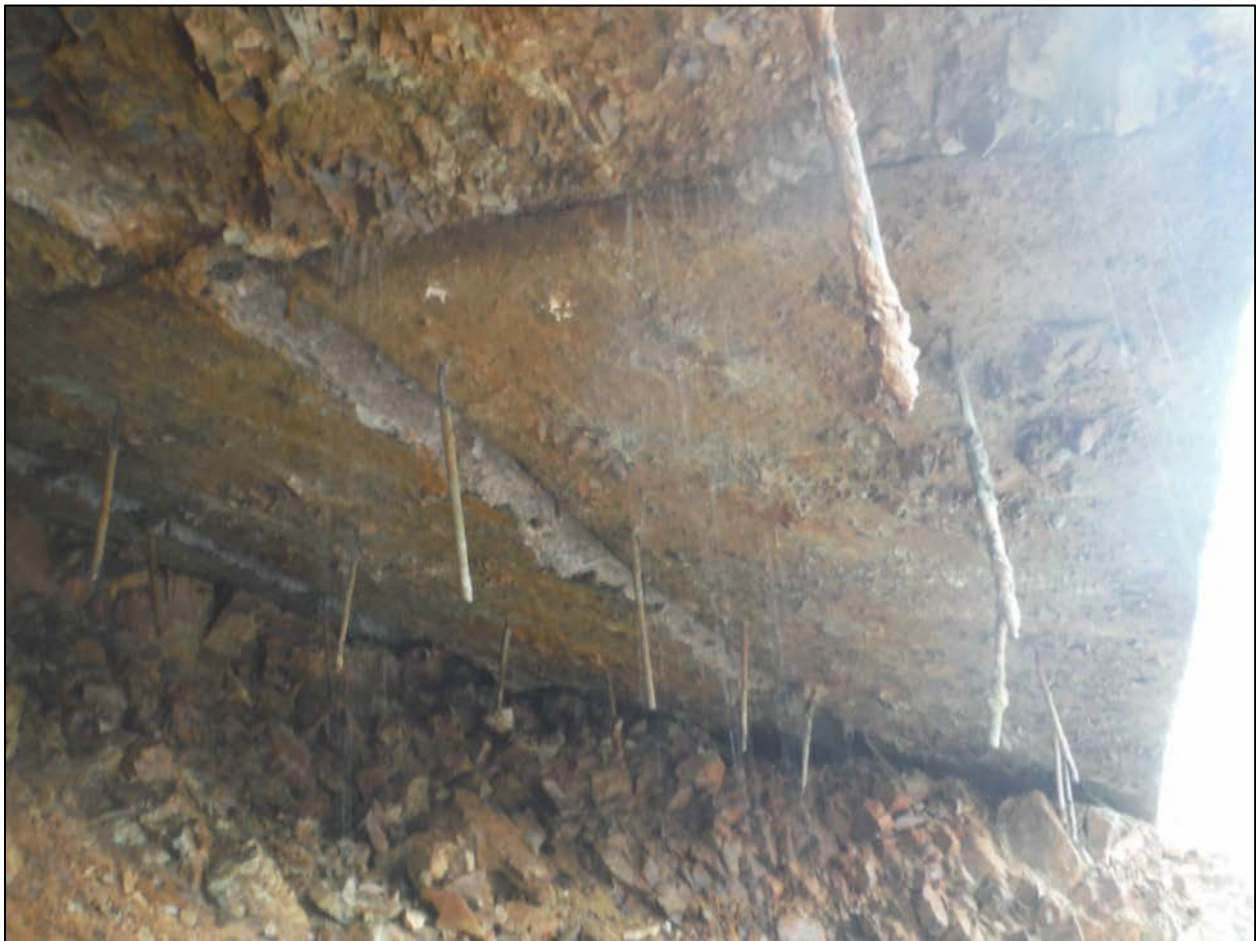
In Figure A-19, the underside of some of the slabs appears to be smooth, indicating that the slab was founded on compacted soil-like material rather than an irregular excavated rock surfaces. The fractured rock in the background of this figure may be somewhat representative of the foundation beneath the exposed slab. There also appears to be a gap at the foundation/rock contact where intact foundation remains, indicating that the “compacted clayey fines” or soil covering may have been extensive. Soil covering the foundation would have been critical at this location, because it would obscure the highly fractured nature of the rock below. Without this knowledge, there would be no way to determine if the anchor bar embedment lengths needed to be extended further into the foundation, due to the conditions being worse than that in the area where embedment lengths were tested.

Figure A-19: Anchor bars on the underside of the slab upstream of Sta. 33+00 (on right edge). Note the smooth underside of the chute slab that was to have been placed on a rock foundation which would have been expected to be irregular. (Photo DSCF9788)

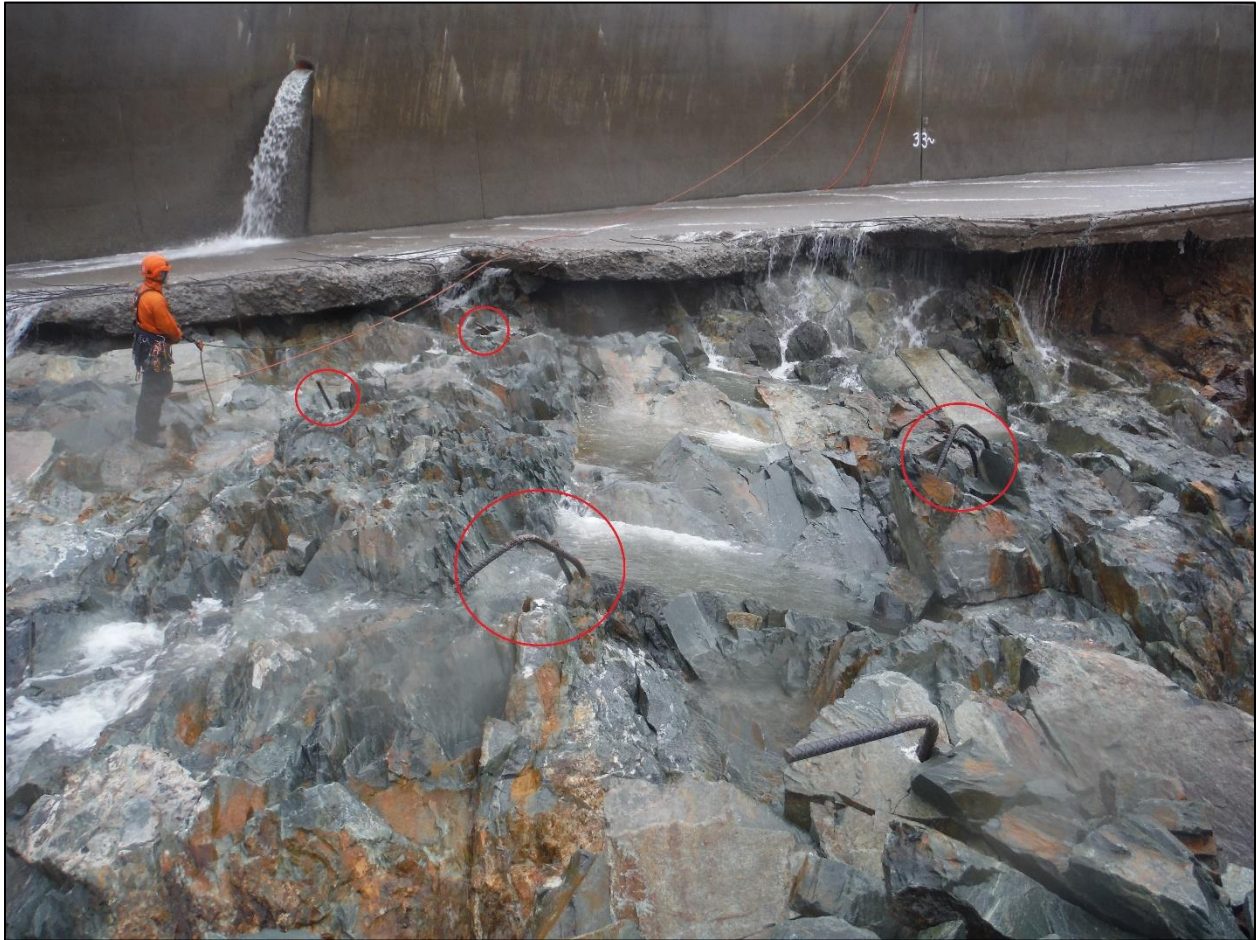
indicates that eight or nine anchors had to be cut off. In Figure A-20, taken on February 8, 2017, the cut bars can be seen alongside of the final anchor bars that pulled out of the concrete. From the figure, it appears that some of the replacement anchor bars pulled out of the concrete, while others apparently pulled out of the foundation. In Figure A-21, the same location can be seen being prepared for placement.

Figure A-20: Damage in Lane 3 downstream from Sta. 33+00. Cut anchor bars are circled. These were replaced because they were tilted. Replacement anchor bars can be seen in two locations. Note the drain discharging from the wall at approximate Sta. 33+60. (Photo DSCF5904r)

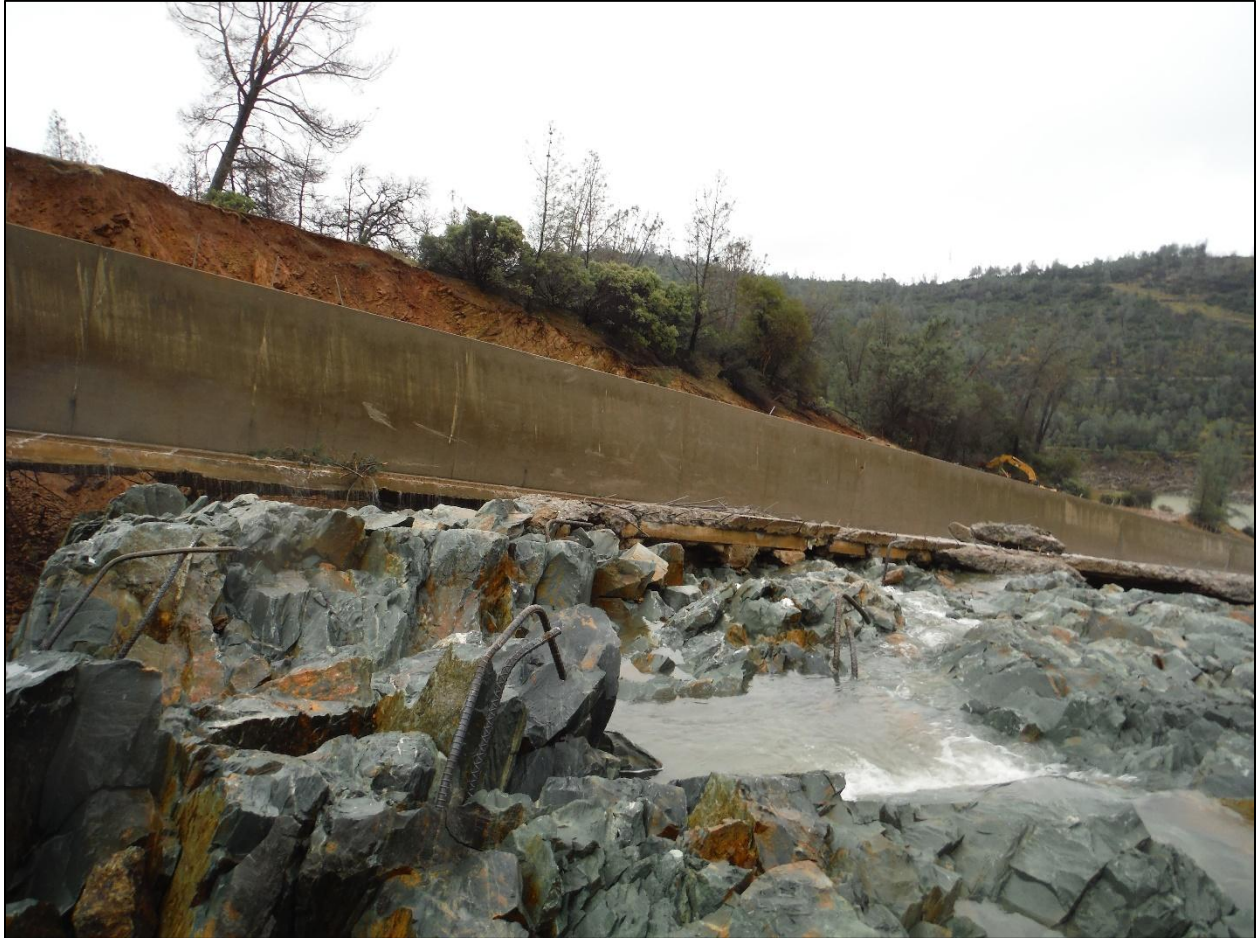
Figure A-22: Lane 3 downstream from Sta. 33+00 showing 3 sets of double anchor bars where one of the pair has been cut off. From this photo, it appears the bars at this location may have been adequately embedded in rock. (Photo DSCF5859)

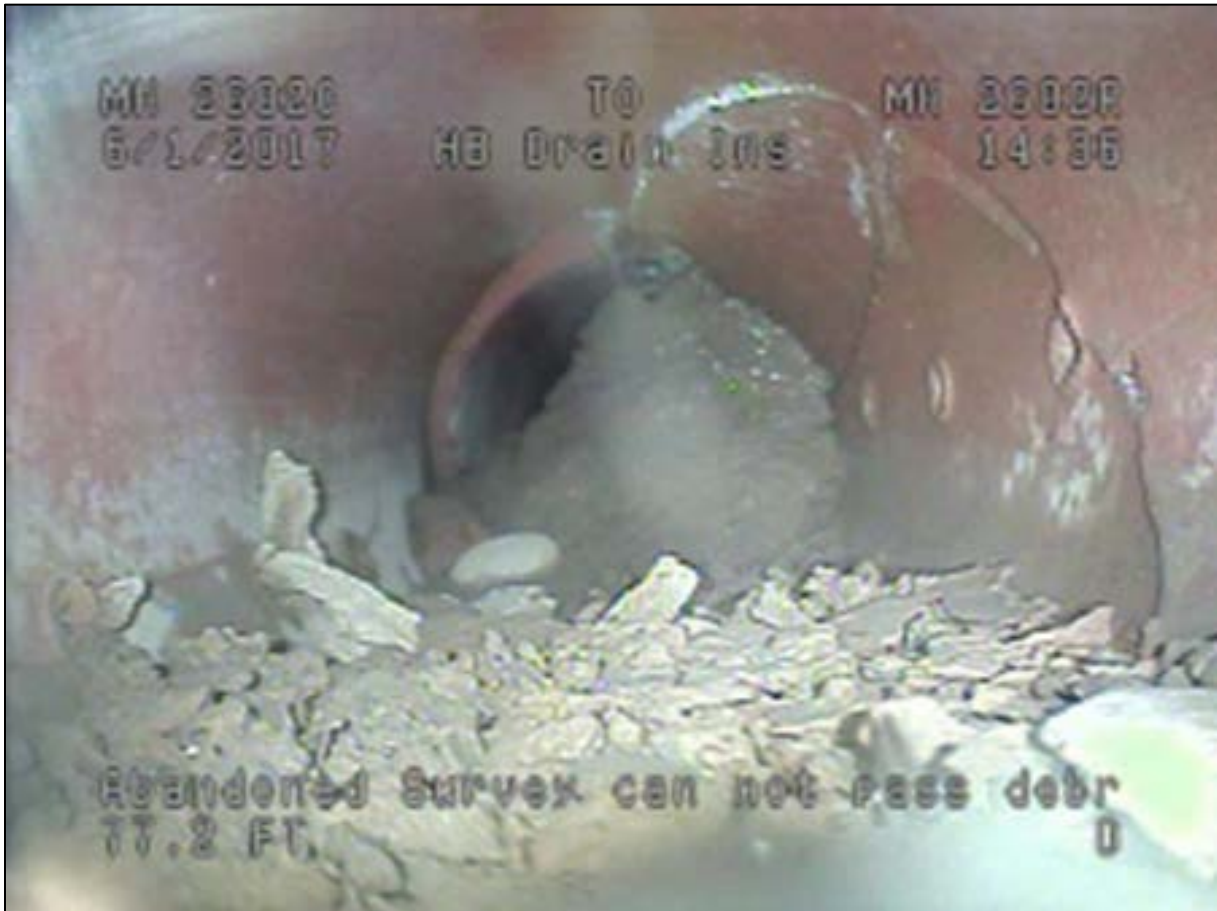
Engineer's Daily Reports indicated that some of the 6-inch herringbone drains were broken when the concrete aggregate (up to 6 inches in diameter) was dropped from the conveyor belt directly onto the drain pipe. Presumably the incidents that were reported were observed by the construction inspectors, and the pipes were repaired. However, it is possible that some broken pipes were unnoticed and therefore not repaired or replaced. These drains were to be placed with the perforations facing the foundation. However, post-incident observations revealed that some pipes were placed with the perforations facing the top of the slab, and some without perforations at all (see Appendix D). HDR investigation included video inspections of drains in the upper chute found numerous issues with the herringbone drains [A-6]. In addition to issues with perforations, some drains were cracked, had open joints, drains sloping uphill against flow, and infilling of debris. Figure A-23 shows a cracked drain with sediment deposits. It is not known if the cracking happened because of construction activities, chute repair work, or from other causes. Figures A-24 and A-25 show some of the additional drain issues. While drains were not found to be plugged, the remaining upper chute drains may not be representative of the conditions where the chute failure initiated.

Figure A-23: Herringbone drain inspection image. Note the drain has been cracked. (from HDR investigation [A-6])

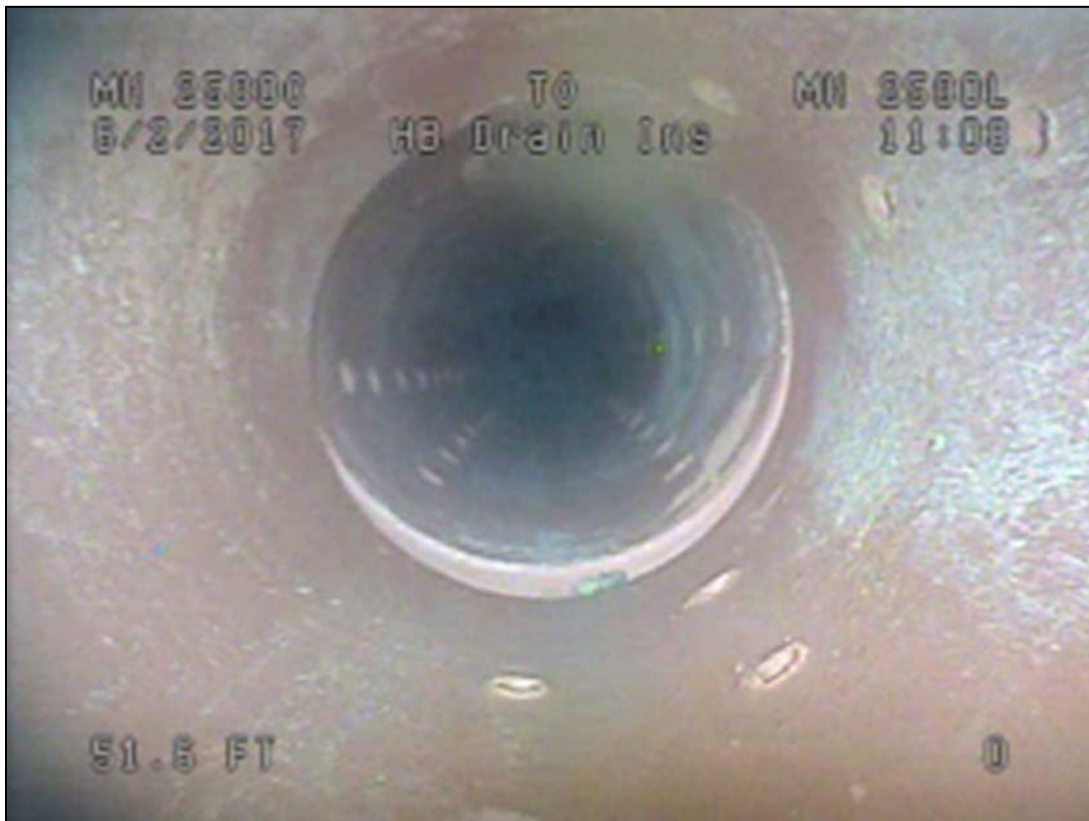
**Figure A-24: Herringbone drain inspection. Note that the perforations are rotated at the joint.
(from HDR investigation)**

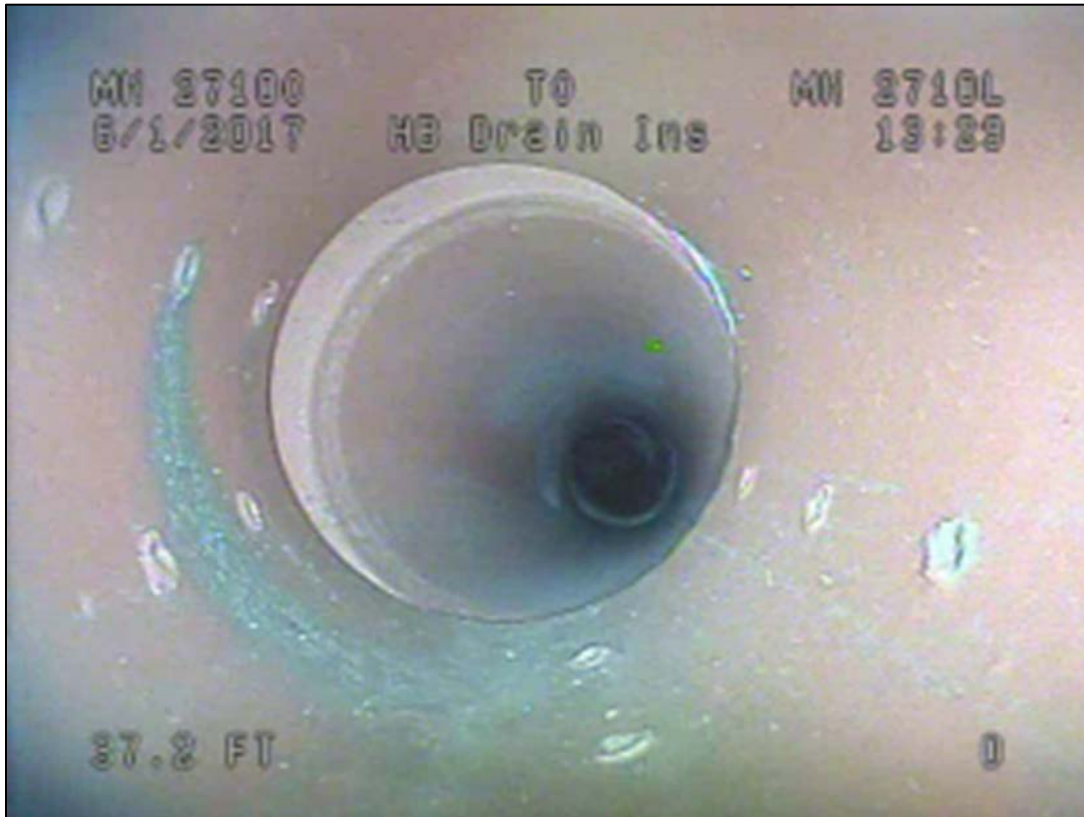
Figure A-25: Herringbone drain inspection. Note that the section beyond the joint has no perforations. (from HDR investigation)

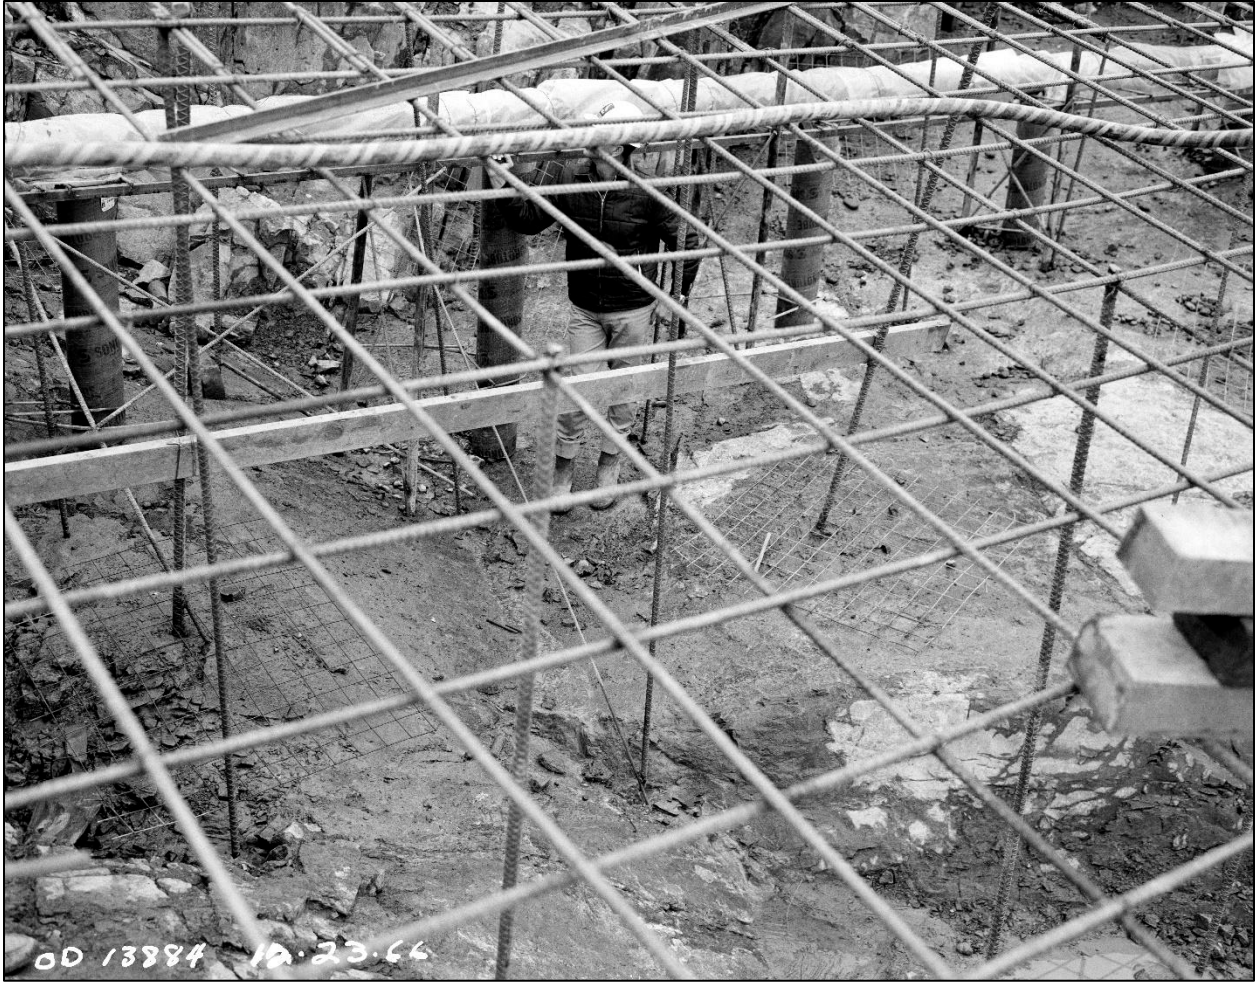
Figure A-26: Herringbone drains being constructed on top of gravel filled sonotubes. The drains appear to be wrapped in plastic. Based on the worker standing beneath the drain pipe, the drains were likely placed up to 6 feet above the foundation they were intended to drain.

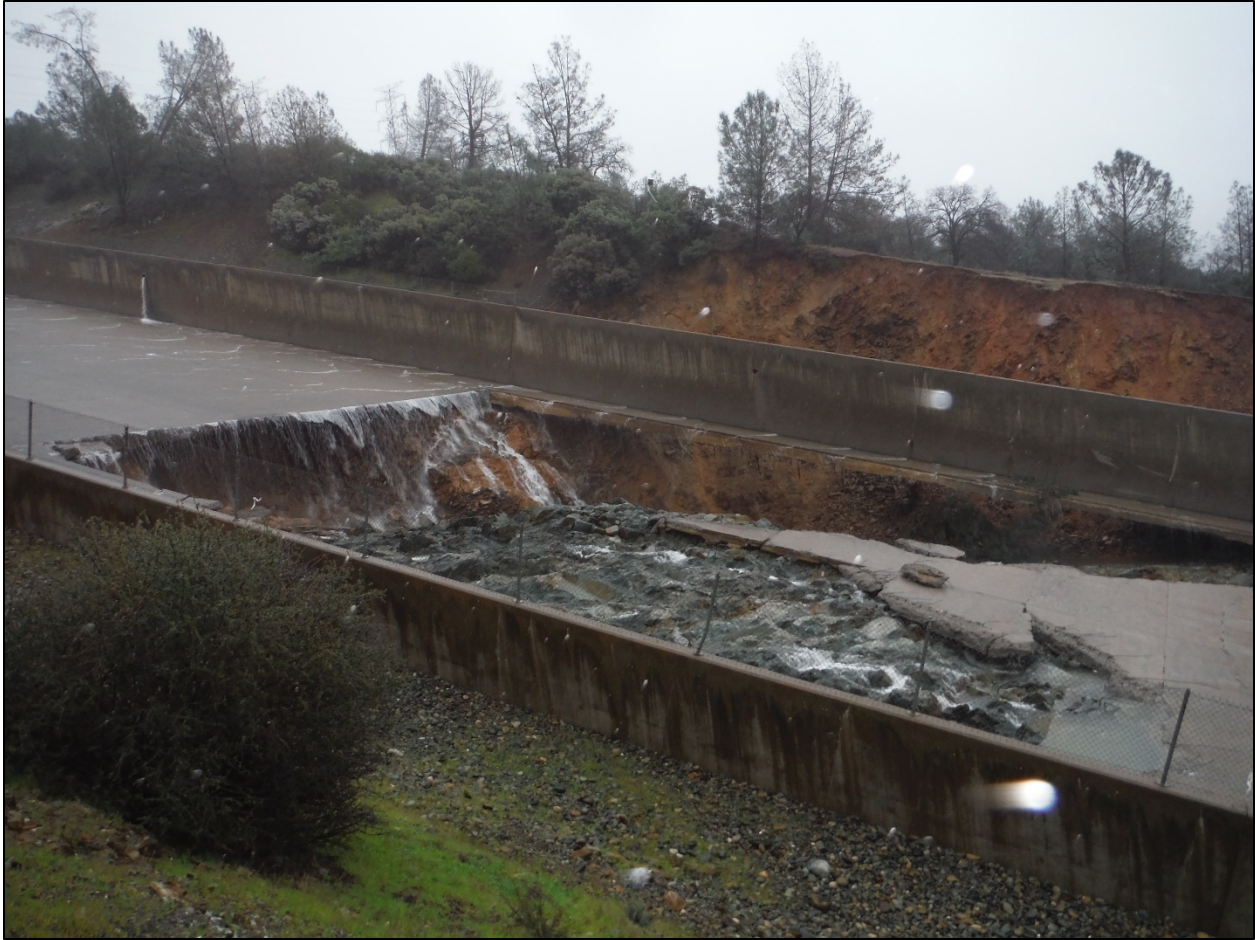
Figure A-27: Damaged area downstream from Sta. 33+00. Note the concrete slab thickness varies in the center of the chute (as discussed in Appendix D).

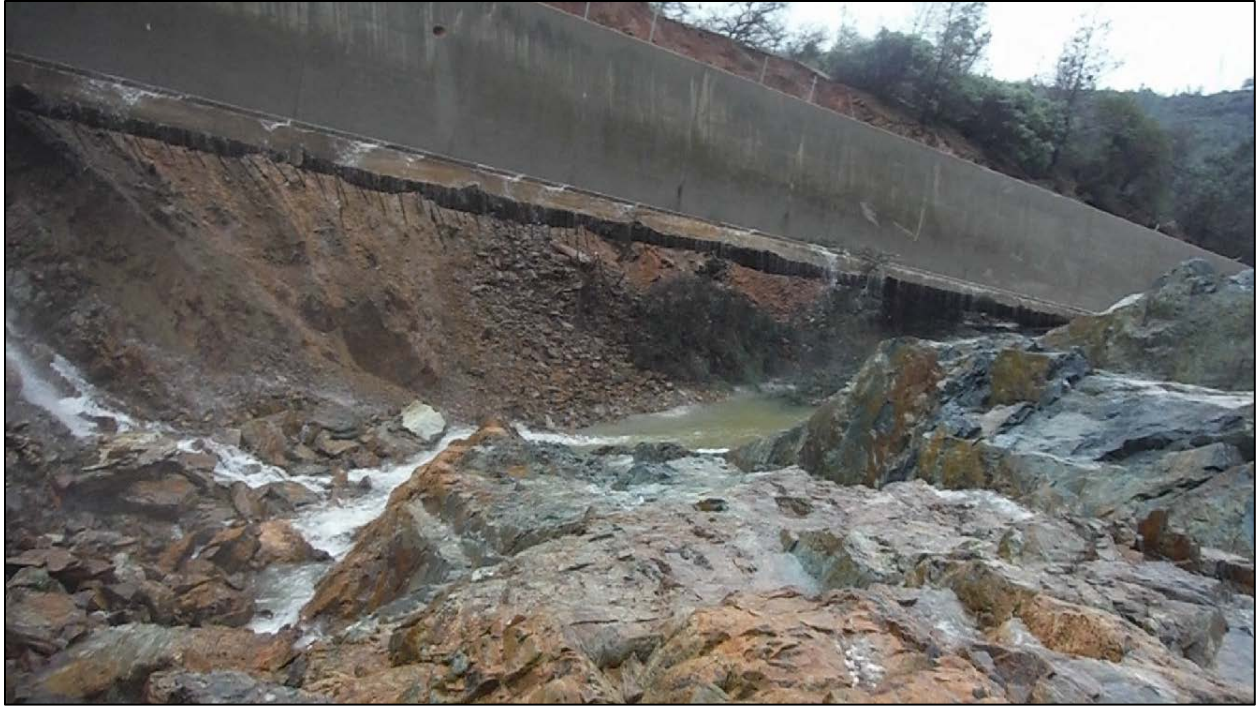
Figure A-28: Damaged area downstream from Sta. 33+00. Note the concrete wall base thickness varies. Also note the unevenness of the broken rock in the foreground.

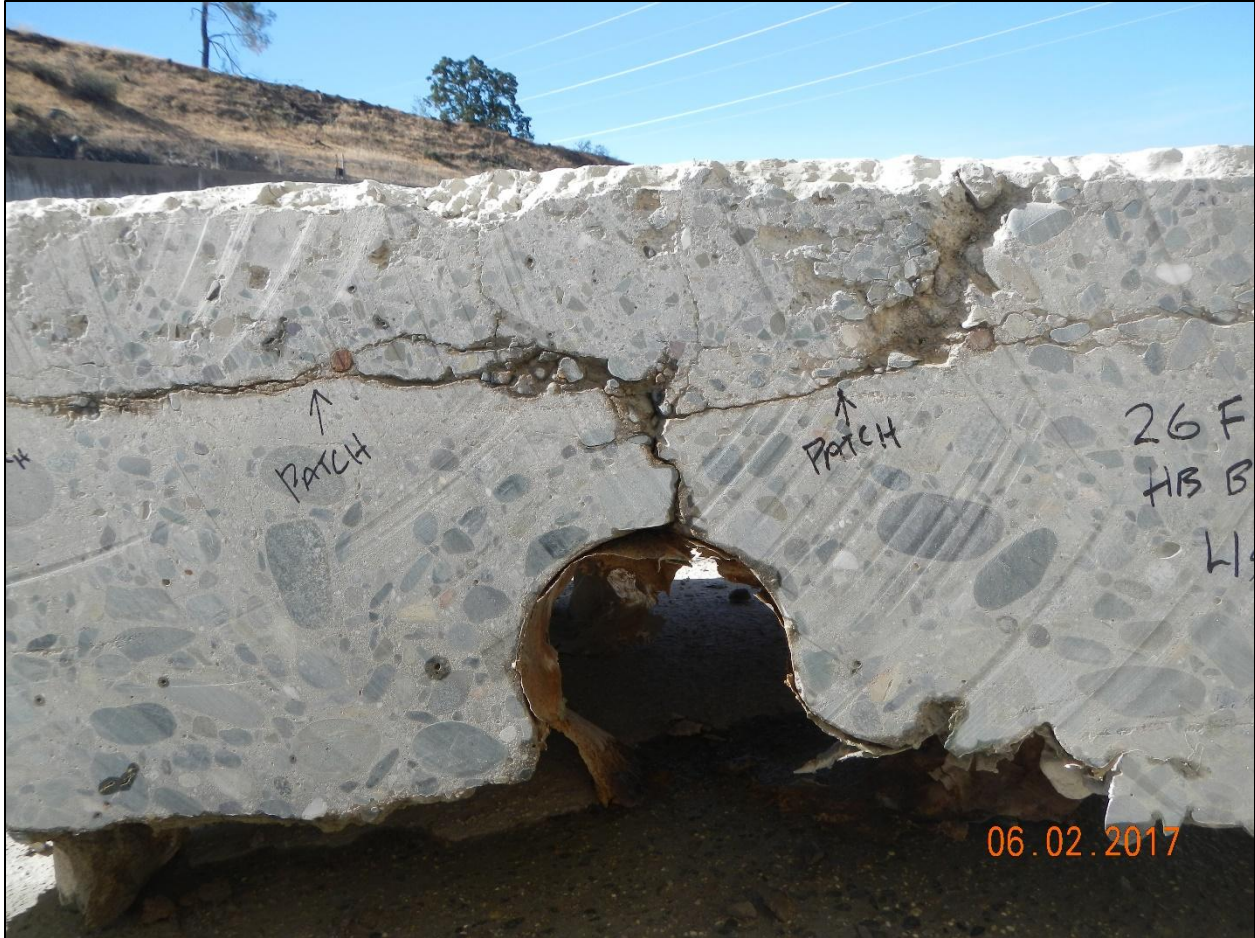
Figure A-29: Excavated section of concrete at herringbone drain location. Note the cracking associated with the drain and the delamination of concrete at the reinforcement layer. (IFT Photo taken during forensic investigation of the chute)

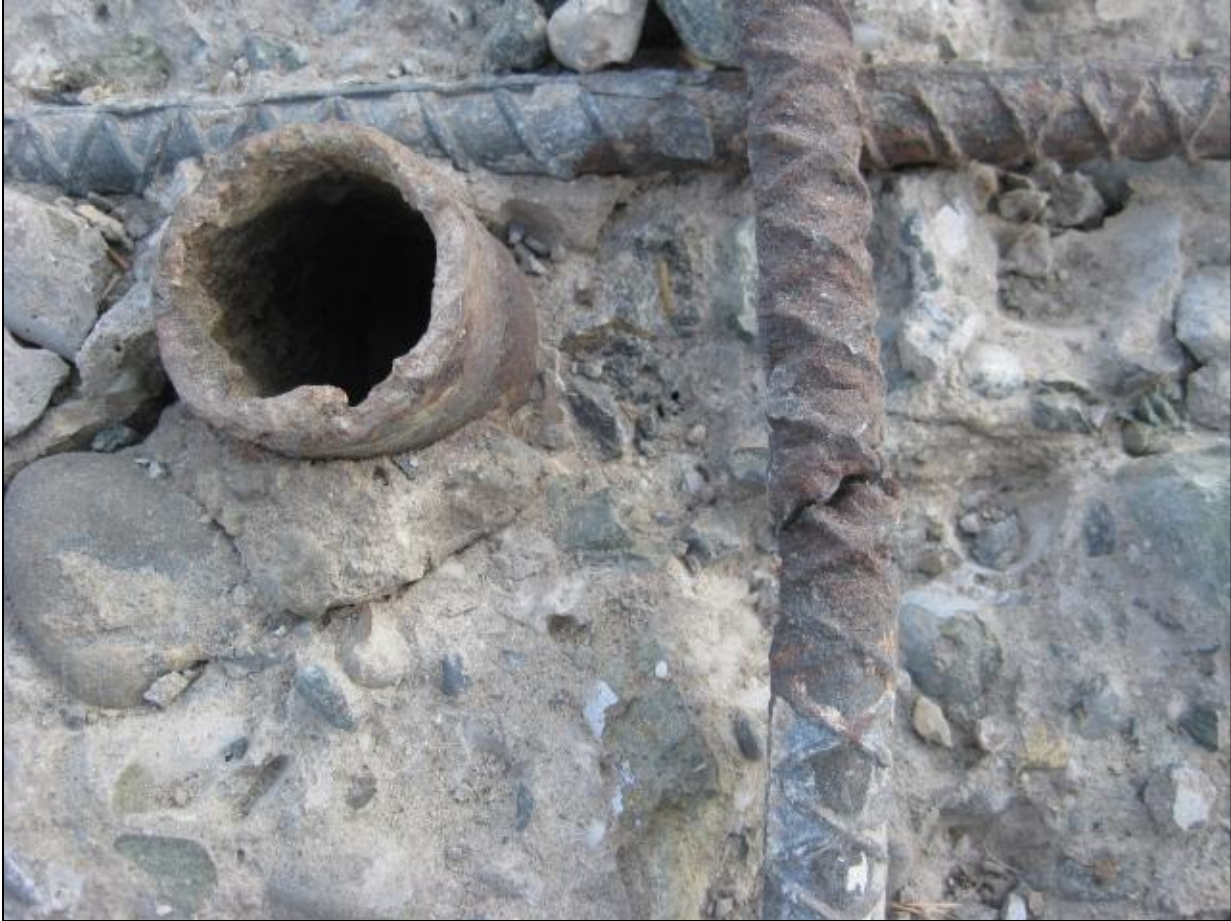
Figure A-30: Broken rebar at location of a crack above a herringbone drain. Note that the pipe shown in this photograph was used to support the wooden form for the gravel that encapsulates the drain pipe. (Photo taken during the 2009 repairs)

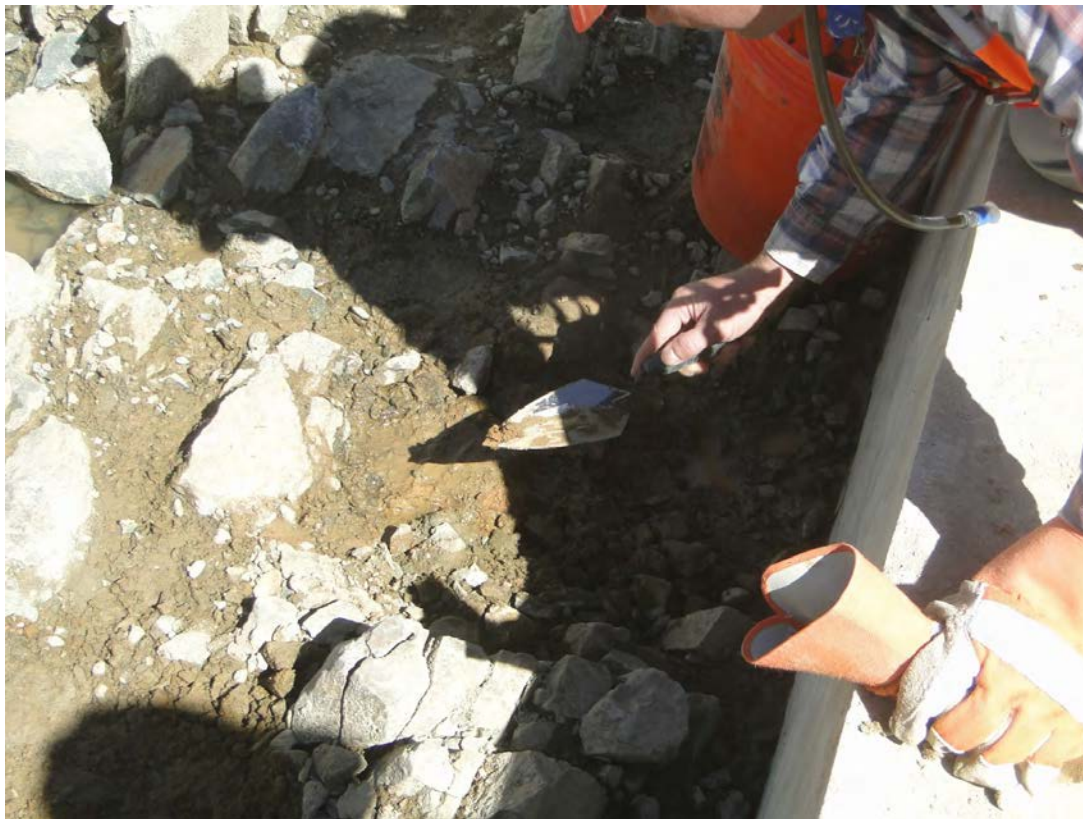
Figure D-7: Photograph Showing “Compacted Clayey Fines” in Forensic Trench 27C in Area D (approximately Sta. 26+85)

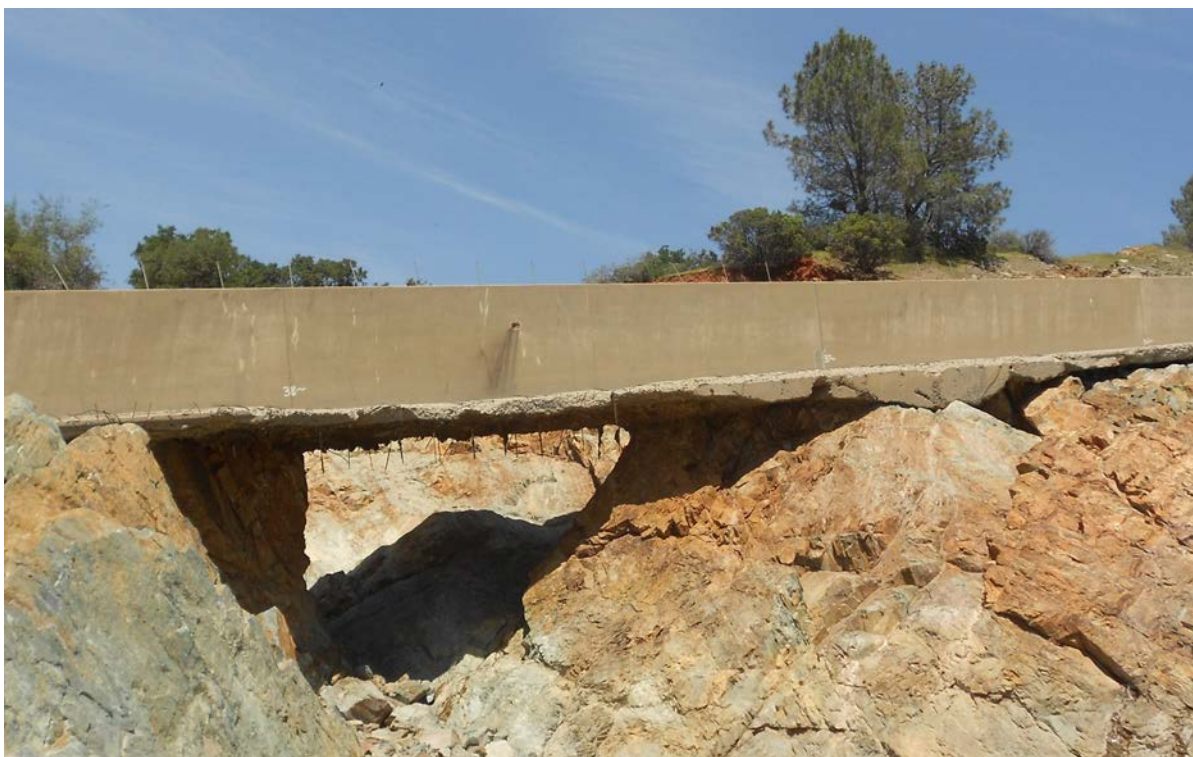
Figure D-12: Photograph of Erosional Feature Between Sta. 37+00 and Sta. 38+50 on Left Side of Lower Chute
