INDEPENDENT FORENSIC TEAM REPORT OROVILLE DAM SPILLWAY INCIDENT

JANUARY 5, 2018

SUMMARY

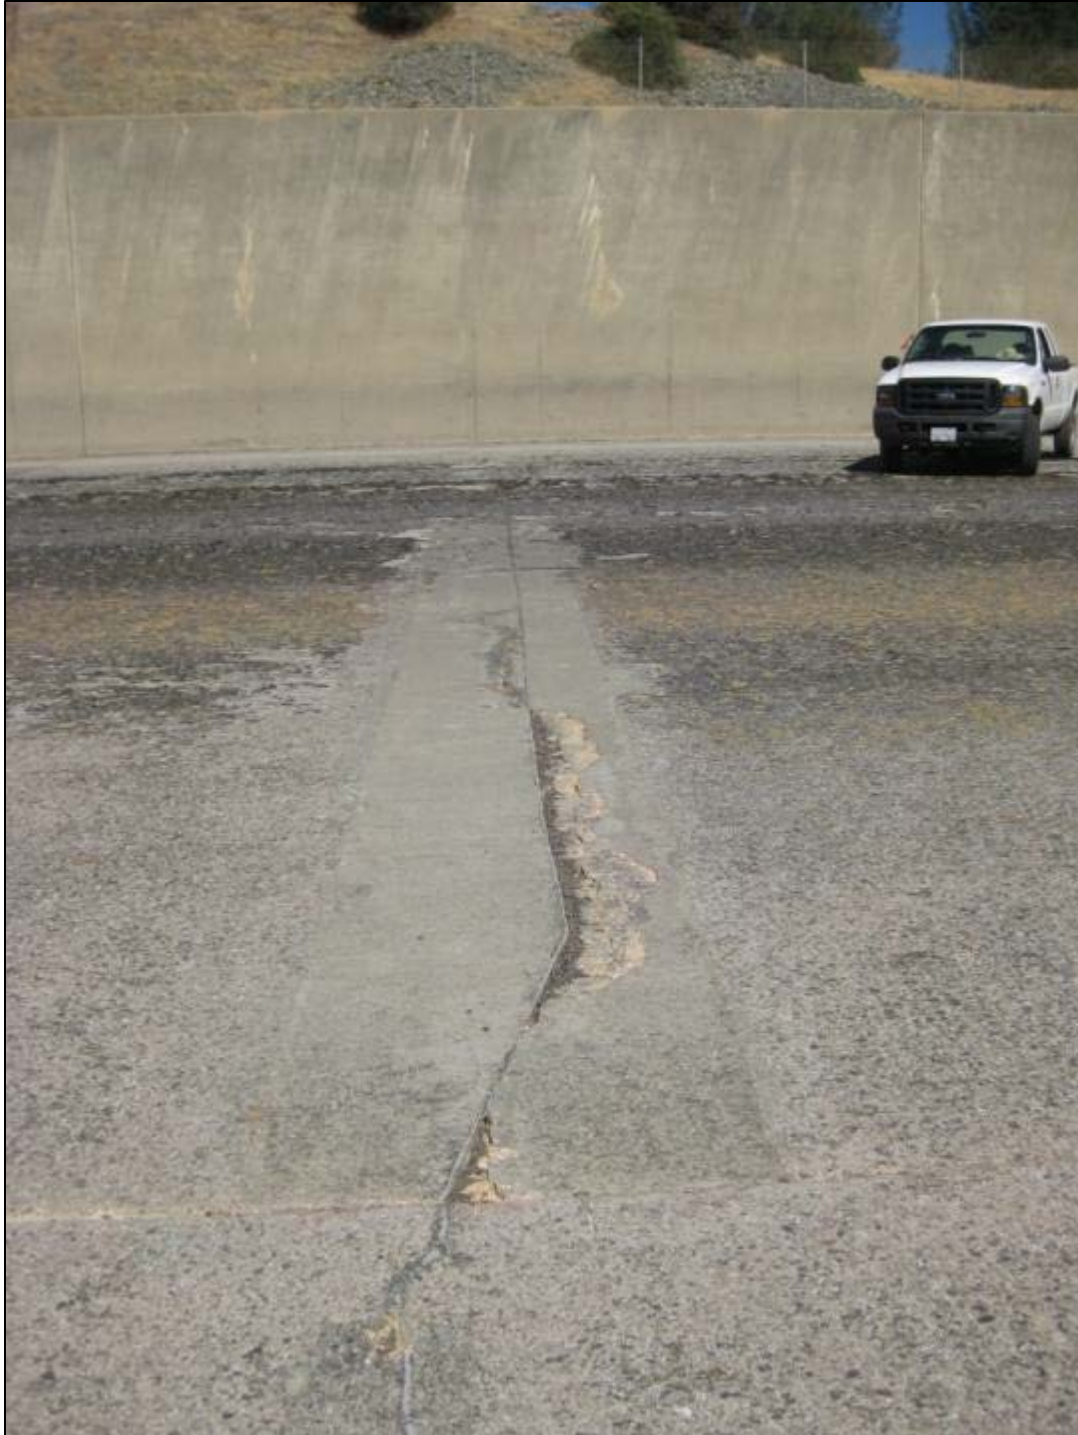
Figure G-7: Spalled Concrete in Previous Repair

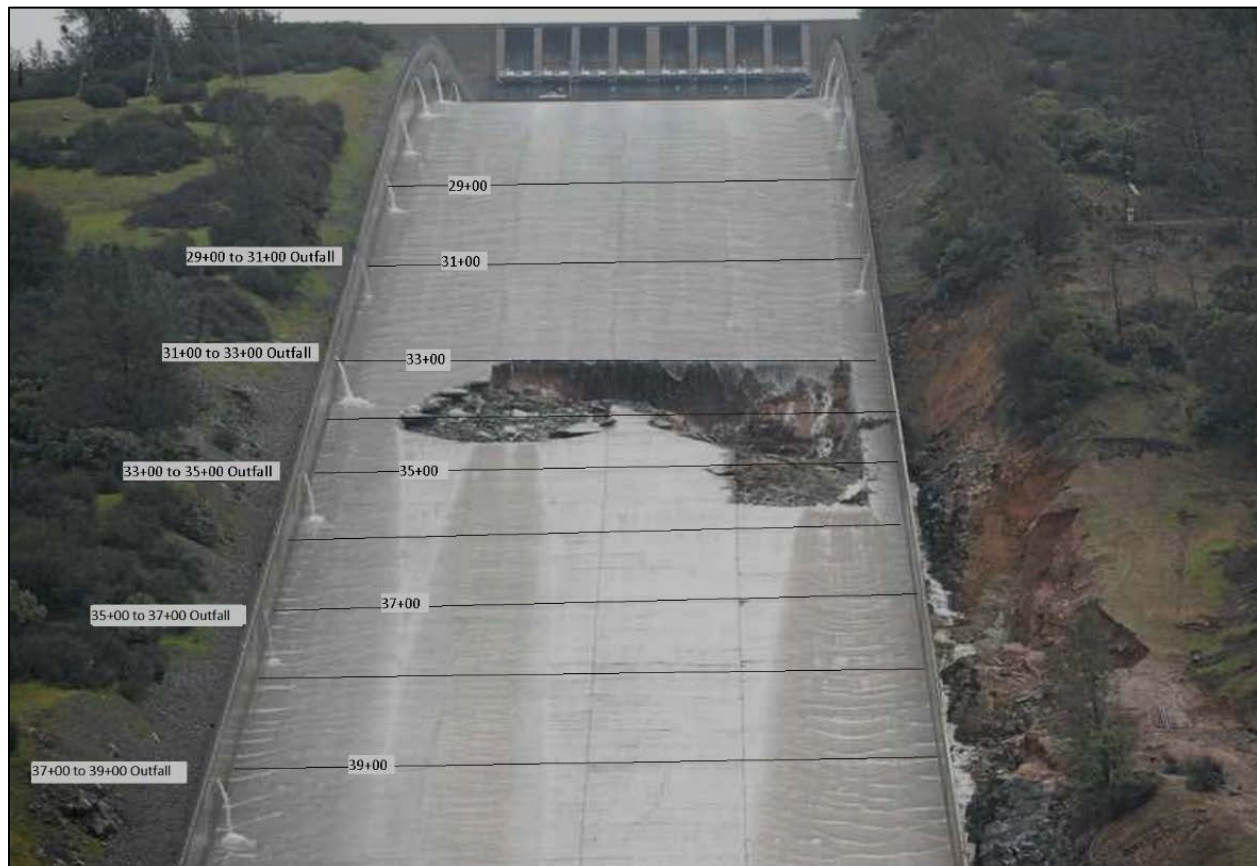
Figure I-1: Damage, February 8, 2017

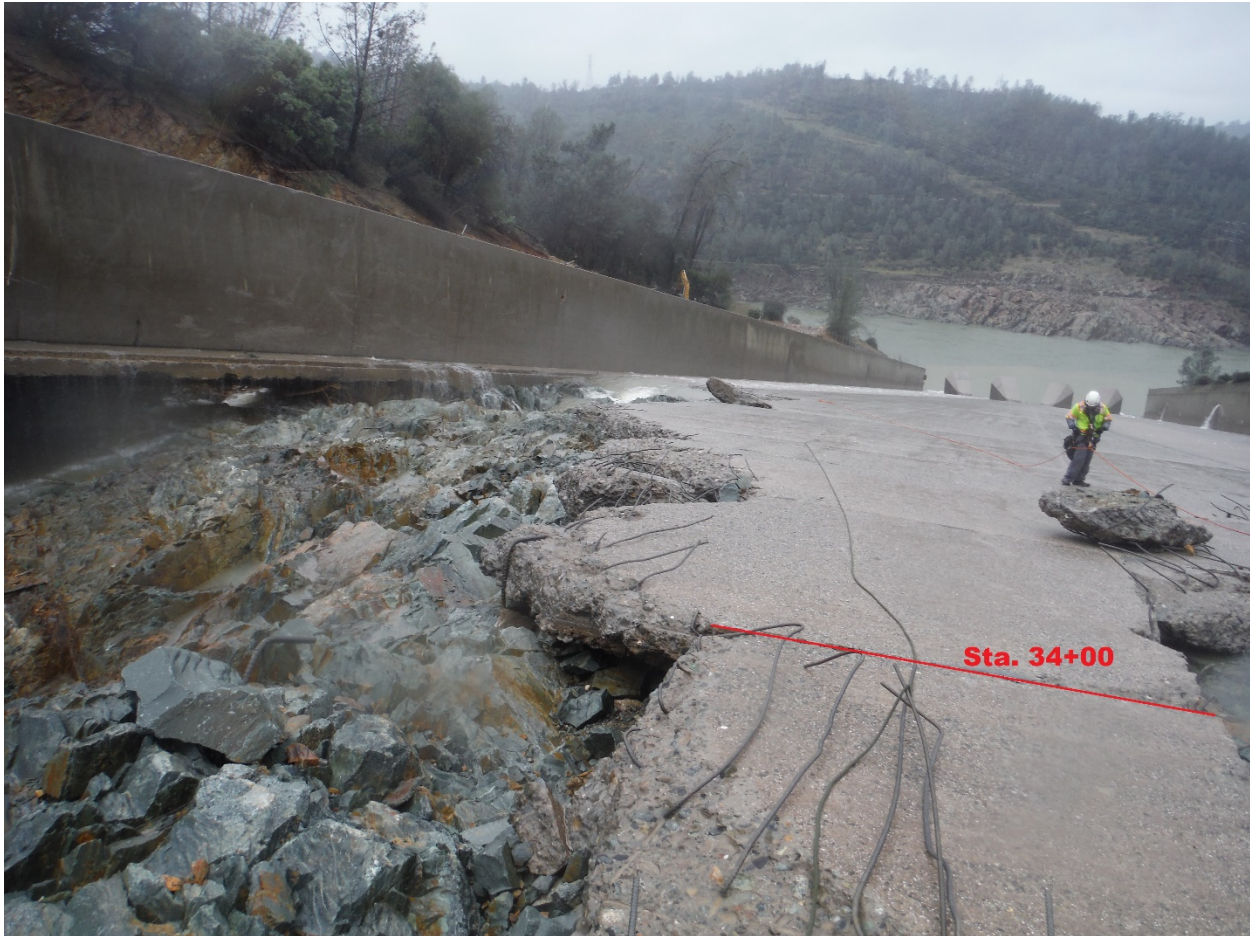
Figure I-10: Initial Damage Area Looking Downstream Showing Bent Bars Upstream of Sta. 34+00

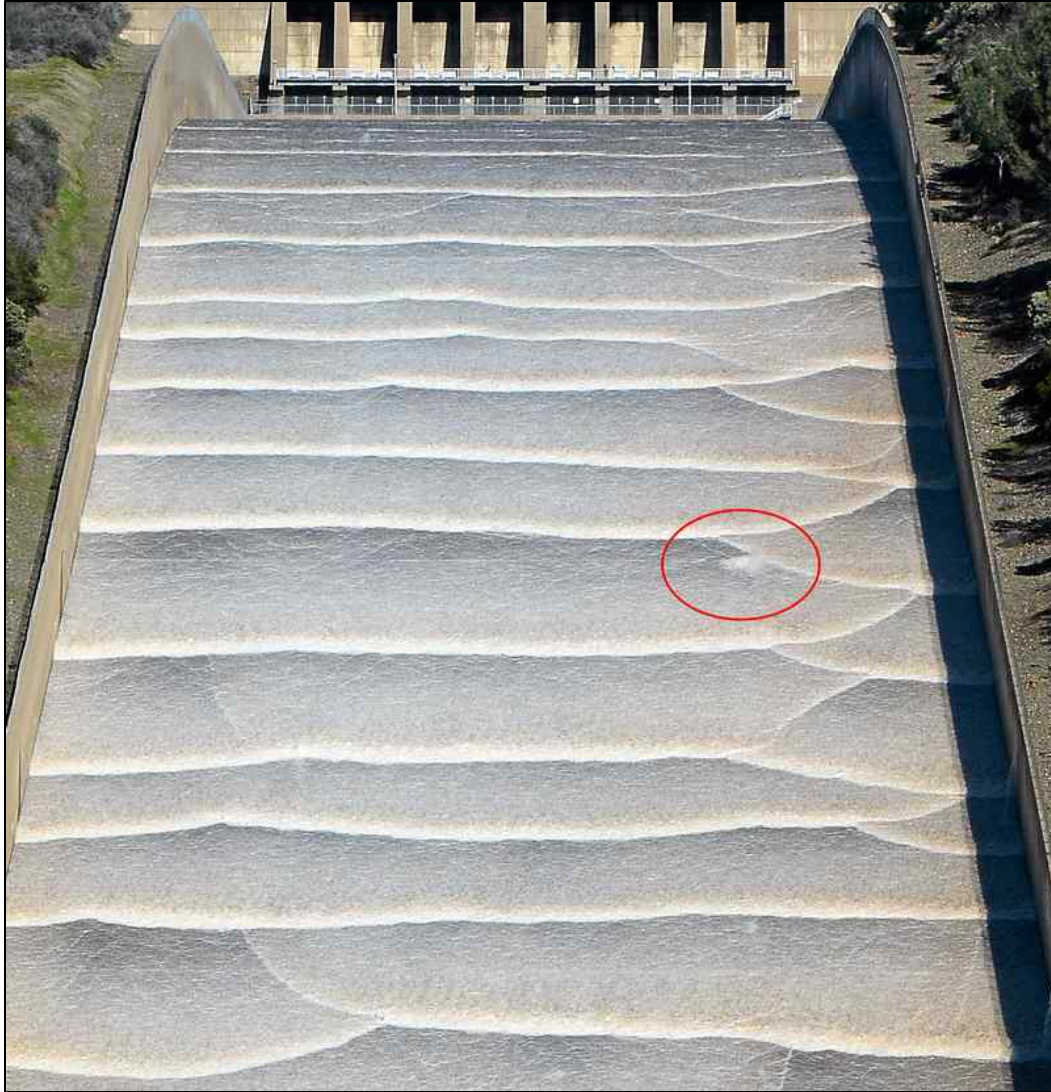
Figure I-15: Flow Disturbance in Lane 5 on January 13, 2017 [I-6]
