Middlemore Hospital – Galbraith Building

Independent Structural Review

Prepared for Counties Manukau District Health Board

26 April 2018

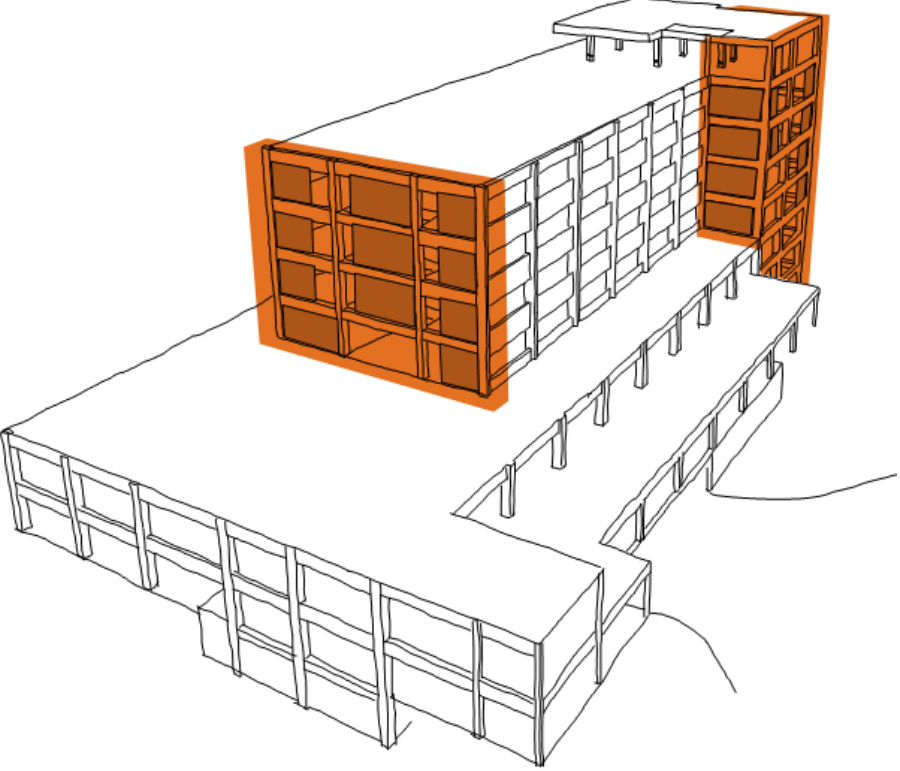
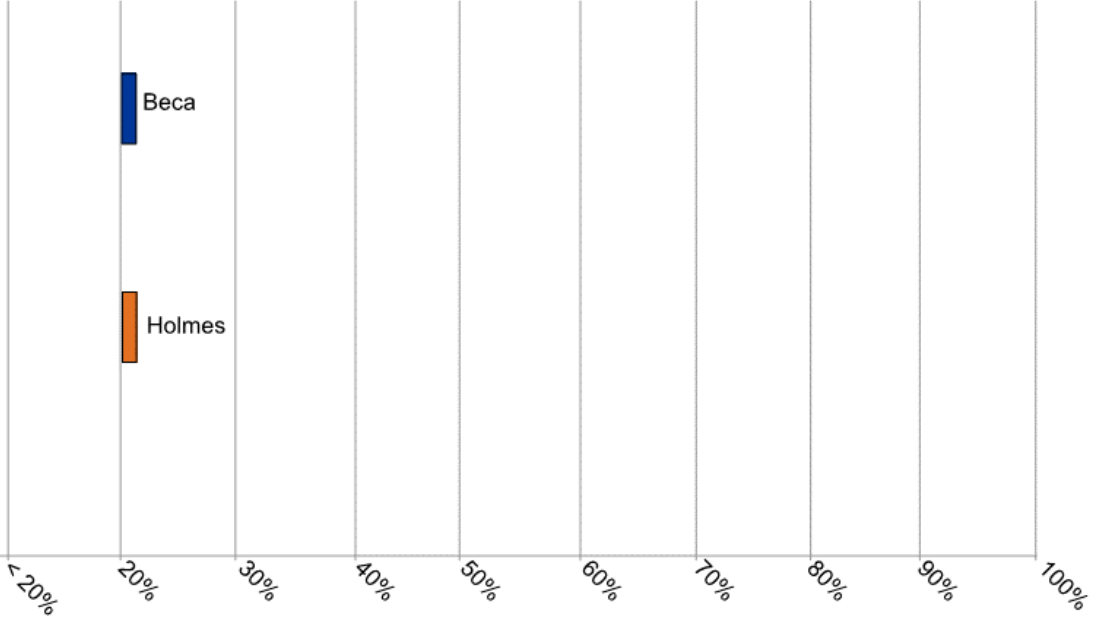
Element	Location	Consequence	
Infills walls out-of-plane.

<p>Damage to infill panels and risk of collapse to the ground or onto structure below due to lack of restraint of the panels.</p> <p>Damage to structure below, particularly the Level 2 plant room.</p> <p>Life safety risk to those outside the structure.</p> <p>20%NBS (IL4)</p>

<p>This infill behaviour is governed by out-of-plane actions, hence the higher certainty than the infill in-plane interaction with the frames.</p>
Infill walls causing column shear failure

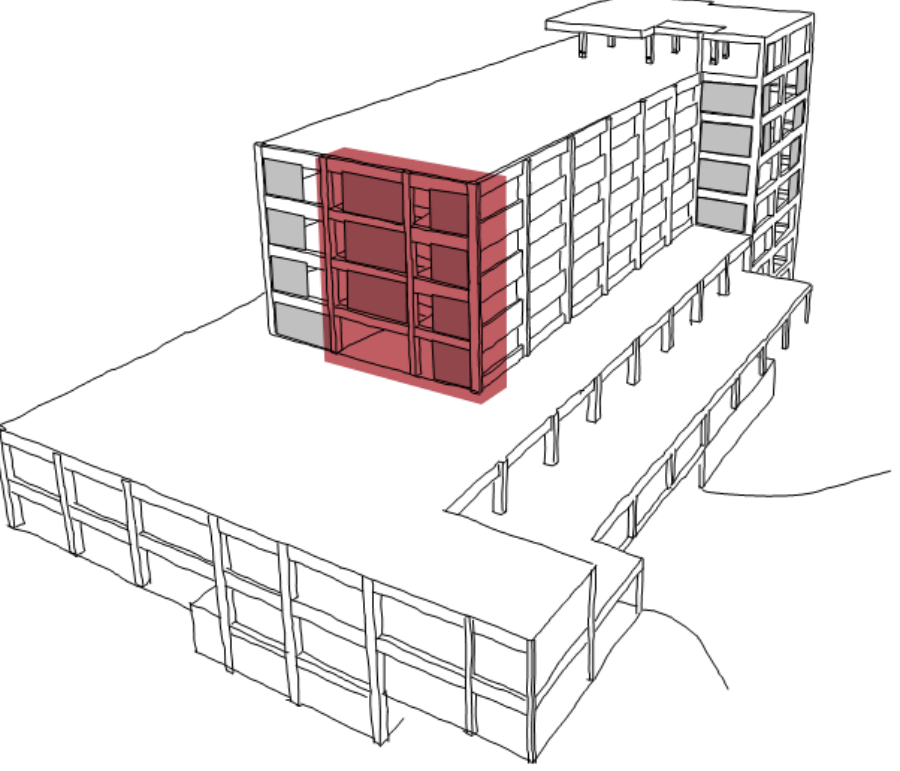
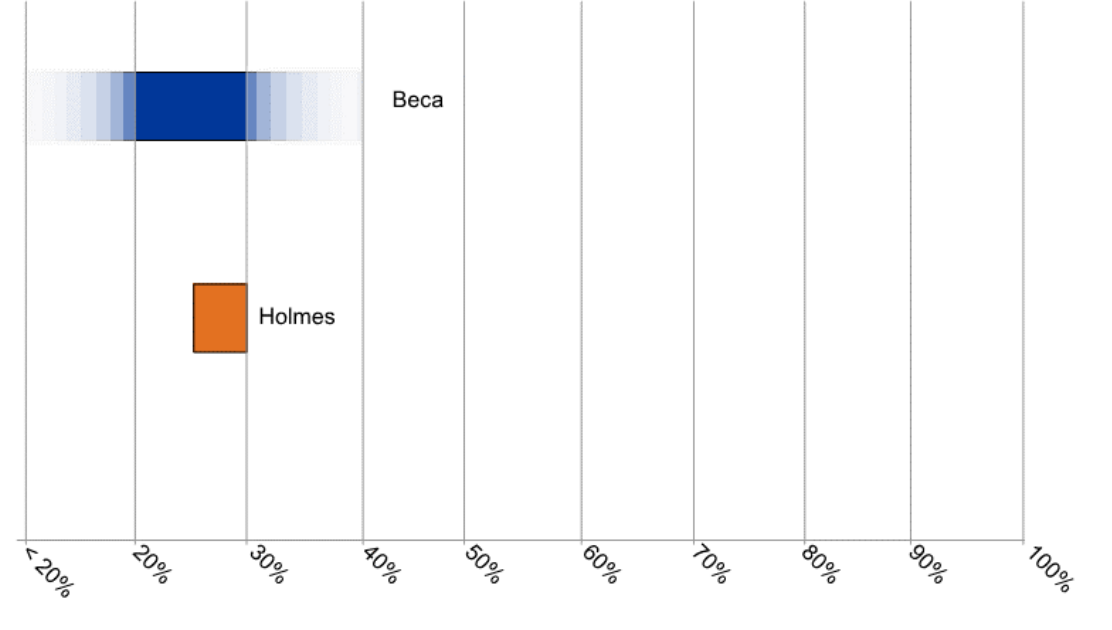
<p>Damage to frame due to infill panel interaction with frame, causing local shear failure to the columns. Occurs to south elevation of tower and around the northern stair and lift core area.</p> <p>Possible damage to nearby structure.</p> <p>Life safety risk to those inside the structure.</p> <p><20% – 30%NBS (IL4)</p>

<p>Differences in score due to modelling of infills and assumptions around behaviour, however we are both in conclusion that the infill panels interacting with the structure impacts significantly on the structural performance of Stage 1. Spread of scores covers both uncertainty in the gap present between the infills and the bounding frame, as well as critical scores from different locations in the structure.</p>

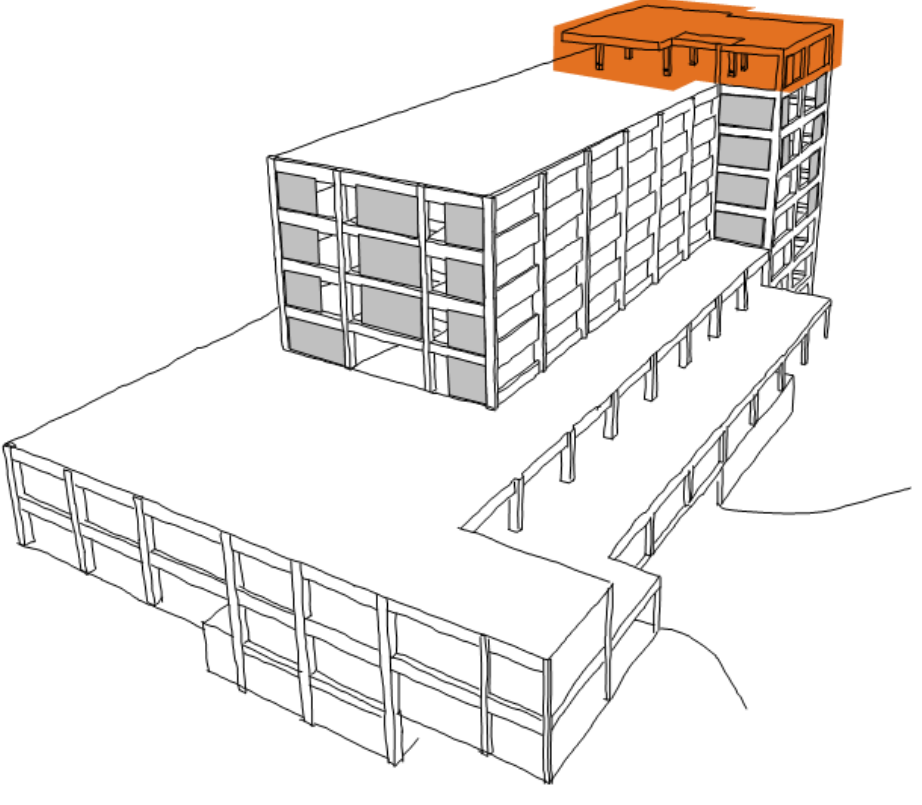
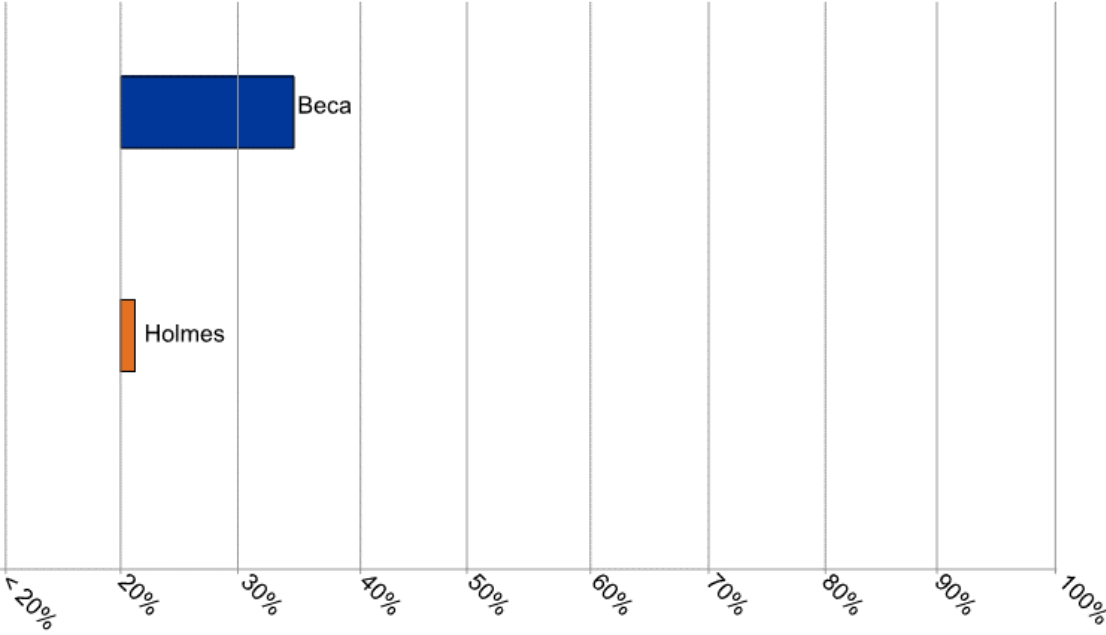
Element	Location	Consequence	
Level 7 Plant Room

<p>Flexure-shear failure in columns below, and beam-column joint shear failure at Level 7, leading to potentially widespread damage to plantroom structure.</p> <p>Possible damage to structure below.</p> <p>Life safety risk to those inside and potentially outside the structure.</p> <p>20% - 34%NBS (IL4)</p>

<p>Both Beca and Holmes are in agreement that the columns supporting the Level 7 plant room have insufficient lateral capacity, however the exact mechanisms responsible for failure vary slightly. Beca presents a range of scores to indicate the level at which initial failure of the column occurs, and when a sufficient number of columns and joints are damaged for there to be a high risk of collapse.</p>
External longitudinal frames to tower

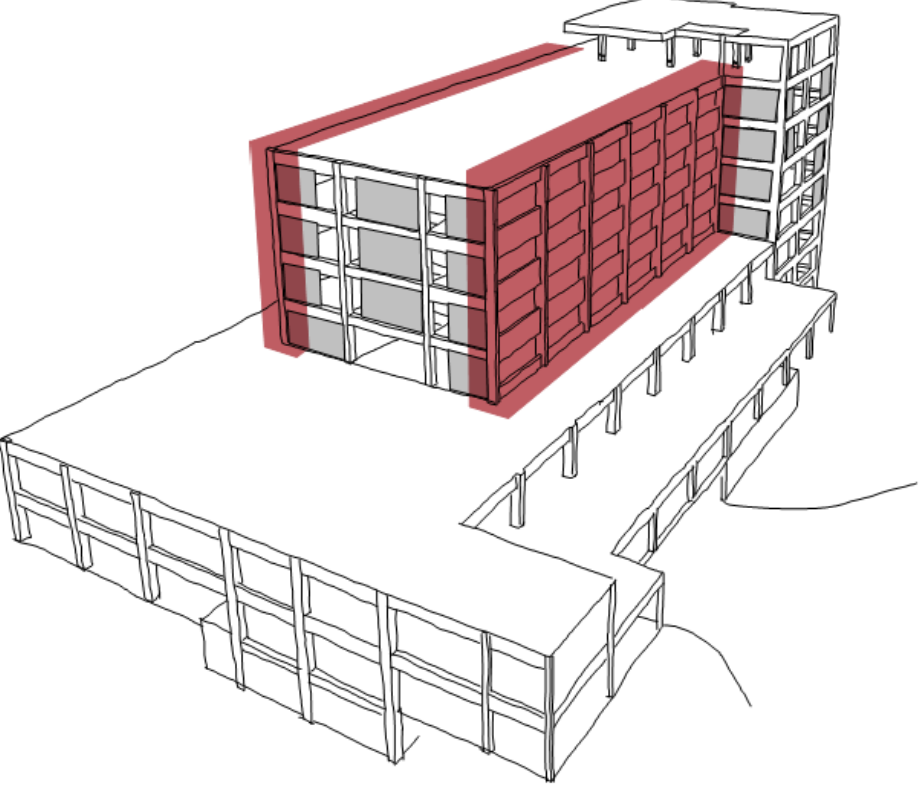
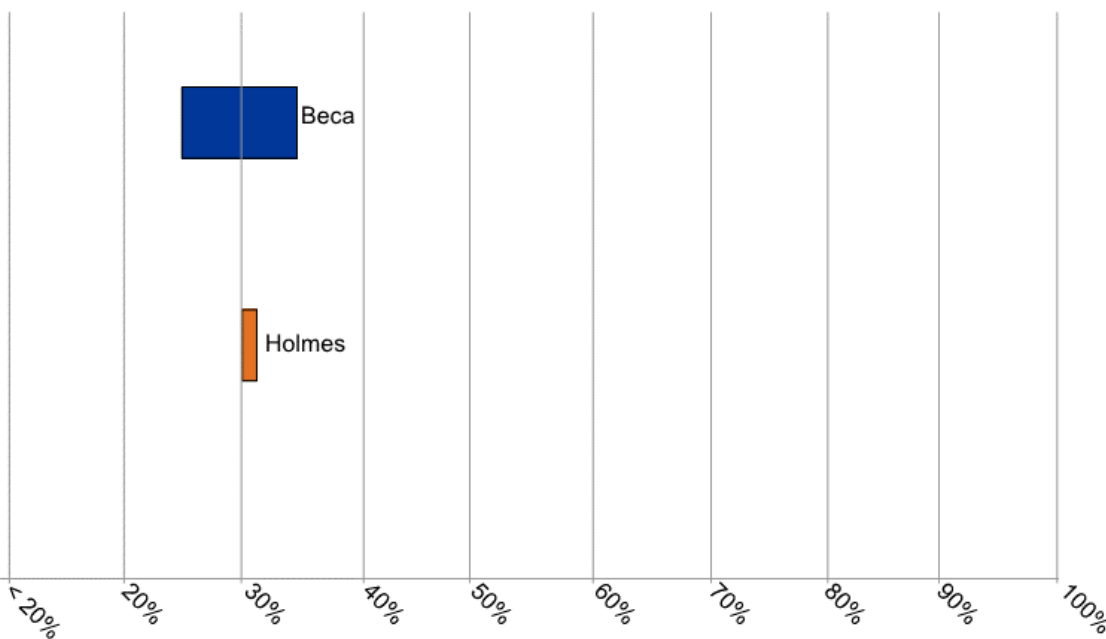
<p>Flexure-shear failure in perimeter columns due to interaction with half-height infill panels, with damage concentrated to Levels 3-5. Potential widespread damage to perimeter frames.</p> <p>Possible damage to structure below.</p> <p>Life safety risk to those inside and potentially outside the structure.</p> <p>25% - 34%NBS (IL4)</p>

<p>Both are in agreement that the half-height concrete panels are detrimental to the tower frames performance. Beca presents a range of scores to cover the initial column element failure, to when there are sufficient columns to constitute a high risk of multiple column failure in the frame line.</p>

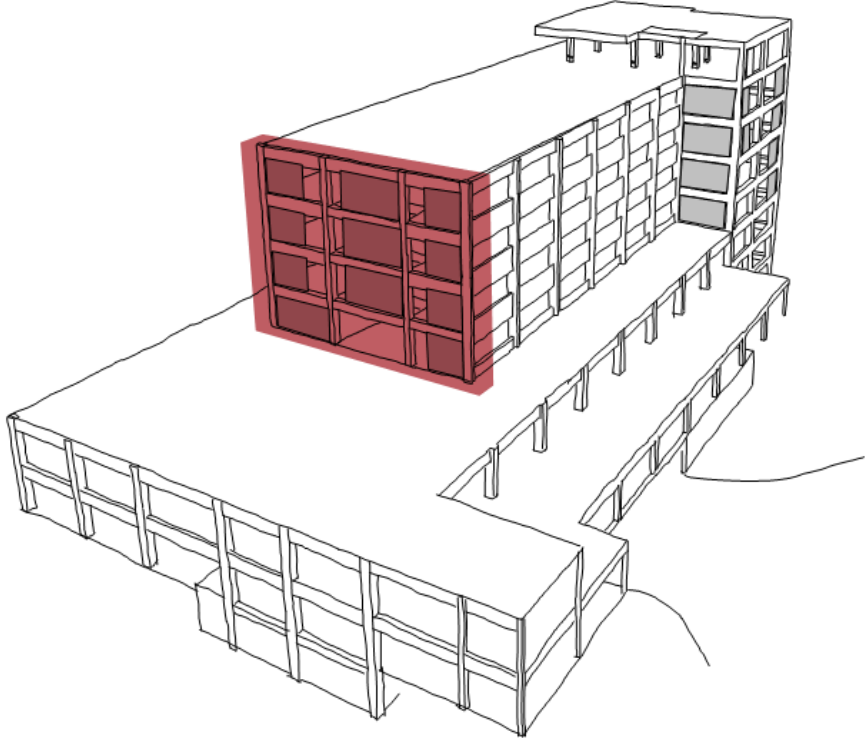
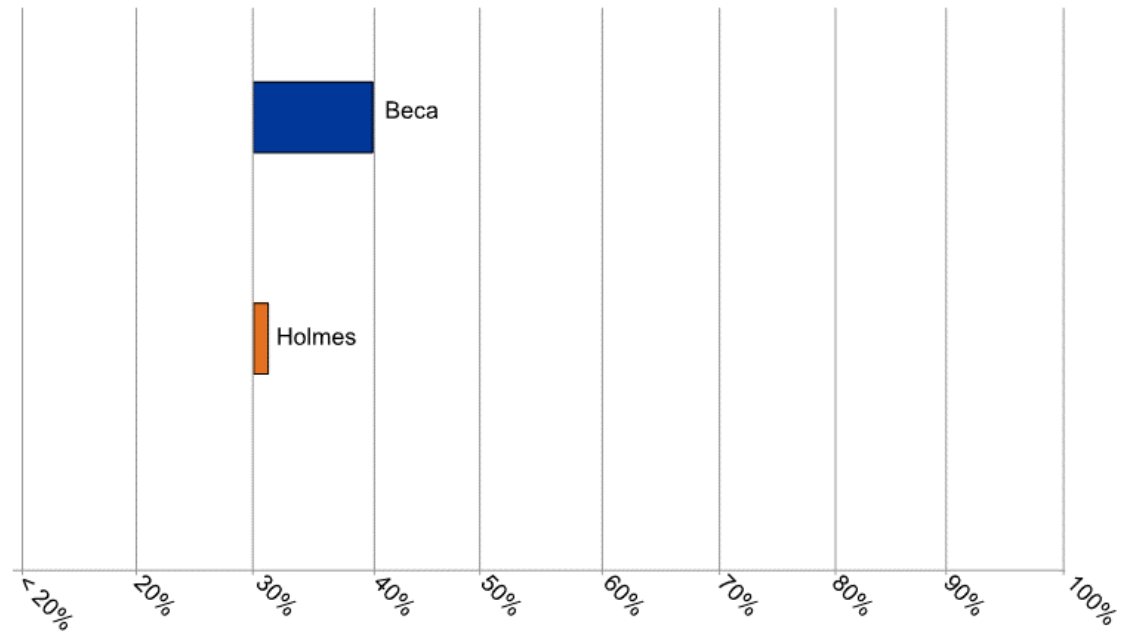
Element	Location	Consequence	
<p>Transverse end frame to south elevation</p>

<p>Beam column joint failure of frames and some shear failure of beams, leading to potential widespread damage to end frames.</p> <p>Possible damage to structure below, notably the Level 2 plant room.</p> <p>Life safety risk to those inside the structure.</p> <p>30% – 40%NBS (IL4)</p>

<p>Both are in agreement that the transverse end frame to the south elevation has insufficient lateral capacity, however the expected failure mechanisms and scores along this frame line differ. Beca expects there to be beam-column joint shear failure, critical at Level 3, leading to the failure of the frame line between 30%-40%NBS (IL4). Holmes has found the columns failing in shear along this gridline. During discussions with Holmes, they noted that this area was sensitive to the type of analysis undertaken.</p>
<p>Transverse and longitudinal direction tower frame failure</p>

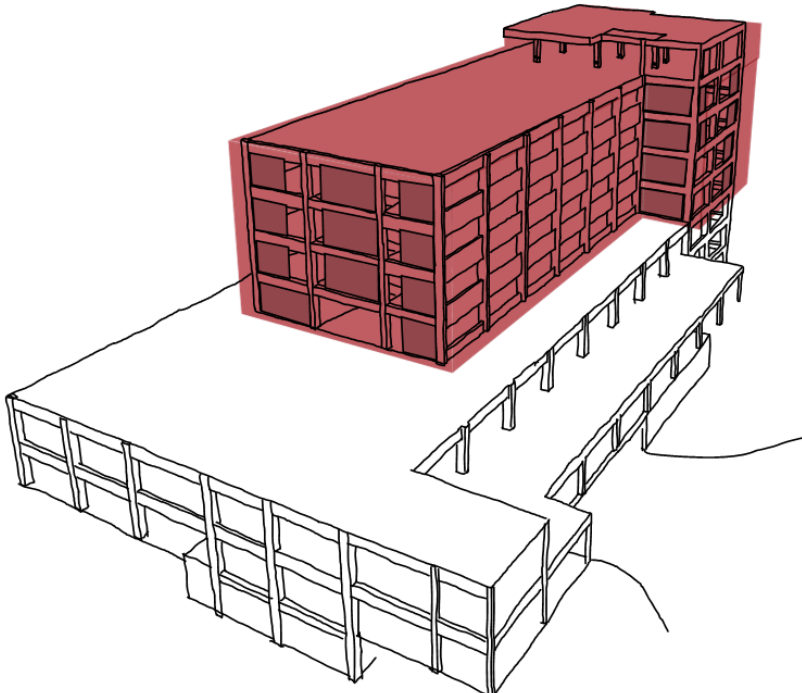
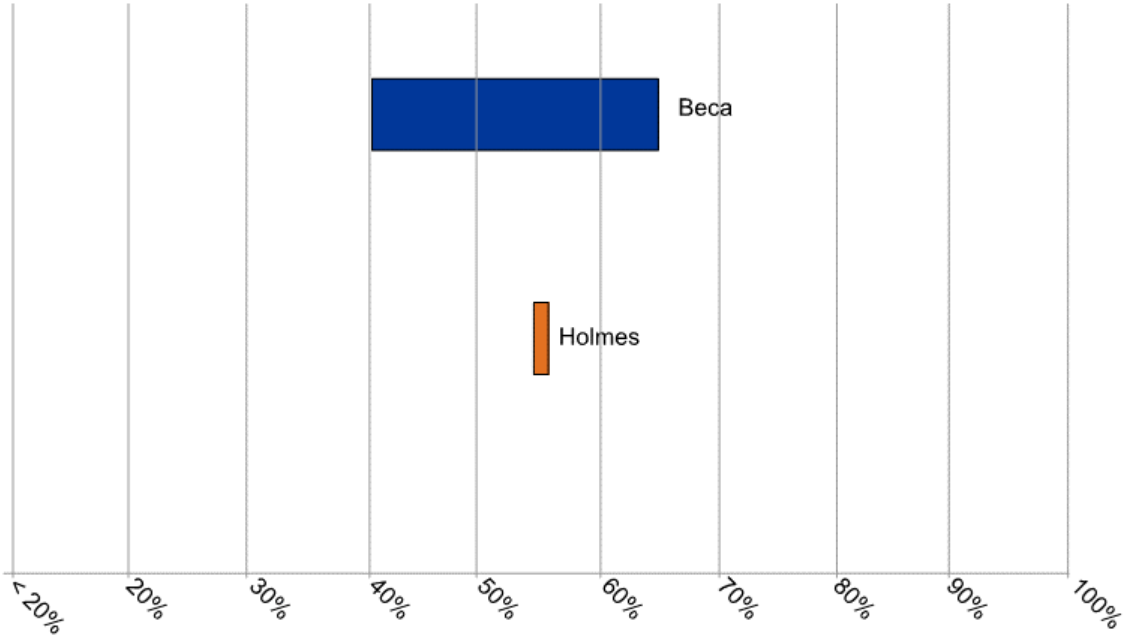
<p>Failure is expected to be a variety of brittle mechanisms, but dominated primarily by beam-column joint failure and column flexure shear mechanisms.</p> <p>Widespread failures throughout tower structure.</p> <p>Significant life safety risk to those inside and outside the structure.</p> <p>40% – 65%NBS (IL4)</p>

<p>Both are in agreement that the tower structure as a system sits somewhere between 34%NBS (IL4) and 67%NBS (IL4), however the expected mechanisms differ. Difference in presented scores and expected mechanisms due to analysis type and ability to report on a singular figure. Beca has found the response is dominated by the transverse frames, with beam column joint shear failure dominant at some levels, and column flexure-shear at others. Scores are presented based on a spread from the lowest scoring internal frames, to the highest. The overall structural mechanism is expected to fall within these values.</p>

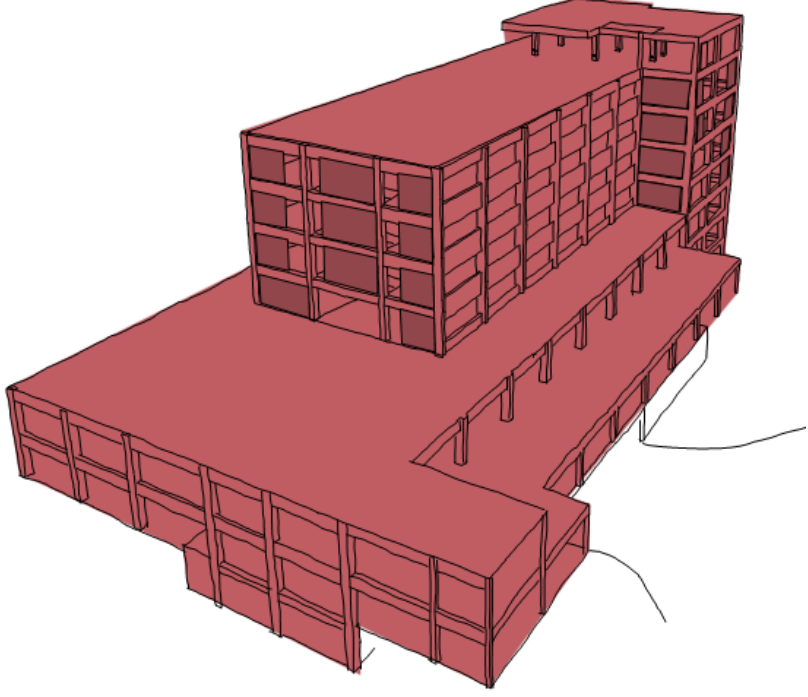
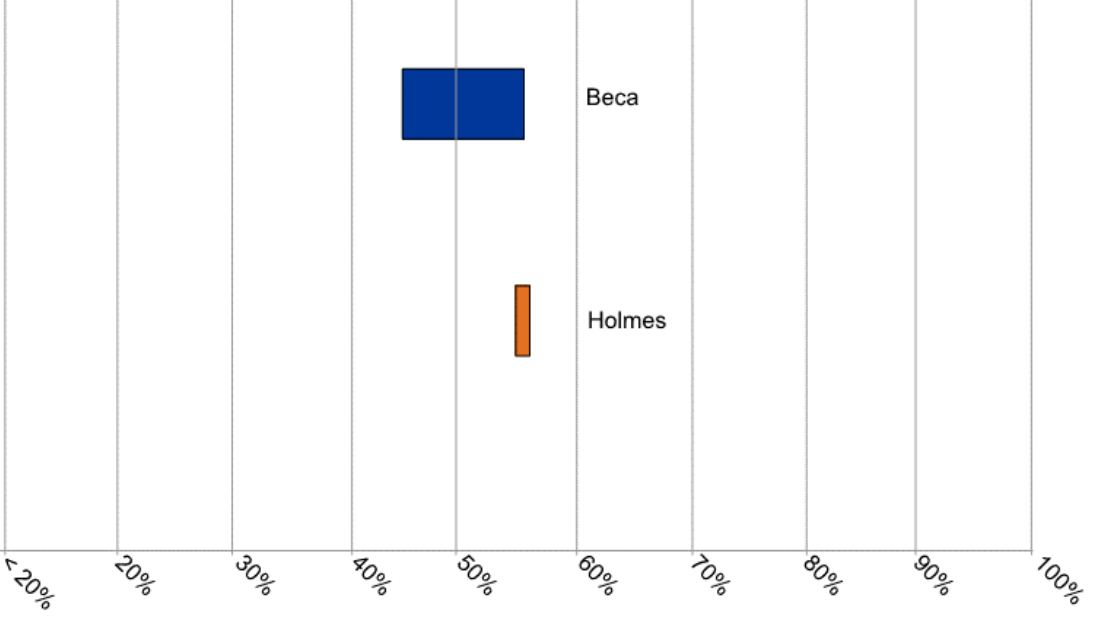
Element	Location	Consequence							
<p>Transverse and longitudinal direction podium frame failure</p>

<p>Failure is a variety of mechanisms, but dominated by column flexure-shear failure.</p> <p>Scores are governed by the western podium level columns with partial height infill. Short columns cause premature shear failure, leading to widespread failures throughout whole structure.</p> <p>Significant life safety risk to those inside and outside the structure.</p> <p>45% - 55%NBS (IL4)</p>

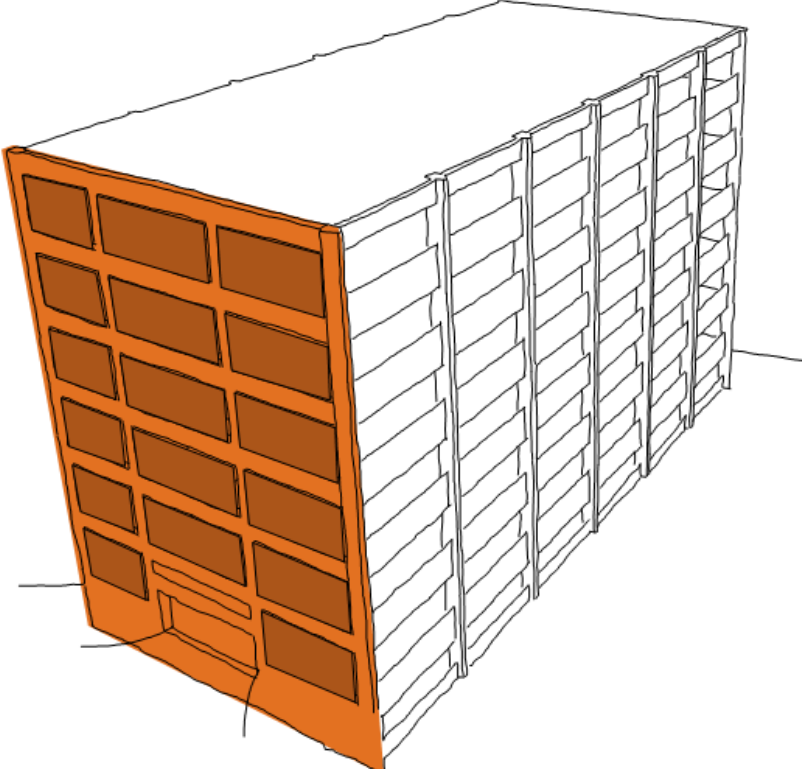
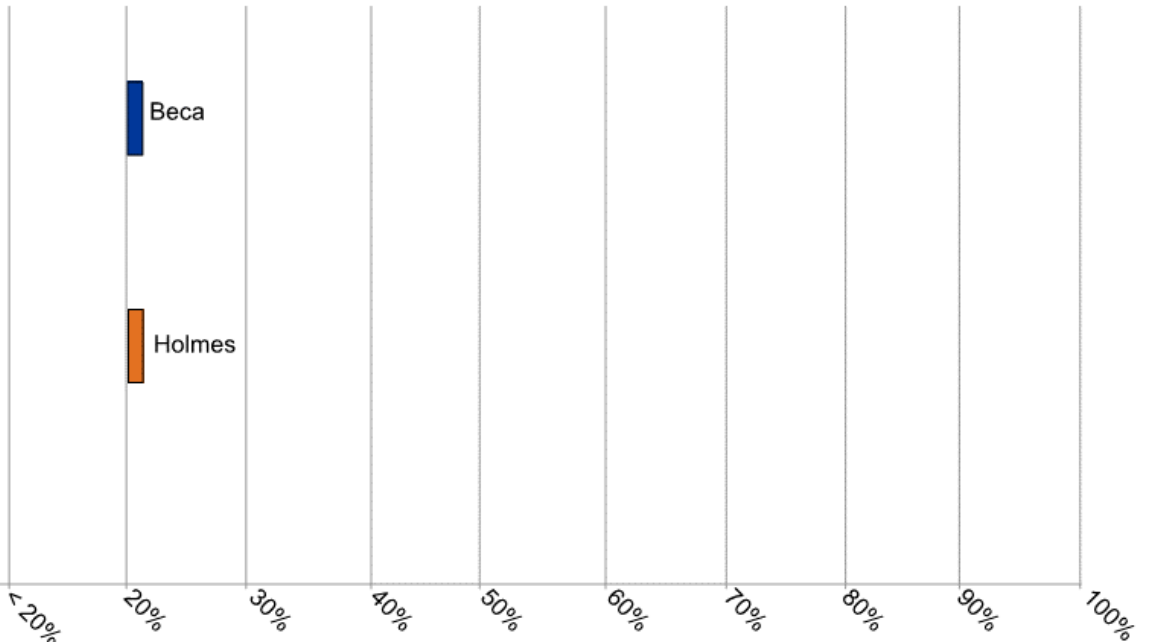
Element	Location	Consequence	Estimated %NBS						
Infills walls out-of-plane.

<p>Damage to infill panels and risk of collapse to the ground or onto structure below due to lack of restraint of the panels.</p> <p>Damage to structure below, particularly the Level 2 plant room.</p> <p>Life safety risk to those outside the structure.</p> <p>20%NBS (IL4)</p>

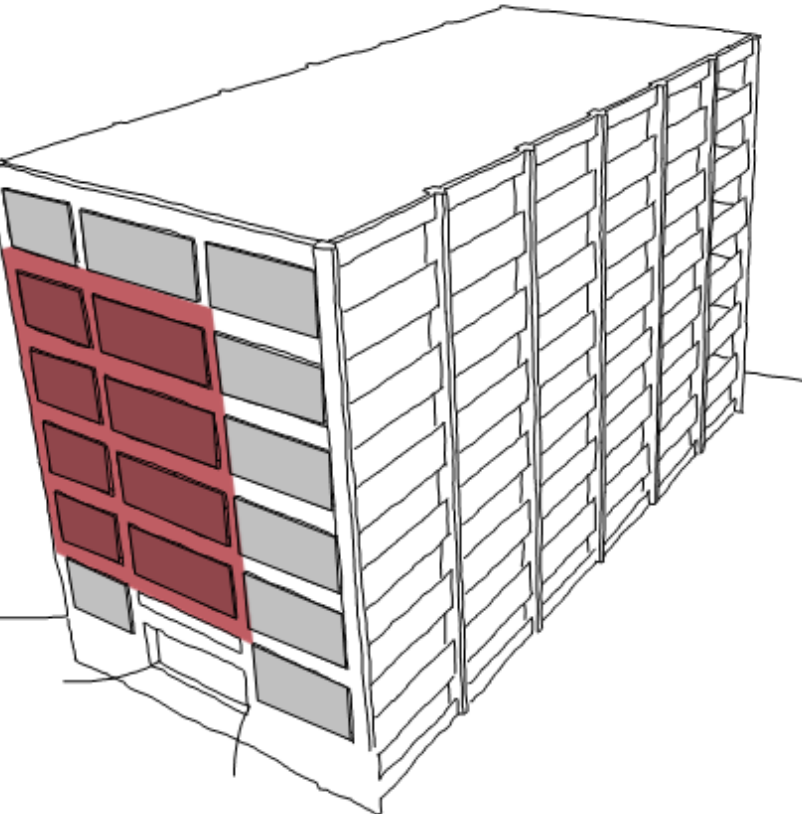
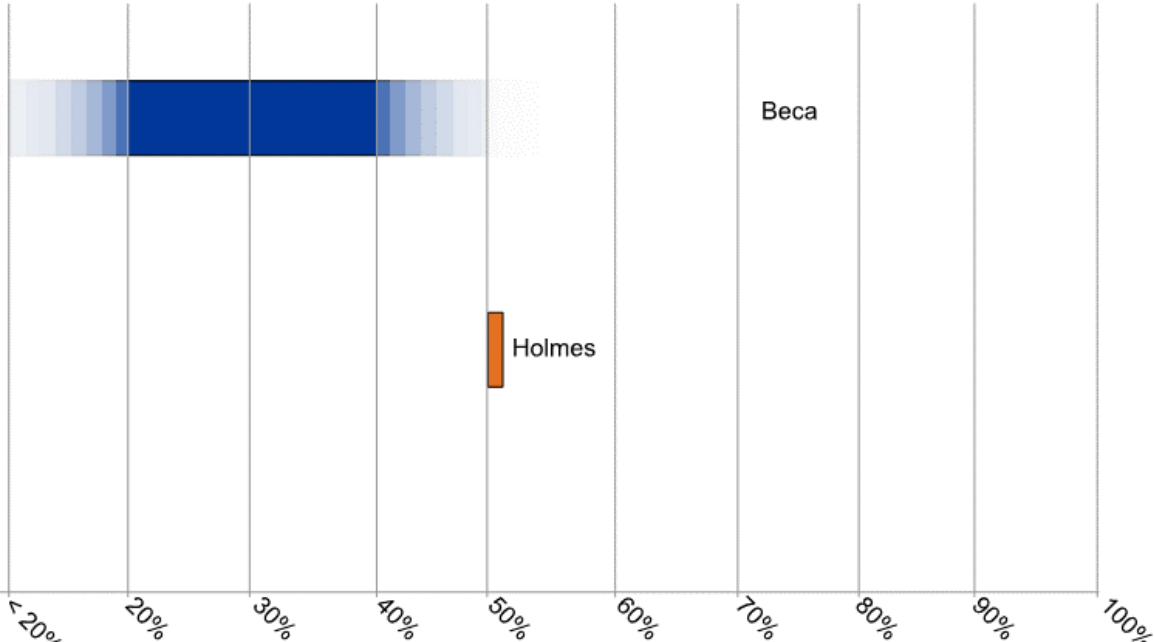
<p>Damage to frame due to infill panel interaction with frame, causing local shear failure to the columns. Occurs to south elevation of tower and around the northern stair and lift core area.</p> <p>Possible damage to nearby structure.</p> <p>Life safety risk to those inside the structure.</p> <p>20% – 40%NBS (IL4)</p>

Differences in score due to modelling of infills and assumptions around behaviour. Spread of scores covers both uncertainty in the gap present between the infills and the bounding frame.

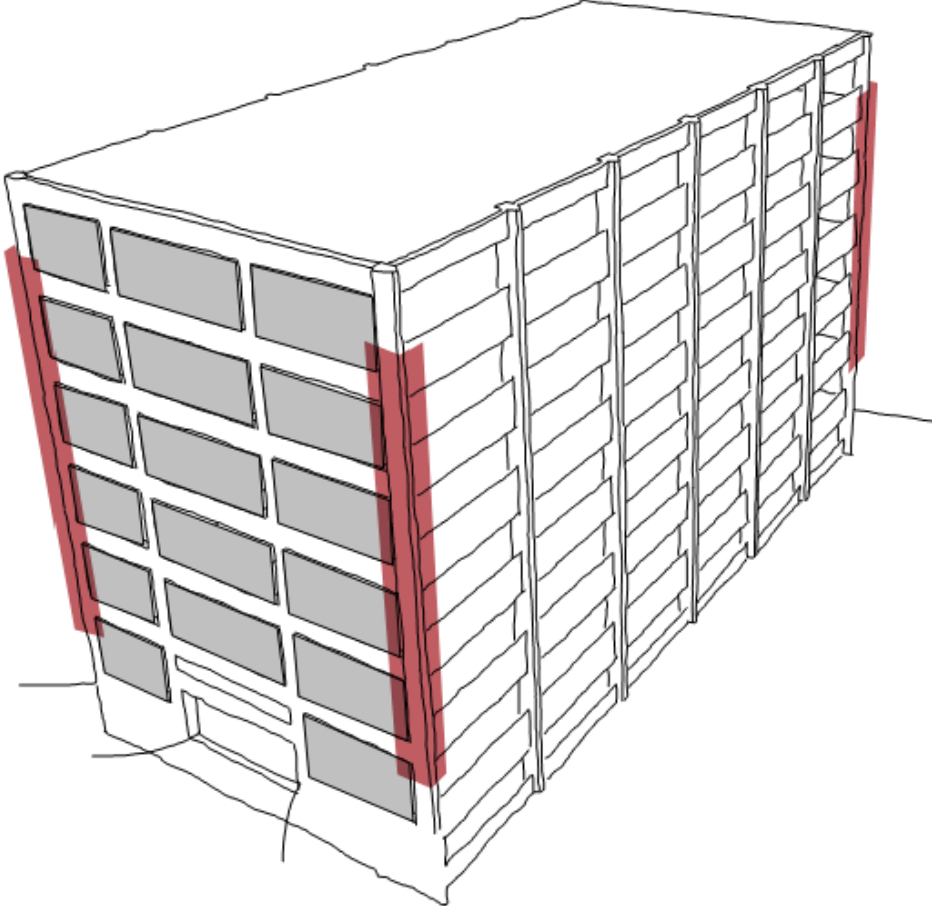
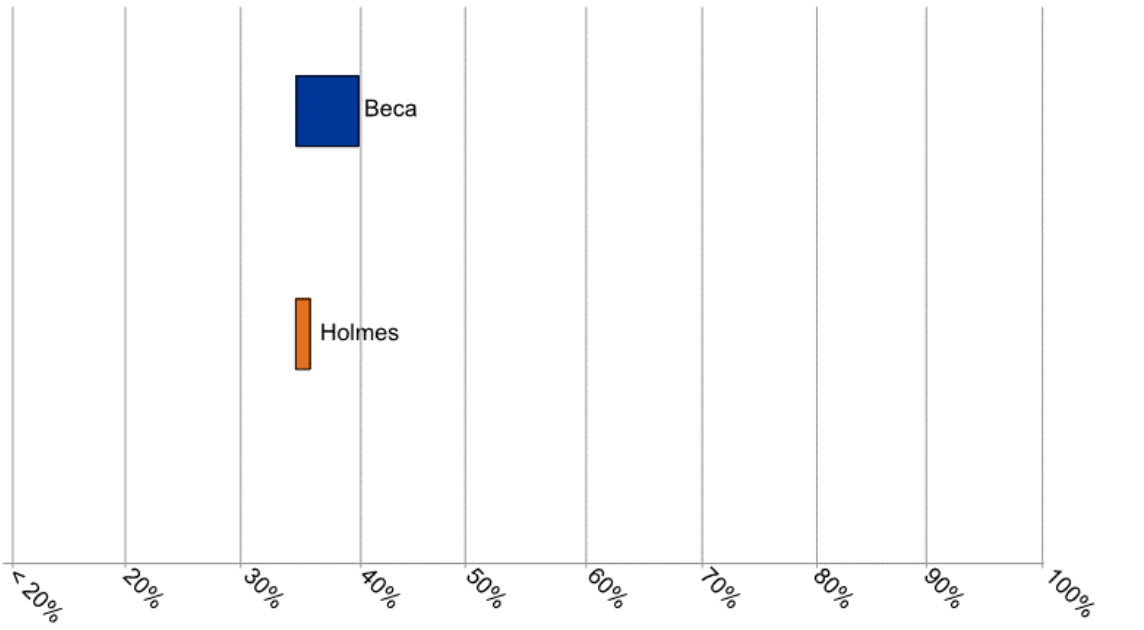
Element	Location	Consequence	Estimated %NBS
<p>North-South elevation beam-column joint failure</p>

<p>Beam column joint shear failure in north and south elevations of structure.</p> <p>Because of the use of deformed bars, we note some load redistribution to the internal frames causing beam column joint failure to the internal transverse frames.</p> <p>The score reported assumes this redistribution.</p> <p>Life safety risk to those inside and outside the structure</p> <p>35% – 40%NBS (IL4)</p>

<p>Both are in general agreement that the beam-column joints to the north and south elevations have insufficient strength. Difference in scores likely due to analysis techniques used – Beca has undertaken an elastic analysis model with joint failure simulated by pinning damaged joints, whilst Holmes have used an inelastic model that considers redistribution of loads based on the non-linear properties of the elements.</p>

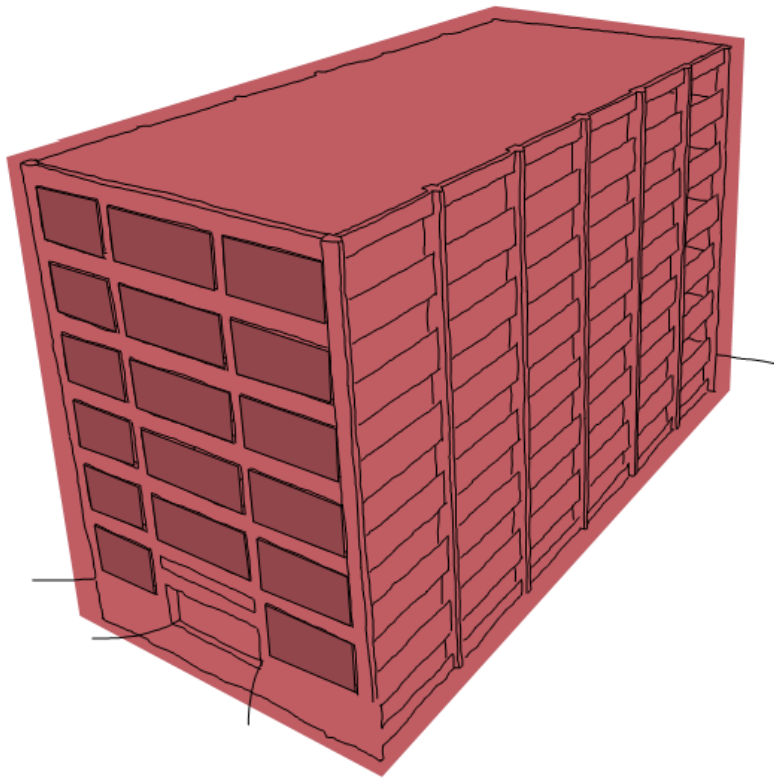
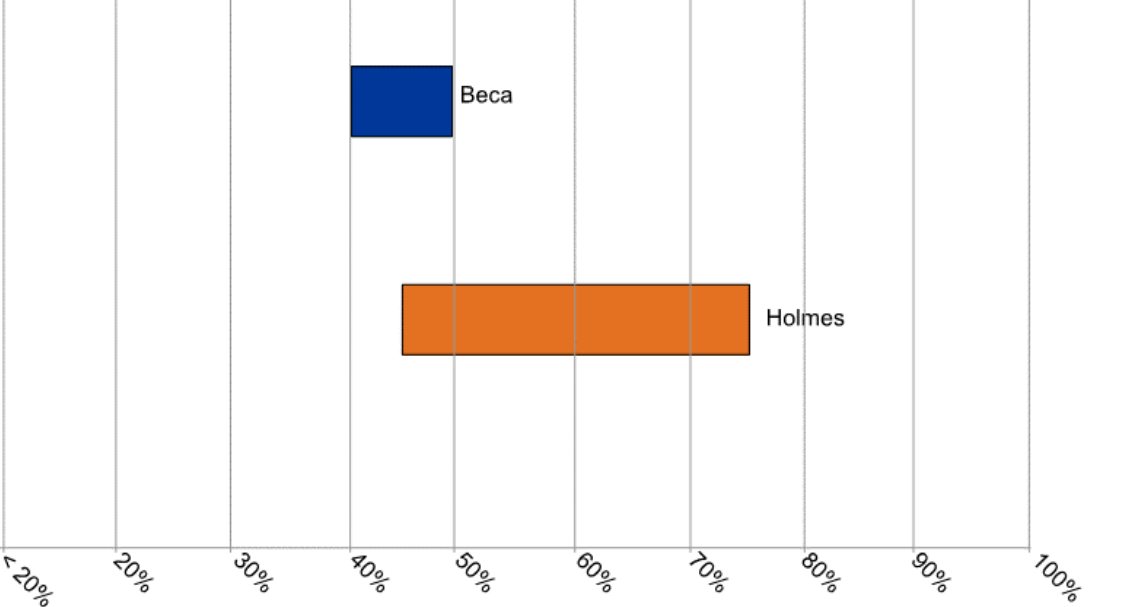
<p>Longitudinal direction frame failure</p>

<p>Beam column joint failure in internal and external joints, leading to loss of stiffness of system and excessive displacement demands on columns.</p> <p>Flexure-shear failure in perimeter columns due to interaction with half-height infill panels. Widespread damage throughout structure.</p> <p>Shear failure of internal beams, leading to widespread damage throughout structure.</p> <p>Life safety risk to those inside and outside the structure</p> <p>40% - 50%NBS (IL4)</p>

<p>Note that it is difficult to compare directly the findings of Beca and Holmes, due to the difference in assessment methodology. Beca's methodology provides scores for the building in each principal frame direction, whereas Holmes' dynamic analysis inherently provides a score in both directions. Holmes' range of scores for elements is provided above, and does not represent an uncertainty range.</p>

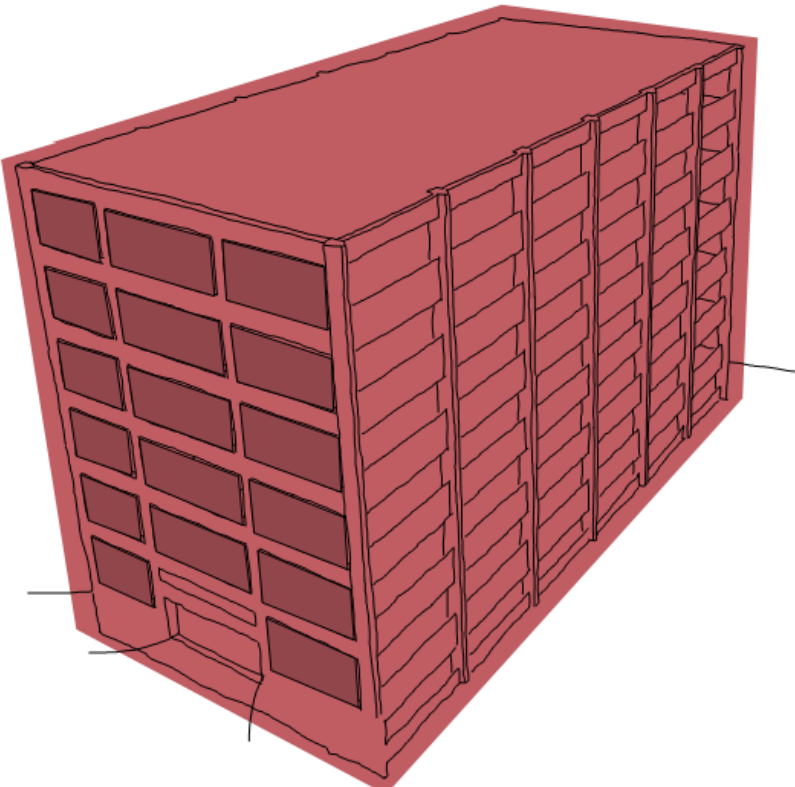
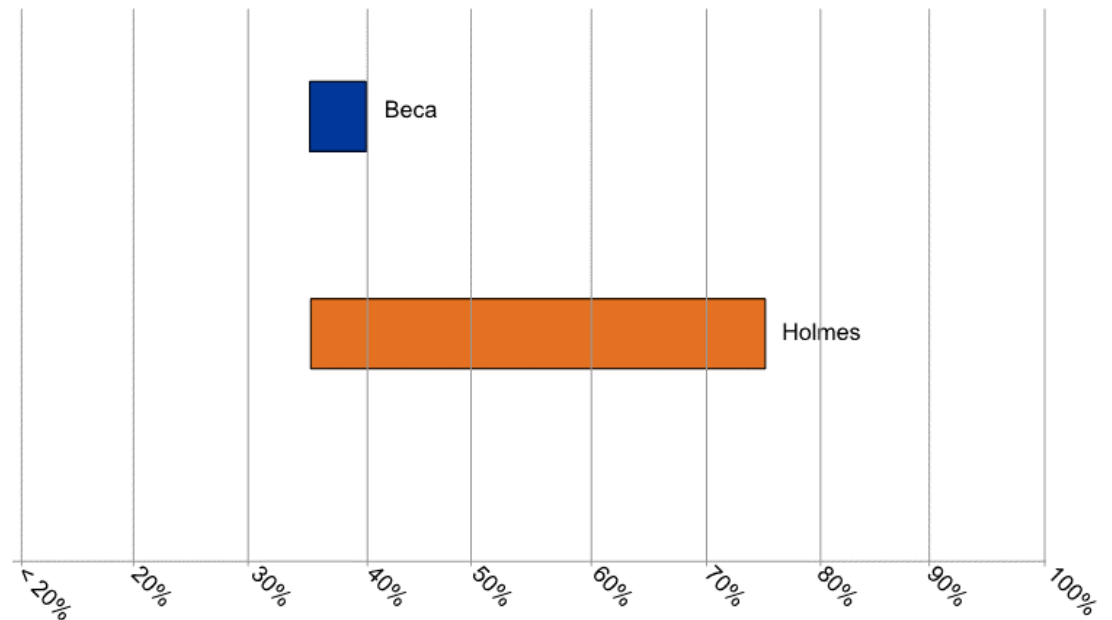
Element	Location	Consequence	Estimated %NBS
Transverse direction frame failure

<p>Beam column joint failure in internal and external frames, leading to loss of stiffness to frames, excessive displacements and widespread damage throughout structure.</p> <p>35% - 40%NBS (IL4)</p>

<p>As noted above, Holmes' range of scores for individual elements is provided above, and does not represent an uncertainty range.</p>

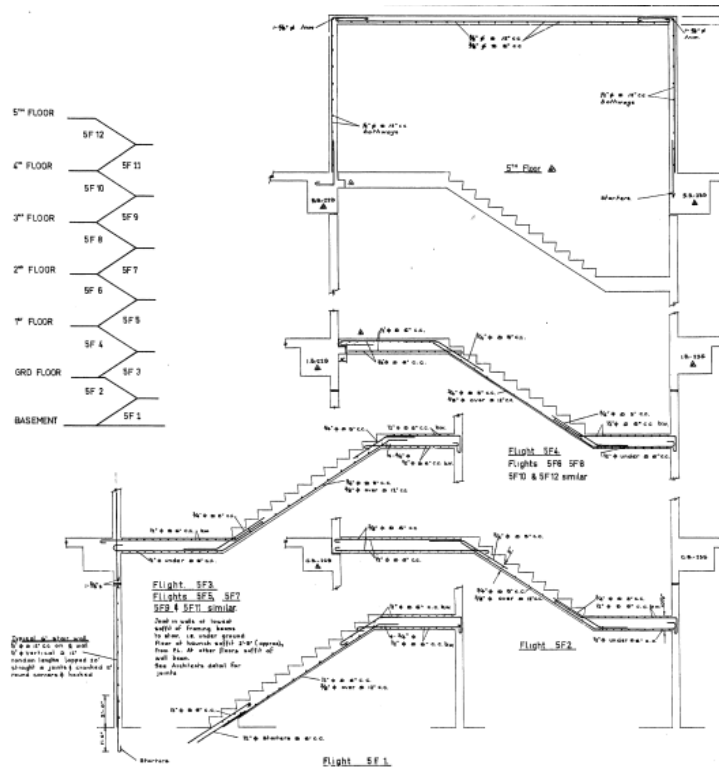
Fig.3.2.1 Stair Details - Galbraith Block Stage 2 Building

The staircases in Galbraith consist of two flights between each floor as shown in Fig. 3.2.1. The stair flights appear to be constructed from in situ reinforced concrete; and are continuously supported by the reinforced concrete walls that enclose the stairwell. The original structural drawings indicate that the stair flights supported on the edge of the reinforced concrete beams at each floor level.

Because the stair cases are built in with no sliding connection, it is likely that stairs won't be able to accommodate the building displacement during the shaking leading to damage to concrete stairs, walls and potential loss of support of stair flights at each floor level.

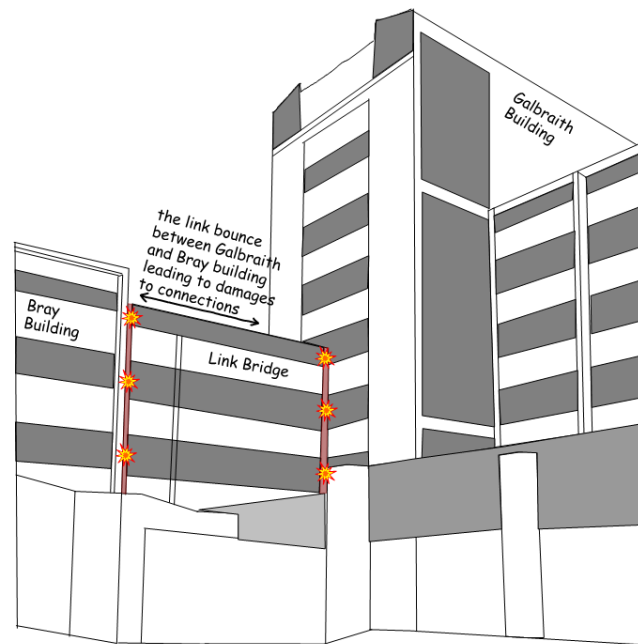
Fig. 4.5.1 Galbraith – Bray Link

Our site visit and review of the available drawings lead us to find the link structure does not include a clearly identifiable defined lateral load resting system and a robust load path in the longitudinal direction. Our discussions with Holmes Consulting confirm this finding. During earthquake shaking the link structure will displace longitudinally and may well "bounce" between the floors of Galbraith building and Bray building.

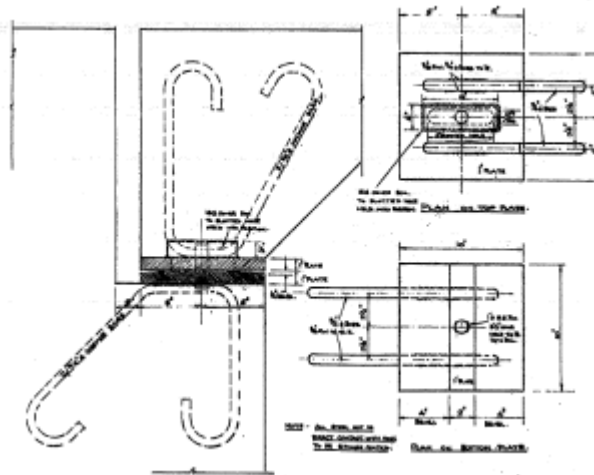
Fig. 4.5.1 Connection Details – Link Structure to Galbraith Building

It is possible that this 'bouncing' would lead to damage to the supporting connections. Of particular concern is the risk of damage to the bolt connecting the link bridge to the Galbraith Building. Should that bolt shear, there is a risk of loss of support at the Galbraith end of the link.

In our view, it is difficult to assess and quantify a reliable %NBS in the absence of a clear lateral load resisting system. While the 'bouncing' between Galbraith and Bray may well contain the link bridge, this is not a reliable load path.

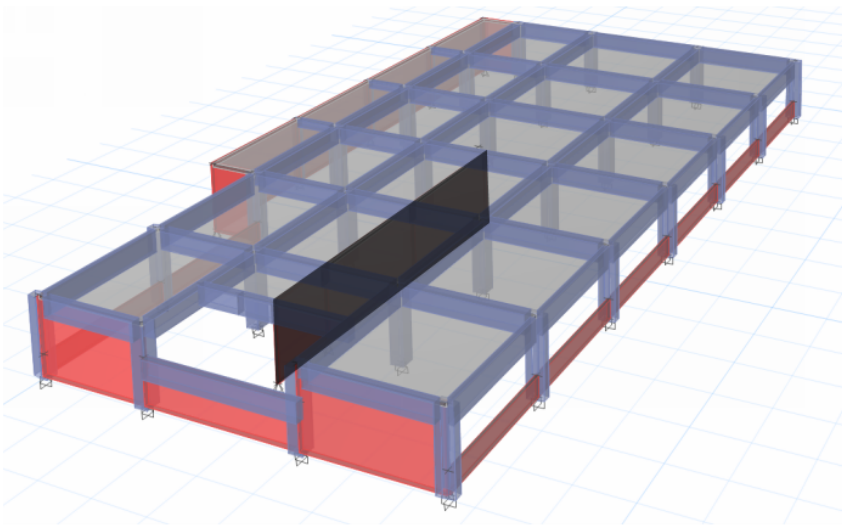
This is not expected to change the reported scores of the structure, however this load path should be considered for any strengthening works undertaken for the building.

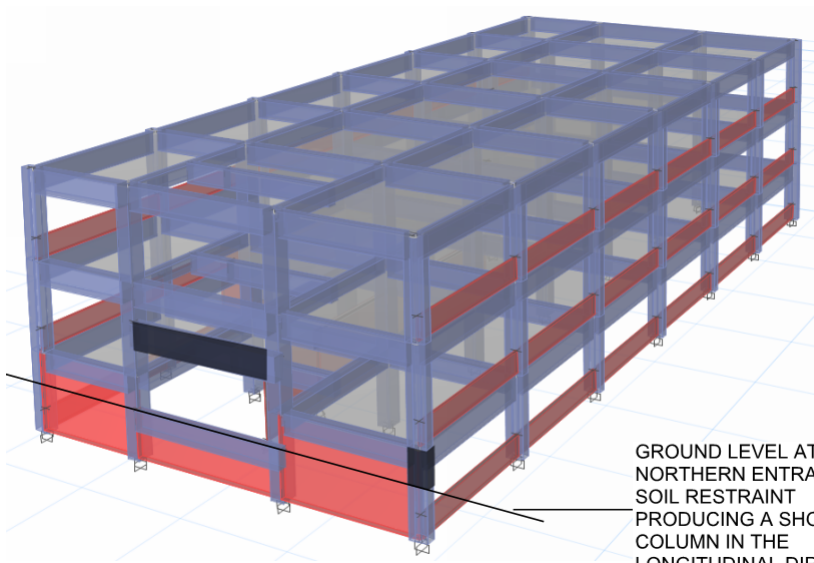
Stage 2 Basement Short Columns

The Holmes report does not specifically mention any impact from the possible short column effects on the north end of the building. The analysis model does not appear to account for the structural configuration or boundary conditions at this end.

GROUND LEVEL AT
NORTHERN ENTRANCE.
SOIL RESTRAINT
PRODUCING A SHORT
COLUMN IN THE
LONGITUDINAL DIRECTION

This is not expected to change the overall score of the structure, however the implications from the as-built geometry and the boundary conditions should be checked for any strengthening works undertaken for the building to ensure undesirable mechanisms are not occurring.
