SUBJECT: A CORROSION MITIGATION PROGRAM FOR THE REDWATER
OIL FIELD

T.A. Scott
Esso Chemical Canada

B.E. Fowlie
Imperial Oil Limited

A Corrosion Mitigation Program for the Redwater Oil Field

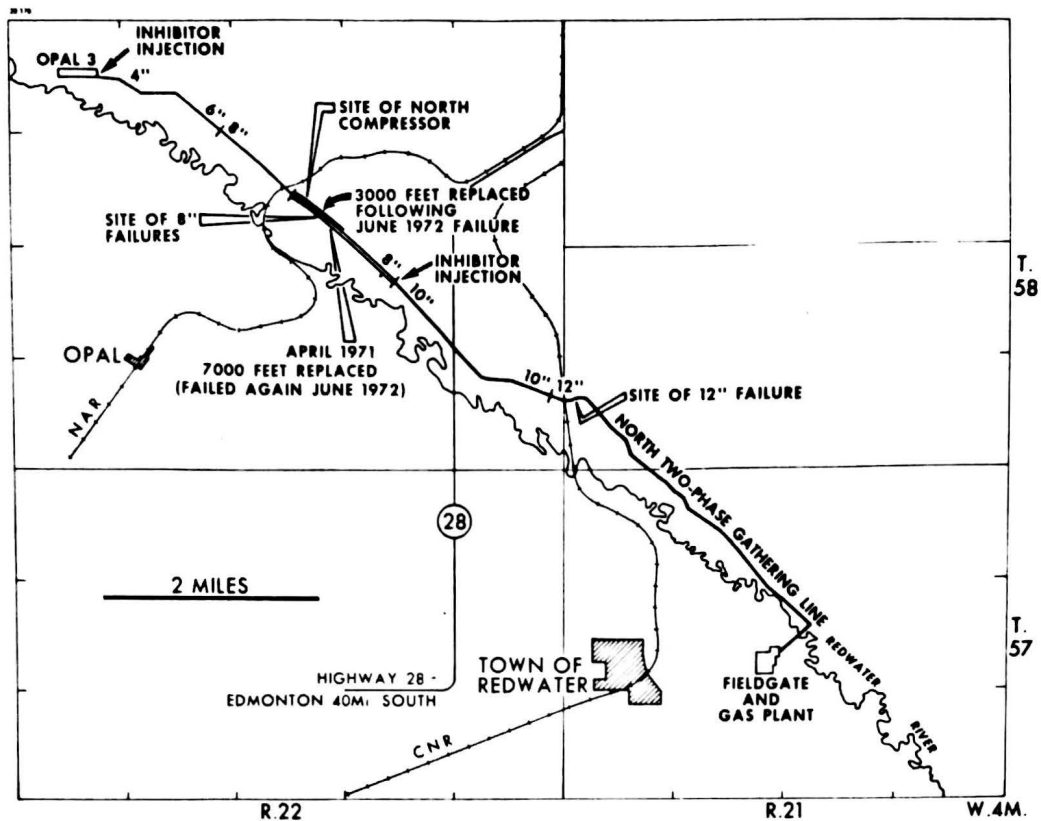
Figure 1 - Map of the Redwater North oil field showing failure locations and inhibitor injection points on North Two-Phase gathering line.

A number of items were considered to be significant to the failure analysis. Two failures had occurred in the same section of line and the hydrogen sulfide and water content of the production was increasing with time. At the time of the June 1972 failure the line was transporting 9600 barrels/day of product and 1500 barrels/day of water. Also significant was that a compressor station was injecting gas into the North Two-Phase line at a point which was upstream of the failure locations (Figure 1).

It was considered that this gas compressor provided a warming trend and a sour wet gas phase which scrubbed the pipe wall free of its natural protective films of iron-sulphide.

Following the failure in the 8 inch section in June 1972, it was decided that an inhibitor program be commenced immediately by injecting continuously a water and oil dispersible corrosion inhibitor. The program consisted of batch treating the line at the North end of the 4 inch section and at the junction of the 8 inch and 10 inch sections at a concentration of 200 ppm. Following the batch treatment a continuous inhibitor injection rate of 20 ppm was injected at the same locations.

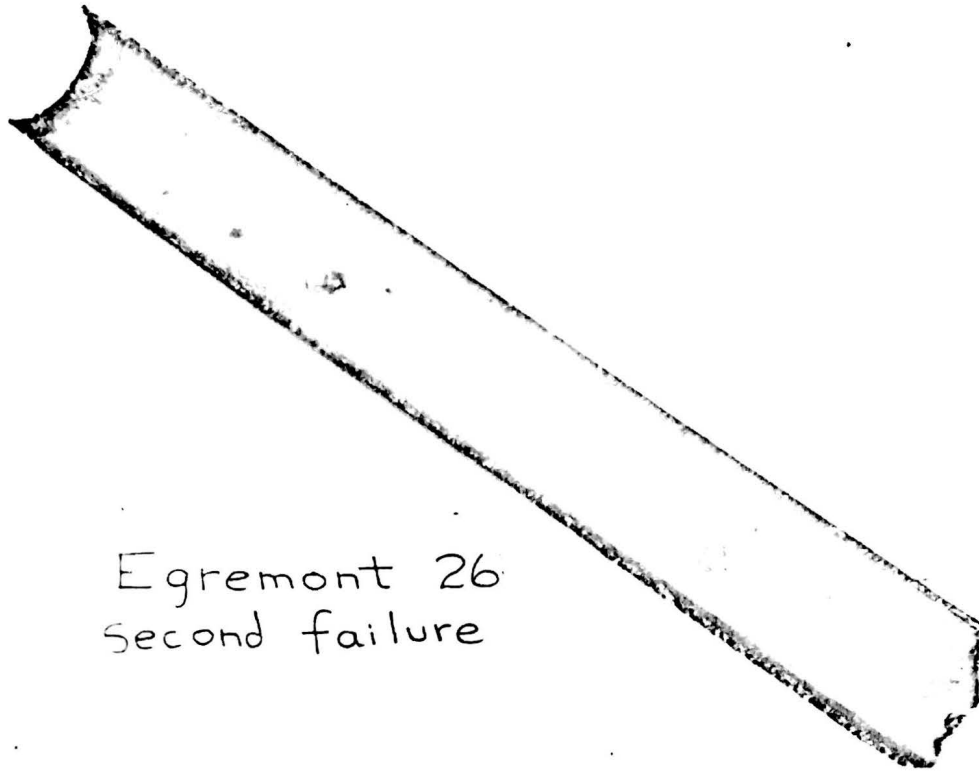
Egremont 26
Second failure

Two failures in flowlines from wells occurred before the start of the inhibition program. On one of these wells a second failure of the flowline occurred two months after the well and the flowline received the first inhibitor treatment. This failure is shown in Figure 9.

Figure 9 - The second failure of the flowline.

This second failure is suspected to have resulted from corrosion damage which occurred prior to inhibition aided by minor corrosion while on inhibition. In December 1975, two more flowlines failed as a result of internal corrosion. These flowlines (and their producing wells) had been on inhibition since mid 1974. These two flowlines which failed represent a small percentage of the 236 wells which are presently being inhibited. The two flowline failures are presently being investigated.
