# Salesforce Transit Center Girder Repairs

Bruce Gibbons, SE

December 13, 2018

## Fremont St. Girders - Repair

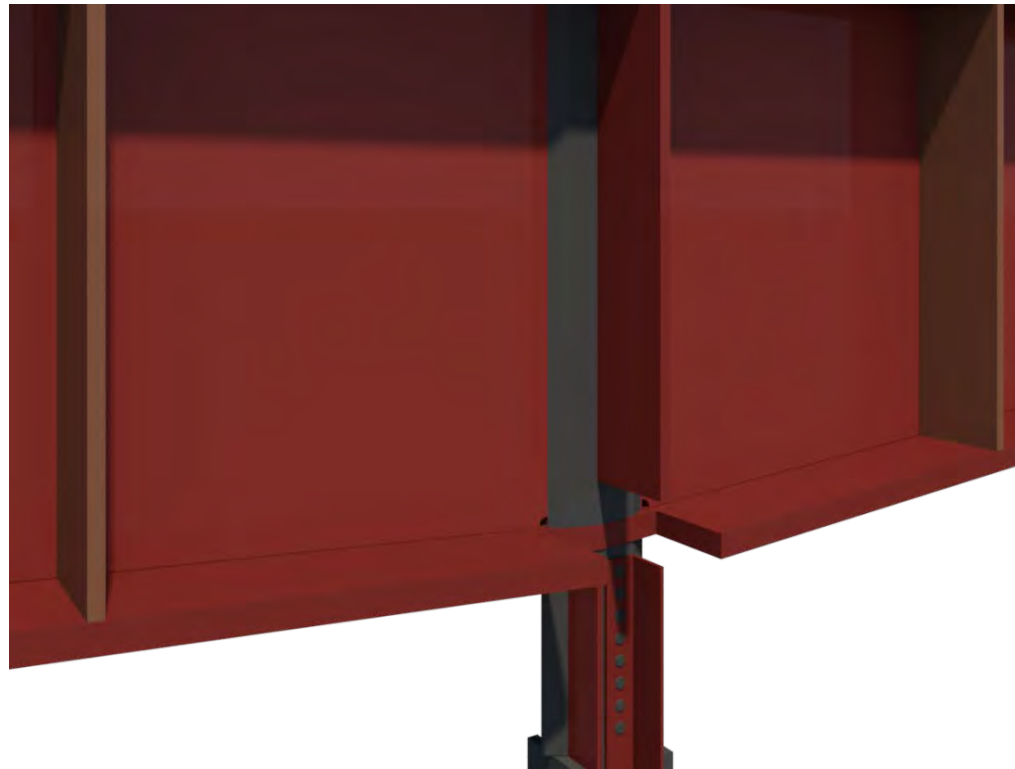
Objective: Restore the bottom flange to its original design capacity.

Grind the flame-cut surface of the web hangers to a smooth surface, and Magnetic Particle test.

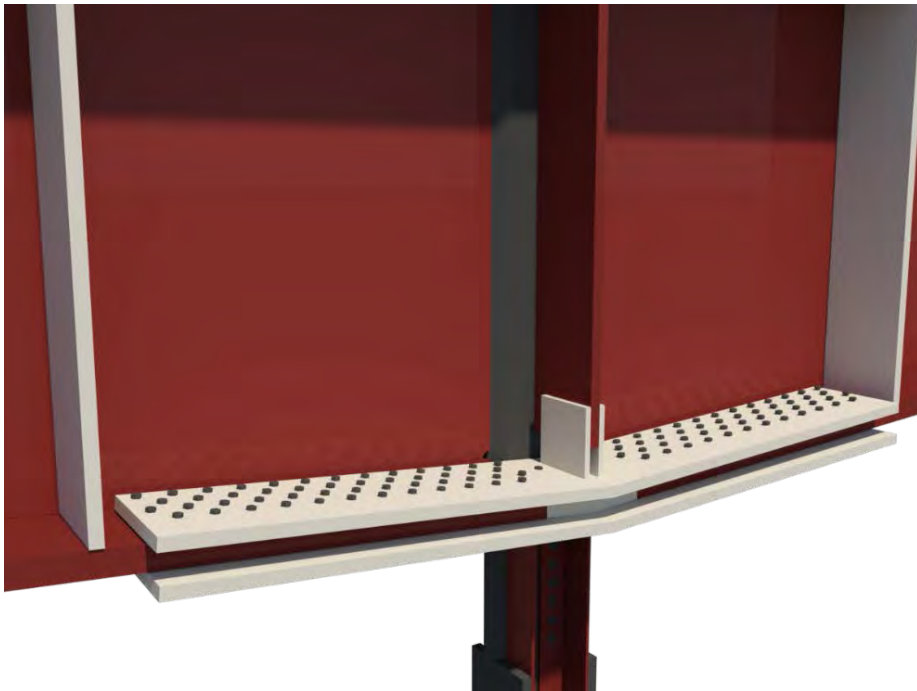
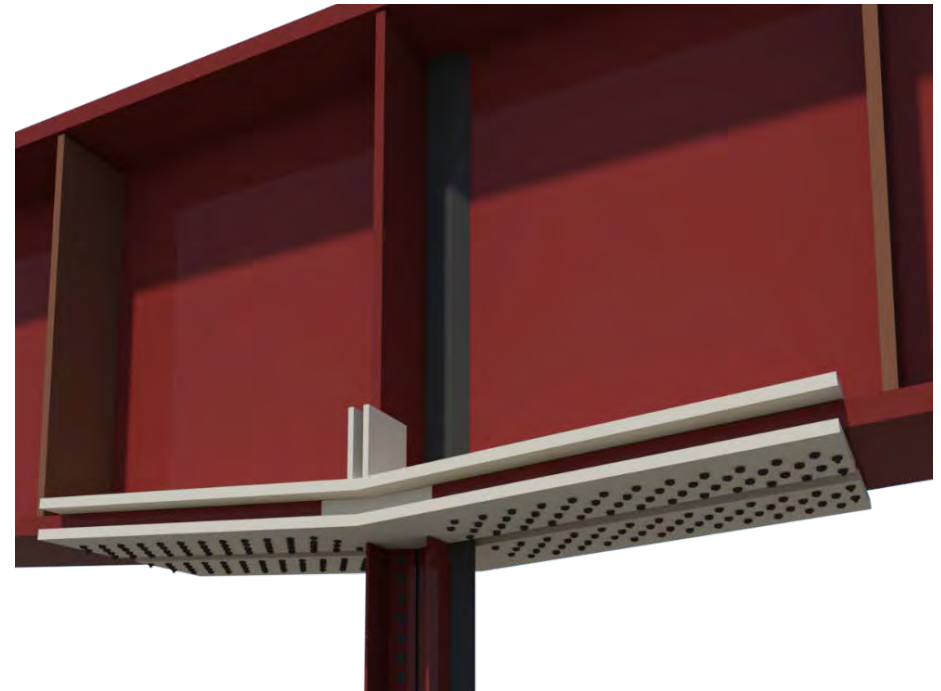
Extent of repair is localized to the fracture area

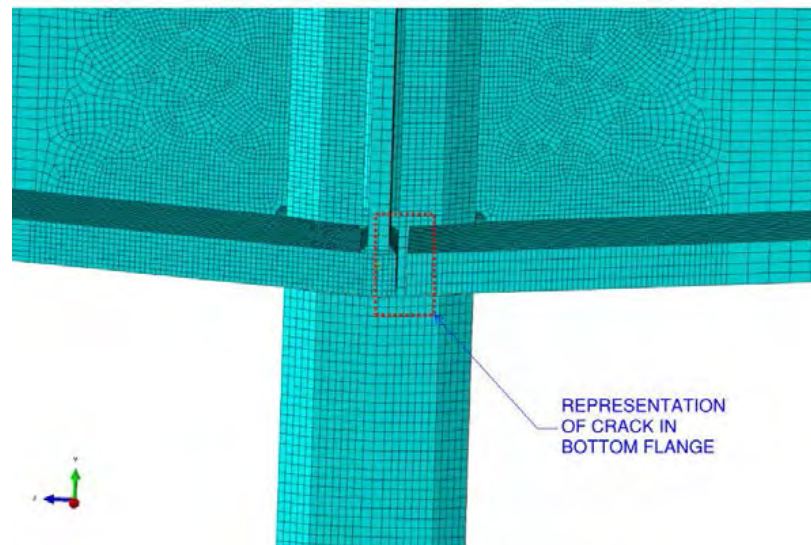
1. The cracked girders with reduced section had sufficient capacity to support the building dead loads and occupancy loads.

2. The actual forces in the girders were less than calculated using normal design procedures.

4. Conclusions:
  - a. Girders deflected 0.75" to 1" after cracking.
  - b. Amount of load shed from the girder was up to 10%.
  - c. Hanger loads reduced after cracking.
  - d. Adjacent beams and columns were not overstressed.
  - e. No indications of any damage, however we will test the integrity of girder bolted connections as a precaution.
