**KOMITE NASIONAL KESELAMATAN TRANSPORTASI
REPUBLIC OF INDONESIA**

KNKT.18.10.35.04

Aircraft Accident Investigation Report

**PT. Lion Mentari Airlines
Boeing 737-8 (MAX); PK-LQP
Tanjung Karawang, West Java
Republic of Indonesia
29 October 2018**

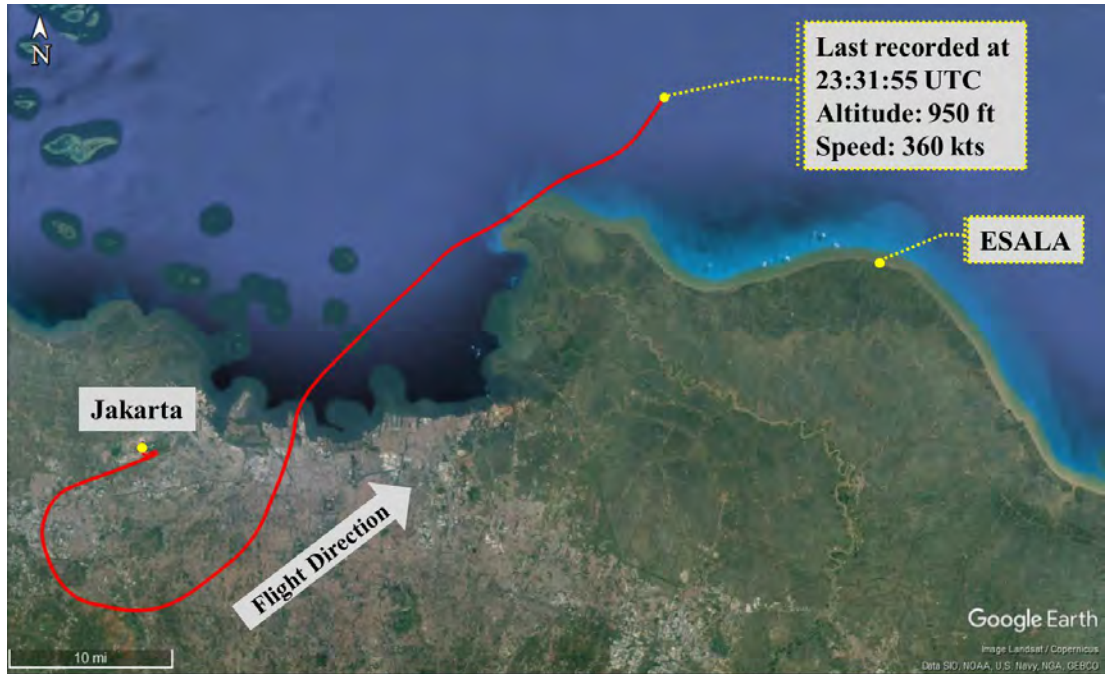
Figure 4: The flight track of LNI610 based on ADS-B

The flight track of the LNI610 based on the ADS-B data superimposed on Google Earth.

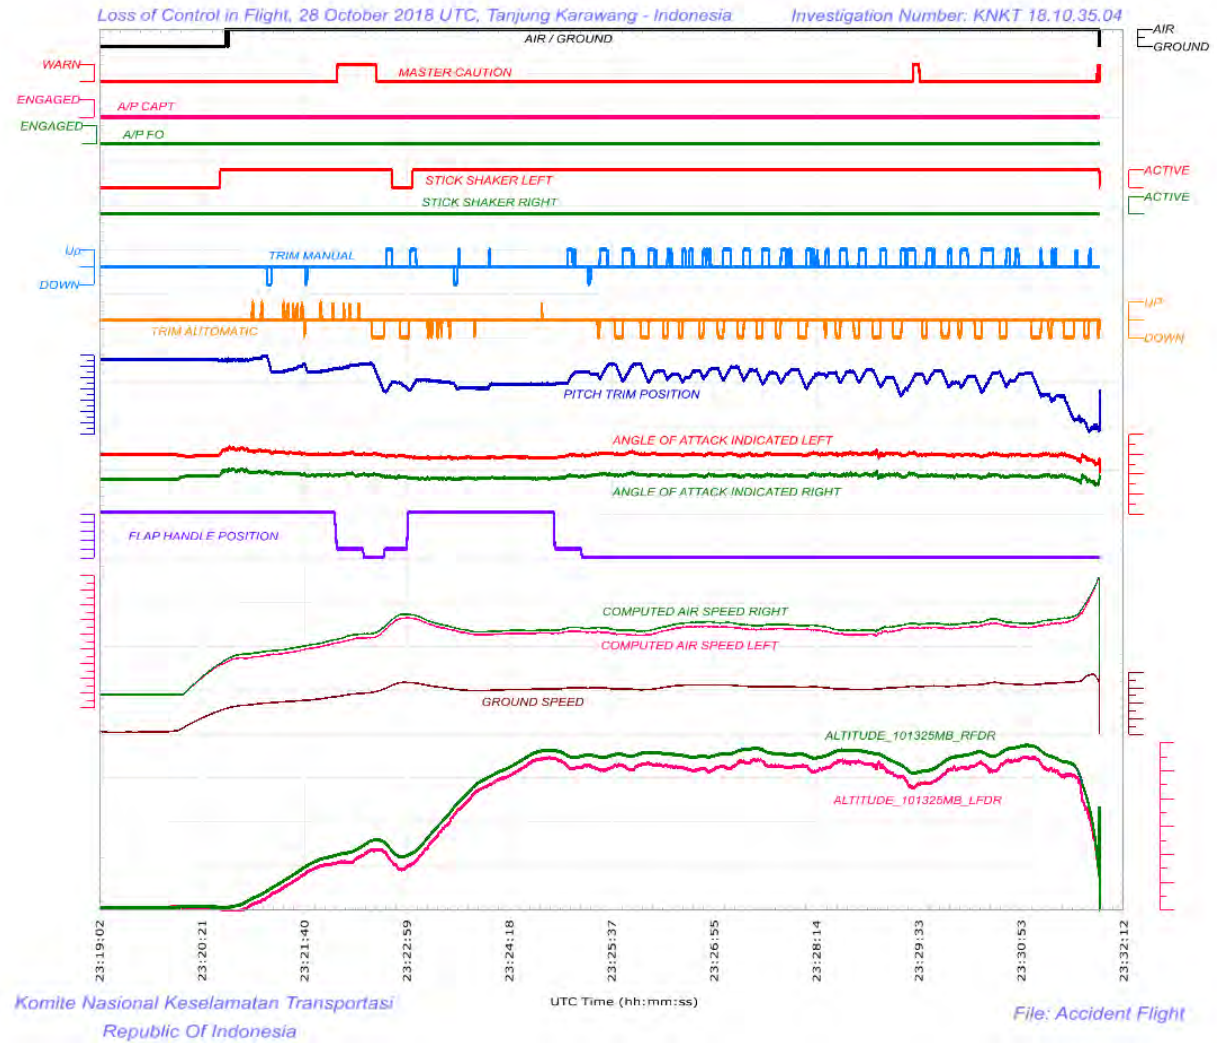
Figure 5: The significant parameters from the accident flight

Several significant parameters of the DFDR are shown on the following figures.

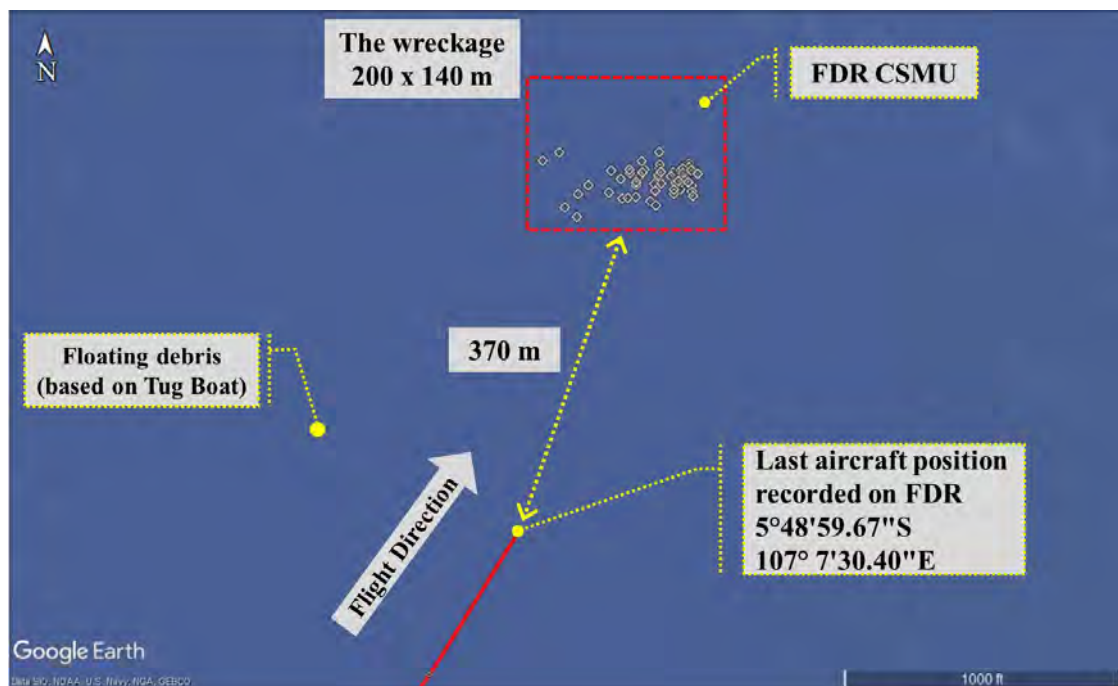
Figure 8: The wreckage distribution

The CSMU was found at 5°48'43.20"S 107°7'37.60"E which was within the wreckage distribution area. Several parts of the aircraft were recovered and transported to Jakarta International Container Terminal (JICT). The wreckage recovered was from all parts of the aircraft from the forward part to the aft part.

The recovered wreckage identified consisted of, but not limited to, the left and right engines, both main landing gears, parts of the empennage, parts of the forward and aft left passenger doors, parts of the wings, a flight crew oxygen bottle, and parts of a circuit breaker panel.

The damage to the aircraft suggested a high energy impact.
