UNITED STATES DISTRICT COURT
SOUTHERN DISTRICT OF FLORIDA

Case No.: 16-20897-CR-SEITZ

PRINCESS CRUISE LINES, LTD.,

FIRST ANNUAL REPORT OF THE COURT APPOINTED MONITOR (2017-2018)

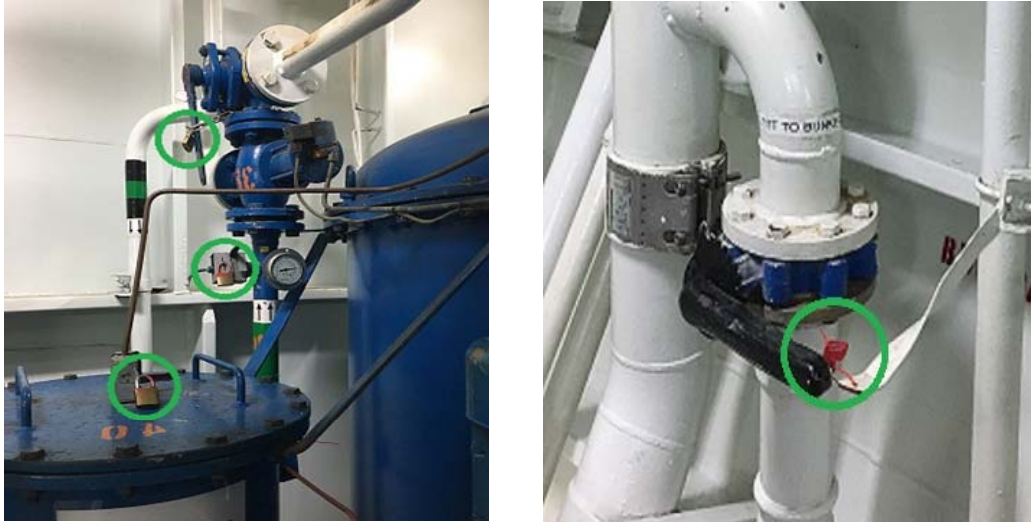
ECP Environmental Control System locks (left) and a seal (right).

Most of the reported incidents involve missing or damaged seals. Often, the Company was unable to identify the cause of the missing or damaged seals, attributing the incidents to accidents or carelessness and stating in a conclusory manner that “no unauthorized access had taken place.” *See, e.g.*, Carnival Corporation & plc HESS Weekly Flash Reports (Aug. 30, 2017 and Sept. 6, 2017). For example, on August 26, 2017, a seal on an Oily Water Separator on the *Carnival Magic* was found missing. “[I]t was concluded that the seal may have been broken and lost during cleaning work carried out in the area. There was no apparent damage or tampering with the [relevant component of the Oily Water Separator] itself.” Carnival Corporation & plc HESS Weekly Flash Reports (Aug. 30, 2017). Similarly, on February 9, 2018, two seals in a sewage room on the *Carnival Triumph* were found missing. “No signs of tampering were found. The seals are believed to have been damaged during maintenance work.” Carnival Corporation & plc HESS Weekly Flash Reports (Feb. 14, 2018).
