KIRKLAND & ELLIS LLP
AND AFFILIATED PARTNERSHIPS

July 26, 2019

As you requested, this is a letter report on the vegetation management field inspections ("VM inspections") the Monitor team is conducting pursuant to the Court's April 3, 2019 Order ("April 3 Order"). This submission includes: (1) background information on the VM inspections; (2) an explanation of the VM inspections process; (3) the Monitor team's preliminary observations; (4) PG&E's feedback based on the Monitor team's preliminary findings; (5) the Monitor team's preliminary suggestions to PG&E, as shared with the Company on July 17, 2019; and (6) concluding thoughts.

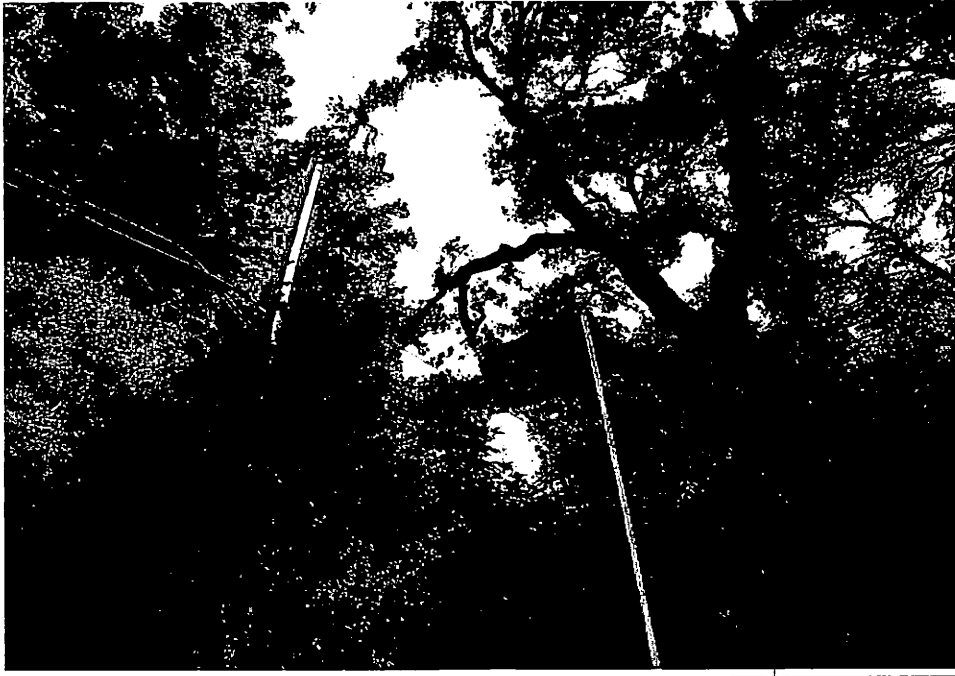
PG&E ArcCollector Project Status	No Work Required Under EVM	
Monitor Team Observed Tree Work in Immediate Vicinity of Subject Tree	Yes	
Species	Coastal Live Oak	
GPS Coordinates	38.410948, -122.947381	
Approx. Distance from Primary Conductor	Trunk of tree 23 feet south	
Approx. Height	56 feet	
Veg Type	Potential Hazard Tree	
Monitor Arborist Comment	Observations of the tree include (a) cavity in trunk displays evidence of decay. (b) guy wire embedded in trunk, and (c) tree leaning toward primary conductor

Figure 8: Photos included in a sample report. Here, the photos substantiate the observations that (1) there is a cavity in the trunk, (2) the tree is leaning towards the primary conductor, and (3) guy wire is embedded in the tree's trunk.

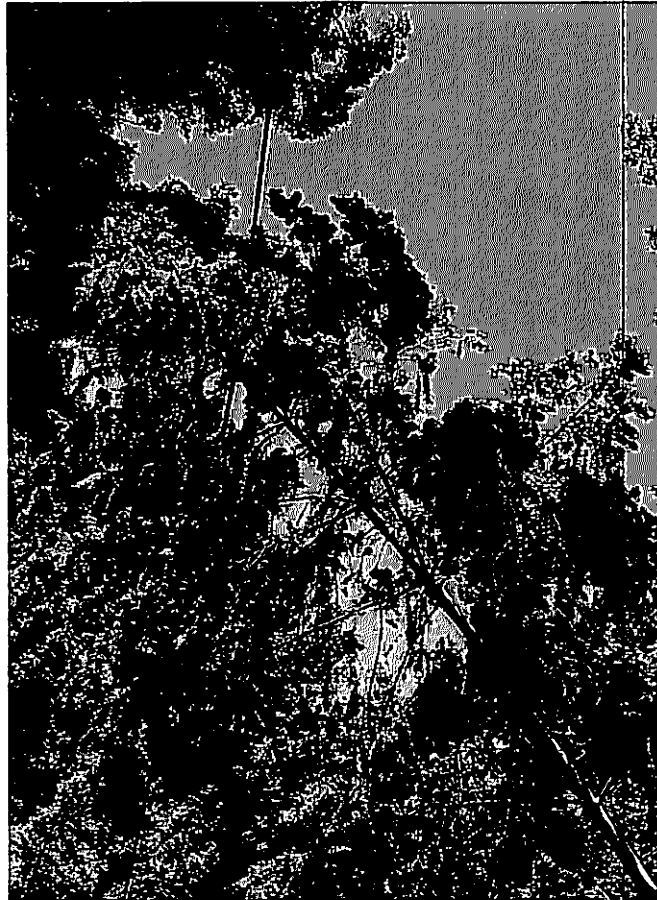
Second, on July 11, 2019, the Monitor team informed PG&E of a tree that was in contact with a primary conductor near the driveway of a private residence (see Figure 10 below). The Monitor team stayed in the area until a PG&E-dispatched pre-inspector arrived. The pre-inspector remained on the scene until a tree crew arrived to address the issue later that day.

Figure 10: Tree found by Monitor team on July 11, 2019 that was in contact with a primary conductor.

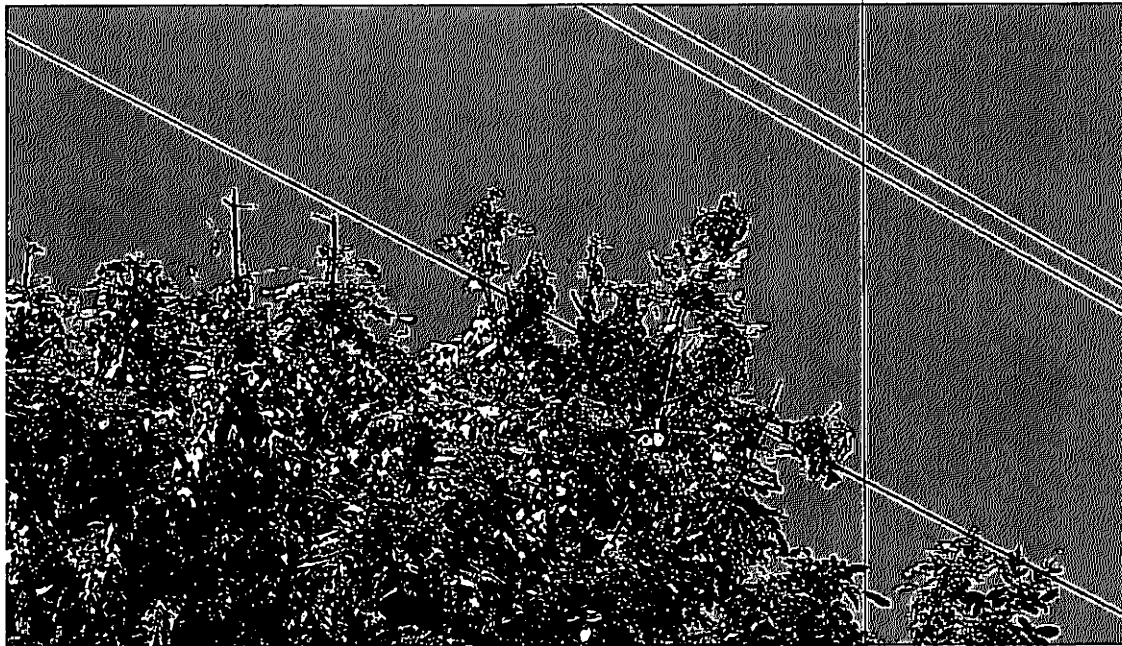
Most recently, on July 12, 2019, the Monitor team informed PG&E of a tree that was within inches of the primary conductor, and had been contacting the conductor during wind gusts. As reflected in Figure 11 below, leaves of the tree had been burned from ongoing contact with the primary conductor. PG&E informed the Monitor team that this particular tree was identified for routine compliance work in November 2018 and a tree work company reported to PG&E that it completed the work in February 2019, even though it was not actually completed (that is, the tree

work company provided a false certification). On April 16, 2019, a different pre-inspector inspected the area under the EVM scope, prescribed the tree for work, but failed to note the urgency.

Figure 11: Tree found by Monitor team on July 12, 2019 within inches of the primary conductor and with evidence that tree leaves had been burned from contact with the primary conductor in a Tier 3 high fire-threat district.

PG&E pruned the tree the same day the Monitor team raised the issue (July 12, 2019). PG&E also investigated the issue, and reported the following to the Monitor team: (1) the tree worker who falsely stated the tree was trimmed may no longer work on PG&E lines; (2) PG&E conducted a “stand down” at the tree work company to discuss how to prevent similar occurrences in the future; (3) PG&E will audit the tree worker’s prior work to identify any similar issues; and (4) the EVM pre-inspector has been stood down while his prior work is also investigated.

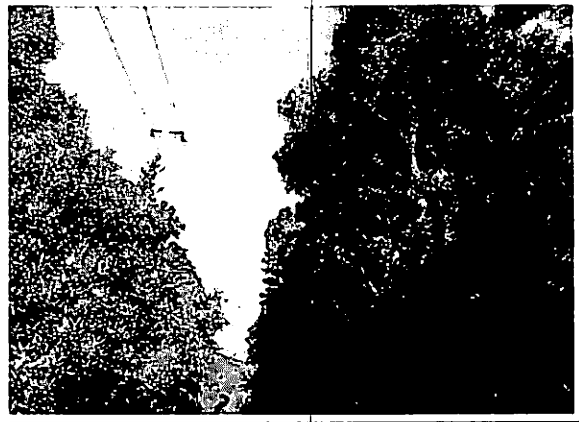
tree exceptions the Monitor team found were not properly documented in Arc Collector or marked for removal with tree paint, as they should be. Further, in some instances, potential hazard trees were marked with a yellow dot for pruning only (that is, not removal), despite the fact that decay, rot, or other defects were observable in the area near the paint dot at the base of the tree, which suggests that removal is appropriate. Additionally, in many instances, the overall health of the tree—along with the EVM scope—suggested that removal may have been the appropriate prescription. The Monitor team’s observation is that pre-inspectors may not be fully assessing the trunk of the tree, which is often where many of the defects are present.

Figure 12: Example of a potential hazard tree exception.

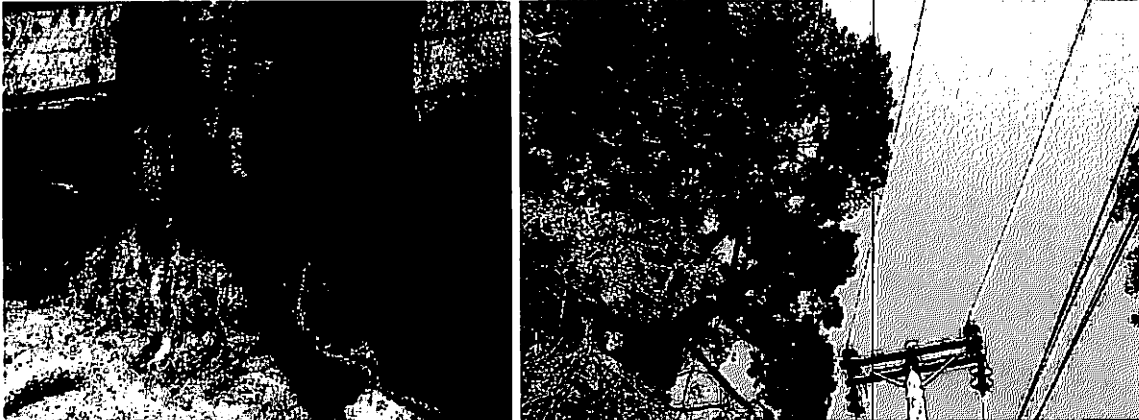
The Monitor team found 524 potential overhang exceptions in 53.49 miles inspected, or 9.80 potential overhang exceptions per mile. The Monitor team noted multiple instances where potential overhangs were not properly cleared to the sky (that is, the tree was pruned up to a certain height, but the higher portions of the tree, which would readily fall on the line if displaced, were not pruned). If there were reasons for not pruning the additional overhanging vegetation (for example, it was unsafe to do so, or it would have compromised the health of the tree), those reasons were not documented in Arc Collector to reflect any reasoned analysis by PG&E.

Figure 13: Example of a potential overhang tree that was partially—but not fully—trimmed.

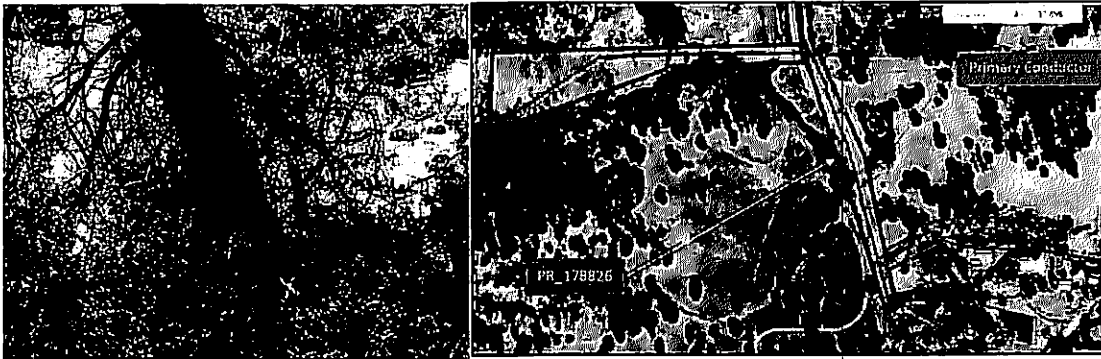
Some workers are simply not entering data into Arc Collector. Trees identified as requiring work under the EVM scope are supposed to be (1) physically marked with yellow paint or flagging, and (2) entered into Arc Collector. This is often not occurring—the Monitor team has identified numerous instances where trees that were physically marked for work were not included in Arc Collector, and vice versa. Either failure materially reduces the chance that proper remediation will occur.

Figure 14: Example of a potential hazard tree that was marked with an X for removal (left photo) but did not appear in Arc Collector (right photo; trees prescribed for work are supposed to appear in Arc Collector as green triangles).

Assuming Arc Collector is retained, the Monitor team specifically recommends that PG&E first ensure that all trees that are identified for work—including the accompanying prescriptions, notations, and status—are reflected in the Arc Collector repository. While PG&E may decide to continue using physical markings to designate tree work, those markings should supplement—and be reflected in—Arc Collector. For example, after a tree is identified for pruning in Arc Collector, it can also be flagged, with a notation in Arc Collector describing the type, location, and color of flagging. This process should improve overall operations and reduce overall risk profiles in the PG&E high-threat geographies.
