From: Rob Wilson
To: "Kirsten Dell-Hartgers"; Garry Van der Krogt
Cc: Margaret Waller; Les Wilson
Subject: RE: Cashmere High - id 340 - monthly fire alarm and sprinklr testing
Date: Monday, 11 February 2019 6:21:37 p.m.
Attachments: [REDACTED]

Project: Cashmere High School – Argest Major Defect Remediation

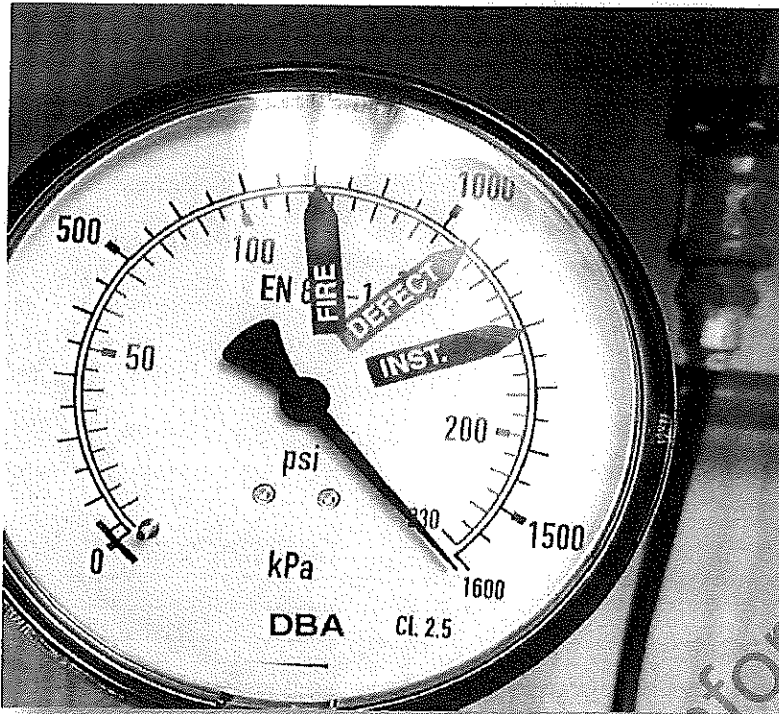
Pressure at 12:30

- **Pressure test:** To make sure there is not leak on sprinkler system we conducted 2 separate pressure tests above alarm valve. First test conducted dated 6-7 2019 @ 1600 KPA for 1 hour. Pass results attached. 2nd test conducted on 9 -07-2019 @ 1600 KPA for 2 hours. Pass results attached.
We suggest monitoring system pressure for couple weeks, if pressure drops might pay to check fire alarm valve seals and gasket etc.

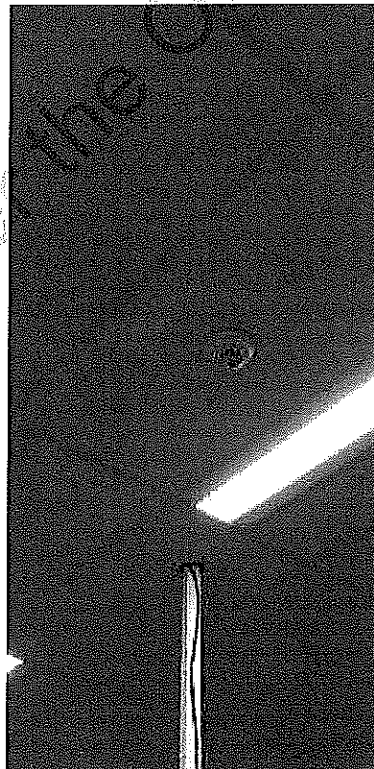
1. Classroom A9 cap on detector

Cover removed by Cashmere High School Caretaker – Confirmed by Optimus Fire
Photo show smoke with no cover

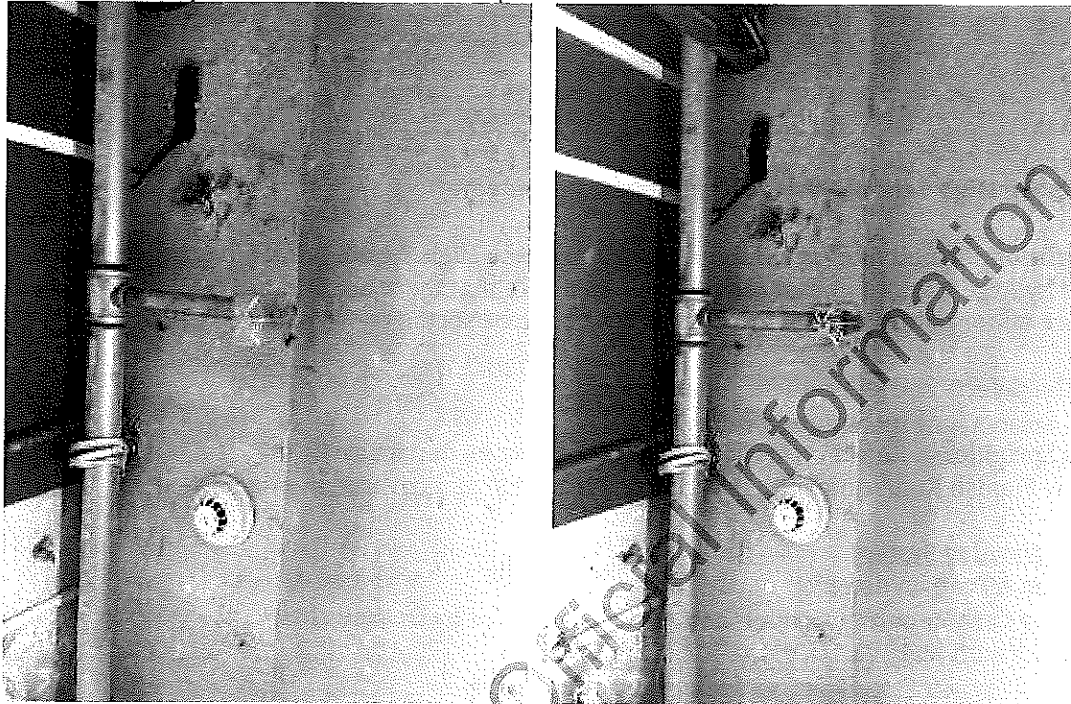
2. Gym smoke detector and sprinkler head covered by store room exit

We understand this was sorted by Cashmere High School Caretaker however we found a Gym store room with plastic cover over sprinkler head held with blue tape. We removed the plastic cover. Photo 1 shows plastic on, Photo 2 shows plastic removed

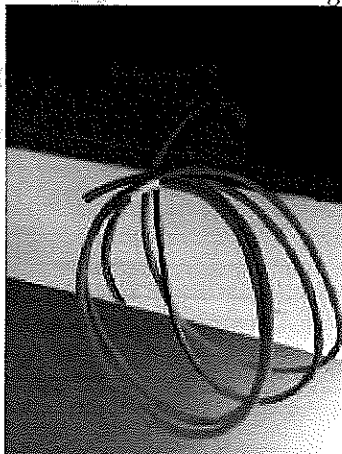
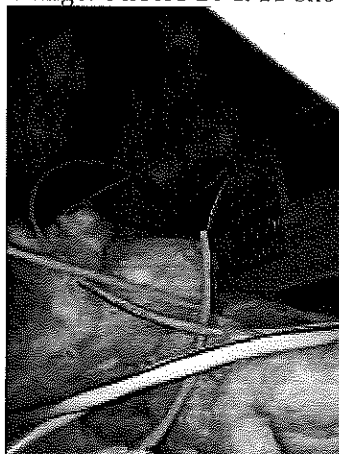
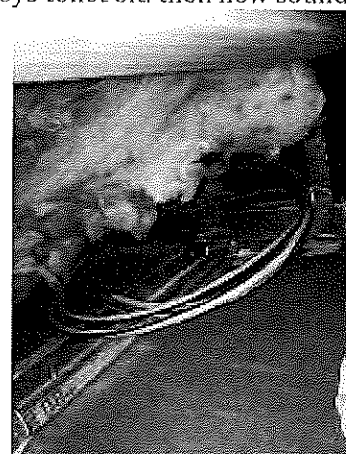
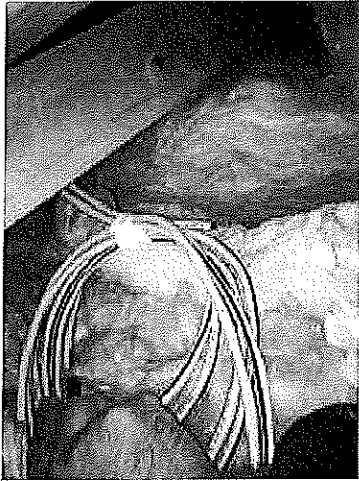
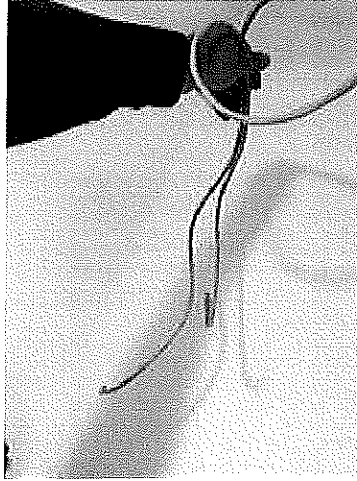
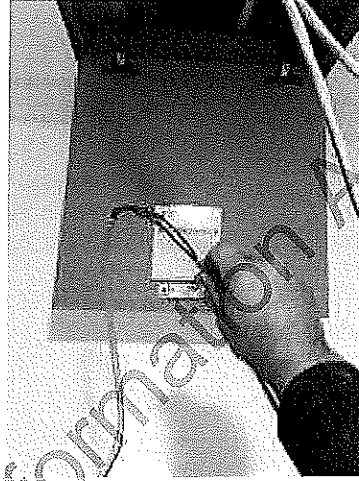
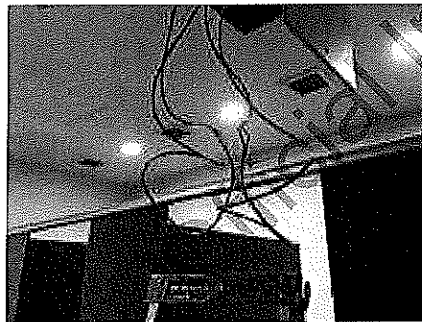
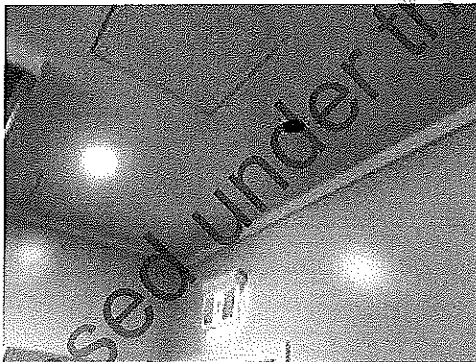
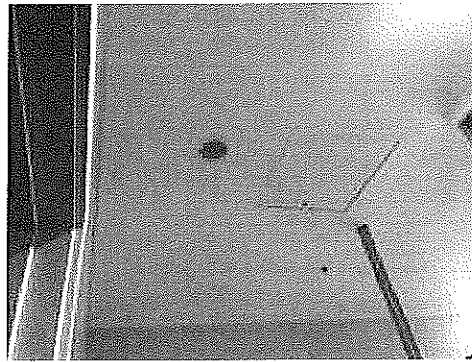
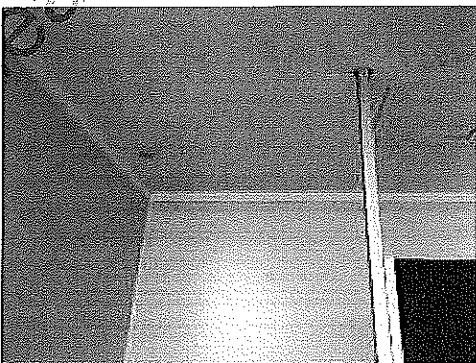
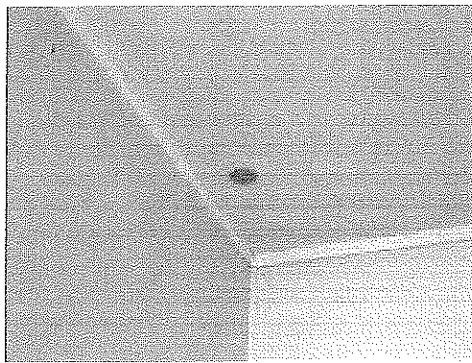
3. Gym toilet/changing rooms low sound levels

We investigated the evacuation devices in the Gym toilet/change areas and found several devices not working. Speakers which failed had no monitoring voltage which they should have if they were in circuit. We accessed the roof void and found five (5) open circuits on the evacuation feed. We expect these were wired for during installation but never brought through the gib. All five open circuits were junctioned which allowed some failed sounder to operate however two (2) still failed. Replaced these old Ampac sounders with new Pertronic ones which operated correctly. The old Ampac sounders were found to be problematic in the past including the grills falling off and were no longer sold as a result.

Photo 1 to 5 shows all 5 open circuits. Photo 6 & 7 show crimp joins to repair circuit. Photos 8 & 9 show old and new sounder in girls change. Photos 10 & 11 show boys toilet old then new sounders.

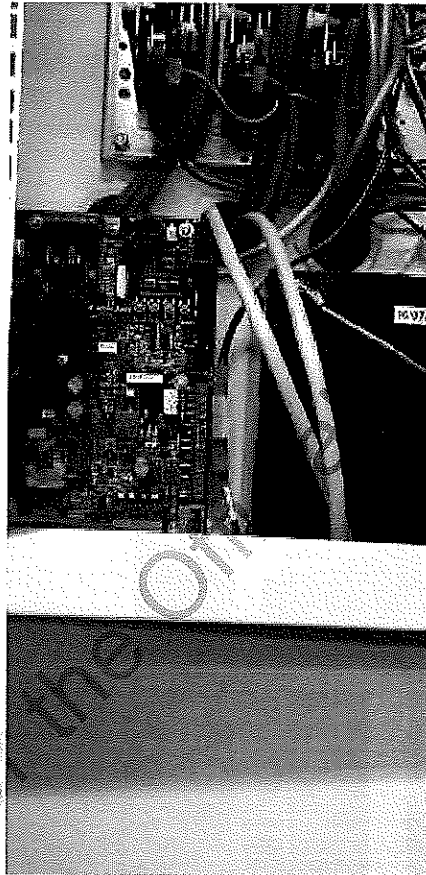
4. Amplifier 3 overloaded at 78watts (this needs urgent attention)

We carried out an impedance test on the evacuation feed to Amplifier 3 and found it to be just over 90Watts. The Amplifier it rated at a maximum of 50Watts so is well overrated. We purchased an FP1116 – 120Watt T-Gen which as stated is rated at 120Watt, 30Watts over the current evacuation load. This was installed, made into the master amplifier and tested ok.

Photo 1 shows the new 120Watt Amplifier installed in the MX1 panel. The green normal light is top centre and the green LCD display is showing normal screen.

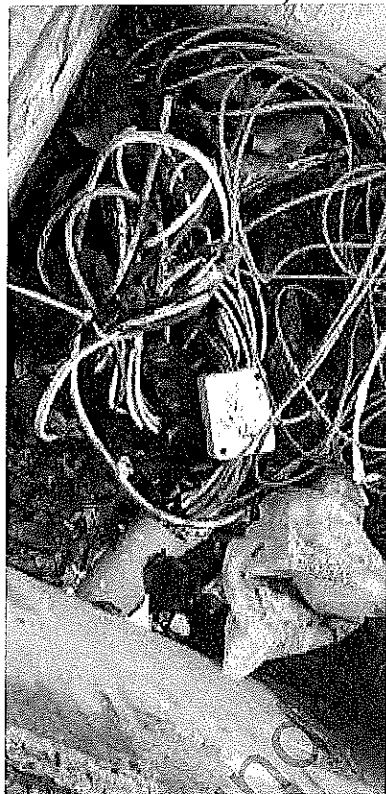
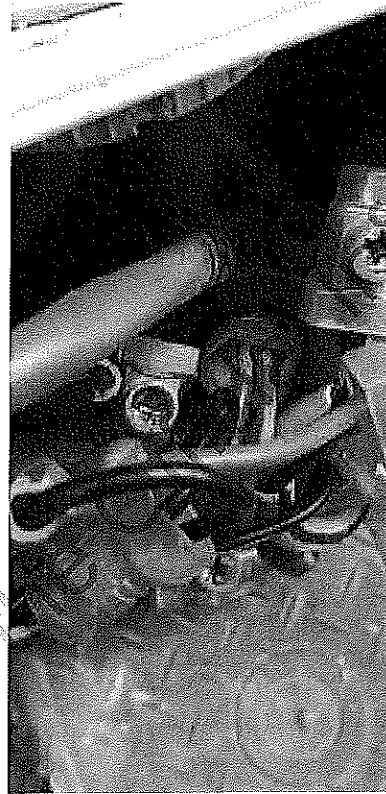
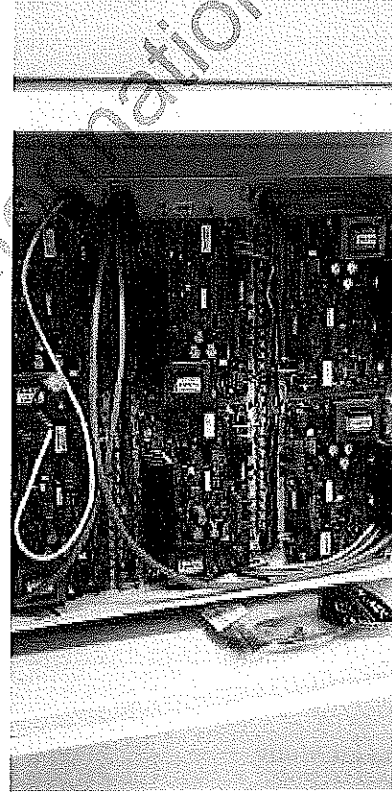
5. Sounder fault on Amp 4 needs attention as this is causing a fault on the panel
We carried out fault finding on evacuation circuit for Amplifier 4. The fault tended to come and go. We tracked it back to some underground junctions that were inadequately terminated. These junctions were temporarily made good and the fault cleared. No sign of a fault on this Amplifier has since occurred. The temporary junction will not cause issue but will require a permanent water protected join which we will look at doing week starting 15 July 2019 during School Holidays. Photo 1 shows underground junction with inadequate water protected terminations. Photo 2 shows another major junction on the side of the Administration Block which also required improved terminations. Photo 3 shows ALL Amplifiers in normal state (defect state shows a bright yellow LED on the left of the board).

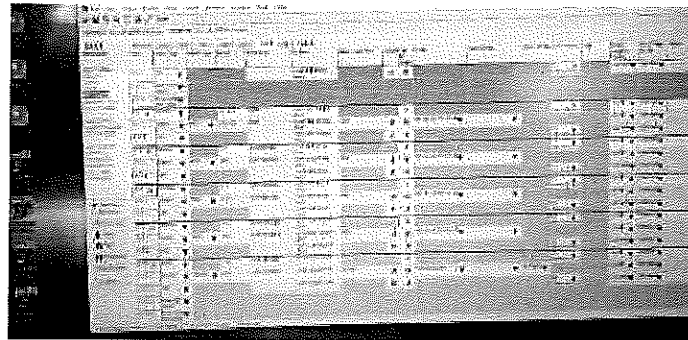
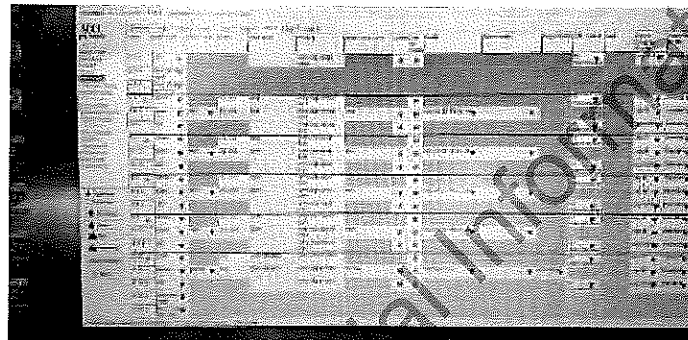
6. 5 minute delay on sounder operation and brigade calling on smoke detectors, sounders are to be instant the delay on the brigade calling is to remain
The 5 minute delay has been changed in the config as required. The fire system now has immediate evacuation on activation of a smoke detector, MCP or sprinkler. There is a 5 minute delay on the Fire Service calling on smoke detectors but not on MCP's or Sprinkler.
Photo 1 shows a snapshot of part of the config with smoke evac delay. Photo 2 shows the same section without smoke evac delay.
