Overpressurization of Natural Gas Distribution System,
Explosions, and Fires in
Merrimack Valley, Massachusetts
September 13, 2018

NTSB/PAR-19/02
PB2019-101365

Pipeline Accident Report

The National Transportation Safety Board determines that the probable cause of the overpressurization of the natural gas distribution system and the resulting fires and explosions was Columbia Gas of Massachusetts' weak engineering management that did not adequately plan, review, sequence, and oversee the construction project that led to the abandonment of a cast iron main without first relocating regulator sensing lines to the new polyethylene main. Contributing to the accident was a low-pressure natural gas distribution system designed and operated without adequate overpressure protection.

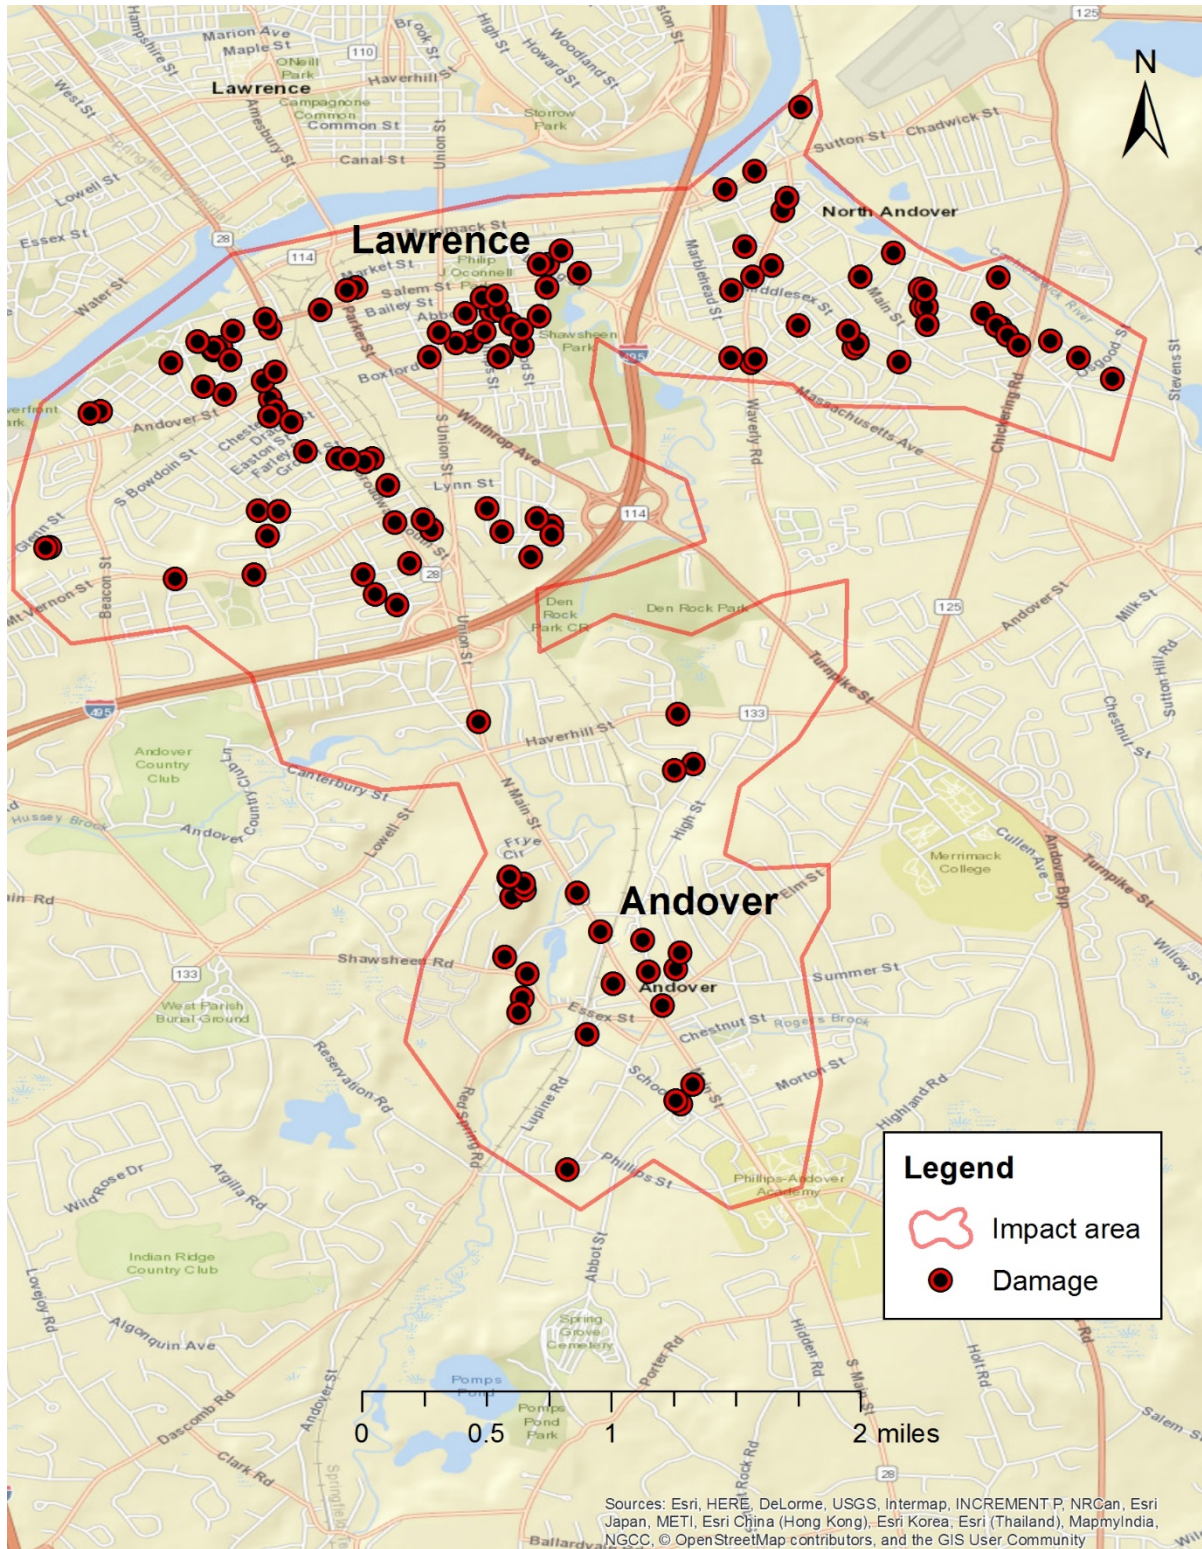
Figure 1. Map of the damaged structures in the area impacted by the overpressurization.

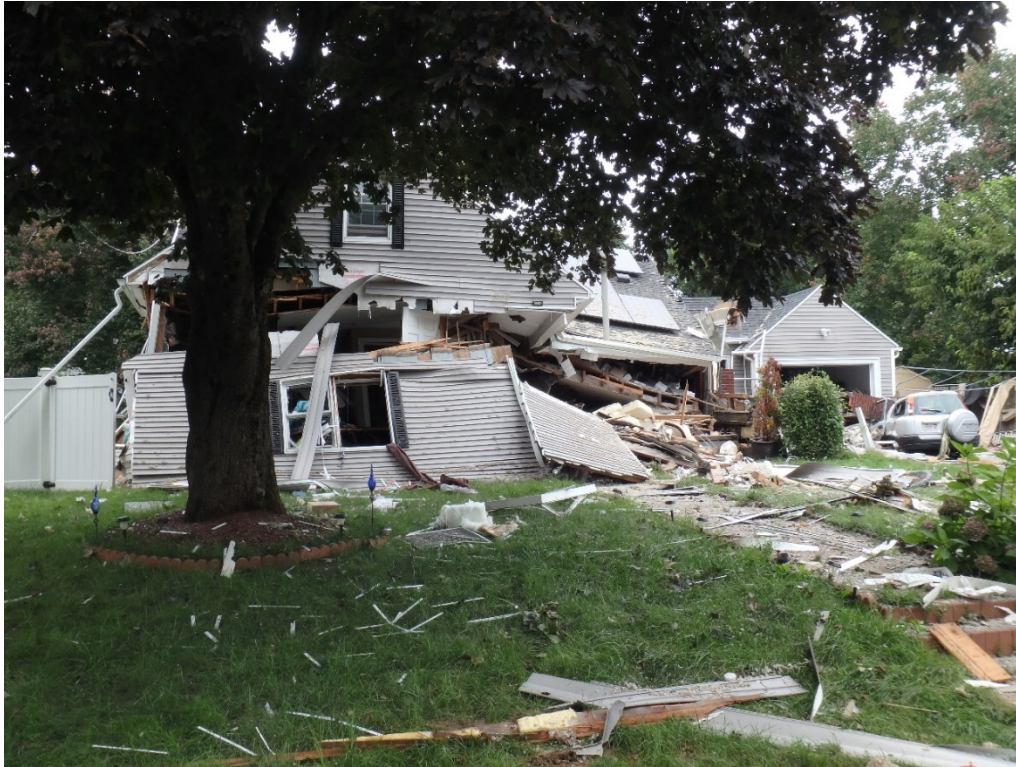
An 18-year-old male was killed when a home exploded, and the chimney fell onto the vehicle where he was sitting. (See figure 2.) Another person in the vehicle at the time of the

explosion was seriously injured, as was someone on the second floor of the house. In total, 22 people, including 3 firefighters, were transported to hospitals for treatment of their injuries. Injuries included respiratory injuries related to smoke inhalation from fires and musculoskeletal injuries from evacuating. Some people were transported to hospitals to maintain ongoing medical treatment that could not be continued in their homes because of the shutdown of natural gas and electricity and the evacuation of residents.

Figure 2. Remnants of house where the fatality and two severe injuries occurred.

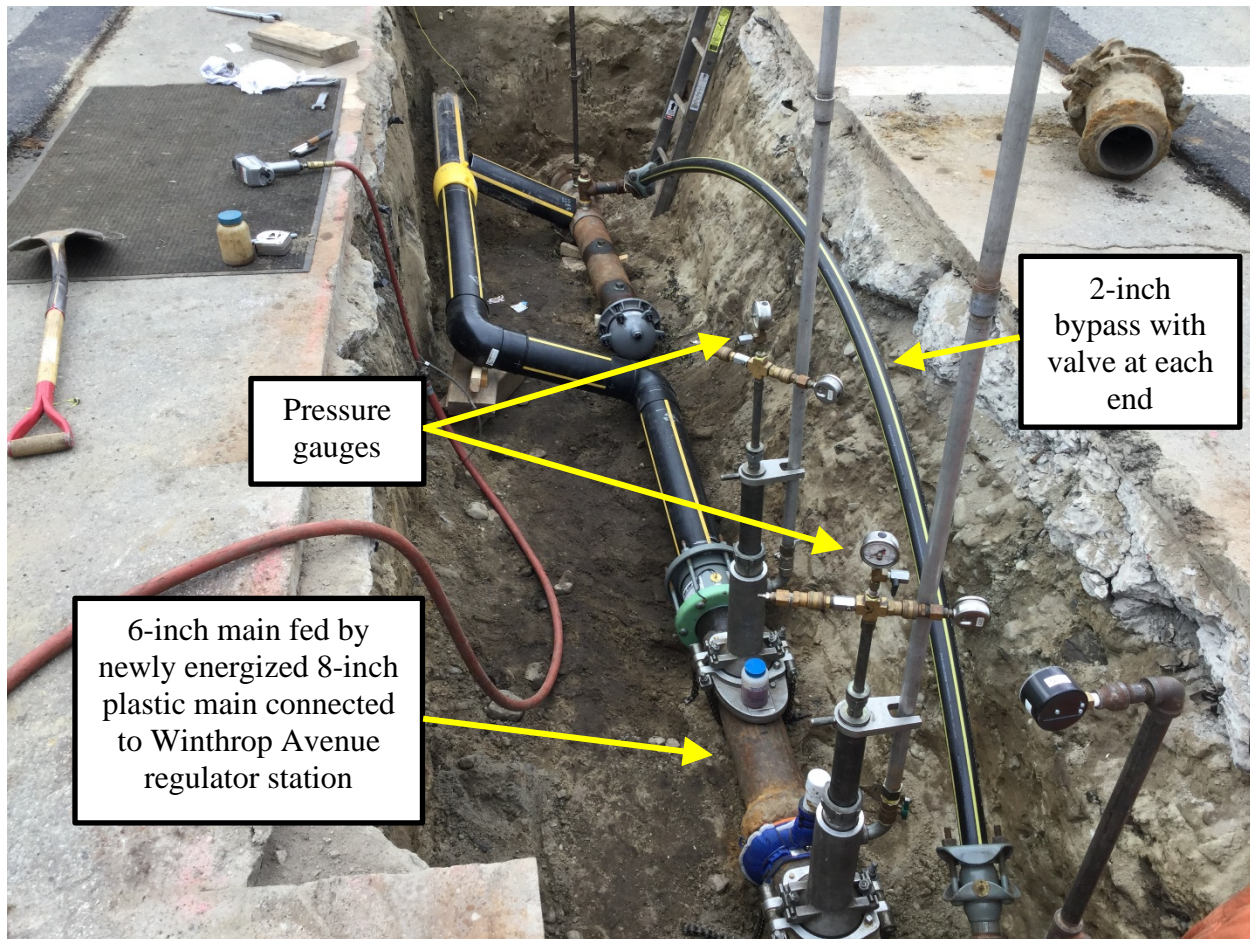
The crew completed the installation according to the CMA work plan, placed the new tie-ins into service, and isolated the existing cast iron main shortly before 4:00 p.m., by closing

valves on a 2-inch plastic bypass pipe between the cast iron and polyethylene mains.⁸ The crew then cut the bypass pipe to abandon the cast iron main. (See figure 5.) In postaccident interviews, crewmembers said that within minutes of closing the valves and cutting the bypass, they observed the pressure gauge on the polyethylene main exceed the expected readings.⁹ Furthermore, a fitting on the polyethylene natural gas main blew off into the hand of one of the workers. The crewmembers said that they responded quickly to plug the blowing natural gas, and they heard emergency vehicles in the neighborhood and observed smoke plumes in multiple directions within minutes.

Figure 5. Salem Street tie-in for the South Union Street project (looking west). Photograph courtesy of Feeney Brothers.

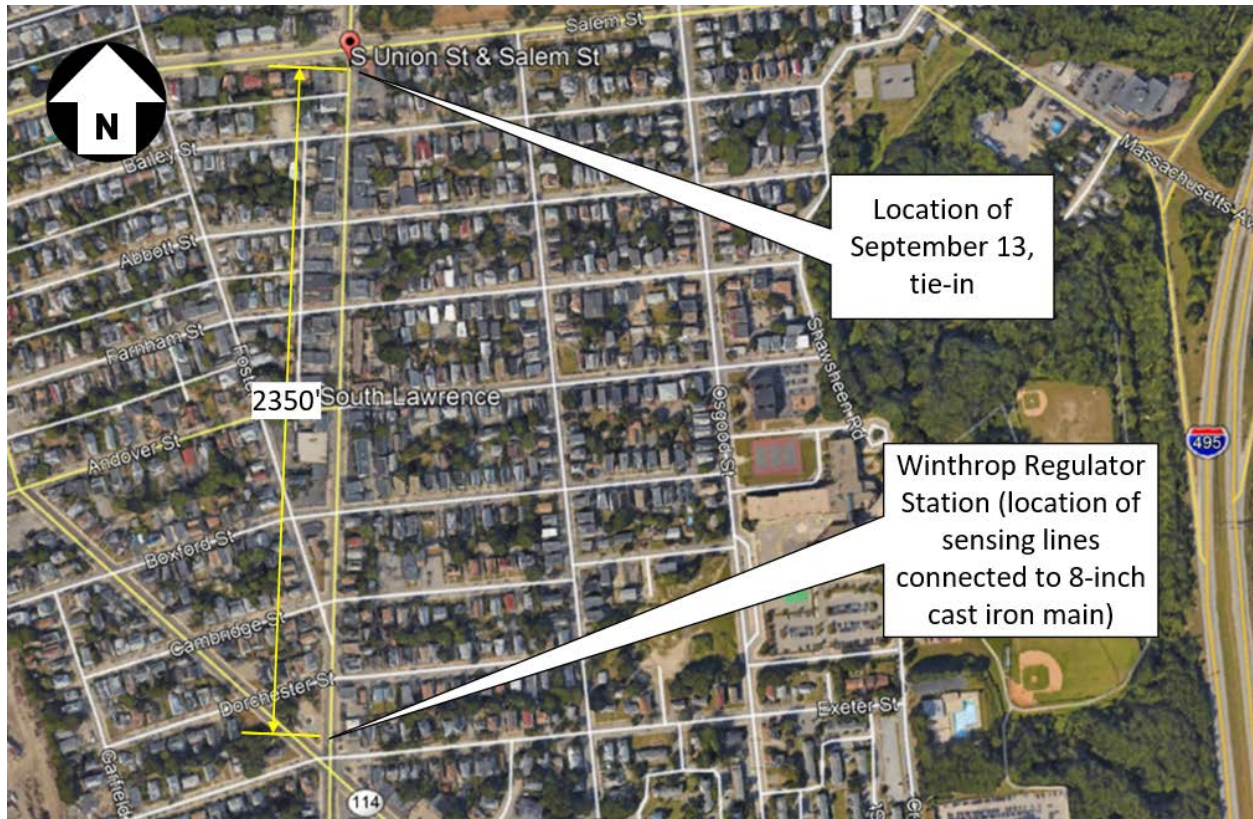
At the Winthrop Avenue regulator station, about 0.5 mile south of the work area, the abandoned cast iron main was still connected to the regulator sensing lines providing input to the two pressure regulators used to control the system pressure.¹⁰ (See figure 6.) Once the contractor

crew isolated the cast iron main, the natural gas pressure began to drop in the cast iron main and in the regulator sensing lines. As the pressure dropped, the pressure regulators responded by opening further, increasing pressure in the natural gas distribution system. Since the Winthrop Avenue regulators no longer sensed system pressure, they fully opened, allowing high-pressure natural gas to be released into the low-pressure natural gas distribution system.

Figure 6. Location of September 13, 2018, tie-in and the Winthrop Avenue regulator station.

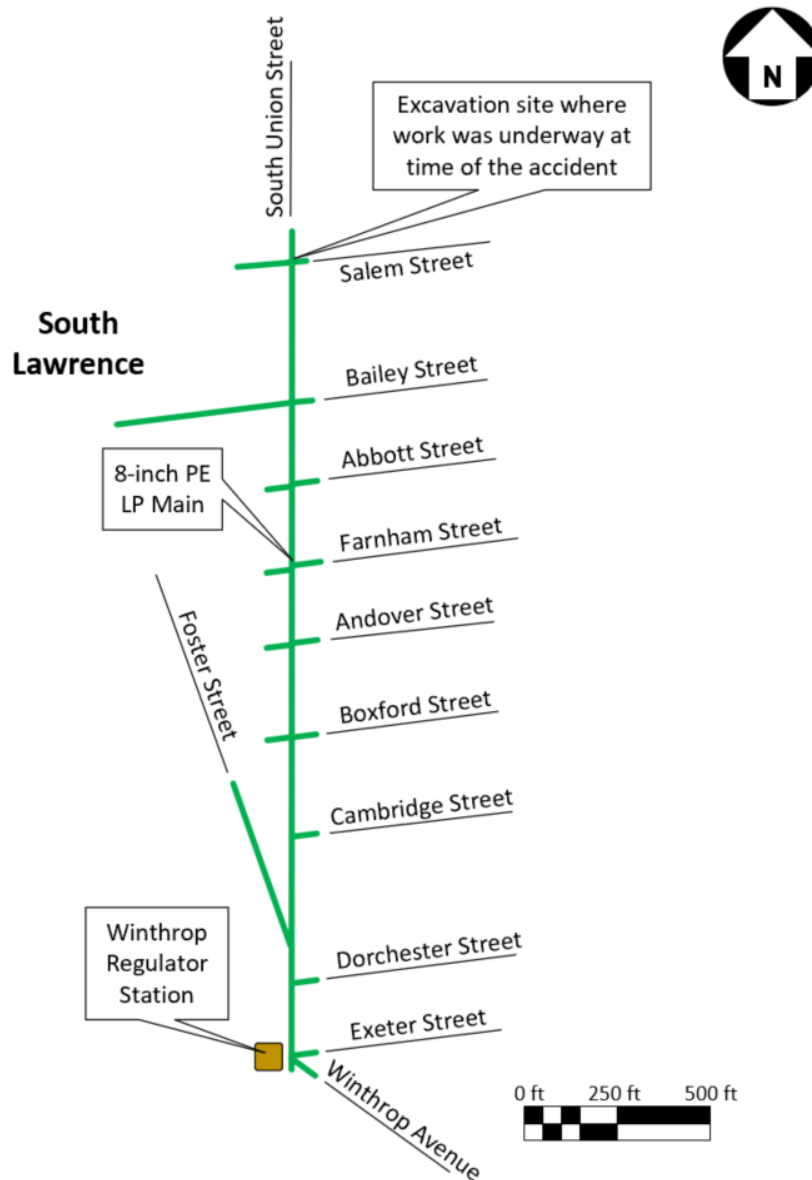
Figure 7 shows the area of the replacement of the natural gas main in South Lawrence along South Union Street with the cross-street tie-ins. The work on the day of the accident was at the north end of the project at Salem Street. The Winthrop Avenue regulator station is at the south end of the project.

Figure 7. Areas along South Union Street with tie-ins impacted by the project.

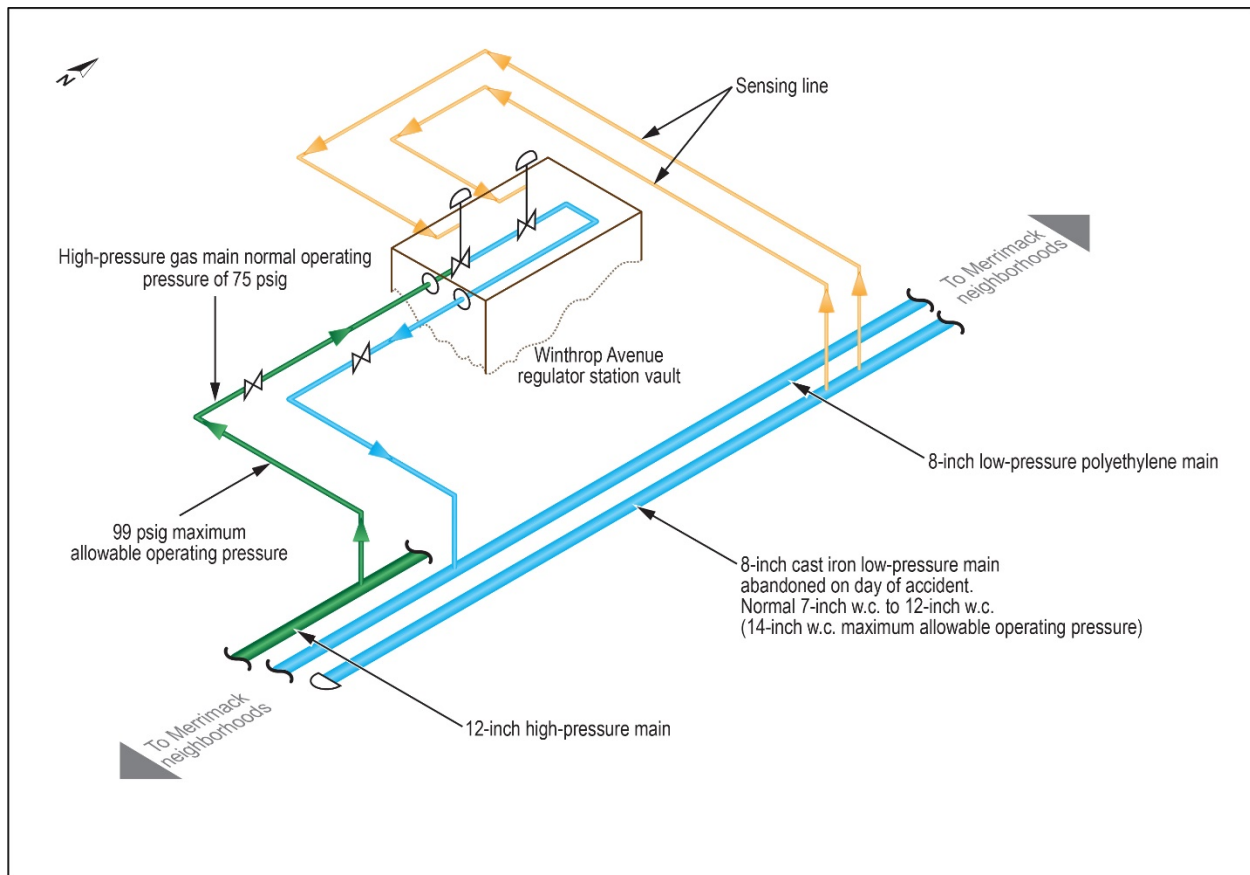
The first stage of the project involved the installation of the polyethylene main, which was completed in late 2016. The regulator sensing lines at the Winthrop Avenue regulator station remained attached to the cast iron main, where they controlled natural gas flow through the

Winthrop Avenue regulator station into both the cast iron and polyethylene mains, which were connected in the low-pressure natural gas distribution system. (See figure 8.)

Figure 8. The Winthrop Avenue regulator station.
