SED Incident Investigation Report for 2018 Camp Fire with Attachments

Incident Investigation Report

Incident Number: E20181108-01

Utility Facilities involved: Caribou-Palermo 115 kV Transmission Line and Big Bend 1101 12 kV Distribution Circuit

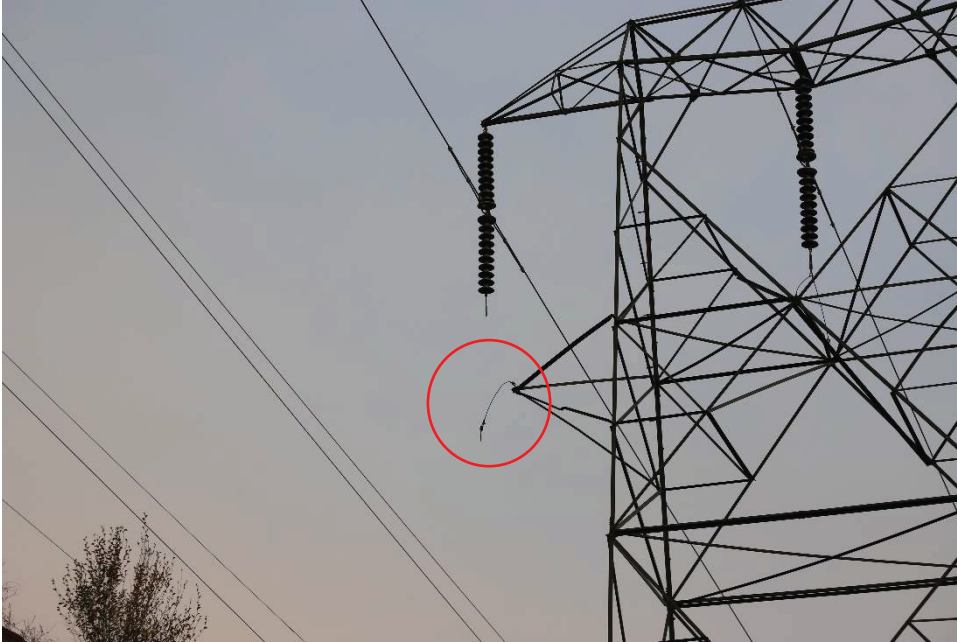
At first, SED made observations at Tower :27/221, adjacent to the Incident Tower. The distance between the two towers is approximately 845 feet.²⁷ SED observed that the hold-down anchor on Tower :27/221 had disconnected from the suspension insulator. This is shown in Figure 2.

Tower :27/221 had disconnected from a suspension insulator. PG&E assigned the condition a Priority Code E.⁴⁸ As defined in the ETPM Manual, the Priority E designation is for conditions which must receive corrective action within 12 months. SED notes that during additional enhanced inspections that PG&E performed after the Camp Fire, PG&E assigned a Priority A code for a separate broken hold-down insulator hardware on a different tower on the Caribou-Palermo Transmission line.⁴⁹ According to a PG&E lineman who was at the site on November 14, 2018 the hold-down anchor on Tower :27/221 was not broken, but rather had become unscrewed. Nevertheless, the hazardous condition created by an unscrewed hold-down anchor is similar to that created by a broken hold-down anchor. SED concludes that the unscrewed insulator hold-down anchor on Tower :27/221 should have been designated Priority A. This is a violation of GO 95, Rule 18.

Figure 2. At Tower :27/221, an insulator hold-down anchor was disconnected. Photo provided by PG&E.⁷⁸

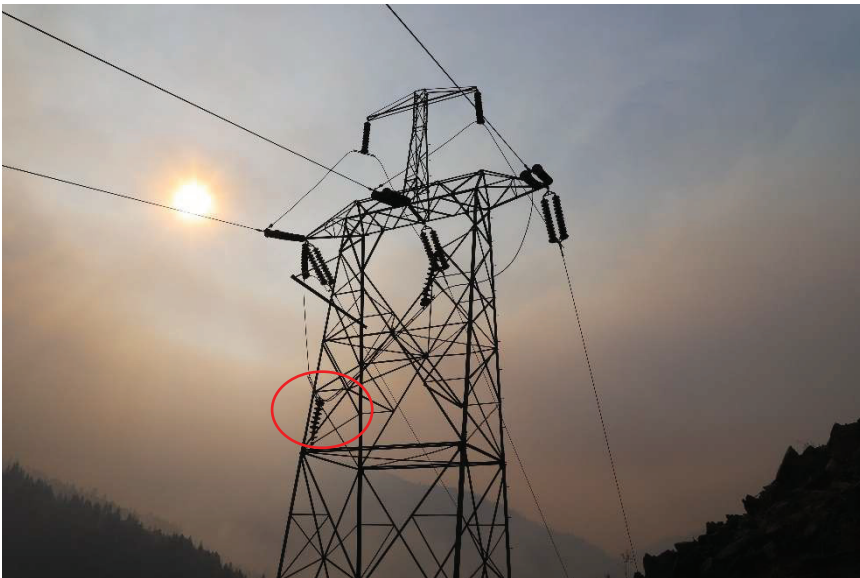
The Incident Tower is a dead-end transposition tower. On the Incident Tower, SED observed that a suspension insulator supporting a transposition jumper had separated from an arm of the tower and remained suspended above the ground (Figure 3). Prior to the failure, two C-hooks provided mechanical support to the incident transposition jumper; and each C-hook carried a load of approximately 143 lbs.²⁸ One of the C-hooks failed at the point where it had been in contact with the hanger plate. SED made a close observation of the portion of the failed C-hook that remained attached to the separated suspension insulator. SED observed that most of the cross-section was flat and smooth. At the upper portion of the cross-section – approximately the top 20 to 25 % of the cross-section of the C-hook where the failure occurred – the surface of the metal was rough, and a small, sharp piece of the material jutted out. In SED's assessment: the smooth portion is an indication of wear that occurred over a long period of time prior to failure; the rough upper portion of the cross-section fractured at the time of the incident. The observations are confirmed by the photo in Figure 4. SED also observed flash marks on the transposition jumper which SED concluded were a result of arcing between the jumper and the tower (Figure 5).

Figure 3. At the Incident Tower, an insulator detached from the hanger plate and hung upside down. Photo provided by PG&E.⁷⁹

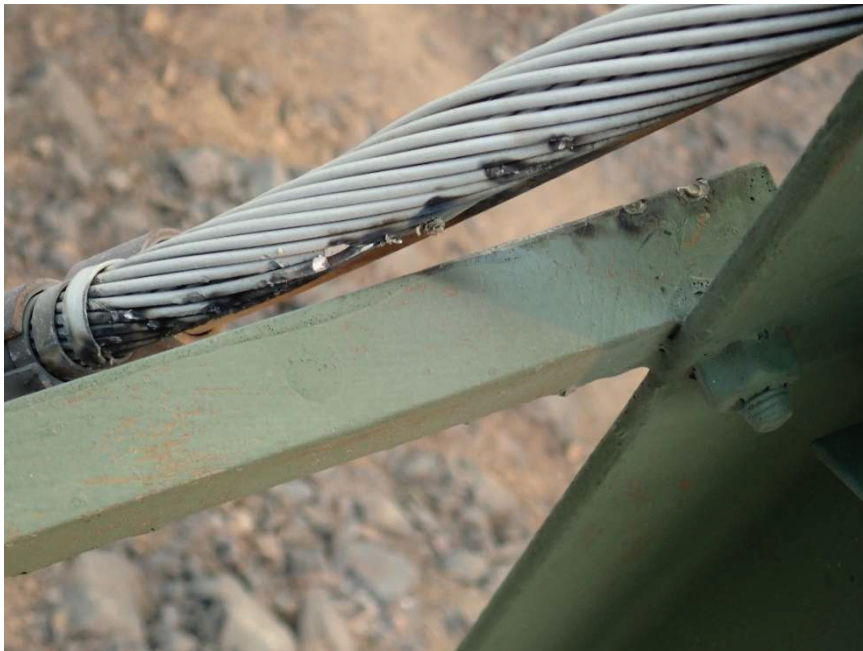
Figure 5. Flash marks on the transposition jumper and steel member on the Incident Tower. Photo provided by PG&E.⁸¹

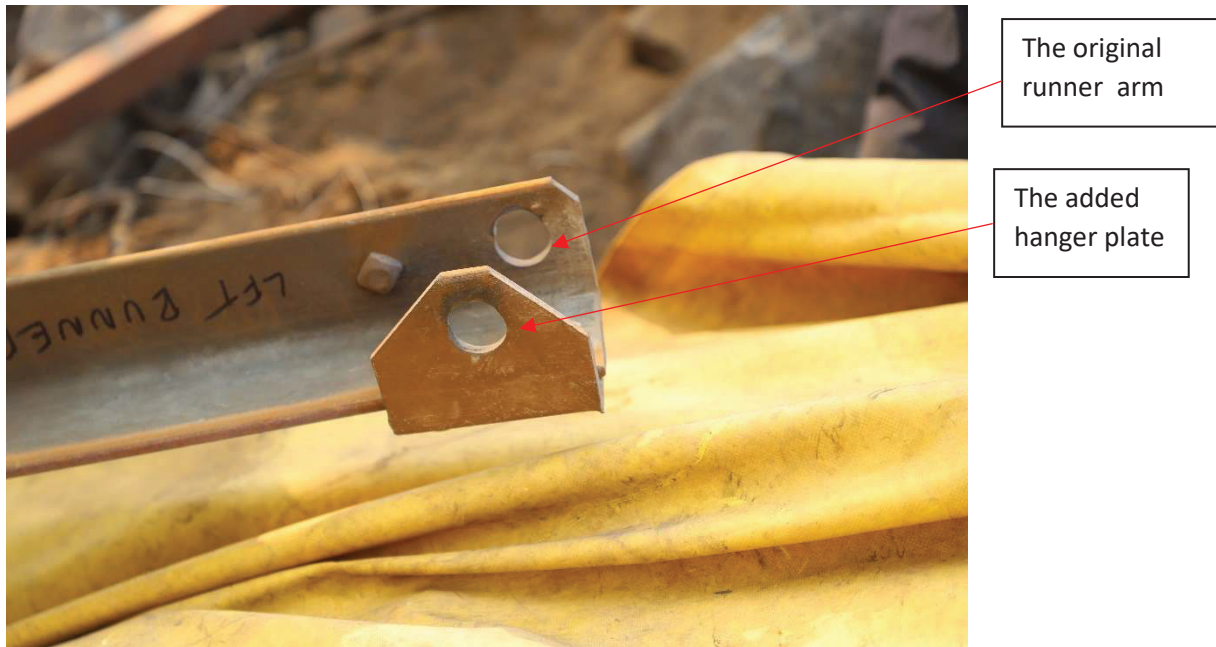
SED observed that hanger plates had been added to the left and right runner arms on the Incident Tower. PG&E could not locate records that identify when the hanger plates were added.²⁹ However, both the original runner arms, which remained in place, and the added hanger plates showed signs of wear on the working eyes as shown by

Also, the visible wear on the original runner arms on the Incident Tower (Figures 6 and 7) should have been an indication of the potential for similar problems with wear on the added hanger plates, triggering planned follow-up detailed climbing inspections. SED notes that during additional enhanced inspections that PG&E performed after the Camp Fire, PG&E assigned a Priority A code for 13 towers on the Caribou-Palermo Transmission Line where similar visible wear on the working eyes of the hanger plate was detected.⁵⁹

The original runner arm

The added hanger plate

Figure 6. The left runner arm and the added hanger plate from the Incident Tower.⁸²

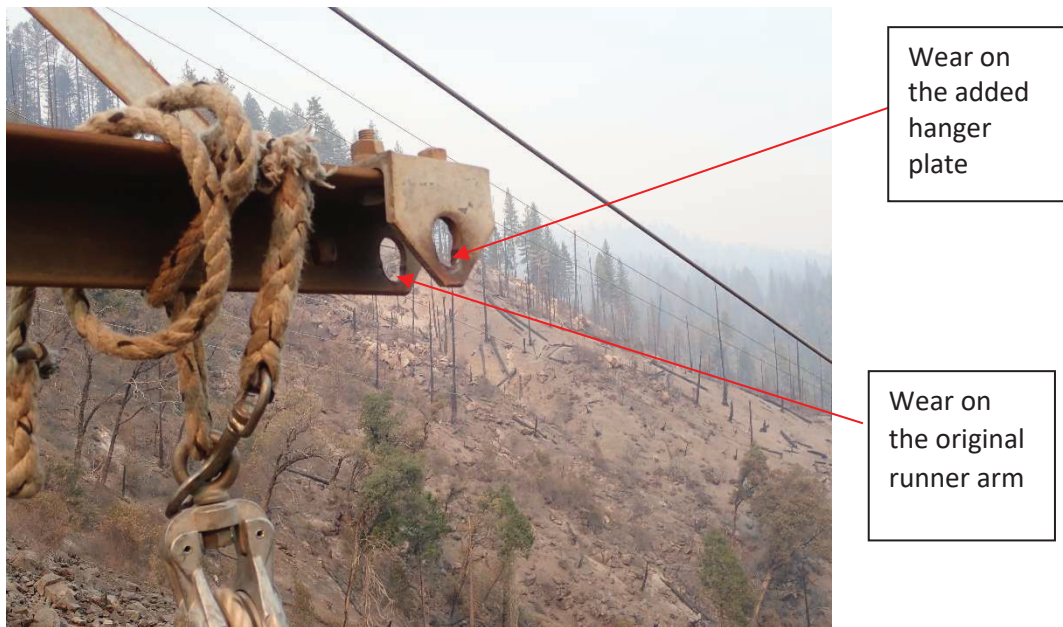
Wear on the added hanger plate

Wear on the original runner arm
