Public Meeting on Remedial Activities at Badin Business Park

Tuesday November 19, 2019 Stanly County Commissioners Meeting Room

Presentation by Anna Wade and Sam Olson, Duke Environmental Law & Policy Clinic

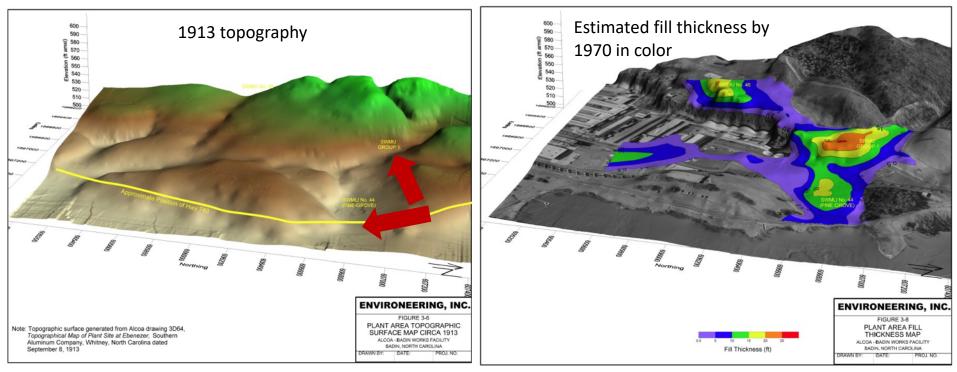
North End SWMU Area is a natural valley that was progressively filled in from 1916 to 1968

Red arrows point to sites where spent potliner was dumped in a valley draining into Badin Lake, from 1910s to 1970s By 1970s, cyanide and fluoride were leaching from **unlined** fill material (in color) into surface water and Badin Lake.

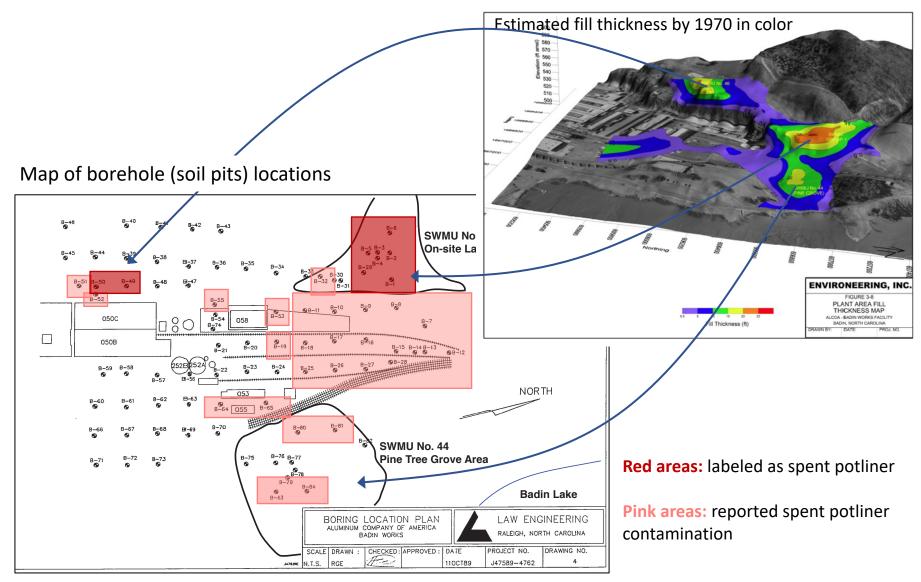
Buried spent potliner found throughout fill material in 1989

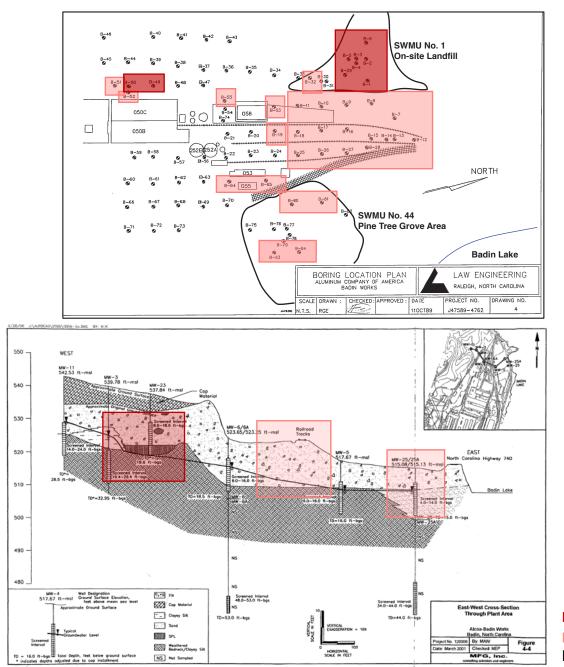
Map of borehole (soil pits) locations.

Known locations of buried spent potliner are not shown in Alcoa's cross sections of the North End SWMU area.

Red areas: labeled as spent potliner **Pink areas:** spent potliner contamination but not labeled

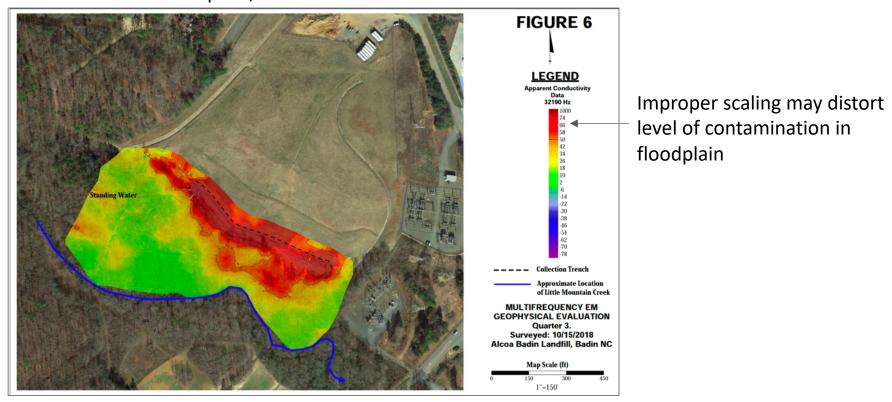
Geophysical survey of electromagnetic conductivity in Little Mountain Creek floodplain, 2019

Contaminant plumes (red) in groundwater going past collection trench (dotted line).

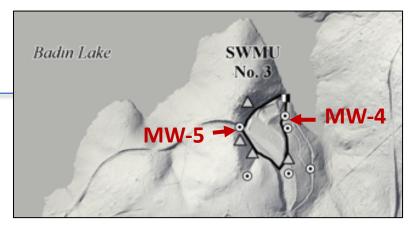
Wells downgradient of landfill (MW-4) exceeded NC 2L groundwater standards during 1990s in comparison to upgradient (MW-5)

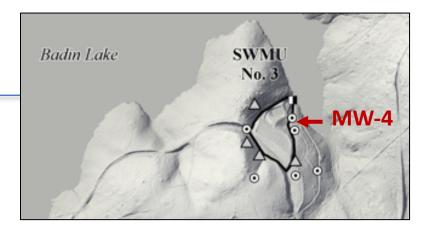
2004 and 2005 study concluded cap on landfill installed in 1990s not sufficient to prevent infiltration into the landfill

Samples taken in 2011 and 2012 within range of 1990s samples

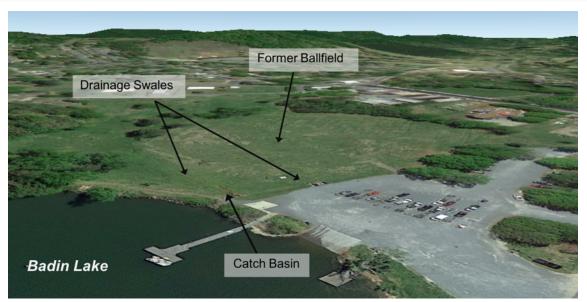
Former Ballfield Area on shore of Badin Lake

Investigations of additional sites of possible buried spent potliner are ongoing

Additional sites possibly contained buried spent potliner.
