RE: SIESMIC ASSESSMENT REPORT, BUILDING A, 41 BUCKLE STREET (SR224676)

Seismic Assessment of Carillon Tower for the Ministry of Culture and Heritage

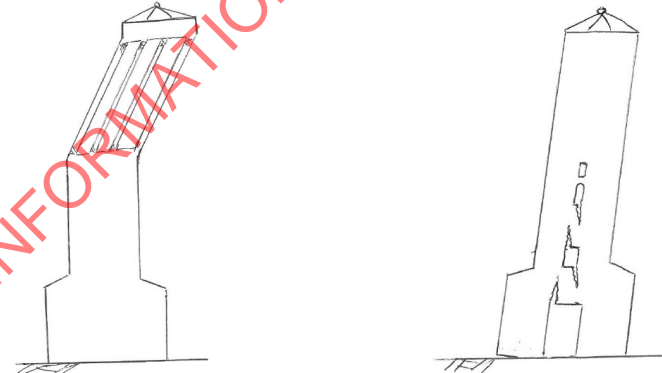
Our assessment of the tower leads us to believe that it can sustain rocking behaviour but its performance is limited by two primary failure mechanisms. The first mechanism identified is a partial collapse of the upper section of the tower (Figure 1a). This mechanism was previously addressed by the installation of the structural steel braces, however these braces buckle at a low load level relative to new building standard. This mechanism limits the performance of the tower to 30-35% of new building standard (NBS).

The second mechanism is failure of the wall sections above and below the window/door openings in the lower section of the tower (Figure 1b). These sections of wall have very little horizontal reinforcing steel, leading to 'unzipping' (separation) of the tower

into two halves and significant, rapid degradation of strength. Should the first failure mechanism be addressed, this mechanism would limit the performance of the tower to 50-60% NBS.

Figure 1: Identified failure mechanisms – (a) instability of upper section of tower; (b) unzipping of lower section of tower.

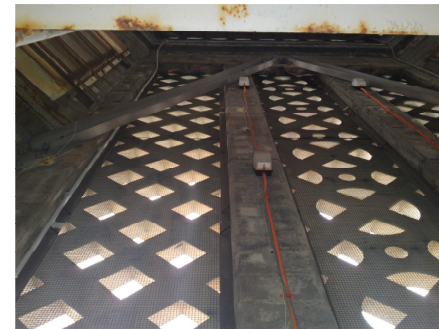
A review of the original drawings shows that the precast screens (Figure 2) are built into rebates in the surrounding concrete work. This provides good restraint under face loads while the screens and surrounding concrete remain un-cracked. The screens are a stiff element within the relatively-flexible upper tower; this leads to significant cracking under a design level earthquake and degradation of the screens, possibly affecting their restraint under face loads. It is difficult to quantify the risk of falling concrete with the information currently available.

Figure 2: Precast concrete screens in the upper belfry.

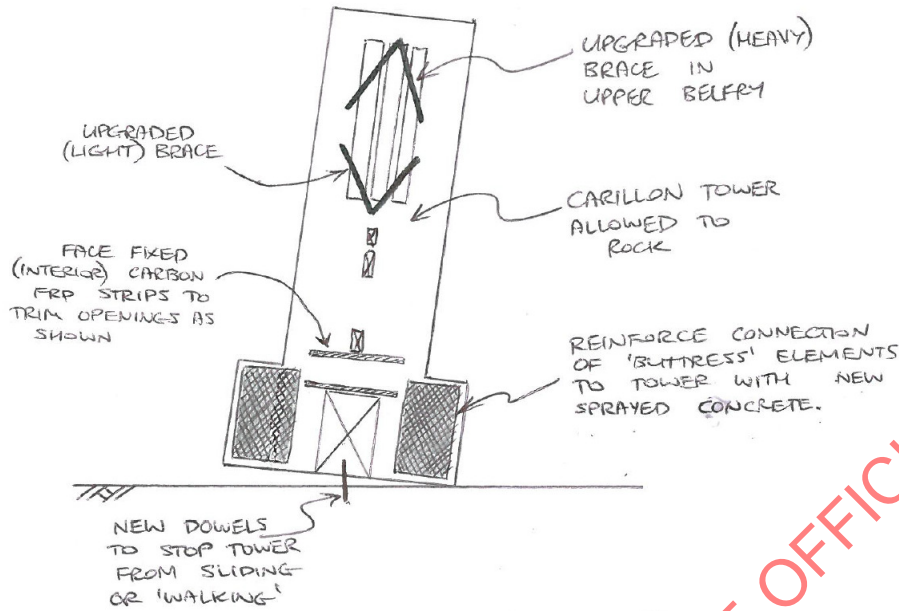
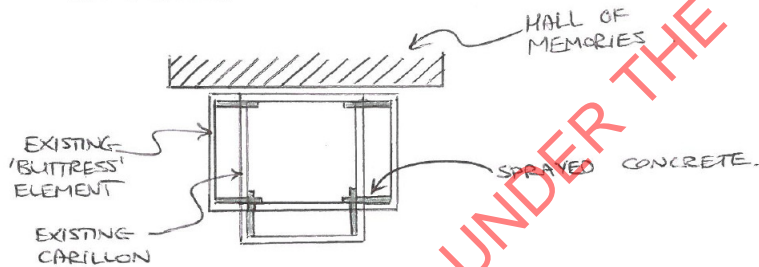
Figure 3: Conventional structural strengthening.

behaviour of the tower. Using the same approach, increasing the target performance from 67% to 100% NBS could be achieved without a significant cost premium – requiring only a modest increase in construction effort. Included in this report is a sketch (Figure 3) indicating the type of work we expect would be required to achieve either 67% or 100% NBS.

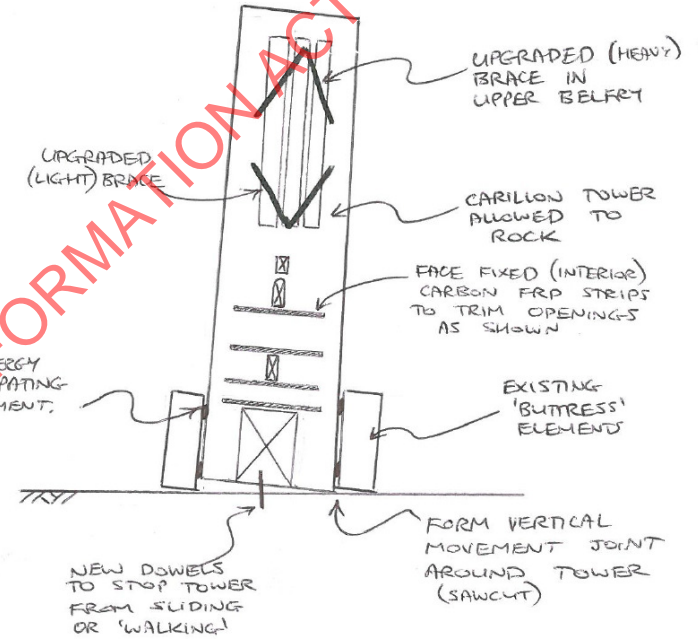
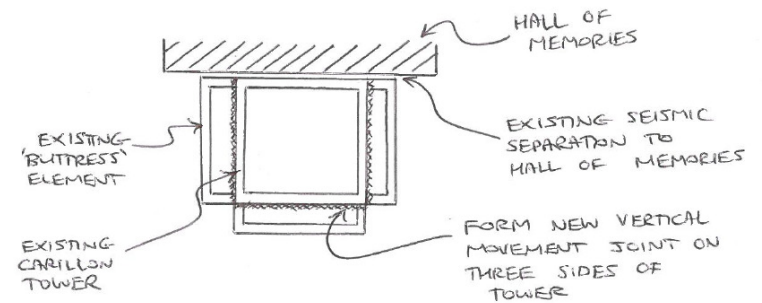
Figure 4: Alternative structural strengthening – damage mitigation

We have also included a second sketch (Figure 4) indicating the type of work we expect would be required for a damage-mitigation design to achieve either 67% or 100% NBS. A damage-mitigation design would reduce the costs of repairs to primary structural elements following a major seismic event. The major cost in most seismic improvement work is the removal and making good of finishes. The making good work required for this alternative is similar to that required for the conventional strengthening; meaning the benefits of damage-mitigation design can be attained without a significant cost premium. Moreover, the energy dissipation this could include would reduce the stress on secondary elements and corrosion-damaged primary elements.
