August 24, 2020

Re: Discharge from the San Antonio Creek Wet Weather Facility and Alice Street Overflow Structure

Attachment 8

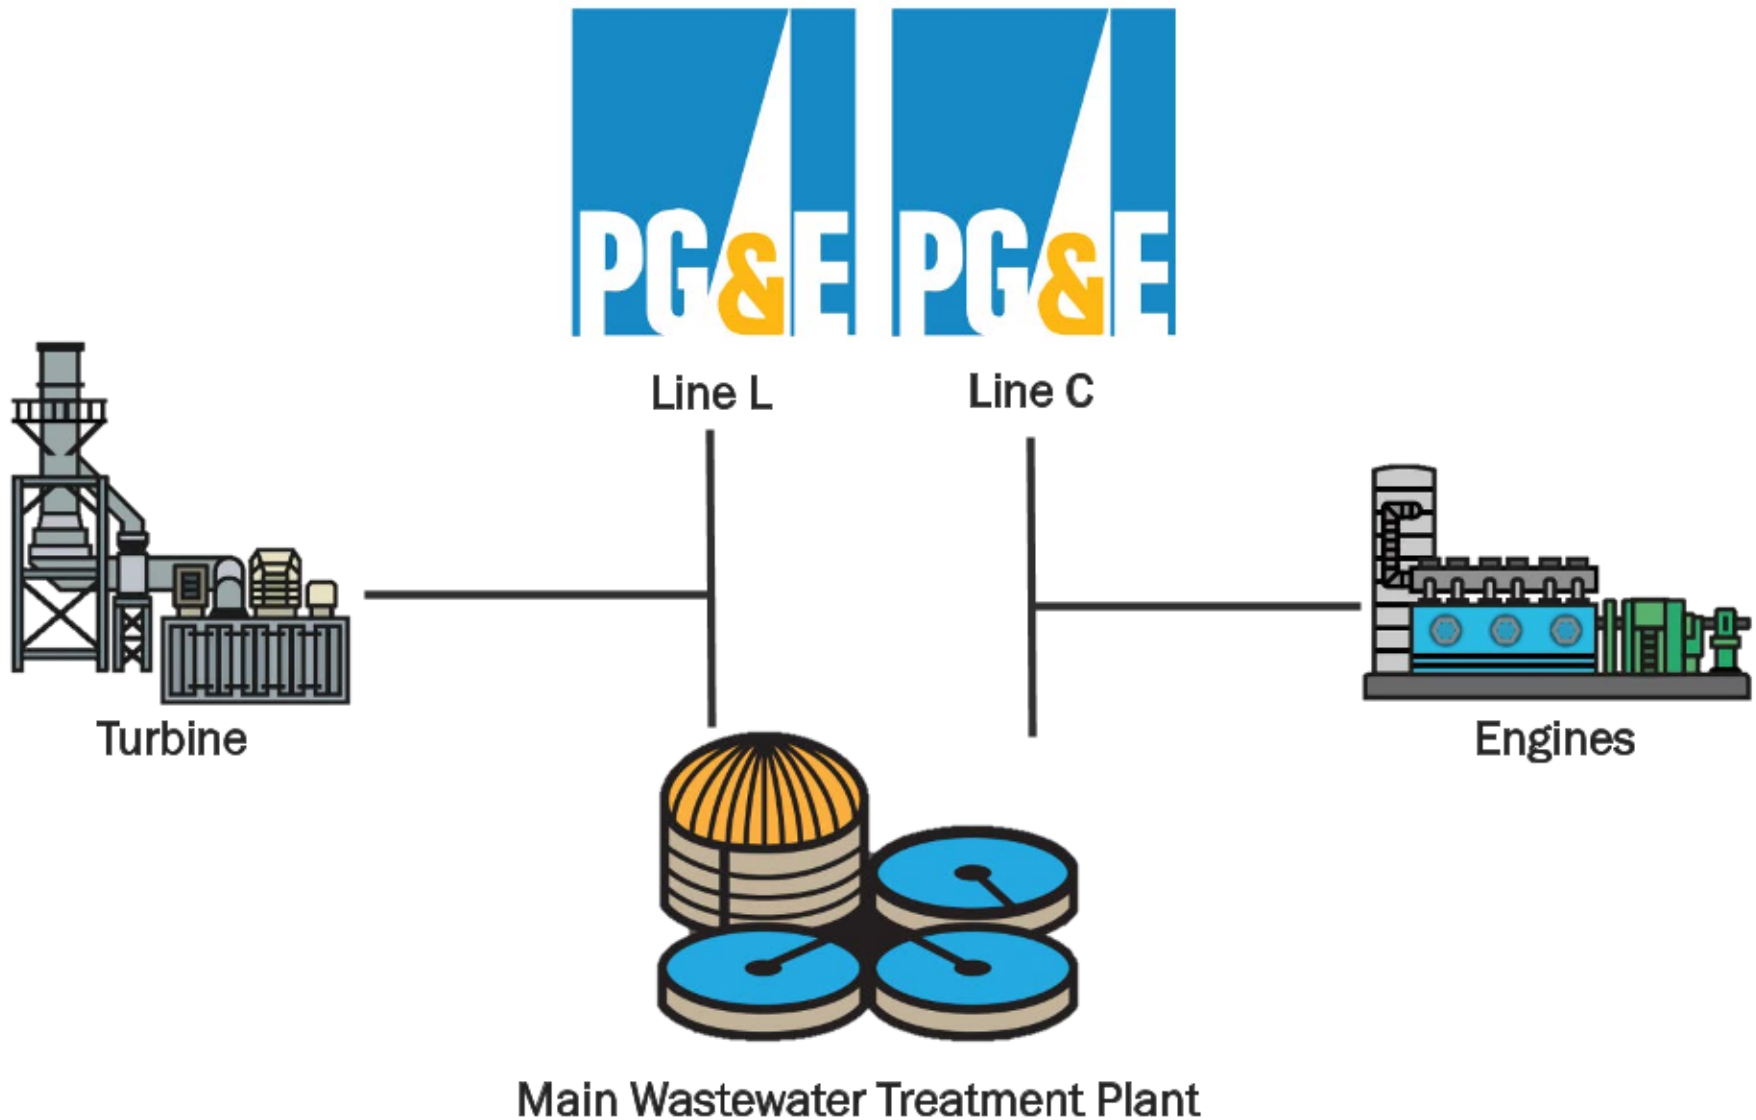
Typical Configuration

Generally, the MWWTP is powered by two onsite systems, comprised of three large engine-generators and a low-emission gas turbine, and two separate PG&E lines, which are fed from two different sub-stations for further redundancy (see Diagram of MWWTP Power Supply, Attachment 7). The causes of this unprecedented near-simultaneous loss of all four power sources, first the three onsite generation facilities, following almost immediately by both PG&E service lines, are as yet unknown. PG&E has stated that it is still investigating the cause of the outages, but that the outages were not part of the rolling blackouts that impacted other parts of California that evening. EBMUD is investigating to determine what the causes of the outages were, whether they were related, and what can be done to prevent recurrence.

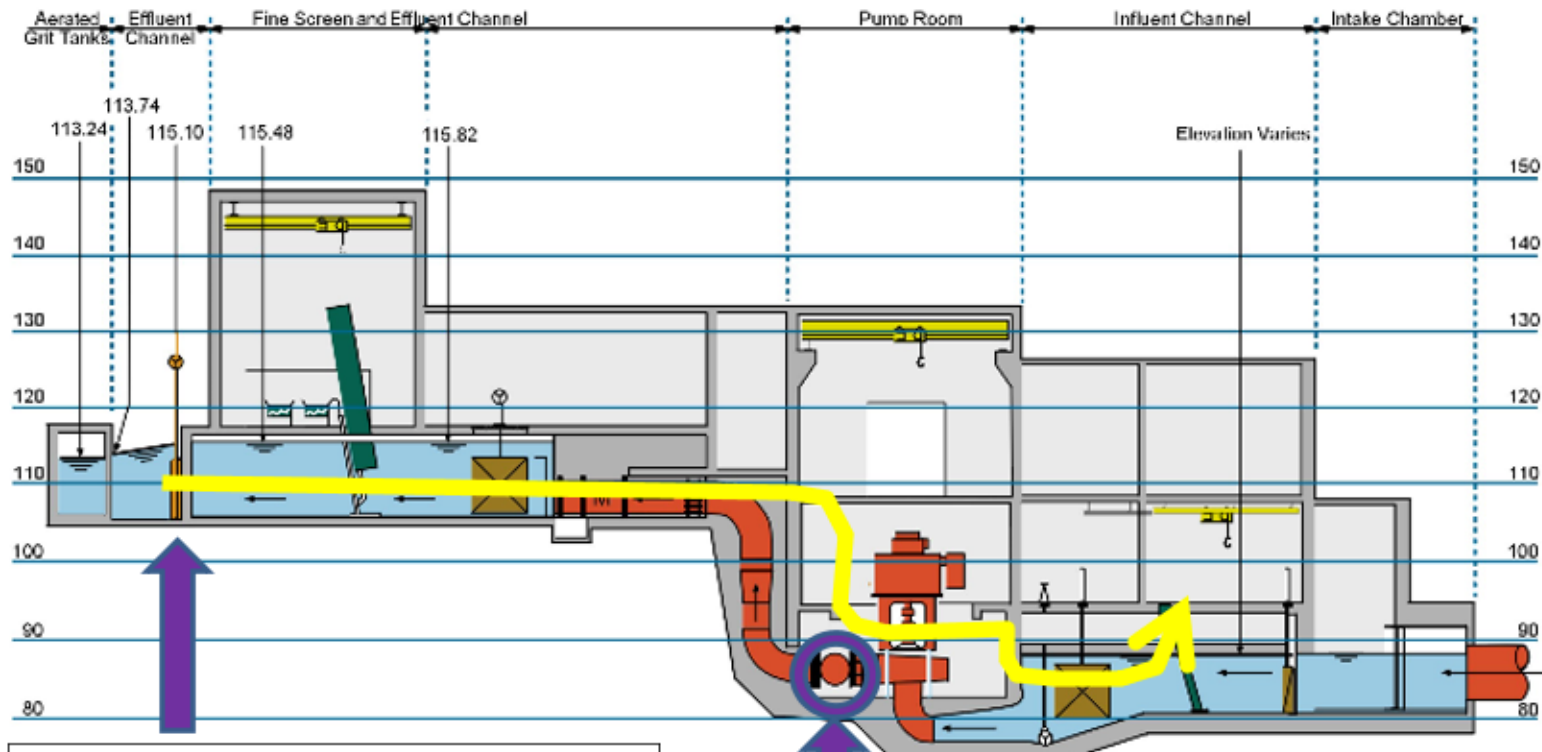
On August 14, 2020, Main Unit 5 pump at IPS was the only pump operating. When power was lost, it is believed that the discharge valve failed to close. This caused water in the channel downstream of IPS to flow backwards through the valve and fill the coarse screen room. As noted above, this valve operates as a check and isolation valve.

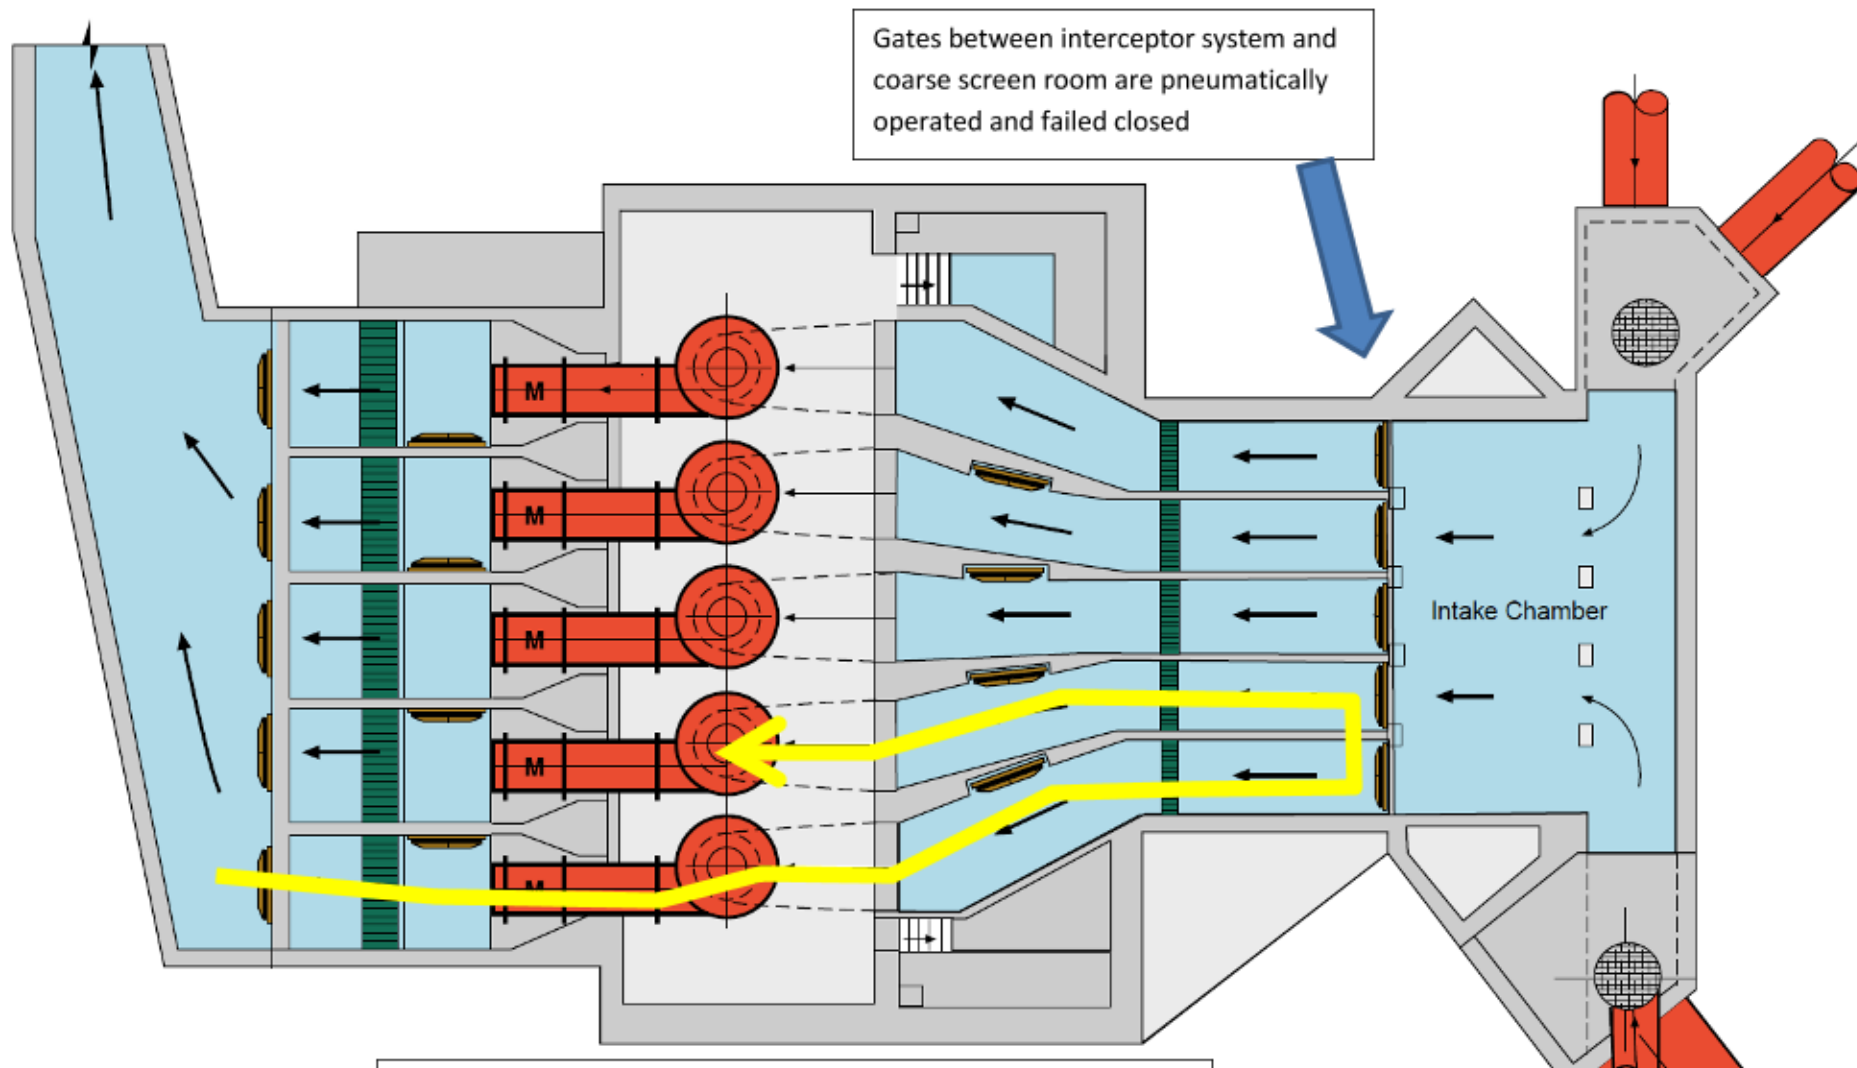
The discharge gate to the effluent channel is electrically powered and failed open.

The discharge valve on Main Unit 5 did not fully close, and water backed up into the coarse screen room.

Gates between interceptor system and coarse screen room are pneumatically operated and failed closed

The flow could not go back into the interceptor system since gates were closed so levels rose and it backed up into the dry pit via MU 4 which was having maintenance work done on it so the motor was off the top and the side inspection plates were removed.

- Replace inspection plates as soon as work is complete or at the end of the shift;
- Fabrication of new lighter inspection plates so that they can be easily installed during inspections to prevent wastewater from traveling through a pump to the dry well and causing flooding;
- Procuring additional submersible pumps for emergency use; and
- Repairing the leaking valve on the influent pump (as planned).

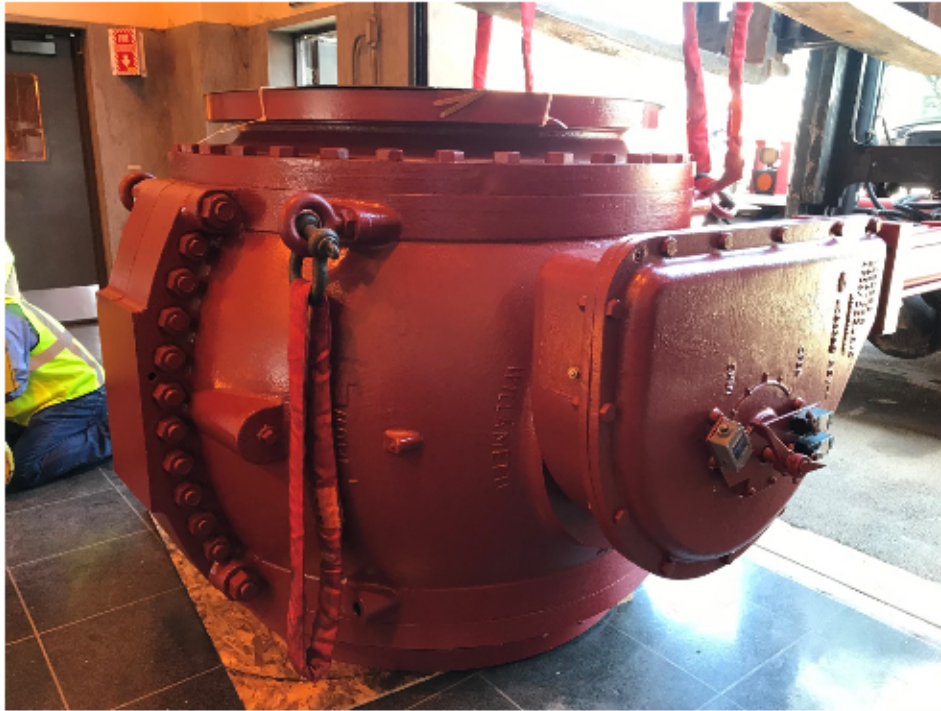
Photo of new ball valve we received in early June. We are in the process of rehabbing each of the five valves one at a time. As we take one out to refurbish we put this new one in so the pump remains operational. Main Unit 3's valve is currently out for work and the next one scheduled is Main Unit 5.
