Document 3

AUCKLAND ◊ HAMILTON ◊ TAURANGA ◊ WELLINGTON

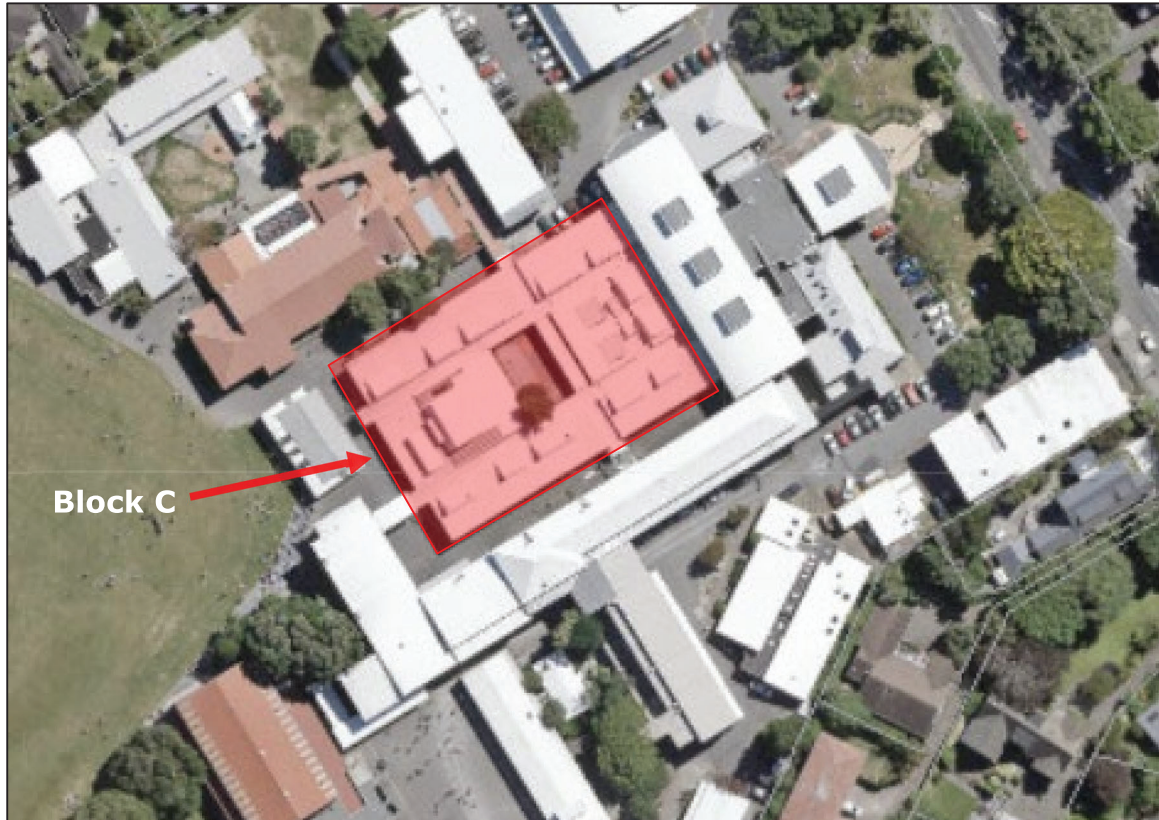
Block C Performance & Condition Report

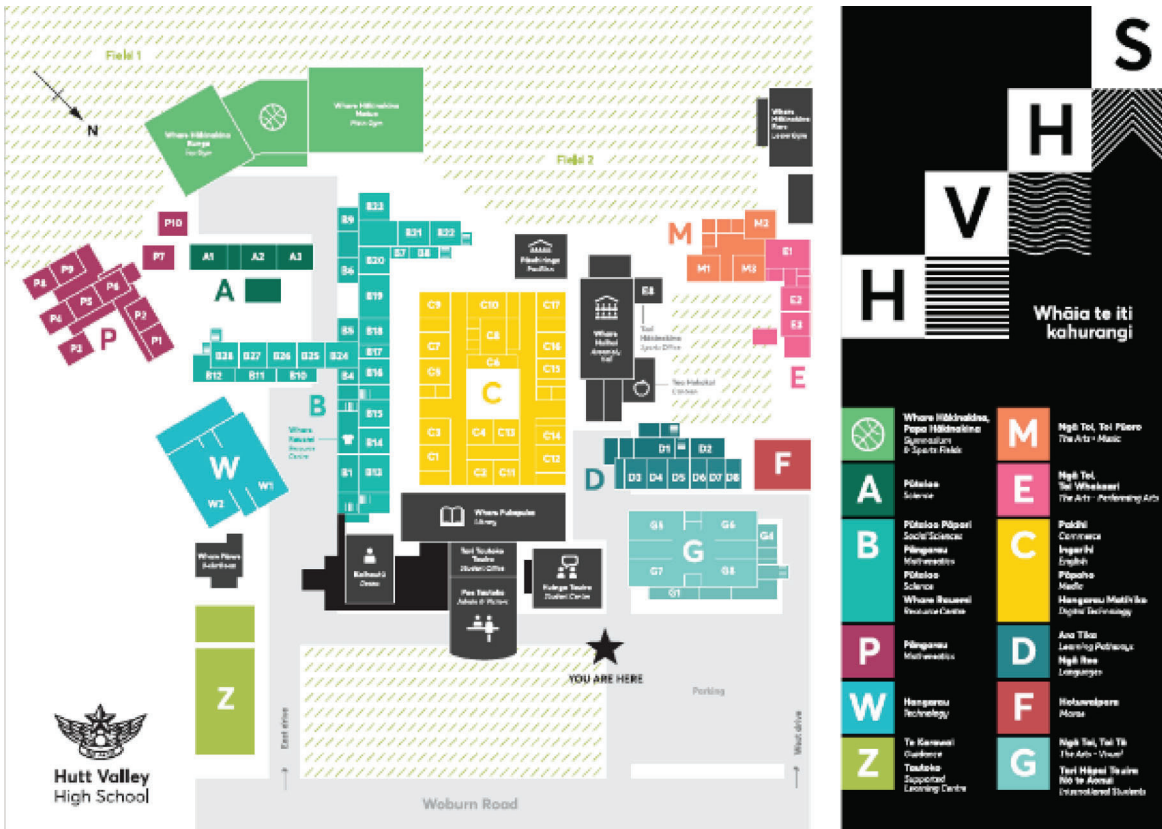
Section 2.0 Performance & Condition Report**2.1 General Description of Construction**

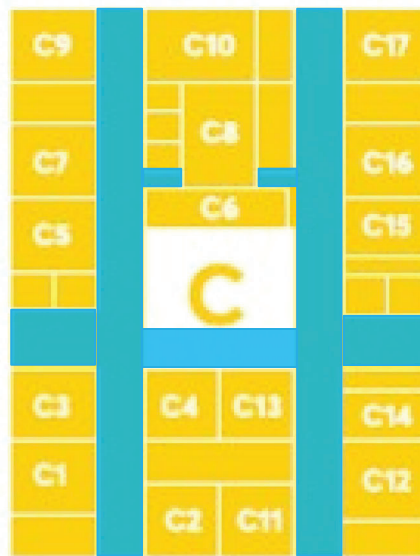
Blue boxes display the roof service void across Block C linking all four quadrants of the Block.

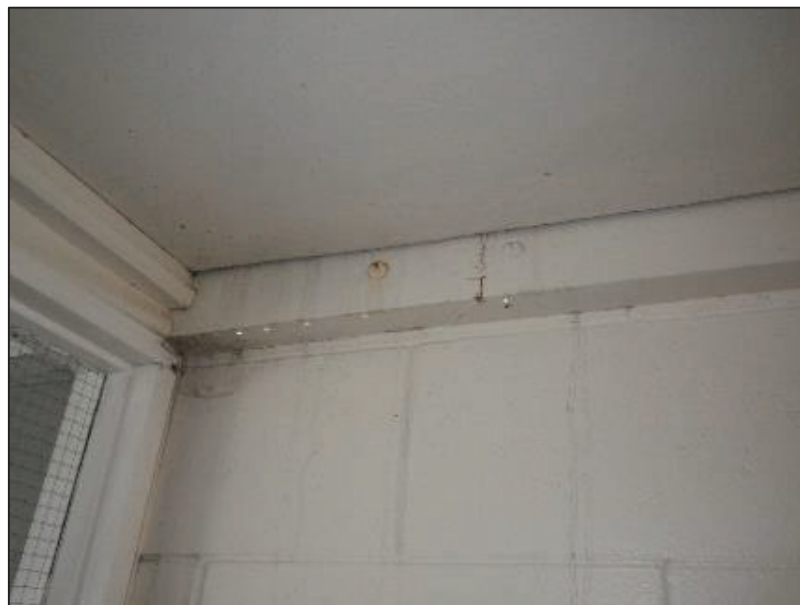
Water leaks into corridor from service void roofing drip onto the floor. There was light mist rain most of the day 29/3/2021.

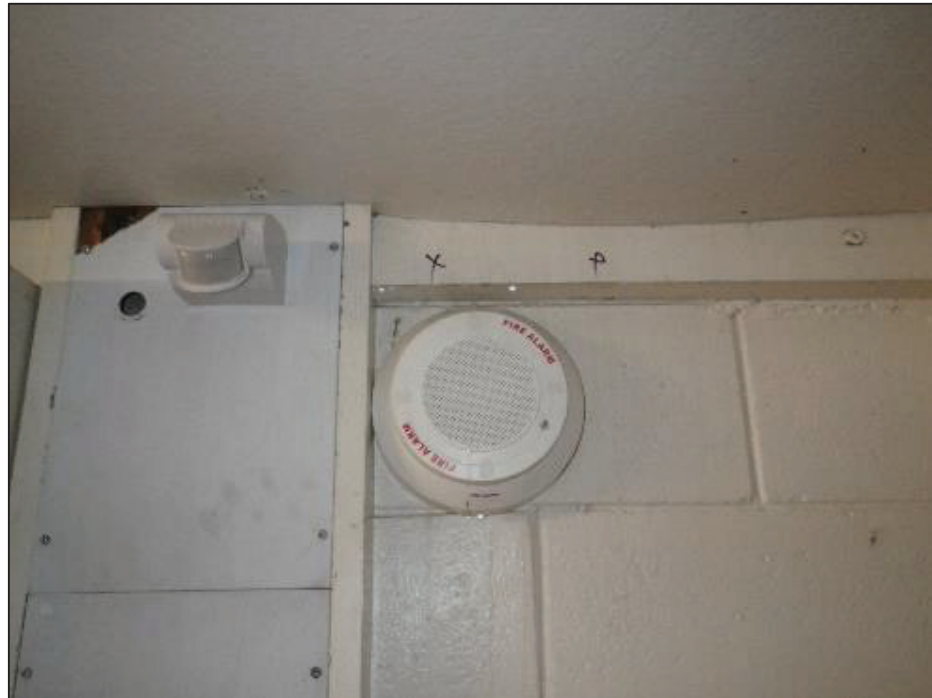
Water leaks from corridor roof drip onto alarm services, ceiling linings swollen and sagging.

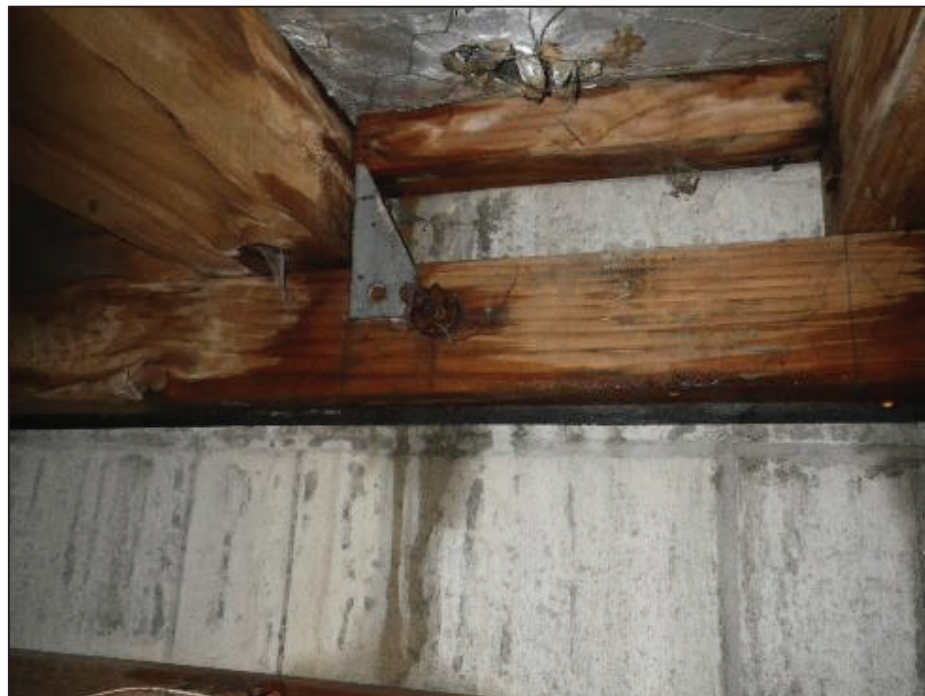
Water leaks corroding anchor bolts, saturating structural timber framing eventually end up at floor level. The leaks increase the moisture loading of the roof cavity leach timber treatments and encourage fungal decay. Foil roof underlay is non-breathable or vapour permeable.

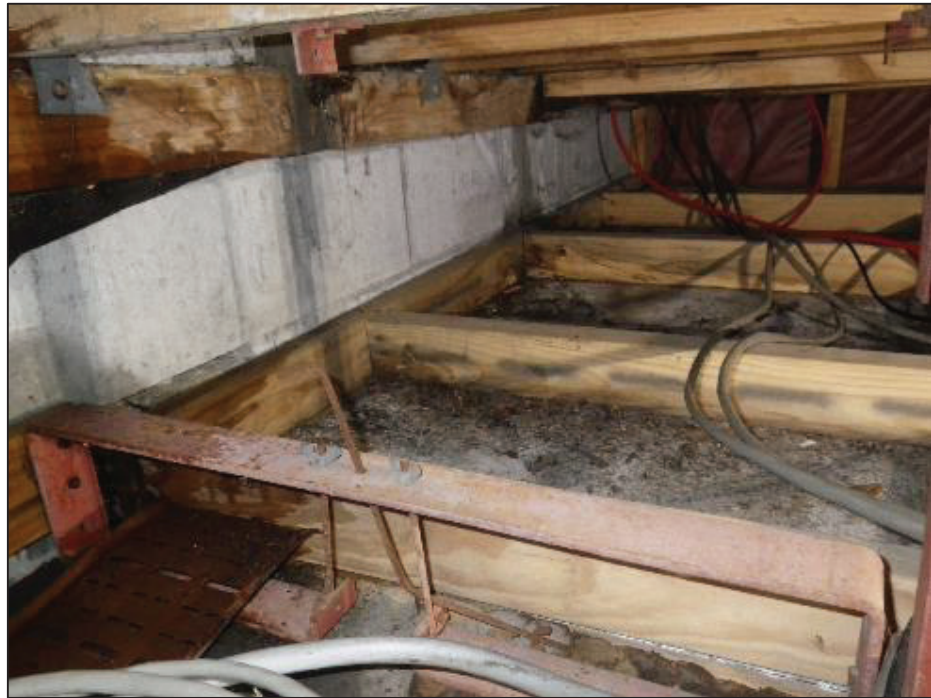
Repeated water damage in the service void ceiling.

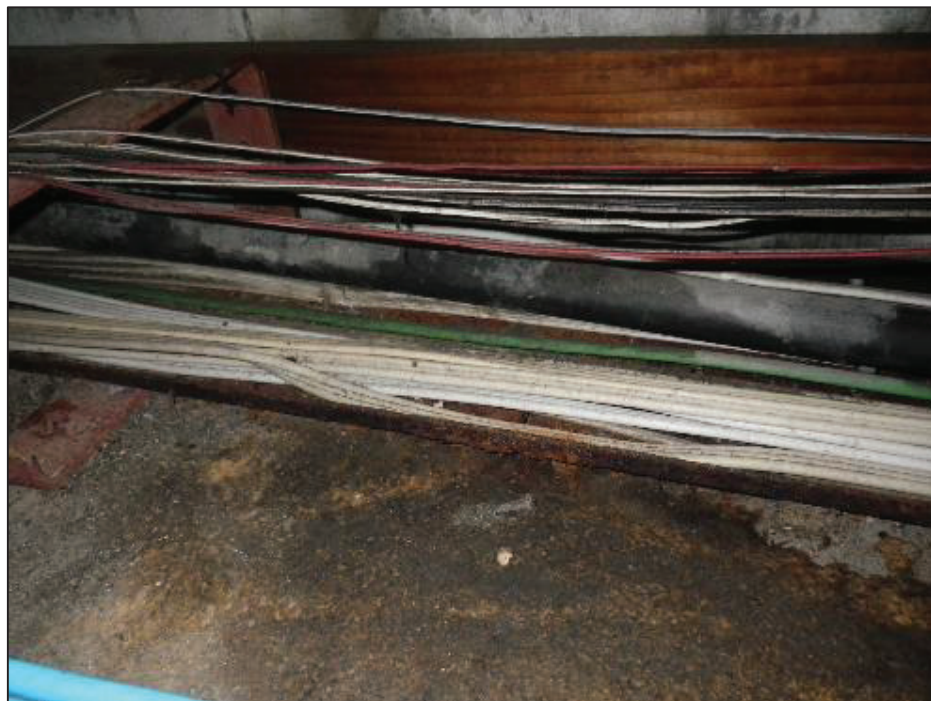
Corroded cable tray, electrical cables sitting in water. Decaying ceiling linings to walkway ceiling.

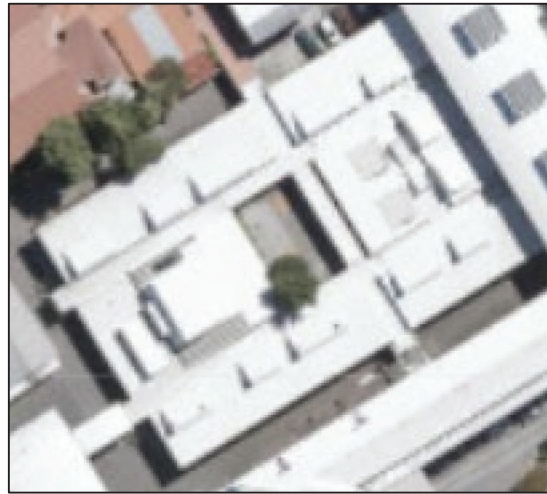
Roof area Block C, the largest area to have direct influence on the internal environment.

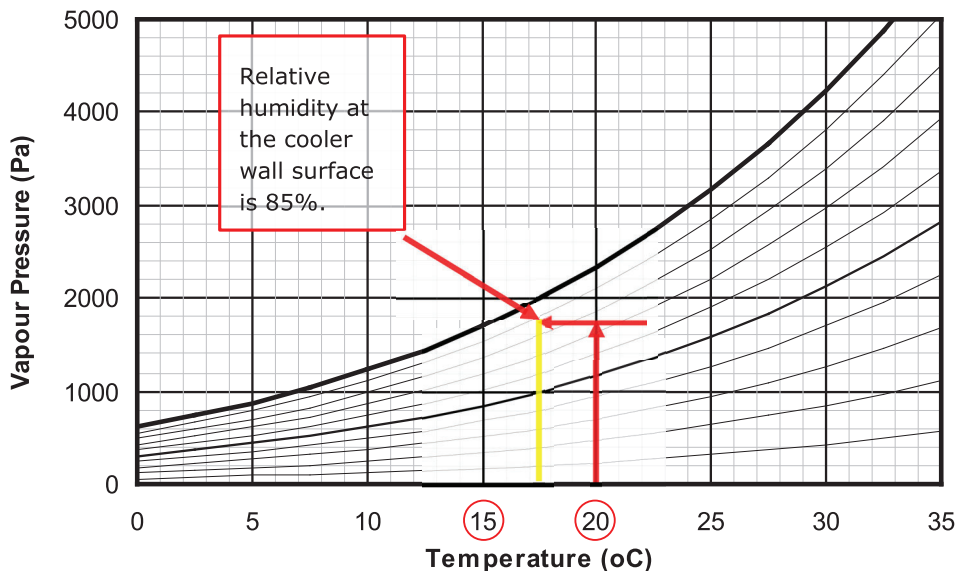
31/3/2021 - Inside Relative Humidity (Rh) 76%, Inside Air temperature 20° wall surface temperature 17.5°. – Rh at the wall surface is 85%, this level of moisture will support fungal growth.

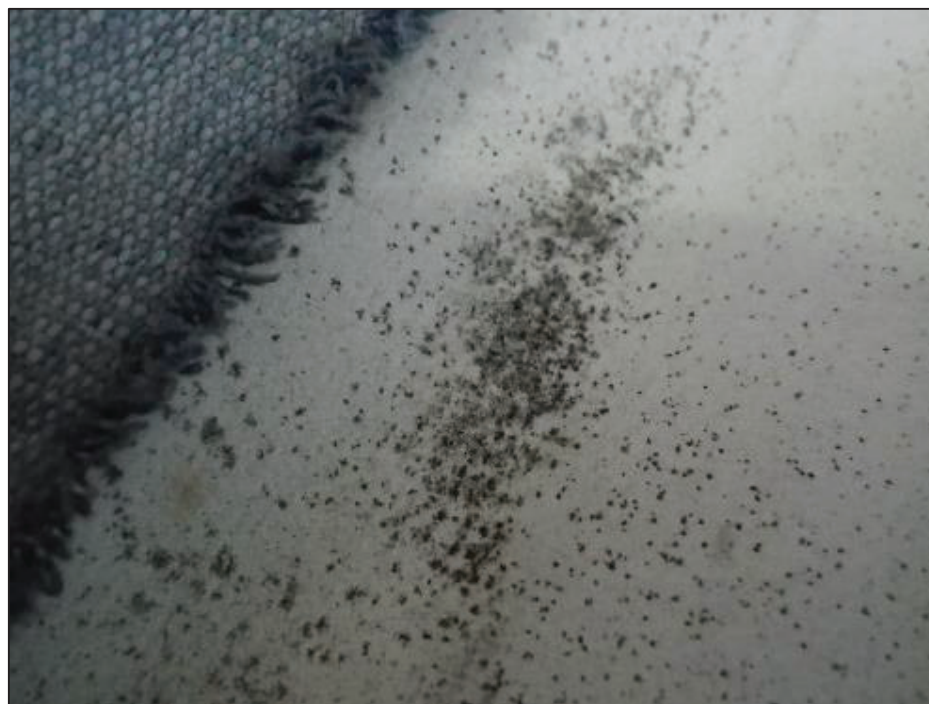
Fungal spotting on the curtain fabrics which absorb and release water vapour in the classrooms.

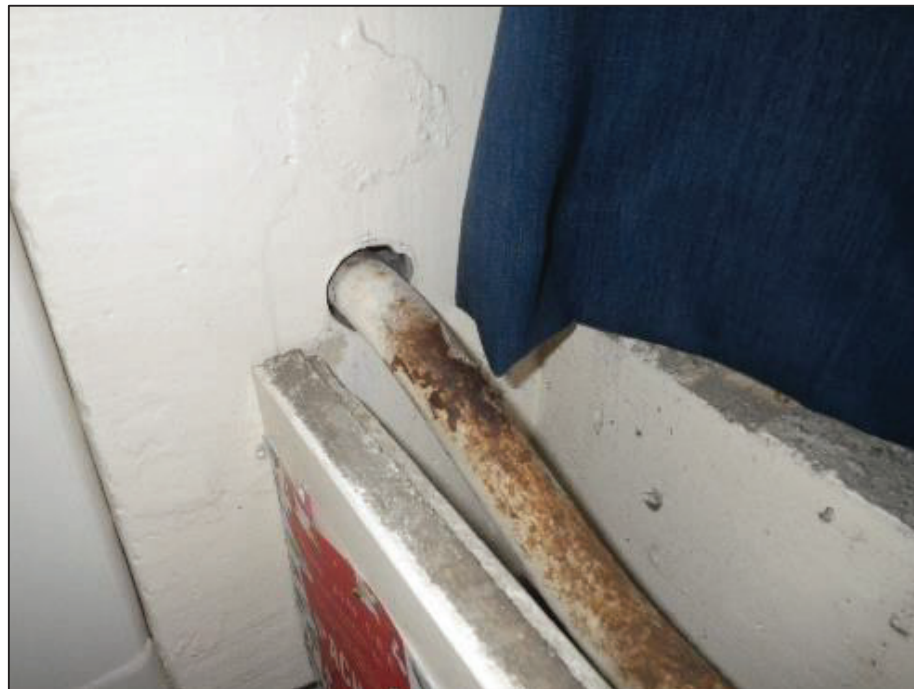
Surface corrosion to service pipes forming a condensation plane. Service pipes at pelmet level within the classrooms sit in the zone of moisture rich damp internal air.

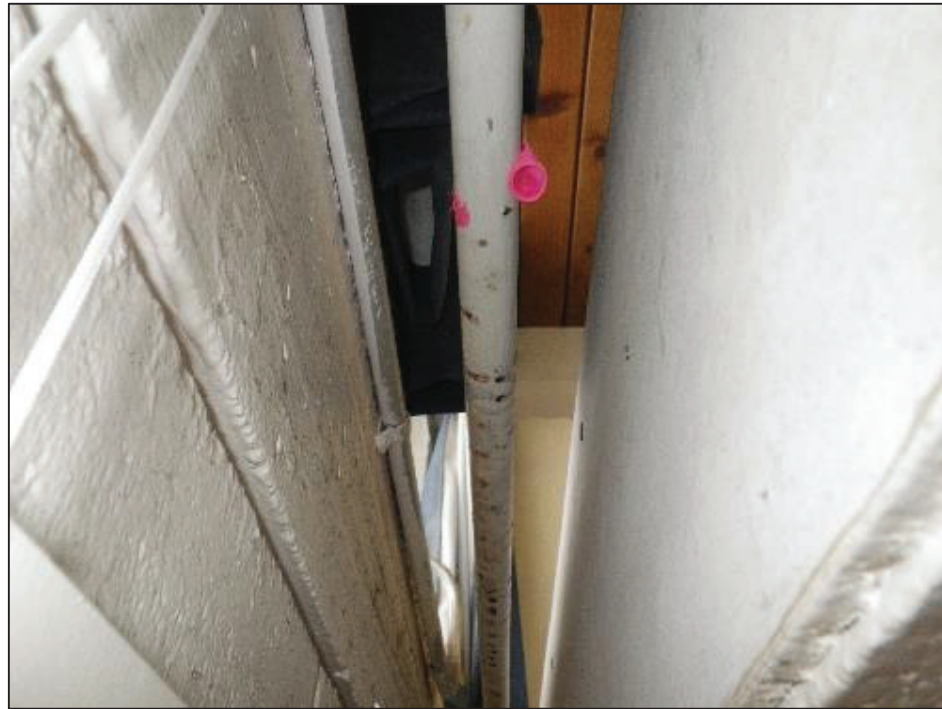
Lower face of same pipe showing water stain trails and drip point from the service pipe.

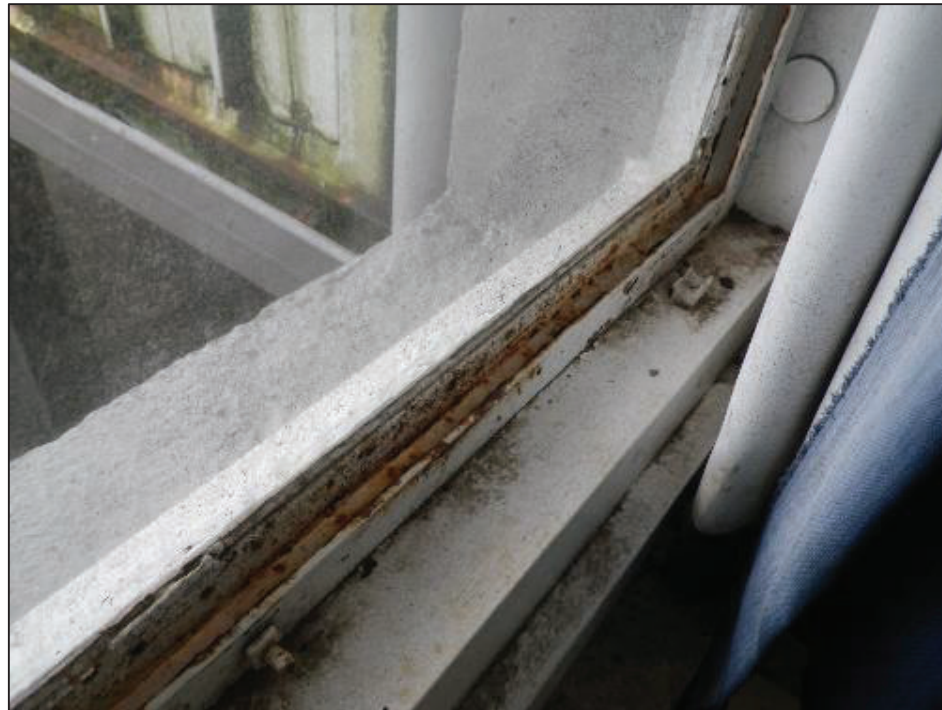
Corroding steel window frame. Slightly open allows saturated internal air to bleed to the exterior keeping the steel frame in a moist environment encouraging corrosion.

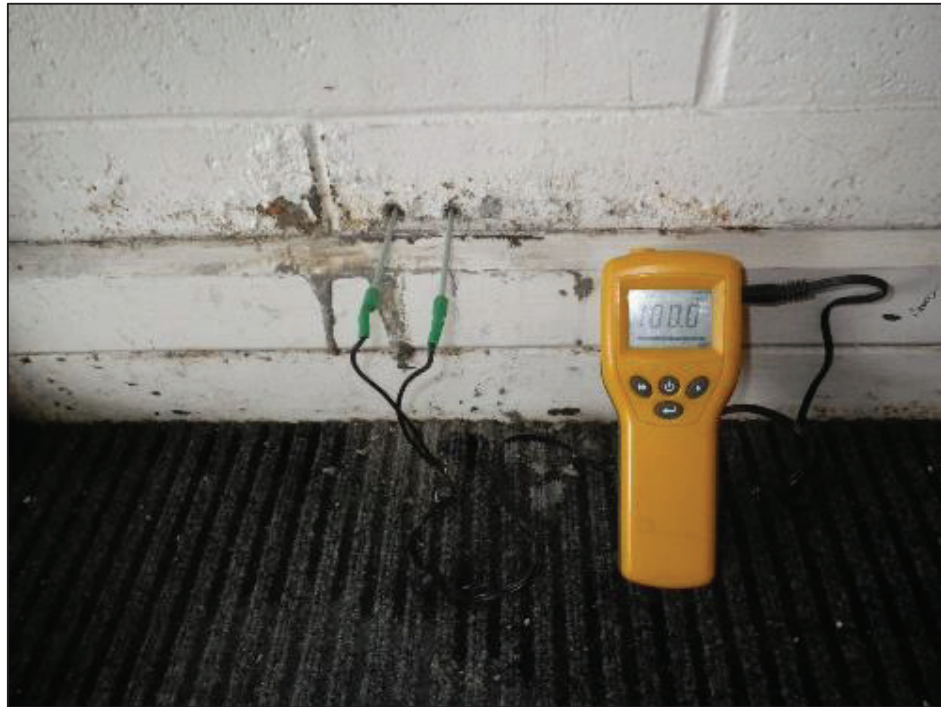
Saturated core to lower course of concrete blocks, corridor internal wall. Results of longstanding roof leaks.

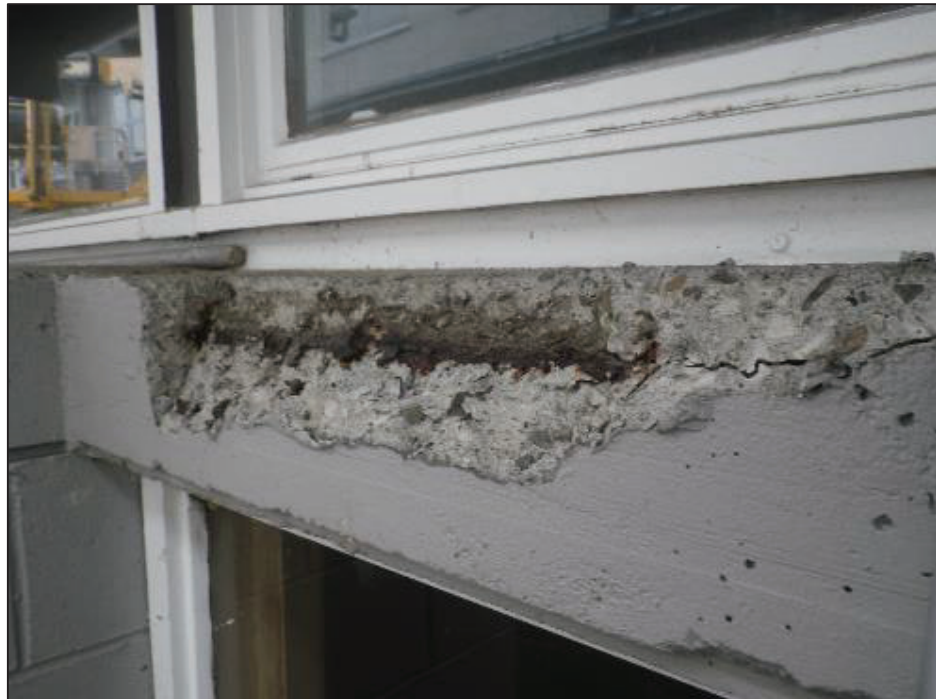
Localised spalling of concrete through sections of the bond beam due to insufficient concrete cover allowing moisture entry and resulting corrosion.

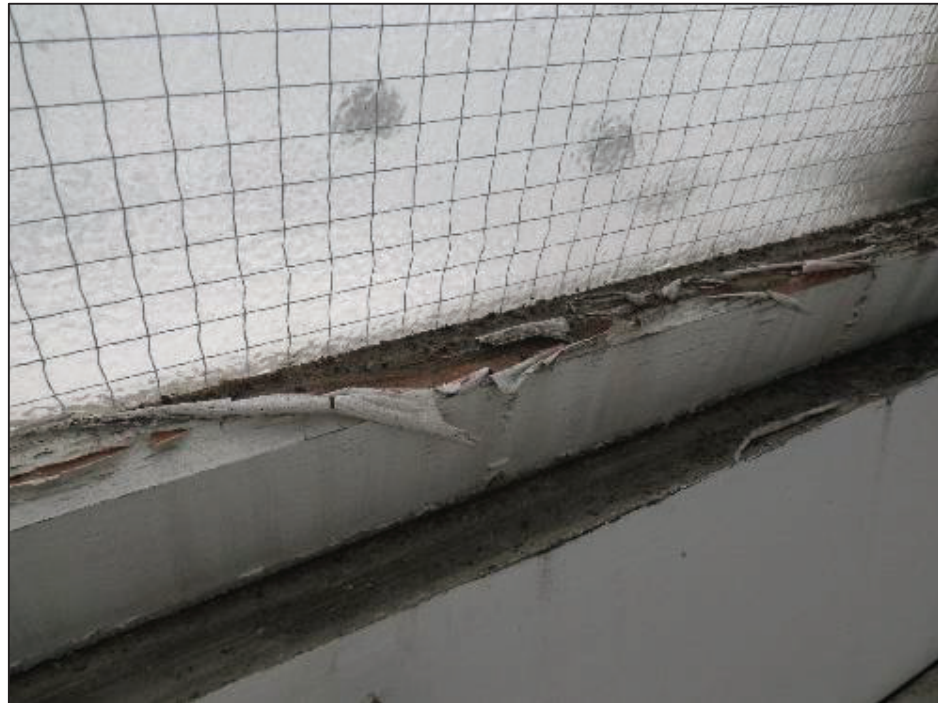
Windowsill of rafter clerestory windows, peeling paint, dust debris including supporting fungal spores, a condensation plane. These areas are too high for standard cleaning operations and require specialist access equipment.

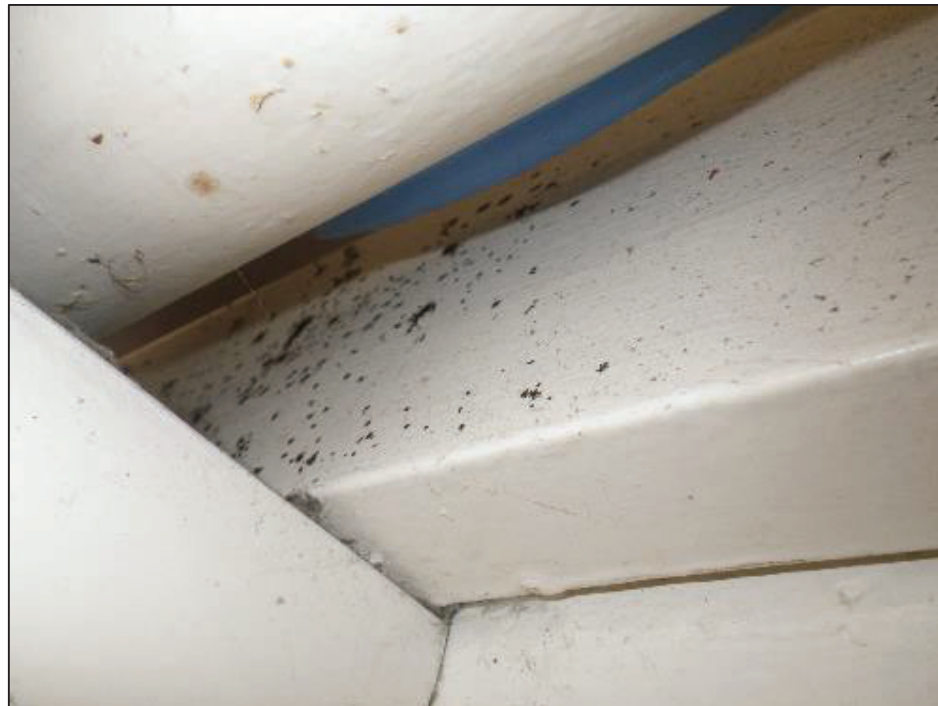
Fungal spotting to surface in roof area with passing moist air in the bathrooms.

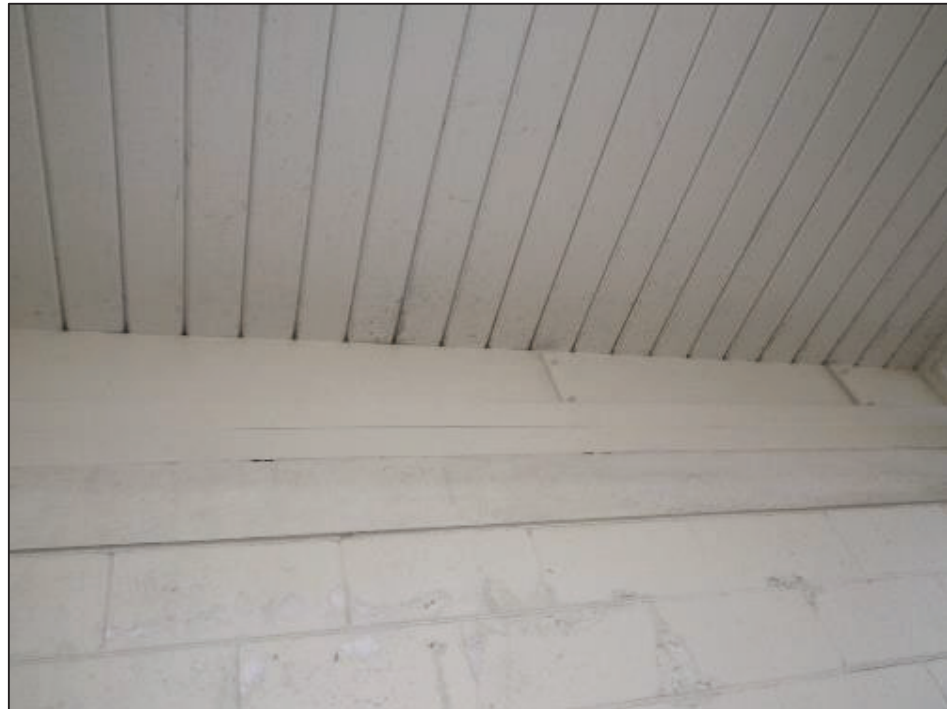
Ceiling / roof forming condensation plane in bathrooms. Discolouration is fungal growth on the ceiling surface.

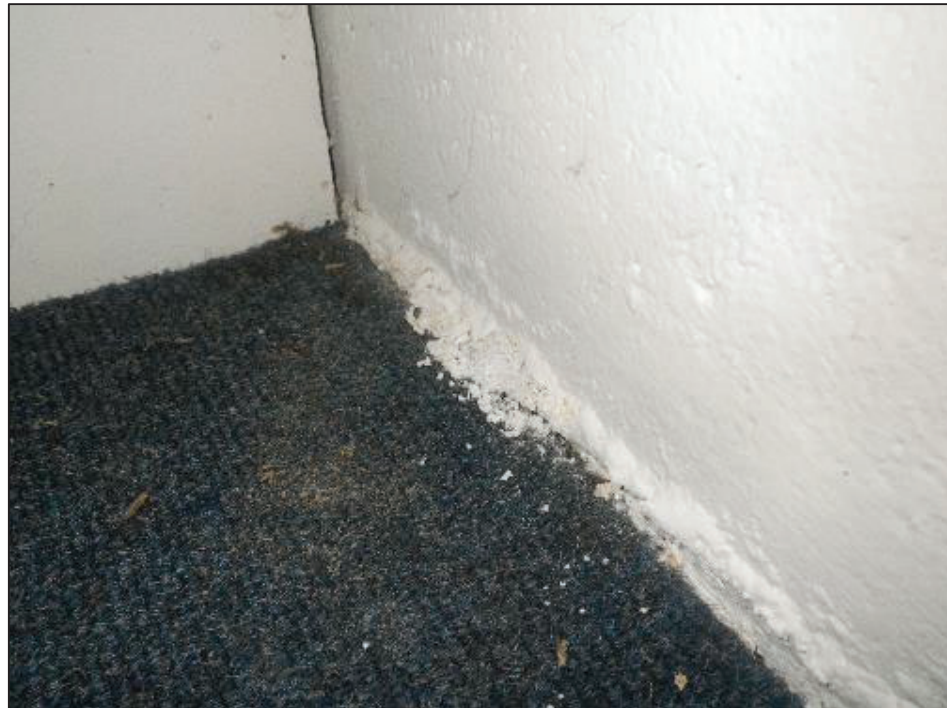
Efflorescence bleed from saturated concrete blocks, results of longstanding roof leaks.

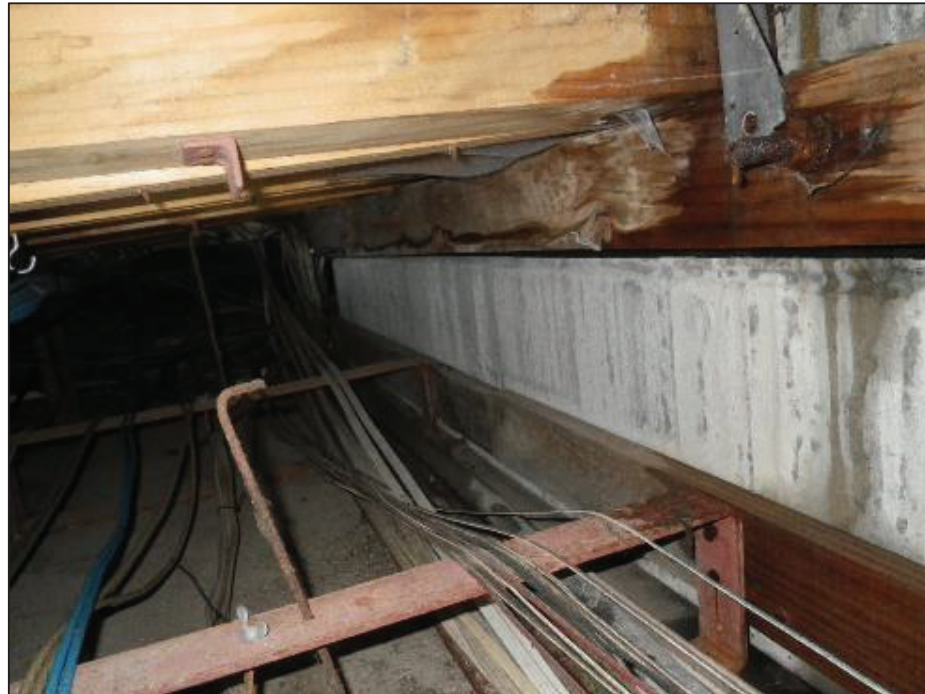
Corroding cable trays and steel hangers, corroding bolt fixings to framing, saturated framing timbers, 50 years of dust debris in service ceiling cavity.

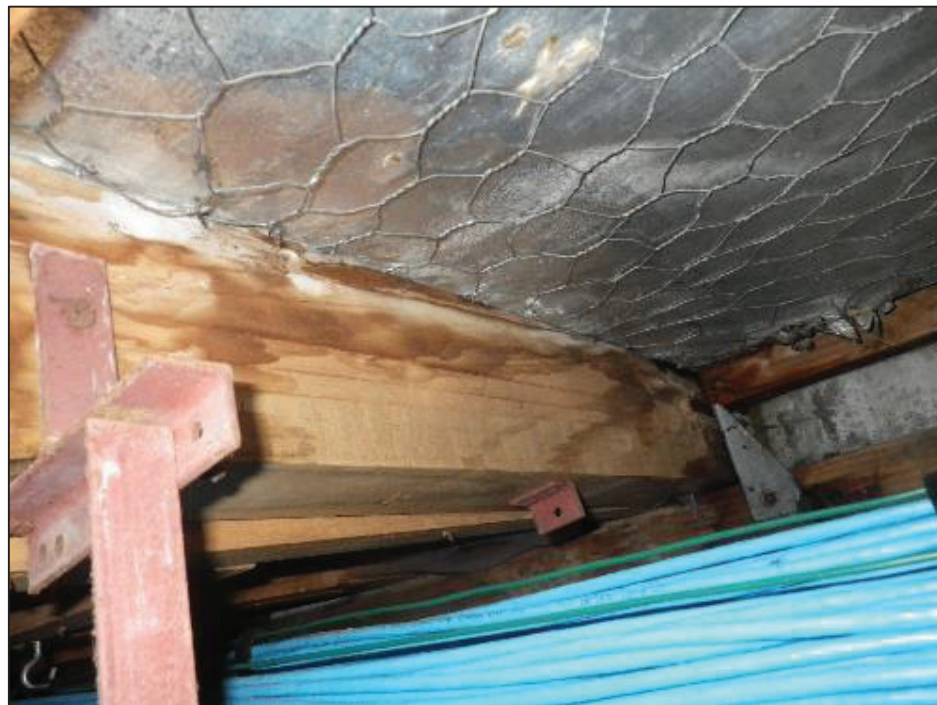
Foil roof underlay non-breathable traps moisture vapour, moisture damage to roof framing, active leak zone.
