**Walmart Inc. (f/k/a Wal-Mart Stores, Inc.) v. Tesla Energy
Operations, Inc. (f/k/a SoalrCity Corporation)**
Document 1

**SUPREME COURT OF THE STATE OF NEW YORK
COUNTY OF NEW YORK: COMMERCIAL DIVISION**

SUMMONS

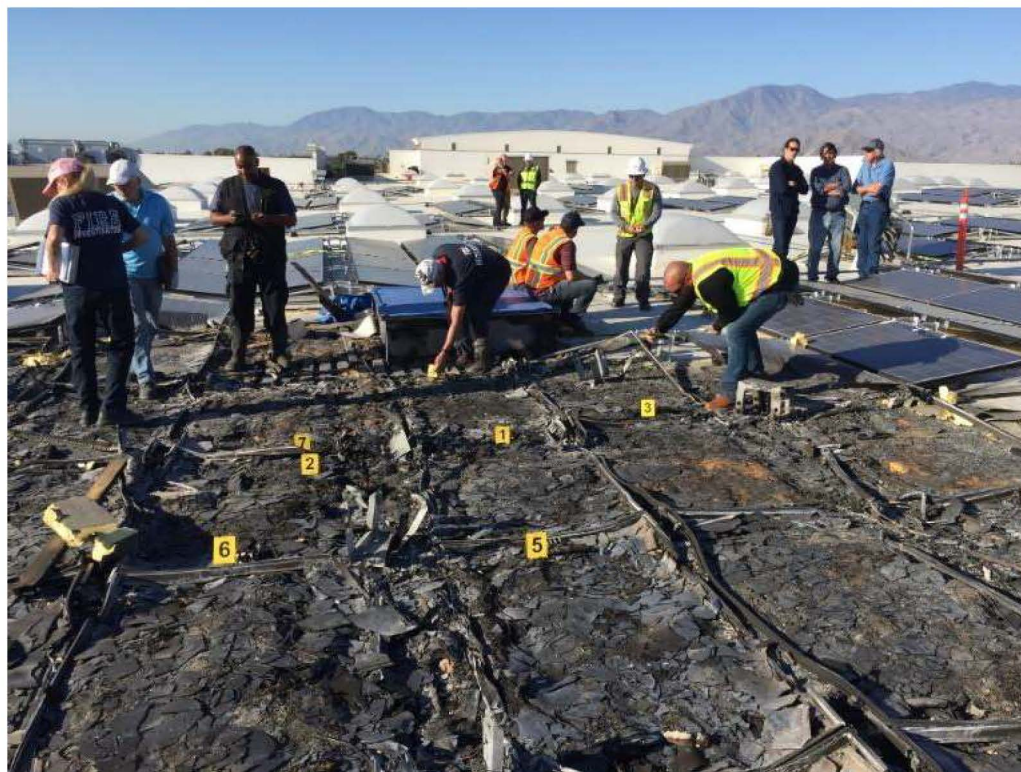
Inspection Team at Site of Indio Fire

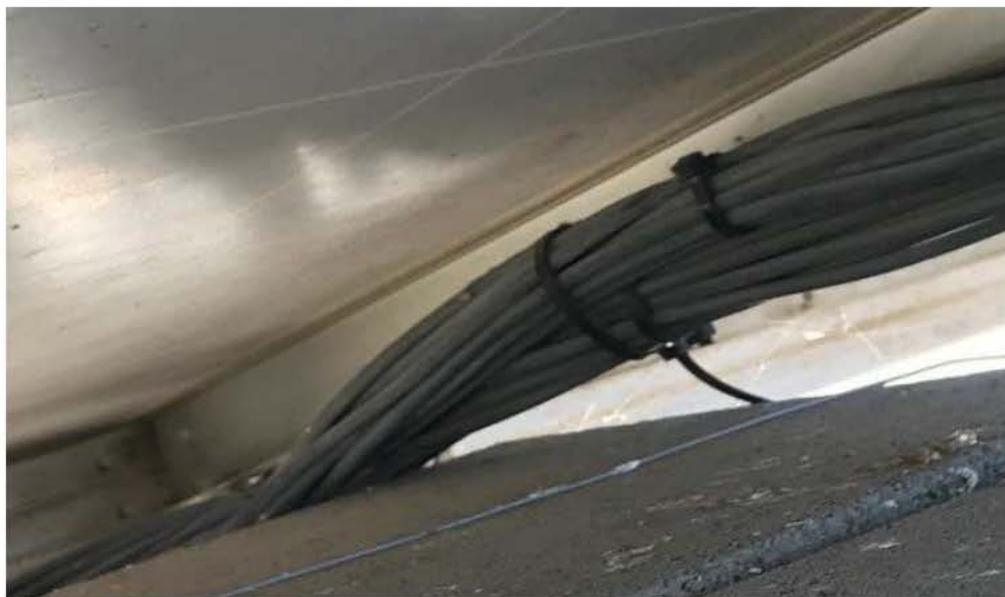
Images of Abraded Wires
