Project 14

Identification and Evaluation of
Remediation Options
(Commercial in Confidence)

The Treasury

Reference: 510555

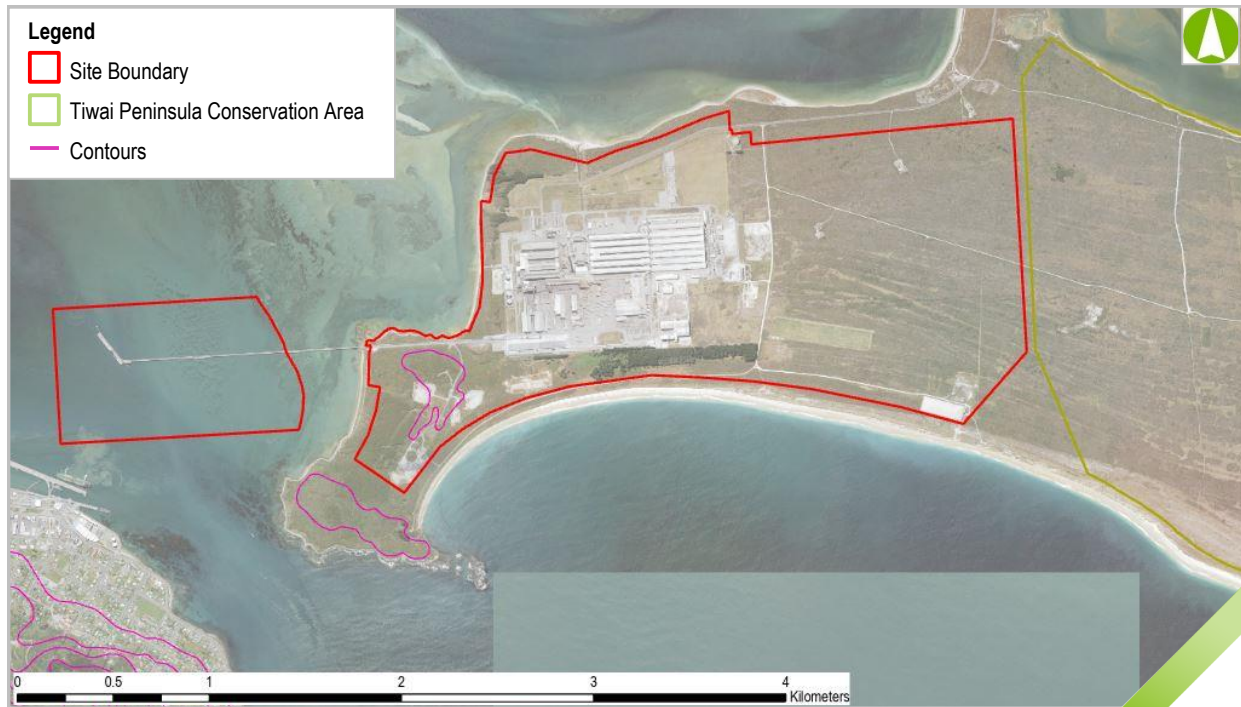
Figure 2 Site Topography. Source: LINZ Data Services.

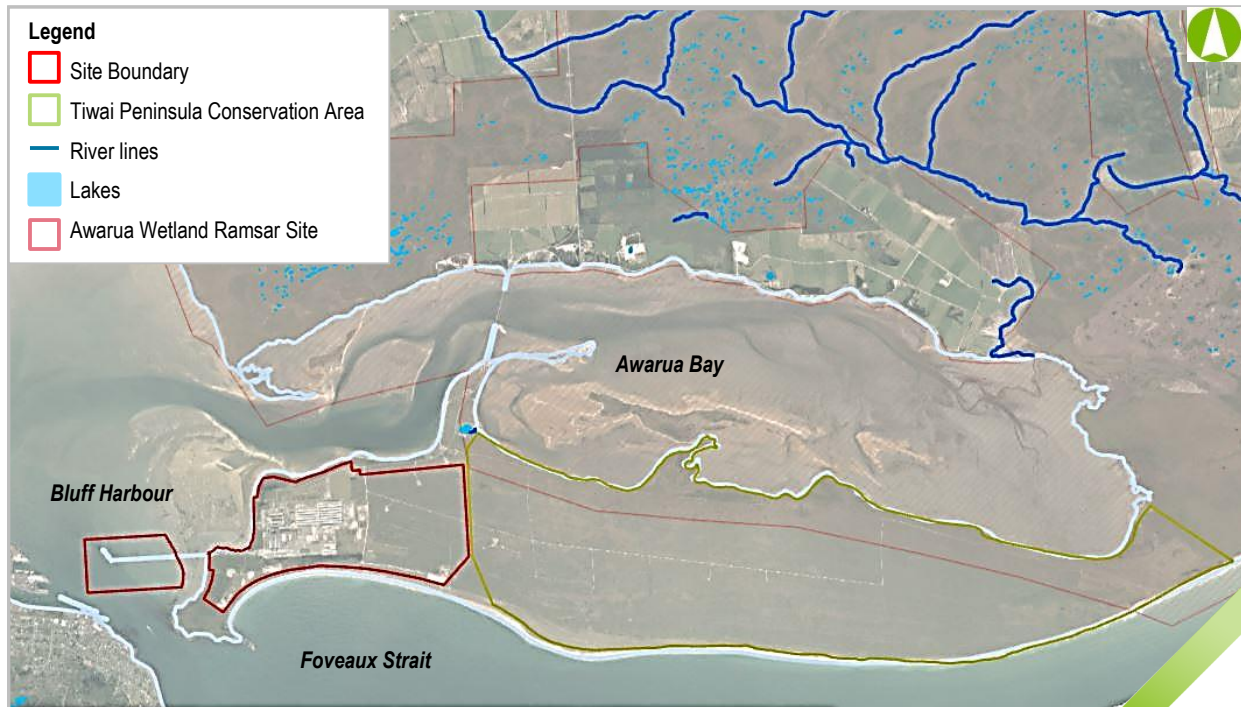
Figure 4 Site Hydrology. Source: ESRC and LINZ Data Services.

A search of ES and LINZ GIS data services has identified a small lake approximately 1.6 km north-east of the industrial precinct. The lake is connected to a nearby stream which flows into Awarua Bay. The Tiwai Peninsula is surrounded by coastal water bodies, with Bluff Harbour to the west, Awarua Bay along the North and Foveaux Strait south of the peninsula. The closest river is the Mokotua Stream, which is situated within the Awarua Plains approximately 6 km north of the Site. The Bluff Harbour, Awarua Bay and Awarua Plains all form part of the Awarua Wetland Ramsar Site (regionally significant wetlands and sensitive waterbodies).

Refer to Figure 4 below and Drawing 510555-0000-DRG-REP-0004-A, Appendix 1.

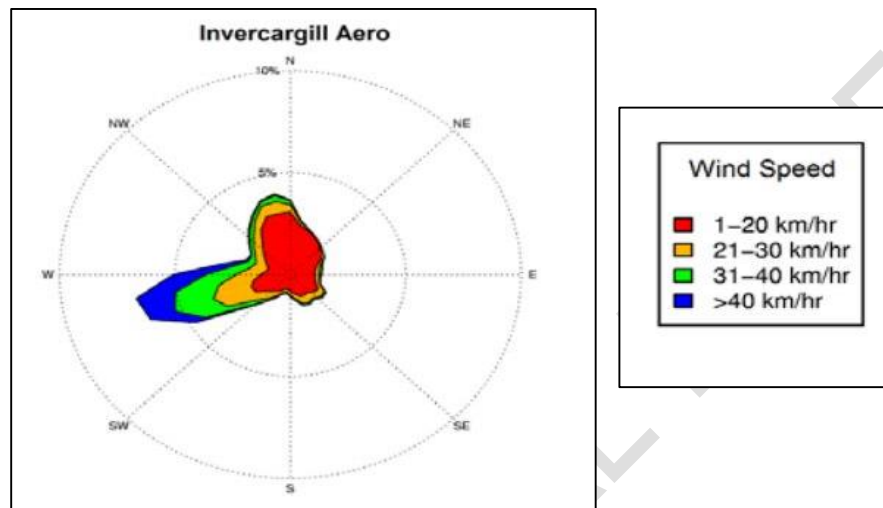
Figure 7 Mean annual wind frequencies (%) of surface wind direction from hourly observations recorded at the nearby Invercargill Airport climate station. The plot shows directions from which the wind blows. Source: NIWA.

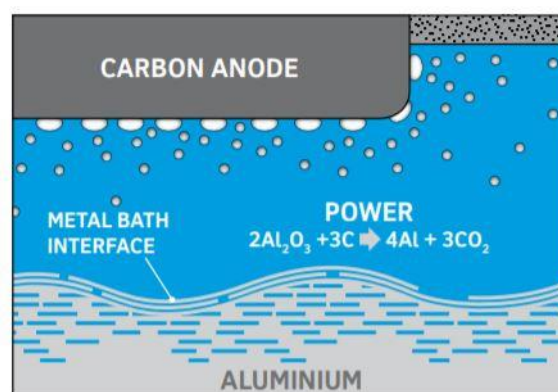
Figure 9 Electro-chemical reaction in a reduction cell. Source: NZAS website (<https://www.nzas.co.nz/>)

A very high electrical direct current of approximately 196,000 amps for Lines 1, 2, 3 and 225,000 amps for Line 4 flows into the reduction cells through carbon anodes which are suspended above the cell on cast iron yokes. Anodes form the positive electrode also supply the carbon for the reduction reaction. The electrical current passing through the alumina bath solution reduces the alumina to aluminium and oxygen. The aluminium is deposited at the cathode while the oxygen is attracted to the carbon anode as shown in Figure 9.

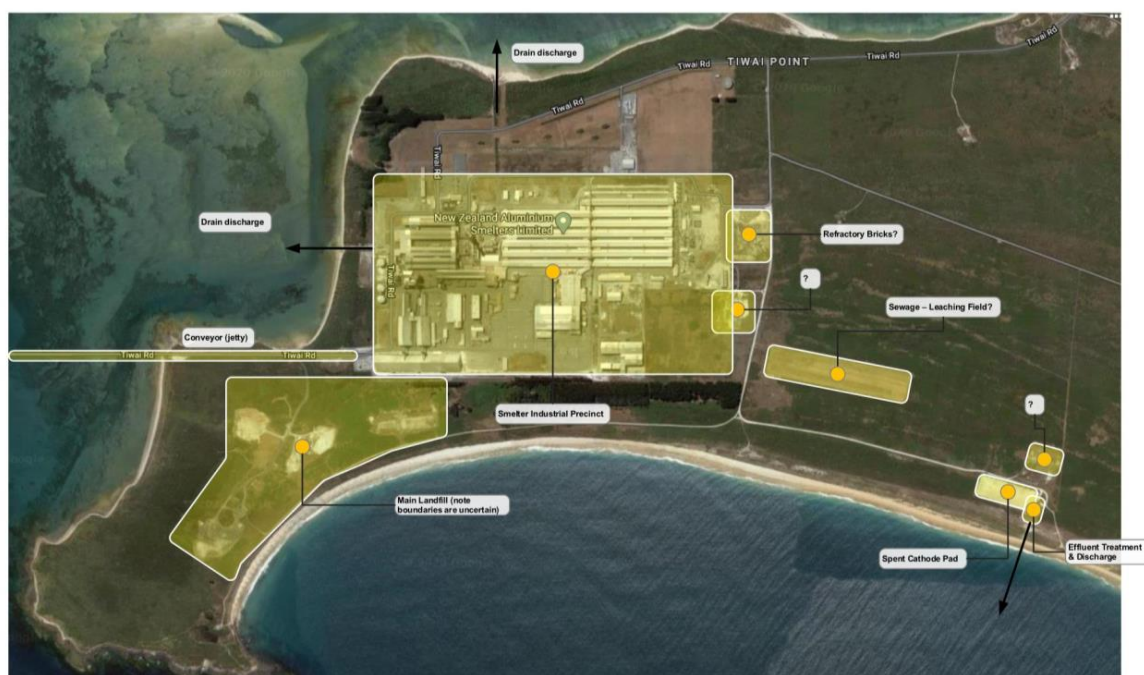
Figure 12 Smelter and Auxiliary Services at Tiwai Peninsula.

Discharge locations are shown in Figure 12 below.

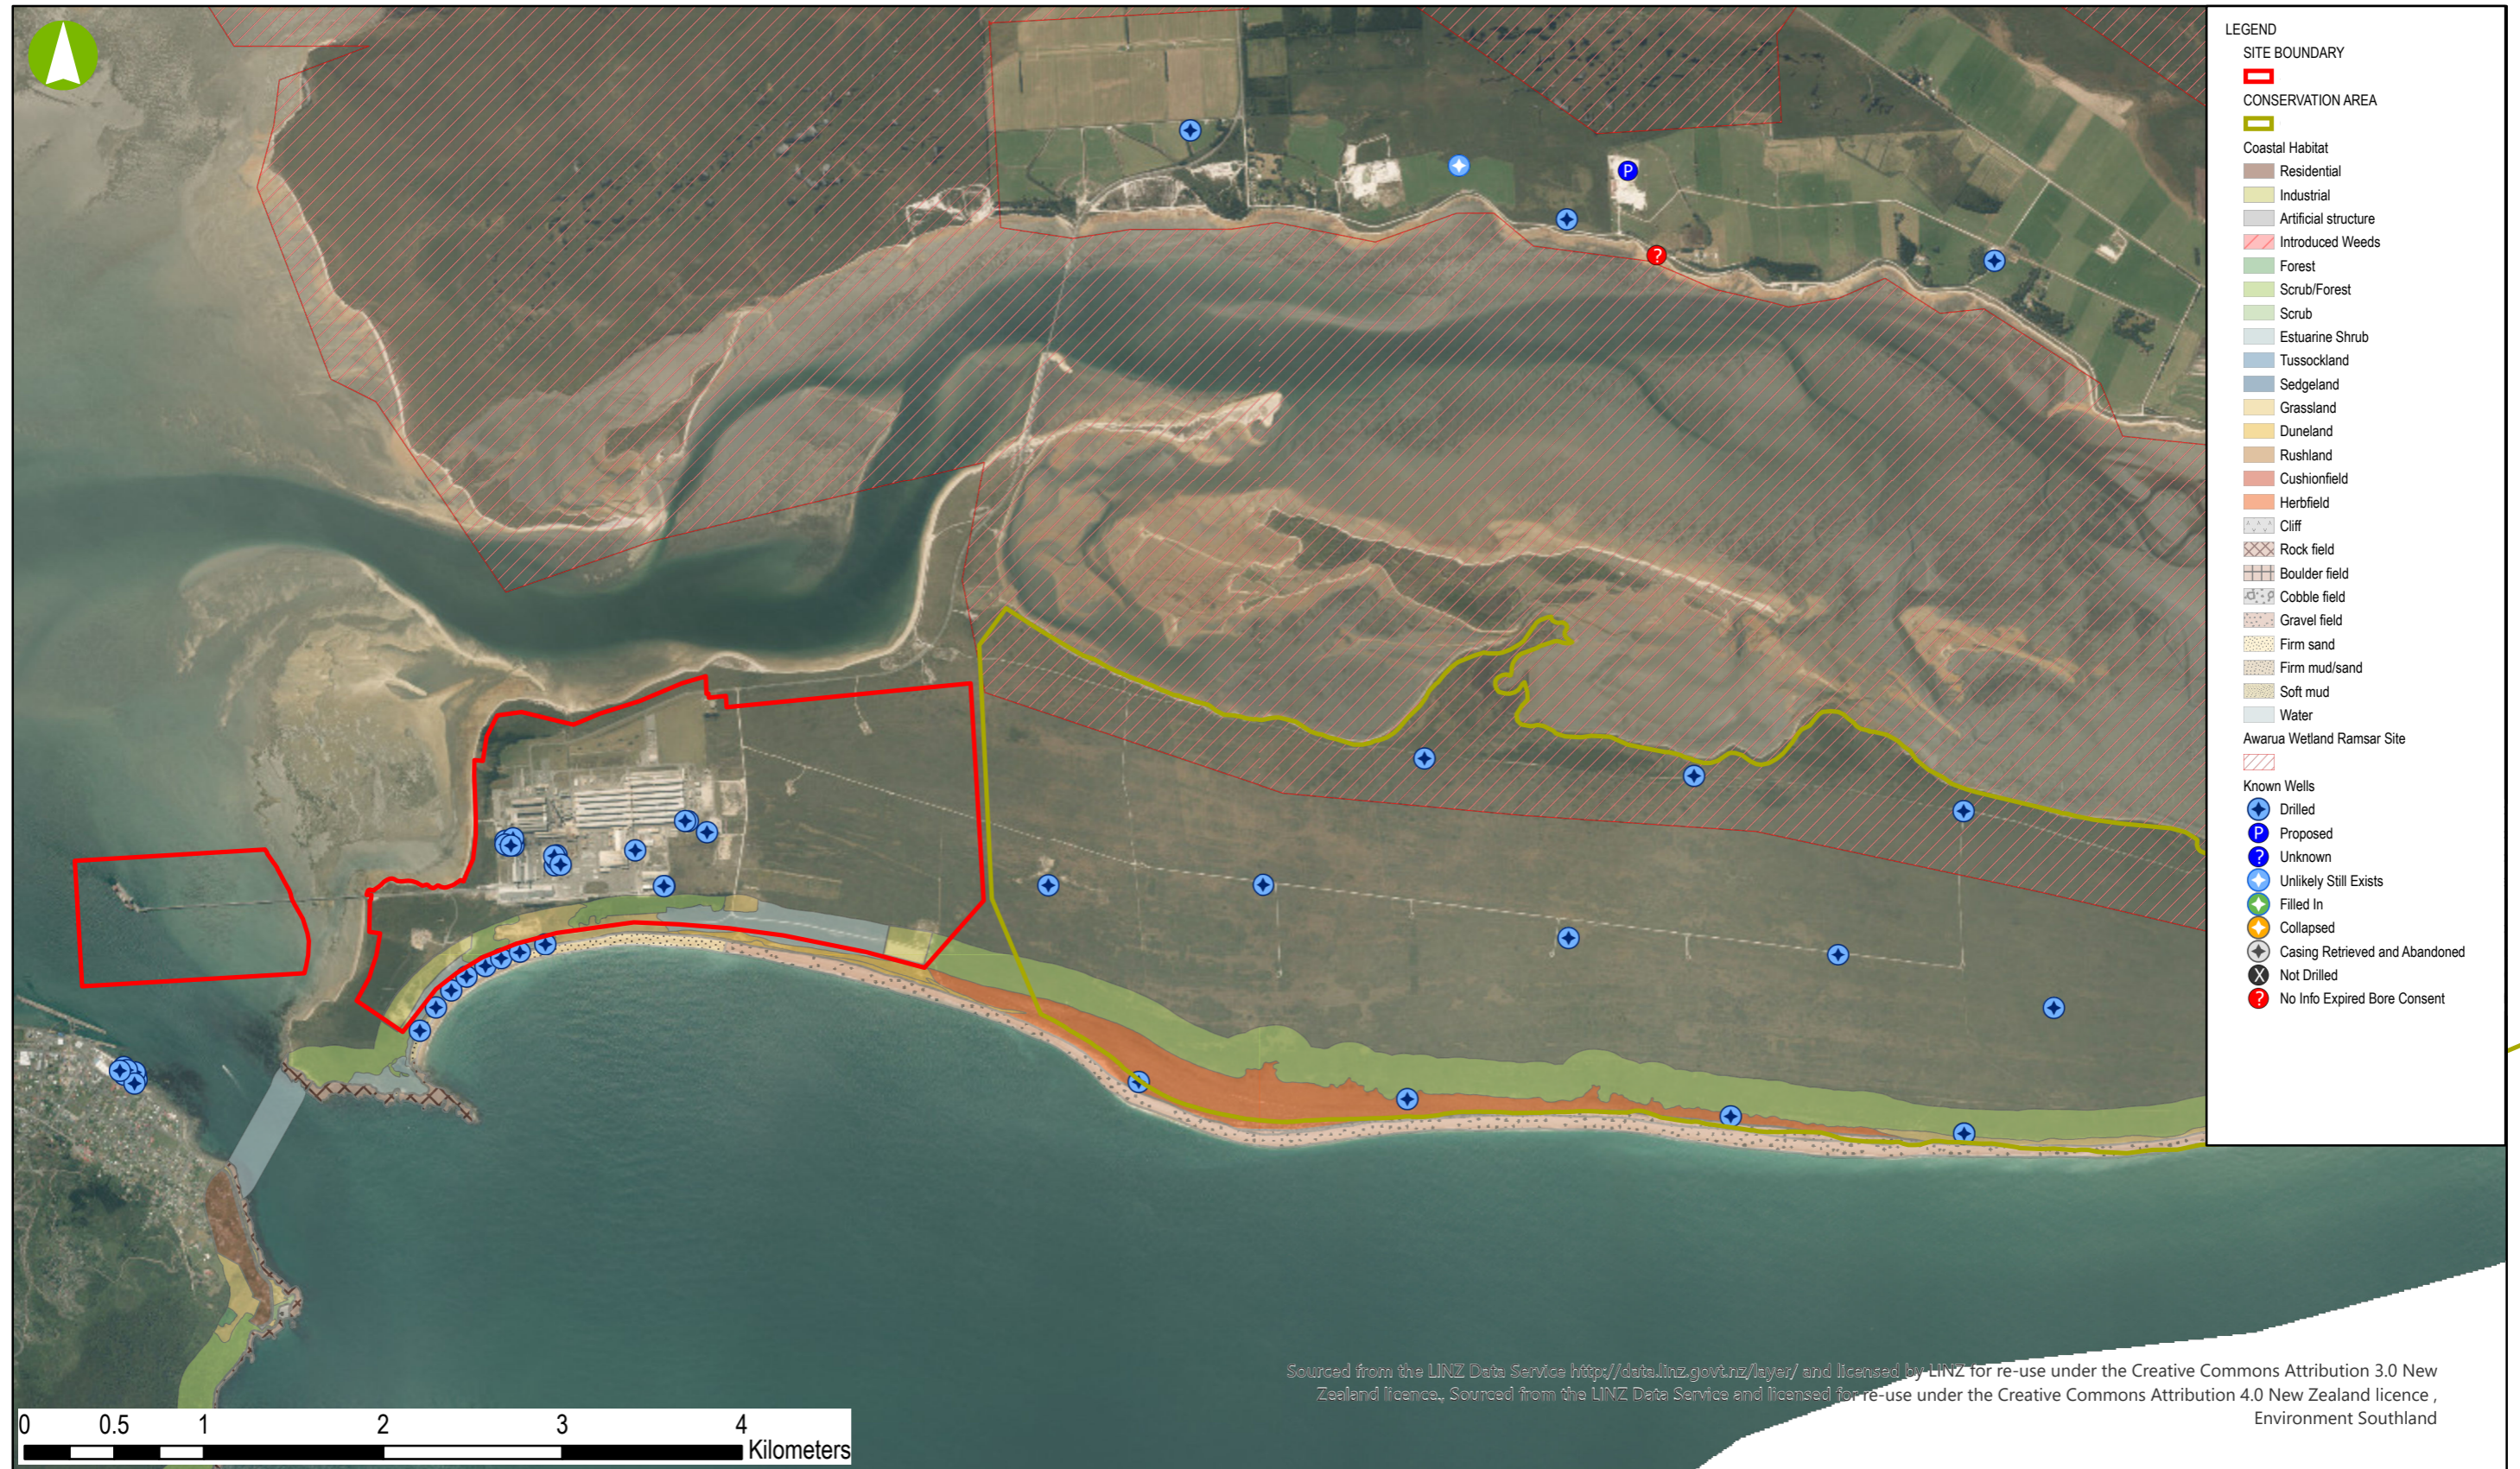
NOTES:
 AREAS OF RZA'S ARE APPROXIMATE AND THE INFORMATION IN THIS DRAWING IS FOR HIGH LEVEL DECISION MAKING ONLY. BOUNDARIES ARE APPROXIMATE AND SHOULD BE SET OUT BY A LICENSED CADASTRAL SURVEYOR. AERIAL IMAGERY SOURCED FROM INVERCARGILL CITY COUNCIL, ENVIRONMENT SOUTHLAND REGIONAL COUNCIL AND LINZ DATA SERVICES AND REPRODUCED UNDER THE CREATIVE COMMONS ATTRIBUTION 3.0 NEW ZEALAND LICENSE.

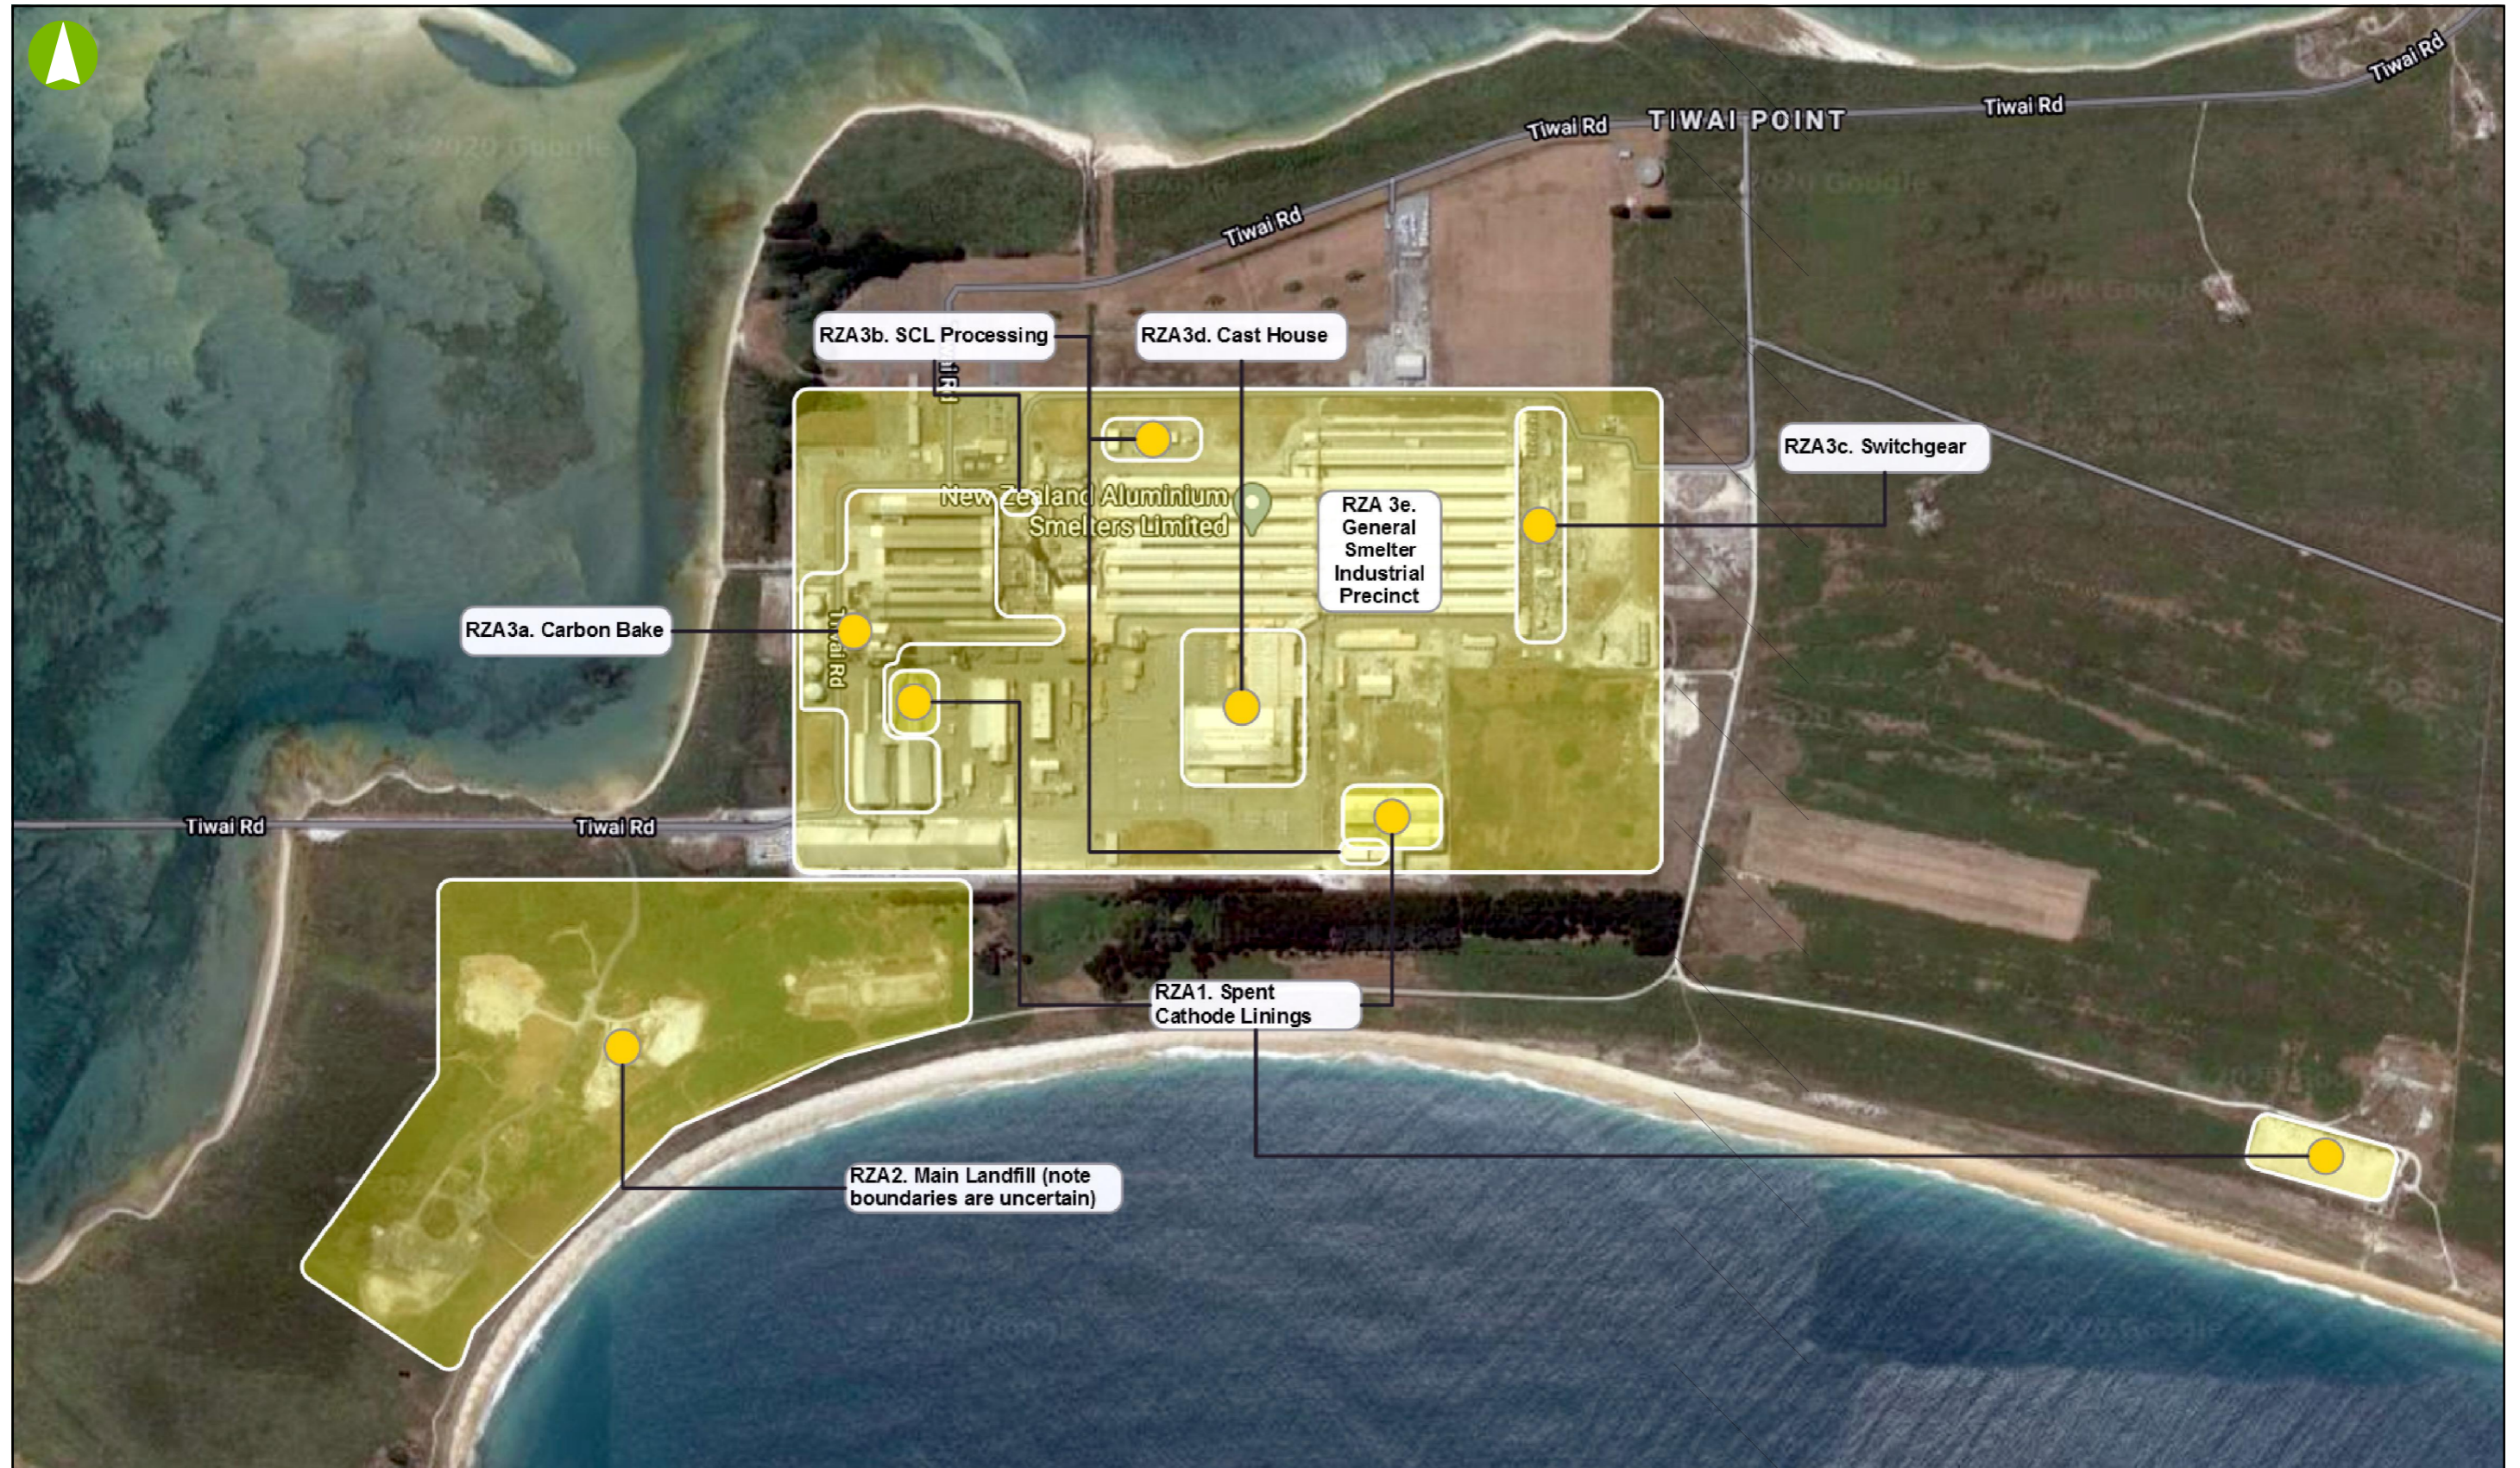
NOTES:
 AREAS OF RZA'S ARE APPROXIMATE AND THE INFORMATION IN THIS DRAWING IS FOR HIGH LEVEL DECISION MAKING ONLY. BOUNDARIES ARE APPROXIMATE AND SHOULD BE SET OUT BY A LICENSED CADASTRAL SURVEYOR. AERIAL IMAGERY SOURCED FROM INVERCARGILL CITY COUNCIL, ENVIRONMENT SOUTHLAND REGIONAL COUNCIL AND LINZ DATA SERVICES AND REPRODUCED UNDER THE CREATIVE COMMONS ATTRIBUTION 3.0 NEW ZEALAND LICENSE.
