## File Note

**Subject:** *New Zealand Aluminium Smelters – Landfill  
Inspection and Closure Plans*

Meeting and audit of the New Zealand Aluminium Smelters Limited Landfill authorised by resource consent 202196 on 16 December 2020 arranged as part of the increased monitoring regime developed in response to the closure announcement.

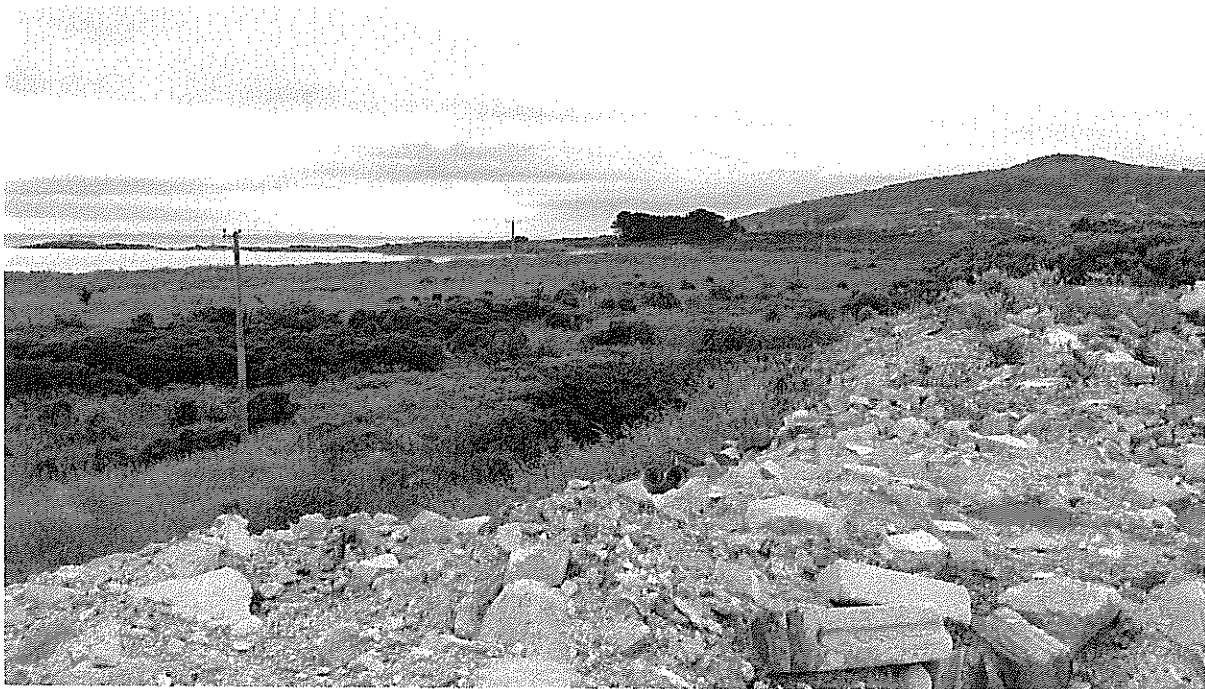
Inspected cleanfill pile and the metal recovery dross cell (currently being mined and processed by Inalco), and refractory bricks.

Figure 1: From cleanfill pile looking towards Tiwai Point

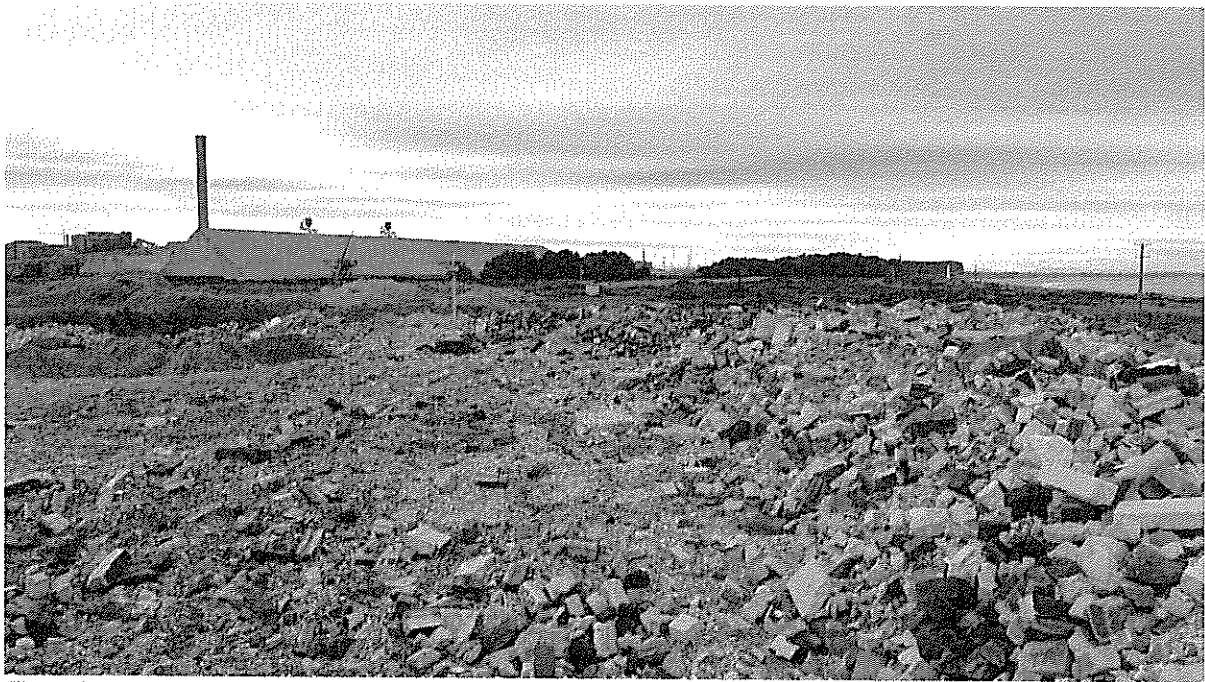
*Figure 2: From cleanfill pile looking east towards the smelter.*

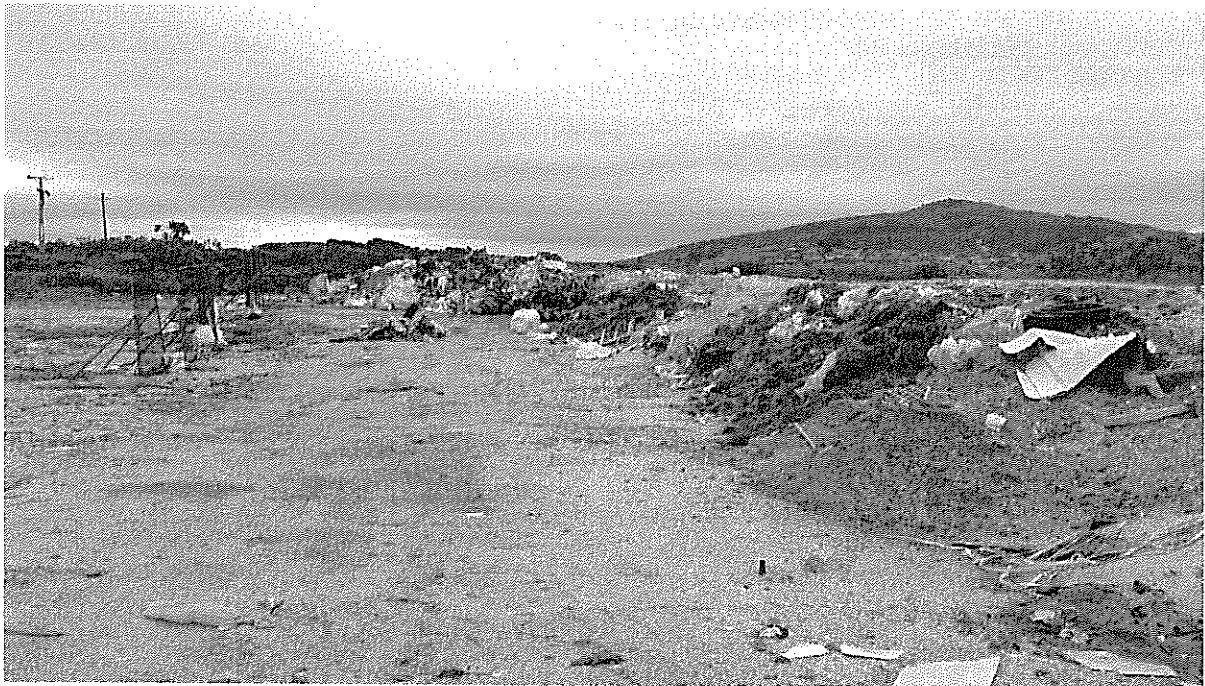
Inspected the general waste pile and the waste carbon pile (spent anode material that could not be reused).

*Figure 3: General waste*

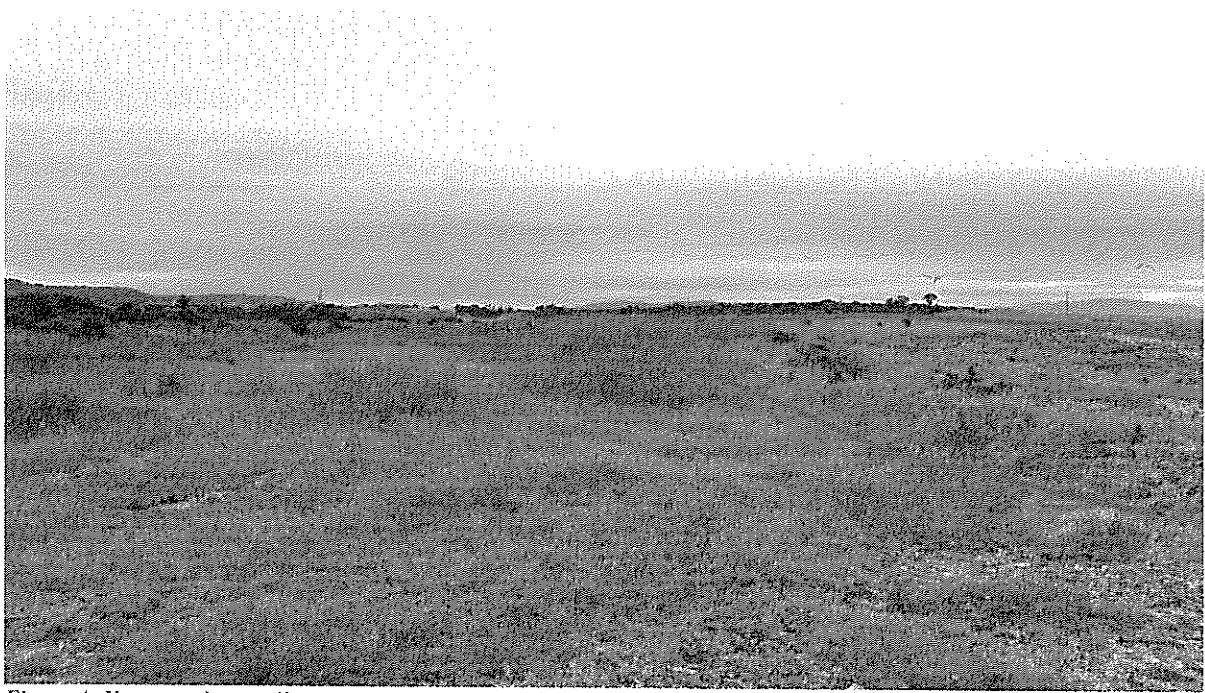
Stopped and looked at the Haysoms dross pile. The capping looked to be intact. The Haysoms dross cell is covered by a geosynthetic textile layer to stop infiltration of rain water, but the base is not lined.

*Figure 4: Haysoms dross cell.*

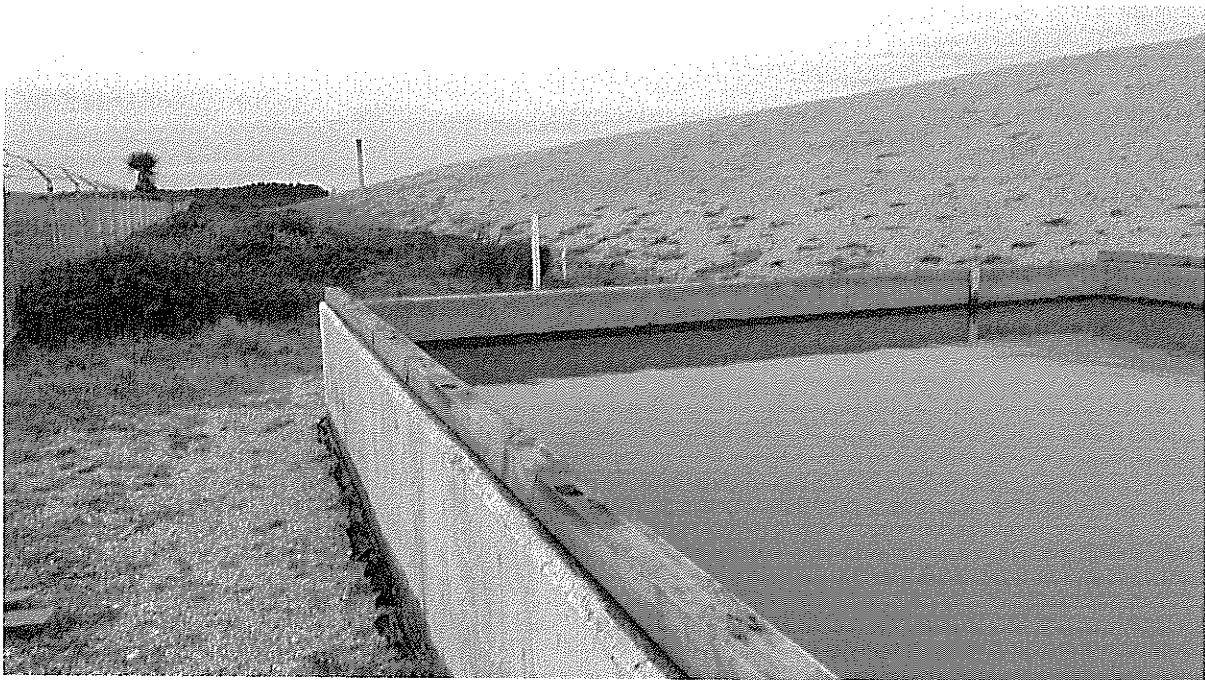
- 1057 Visited the "Cathode Pad". [REDACTED] explained, spent cell liner is produced as part of the process. It can be used as an additive to cement. Currently NZAS pays for this product to be used/disposed of by overseas plants. No spent cell liner is disposed of in New Zealand. Approximately 106kt is stored on the storage pad, while approximately 70kt is stored in storage sheds. The spent cell liner storage sheds have been recently assessed by engineers (last couple of weeks) and it has been determined to be structurally weakened. We were told that the bores that they monitor next to the shed cannot be monitored for a few months while structural strengthening is completed.

*Figure 5: Cathode (SCL) Storage Pad with settling basin in the foreground, during a previous visit – 5 August 2020.*
