REPORT INTO CARDAN SHAFT PARK BRAKES

In-service Testing and Evaluation

WAKA KOTAHI NZ TRANSPORT AGENCY – VEHICLE STANDARDS

MARCH 2021

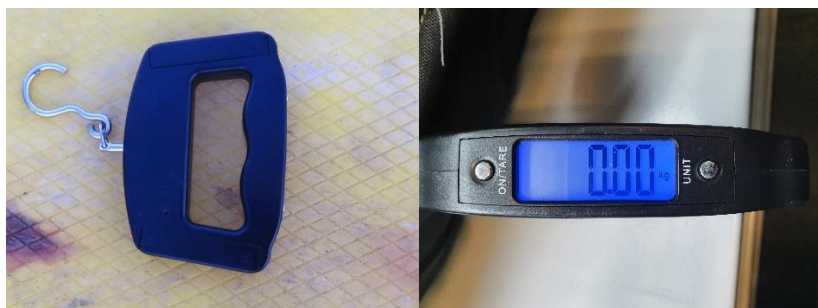
Each vehicle had the park brake applied using a digital scale (Figure 1) to a lever pull force of 15kgf, the number of lever ratchet clicks was recorded, and the vehicle stall tested to simulate a CoF inspection test. Each stall test was done in 3rd gear for manual transmissions and drive for automatic transmissions, although it must be noted the engine cannot be stalled because of torque converter slippage.

Figure 1: Components of the digital scale used during testing

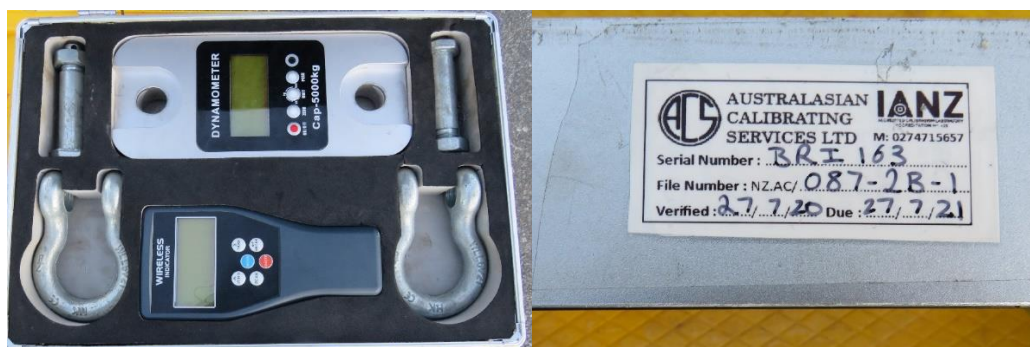
Once the stall test had been completed the vehicle was attached to an anchor vehicle and the pull force was applied to see if the CSB could withstand the pull applied equivalent to being placed on a 18% slope with the brake applied. The vehicle was connected by 3000kg rated webbing straps through a calibrated digital 5000kg rated load cell (Figure 2) to a 5000kg hand winch so load could be applied (Figure 3) and tabulated.

Figure 2: Load cell used for testing

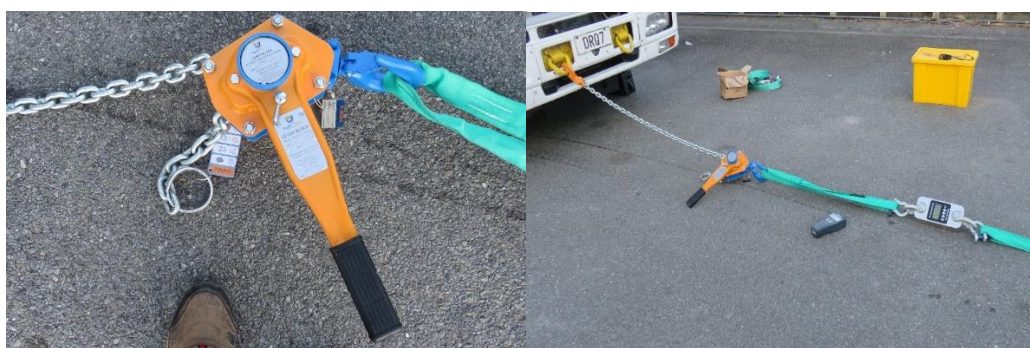
Figure 3: Hand winch used for testing

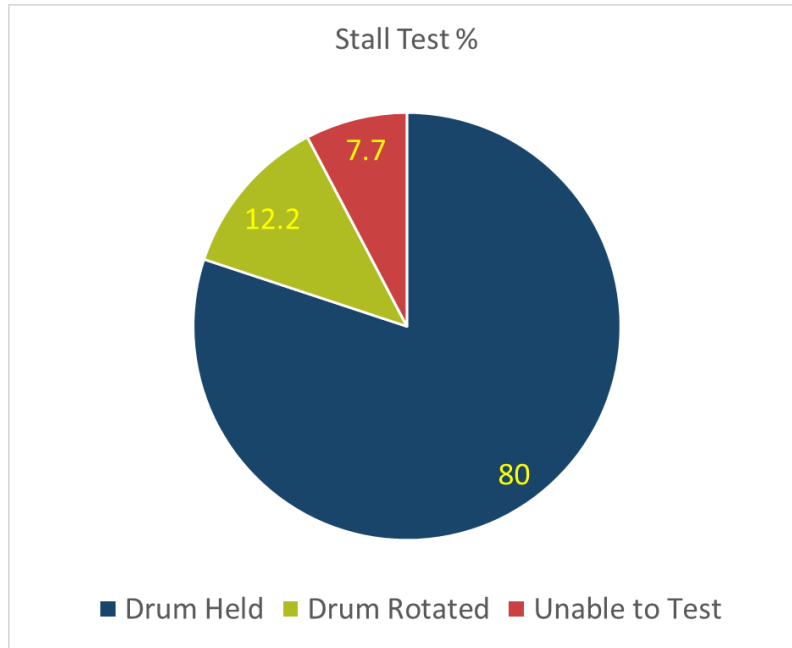
Stall Test in Detail

The first series of tests was to carry a stall test at a specified figure, based on an average person's application of the lever, a force of 15kgf was placed perpendicular to and at 50mm from the head of the park brake lever and the number of ratchet clicks counted. The chart below plots the percentage of vehicles where the drum held stationary (passed), drum rotated (failed) and those unable to be stalled due to an automatic or automated manual transmission being fitted.

- All vehicles with manual transmissions were tested in 3rd gear
- The average travel of the park brake lever was 7.6 clicks of the ratchet to achieve the 15kgf
- The lowest number of clicks was 3
- The highest number of clicks was 18
- The highest lever force was 48kgf (vehicle did not hold)

When comparing the stall test against the first pull tests in either direction using the same lever settings the results showed the pull test kgf figure was very low. In 69 (76%) of the 90 vehicles tested the figures show less than half of the pull force required to hold the vehicle on a 1-5 gradient was produced.

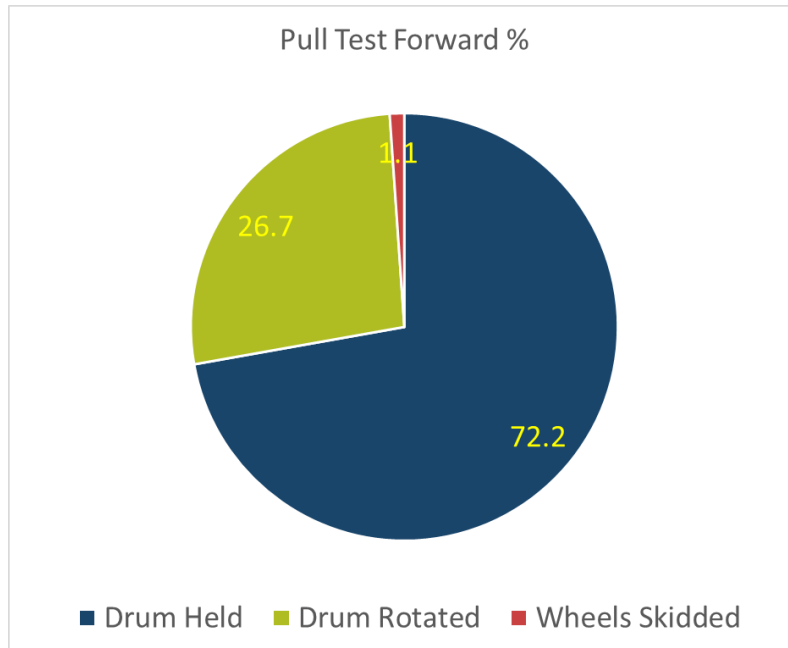
Pull Test Forward in Detail

The second series of tests simulated the holding power of the brake with the vehicle being pull tested in a forward direction (downhill if placed on a 18% slope), the target pull force represented 20% of the vehicles GVM. The base starting point was the same as used for the stall test, if the park brake drum rotated the force on the lever was increased and each additional click of the ratchet was recorded until the “drum held”. If the drum did not hold at a total of 5 extra lever clicks or when a maximum of 50kgf was applied to the lever, the test was stopped, and the result recorded as “drum rotated”. The chart below plots the percentage of vehicles where the drum held stationary or the drum rotated.

The target pull force was not met by 25 of the 90 vehicles (26.7%) and of the 64 (72.2%) vehicles where the park brake has held 25 (39%) required more than 3 extra clicks of the lever and 15 (23%) required more than the average lever force.

- The highest lever travel was 22 clicks
- The highest lever force was 50+kgf
- 1 (1.1%) vehicle met the target pull force at the same setting as the stall test
- 16 (17.7%) vehicles met the target pull force at 1 extra click
- 22 (24.4%) vehicles met the target pull force at 2 extra clicks
- 23 (25.5%) vehicles met the target pull force at 3 extra clicks
- 1 (1.1%) vehicle failed to develop any pull force at full lever travel

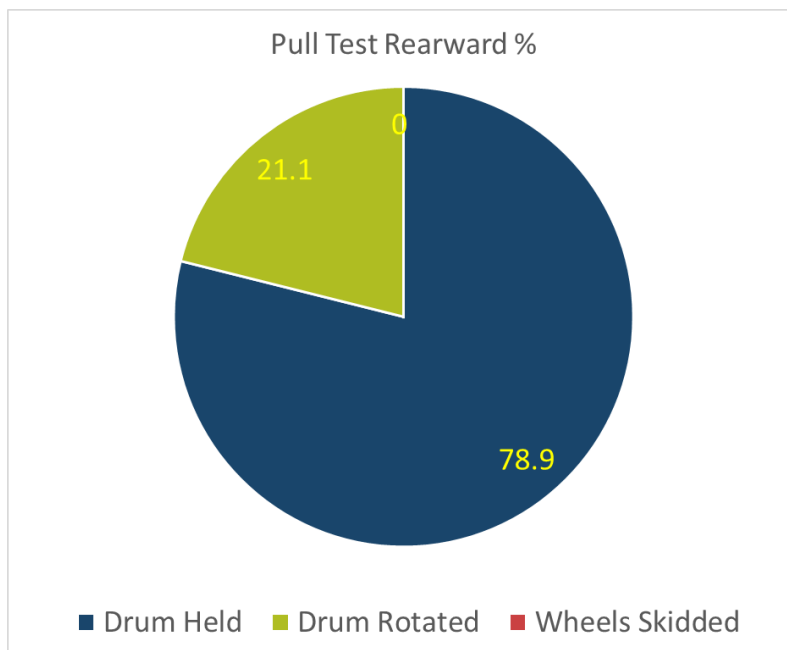
Pull Test Rearward in Detail

The third series of tests was to simulate the holding power of the brake with the vehicle being pull tested in a rearward direction (downhill if placed on a 18% slope), the target pull force represented 20% of the vehicles GVM. The base starting point was the same as used for the stall test, if the park brake drum rotated the force on the lever was increased and each additional click of the ratchet was recorded until the “drum held”. If the drum did not hold at a total of 5 extra lever clicks or with a maximum of 50kgf applied, the test was stopped, and the result recorded as “drum rotated”. The chart below plots the percentage of vehicles where the drum held stationary or the drum rotated.

The target pull force was not met by 19 of the 90 vehicles (21.1%) and of the 71 (78.9%) vehicles where the park brake has held 29 (40.8%) required more than 3 extra clicks of the lever and 16 (22.5%) required more than the average lever force.

- The highest lever travel was 22 clicks
- The highest lever force was 50+kgf
- 5 (5.5%) vehicles met the target pull force at the same setting as the stall test
- 15 (16.6%) vehicles met the target pull force at 1 extra click
- 15 (16.6%) vehicles met the target pull force at 2 extra clicks
- 24 (26.6%) vehicles met the target pull force at 3 extra clicks
- 1 (1.1%) vehicle failed to develop any pull force at full lever travel

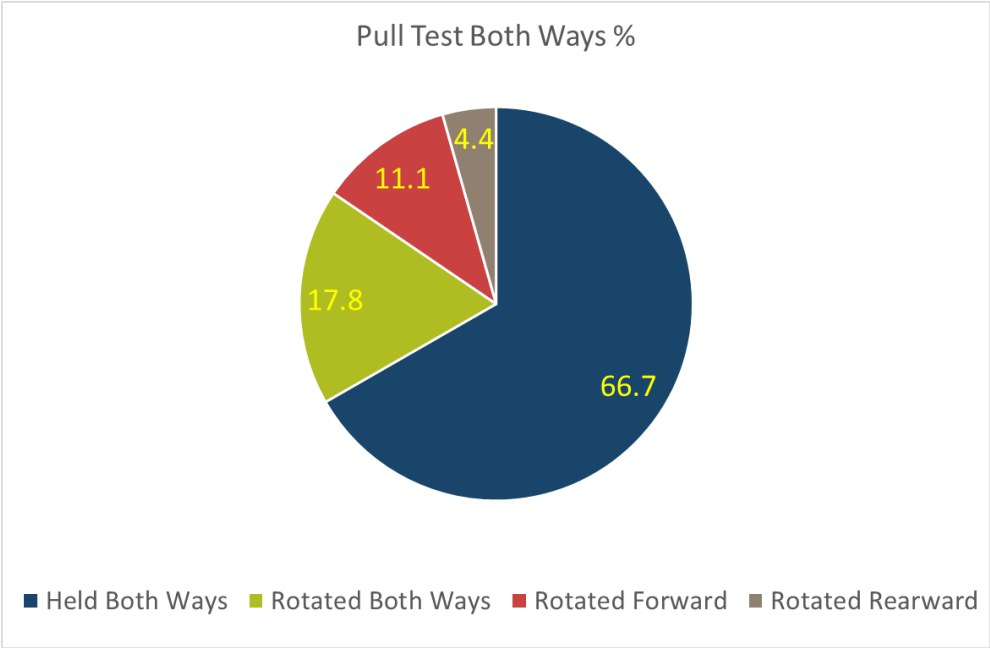
Pull Test - Both Directions in Detail

The target pull force in both directions was achieved by 60 (66.7%) vehicles, while 10 (11.1%) did not hold in the forward direction and 4 (4.5%) did not hold in the rearward direction. The target pull force in both directions was not met by 16 of the 90 vehicles (17.8%).

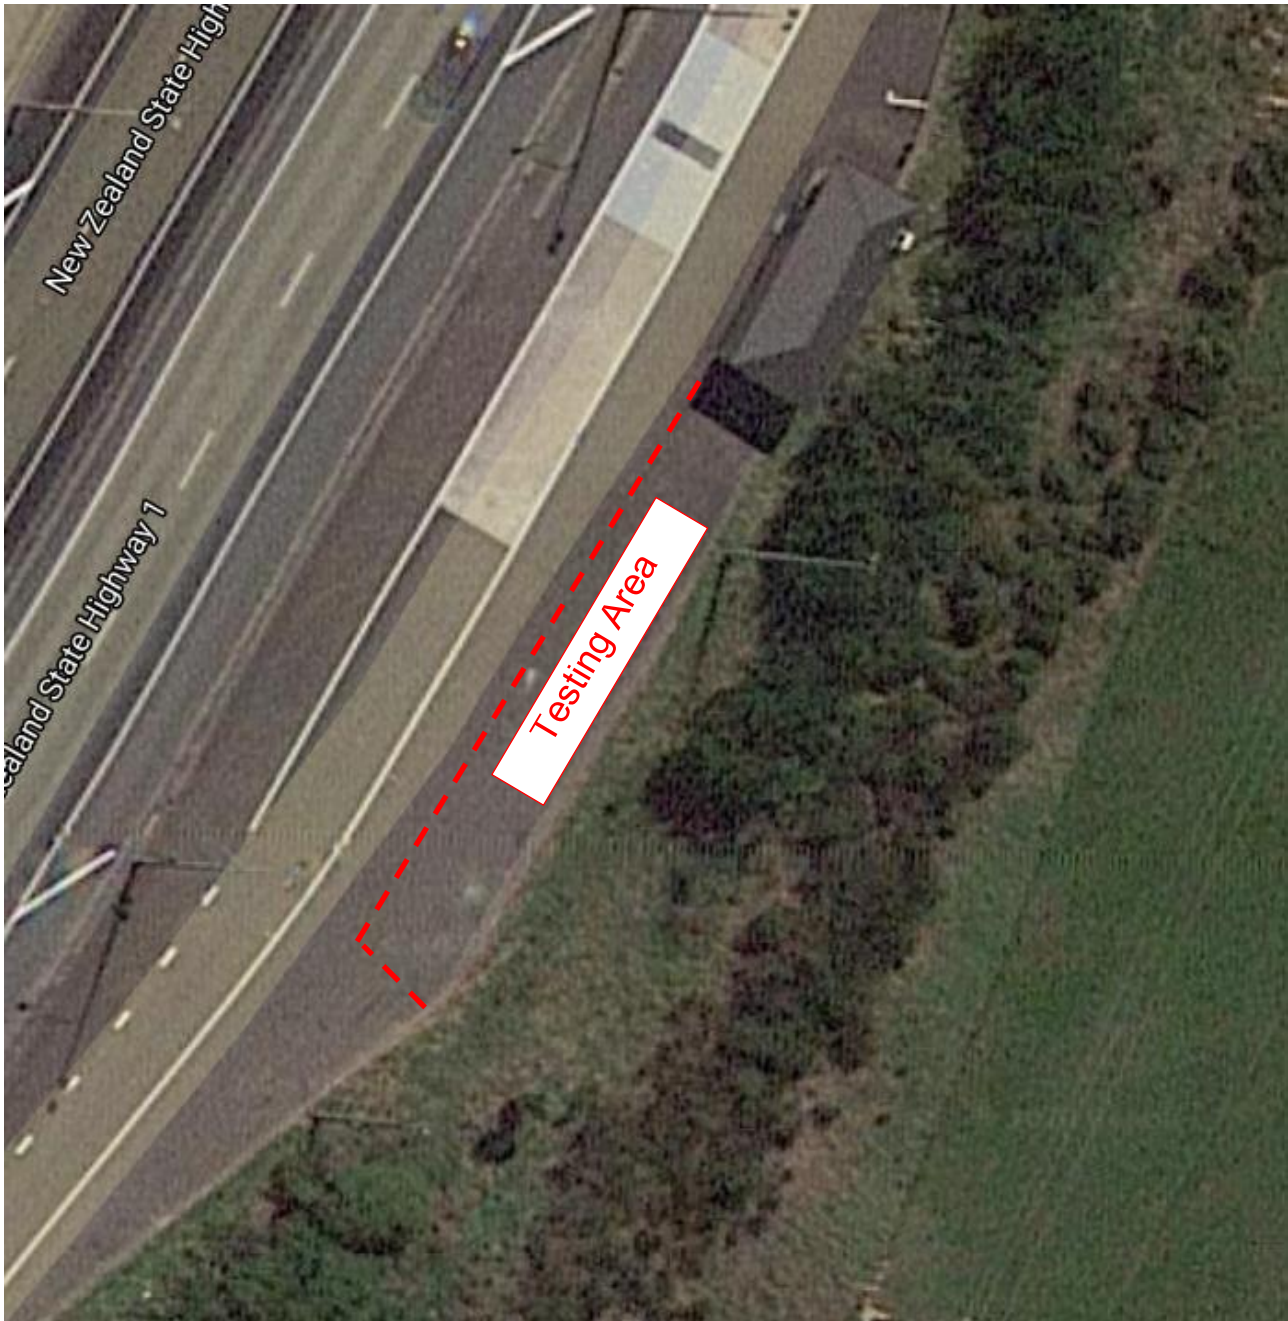
2. Southbound

900mm road cones are to be placed at 2mtr intervals, extending southward from the Commercial Vehicle Safety Centre building, to a point approx. 5mtrs past the light pole, entrance and exit to be controlled by removing and replacing cones as required.
