**Ruapehu District Council**  
RB292 Mangateitei Road Rail Overbridge  
Detailed Investigation and Posting Evaluation

April 2021

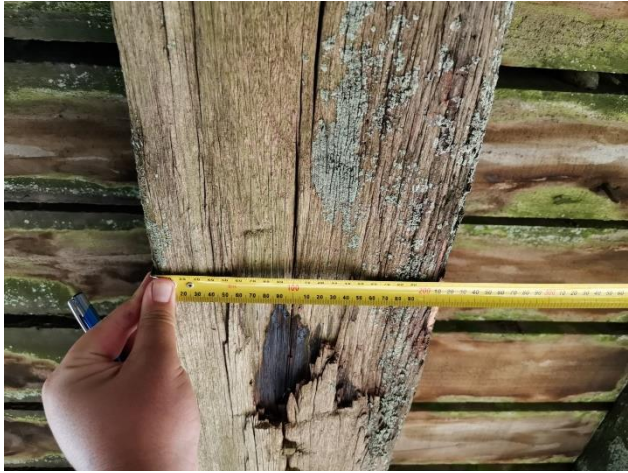
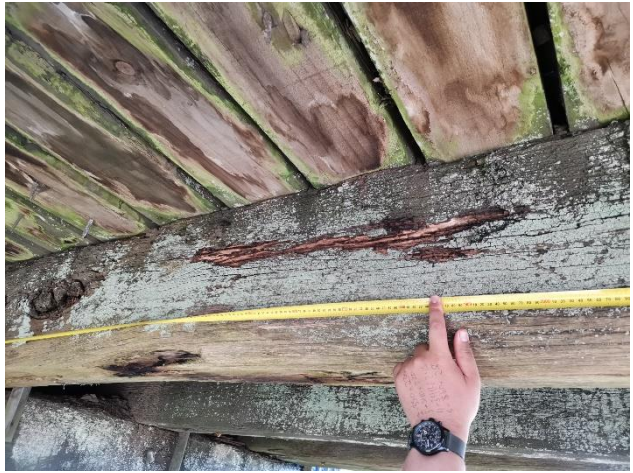
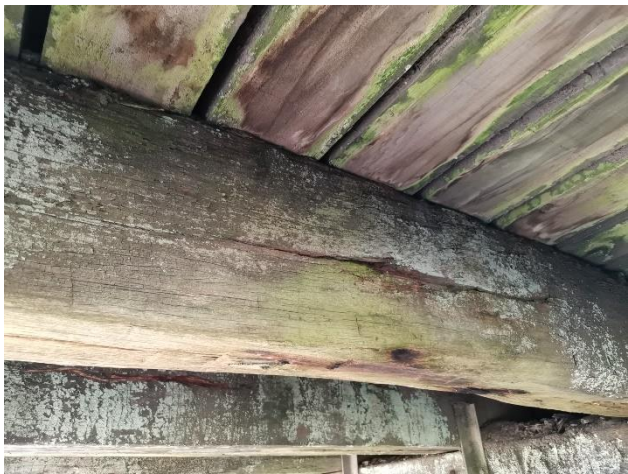
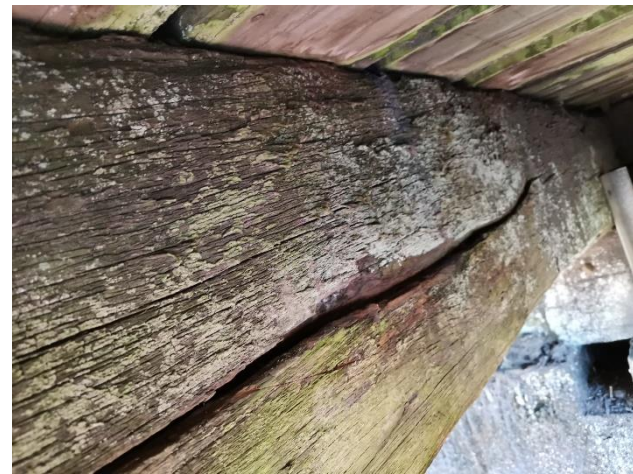
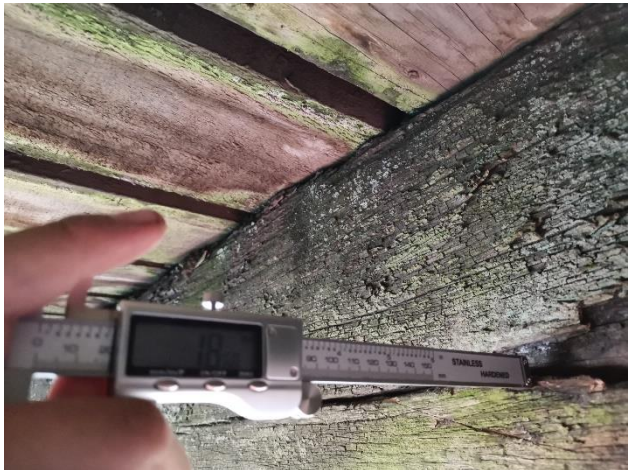
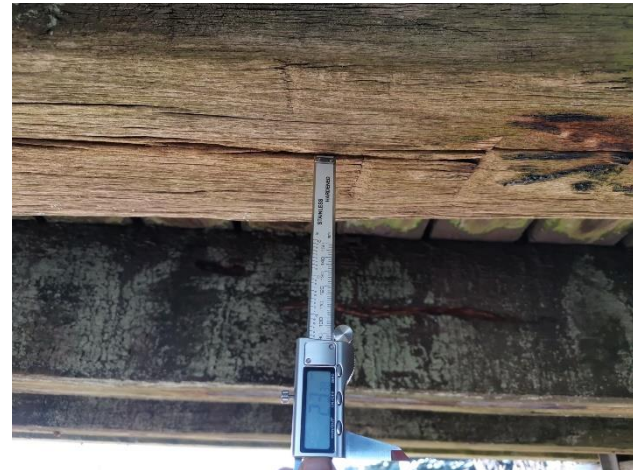
**Figure 3 Timber Stringer No. 3 Defects**

The stringers have deterioration as cracking and timber decay are primarily recorded on them. At Span 3; timber stringers No. 3 and 4 were recorded as the most deteriorated with cracks and timber decay.

On both faces of Stringer No. 3, a longitudinal crack of approximately 1 m long and 18 mm deep was observed roughly at 1.7 m from the Abutment support and about 150 mm from the top of the stringer. Also, extensive cracking was observed in the soffit, with variable depths and lengths. Refer to Figure 3 below.

From the investigation conducted, replacing the bridge is recommended, as the existing bridge is all comprised of timber and repairing or replacing the timbers is not recommended. The only way forward by maintaining the existing bridge is to replace individual elements and to keep it a three-span bridge which will be more expensive, where the new piers will require pier protection works, and the level of the road will need to be raised at least another 1 metre to meet Kiwirail clearances. This clearance requirement is similar for both renewal and replacing of elements.

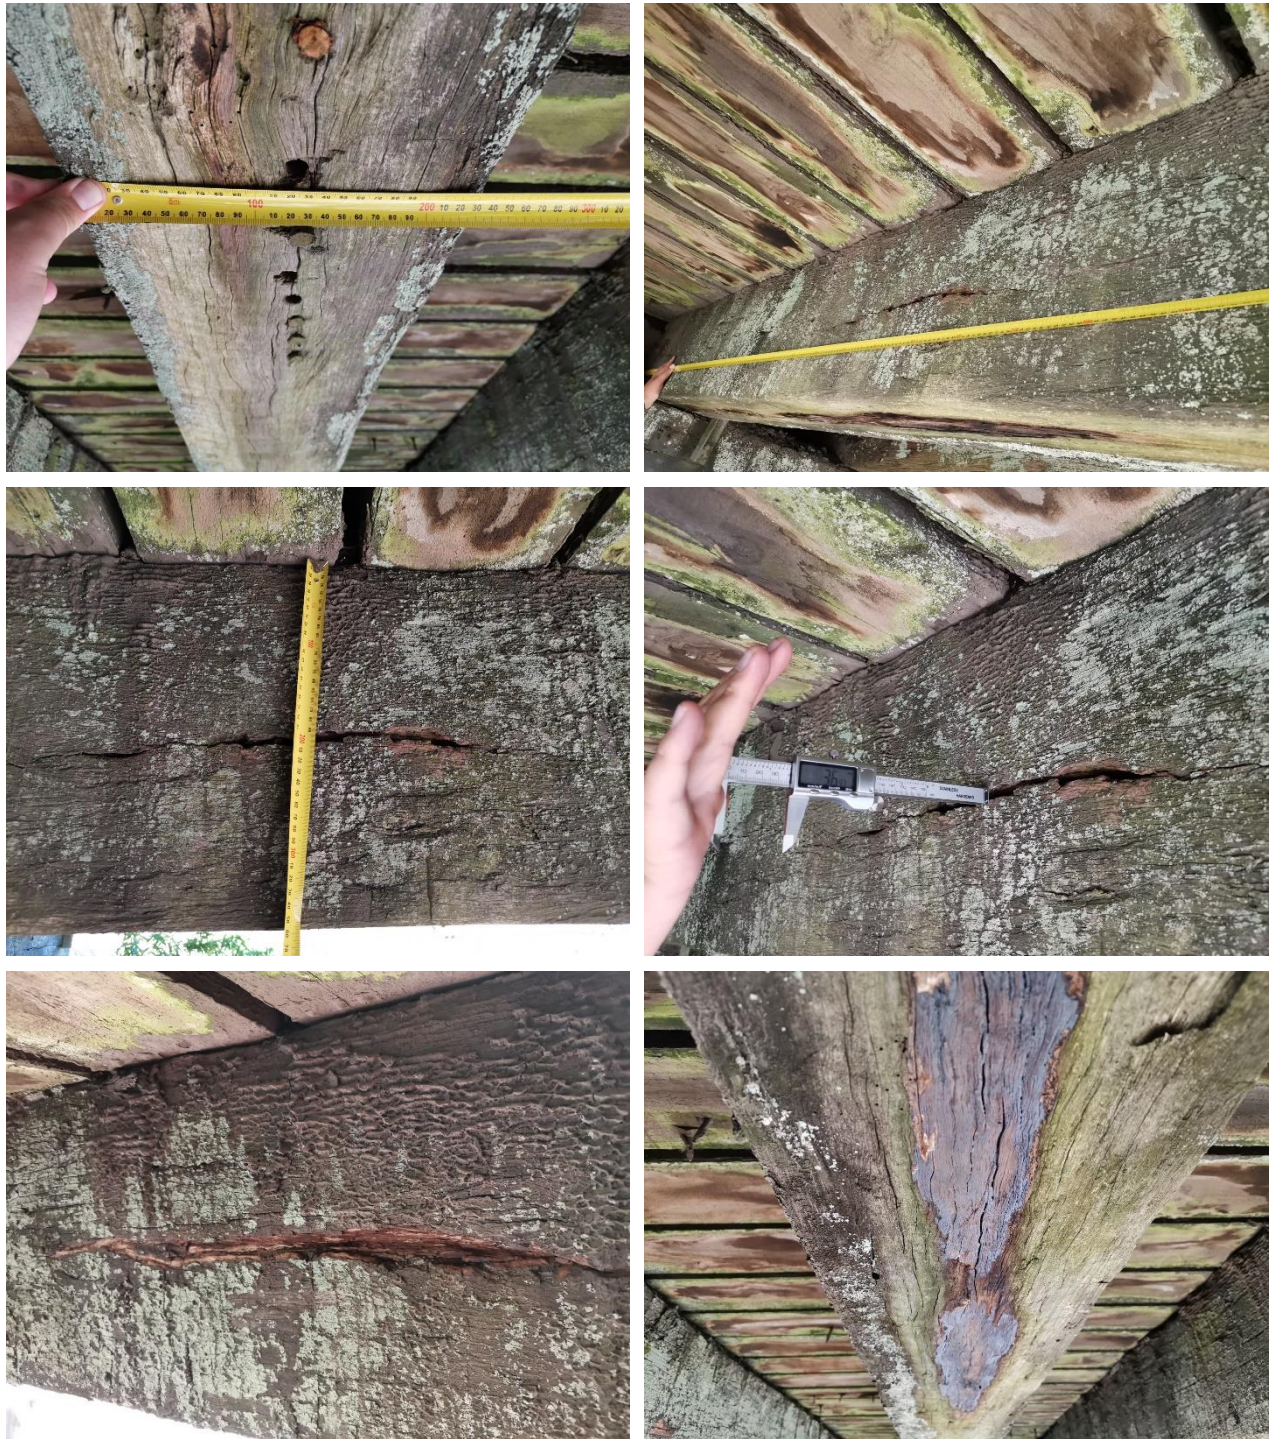
**Figure 4 Timber Stringer No. 4 Defects**

On both faces of Stringer No. 4, a longitudinal crack of approximately 0.8 m long and 36 mm deep was observed roughly at 1.9 m from the Abutment support and about 200 mm from the top of the stringer. Refer to Figure 4 below.

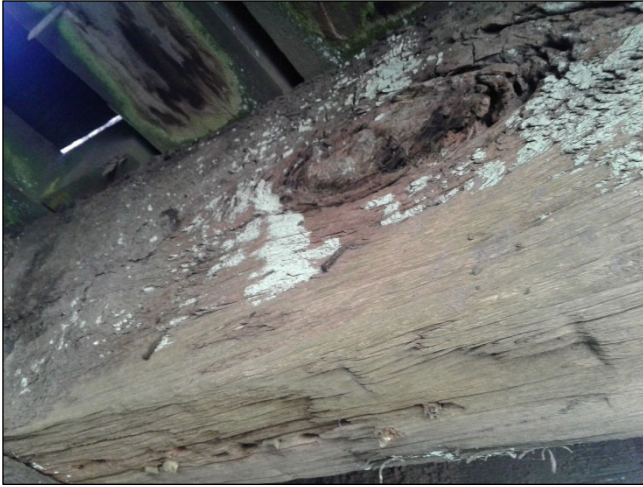
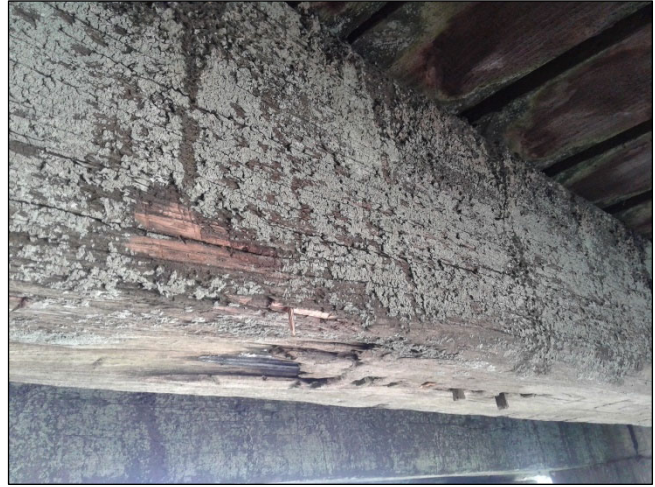
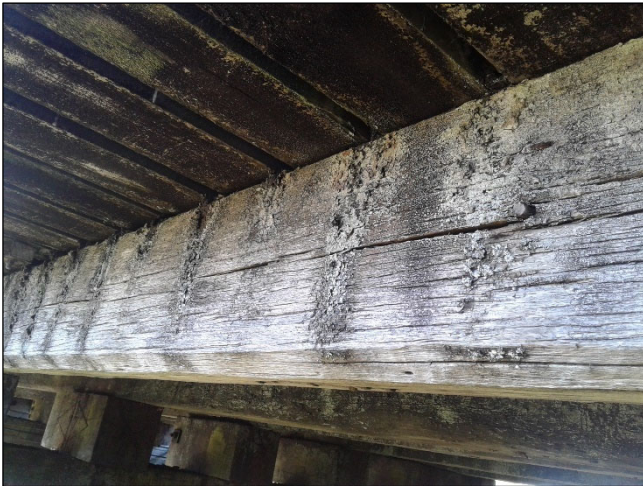
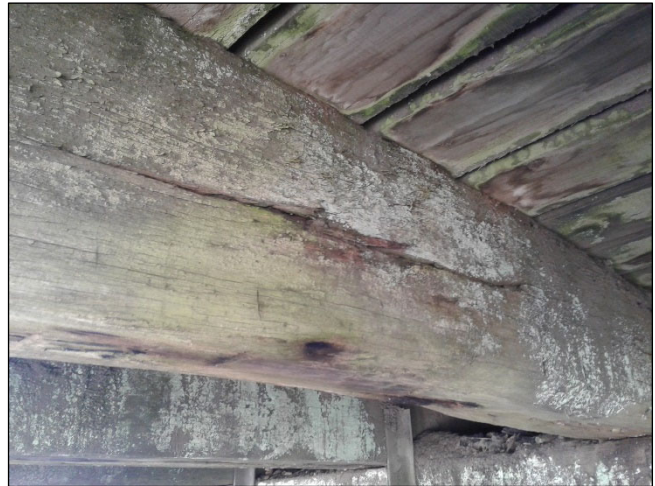
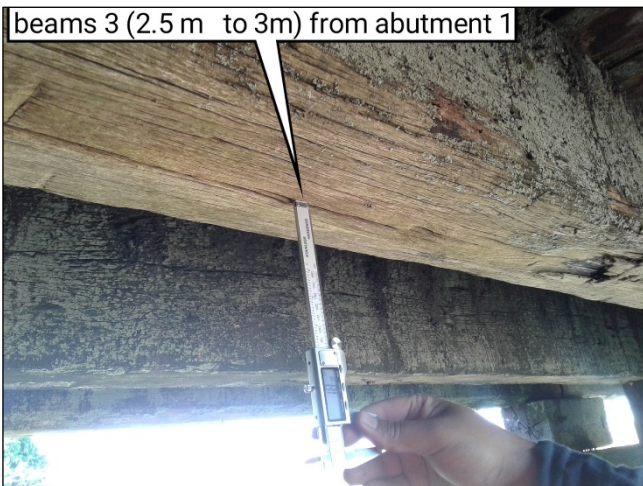
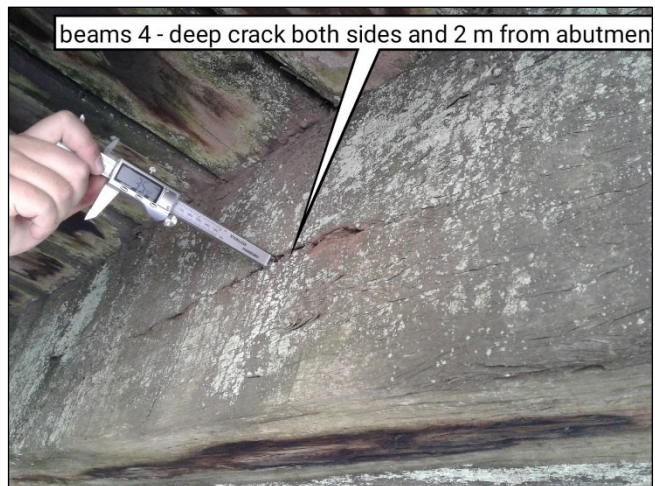
**1 : Primary load carrying element**

Timber Decay (main stringers old, cracks and decayed. Also peppered with core holes, SRF less than 0.80. Beam 3 & 4 severe weathering near abutment 1)

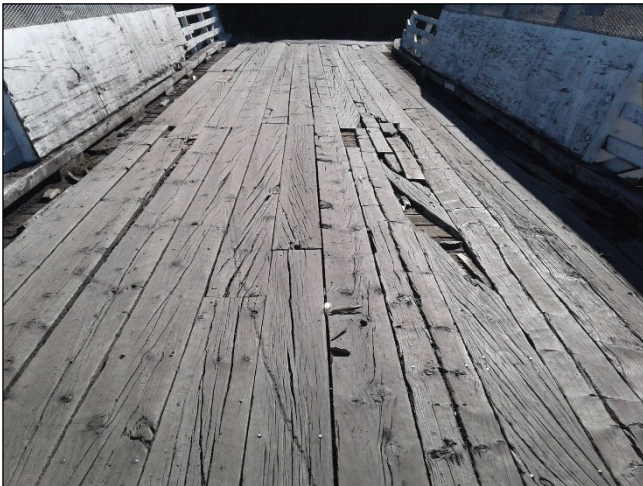
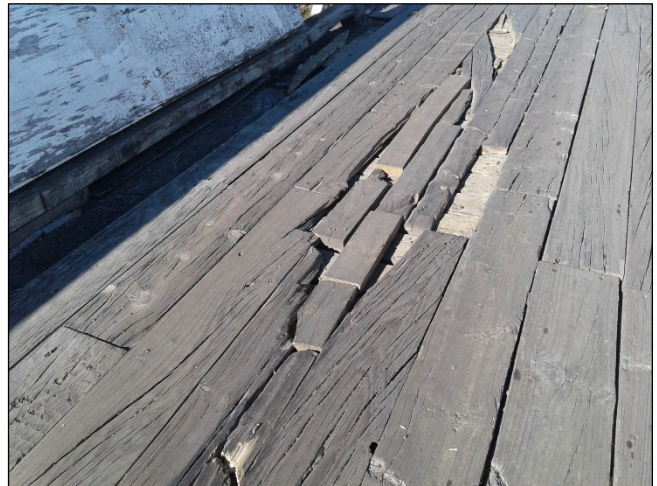
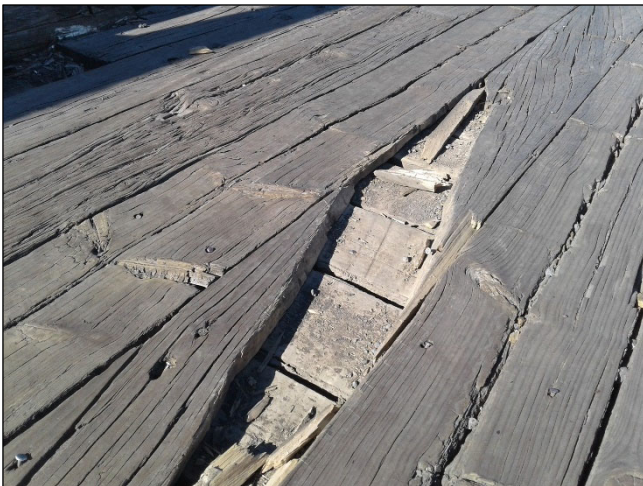
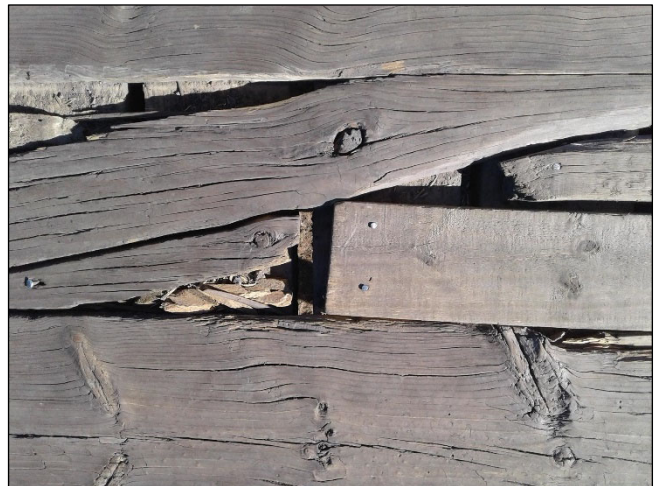
**3 : Secondary - Other (incl. deck)**

Broken Running boards (running boards badly worn)

Broken Cross beams North (timber decking requires urgent replacement near abutment 1)

2.	3	Replace (running board and first couple timber cross timber boards on approach North)	H	\$15,000 - \$20,000
3.	6	Replace (broken kerbs - 4 off)	M	\$7,500 - \$10,000

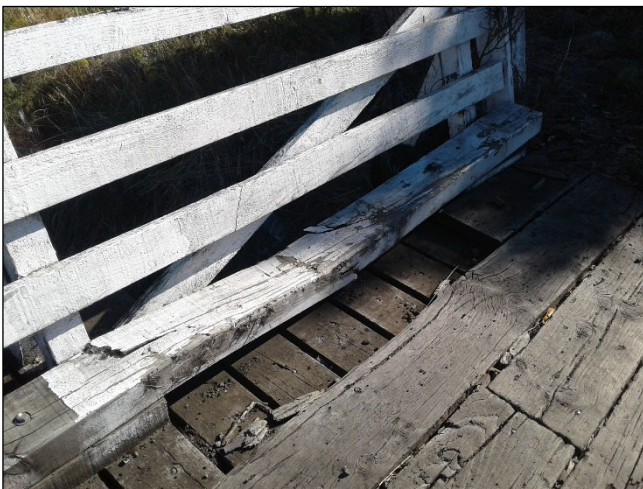
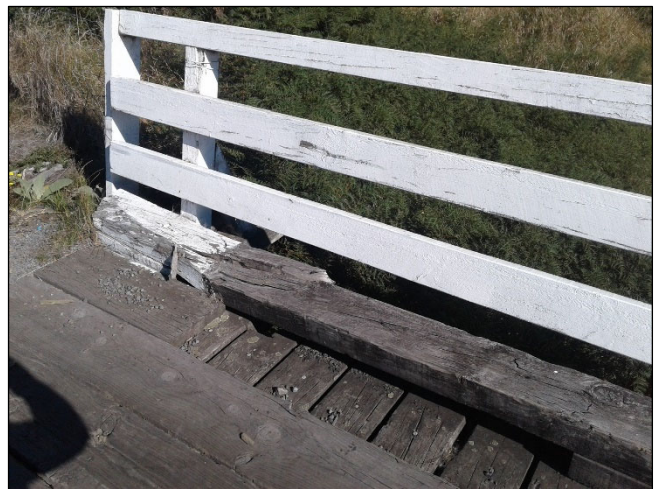
**6 : Parapet beam or cantilever**

Broken Kerbs

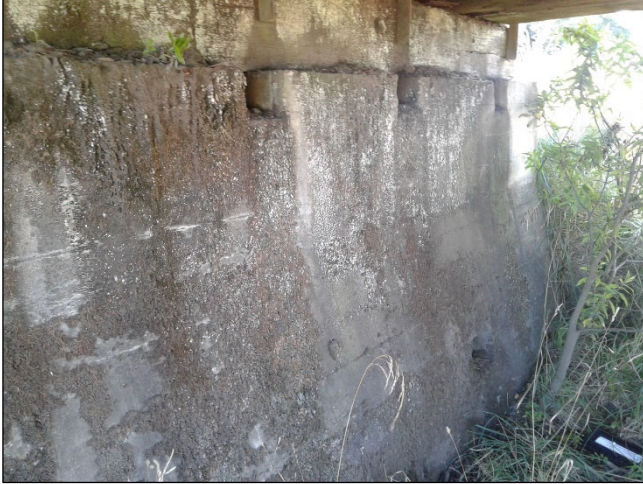
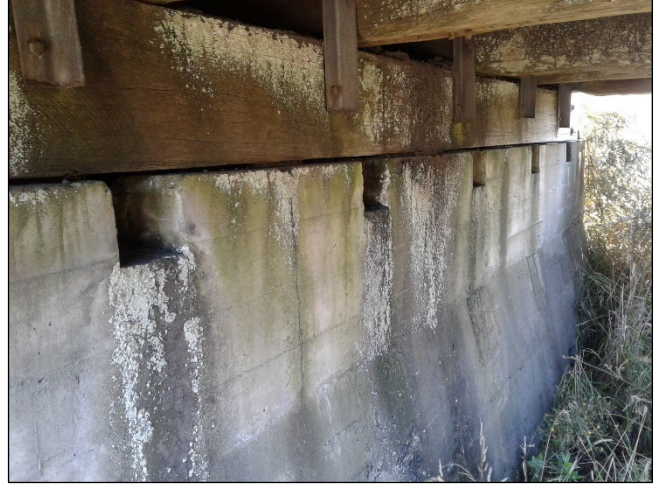
**9 : Abutments**

Lichen / Moss / Vegetation Abutment (lichen covering concrete surface)

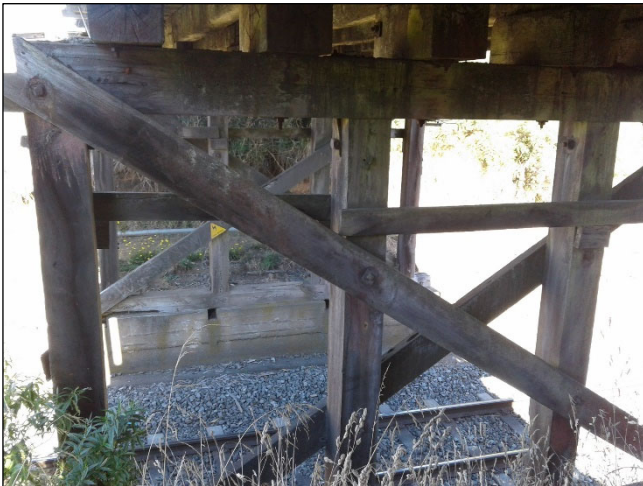
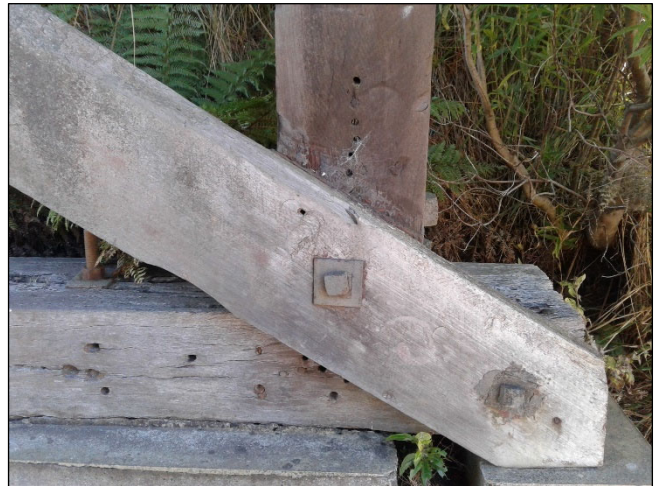
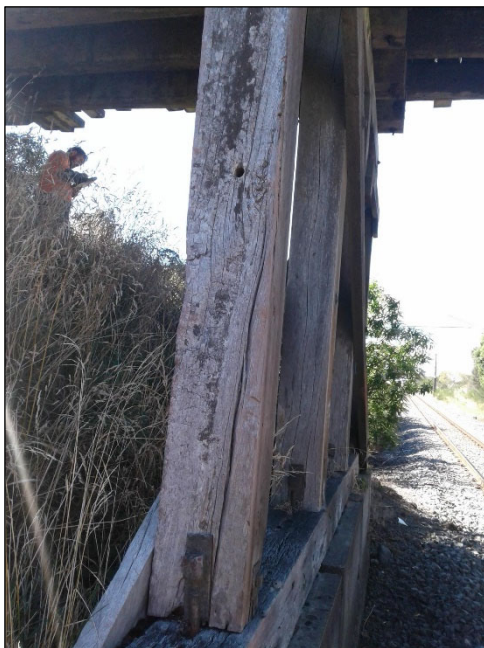
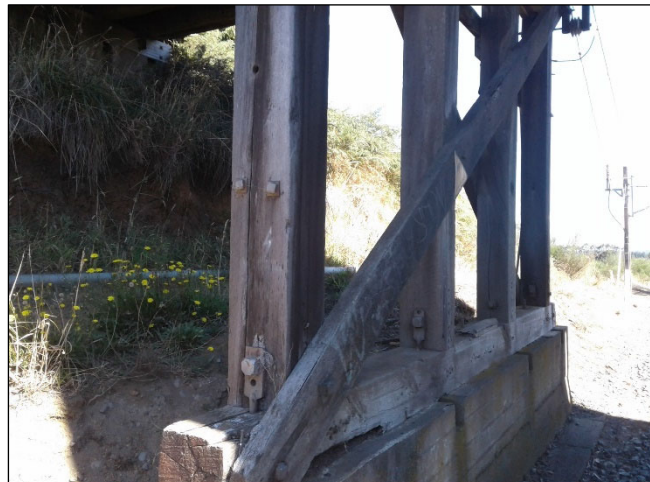
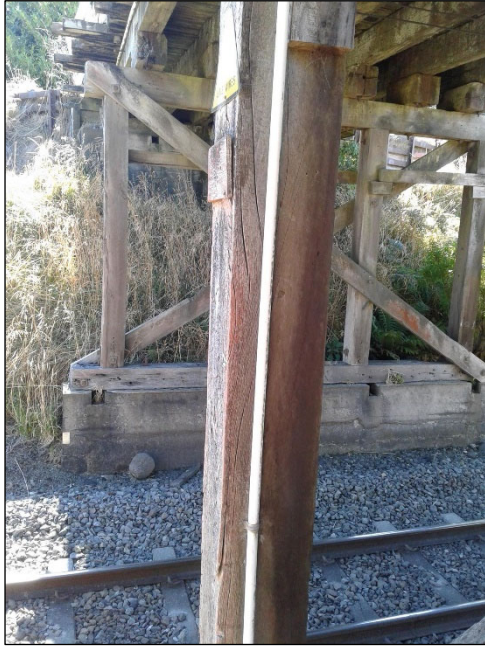
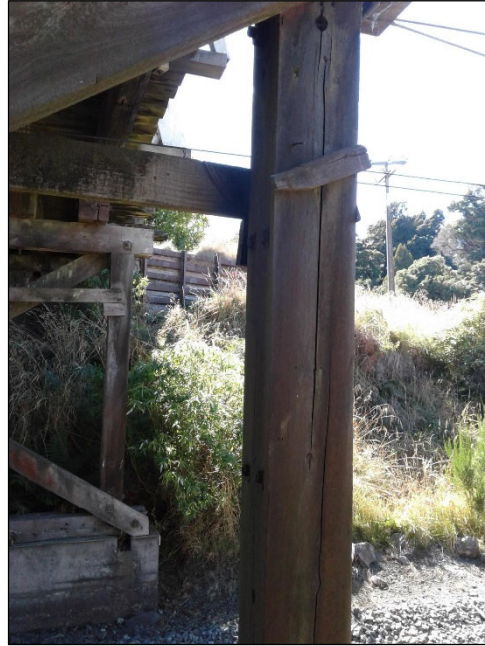
**11 : Pier / column**

Aged Pier (columns deteriorate / split "decayed" which in some cases have been bolted - SRF=0.80)

pier 2 - column 1 (transverse direction)

pier 2 - column 1 (longitudinal direction)

4.	11,12	Monitor (pier columns, capping beams and cobbles - no change from previous inspection)	H	
5.	22	Tighten Bolts (re-nail, brace cracked timbers and fix loose handrails)	M	\$5,000 - \$7,500

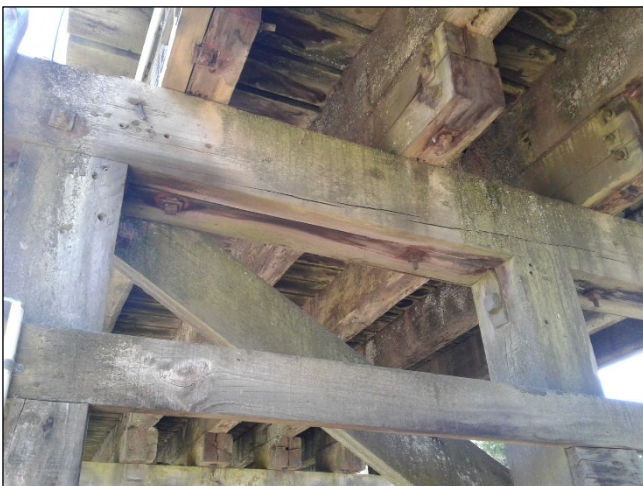
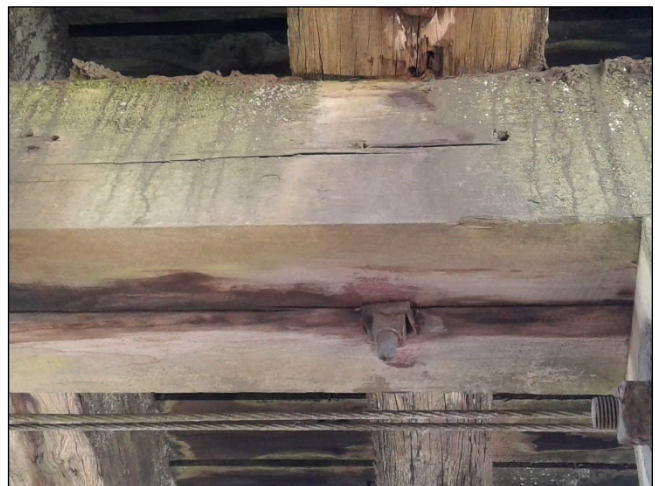
**12 : Cross-head / capping beam**

Crack Pier Capping beam/bearing plinth (cross head longitudinal cracks/ splitting)  
Crack Pier (corbels show significant splitting/ cracking)

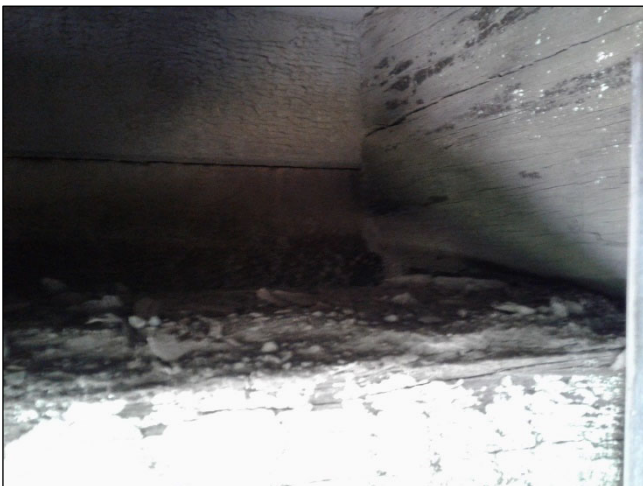
**14 : Bearing plinth / shelf**

Debris Abutment bearing plinth

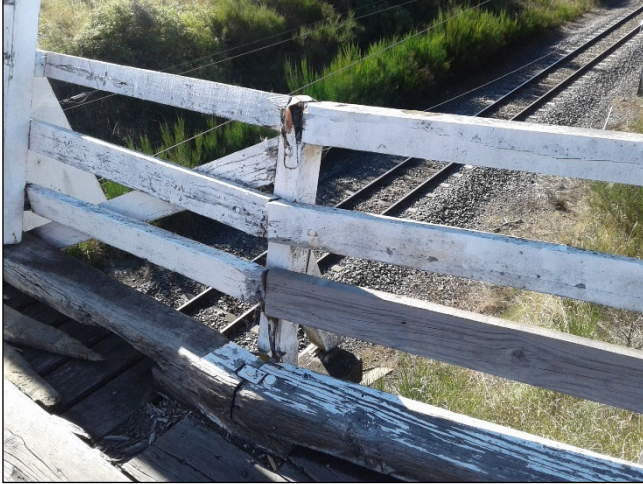
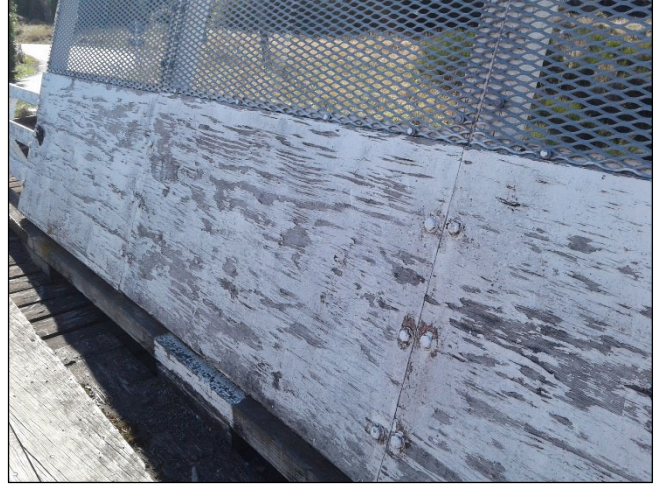
**20 : Painting : Barriers / guardrails**

Paint Loss Handrails

6.	20	Clean & Repaint (all timber rails)	L	\$5,000 - \$7,500
7.	23,36	Regrade, New Seal (Surface) (realign approach and repair deformed surface seal)	M	\$10,000 - \$15,000

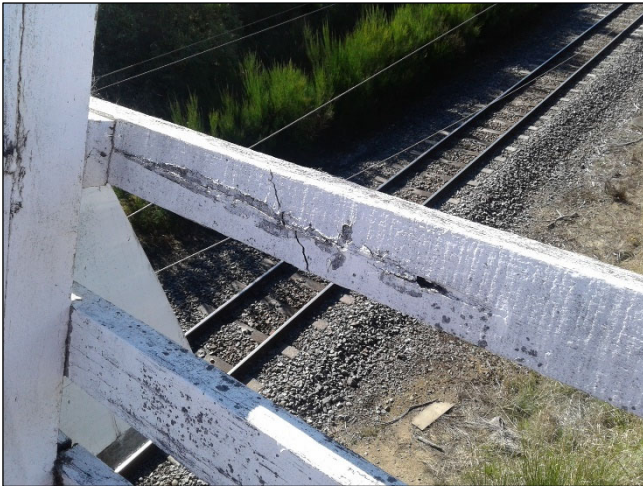
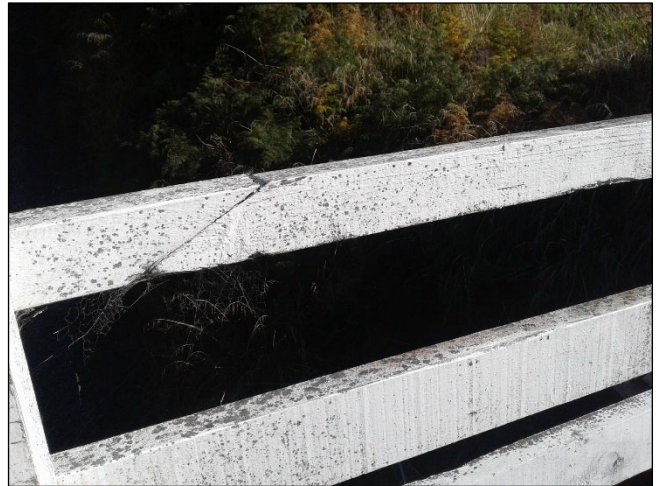
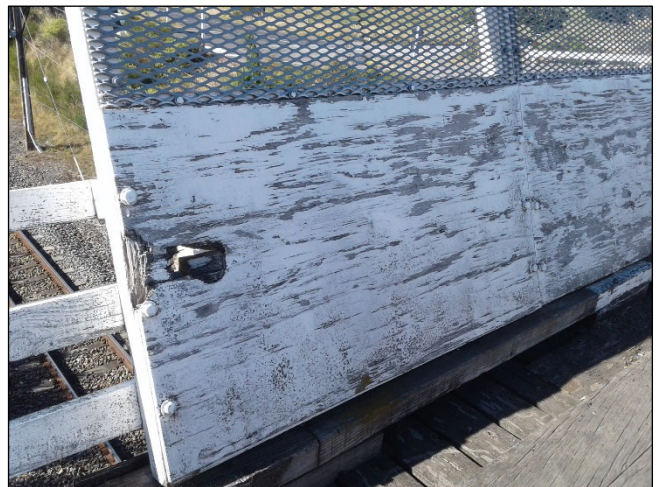
**22 : Guardrail / handrail / safety fences**

Broken Handrails

Loose Handrails

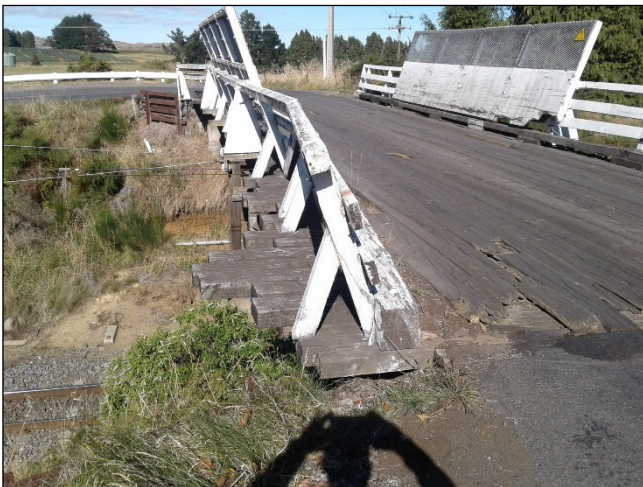
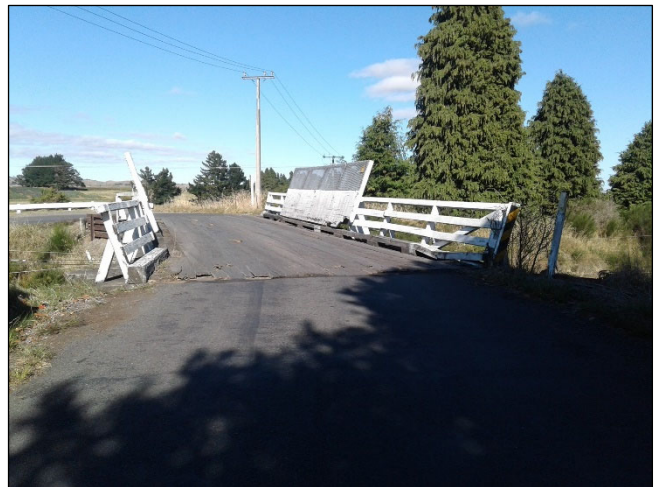
### 37 : Signs

Missing Bridge end markers (BEM)

8.	35	Install New (approach rails where missing)	H	\$2,500 - \$5,000
9.	37	Install New, Capacity Check (missing BEM and update restriction sign after assessment)	H	\$1,000 - \$2,500

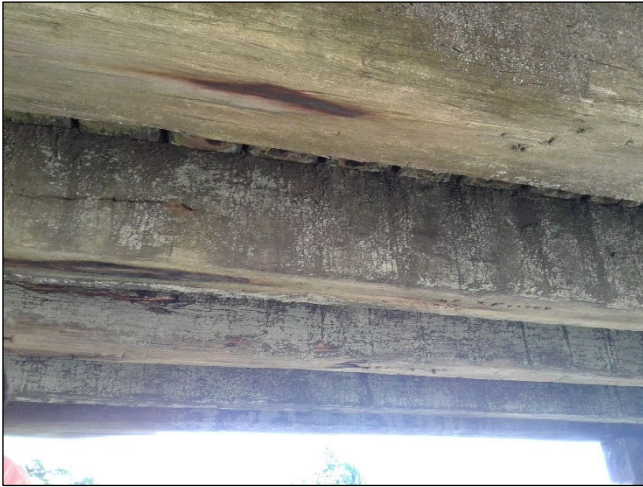
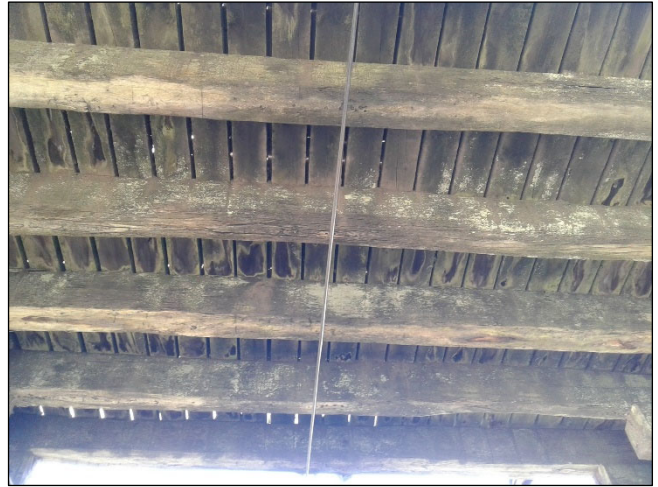
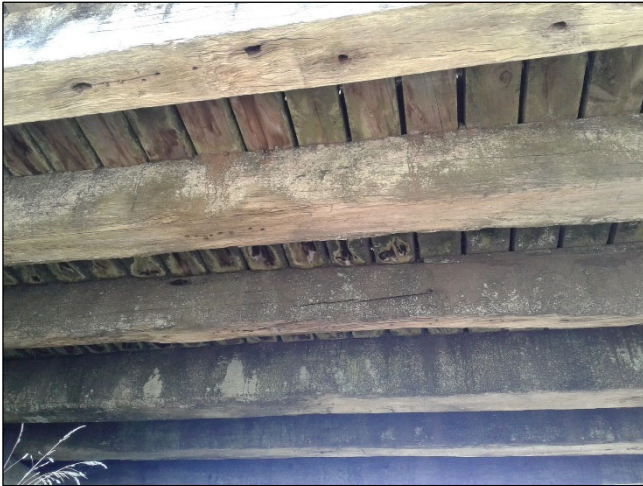
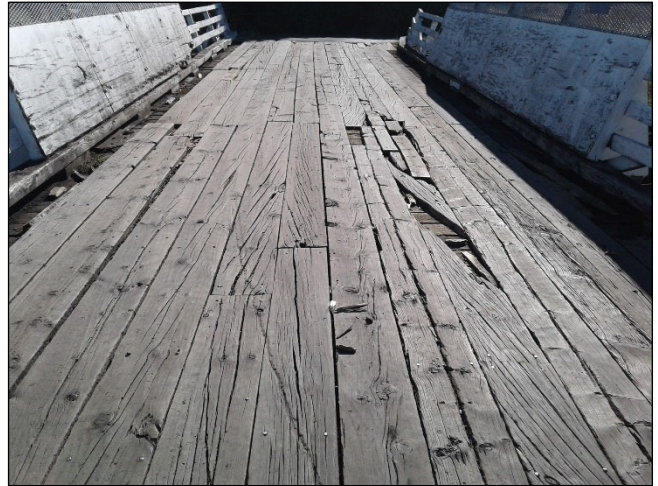
### 40 : Appearance

Aged Deck (all timber members exceeded their life span and bridge to be replaced)
