NEW MEXICO STATE LAND OFFICE

**INVESTIGATION REPORT
PRIVATE AND CONFIDENTIAL
ATTORNEY/CLIENT PRIVILEGE**

**San Jose Rock Theft / Illegal Dumping
GT0402**

Prepared by Kenny Baca, Compliance Officer
10/14/15

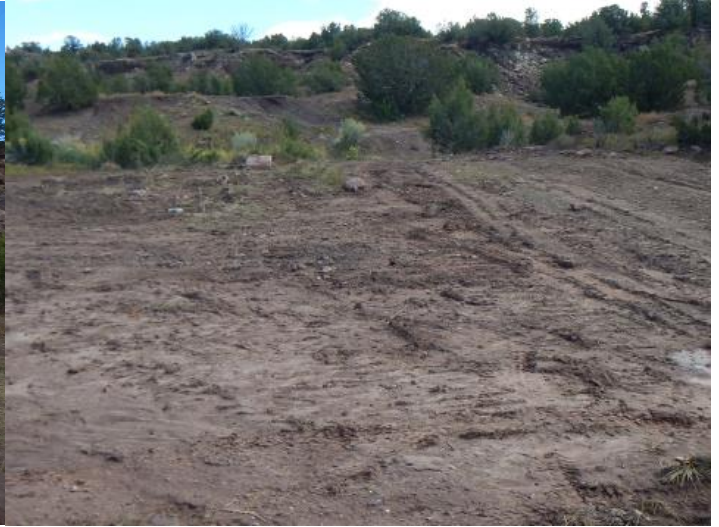
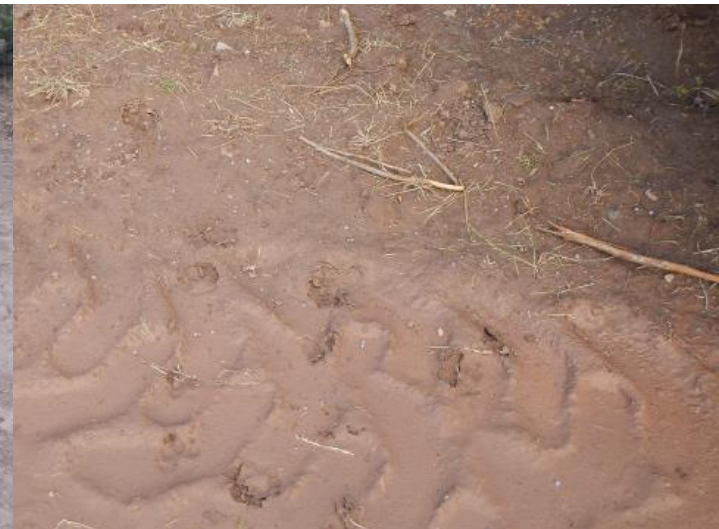
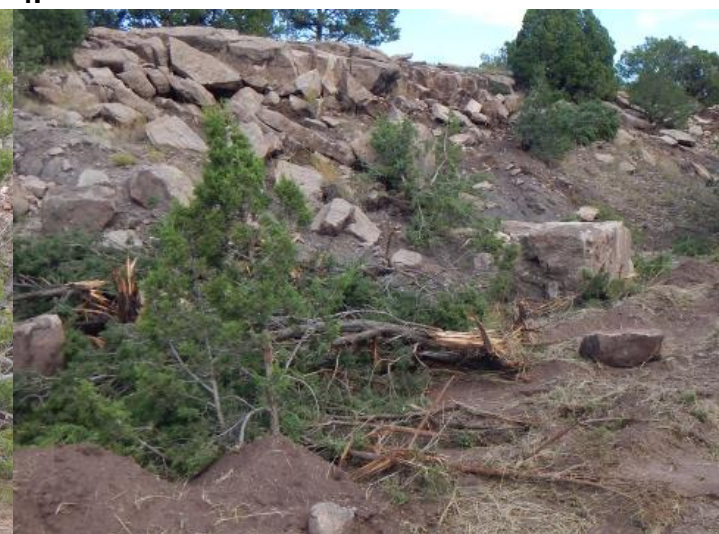
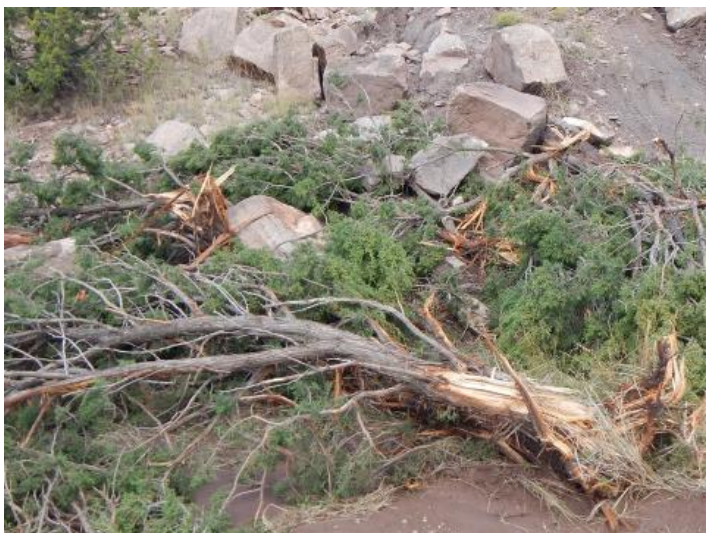
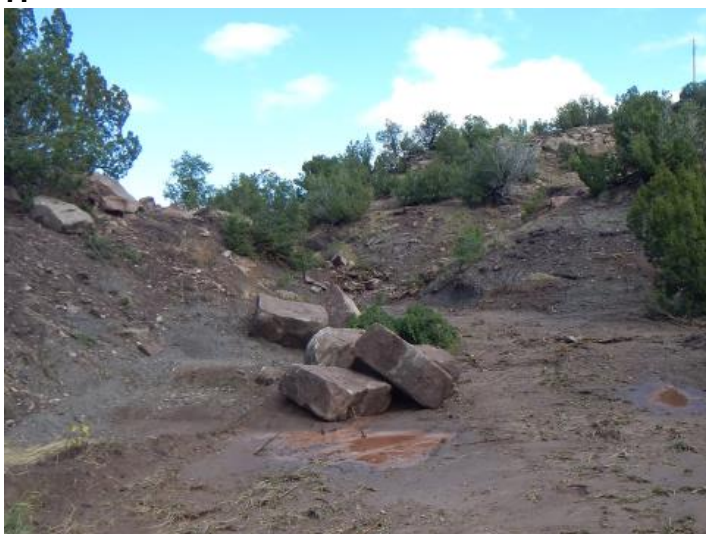
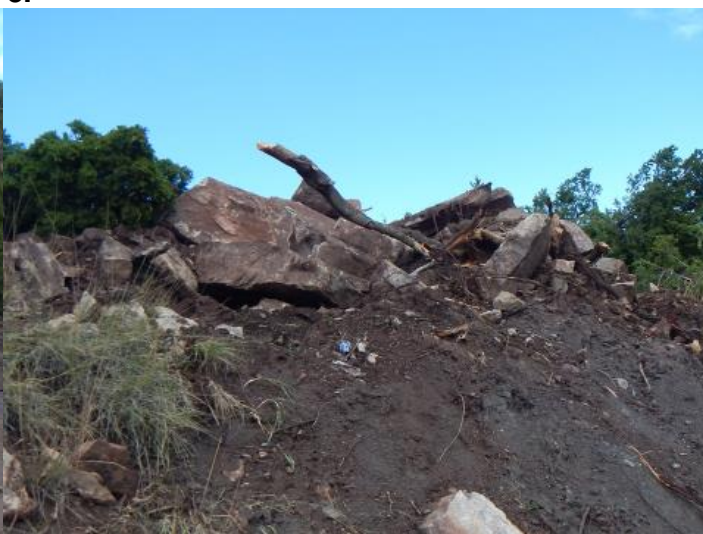
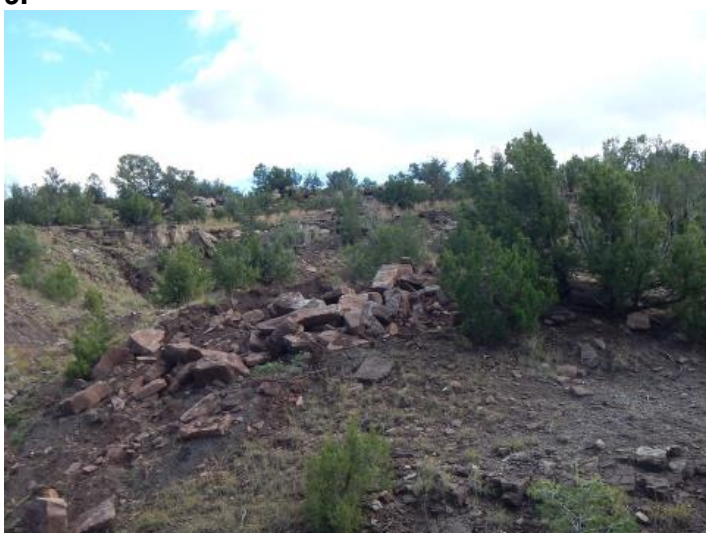
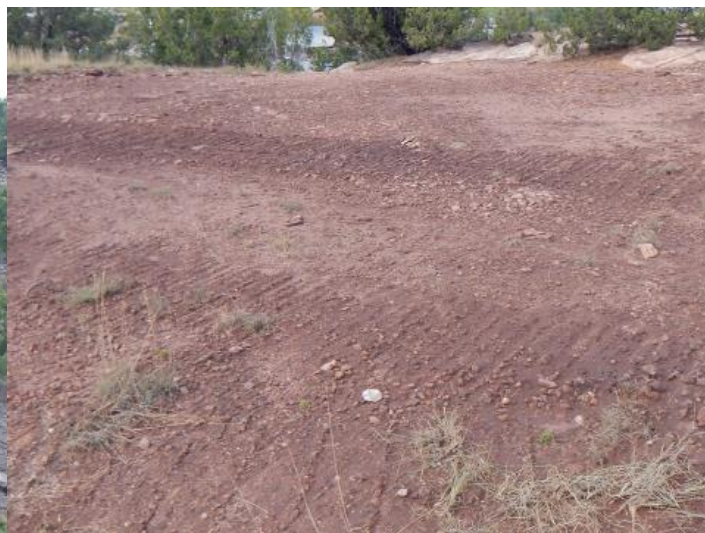
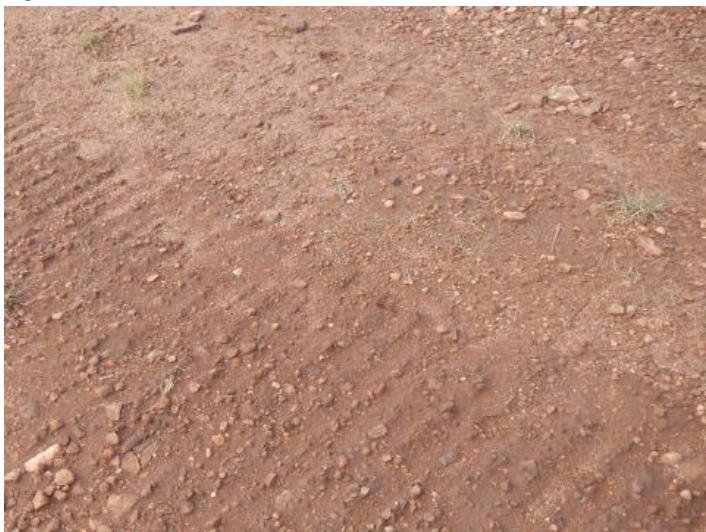
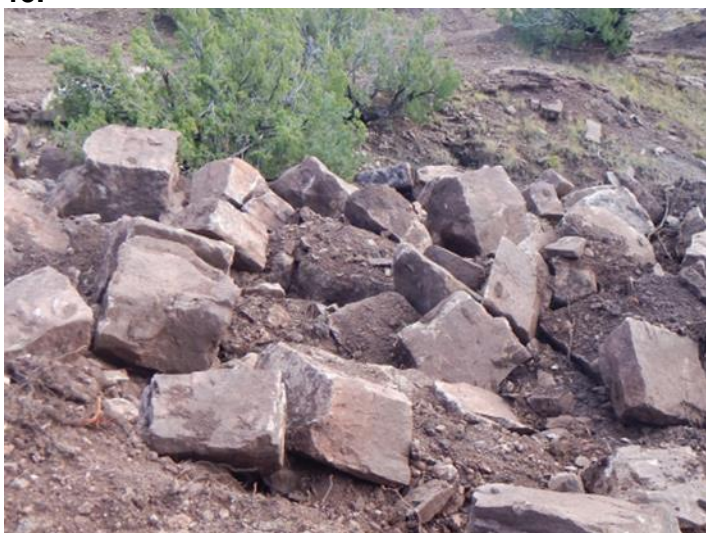
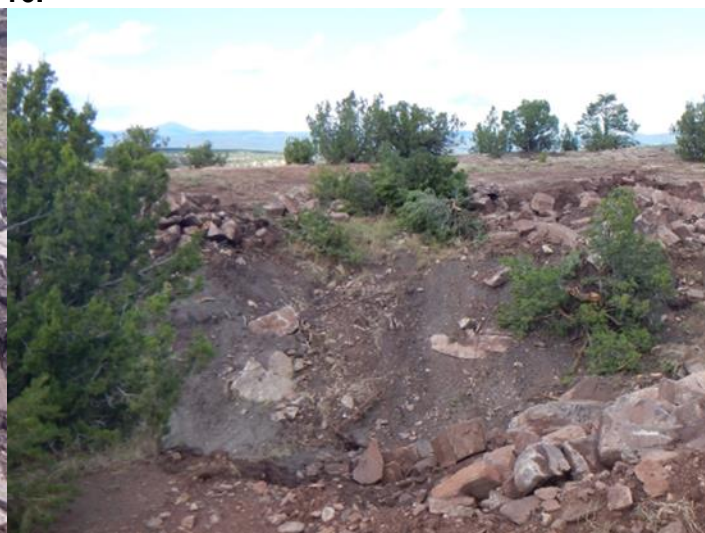
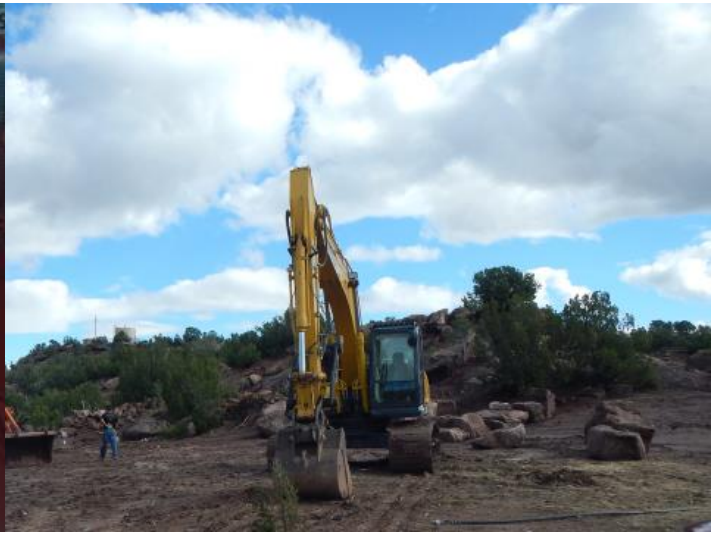
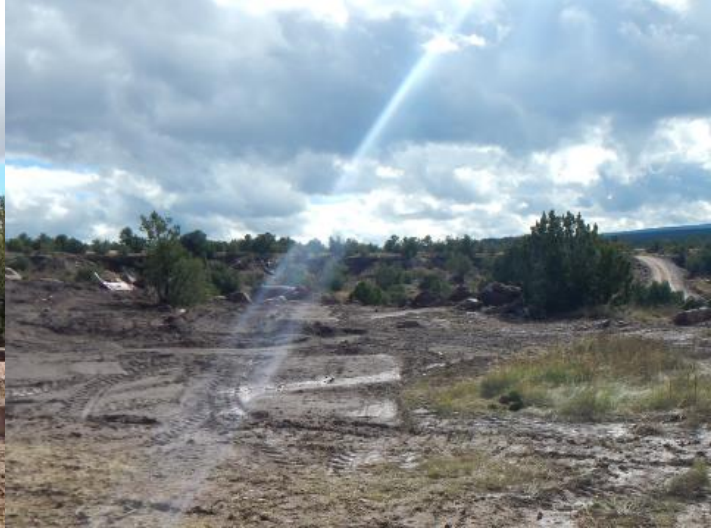
Photos 1-23

Upon arriving, two (2) forms of heavy equipment were observed parked near the boundary of STL located off of San Miguel County Road B41C. The first piece of equipment was a track hoe the second was a front end loader. The area appeared to have been leveled off and cleared of brush. I also observed a pile of large boulders nearby.

We also drove along the roadway and followed tracks from the heavy equipment, which lead me to another area cleared of brush and rocks. The tracks continued into a draw where various piles of dirt and rocks from excavation were obvious. We also located freshly damaged trees from the heavy equipment.

Location of Rock Excavation T14N, R14E, Sec. 32

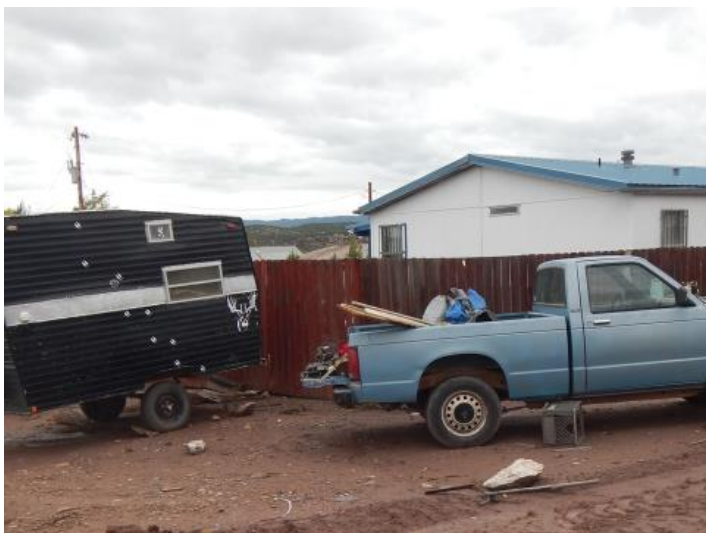
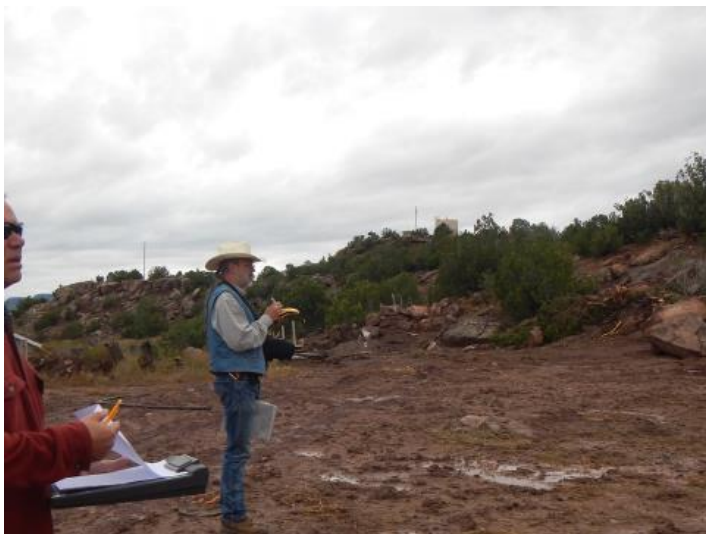
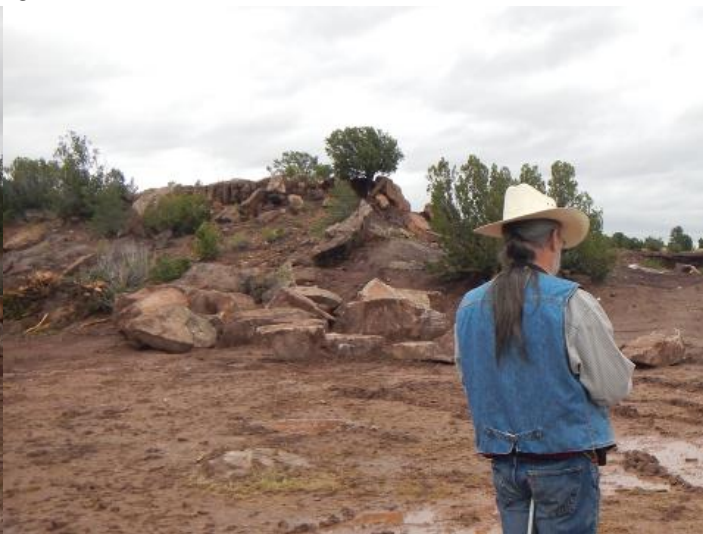
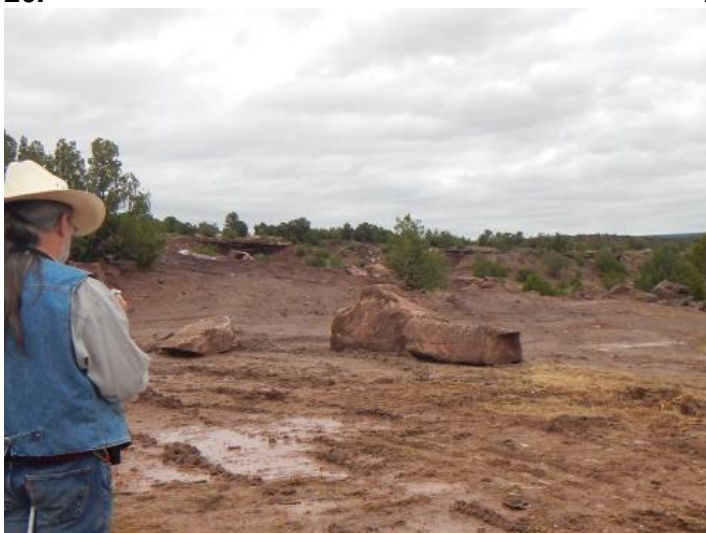
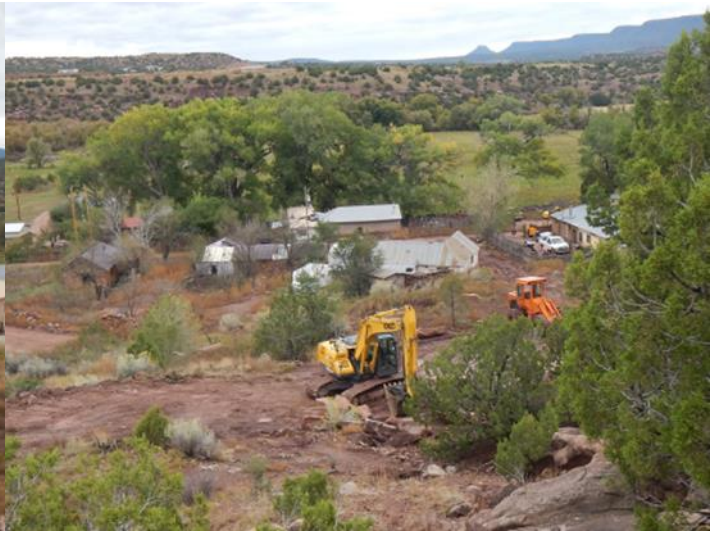
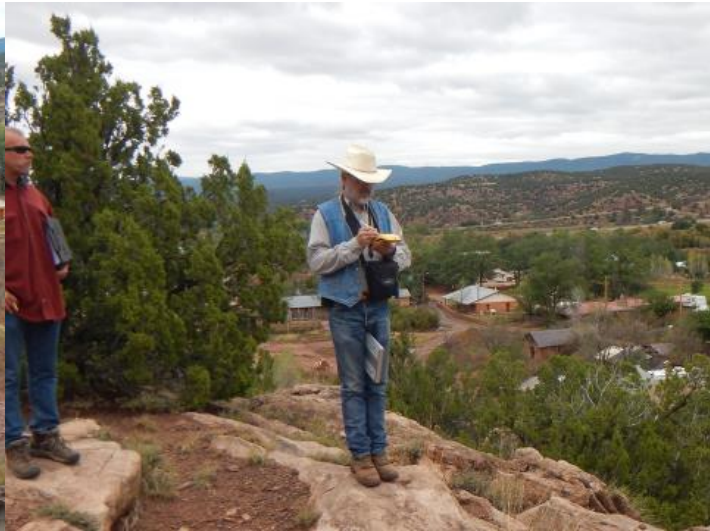
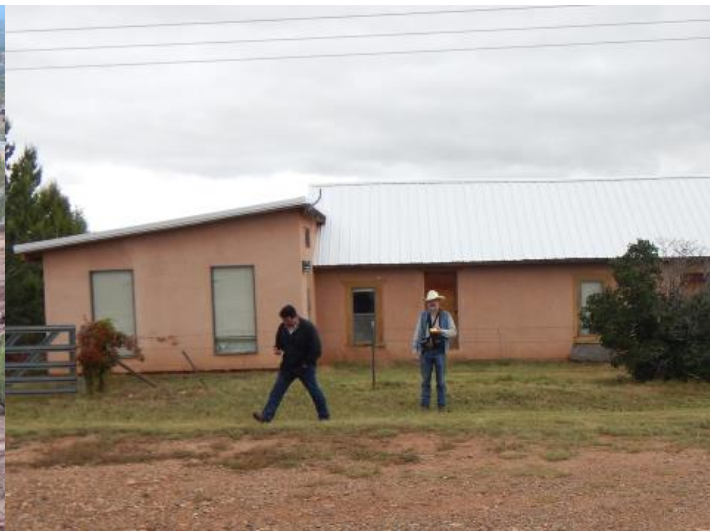
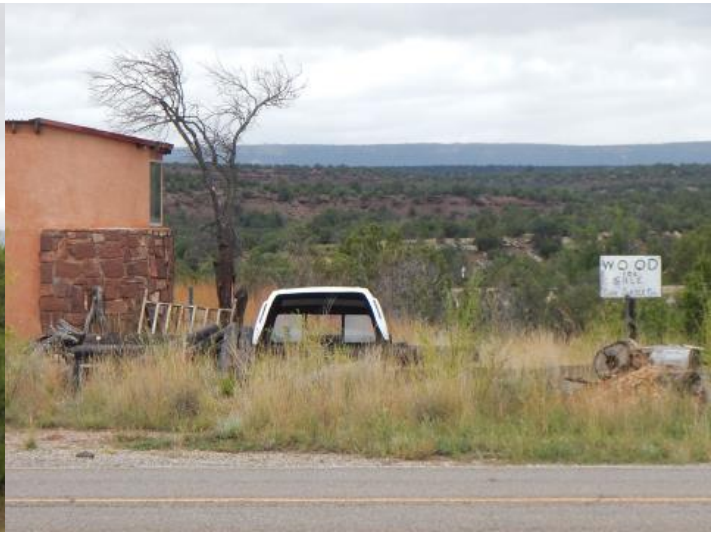
Photos 24-37

"I noted the presence of numerous archaeological artifacts within and near the disturbed areas on the ridge top. I recommend that the lessee be required to complete an archaeological damage assessment survey of all the area lying east of the cemetery road within Lot 4, Section 32, T14N, R14E, N.M.P.M."

Location of Rock Excavation T14N, R14E, Sec. 32

Verifying NMSTL property lines with Trimble GPS Unit

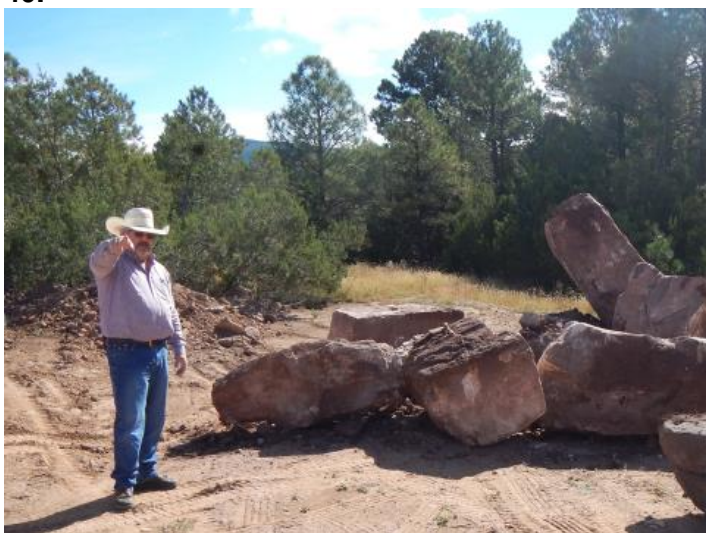
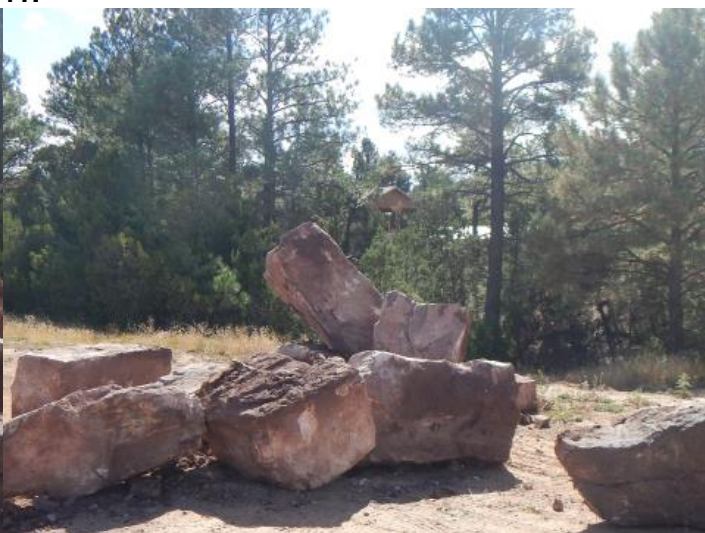
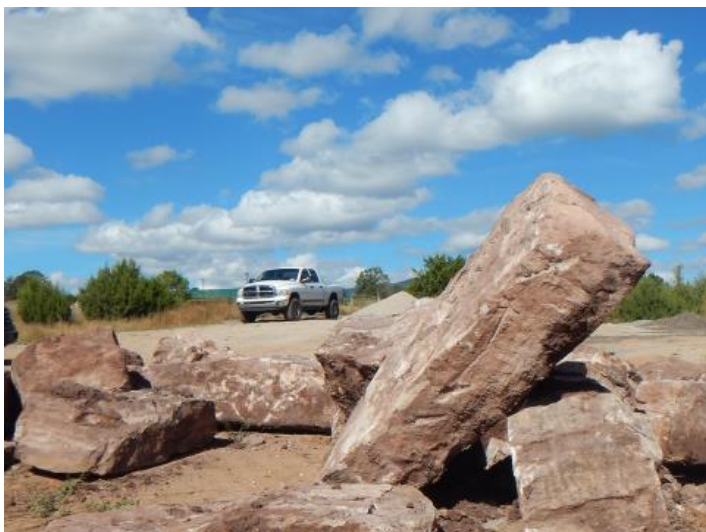
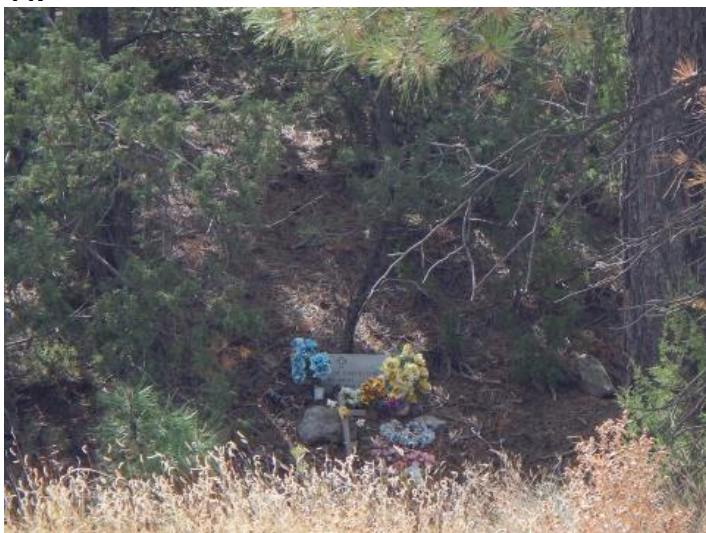
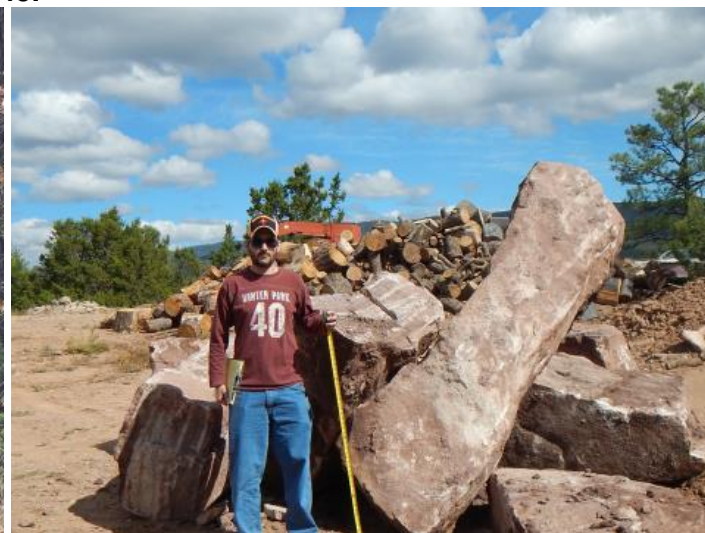
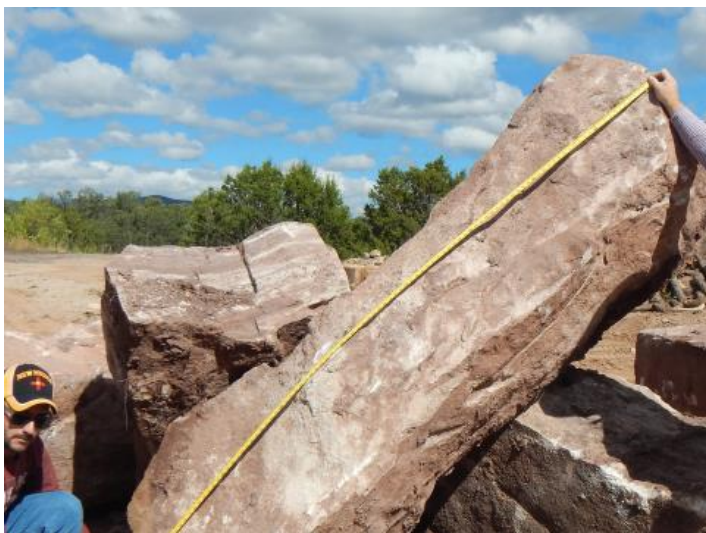
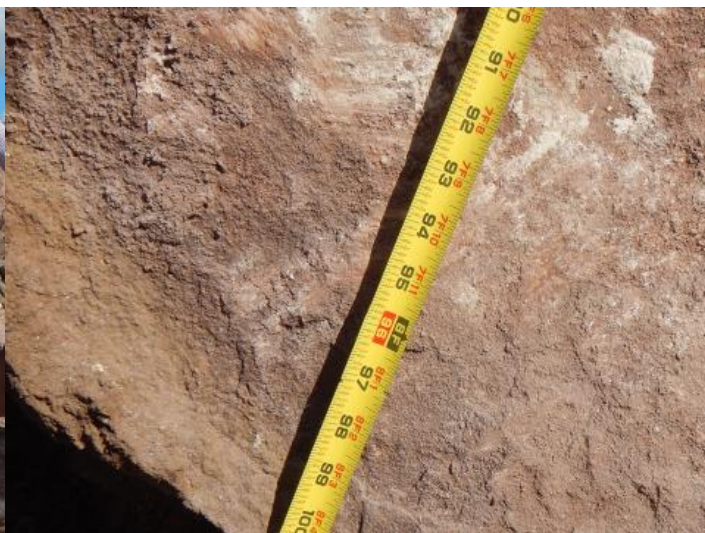
Photos 38-51

Also on October 9th, 2015, SLO Employees Tom Perkins, District Resource Specialist and David Gallegos, Agricultural Leasing Analyst traveled to Pecos to count, size and photograph the rocks. Mr. Encinas provided directions to the location where the off-site rocks were being held. Upon investigation of the said off-site location, the rock in the yard appeared to have been recently dumped as there were fresh tracks of a large truck in the vicinity. Upon review of the pictures provided by Mr. Encinas and their comparison to the area where the rocks were actually located, it was obvious that the pictures were not taken in the area where the rocks were now located. Upon questioning Mr. Encinas about this he stated he had moved the rock from his brother's property because he wanted to keep him out of the situation. The area and rocks were photographed again. Tom Perkins estimated there to be about 8.8 cubic yards of rock. We counted 20 large boulders and a few smaller pieces of rock. We left the area at approximately 11:30am.

Location of Peter Encinas Property – Rock Claimed to have been removed from STL
