NEW MEXICO STATE LAND OFFICE

**INVESTIGATION REPORT
PRIVATE AND CONFIDENTIAL
ATTORNEY/CLIENT PRIVILEGE**

**San Jose Rock Theft / Illegal Dumping
GT0402**

Prepared by Kenny Baca, Compliance Officer
10/14/15

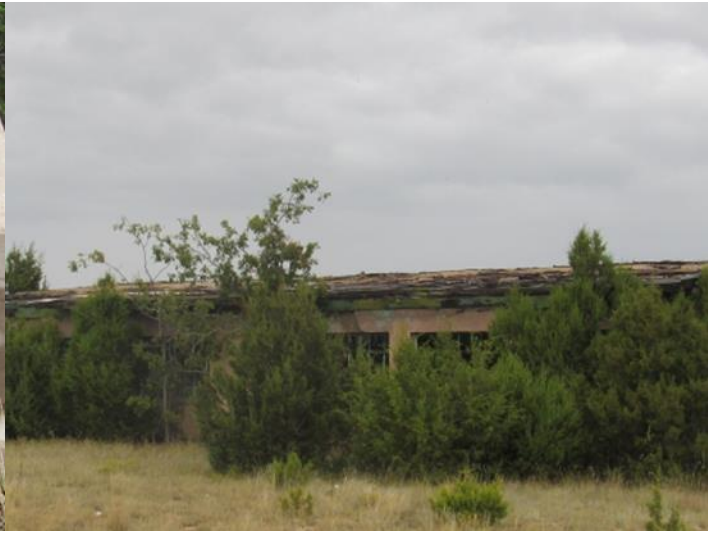
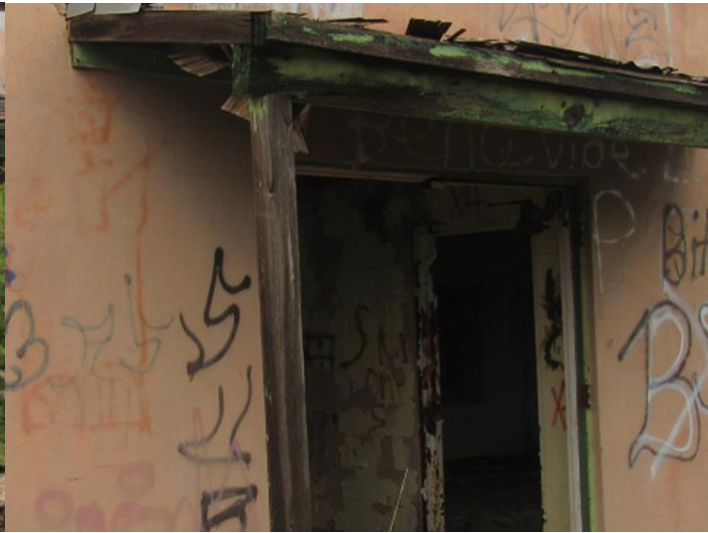
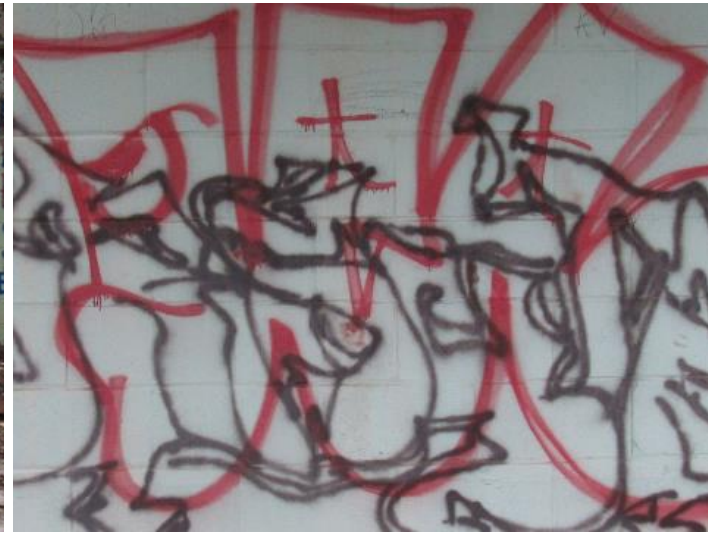
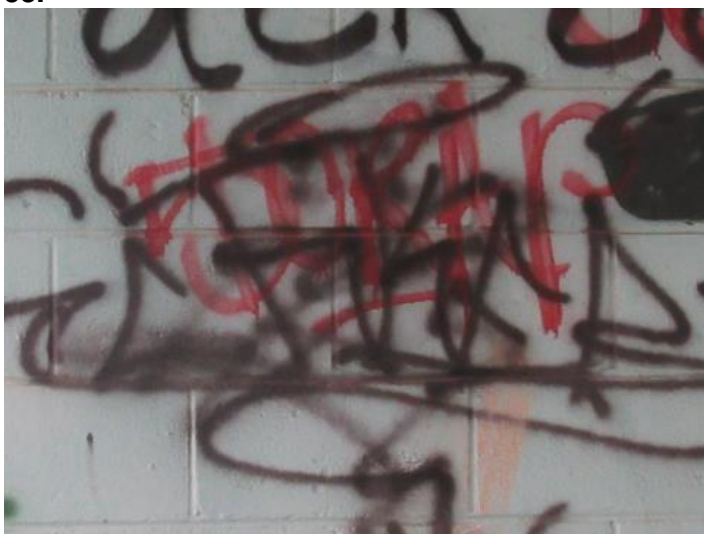
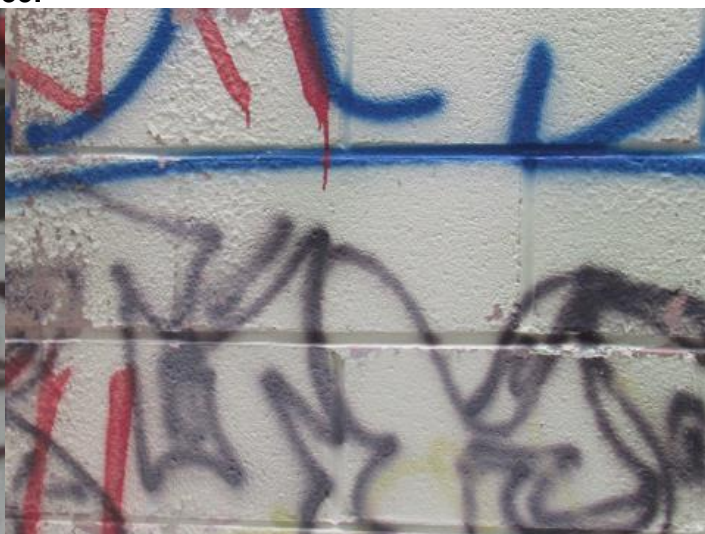
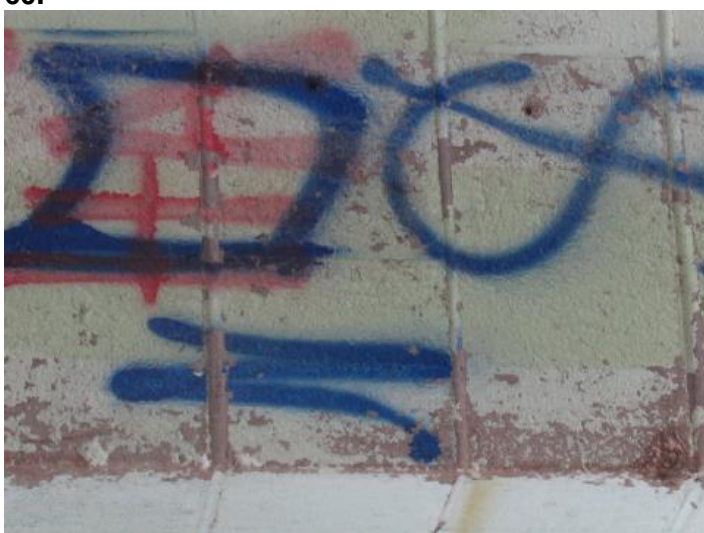
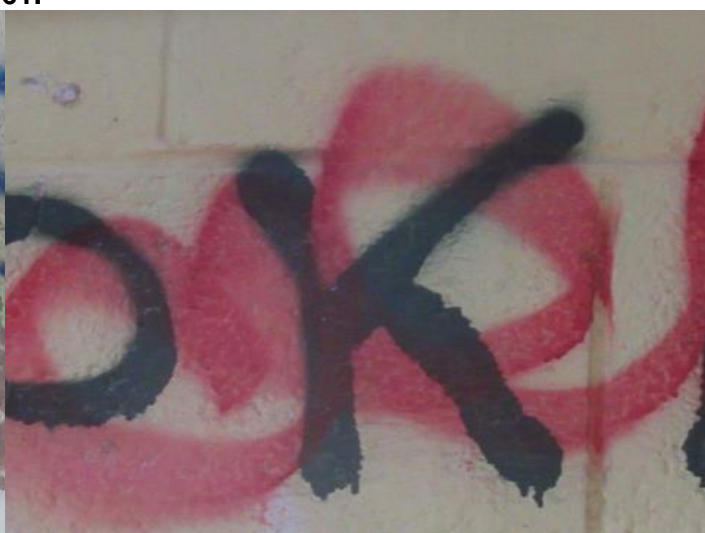
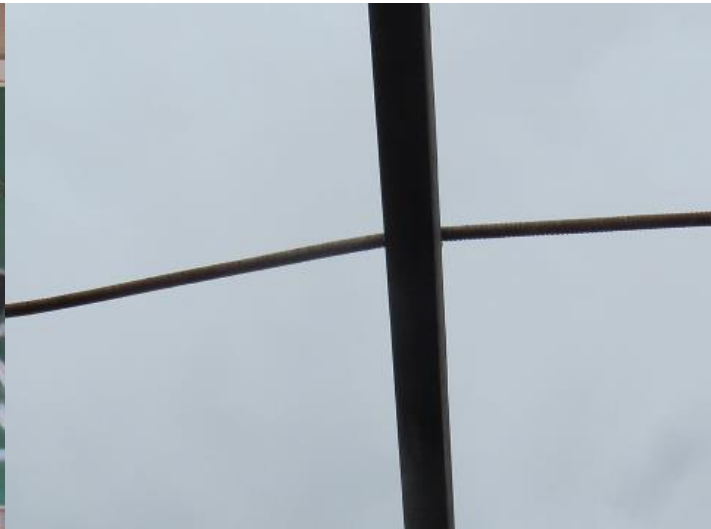
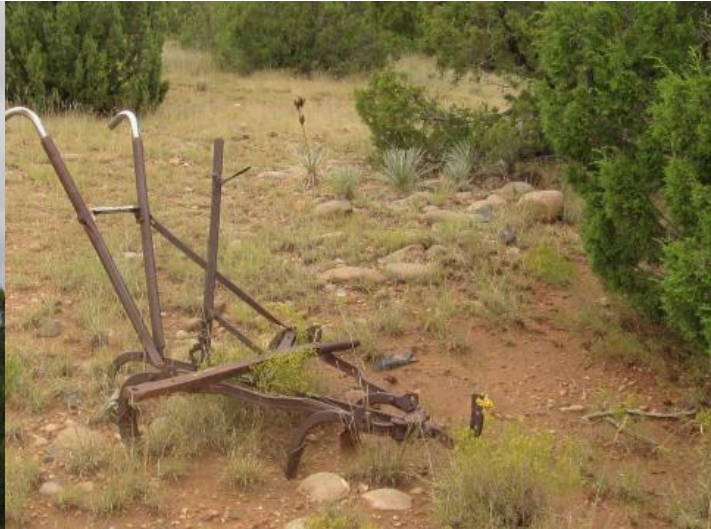
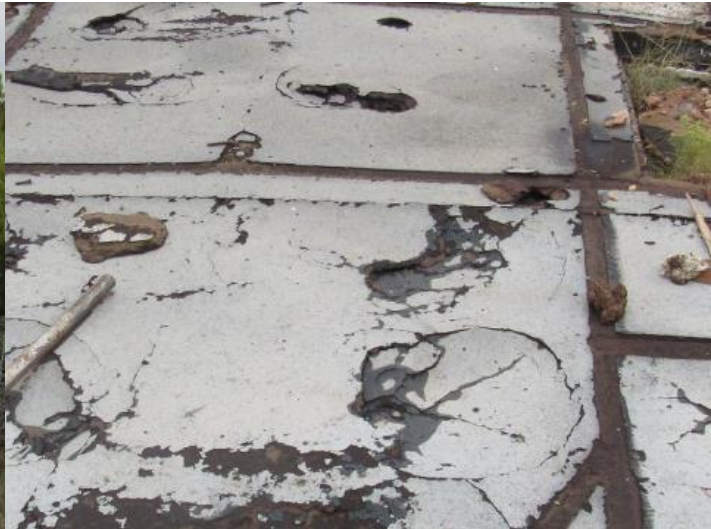
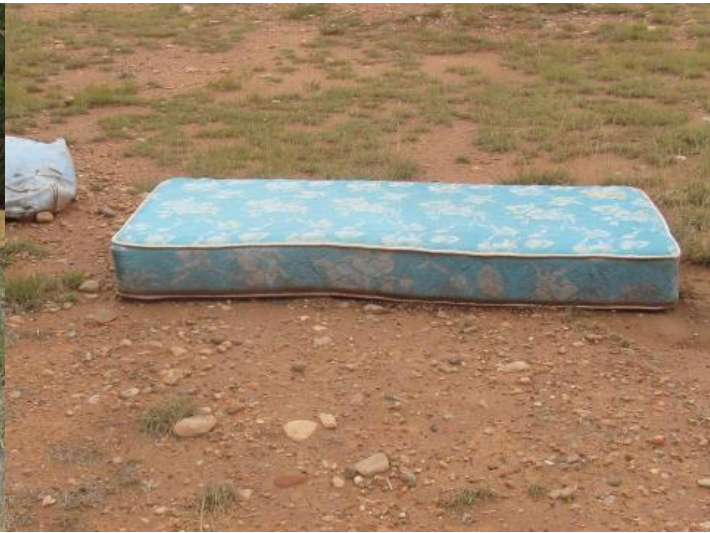
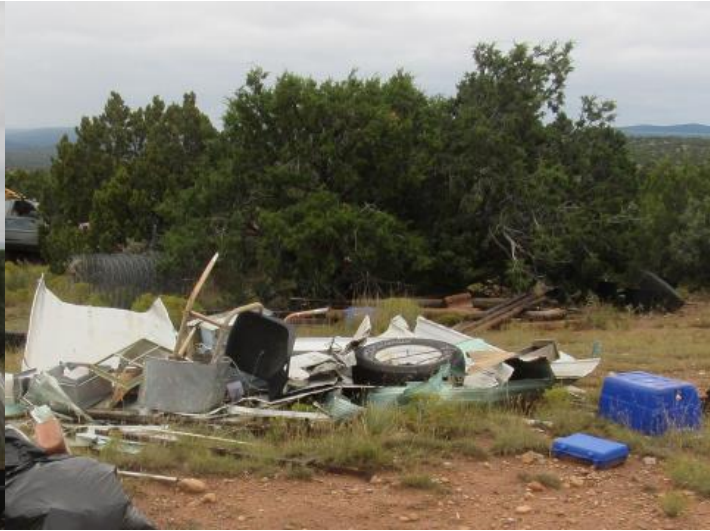
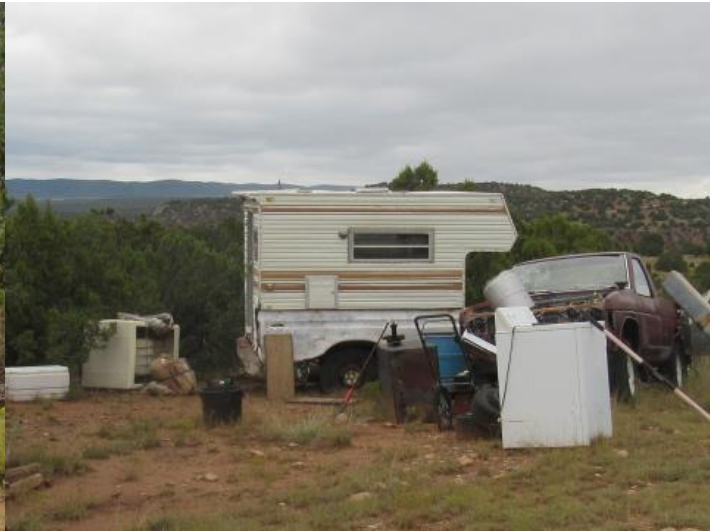
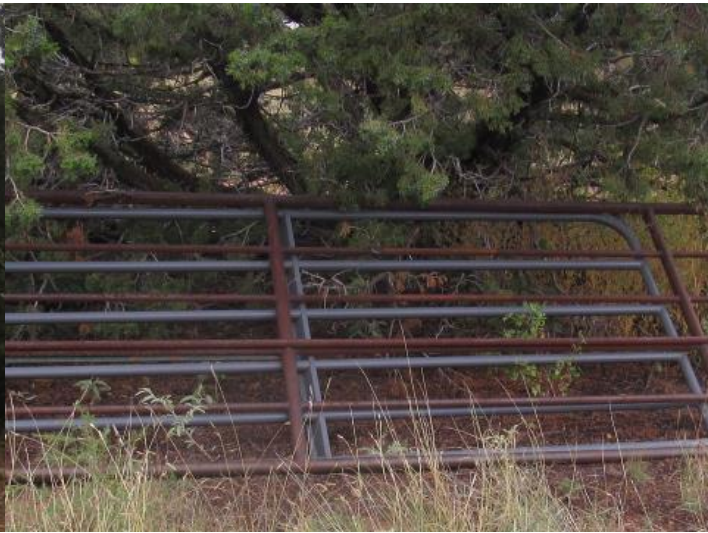
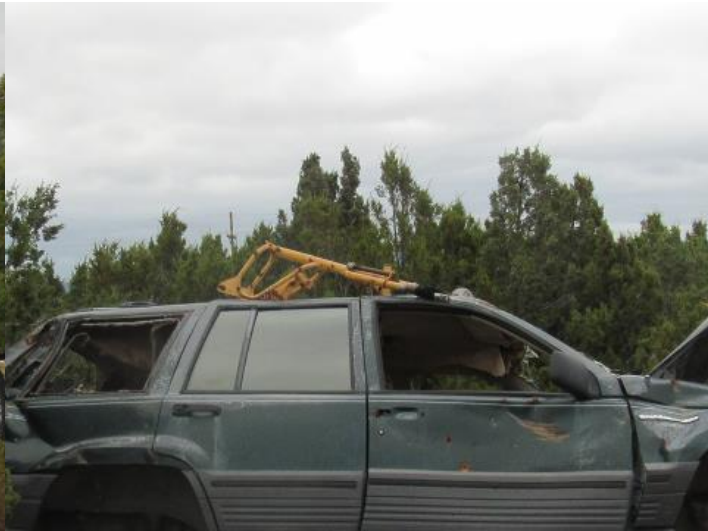
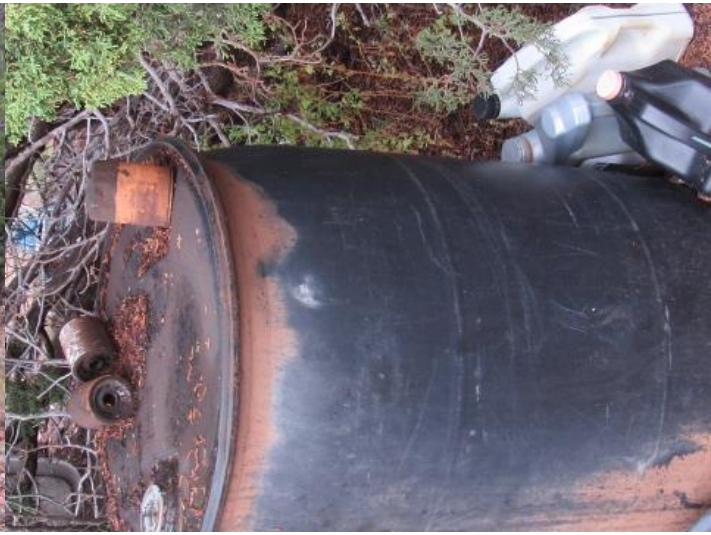
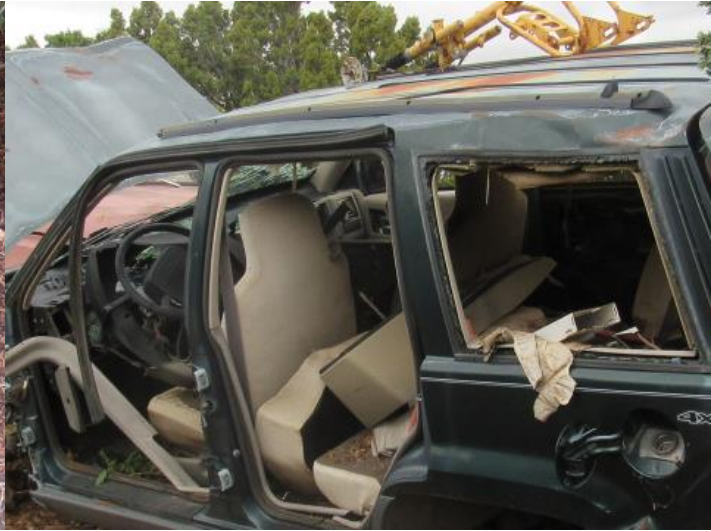
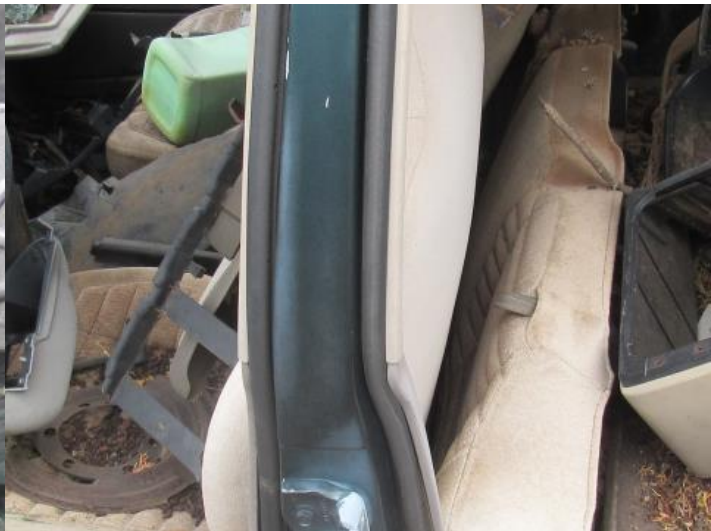
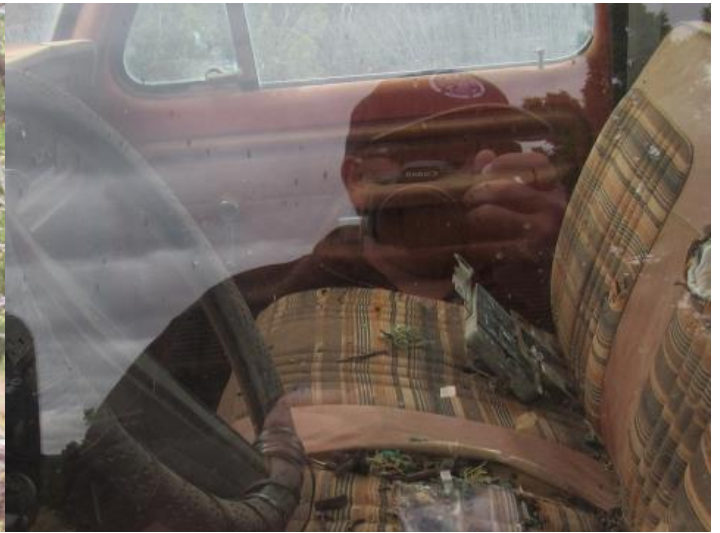
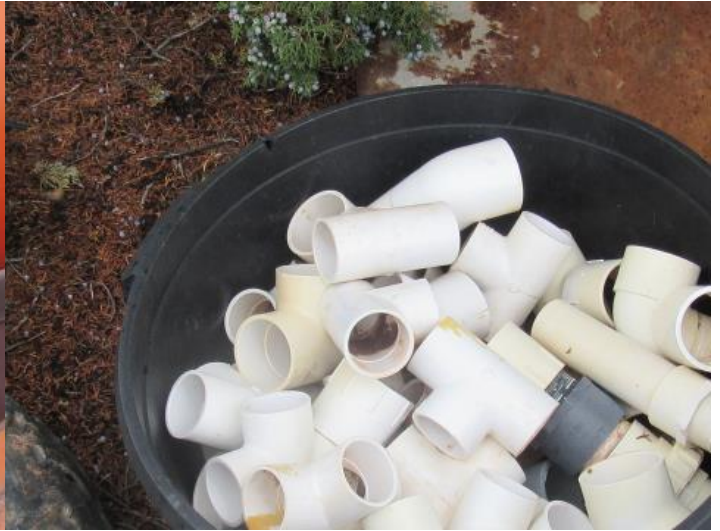
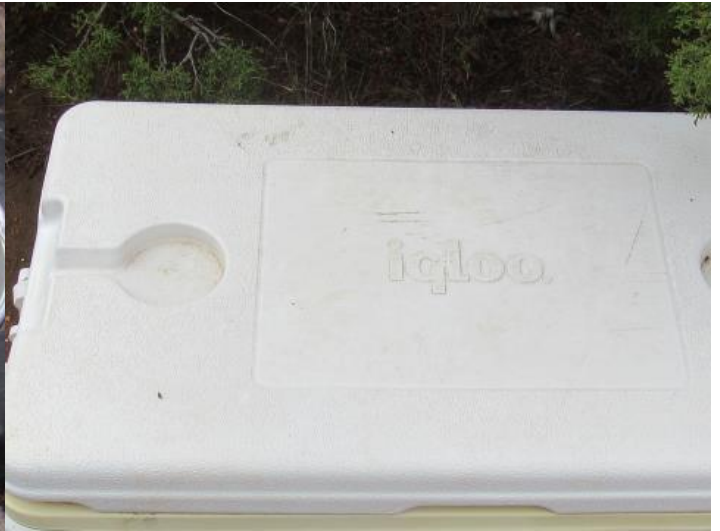
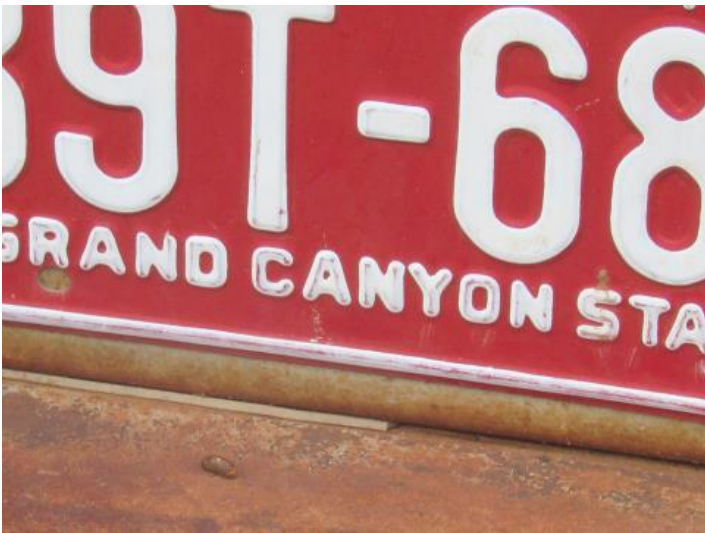
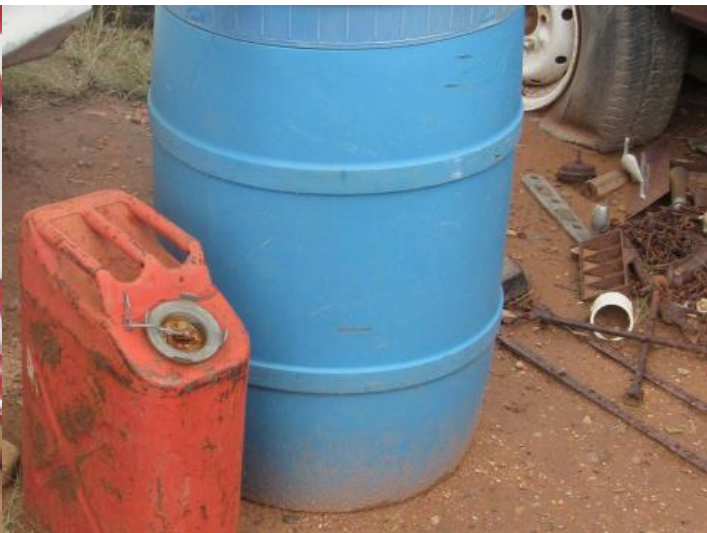
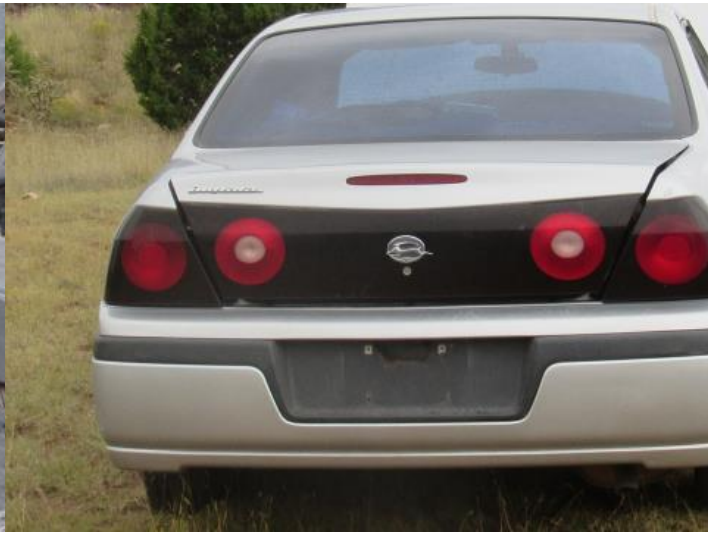
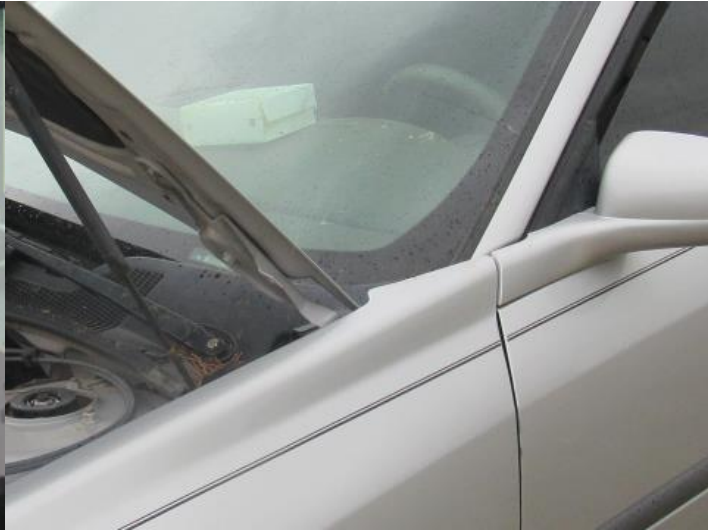
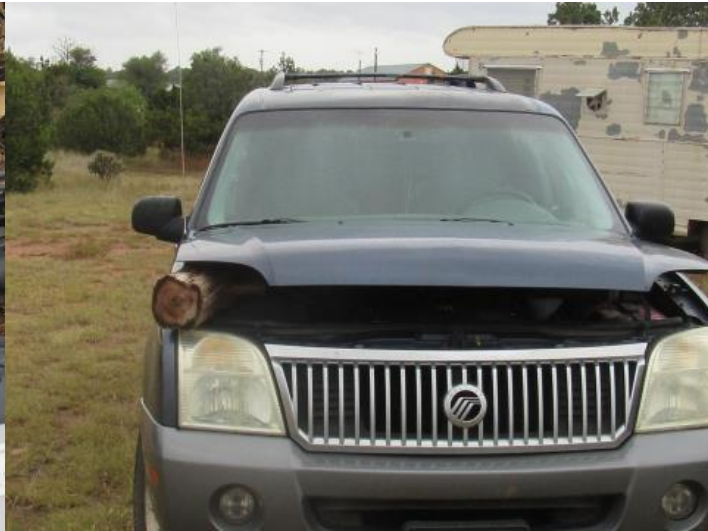
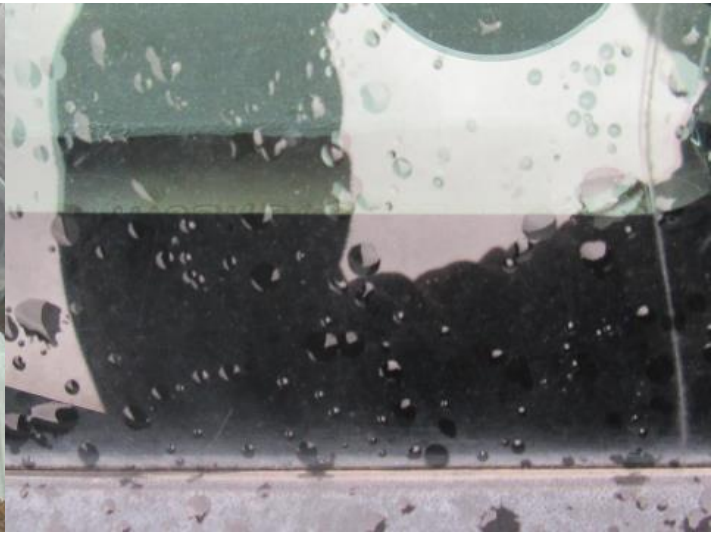
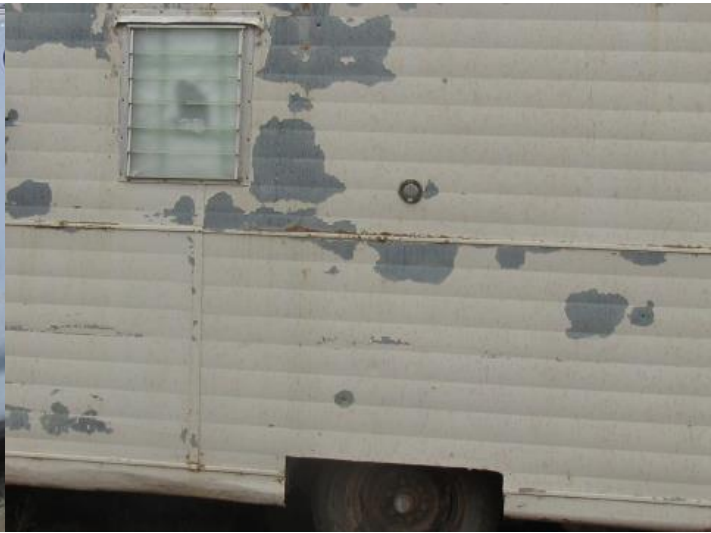
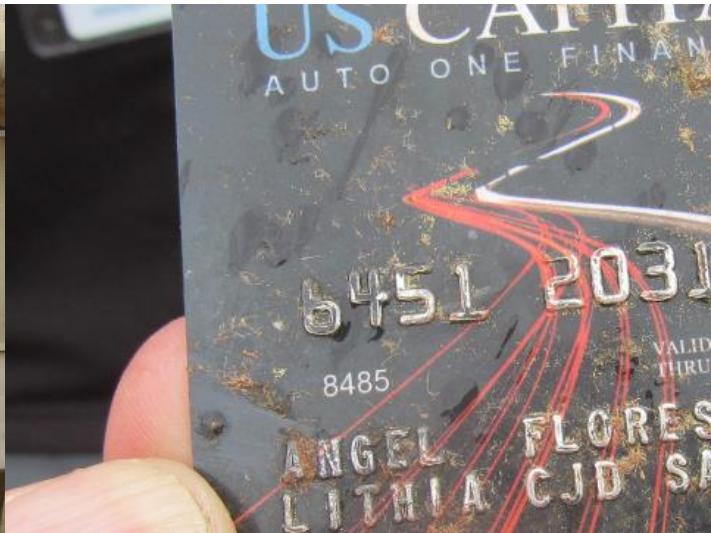
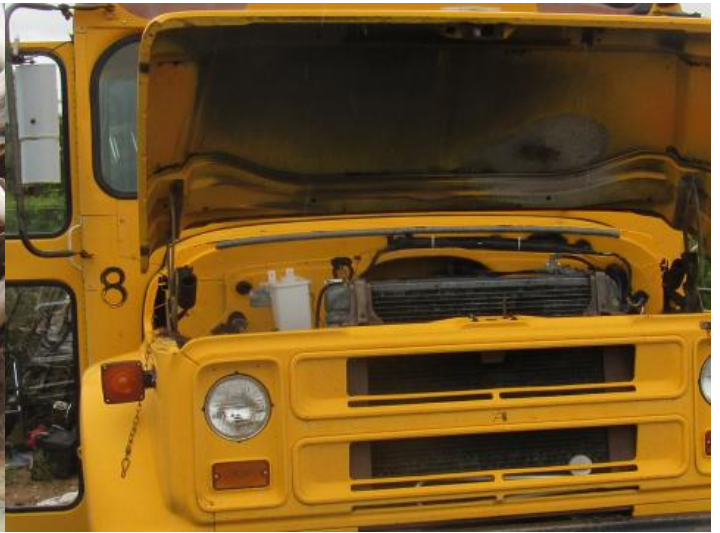
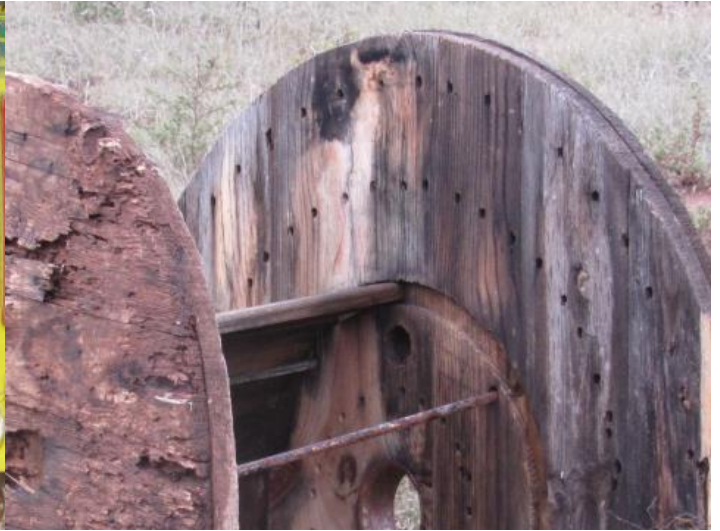
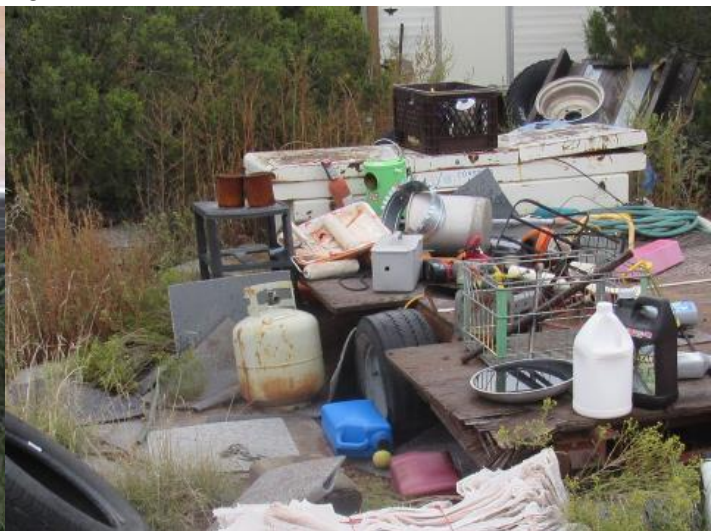
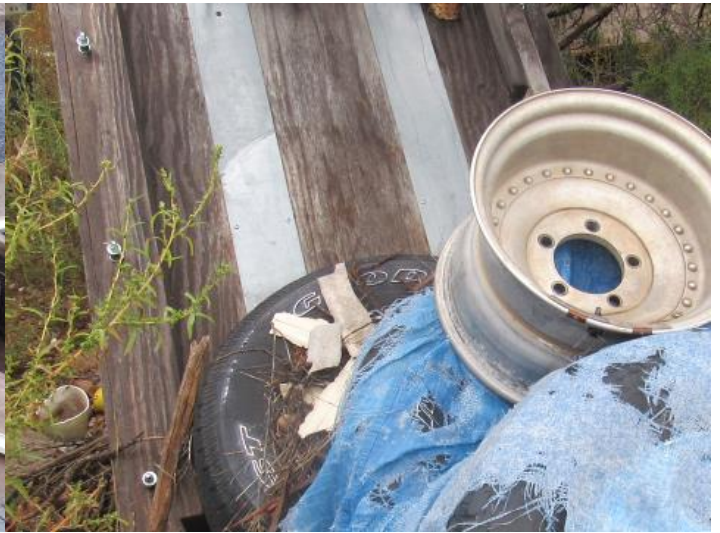
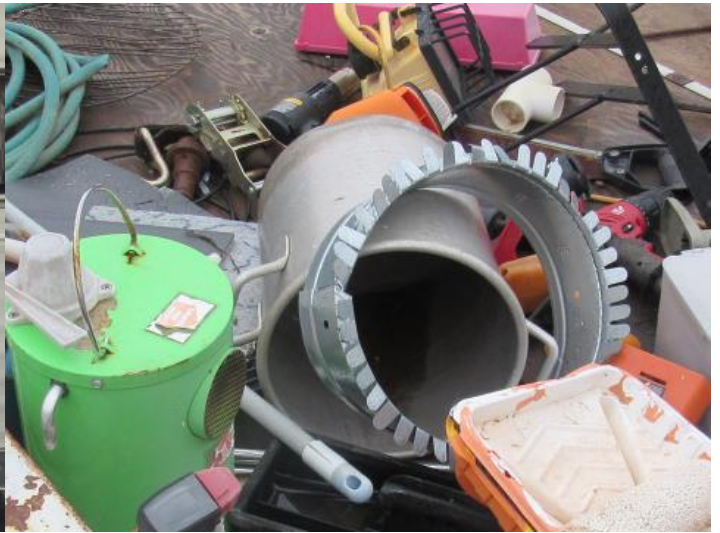
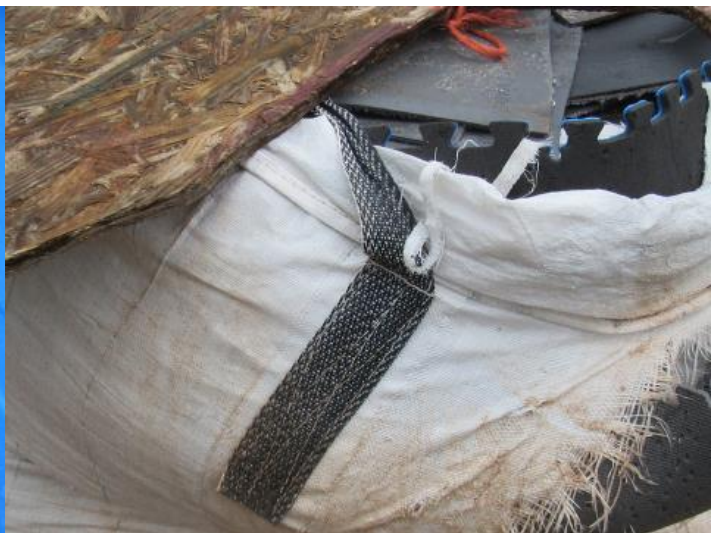
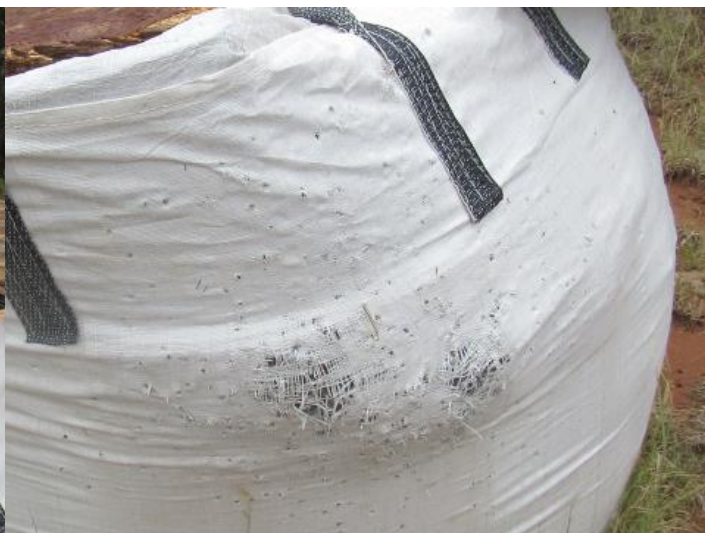
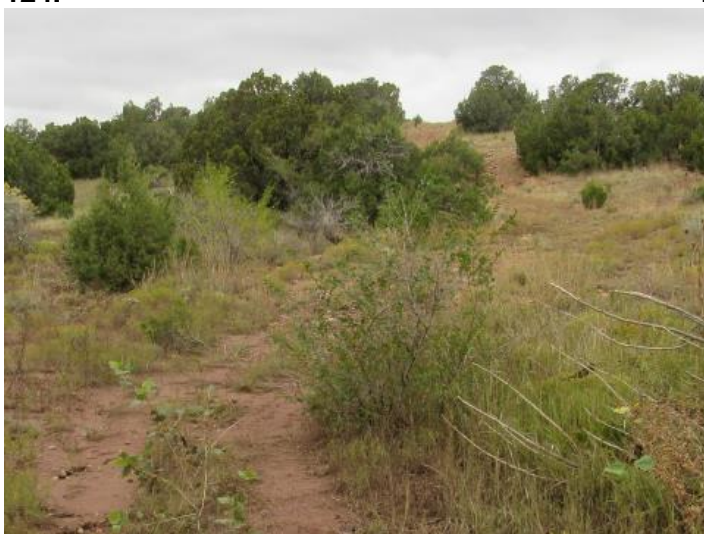
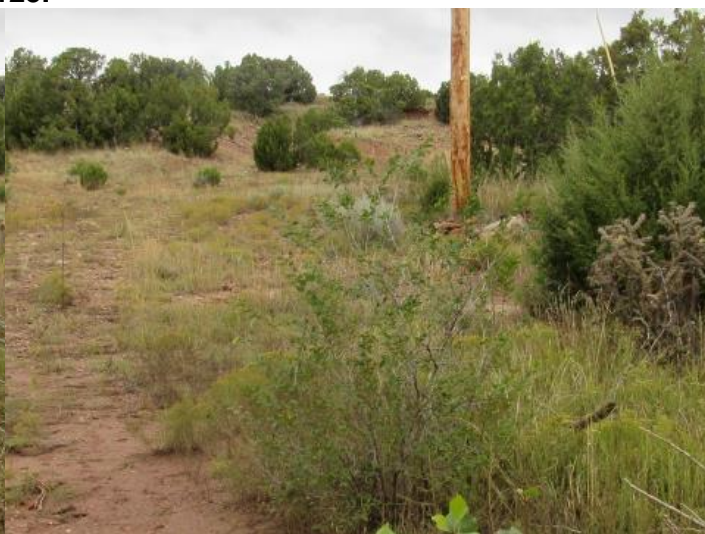
Photos 52-128

Fernando Roybal and Julian Ortiz found illegal dumping north of Interstate 25. They confirmed the property was SLO property. They also located what appeared to be an open septic tank in the area. Various cars, a bus, campers, and various forms of trash were discovered and confirmed (through GPS) to be on SLO property. The vehicles in the area were photographed and inventoried.

The area mentioned in the report has various vehicles, campers, motorcycles, tires, metal and other trash that will need to be removed from the site. There also appears to be oil and other hazardous materials that may need to be removed from the site which may involve proper cleanup for such.

The building on site was a former school house and later became a community center. It has since been abandoned and has become a nuisance and could be considered dangerous. The walls show signs of graffiti related to gang activity. The structure presents a hazard as far as instability of roof and on the ground. There is an open septic tank that should be addressed appropriately to address the hazard it presents. According to records presented on lease, the building may have been built in approximately 1955.

**Location of Illegal Dumping and Abandoned Structure
T14N, R14E Sec. 32**

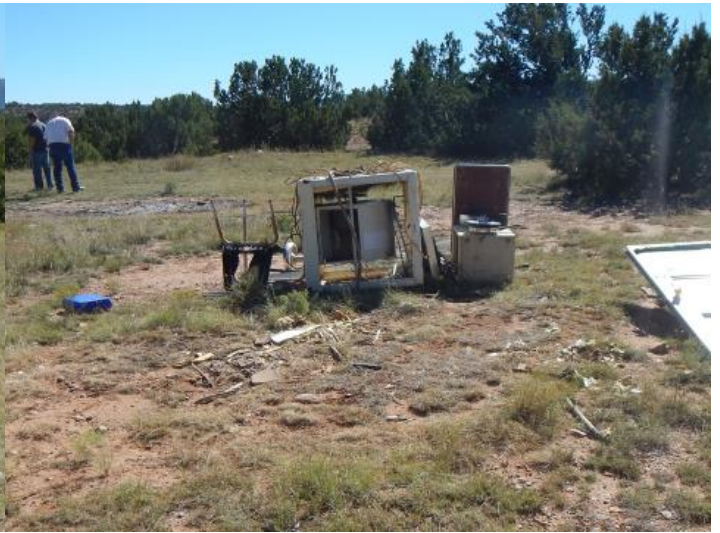
Photos 129-137

Upon another visit to the site it was determined that there appeared to be no new activity with the rock since October 5th. Upon approaching the area where the vehicles and trash were dumped a gold colored GM model extended cab truck was observed parked in the vicinity of the dumping. Following a vehicle registration check by Officer Vigil, it was determined that Desi Flores was the registered owner. Mr. Flores was one of the individuals who had approached on October 6th as SLO employees were investigating the dump site. Various trash items had been moved since last time the site was investigated, some vehicles had been moved, certain things were piled up and burned, and some trash piles appeared to have been bagged in black trash bags. The area was photographed.

Location of Illegal Dumping T14N, R14E Sec. 32

Some vehicles, trash etc. have been moved- Desi Flores Truck.

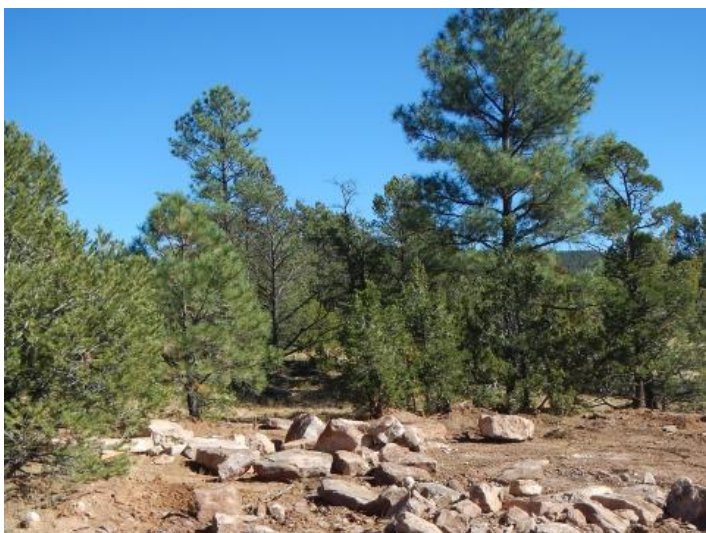
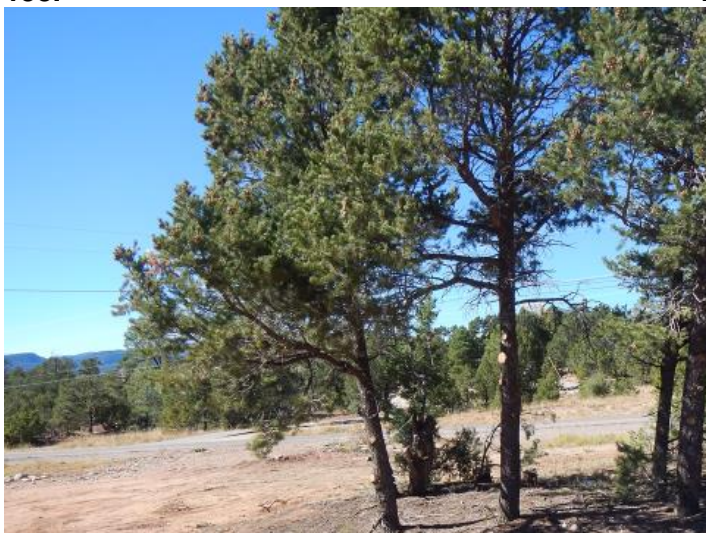
Photos 138-141

Location of Peter Encinas Rock – 2nd Location, East Pecos
